# **Culvert Assessment and Prioritization Plan for Fish Passage in the Tillamook Bay Watershed, Tillamook County, Oregon – Version 1.1**

**Tillamook  
Estuaries  
Partnership**

**September 2012**

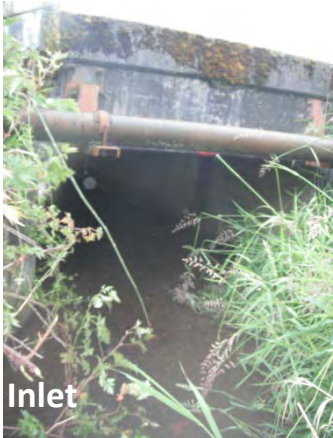
LOCATION INFO				Culvert #	629	Priority	H
Watershed				Kilchis River			
Stream Name				Vaughn Creek			
Township-Range-Section-1/4				T1S, R10W, Sec. 1, SW¼ of NE¼			
UTM Easting/Northing (Zone 10, NAD 1983)				433319/5040431			
Road Name				Doughty Road			
Road/Culvert Owner				Tillamook County			
Adjacent Landowners				R. Rasmussen and R. Carver			
CULVERT INFO		CHANNEL INFO					
Shape	Circular	Inlet Gradient (%)	8.7(7.4)				
Material	Concrete	Upstream Gradient (%)	1.0				
Length (ft)	35(31)	Bankfull Width (ft)	8.1				
Width (in)	29(29)	Bankfull:Culvert Ratio	0.6*				
Height (in)	29(29)						
Outlet Perch (ft)	0.1(0.2)						
Slope (%)	1.9(1.4)						
Rustline Height (in)	N/A						
Overall Condition	Poor						
PRIORITIZATION ANALYSIS							
Upstream Habitat Length (mi)	0.9	Habitat Points	2				
Habitat Quality	Fair(-)	Habitat Quality Points	2				
Fish Species	Anad.	Fish Points	3				
Barrier Type	Red	Barrier Points	3

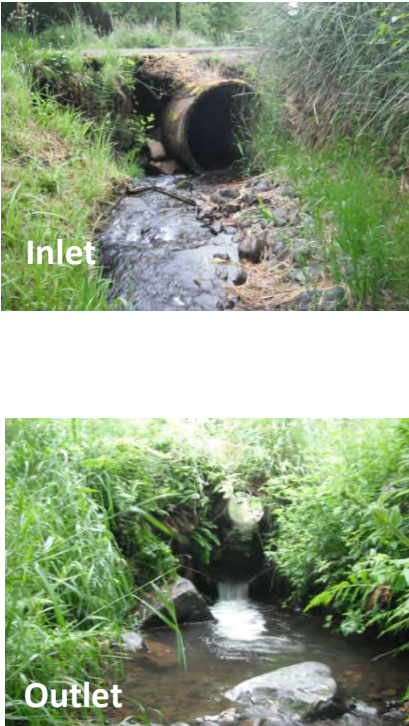
Shape	Circular	Inlet Gradient (%)	12.7				
Material	Concrete	Upstream Gradient (%)	7.2				
Length (ft)	34	Bankfull Width (ft)	7.4				
Width (in)	48	Bankfull:Culvert Ratio	0.5				
Height (in)	48						
Outlet Perch (ft)	0.8						
Slope (%)	5.9						
Rustline Height (in)	N/A						
Overall Condition	Fair						
PRIORITIZATION ANALYSIS							
Upstream Habitat Length (mi)	0.6	Habitat Points	2				
Habitat Quality	Fair(-)	Habitat Quality Points	2				
Fish Species	Anad.	Fish Points	3				
Barrier Type	Red	Barrier Points	3				
		Prioritization Total Points	10

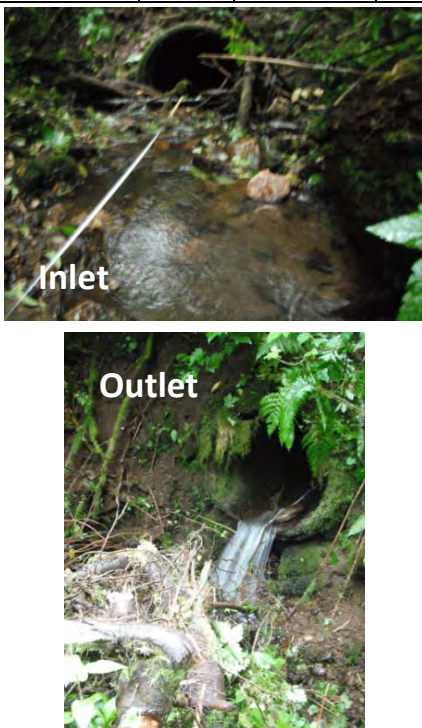
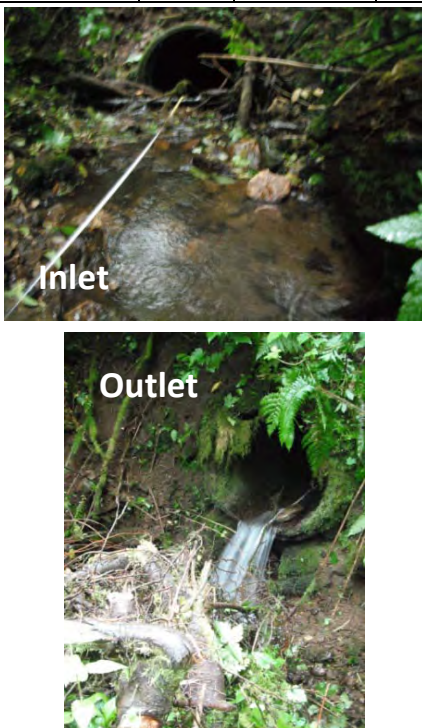
Shape	Circular	Inlet Gradient (%)	11.1				
Material	Concrete	Upstream Gradient (%)	12.3				
Length (ft)	69	Bankfull Width (ft)	7.3				
Width (in)	30	Bankfull:Culvert Ratio	0.3				
Height (in)	30						
Outlet Perch (ft)	3.1						
Slope (%)	5.6						
Rustline Height (in)	none						
Overall Condition	Fair						
PRIORITIZATION ANALYSIS

Upstream Habitat Length (mi)	0.1	Habitat Points	1				
Habitat Quality	Poor	Habitat Quality Points	1				
Fish Species	Anad.	Fish Points	3				
Barrier Type	Red	Barrier Points	3

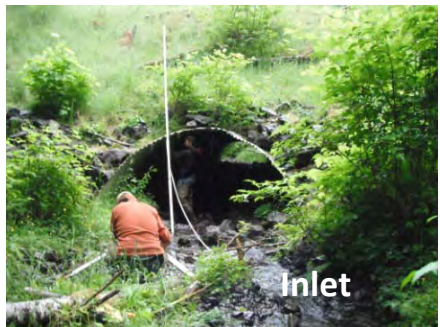
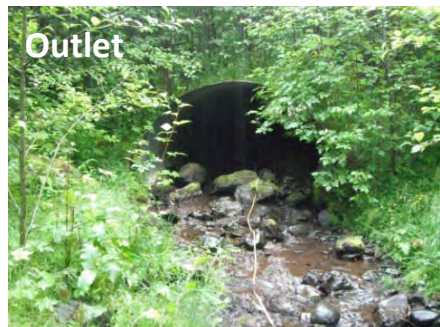
Inlet	
Shape	Pipe Arch	Inlet Gradient (%)	4.5				
Material	Corrugated metal	Upstream Gradient (%)	3.6				
Length (ft)	95	Bankfull Width (ft)	9.6				
Width (in)	144	Bankfull:Culvert Ratio	1.25				
Height (in)	90						
Outlet Perch (ft)	None						
Slope (%)	6.7						
Rustline Height (in)	N/A						
Overall Condition	Good						
PRIORITIZATION ANALYSIS

Outlet	
Upstream Habitat Length (mi)	0.4	Habitat Points	1				
Habitat Quality	Fair	Habitat Quality Points	2				
Fish Species	Anad.	Fish Points	3

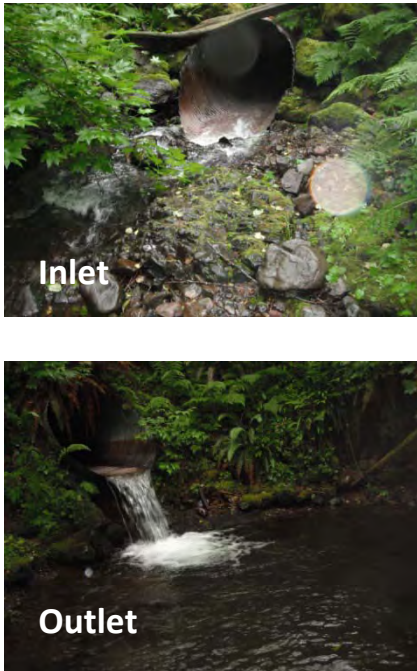
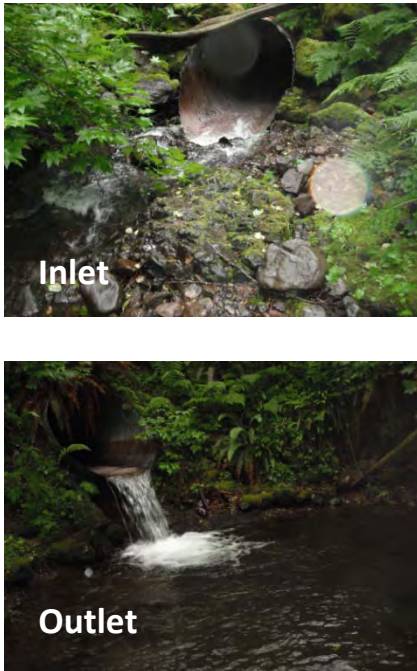
Shape	Circular	Inlet Gradient (%)	20.2				
Material	Corrugated metal	Upstream Gradient (%)	13.3				
Length (ft)	100	Bankfull Width (ft)	10.3				
Width (in)	60	Bankfull:Culvert Ratio	0.5				
Height (in)	60						
Outlet Perch (ft)	2.5						
Slope (%)	4.0						
Rustline Height (in)	42						
Overall Condition	Fair						
PRIORITIZATION ANALYSIS

Upstream Habitat Length (mi)	0.5	Habitat Points	1				
Habitat Quality	Fair	Habitat Quality Points	2				
Fish Species	Anad.	Fish Points	3				
Barrier Type	Red	Barrier Points	3

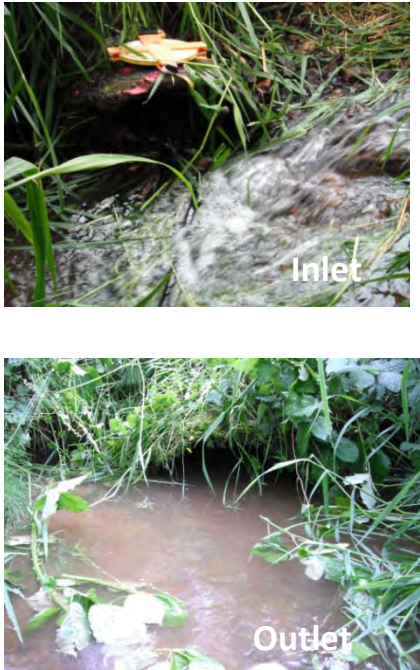
Shape	Circular	Inlet Gradient (%)			11.0		
Material	Concrete	Upstream Gradient (%)			5.3		
Length (ft)	43	Bankfull Width (ft)			4.1		
Width (in)	24	Bankfull:Culvert Ratio			0.5		
Height (in)	24						
Outlet Perch (ft)	None						
Slope (%)	4.6						
Rustline Height (in)	N/A						
Overall Condition	Poor						
PRIORITIZATION ANALYSIS							
Upstream Habitat Length (mi)	0.5	Habitat Points			1		
Habitat Quality	Fair	Habitat Quality Points			2		
Fish Species	Anad.	Fish Points			3		
Barrier Class	Red	Barrier Points			3		
		Prioritization Total Points			9

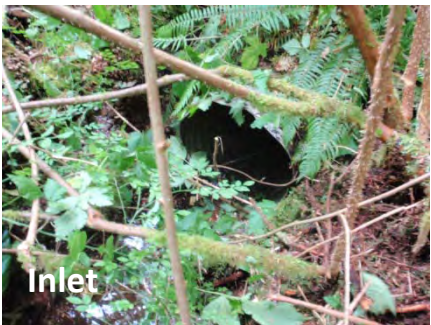
Inlet			
Stream Name		Miami River					
Township-Range-Section-1/4		Minich Creek					
UTM Easting/Northing (Zone 10, NAD 1983)		T1N, R11W, Sec. 10, SE¼ of NE¼					
Road Name		431133/5048601					
Road/Culvert Owner		Minich Creek Road					
Adjacent Landowners		Oregon Department of Forestry					
Overall Condition		Poor					
CULVERT INFO		CHANNEL INFO

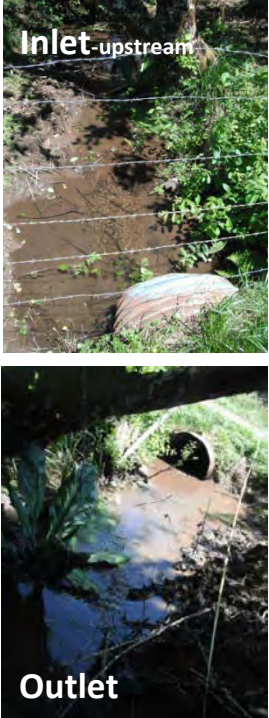
Shape	Circular	Inlet Gradient (%)	42.7				
Material	Corrugated metal	Upstream Gradient (%)	0.1				
Length (ft)	20	Bankfull Width (ft)	4.3				
Width (in)	36	Bankfull:Culvert Ratio	0.7				
Height (in)	36						
Outlet Perch (ft)	None						
Slope (%)	0.1						
Rustline Height (in)	24						
Overall Condition	Poor						
PRIORITIZATION ANALYSIS							
Upstream Habitat Length (mi)	0.6	Habitat Points	2				
Habitat Quality	Poor	Habitat Quality Points	1				
Fish Species	Anad.	Fish Points	3				
Barrier Class	Gray	Barrier Points	2

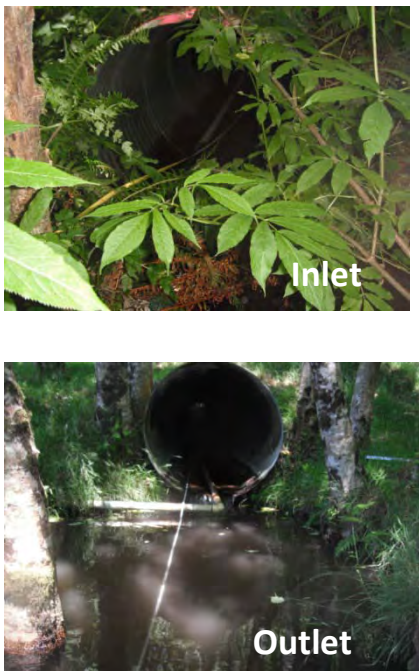
Shape	Circular	Inlet Gradient (%)	11.0				
Material	Corrugated metal	Upstream Gradient (%)	10.2				
Length (ft)	93	Bankfull Width (ft)	9.0				
Width (in)	48	Bankfull:Culvert Ratio	0.4				
Height (in)	48						
Outlet Perch (ft)	0.9						
Slope (%)	4.7						
Rustline Height (in)	11						
Overall Condition	Poor						
PRIORITIZATION ANALYSIS							
Upstream Habitat Length (mi)	0.2	Habitat Points	1				
Habitat Quality	Poor	Habitat Quality Points	1				
Fish Species	Anad.	Fish Points	3				
Barrier Class	Red	Barrier Points	3

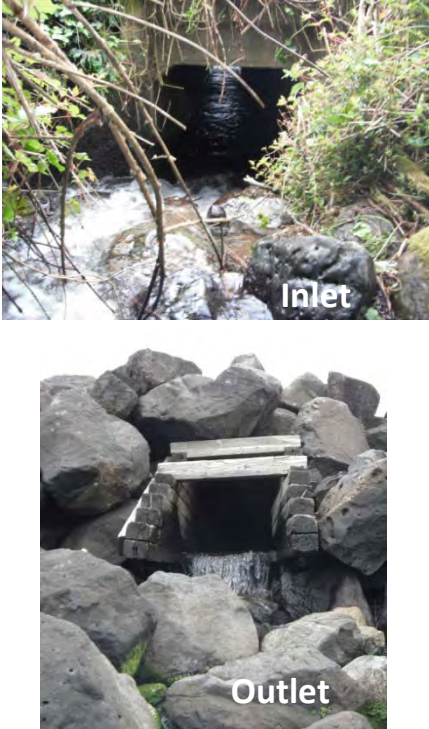
Shape	Box	Inlet Gradient (%)	8.1				
Material	Concrete	Upstream Gradient (%)	7.1				
Length (ft)	81	Bankfull Width (ft)	8.5				
Width (in)	48	Bankfull:Culvert Ratio	0.5				
Height (in)	48						
Outlet Perch (ft)	7.7						
Slope (%)	1.0						
Rustline Height (in)	N/A						
Overall Condition	Poor						
PRIORITIZATION ANALYSIS							
Upstream Habitat Length (mi)	1.0	Habitat Points	2				
Habitat Quality	Fair	Habitat Quality Points	2				
Fish Species	Anad.	Fish Points	3				
Barrier Type	Red	Barrier Points	3				
		Prioritization Total Points	10

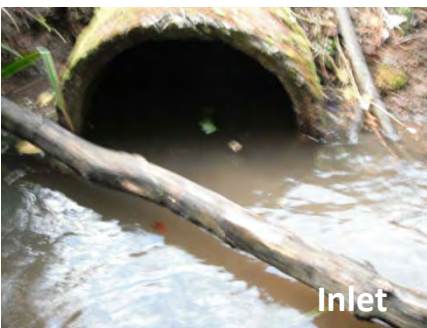
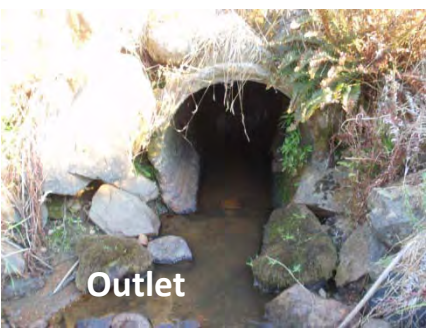
Shape	Circular	Inlet Gradient (%)	17.0				
Material	Concrete	Upstream Gradient (%)	2.0				
Length (ft)	55	Bankfull Width (ft)	7.2				
Width (in)	36	Bankfull:Culvert Ratio	0.4				
Height (in)	36						
Outlet Perch (ft)	None						
Slope (%)	1.0						
Rustline Height (in)	14						
Overall Condition	Poor						
PRIORITIZATION ANALYSIS

Upstream Habitat Length (mi)	0.5	Habitat Points	1				
Habitat Quality	Poor	Habitat Quality Points	1				
Fish Species	Anad.	Fish Points	3				
Barrier Type	Red	Barrier Points	3

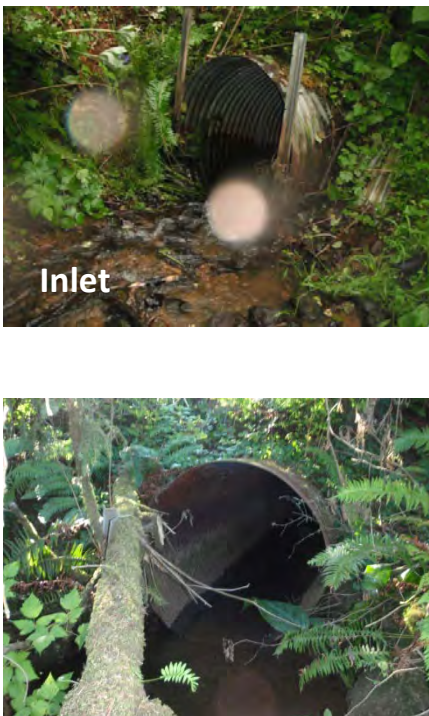
Material	Corrugated metal		Upstream Gradient (%)	1.1			
Length (ft)	~160		Bankfull Width (ft)	5.2			
Width (in)	48 (inlet) 60 (outlet)		Bankfull:Culvert Ratio	1.0			
Height (in)	48 (inlet) 60 (outlet)						
Outlet Perch (ft)	None						
Slope (%)	Variable						
Rustline Height (in)	30						
Overall Condition	Critical						
PRIORITIZATION ANALYSIS							
Upstream Habitat Length (mi)	1.0		Habitat Points	2			
Habitat Quality	Poor		Habitat Quality Points	1			
Fish Species	Anad.		Fish Points	3

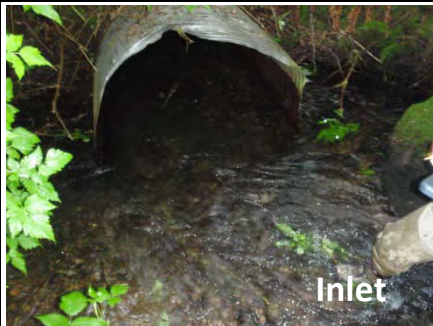
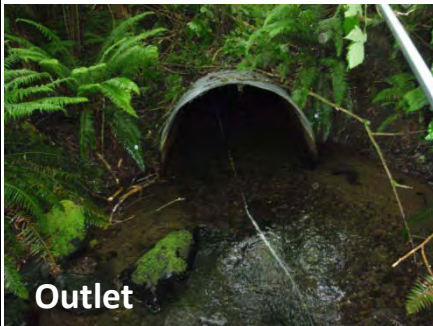
<b>Inlet</b>	
Shape	Circular	Inlet Gradient (%)	12.9				
Material	CMP	Upstream Gradient (%)	8.5				
Length (ft)	41	Bankfull Width (ft)	11.2				
Width (in)	56	Bankfull:Culvert Ratio	0.4				
Height (in)	56						
Outlet Perch (ft)	None						
Slope (%)	-0.2						
Rustline Height (in)	30						
Overall Condition	Critical						
PRIORITIZATION ANALYSIS

<b>Outlet</b>	
Upstream Habitat Length (mi)	2.3	Habitat Points	4				
Habitat Quality	Fair(-)	Habitat Quality Points	2				
Fish Species	Anad.	Fish Points	3

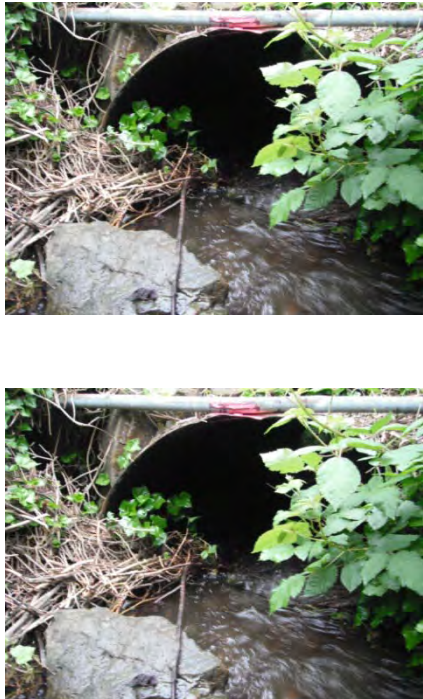
Stream Name		Patterson Creek					
Township-Range-Section-1/4		T1N, R10W, Sec. 35, SE¼ of NW¼					
UTM Easting/Northing (Zone 10, NAD 1983)		430901/5041865					
Road Name		9 <sup>th</sup> Street					
Road/Culvert Owner		City of Bay City					
Adjacent Landowners		C. Bosch and G. & S. Petty					
CULVERT INFO		CHANNEL INFO					
Shape	Pipe arch	Inlet Gradient (%)	15.3				
Material	Corrugated metal	Upstream Gradient (%)	4.6				
Length (ft)	42	Bankfull Width (ft)	6.0				
Width (in)	48	Bankfull:Culvert Ratio	0.7				
Height (in)	48	Couldn't access downstream end of pipe. Area is fenced and includes a fish ladder.					
Outlet Perch (ft)	Unknown						
Slope (%)	Unknown						
Rustline Height (in)	17						
Overall Condition	Fair						
PRIORITIZATION ANALYSIS							
Upstream Habitat Length (mi)	2.2	Habitat Points	4				
Habitat Quality	Fair	Habitat Quality Points	2

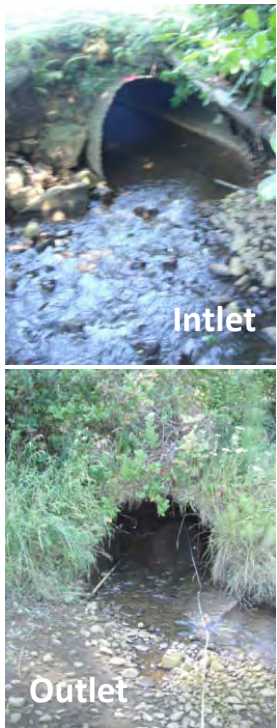
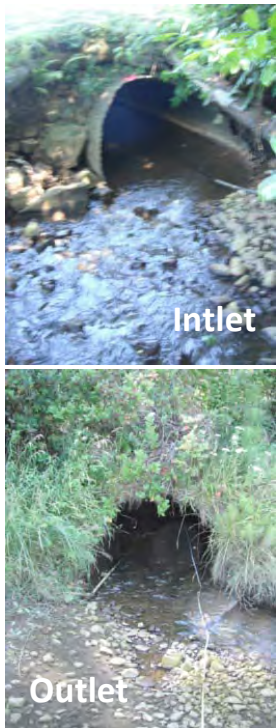
Shape	Pipe Arch	Inlet Gradient (%)	1.5				
Material	Corrugated metal	Upstream Gradient (%)	3.8				
Length (ft)	44	Bankfull Width (ft)	11.4				
Width (in)	72	Bankfull:Culvert Ratio	0.5				
Height (in)	42						
Outlet Perch (ft)	Not measurable						
Slope (%)	2.1						
Rustline Height (in)	6						
Overall Condition	Poor						
PRIORITIZATION ANALYSIS

Upstream Habitat Length (mi)	0.5	Habitat Points	1				
Habitat Quality	Fair	Habitat Quality Points	2				
Fish Species	Anad.	Fish Points	3				
Barrier Type	Gray	Barrier Points	2				
		Prioritization Total Points	8

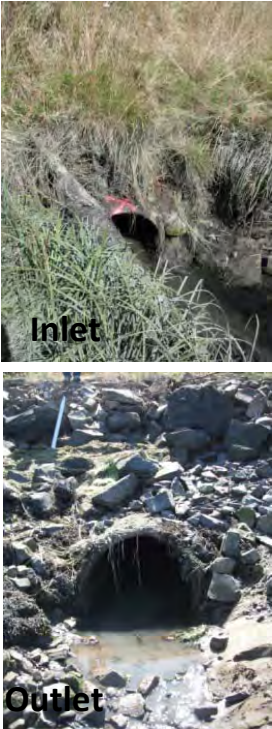
Material	Concrete	Upstream Gradient (%)	1.1				
Length (ft)	59	Bankfull Width (ft)	5.8				
Width (in)	36	Bankfull:Culvert Ratio	0.5				
Height (in)	36						
Outlet Perch (ft)	Not measurable						
Slope (%)	0.0						
Rustline Height (in)	12						
Overall Condition	Fair						
PRIORITIZATION ANALYSIS							
Upstream Habitat Length (mi)	0.3	Habitat Points	1				
Habitat Quality	Fair	Habitat Quality Points	2				
Fish Species	Anad.	Fish Points	3				
Barrier Type	Gray	Barrier Points	2

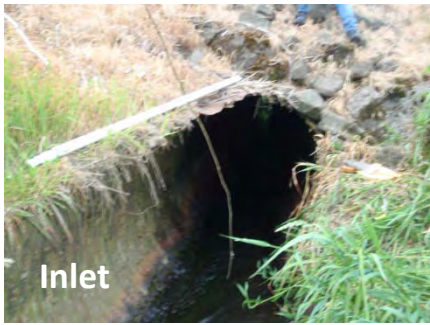
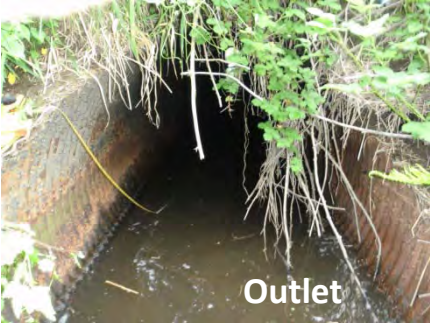
Inlet	
Shape	Circular	Inlet Gradient (%)	unknown				
Material	Corrugated metal	Upstream Gradient (%)	unknown				
Length (ft)	109	Bankfull Width (ft)	~15.0 *				
Width (in)	56	Culvert:Bankfull Ratio	0.3				
Height (in)	56	*Unable to access upstream. BFW based on visual estimate.					
Outlet Perch (ft)	Not perched						
Slope (%)	3.5						
Rustline Height (in)	30						
Overall Condition	Fair						
PRIORITIZATION ANALYSIS

Outlet	
Upstream Habitat Length (mi)	1.6	Habitat Points	4

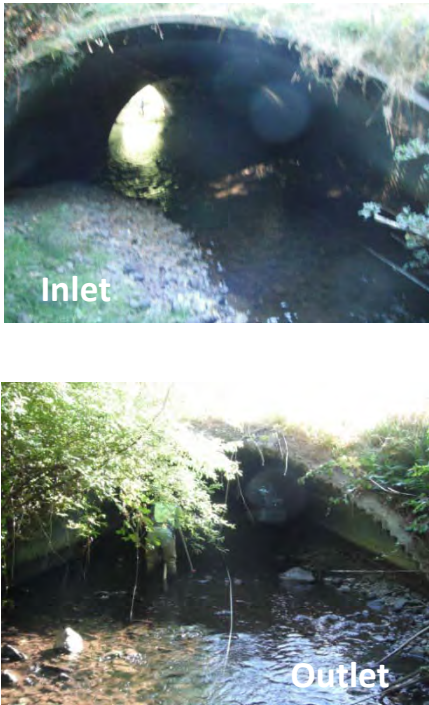
Shape	Open Bottom Arch	Inlet Gradient (%)	8.9				
Material	Corrugated metal	Upstream Gradient (%)	2.6				
Length (ft)	113	Bankfull Width (ft)	18.6				
Width (in)	240	Culvert:Bankfull Ratio	1.1				
Height (in)	108						
Outlet Perch (ft)	0.2						
Slope (%)	0.4						
Rustline Height (in)	6						
Overall Condition	Fair						
PRIORITIZATION ANALYSIS							
Upstream Habitat Length (mi)	6.5	Habitat Points	4				
Habitat Quality	Good	Habitat Quality Points	3				
Fish Species	Anad.	Fish Points	3				
Barrier Class	Green	Barrier Points	1

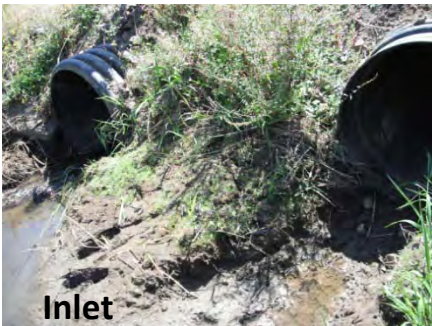
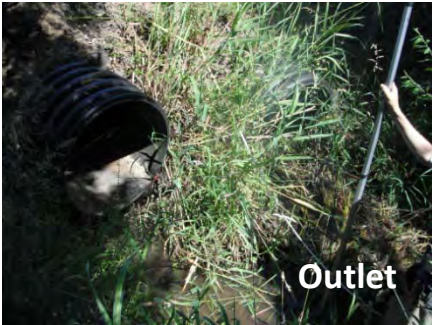
<b>Inlet</b>	
Shape	Circular	Inlet Gradient (%)	1.2(4.6)				
Material	Plastic	Upstream Gradient (%)	1.6				
Length (ft)	22	Bankfull Width (ft)	10.0				
Width (in)	36(36)	Bankfull:Culvert Ratio	0.6*				
Height (in)	36(36)	*Bankfull:Culvert ratio based on combined width of both pipes.					
Outlet Perch (ft)	0.2(1.0)						
Slope (%)	2.3(0.4)						
Rustline Height (in)	N/A						
Overall Condition	Fair

<b>Outlet</b>	
PRIORITIZATION ANALYSIS							
Upstream Habitat Length (mi)	1.8	Habitat Points	4

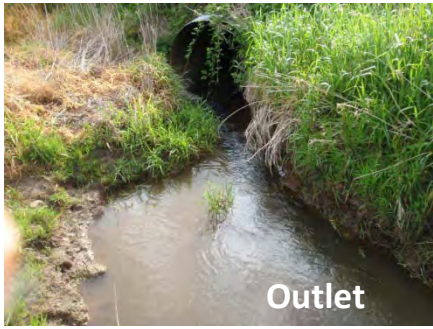
Shape	Circular	Inlet Gradient (%)	-4.0				
Material	Corrugated metal	Upstream Gradient (%)	1.2				
Length (ft)	59	Bankfull Width (ft)	9.2				
Width (in)	54	Bankfull:Culvert Ratio	0.5				
Height (in)	54						
Outlet Perch (ft)	0.5						
Slope (%)	0.3						
Rustline Height (in)	48						
Overall Condition	Poor						
PRIORITIZATION ANALYSIS							
Upstream Habitat Length (mi)	0.6	Habitat Points	2				
Habitat Quality	Poor	Habitat Quality Points	1				
Fish Species	Anad.	Fish Points	3

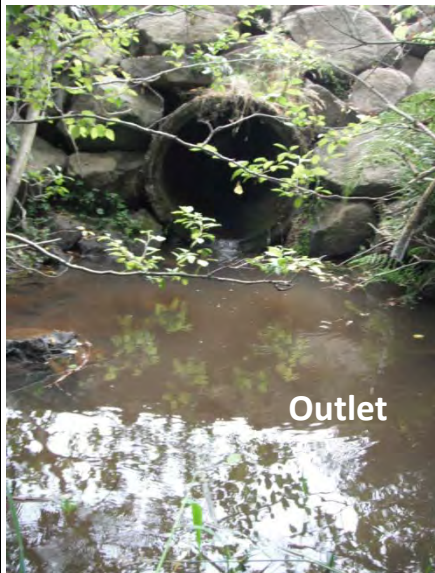
Adjacent Landowners		L. Vogt, P. Wirfs, and C. McClure					
CULVERT INFO		CHANNEL INFO					
Shape	Circular	Inlet Gradient (%)	~7.0				
Material	Concrete	Downstream Gradient (%)	3.3				
Length (ft)	40	Bankfull Width (ft)	3.1				
Width (in)	54	Bankfull:Culvert Ratio	1.5				
Height (in)	54	Inlet inaccessible due to dense blackberry plants and a fence					
Outlet Perch (ft)	0.6						
Slope (%)	2.5						
Rustline Height (in)	N/A						
Overall Condition	Fair						
PRIORITIZATION ANALYSIS							
Upstream Habitat Length (mi)	0.2	Habitat Points	1				
Habitat Quality	Poor	Habitat Quality Points	1				
Fish Species	Anad.	Fish Points	3

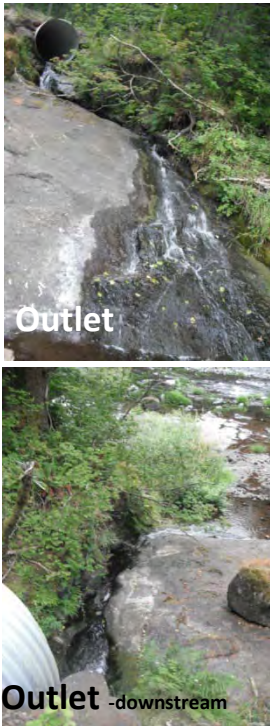
LOCATION INFO				Culvert #	889	Priority	L
Watershed				Trask River			
Stream Name				Burton Creek			
Township-Range-Section-1/4				T1S, R8W, Sec. 21, SE¼ of SW¼			
UTM Easting/Northing (Zone 10, NAD 1983)				447331/5034084			
Road Name				Trask River Road			
Road/Culvert Owner				Tillamook County			
Adjacent Landowners				Oregon Department of Forestry			
CULVERT INFO		CHANNEL INFO					
Shape	Circular	Inlet Gradient (%)	26.5				
Material	Corrugated metal	Upstream Gradient (%)	4.1				
Length (ft)	57	Bankfull Width (ft)	12.2				
Width (in)	90	Bankfull:Culvert Ratio	0.6				
Height (in)	90						
Outlet Perch (ft)	Unknown						
Slope (%)	5.5						
Rustline Height (in)	26						
Overall Condition	Critical						
PRIORITIZATION ANALYSIS							
Upstream Habitat Length (mi)	0.1	Habitat Points	1				
Habitat Quality	Poor	Habitat Quality Points	1				
Fish Species	Anad.	Fish Points	3				
Barrier Class	Red	Barrier Points	3

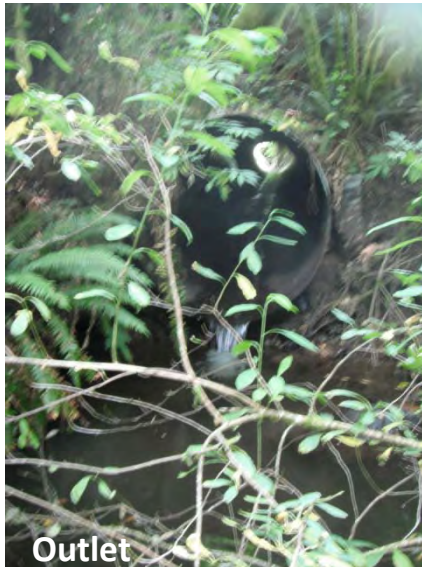
Shape	Circular	Inlet Gradient (%)	11.0				
Material	Corrugated metal	Downstream Gradient (%)	8.0				
Length (ft)	70	Bankfull Width (ft)	8.4				
Width (in)	60	Bankfull:Culvert Ratio	0.6				
Height (in)	60	*Topography and vegetation precluded use of survey equipment to obtain longitudinal profile data.					
Outlet Perch (ft)	~0.6*						
Slope (%)	7.0						
Rustline Height (in)	29						
Overall Condition	Poor						
PRIORITIZATION ANALYSIS							
Upstream Habitat Length (mi)	0.6	Habitat Points				2	
Habitat Quality	Poor	Habitat Quality Points				1

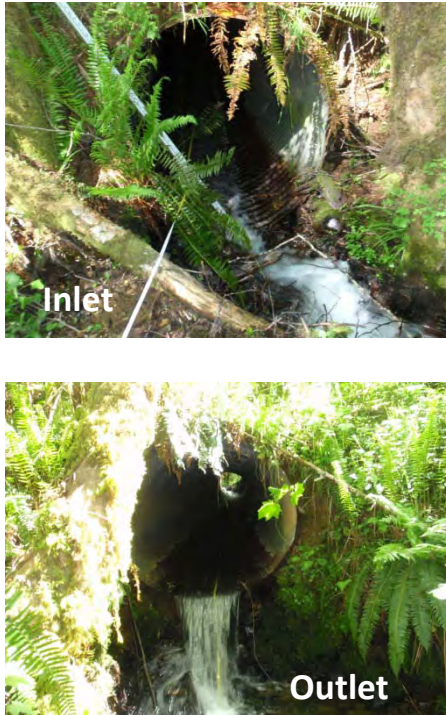
Shape	Circular	Inlet Gradient (%)			14.7		
Material	Corrugated metal (SSP)	Upstream Gradient (%)			4.4		
Length (ft)	61	Bankfull Width (ft)			5.9		
Width (in)	55	Bankfull:Culvert Ratio			0.8		
Height (in)	64						
Outlet Perch (ft)	2.7						
Slope (%)	9.9						
Rustline Height (in)	18						
Overall Condition	Poor						
PRIORITIZATION ANALYSIS							
Upstream Habitat Length (mi)	0.2	Habitat Points			1		
Habitat Quality	Poor	Habitat Quality Points			1		
Fish Species	Anad.	Fish Points			3

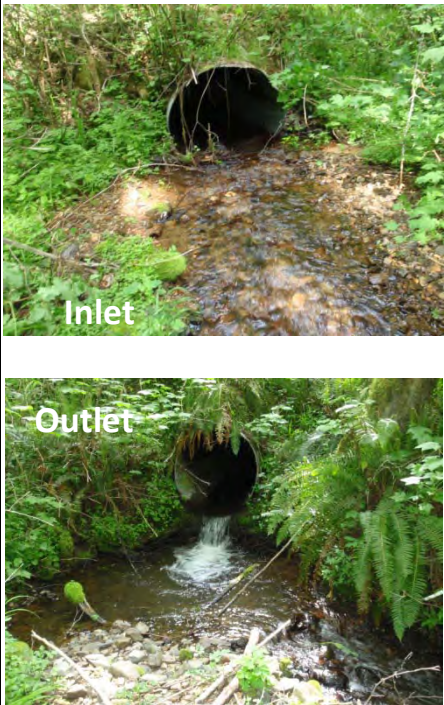
Shape	Circular	Inlet Gradient (%)	10.3				
Material	Corrugated metal	Upstream Gradient (%)	5.9				
Length (ft)	61	Bankfull Width (ft)	7.1				
Width (in)	56	Bankfull:Culvert Ratio	0.7				
Height (in)	56						
Outlet Perch (ft)	1.6						
Slope (%)	5.9						
Rustline Height (in)	11						
Overall Condition	Fair						
PRIORITIZATION ANALYSIS							
Upstream Habitat Length (mi)	0.2	Habitat Points	1				
Habitat Quality	Fair	Habitat Quality Points	2				
Fish Species	Anad.	Fish Points	3

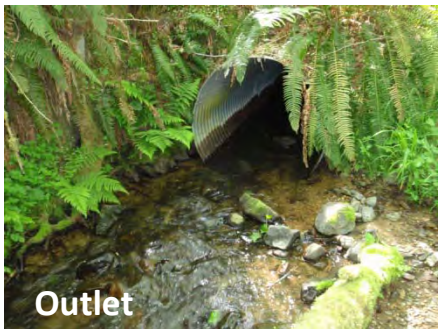
Outlet			
Material	Corrugated metal	Upstream Gradient (%)	4.1				
Length (ft)	45	Bankfull Width (ft)	8.0				
Width (in)	48	Bankfull:Culvert Ratio	0.5				
Height (in)	48						
Outlet Perch (ft)	None						
Slope (%)	6.2						
Rustline Height (in)	16						
Overall Condition	Poor						
PRIORITIZATION ANALYSIS							
Upstream Habitat Length (mi)	0.7	Habitat Points	2				
Habitat Quality	Good	Habitat Quality Points	3				
Fish Species	Anad.	Fish Points	3

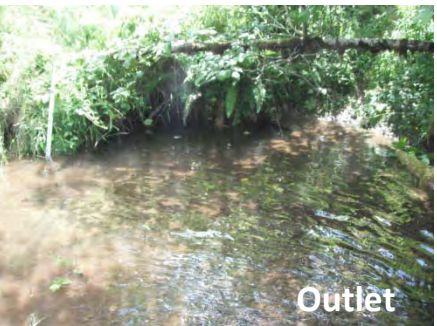
Material	Corrugated metal	Upstream Gradient (%)	5.5				
Length (ft)	50	Bankfull Width (ft)	9.1				
Width (in)	114	Bankfull:Culvert Ratio	1.0				
Height (in)	48						
Outlet Perch (ft)	None						
Slope (%)	0						
Rustline Height (in)	30						
Overall Condition	Fair						
PRIORITIZATION ANALYSIS							
Upstream Habitat Length (mi)	1.6	Habitat Points	4				
Habitat Quality	Good	Habitat Quality Points	3				
Fish Species	Anad.	Fish Points	3				
Barrier Class	Green	Barrier Points	1

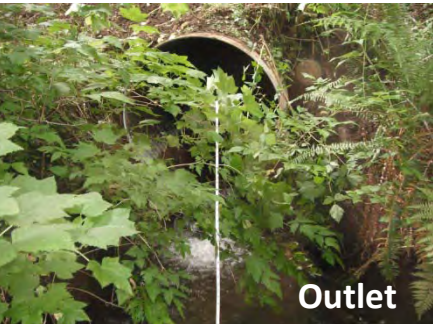
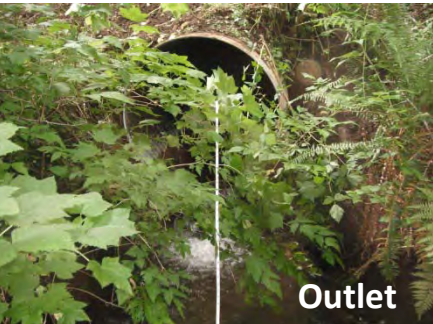
Width (in)	48	Bankfull:Culvert Ratio	0.5				
Height (in)	48						
Outlet Perch (ft)	1.2						
Slope (%)	2.2						
Rustline Height (in)	24						
Overall Condition	Fair						
PRIORITIZATION ANALYSIS

Upstream Habitat Length (mi)	0.7	Habitat Points	2				
Habitat Quality	Poor	Habitat Quality Points	1				
Fish Species	Anad.	Fish Points	3				
Barrier Class	Red	Barrier Points	3

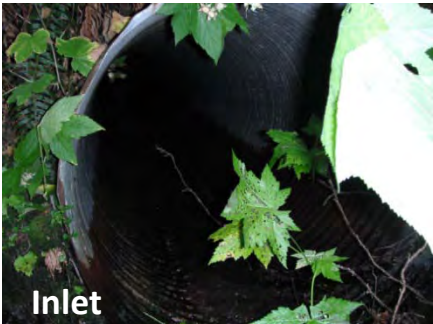
<b>Inlet</b>		
Shape	Circular	Inlet Gradient (%)						7.5
Material	Corrugated metal	Upstream Gradient (%)						0.5
Length (ft)	67	Bankfull Width (ft)						4.9
Width (in)	36	Bankfull:Culvert Ratio						0.6
Height (in)	36							
Outlet Perch (ft)	6.6							
Slope (%)	1.4							
Rustline Height (in)	20							
Overall Condition	Poor							
PRIORITIZATION ANALYSIS								
Upstream Habitat Length (mi)	0.1	Habitat Points				1

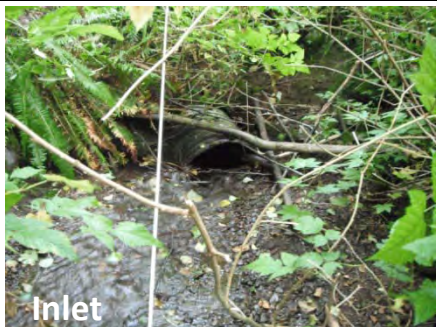
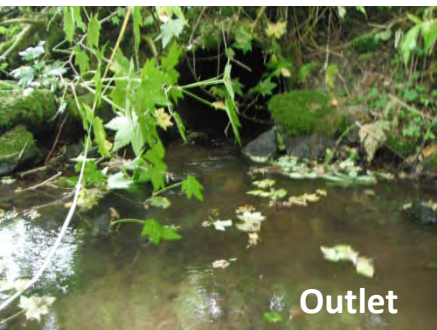
Shape	Circular	Inlet Gradient (%)	21.9				
Material	Corrugated metal	Upstream Gradient (%)	3.4				
Length (ft)	32	Bankfull Width (ft)	8.5				
Width (in)	30	Bankfull:Culvert Ratio	0.3				
Height (in)	30						
Outlet Perch (ft)	None						
Slope (%)	5.7						
Rustline Height (in)	entirely rusted						
Overall Condition	Poor						
PRIORITIZATION ANALYSIS

Upstream Habitat Length (mi)	1.0	Habitat Points	2				
Habitat Quality	Poor(+)	Habitat Quality Points	1				
Fish Species	Anad.	Fish Points	3				
Barrier Class	Red	Barrier Points	3

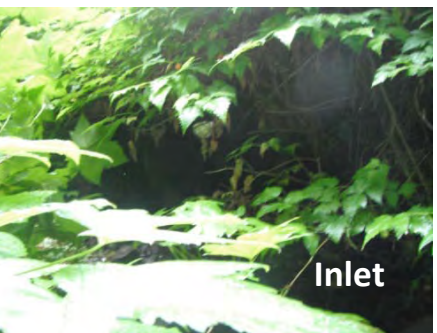
<b>Inlet</b>			
Shape	Circular	Inlet Gradient (%)	4.0				
Material	Corrugated metal	Upstream Gradient (%)	12.5				
Length (ft)	55	Bankfull Width (ft)	3.4				
Width (in)	30	Bankfull:Culvert Ratio	0.9				
Height (in)	30	Topography and obstructions precluded the use of surveying equipment to obtain longitudinal profile data.					
Outlet Perch (ft)	1.0 to 1.5						
Slope (%)	5.0						
Rustline Height (in)	13						
Overall Condition	Fair						
PRIORITIZATION ANALYSIS							
Upstream Habitat Length (mi)	0.5	Habitat Points	1

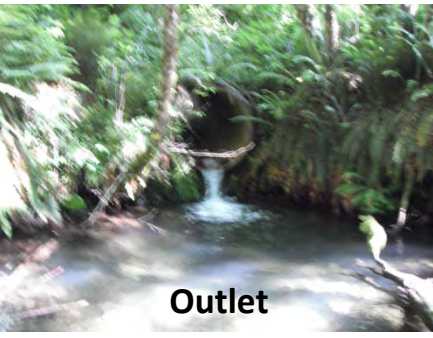
<p style="font-weight: bold; font-size: 1.2em;">Outlet</p>			
Adjacent Landowners		Oregon Department of Forestry					
CULVERT INFO		CHANNEL INFO					
Shape	Circular	Inlet Gradient (%)	11.5				
Material	steel lined with plastic	Upstream Gradient (%)	5.1				
Length (ft)	53	Bankfull Width (ft)	9.3				
Width (in)	60	Bankfull:Culvert Ratio	0.5				
Height (in)	60						
Outlet Perch (ft)	1.3						
Slope (%)	6.6						
Rustline Height (in)	N/A						
Overall Condition	Fair						
PRIORITIZATION ANALYSIS							
Upstream Habitat Length (mi)	0.4	Habitat Points	2

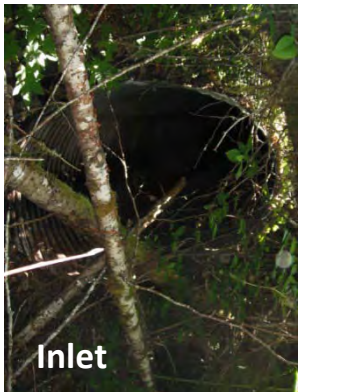
Shape	Circular	Inlet Gradient (%)			28.3		
Material	Corrugated metal	Upstream Gradient (%)			4.0		
Length (ft)	72	Bankfull Width (ft)			4.3		
Width (in)	50	Bankfull:Culvert Ratio			1.0		
Height (in)	50						
Outlet Perch (ft)	4.3						
Slope (%)	6.4						
Rustline Height (in)	14						
Overall Condition	Fair						
PRIORITIZATION ANALYSIS							
Upstream Habitat Length (mi)	0.1	Habitat Points			1

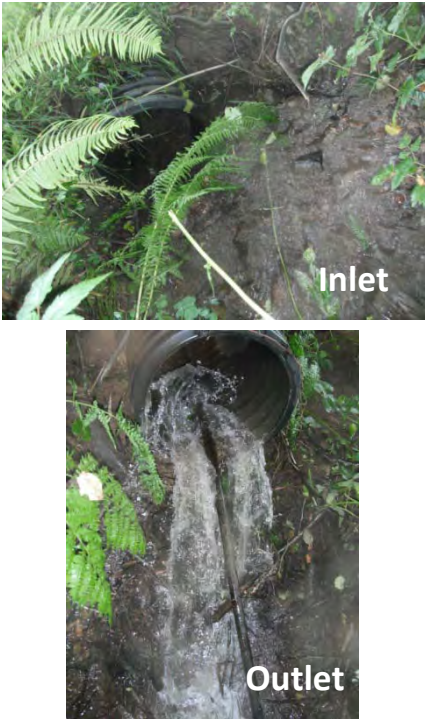
Shape	Circular	Inlet Gradient (%)	3.1				
Material	Plastic	Upstream Gradient (%)	4.1				
Length (ft)	34	Bankfull Width (ft)	5.1				
Width (in)	18	Bankfull:Culvert Ratio	0.3				
Height (in)	18						
Outlet Perch (ft)	5.7						
Gradient (%)	4.4						
Rustline Height (in)	18						
Overall Condition	Fair						
PRIORITIZATION ANALYSIS							
Upstream Habitat Length (mi)	0.1	Habitat Points	1				
Habitat Quality	Poor	Habitat Quality Points	1				
Fish Species	Anad.	Fish Points	3				
Barrier Class	Red	Barrier Points	3				
		Prioritization Total Points	8

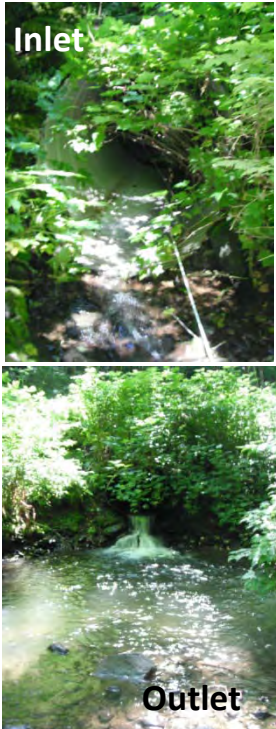
Shape	Pipe arch	Inlet Gradient (%)	14.2				
Material	Circular	Upstream Gradient (%)	6.7				
Length (ft)	79	Bankfull Width (ft)	15.4				
Width (in)	90	Bankfull:Culvert Ratio	0.5				
Height (in)	90						
Outlet Perch (ft)	4.1						
Gradient (%)	4.2						
Rustline Height (in)	13						
Overall Condition	Poor						
PRIORITIZATION ANALYSIS							
Upstream Habitat Length (mi)	0.1	Habitat Points	1				
Habitat Quality	Poor	Habitat Quality Points	1				
Fish Species	Resident	Fish Points	2				
Barrier Class	Red	Barrier Points	3
