**Kilchis River Basin
Culverts**

Kilchis Basin Crossings

Kilchis River Basin Clusters

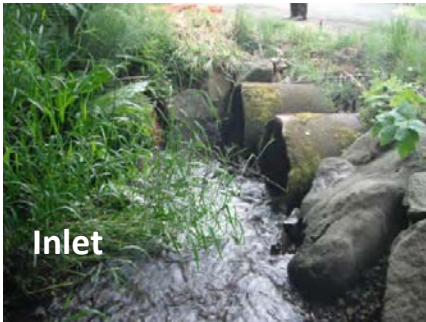
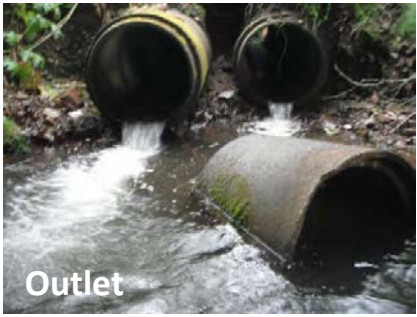
LOCATION INFO				Culvert #	629	Priority	H
Watershed		Kilchis River					
Stream Name		Vaughn Creek					
Township-Range-Section-1/4		T1S, R10W, Sec. 1, SW¼ of NE¼					
UTM Easting/Northing (Zone 10, NAD 1983)		433319/5040431					
Road Name		Doughty Road					
Road/Culvert Owner		Tillamook County					
Adjacent Landowners		R. Rasmussen and R. Carver					
CULVERT INFO		CHANNEL INFO					
Shape	Circular	Inlet Gradient (%)		8.7(7.4)			
Material	Concrete	Upstream Gradient (%)		1.0			
Length (ft)	35(31)	Bankfull Width (ft)		8.1			
Width (in)	29(29)	Bankfull:Culvert Ratio		0.6*			
Height (in)	29(29)						
Outlet Perch (ft)	0.1(0.2)						
Slope (%)	1.9(1.4)						
Rustline Height (in)	N/A						
Overall Condition	Poor						
PRIORITIZATION ANALYSIS							
Upstream Habitat Length (mi)		0.9	Habitat Points		2		
Habitat Quality		Fair(-)	Habitat Quality Points		2		
Fish Species		Anad.	Fish Points		3		
Barrier Type		Red	Barrier Points		3

Notes: Twin concrete pipes at this crossing. * bankful:culvert ratio based on combined pipe diameters. Water backed up at inlet and flowed over Doughty Road during most of the winter of 2011-12. This adversely affects road condition and water quality.

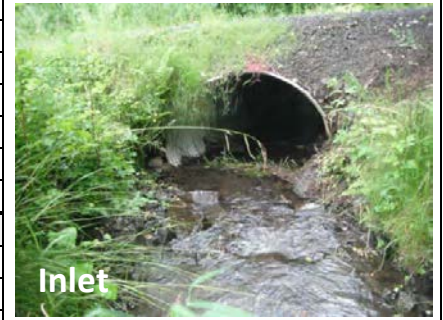
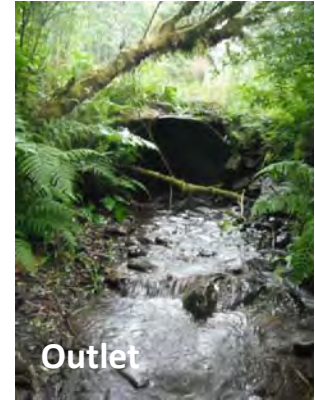
LOCATION INFO				Culvert #	621	Priority	H
Watershed		Kilchis River					
Stream Name		Vaughn Creek					
Township-Range-Section-1/4		T1S, R10W, Sec. 36, SW¼ of SE¼					
UTM Easting/Northing (Zone 10, NAD 1983)		433393/5040779					
Road Name		Private driveway off Pike Road					
Road/Culvert Owner		J. Bender					
Adjacent Landowners		J. Bender, M. & L. McClaskey, and R. & C. Watt					
CULVERT INFO		CHANNEL INFO					
Shape	Pipe arch	Inlet Gradient (%)	5.0				
Material	Corrugated metal	Upstream Gradient (%)	2.0				
Length (ft)	23	Bankfull Width (ft)	7.4				
Width (in)	74	Bankfull:Culvert Ratio	0.9				
Height (in)	52						
Outlet Perch (ft)	0.4						
Slope (%)	1.7						
Rustline Height (in)	3						
Overall Condition	Fair						
PRIORITIZATION ANALYSIS							
Upstream Habitat Length (mi)	0.7	Habitat Points	2				
Habitat Quality	Fair(-)	Habitat Quality Points	2				
Fish Species	Anad.	Fish Points	3				
Barrier Type	Red	Barrier Points	3

Prioritization Total Points	10				
<p>Notes: Pipe 628 is between this pipe and 629. We did not have landowner permission to survey pipe 628, but it was likely a barrier culvert as well based on remote observation. The degree to which 628 may impede passage was unknown at the time of this report.</p>

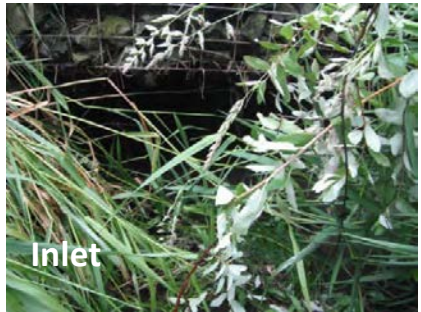
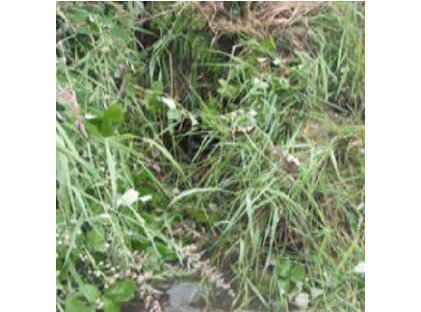
LOCATION INFO				Culvert #	673	Priority	L
Watershed				Kilchis River			
Stream Name				Hathaway Slough			
Township-Range-Section-1/4				T1S, R10W, Sec. 12, NW¼ of NE¼			
UTM Easting/Northing (Zone 10, NAD 1983)				433617/5039600			
Road Name				Alderbrook Road			
Road/Culvert Owner				Tillamook County			
Adjacent Landowners				T. Gienger, S. & E. Vermilyea, and J. Smith			
CULVERT INFO		CHANNEL INFO

Shape	Circular	Inlet Gradient (%)	3.5				
Material	Concrete	Upstream Gradient (%)	<1.0				
Length (ft)	38	Bankfull Width (ft)	6.1				
Width (in)	24	Bankfull:Culvert Ratio	0.3				
Height (in)	24						
Outlet Perch (ft)	0.1						
Slope (%)	1.0						
Rustline Height (in)	N/A						
Overall Condition	Poor						
PRIORITIZATION ANALYSIS							
Upstream Habitat Length (mi)	0.3	Habitat Points	1				
Habitat Quality	Poor	Habitat Quality Points	1				
Fish Species	Anad.	Fish Points	3				
Barrier Type	Red	Barrier Points	3

Prioritization Total Points	8				
Notes: Upstream listed as nonfish. However, although low-quality habitat, technical reviewers suggested that a short segment of the upstream west channel remains suitable for fish use if access issues are addressed.

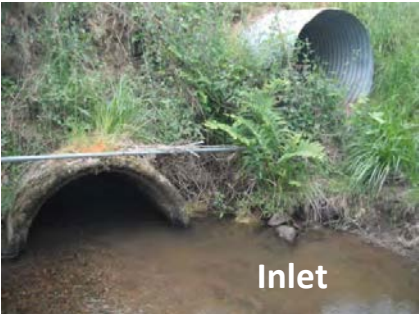
<p align="center">Inlet</p>

Habitat Quality	Fair	Habitat Quality Points	2				
Fish Species	Anad.	Fish Points	3				
Barrier Type	Gray	Barrier Points	2				
		Prioritization Total Points	11				
Notes: Barrel of concrete pipe is approximately 40 percent full of stream bed substrate.

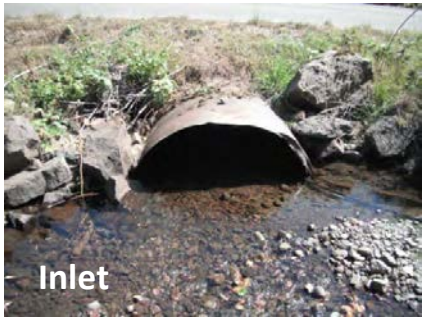
<p style="text-align: right; font-weight: bold;">Inlet</p>

Fish Species	Anad.	Fish Points	3				
Barrier Type	Gray	Barrier Points	2				
		Prioritization Total Points	11				
Notes: Barrel of pipe is approximately 50 percent filled with stream bed substrate. Crossing 641 immediately upstream of this crossing, is a livestock bridge.

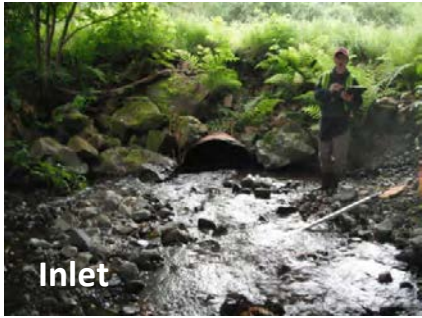
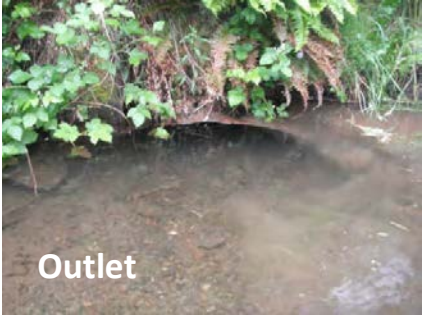
Stream Name		Mapes Creek					
Township-Range-Section-1/4		T1S, R9W, Sec. 6, NW¼ of NE¼					
UTM Easting/Northing (Zone 10, NAD 1983)		435239/5041132					
Road Name		Kilchis River Road					
Road/Culvert Owner		Tillamook County					
Adjacent Landowners		S. Schafer					
CULVERT INFO		CHANNEL INFO					
Shape	Circular	Inlet Gradient (%)	13.4				
Material	Corrugated metal	Upstream Gradient (%)	1.2				
Length (ft)	50	Bankfull Width (ft)	15.4				
Width (in)	54	Bankfull:Culvert Ratio	0.3				
Height (in)	54						
Outlet Perch (ft)	Outlet submerged						
Slope (%)	2.5						
Rustline Height (in)	Entire pipe rusted						
Overall Condition	Poor						
PRIORITIZATION ANALYSIS

Prioritization Total Points	10				
Notes: Barrel of pipe is approximately 60 percent filled with stream bed substrate.

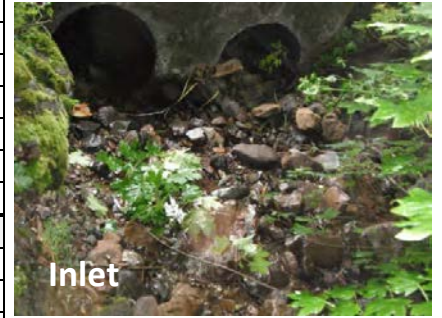
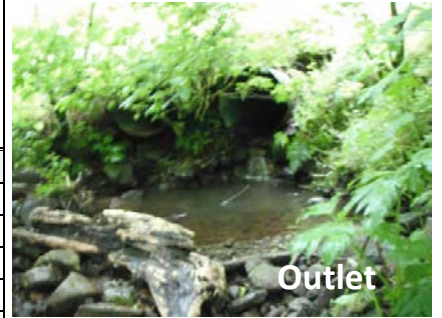
LOCATION INFO				Culvert #	589	Priority	L
Watershed		Kilchis River					
Stream Name		Thomas Creek					
Township-Range-Section-1/4		T1N, R9W, Sec. 32, SE¼ of SE¼					
UTM Easting/Northing (Zone 10, NAD 1983)		437077/5041645					
Road Name		Kilchis River Road					
Road/Culvert Owner		Tillamook County					
Adjacent Landowners		R. & S. Deloe, A. Bell					
CULVERT INFO		CHANNEL INFO					
Shape	Circular	Inlet Gradient (%)	24.0				
Material	Corrugated metal	Upstream Gradient (%)	8.1				
Length (ft)	43	Bankfull Width (ft)	12.6				
Width (in)	48	Bankfull:Culvert Ratio	0.6*				
Height (in)	48	Two pipes side-by-side at this crossing. This section includes information on the left pipe in inlet photo. This pipe appears to carry most flows through this crossing. Both pipes are 4 ft. circular CMP and both are perched.					
Outlet Perch (ft)	3.4						
Slope (%)	1.8						
Rustline Height (in)	Entire pipe rusted						
Overall Condition	Poor

PRIORITIZATION ANALYSIS							
Upstream Habitat Length (mi)	0.5	Habitat Points	1				
Habitat Quality	Poor(+)	Habitat Quality Points	1				
Fish Species	Anad.	Fish Points	3				
Barrier Type	Red	Barrier Points	3				
		Prioritization Total Points	8				
Notes: *used combined width of both pipes for this calculation. Right pipe appears to only flow periodically due to thalweg alignment and rocks blocking inlet.

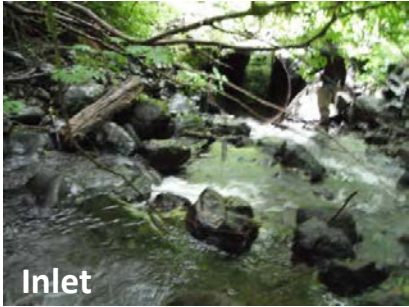
<p>Inlet</p>

<p>Outlet</p>			
Shape	Circular	Inlet Gradient (%)	18.2				
Material	Corrugated metal	Upstream Gradient (%)	16.2				
Length (ft)	54	Bankfull Width (ft)	9.7				
Width (in)	66	Bankfull:Culvert Ratio	0.6				
Height (in)	66						
Outlet Perch (ft)	6.2						
Slope (%)	1.9						
Rustline Height (in)	42						
Overall Condition	Poor						
PRIORITIZATION ANALYSIS							
Upstream Habitat Length (mi)	0.1	Habitat Points	1				
Habitat Quality	Poor	Habitat Quality Points	1				
Fish Species	Anad.	Fish Points	3

Barrier Class	Red	Barrier Points	3				
		Prioritization Total Points	8				
Notes: Although designated a nonfish stream, technical reviewers felt that a short reach of this stream would be suitable for fish use if passage were not prevented by this culvert.

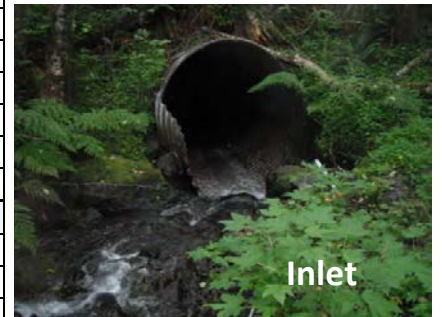
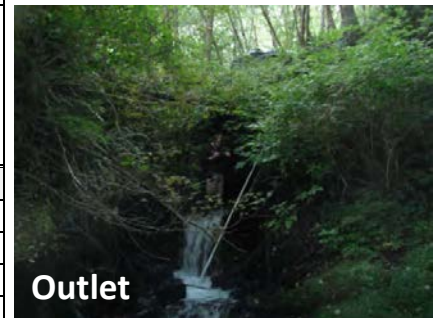
LOCATION INFO				Culvert #	262	Priority	H
Watershed		Kilchis River					
Stream Name		Whitney Creek					
Township-Range-Section-1/4		T1N, R9W, Sec. 4, SE¼ of NE¼					
UTM Easting/Northing (Zone 10, NAD 1983)		440298/5049327					
Road Name		Kilchis Forest Road					
Road/Culvert Owner		Oregon Department of Forestry					
Adjacent Landowners		Oregon Department of Forestry					
CULVERT INFO		CHANNEL INFO					
Shape	Circular	Inlet Gradient (%)	12.0				
Material	Corrugated metal	Upstream Gradient (%)	8.0				
Length (ft)	100	Bankfull Width (ft)	13.4				
Width (in)	84	Bankfull:Culvert Ratio	0.5				
Height (in)	96	Outlet cascades onto bedrock.					
Outlet Perch (ft)	4.5						
Slope (%)	7.0						
Rustline Height (in)	36						
Overall Condition	Poor						
PRIORITIZATION ANALYSIS							
Upstream Habitat Length (mi)	1.1	Habitat Points	3				
Habitat Quality	Fair	Habitat Quality Points	2				
Fish Species	Anad.	Fish Points	3

Barrier Type	Red	Barrier Points	3				
		Prioritization Total Points	11				
Notes: Water entering through holes in side of pipe. 4-6" holes in invert. Water flows under and alongside pipe. This pipe appears to sit on bedrock and it is unclear whether an accessible crossing can be created without considerable earthwork. Closer inspection of this location is in order.
