**Miami River Basin  
Culverts**

### Miami River Basin Clusters

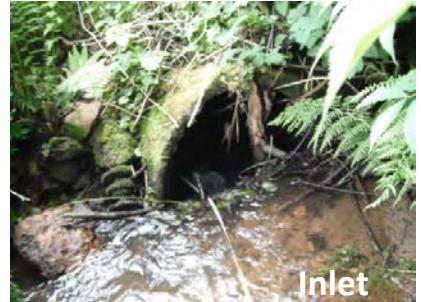
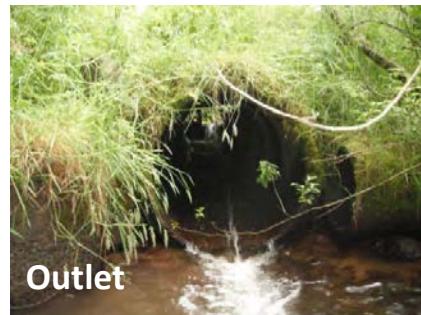
LOCATION INFO				Culvert #	448	Priority	H
<b>Watershed</b>		Miami River					
<b>Stream Name</b>		Hobson Creek					
<b>Township-Range-Section-1/4</b>		T1N, R10W, Sec. 15, SE ¼ of SW ¼					
<b>UTM Easting/Northing (Zone 10, NAD 1983)</b>		430234/5046127					
<b>Road Name</b>		Hobson Creek Road					
<b>Road/Culvert Owner</b>		A. Hutchison					
<b>Adjacent Landowners</b>		D. Schecter					
CULVERT INFO		CHANNEL INFO					
Shape	Circular	Inlet Gradient (%)	45.0				
Material	Concrete	Upstream Gradient (%)	4.2				
Length (ft)	27	Bankfull Width (ft)	8.0				
Width (in)	42	Bankfull:Culvert Ratio	0.4				
Height (in)	42						
Outlet Perch (ft)	0.3						
Slope (%)	2.7						
Rustline Height (in)	N/A						
Overall Condition	Poor						
PRIORITIZATION ANALYSIS							
Upstream Habitat Length (mi)	0.8	Habitat Points	2				
Habitat Quality	Fair	Habitat Quality Points	2				
Fish Species	Anad.	Fish Points	3				
Barrier Class	Red	Barrier Points	3

Prioritization Total Points	10				
Notes: Inlet approximately 1/2 blocked with debris and sediment.

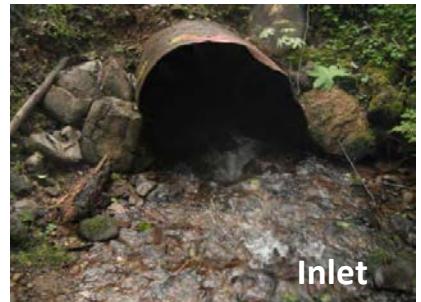
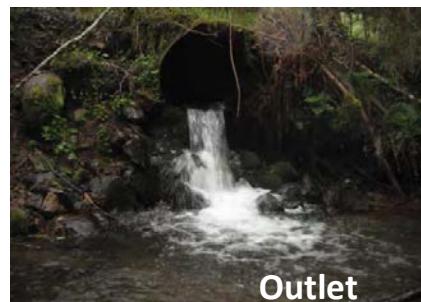
LOCATION INFO				Culvert #	432	Priority	H
<b>Watershed</b>		Miami River					
<b>Stream Name</b>		Hobson Creek					
<b>Township-Range-Section-1/4</b>		T1N, R10W, Sec. 15, SE ¼ of SW ¼					
<b>UTM Easting/Northing (Zone 10, NAD 1983)</b>		430115/5046264					
<b>Road Name</b>		Hobson Creek Road					
<b>Road/Culvert Owner</b>		A. Hutchison					
<b>Adjacent Landowners</b>		TNC, Tillamook County, and D. Schecter					
CULVERT INFO		CHANNEL INFO					
Shape	Pipe Arch	Inlet Gradient (%)	1.4				
Material	Smooth metal	Upstream Gradient (%)	6.5				
Length (ft)	24	Bankfull Width (ft)	8.7				
Width (in)	40	Bankfull:Culvert Ratio	0.38				
Height (in)	40						
Outlet Perch (ft)	3.6						
Slope (%)	1.3						
Rustline Height (in)	Entire pipe rusted						
Overall Condition	Poor						
PRIORITIZATION ANALYSIS							
Upstream Habitat Length (mi)	0.7	Habitat Points	2				
Habitat Quality	Fair	Habitat Quality Points	2				
Fish Species	Anad.	Fish Points	3

Barrier Class	Red	Barrier Points	3				
		Prioritization Total Points	10				
Notes:

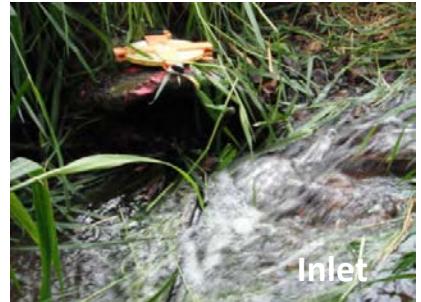
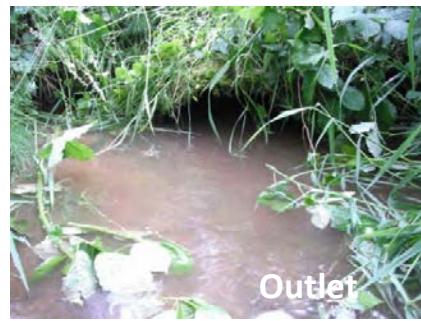
LOCATION INFO				Culvert #	444	Priority	M
Watershed			Miami River				
Stream Name			Struby Creek				
Township-Range-Section-1/4			T1N, R10W, Sec. 22, NE $\frac{1}{4}$ of NE $\frac{1}{4}$				
UTM Easting/Northing (Zone 10, NAD 1983)					430542/5045965		
Road Name			Miami Foley Road				
Road/Culvert Owner			Tillamook County				
Adjacent Landowners			G. Merritt, L. Parks, and TNC				
CULVERT INFO		CHANNEL INFO					
Shape	Circular	Inlet Gradient (%)	11.0				
Material	Concrete	Upstream Gradient (%)	5.3				
Length (ft)	43	Bankfull Width (ft)	4.1				
Width (in)	24	Bankfull:Culvert Ratio	0.5				
Height (in)	24						
Outlet Perch (ft)	None						
Slope (%)	4.6						
Rustline Height (in)	N/A						
Overall Condition	Poor						
PRIORITIZATION ANALYSIS							
Upstream Habitat Length (mi)	0.5	Habitat Points	1				
Habitat Quality	Fair	Habitat Quality Points	2				
Fish Species	Anad.	Fish Points	3				
Barrier Class	Red	Barrier Points	3

Prioritization Total Points	9				
Notes: Culvert was segmented and had begun to separate. Water was flowing alongside the pipe and entering the pipe from one of the separations under the road bed.

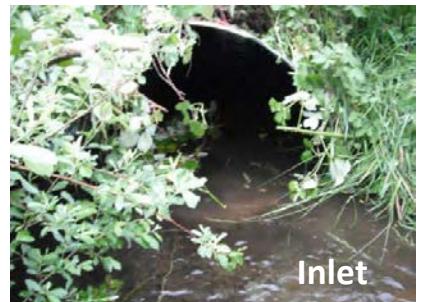
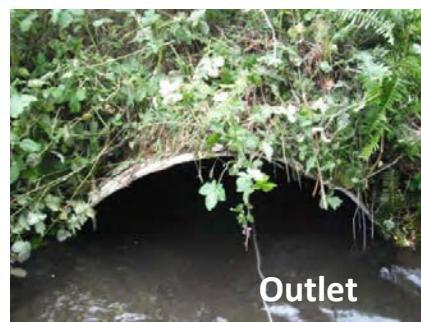
LOCATION INFO				Culvert #	462	Priority	H
Watershed			Miami River				
Stream Name			Illingsworth Creek				
Township-Range-Section-1/4			T1N, R10W, Sec. 23, NW $\frac{1}{4}$ of NW $\frac{1}{4}$				
UTM Easting/Northing (Zone 10, NAD 1983)					431174/5045718		
Road Name			Ekroth Road				
Road/Culvert Owner			Tillamook County				
Adjacent Landowners			State of Oregon, F. Underhill, and T. & K. Roach				
CULVERT INFO		CHANNEL INFO					
Shape	Pipe Arch	Inlet Gradient (%)	7.0				
Material	Corrugated metal	Upstream Gradient (%)	0.6				
Length (ft)	37	Bankfull Width (ft)	13.2				
Width (in)	72	Bankfull:Culvert Ratio	0.5				
Height (in)	50						
Outlet Perch (ft)	None						
Slope (%)	0.1						
Rustline Height (in)	22						
Overall Condition	Fair						
PRIORITIZATION ANALYSIS							
Upstream Habitat Length (mi)	1.6	Habitat Points	4				
Habitat Quality	Good	Habitat Quality Points	3				
Fish Species	Anad.	Fish Points	3

Barrier Class	Gray	Barrier Points	2				
		Prioritization Total Points	12				
Notes:

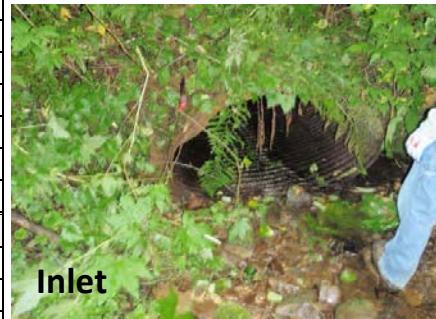
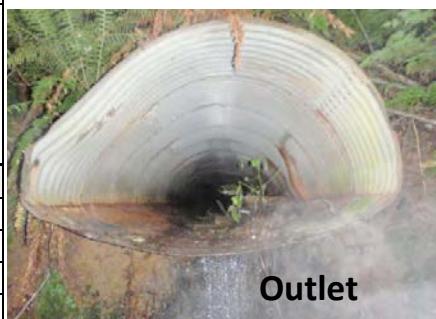
LOCATION INFO				Culvert #	278	Priority	M
<b>Watershed</b>		Miami River					
<b>Stream Name</b>		Unnamed tributary of Minich Creek					
<b>Township-Range-Section-1/4</b>		T1N, R11W, Sec. 10, SW $\frac{1}{4}$ of NE $\frac{1}{4}$					
<b>UTM Easting/Northing (Zone 10, NAD 1983)</b>		430917/5048132					
<b>Road Name</b>		Minich Creek Road					
<b>Road/Culvert Owner</b>		Oregon Department of Forestry					
<b>Adjacent Landowners</b>		Oregon Department of Forestry					
CULVERT INFO		CHANNEL INFO					
Shape	Pipe arch	Inlet Gradient (%)	23.0				
Material	Corrugated metal	Upstream Gradient (%)	7.0				
Length (ft)	75	Bankfull Width (ft)	11.0				
Width (in)	60	Bankfull:Culvert Ratio	0.5				
Height (in)	36						
Outlet Perch (ft)	3.0						
Slope (%)	4.0						
Rustline Height (in)	18						
Overall Condition	Poor						
PRIORITIZATION ANALYSIS							
Upstream Habitat Length (mi)	0.3	Habitat Points	1				
Habitat Quality	Fair	Habitat Quality Points	2

Fish Species	Anad.	Fish Points	3				
Barrier Class	Red	Barrier Points	3				
		Prioritization Total Points	9				
Notes: Culvert barrel was very deformed and its structural integrity appeared compromised.

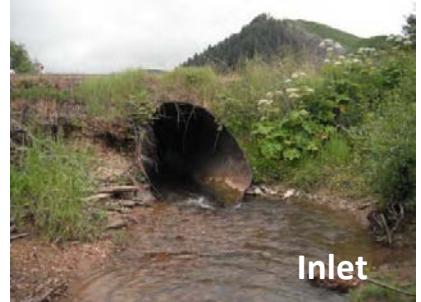
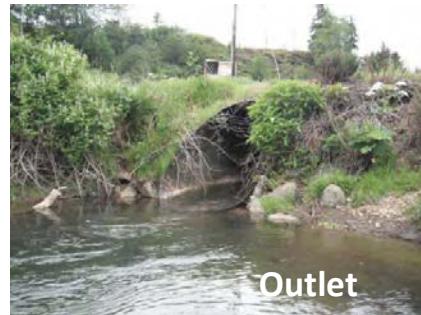
LOCATION INFO			Culvert #	189	Priority	H
Watershed		Miami River				
Stream Name		Peterson Creek				
Township-Range-Section-1/4		T1N, R10W, Sec. 2, NE $\frac{1}{4}$ of NW $\frac{1}{4}$				
UTM Easting/Northing (Zone 10, NAD 1983)		431586/5030520				
Road Name		Miami Foley Road				
Road/Culvert Owner		Tillamook County				
Adjacent Landowners		A. Waldron				
CULVERT INFO		CHANNEL INFO				
Shape	Circular	Inlet Gradient (%)	4.1			
Material	Corrugated metal	Upstream Gradient (%)	1.4			
Length (ft)	46	Bankfull Width (ft)	15.4			
Width (in)	96	Bankfull:Culvert Ratio	0.5			
Height (in)	96					
Outlet Perch (ft)	0.2*					
Slope (%)	1.0					
Rustline Height (in)	30					
Overall Condition	Poor					
PRIORITIZATION ANALYSIS						
Upstream Habitat Length (mi)	6.2	Habitat Points	4			
Habitat Quality	Good	Habitat Quality Points	3			
Fish Species	Anad.	Fish Points	3			
Barrier Class	Gray	Barrier Points	2			
		Prioritization Total Points	12

**Notes:** \*Outlets into Miami River mainstem. Tailwater control point not measurable so perch height was estimated.

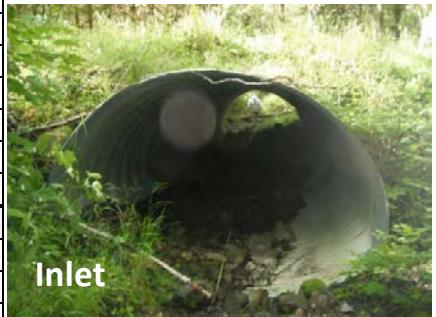
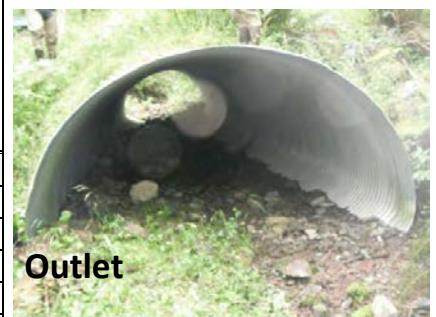
LOCATION INFO				Culvert #	84	Priority	L				
<b>Watershed</b>		Miami River									
<b>Stream Name</b>		Unnamed tributary to Miami River									
<b>Township-Range-Section-1/4</b>		T2N, R9W, Sec. 21, NW $\frac{1}{4}$ of SW $\frac{1}{4}$									
<b>UTM Easting/Northing (Zone 10, NAD 1983)</b>		439281/5054779									
<b>Road Name</b>		Miami Forest River Road									
<b>Road/Culvert Owner</b>		Oregon Dept. of Forestry									
<b>Adjacent Landowners</b>		Oregon Department of Forestry									
CULVERT INFO		CHANNEL INFO									
<b>Shape</b>	Pipe Arch	<b>Inlet Gradient (%)</b>	12.5								
<b>Material</b>	Corrugated metal	<b>Upstream Gradient (%)</b>	10.1								
<b>Length (ft)</b>	55	<b>Bankfull Width (ft)</b>	9.7								
<b>Width (in)</b>	120	<b>Bankfull:Culvert Ratio</b>	1.2								
<b>Height (in)</b>	96										
<b>Outlet Perch (ft)</b>	10.3*	Stream dry during summer 2011 site visit.									
<b>Slope (%)</b>	3.6

<b>Rustline Height (in)</b>	N/A										
<b>Overall Condition</b>	Fair										
PRIORITIZATION ANALYSIS											
<b>Upstream Habitat Length (mi)</b>	0.2	<b>Habitat Points</b>	1								
<b>Habitat Quality</b>	Poor	<b>Habitat Quality Points</b>	1								
<b>Fish Species</b>	Anad.	<b>Fish Points</b>	3								
<b>Barrier Class</b>	Red	<b>Barrier Points</b>	3								
		<b>Prioritization Total Points</b>	8								
<b>Notes:</b> *Stream cascades over steep boulders and cobbles into the mainstem Miami River shortly after exiting this culvert. Barrier class and outlet perch based on this fact.
