**Tillamook Bay Tributaries  
Culverts**

Tillamook Bay Tributaries Crossings

## **North Tillamook Bay Tributaries Culverts**

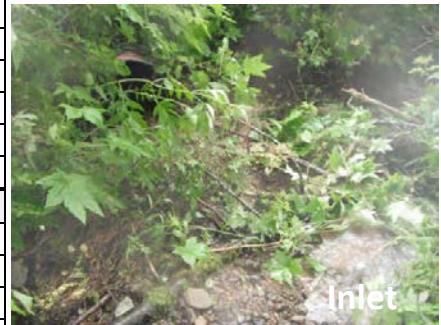
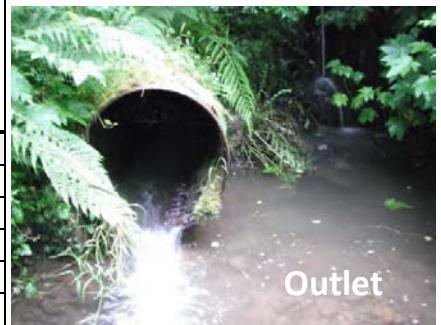
LOCATION INFO				Culvert #	413	Priority	M
Watershed			Tillamook Bay				
Stream Name			Smith Creek				
Township-Range-Section-1/4			T1N, R10W, Sec. 20, NE $\frac{1}{4}$ of SE $\frac{1}{4}$				
UTM Easting/Northing (Zone 10, NAD 1983)				427659/5046723			
Road Name			Barview Forest Road				
Road/Culvert Owner			Private Drive – ORM Timber				
Adjacent Landowners			ORM Timber				
CULVERT INFO		CHANNEL INFO					
Shape	Circular	Inlet Gradient (%)	12.0(N/A)				
Material	Corrugated metal	Upstream Gradient (%)	1.1				
Length (ft)	45(45)	Bankfull Width (ft)	10.1				
Width (in)	36(36)	Bankfull:Culvert Ratio	0.6*				
Height (in)	36(36)	Two pipes at this location. The outlet picture depicts pipe 2 in the foreground and the outfall of pipe 1 in the background (upper right corner of photo).					
Outlet Perch (ft)	7.5(0.8)						
Slope (%)	3.0(N/A)						
Rustline Height (in)	16(N/A)						
Overall Condition	Poor						
PRIORITIZATION ANALYSIS

Upstream Habitat Length (mi)	0.3	Habitat Points	1				
Habitat Quality	Fair	Habitat Quality Points	2				
Fish Species	Anad.	Fish Points	3				
Barrier Type	Red	Barrier Points	3				
		Prioritization Total Points	9

**Notes:** \*Bankfull:Culvert Ratio is based on both pipes. Both are 3 ft circular pipes and both were conveying flows during summer 2011 field visit. We were unable to locate the inlet for pipe 2 and it was unclear how flows were entering the pipe. Pipe 2 was perched 0.8 ft.

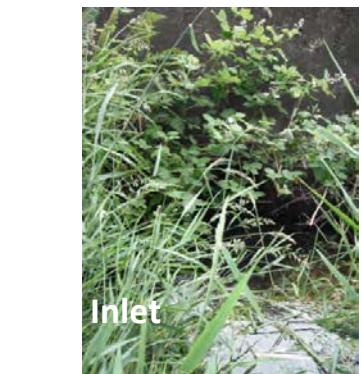
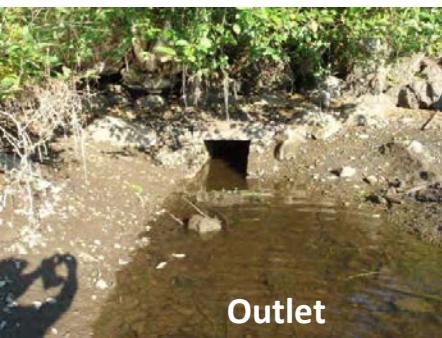
LOCATION INFO		Culvert #	453/454	Priority	?
Watershed	Tillamook Bay				
Stream Name	School Creek				
Township-Range-Section-1/4	T1N, R10W, Sec. 21, SE $\frac{1}{4}$ of NE $\frac{1}{4}$				
UTM Easting/Northing (Zone 10, NAD 1983)	429205/5045779 (inlet)				
Road Name	Several within Garibaldi Town Limits				
Road/Culvert Owner	City of Garibaldi				
Adjacent Landowners	Numerous private properties in Garibaldi				
CULVERT INFO		CHANNEL INFO			
Shape	Circular	Inlet Gradient (%)	1.0		
Material (at inlet)	Corrugated Metal	Upstream Gradient (%)	1.0		
Length (ft)	~700*	Bankfull Width (ft)	5.0		
Width (in)	36	Bankfull:Culvert Ratio	0.6		
Height (in)	36	*Slope and length estimated from aerial photograph and GIS data. A board across stream creates an ~1ft step in stream ~5ft above inlet.			
Outlet Perch (ft)	None	*Slope and length estimated from aerial photograph and GIS data. A board across stream creates an ~1ft step in stream ~5ft above inlet.

Slope (%)	~2.0*	*Slope and length estimated from aerial photograph and GIS data. A board across stream creates an ~1ft step in stream ~5ft above inlet.			
Rustline Height (in)	20	*Slope and length estimated from aerial photograph and GIS data. A board across stream creates an ~1ft step in stream ~5ft above inlet.			
Overall Condition	unknown	*Slope and length estimated from aerial photograph and GIS data. A board across stream creates an ~1ft step in stream ~5ft above inlet.			
PRIORITIZATION ANALYSIS					
Upstream Habitat Length (mi)	0.9	Habitat Points	2		
Habitat Quality	Poor	Habitat Quality Points	1		
Fish Species	Anad.	Fish Points	3		
Barrier Type	Red	Barrier Points	3		
		Prioritization Total Points	9		
<b>Notes:</b> Originally identified as two crossings. Stream enters culvert at crossing location 453 and flows underground to crossing location 454, where it passes under Highway 101 before flowing into the bay. Pipe either passes under buildings or is not routed in a straight line (probably the latter, but unknown). The outlet end of this culvert is constructed entirely from treated timbers.

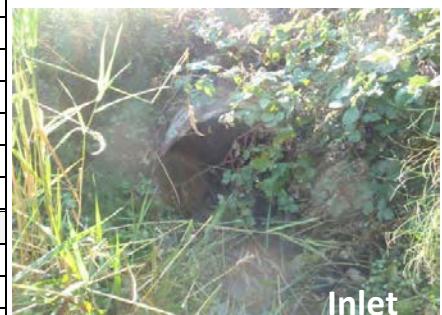
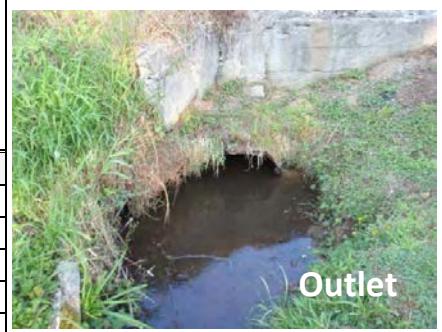
LOCATION INFO		Culvert #	5304	Priority	M
Watershed	Tillamook Bay				
Stream Name	School Creek				
Township-Range-Section-1/4	T1N, R10W, Sec. 20, SW $\frac{1}{4}$ of NE $\frac{1}{4}$				
UTM Easting/Northing (Zone 10, NAD 1983)	429112/5045771				
Road Name	Church Parking Lot				
Road/Culvert Owner	Private Drive				
Adjacent Landowners	Garibaldi Faith Church				
CULVERT INFO		CHANNEL INFO			
Shape	Circular	Inlet Gradient (%)	7.0		
Material	Corrugated Metal	Upstream Gradient (%)	4.0		
Length (ft)	125	Bankfull Width (ft)	8.0		
Width (in)	36	Bankfull:Culvert Ratio	0.4		
Height (in)	36	Natural substrate throughout pipe.			
Outlet Perch (ft)	None	Natural substrate throughout pipe.			
Slope (%)	1.0	Natural substrate throughout pipe.			
Rustline Height (in)	18	Natural substrate throughout pipe.			
Overall Condition	Poor	Natural substrate throughout pipe.			
PRIORITIZATION ANALYSIS					
Upstream Habitat Length (mi)	0.7	Habitat Points	2

Habitat Quality	Poor	Habitat Quality Points	1		
Fish Species	Anad.	Fish Points	3		
Barrier Type	Red	Barrier Points	3		
		Prioritization Total Points	9		
<b>Notes:</b> Barrel of pipe is deformed. In addition, the outlet is wider (42 inch width) and a different shape than the inlet (it is a pipe arch). Two different pipes may have been joined to allow construction of the church parking lot. Barrier rating based on BFW:Culvert ratio, but during low flows (e.g., when we observed the pipe during summer 2012) it appears that juvenile fish could pass through the culvert.

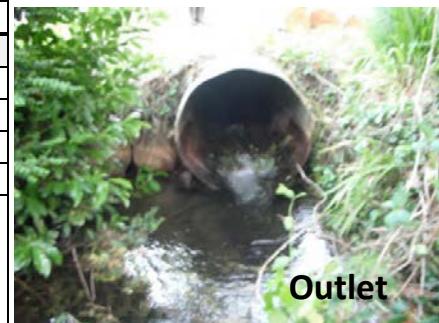
LOCATION INFO				Culvert #	5303	Priority	L				
Watershed				Tillamook Bay							
Stream Name				Whitney Creek							
Township-Range-Section-1/4				T1N, R10W, Sec. 22, NE <sup>1/4</sup> of NW <sup>1/4</sup>							
UTM Easting/Northing (Zone 10, NAD 1983)				429760/5045944							
Road Name				Martin Smith Lane							
Road/Culvert Owner				Private							
Adjacent Landowners				R. Perigo and T. & C. North							
CULVERT INFO		CHANNEL INFO									
Shape	Circular	Inlet Gradient (%)	6.5								
Material	Corrugated metal	Upstream Gradient (%)	4.5								
Length (ft)	55	Bankfull Width (ft)	5.2								
Width (in)	36	Bankfull:Culvert Ratio	0.6								
Height (in)	36										
Outlet Perch (ft)	0.7										
Slope (%)	3.5										
Rustline Height (in)	18										
Overall Condition	Critical										
PRIORITIZATION ANALYSIS											
Upstream Habitat Length (mi)	0.4	Habitat Points	1								
Habitat Quality	Poor	Habitat Quality Points	1

Fish Species	Anad.	Fish Points	3								
Barrier Type	Red	Barrier Points	3								
		Prioritization Total Points	8								
Notes: Bottom completely worn through. Culvert in extremely poor condition. Couldn't access inlet.

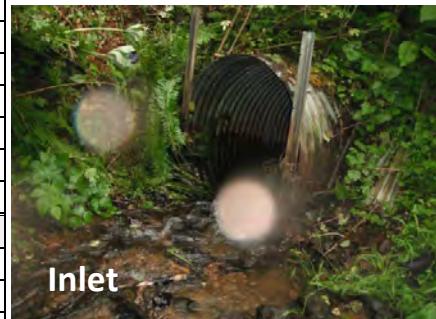
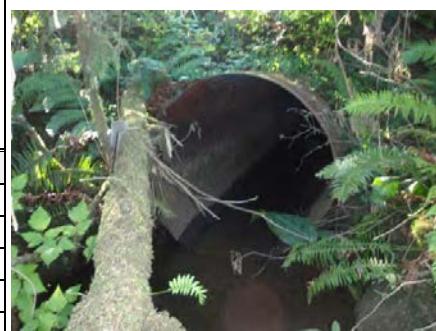
LOCATION INFO		Culvert #	476	Priority	M
Watershed	Tillamook Bay				
Stream Name	Electric Creek				
Township-Range-Section-1/4	T1N, R10W, Sec. 22, SW $\frac{1}{4}$ of NE $\frac{1}{4}$				
UTM Easting/Northing (Zone 10, NAD 1983)	430186/5045387				
Road Name	Highway 101				
Road/Culvert Owner	Oregon Department of Transportation				
Adjacent Landowners	B. Green				
CULVERT INFO		CHANNEL INFO			
Shape	Circular	Inlet Gradient (%)	1.1		
Material	Corrugated metal	Upstream Gradient (%)	1.1		
Length (ft)	~160	Bankfull Width (ft)	5.2		
Width (in)	48 (inlet) 60 (outlet)	Bankfull:Culvert Ratio	1.0		
Height (in)	48 (inlet) 60 (outlet)				
Outlet Perch (ft)	None				
Slope (%)	Variable				
Rustline Height (in)	30				
Overall Condition	Critical				
PRIORITIZATION ANALYSIS					
Upstream Habitat Length (mi)	1.0	Habitat Points	2		
Habitat Quality	Poor	Habitat Quality Points	1		
Fish Species	Anad.	Fish Points	3		
Barrier Type	Red	Barrier Points	3

**Notes:** Inlet and outlet are corrugated metal, but a portion of the middle of the pipe is concrete. Corrugated sections are highly corroded and severe cross sectional deformation was noted for portions of the pipe. Unable to survey or use Abney level to obtain several pieces of data used to characterize culverts. Gradient of the inlet section of pipe was extremely steep (~20 %), outlet section was much less steep.

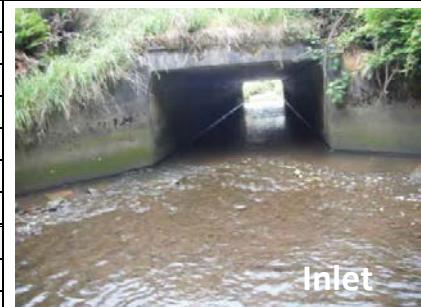
LOCATION INFO				Culvert #	581	Priority	H
Watershed		Tillamook Bay					
Stream Name		Patterson Creek					
Township-Range-Section-1/4		T1N, R10W, Sec. 34, SW $\frac{1}{4}$ of SE $\frac{1}{4}$					
UTM Easting/Northing (Zone 10, NAD 1983)		430242/5041650					
Road Name		Highway 101					
Road/Culvert Owner		Oregon Department of Transportation					
Adjacent Landowners		ODOT, Port of Garibaldi					
CULVERT INFO		CHANNEL INFO					
Shape	Box	Inlet Gradient (%)	0.1				
Material	Concrete	Upstream Gradient (%)	0.2				
Length (ft)	105	Bankfull Width (ft)	22.0				
Width (in)	96	Bankfull:Culvert Ratio	0.4				
Height (in)	96						
Outlet Perch (ft)	None						
Slope (%)	0.2						
Rustline Height (in)	48						
Overall Condition	Fair						
PRIORITIZATION ANALYSIS							
Upstream Habitat Length (mi)	3.8	Habitat Points	4				
Habitat Quality	Fair(-)	Habitat Quality Points	2				
Fish Species	Anad.	Fish Points	3				
Barrier Class	Gray	Barrier Points	2

Prioritization Total Points	11				
<p><b>Notes:</b> Although classified as Gray, this culvert likely passes fish under most conditions. Classification is based on BFW:Width Ratio, but because culvert is tidally influence and completely backwatered under most conditions, it seems likely that passage is rarely inhibited by this crossing. That being said, the culvert is undersized and almost certainly impairs tidal processes.</p>

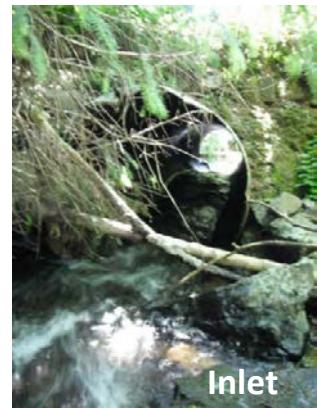
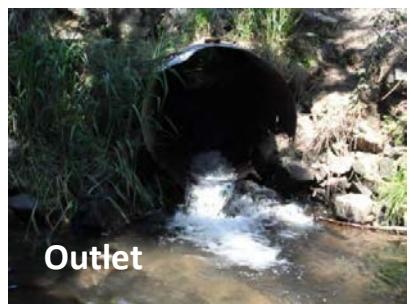
LOCATION INFO				Culvert #	575	Priority	H
Watershed			Tillamook Bay				
Stream Name			Patterson Creek				
Township-Range-Section-1/4			T1N, R10W, Sec. 35, SE $\frac{1}{4}$ of NW $\frac{1}{4}$				
UTM Easting/Northing (Zone 10, NAD 1983)			430727/5041881				
Road Name			Unnamed drive off Main Ave.				
Road/Culvert Owner			City of Bay City				
Adjacent Landowners			D. Buxton, R. & S. Blodget				
CULVERT INFO		CHANNEL INFO					
Shape	Circular	Inlet Gradient (%)	2.8				
Material	Corrugated metal	Upstream Gradient (%)	2.2				
Length (ft)	36	Bankfull Width (ft)	11.6				
Width (in)	60	Bankfull:Culvert Ratio	0.4				
Height (in)	60						
Outlet Perch (ft)	0.8						
Slope (%)	3.4						
Rustline Height (in)	18						
Overall Condition	Critical						
PRIORITIZATION ANALYSIS							
Upstream Habitat Length (mi)	2.3	Habitat Points	4				
Habitat Quality	Fair(-)	Habitat Quality Points	2				
Fish Species	Anad.	Fish Points	3

Barrier Type	Red	Barrier Points	3				
		Prioritization Total Points	12				
Notes: Bottom and side of culvert completely worn through.

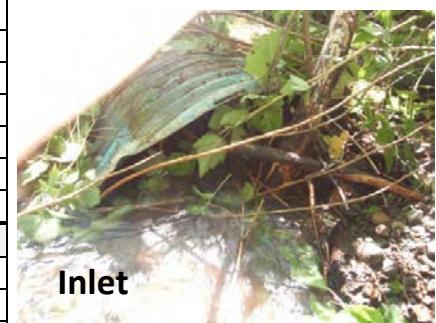
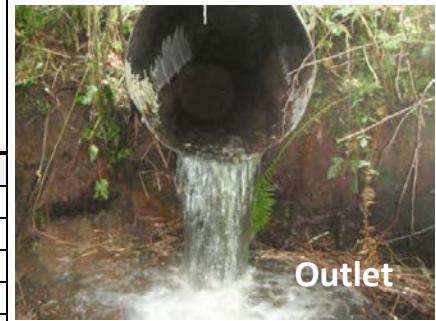
LOCATION INFO				Culvert #	542	Priority	M
Watershed		Tillamook Bay					
Stream Name		Patterson Creek					
Township-Range-Section-1/4		T1N, R10W, Sec. 26, SE $\frac{1}{4}$ of SW $\frac{1}{4}$					
UTM Easting/Northing (Zone 10, NAD 1983)		431891/5042999					
Road Name		Unnamed Forest Road					
Road/Culvert Owner		Oregon Department of Forestry					
Adjacent Landowners		Oregon Department of Forestry					
CULVERT INFO		CHANNEL INFO					
Shape	Circular	Inlet Gradient (%)	28.8				
Material	Corrugated metal	Upstream Gradient (%)	3.6				
Length (ft)	43	Bankfull Width (ft)	8.7				
Width (in)	36	Bankfull:Culvert Ratio	0.3				
Height (in)	36						
Outlet Perch (ft)	1.6						
Slope (%)	5.0						
Rustline Height (in)	7						
Overall Condition	Poor						
PRIORITIZATION ANALYSIS							
Upstream Habitat Length (mi)	0.5	Habitat Points	1				
Habitat Quality	Fair	Habitat Quality Points	2				
Fish Species	Anad.	Fish Points	3

Barrier Type	Red	Barrier Points	3				
		Prioritization Total Points	9				
Notes: Large amount of sediment and debris in inlet. Water overflowing pipe inlet during early summer survey visit.

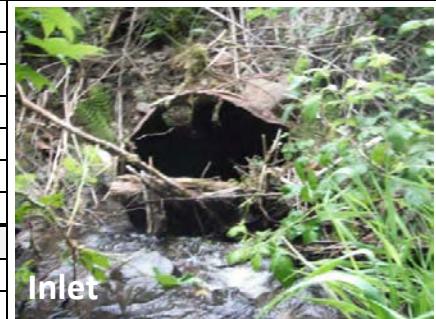
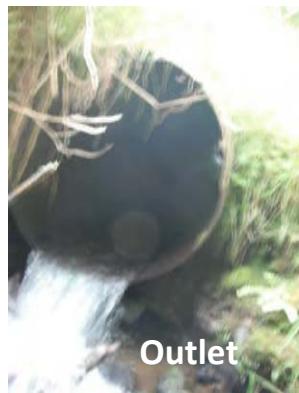
LOCATION INFO			Culvert #	543	Priority	M
Watershed		Tillamook Bay				
Stream Name		Unnamed tributary to Patterson Creek				
Township-Range-Section-1/4		T1N, R10W, Sec. 25, NW $\frac{1}{4}$ of SE $\frac{1}{4}$				
UTM Easting/Northing (Zone 10, NAD 1983)		431979/5042920				
Road Name		Unnamed Forest Road				
Road/Culvert Owner		Oregon Department of Forestry				
Adjacent Landowners		Oregon Department of Forestry				
CULVERT INFO		CHANNEL INFO				
Shape	Circular	Inlet Gradient (%)	66.3			
Material	Corrugated metal	Upstream Gradient (%)	7.3			
Length (ft)	41	Bankfull Width (ft)	5.7			
Width (in)	42	Bankfull:Culvert Ratio	0.6			
Height (in)	42					
Outlet Perch (ft)	3.1					
Slope (%)	4.2					
Rustline Height (in)	23					
Overall Condition	Poor					
PRIORITIZATION ANALYSIS						
Upstream Habitat Length (mi)	0.4	Habitat Points	1			
Habitat Quality	Fair	Habitat Quality Points	2			
Fish Species	Anad.	Fish Points	3

**Notes:** Large amount of debris in inlet.

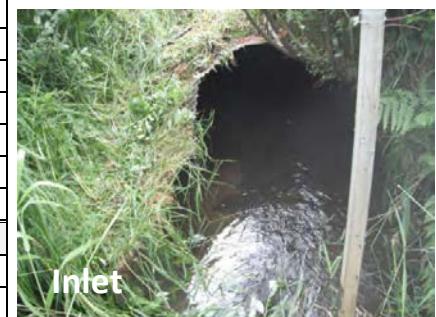
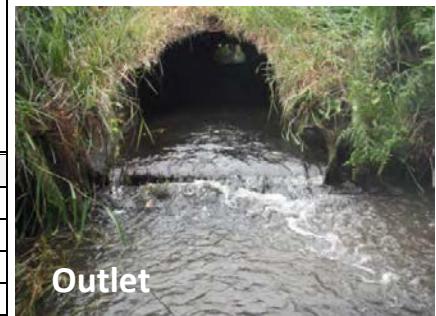
LOCATION INFO			Culvert #	647	Priority	H
Watershed		Kilchis River				
Stream Name		Doty Creek				
Township-Range-Section-1/4		T1S, R10W, Sec. 2, SW $\frac{1}{4}$ of SE $\frac{1}{4}$				
UTM Easting/Northing (Zone 10, NAD 1983)		431728/5039890				
Road Name		Highway 101				
Road/Culvert Owner		Oregon Department of Transportation				
Adjacent Landowners		M. Farrington, F. & L. Adkins				
CULVERT INFO		CHANNEL INFO				
Shape	Pipe Arch	Inlet Gradient (%)	2.7			
Material	Corrugated metal	Upstream Gradient (%)	13.2			
Length (ft)	75	Bankfull Width (ft)	5.8			
Width (in)	66	Bankfull:Culvert Ratio	0.9			
Height (in)	36					
Outlet Perch (ft)	0.5					
Slope (%)	0.7					
Rustline Height (in)	10					
Overall Condition	Fair					
PRIORITIZATION ANALYSIS						
Upstream Habitat Length (mi)	1.7	Habitat Points	4			
Habitat Quality	Fair	Habitat Quality Points	2			
Fish Species	Anad.	Fish Points	3			
Barrier Type	Red	Barrier Points	3

Prioritization Total Points	12			
Notes: Integrated apron on outlet.

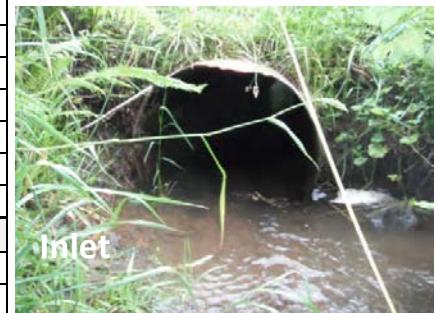
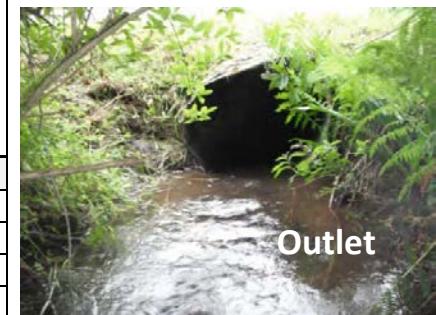
LOCATION INFO		Culvert #	636	Priority	H
<b>Watershed</b>		Tillamook Bay			
<b>Stream Name</b>		Doty Creek			
<b>Township-Range-Section-1/4</b>		T1S, R10W, Sec. 2, NE $\frac{1}{4}$ of SE $\frac{1}{4}$			
<b>UTM Easting/Northing</b> (Zone 10, NAD 1983)		432285/5040153			
<b>Road Name</b>		Vaughan Road			
<b>Road/Culvert Owner</b>		City of Bay City			
<b>Adjacent Landowners</b>		J. Johnson, M. Smith, J.&J. Keppner			
CULVERT INFO		CHANNEL INFO			
<b>Shape</b>	Circular	<b>Inlet Gradient (%)</b>	2.9		
<b>Material</b>	Corrugated metal	<b>Upstream Gradient (%)</b>	1.2		
<b>Length (ft)</b>	37	<b>Bankfull Width (ft)</b>	6.8		
<b>Width (in)</b>	36	<b>Bankfull:Culvert Ratio</b>	0.4		
<b>Height (in)</b>	36				
<b>Outlet Perch (ft)</b>	0.1				
<b>Slope (%)</b>	0.3				
<b>Rustline Height (in)</b>	16				
<b>Overall Condition</b>	Fair				
PRIORITIZATION ANALYSIS					
<b>Upstream Habitat Length (mi)</b>	1.2	<b>Habitat Points</b>	3

<b>Habitat Quality</b>	Fair	<b>Habitat Quality Points</b>	2		
<b>Fish Species</b>	Anad.	<b>Fish Points</b>	3		
<b>Barrier Type</b>	Red	<b>Barrier Points</b>	3		
		<b>Prioritization Total Points</b>	11		
<b>Notes:</b> Entire culvert rusty.

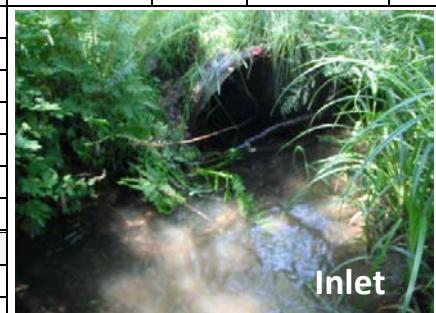
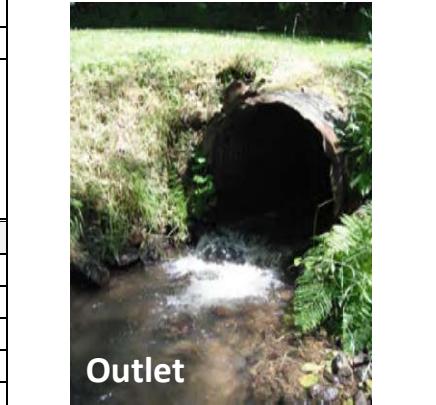
LOCATION INFO		Culvert #	622	Priority	H
<b>Watershed</b>		Tillamook Bay			
<b>Stream Name</b>		Doty Creek			
<b>Township-Range-Section-1/4</b>		T1S, R10W, Sec. 1, SW $\frac{1}{4}$ of NW $\frac{1}{4}$			
<b>UTM Easting/Northing</b> (Zone 10, NAD 1983)		432654/5040550			
<b>Road Name</b>		Private Drive off Doughty Road			
<b>Road/Culvert Owner</b>		G. Oldenkamp			
<b>Adjacent Landowners</b>		R. Rasmussen, J.&T. Jepson			
CULVERT INFO		CHANNEL INFO			
<b>Shape</b>	Circular	<b>Inlet Gradient (%)</b>	11.8		
<b>Material</b>	Corrugated metal	<b>Upstream Gradient (%)</b>	1.2		
<b>Length (ft)</b>	19	<b>Bankfull Width (ft)</b>	8.6		
<b>Width (in)</b>	45	<b>Bankfull:Culvert Ratio</b>	0.4		
<b>Height (in)</b>	45				
<b>Outlet Perch (ft)</b>	0.6				
<b>Slope (%)</b>	8.0				
<b>Rustline Height (in)</b>	18				
<b>Overall Condition</b>	Poor				
PRIORITIZATION ANALYSIS					
<b>Upstream Habitat Length (mi)</b>	0.8	<b>Habitat Points</b>	2

<b>Habitat Quality</b>	Fair	<b>Habitat Quality Points</b>	2		
<b>Fish Species</b>	Anad.	<b>Fish Points</b>	3		
<b>Barrier Type</b>	Red	<b>Barrier Points</b>	3		
		<b>Prioritization Total Points</b>	10		
<b>Notes:</b> Cascade into inlet and bottom worn through on outlet.

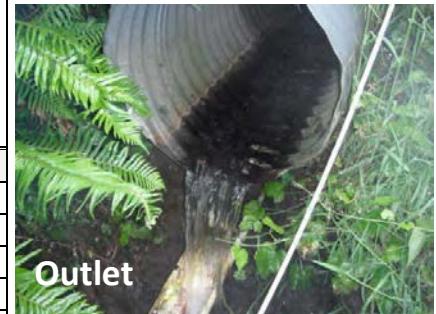
LOCATION INFO				Culvert #	593	Priority	
Watershed		Tillamook Bay					
Stream Name		Doty Creek					
Township-Range-Section-1/4		T1N, R10W, Sec. 36, SE $\frac{1}{4}$ of NW $\frac{1}{4}$					
UTM Easting/Northing (Zone 10, NAD 1983)		432915/5041390					
Road Name		Private drive off Willowbrook Drive					
Road/Culvert Owner		Alderbrook Hills Road & Maintenance					
Adjacent Landowners		E.&K. Heuberger, B. Germond					
CULVERT INFO		CHANNEL INFO					
Shape	Circular	Inlet Gradient (%)	5.6				
Material	Corrugated metal	Upstream Gradient (%)	1.9				
Length (ft)	44	Bankfull Width (ft)	5.2				
Width (in)	24	Bankfull:Culvert Ratio	0.4				
Height (in)	24						
Outlet Perch (ft)	4.2						
Slope (%)	6.3						
Rustline Height (in)	unknown						
Overall Condition	Fair						
PRIORITIZATION ANALYSIS							
Upstream Habitat Length (mi)	0.3	Habitat Points	1				
Habitat Quality	Fair	Habitat Quality Points	2				
Fish Species	Anad.	Fish Points	3

Barrier Type	Red	Barrier Points	3				
		Prioritization Total Points	9				
Notes: Small PVC "apron" on outlet
