# **Tillamook River Basin Culverts**

### Tillamook River Basin Clusters

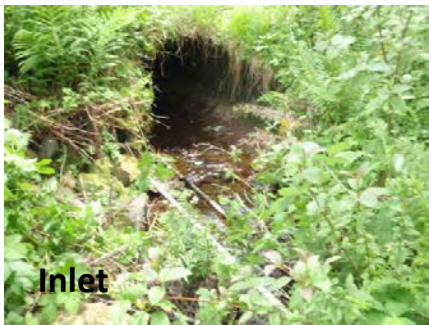
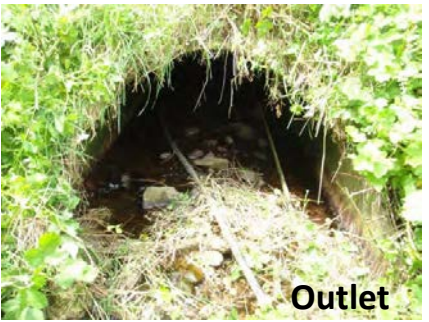
| LOCATION INFO | | | | Culvert # | 848 | Priority | L |
|---|---|--|---|---|---|---|---|
| Overall Condition | Poor | | | | | | |
| Barrier Class | Red | | Barrier Points | 3 | | | |
| <b>Notes:</b> Mixed construction crossing: inlet and outlet were corrugated metal pipe arches and central portion of crossing was a concrete box. Dimensions above are for the pipe arch portions. | | | | | | | |

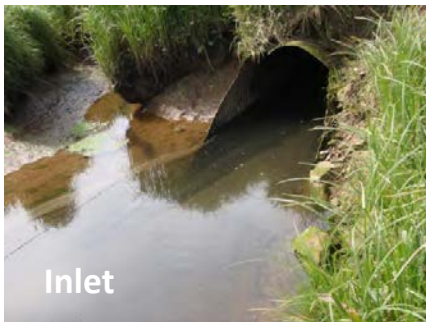
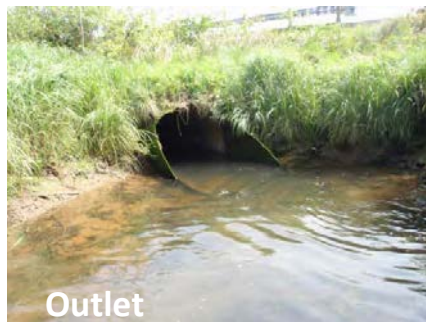
| LOCATION INFO | | | | Culvert # | 908 | Priority | H |
|---|---|---|---|---|---|---|---|
| Height (in) | 78 | Seam separation and culvert barrel deformation noted. Also, there was a dike and system of tidegates that was not surveyed as part of this study approximately 100 m upstream of this culvert. | | | | | |
| Rustline Height (in) | Entirely rusted | | | | | | |
| Overall Condition | Poor | | | | | | |
| Barrier Class | Gray | Barrier Points | | | | 2 | |
| <b>Notes:</b> Classification is based on BFW:Width Ratio. Because culvert is tidally influenced and completely backwatered under most conditions, it seems likely that passage is rarely inhibited by this crossing. However, the culvert is undersized and almost certainly impairs tidal processes. | | | | | | | |

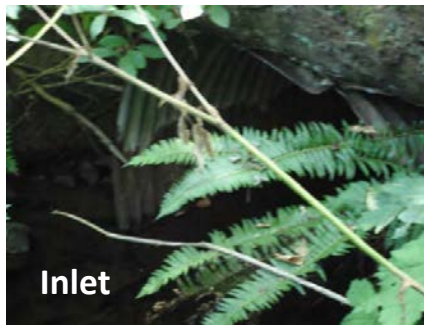
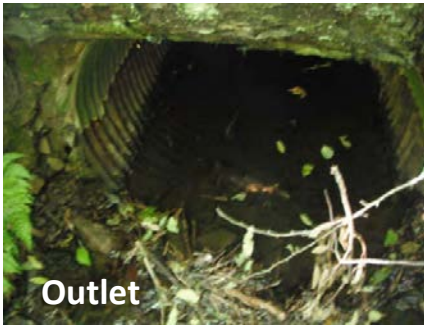
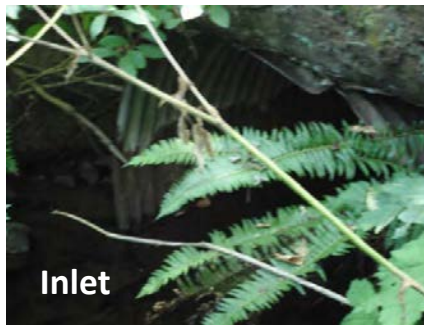
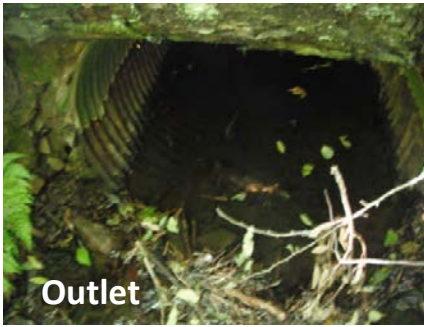
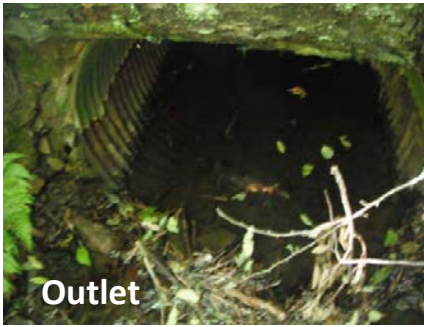
| LOCATION INFO | | | | Culvert # | 893 | Priority | H |
|---|---|---|---|---|---|---|---|
| Height (in) | 48* | *Logs placed on top of pipe on inlet and outlet. Top of pipe bent down flat to accommodate logs (hence the 48" vertical dimension). Invert was very corroded and in critical condition. | | | | | |
| Overall Condition | Critical | | | | | | |
| Barrier Class | Red | Barrier Points | 3 | | | | |
| <b>Notes:</b> Based on review of RBA data, it appears that a second pipe also occurs along this stream that we were unable to survey. That report indicates that that pipe was perched >1.0 ft and impassable for juvenile fish. | | | | | | | |

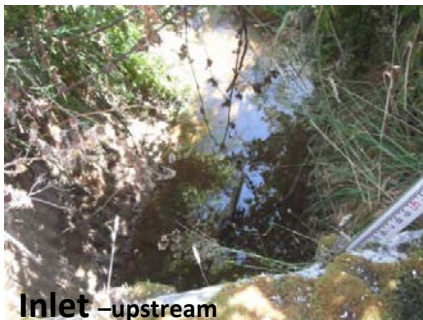
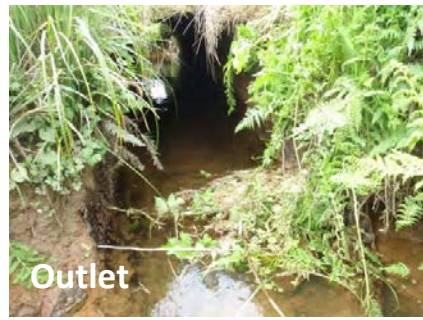
| LOCATION INFO | | | | Culvert # | 931 | Priority | H | |
|---|---|---|--|---|---|---|---|---|
| Overall Condition | Poor | | | | | | | |
| Barrier Class | Gray | Barrier Points | | | | 2 | | |
| <b>Notes:</b> A substantial portion of this stream flows through pastures and has highly impaired riparian habitats. Nervertheless, this system is well-used by juvenile salmonids. | | | | | | | | |

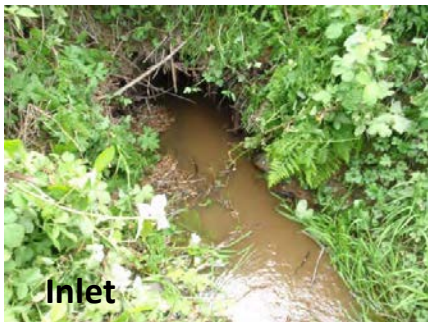
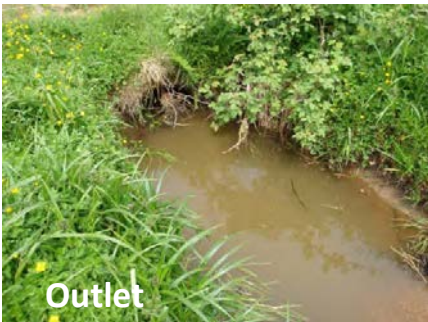
| LOCATION INFO | | | | Culvert # | 932 | Priority | H |

| LOCATION INFO | | | | Culvert # | 932 | Priority | H |
|---|---|---|---|---|---|---|---|
| Overall Condition | Fair | | | | | | |
| Barrier Class | Gray | Barrier Points | 2 | | | | |
| Notes: A portion of this stream flows through pastures and has highly impaired riparian habitats. | | | | | | | |

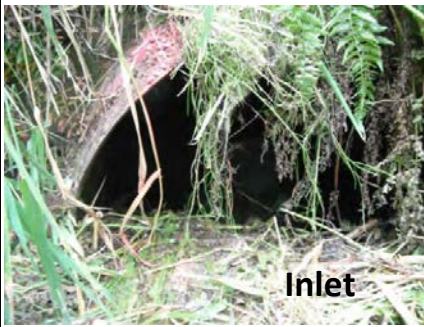
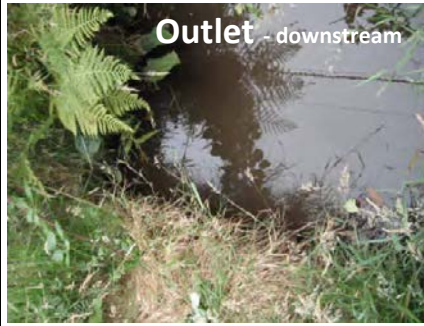
| LOCATION INFO | | | | Culvert # | 985 | Priority | L |

| LOCATION INFO | | | | Culvert # | 985 | Priority | L |
|---|---|---|---|---|---|---|---|
| Overall Condition | | Fair | | | | | |
| Barrier Class | | Red | Barrier Points | | 3 | | |

**Notes:** Inlet is a circular metal pipe that is approximately 75% blocked by sediment. Outlet was mostly submerged and concrete. The pipes appear to connect at a manhole near the intersection of Hwy 131 and a private drive. These two pipes appear to run approximately perpendicular to one another. Length of pipe estimated. In May 2012, we observed spawning Western Brook Lamprey immediately above this culvert.

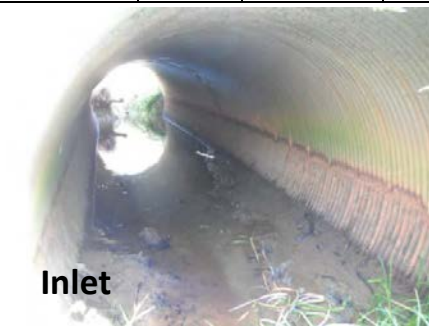
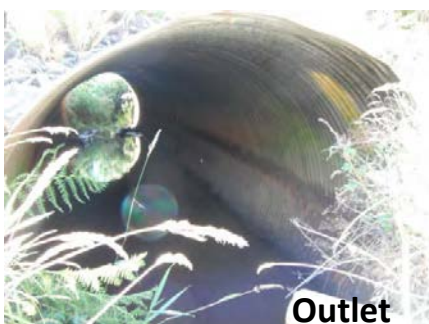
| LOCATION INFO | | | | Culvert # | 1102 | Priority | NA |
|---|---|---|---|---|---|---|---|
| Overall Condition | Poor | | | | | <br><b>Outlet</b> | |
| <b>Notes:</b> Although, based on most factors, this culvert does not appear to be a barrier; it is included here due to its poor condition assessment which indicates it should be replaced in the near future. | | | | | | | |

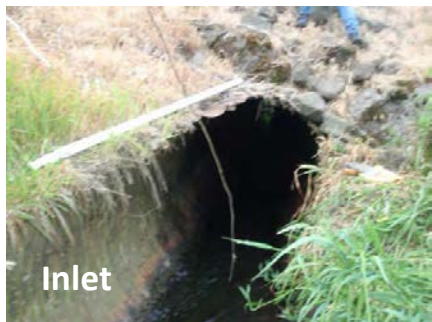
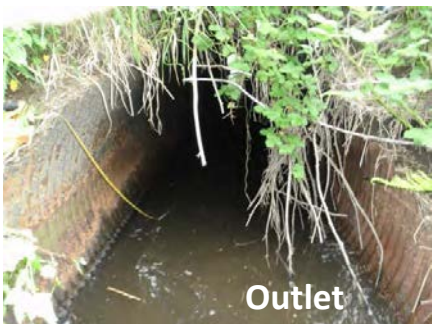
| LOCATION INFO | | | | Culvert # | 6666 | Priority | H |

| LOCATION INFO | | | | Culvert # | 6666 | Priority | H |
|---|---|---|---|---|---|---|---|
| Height (in) | 56 | *Unable to access upstream. BFW based on visual estimate. | | | | | |
| Overall Condition | Fair | | | | | | |
| Barrier Class | Gray | Barrier Points | 2 | | | | |

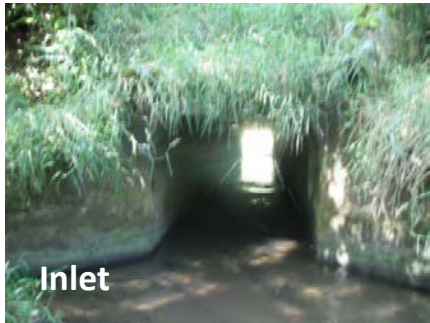
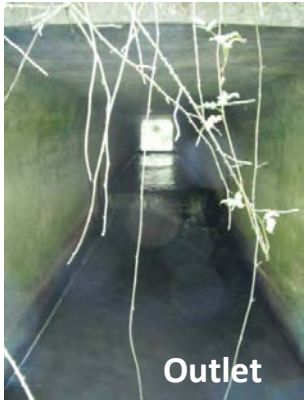
| LOCATION INFO | | | | Culvert # | 1234 | Priority | H |
|---|---|---|---|---|---|---|---|
| Height (in) | 96 | Three ~1ft baffles inside pipe. Also includes a fish ladder where culvert outlets into Tillamook River mainstem. Ladder has two ~3ft sills. An ~1ft jump is required to clear each sill and enter the culvert. | | | | | |
| Outlet Perch (ft) | 4.4 | | | | | | |
| Barrier Class | Red | Barrier Points | 3 | | | | |
| <b>Notes:</b> Perch based on elevation difference between outlet invert and outlet pool tailwater control point below fish ladder. Fish surveys indicate that adults are able to pass this culvert, but the ladder is clearly a barrier to juvenile passage. | | | | | | | |

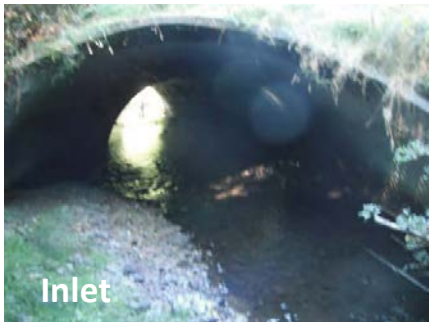
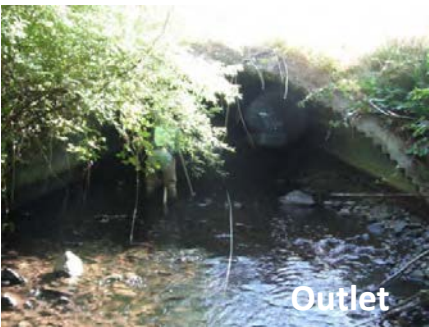
| LOCATION INFO | | | | Culvert # | 1330 | Priority | NA |
|---|---|---|---|---|---|---|---|
| Overall Condition | Fair | | | | | | |
| <b>Notes:</b> Pipe barrel is not straight. It bends in the middle, but it is unclear whether it was constructed this way or has become deformed over time. | | | | | | | |

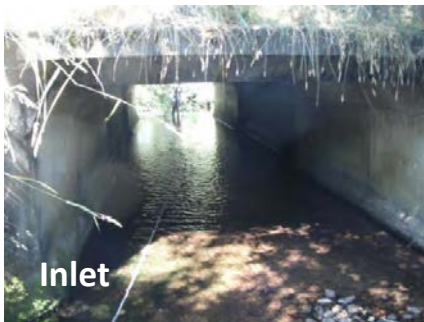
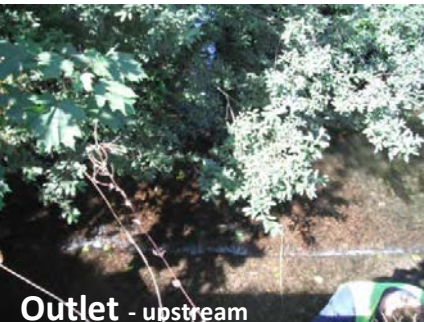
| LOCATION INFO | | | | Culvert # | 1381 | Priority | H |

| LOCATION INFO | | | | Culvert # | 1381 | Priority | H |
|---|---|---|---|---|---|---|---|
| Outlet Perch (ft) | 1.0 | | | | | | |
| Barrier Class | Red | Barrier Points | 3 | | | | |
| <b>Notes:</b> Rating based on perch and laminar flows across pipe invert (no natural substrate on culvert invert). | | | | | | | |

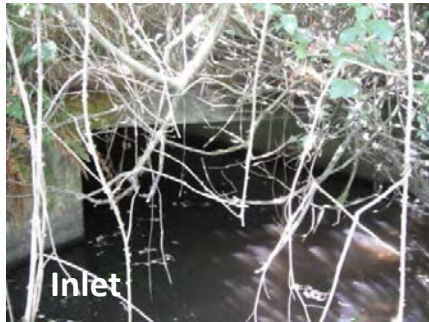
| LOCATION INFO | | | | Culvert # | 1457 | Priority | NA |

| LOCATION INFO | | | | Culvert # | 1457 | Priority | NA |
|---|---|---|---|---|---|---|---|
| Overall Condition | Fair | | | | | | |

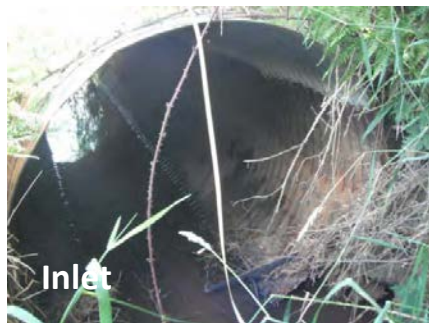
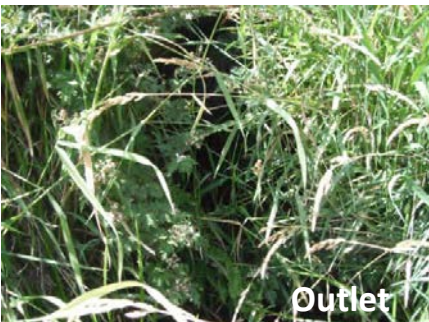
| LOCATION INFO | | | | Culvert # | 1438 | Priority | H |

| LOCATION INFO | | | | Culvert # | 1438 | Priority | H |
|---|---|---|---|---|---|---|---|
| Overall Condition | Critical | | | | | | |
| Notes: Invert and sides very corroded. Numerous holes in pipe noted. | | | | | | | |
