Lower South Fork Trask River Area Culverts, Trask River Basin

Edwards Creek Area Culverts, Trask River Basin

**UPPER SOUTH FORK TRASK RIVER AREA CULVERTS**

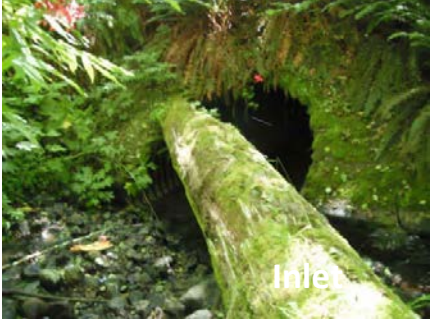
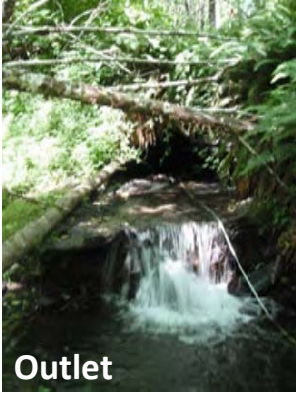
LOCATION INFO				Culvert #	1120	Priority	H
<b>Watershed</b>		Trask River

<b>Upstream Habitat Length (mi)</b>	0.8	<b>Habitat Points</b>	2				
<b>Habitat Quality</b>	Good	<b>Habitat Quality Points</b>	3				
<b>Fish Species</b>	Anad.	<b>Fish Points</b>	3				
<b>Barrier Class</b>	Red	<b>Barrier Points</b>	3				
		<b>Prioritization Total Points</b>	11				
<p><b>Notes:</b> Inlet was partially blocked by large log during summer 2011. It is our understanding that ODF intends to block this road and replace this culvert with a small bridge to facilitate foot and motorcycle traffic.</p>

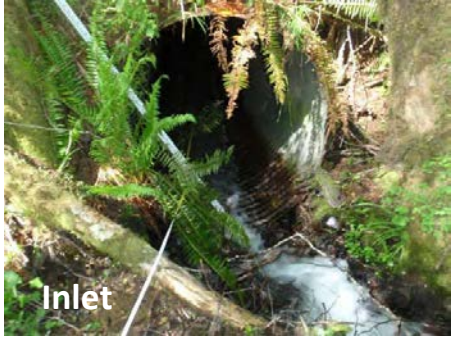
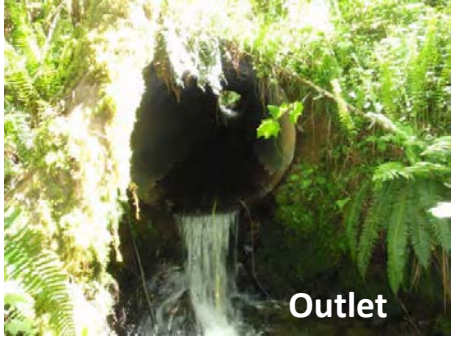
LOCATION INFO				Culvert #	5001	Priority	L
Watershed		Trask River

Fish Species	Anad.	Fish Points	3				
Barrier Class	Red	Barrier Points	3				
		Prioritization Total Points	8				
<p><b>Notes:</b> A few seams were separating causing cross-sectional deformation of pipe and allowing water to move along outside of pipe. Also the top of the portion of the pipe under the road bed was "sagging"</p>

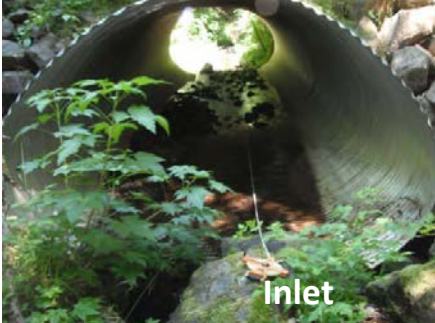
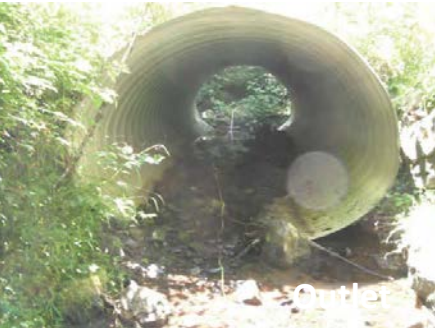
LOCATION INFO				Culvert #	1448	Priority	M
Watershed		Trask River

<b>Prioritization Total Points</b>	<b>10</b>				
<p><b>Notes:</b> Water flowing under inlet invert. Culvert is appropriately sized, but apparently wasn't sufficiently countersunk when initially installed (which allows a portion of stream flow to run under pipe. Boulders at inlet also appear to have ability to impede passage.</p>

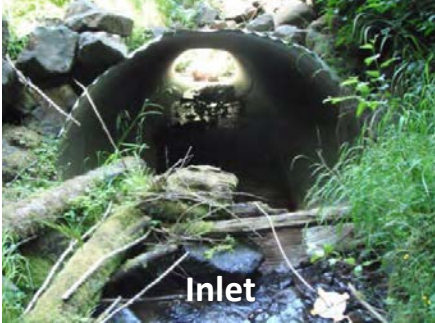
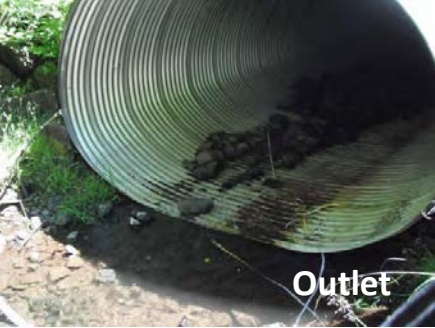
LOCATION INFO				Culvert #	1453	Priority	L
Watershed		Trask River

<b>Prioritization Total Points</b>	<b>9</b>				
<p><b>Notes:</b> Inlet substantially blocked by wood and boulders. Outlet end becoming undercut. Culvert is appropriately sized, but apparently wasn't sufficiently countersunk when initially installed.</p>

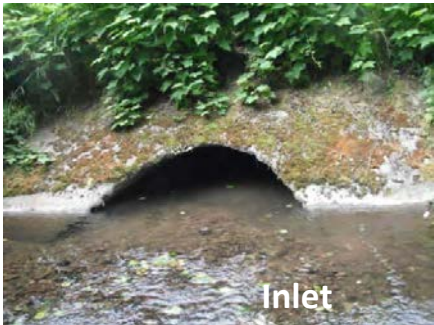
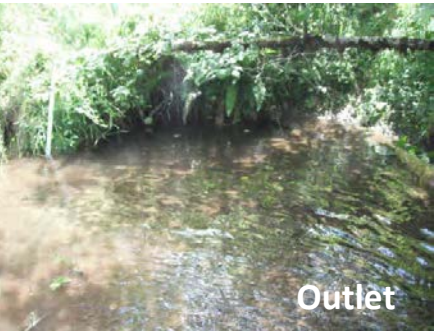
LOCATION INFO				Culvert #	1476	Priority	NA
Watershed		Trask River

Fish Species	Anad.	Fish Points	3				
Barrier Class	Green	Barrier Points	1				
		Prioritization Total Points	11				
Notes: Extensive pooling on both side of pipe.

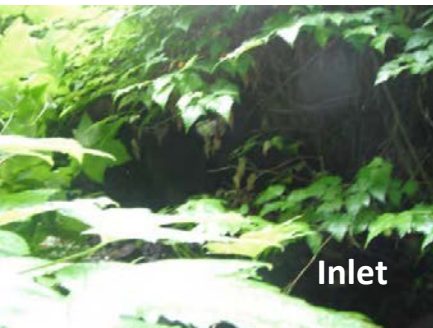
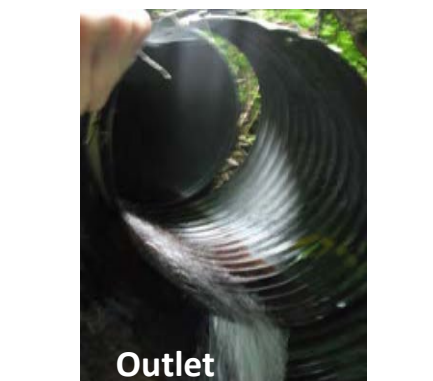
**Notes:** At outlet, an ~3' section of pipe was detached from the pipe barrel at the top but remained attached at the invert. This segment was angled down towards the stream channel. Water cascaded approximately 6" from the outlet of this segment onto an ~12' long chute constructed of half-round corrugated pipe. Water flowed down this chute and into the stream channel. The end of this chute was perched above the stream channel by 6-12". The configuration resulted in the outlet being perched a total of 12 to 18". In addition, there was an in-channel water measuring device a short distance upstream of this culvert that also created a 6-12" step at its outlet.

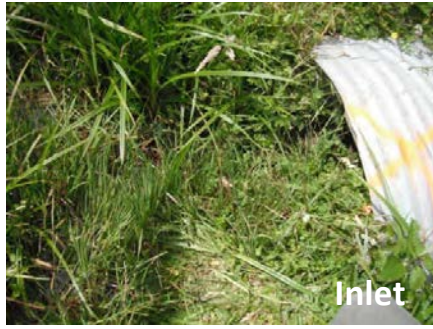
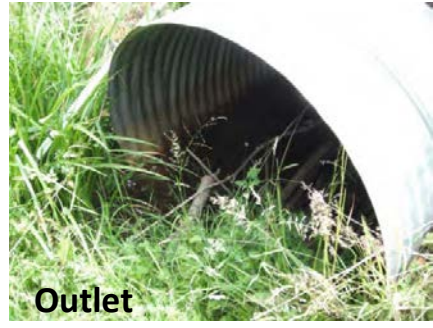
Fish Species	Anad.	Fish Points	3				
Barrier Class	Red	Barrier Points	3				
		Prioritization Total Points	10				
Notes: Inlet blocked with sediment. No flow apparent through inlet, but water was freely flowing from outlet.

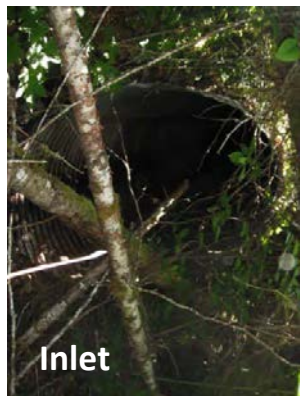
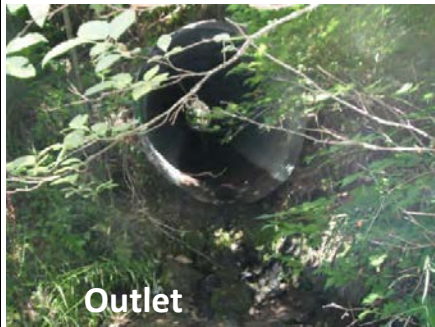
LOCATION INFO				Culvert #	1059	Priority	L
Watershed		Trask River

Prioritization Total Points	8				
Notes: Stream channel dry during summer 2011 survey effort.

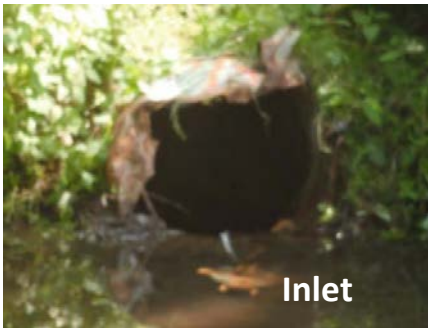
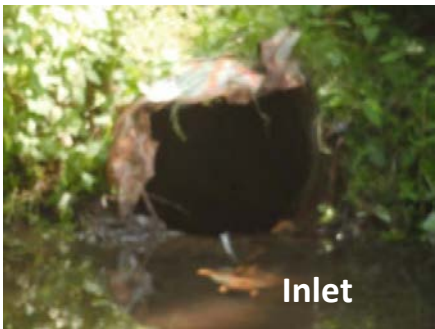
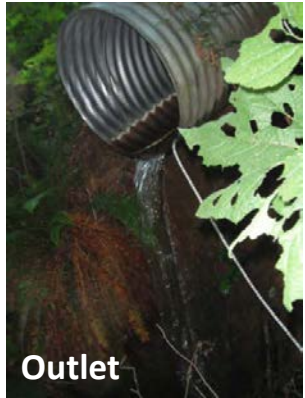
LOCATION INFO				Culvert #	962	Priority	L
Watershed		Trask River

Barrier Class	Red	Barrier Points	3				
		Prioritization Total Points	8				
Notes: Invert was worn completely through for a substantial length of the pipe. Also, the inlet was partially blocked with debris and badly damaged.
