**Trask River Basin
Culverts**

Trask Basin Crossings

Trask River Basin Clusters

HOLDEN CREEK CULVERTS

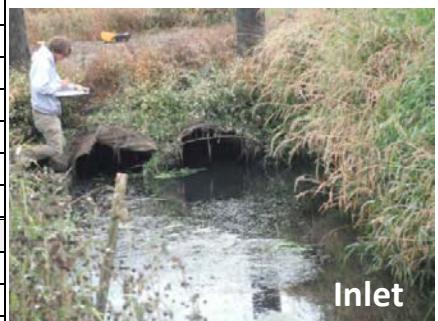
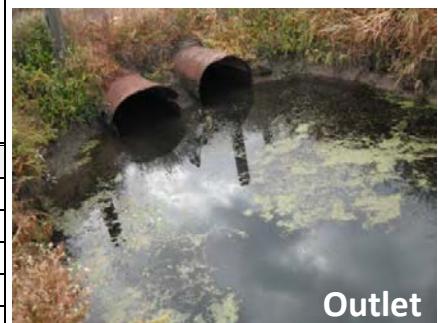
| LOCATION INFO | | Culvert # | 955 | Priority | M |

| LOCATION INFO | | Culvert # | 955 | Priority | M |
|--|---|---|---|---|---|
| Slope (%) | -1.6 | Both pipes were identical. | | | |
| Rustline Height (in) | Entirely rusted | | | | |
| Overall Condition | Critical | | | | |
| Notes: Dual pipes at this location. *Based on combined inlet widths. Water quality in channel appeared very poor. | | | | | |

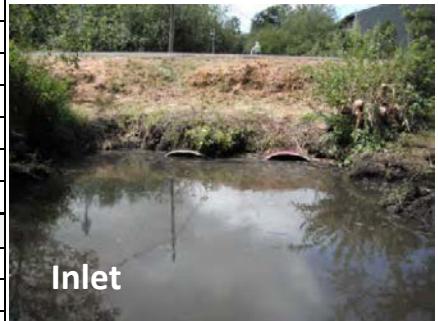
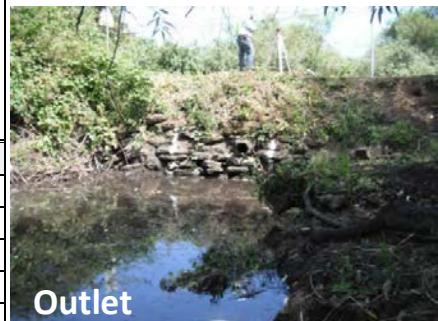
| LOCATION INFO | | Culvert # | 952 | Priority | M |

| LOCATION INFO | | Culvert # | 952 | Priority | M |
|---|---|---|---|---|---|
| Outlet Perch (ft) | None | Both pipes were identical. Pipe inverts have 1.5 to 2 ft sediment and so neither pipe was capable of conveying their designed volume. *We were unable to measure the full vertical dimensions of either pipe inlet (probably due to sedimentation). | | | |
| Rustline Height (in) | 52 | | | | |
| Overall Condition | Poor | | | | |
| Notes: Dual pipes at this location. Both outlets submerged and not accessible for measuring outlet invert elevation. As a result, we were unable to calculate the gradient of the pipes. **Based on combined inlet widths. | | | | | |

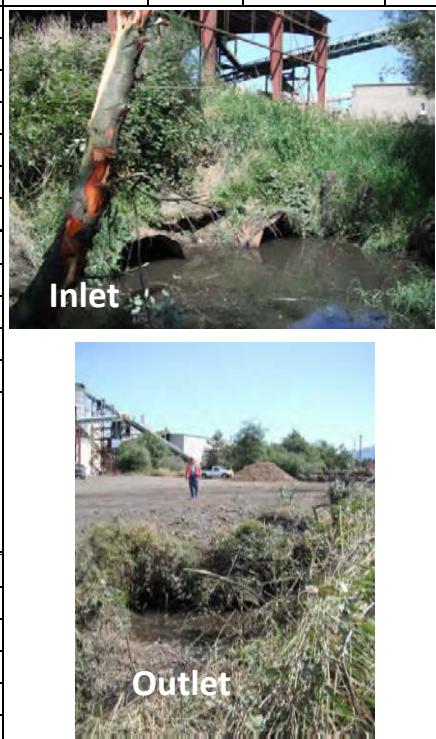
| LOCATION INFO | | | | Culvert # | 942 | Priority | H | | | | |

| LOCATION INFO | | | | Culvert # | 942 | Priority | H | | | | |
|--|---|--|---|---|---|---|---|--|--|--|--|
| Height (in) | 78* | Pipe length approximate because pipe barrel bends under roadway. | | | | | | | | | |
| Rustline Height (in) | Entirely rusted | | | | | | | | | | |
| Overall Condition | Poor | | | | | | | | | | |
| Notes: Dual pipes at this location. * Heavy sedimentation in pipes, unable to find inverts on either end. **Based on combined inlet widths. | | | | | | | | | | | |

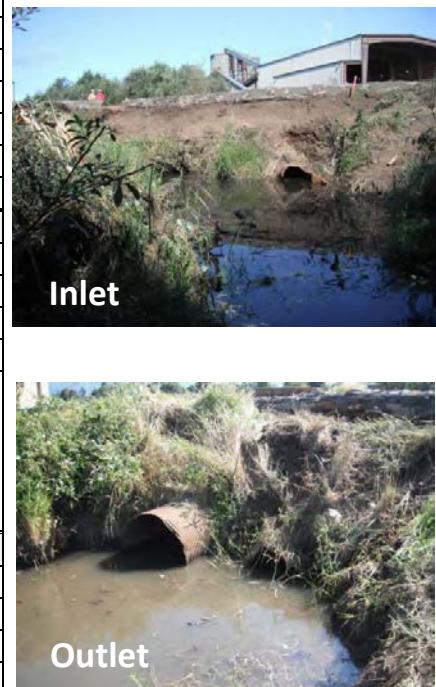
| LOCATION INFO | | | | Culvert # | 945 | Priority | H | | | | |

| LOCATION INFO | | | | Culvert # | 945 | Priority | H | | | | |
|---|---|---|---|---|---|---|---|--|--|--|--|
| Rustline Height (in) | entirely rusted | | | | | | | | | | |
| Overall Condition | Critical | | | | | | | | | | |
| Notes: Dual pipes at this location. *Based on combined inlet widths. Both inlets very damaged. | | | | | | | | | | | |

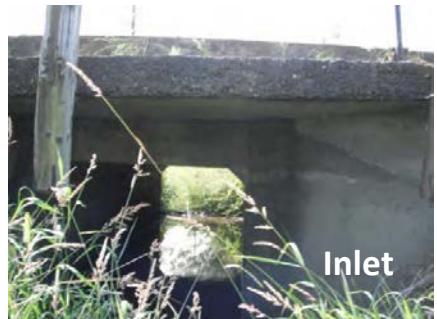
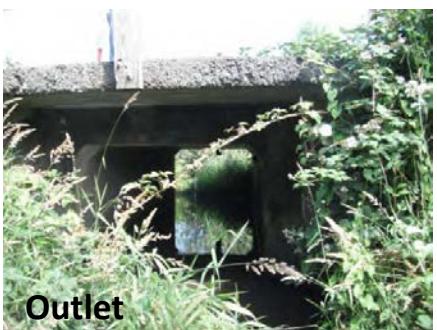
| LOCATION INFO | | | | Culvert # | 946 | Priority | M |

| LOCATION INFO | | | | Culvert # | 946 | Priority | M |
|--|---|---|---|---|---|---|---|
| Rustline Height (in) | 18 | | | | | | |
| Overall Condition | Fair | | | | | | |
| Notes: Continuous stream substrate through culvert. | | | | | | | |

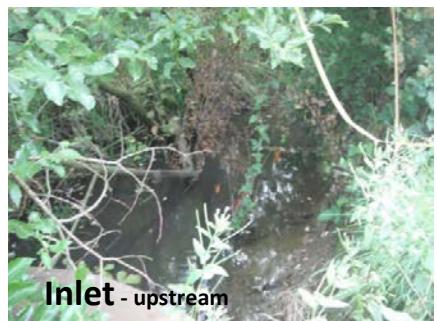
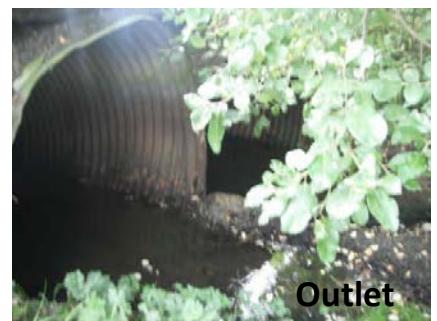
| LOCATION INFO | | | | Culvert # | 948 | Priority | H |

| LOCATION INFO | | | | Culvert # | 948 | Priority | H |
|---|--|---|---|---|---|---|---|
| Rustline Height (in) | entirely rusted | | | | | | |
| Overall Condition | Poor | | | | | | |
| Notes: Dual pipes at this location. *Based on combined inlet widths. | | | | | | | |

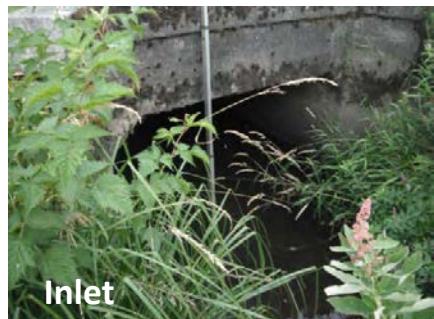
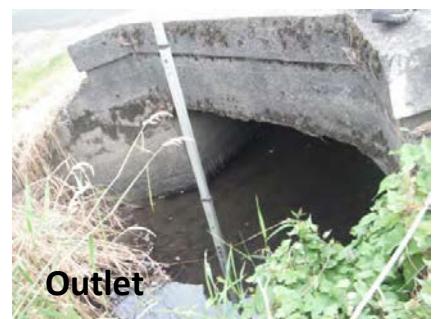
| LOCATION INFO | | | Culvert # | 947 | Priority | M |

| LOCATION INFO | | | Culvert # | 947 | Priority | M |
|--|---|--|---|---|---|---|
| Rustline Height (in) | N/A | | | | | |
| Overall Condition | Fair | | | | | |
| Notes: Continuous stream substrate through culvert. | | | | | | |

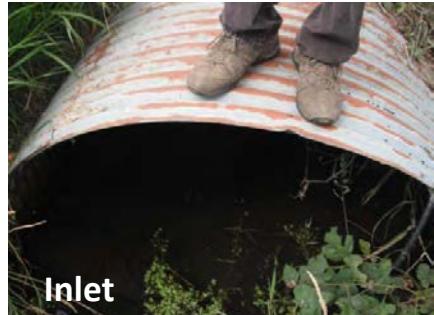
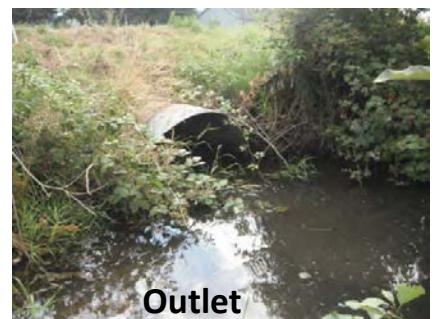
| LOCATION INFO | | | Culvert # | 930 | Priority | M |

| LOCATION INFO | | | Culvert # | 930 | Priority | M |
|---|--|--|---|---|---|---|
| Rustline Height (in) | 23 | | | | | |
| Overall Condition | Poor | | | | | |

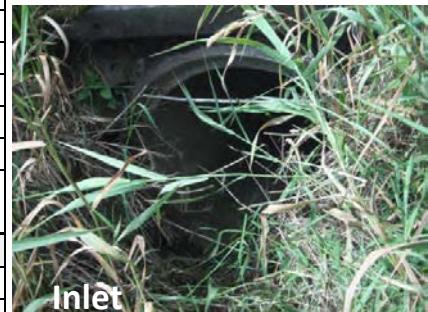
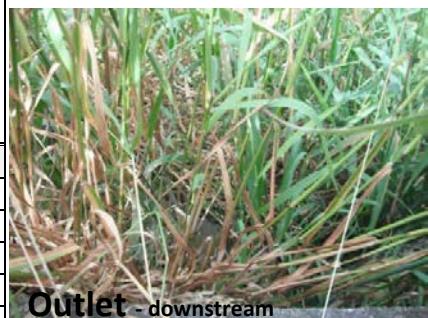
| LOCATION INFO | | | Culvert # | 929 | Priority | L | | | |

| LOCATION INFO | | | Culvert # | 929 | Priority | L | | | |
|---|--|--|---|---|---|---|--|--|--|
| Rustline Height (in) | N/A(20) | | | | | | | | |
| Overall Condition | Fair(Poor) | | | | | | | | |

Notes: Dual pipes at this crossing. *Bankfull:Culvert Ratio based on combined width of pipes. Channel was dry during summer 2011 site visit.

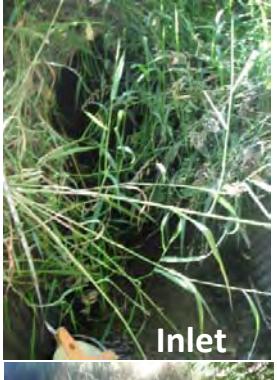
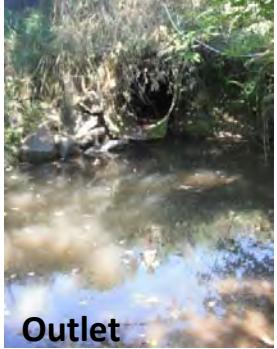
| LOCATION INFO | | Culvert # | 1094 | Priority | H | | | |
|---|---|--|---|--|---|--|--|--|
| Rustline Height (in) | entirely rusted | | | | | | | |
| Overall Condition | Poor | | | | | | | |
| Notes: Pipe is in very poor condition. Invert worn through along a considerable portion of the pipe. | | | | | | | | |

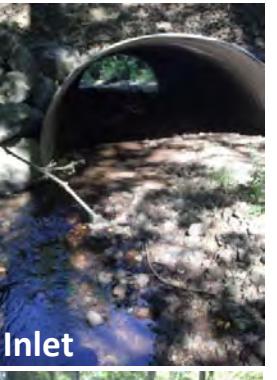
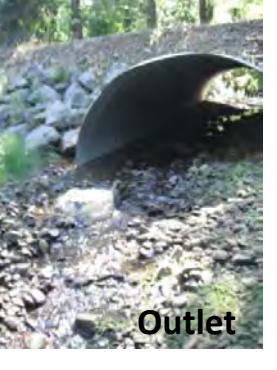
| LOCATION INFO | | Culvert # | 1095 | Priority | NA | | | |
|---|---|---|---|--|---|--|--|--|
| Rustline Height (in) | 21 | | | | | | | |
| Overall Condition | Good | | | | | | | |

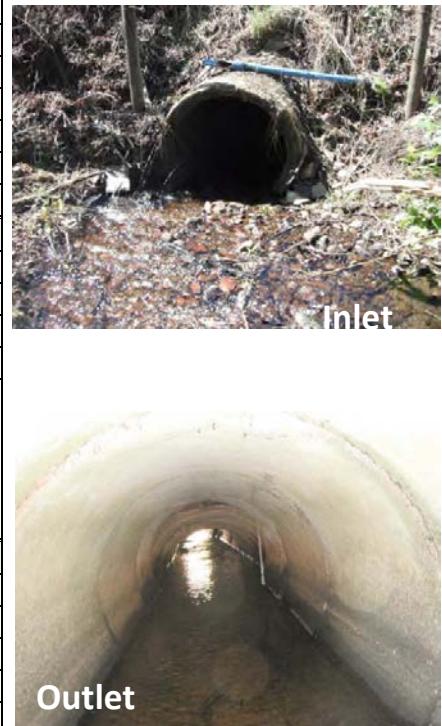
| LOCATION INFO | | | | Culvert # | 1106 | Priority | H |
|---|---|---|---|---|---|---|---|
| Rustline Height (in) | 15 | | | | | | |
| Overall Condition | Poor | | | | | | |
| Notes: Segments are separating causing culvert barrel to be deformed. | | | | | | | |

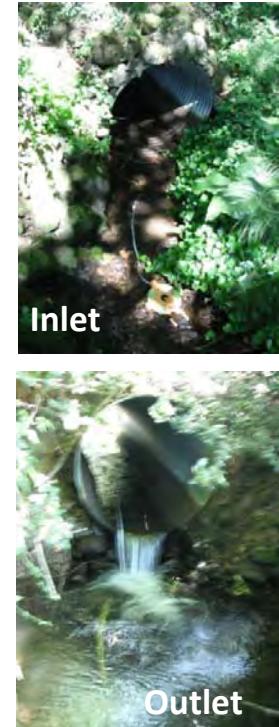
| LOCATION INFO | | | | Culvert # | 1107 | Priority | H |

| LOCATION INFO | | | | Culvert # | 1107 | Priority | H |
|--|---|---|---|---|---|---|---|
| Rustline Height (in) | 17 | | | | | | |
| Overall Condition | Poor | | | | | | |

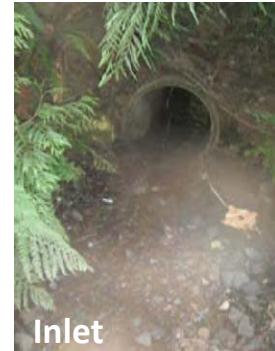
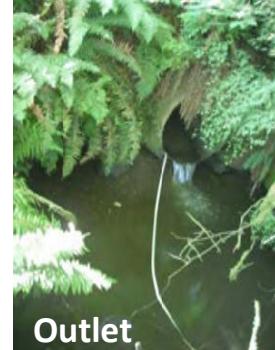
| LOCATION INFO | | | | Culvert # | 1127 | Priority | H |

| LOCATION INFO | | | | Culvert # | 1127 | Priority | H |
|--|---|---|---|---|---|---|---|
| Rustline Height (in) | 21 | | | | | | |
| Overall Condition | Poor | | | | | | |
| Notes: Segments of pipe are separating, causing deformation of the culvert barrel. | | | | | | | |

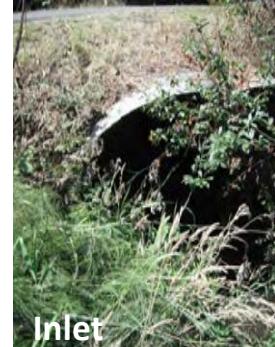
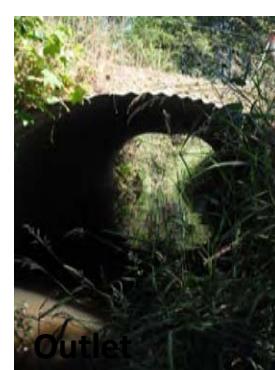
| LOCATION INFO | | | | Culvert # | 1134 | Priority | H |

| LOCATION INFO | | | | Culvert # | 1134 | Priority | H |
|--|---|---|---|---|---|---|---|
| Rustline Height (in) | 28 | | | | | | |
| Overall Condition | Fair | | | | | | |

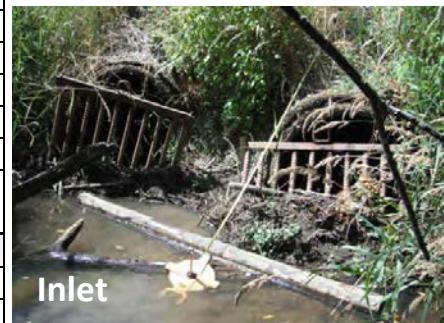
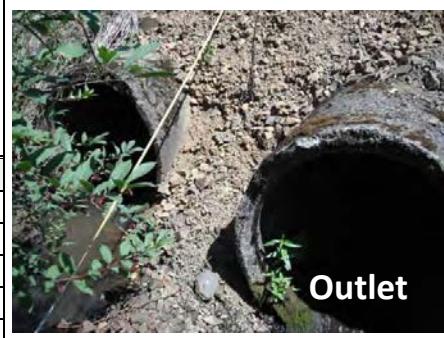
| LOCATION INFO | | | | Culvert # | 1137 | Priority | H | | | | |

| LOCATION INFO | | | | Culvert # | 1137 | Priority | H | | | | |
|---|---|--|---|---|---|---|---|--|--|--|--|
| Overall Condition | Fair | | | | | | | | | | |

Notes: Dual pipes at this location. Trash rack at inlet had not been maintained and had a considerable amount of debris built up.

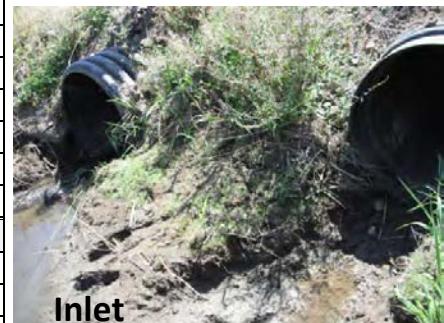
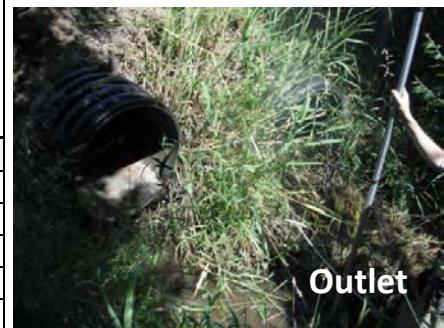
| LOCATION INFO | | | | Culvert # | 1136 | Priority | H | | | | |

| LOCATION INFO | | | | Culvert # | 1136 | Priority | H | | | | |
|---|---|--|---|---|---|---|---|--|--|--|--|
| Overall Condition | Fair | | | | | | | | | | |

Notes: Dual pipes at this location. RBA data indicates numerous beaver impoundments, low flows and limited anadromous potential above this crossing. Culverts were not conveying water during summer 2011 field visit.

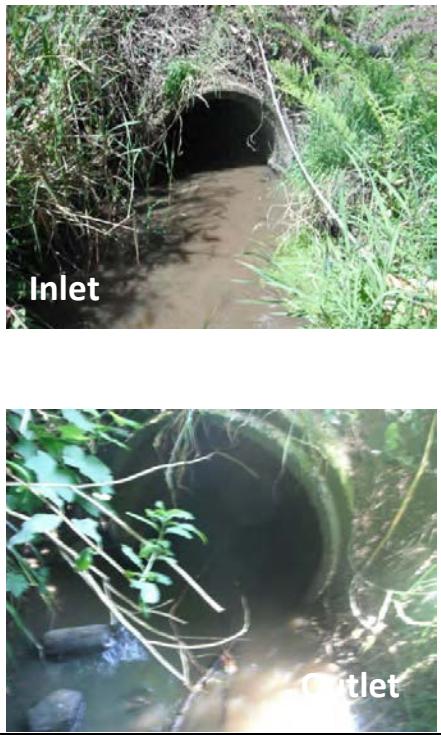
| LOCATION INFO | | | | Culvert # | 1146 | Priority | L | | | | | |

| LOCATION INFO | | | | Culvert # | 1146 | Priority | L | | | | | |
|--|---|---|---|---|---|---|---|--|--|--|--|--|
| Overall Condition | Poor | | | | | | | | | | | |
| Notes: Water quality appeared very poor during summer 2011 site visit. | | | | | | | | | | | | |

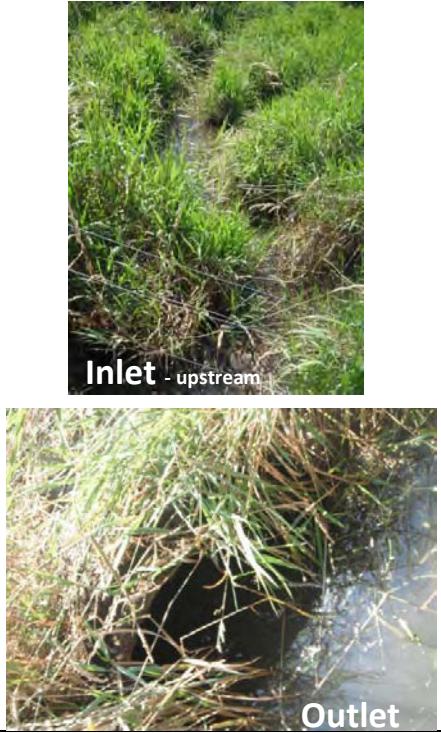
| LOCATION INFO | | | | Culvert # | 1156 | Priority | L | | | | | |

| LOCATION INFO | | | | Culvert # | 1156 | Priority | L | | | | | |
|---|---|---|---|---|---|---|---|--|--|--|--|--|
| Overall Condition | Poor | | | | | | | | | | | |

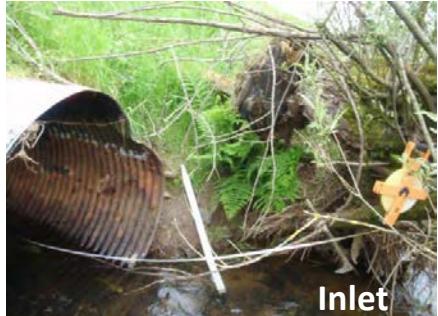
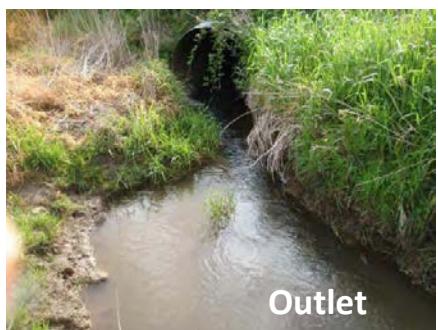
| LOCATION INFO | | Culvert # | 1027 | Priority | L | | | |
|--|---|--|---|---|---|--|--|--|
| Rustline Height (in) | 48 | | | | | | | |
| Overall Condition | Poor | | | | | | | |
| Notes: Stream listed as Nonfish-modeled. However, a member of our advisory team has observed juvenile salmon in this stream above culvert 1039. As a result, we considered this stream as suitable habitat for salmonids up to a short distance above culvert 1039. | | | | | | | | |

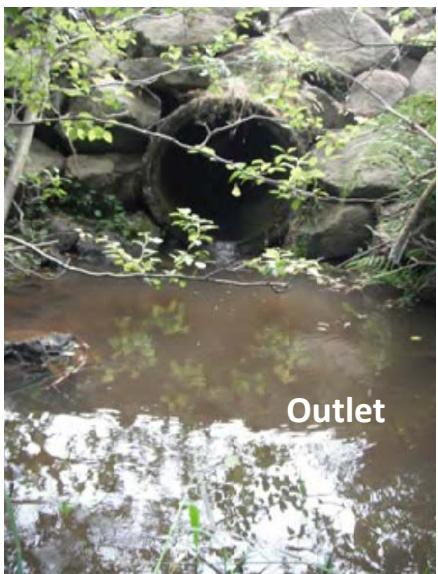
| LOCATION INFO | | Culvert # | 1039 | Priority | L | | | |

| LOCATION INFO | | Culvert # | 1039 | Priority | L | | | |
|---|---|--|---|---|---|--|--|--|
| Overall Condition | Fair | | | | | | | |

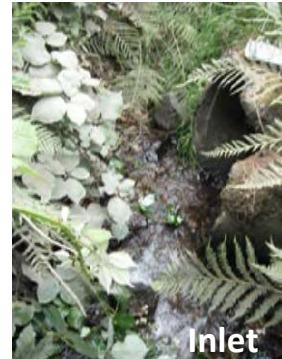
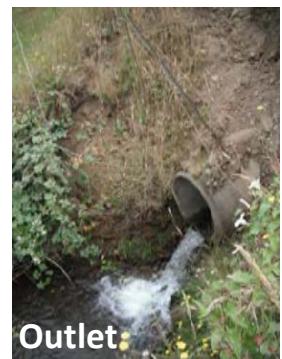
| LOCATION INFO | | | | Culvert # | 1021 | Priority | L |

| LOCATION INFO | | | | Culvert # | 1021 | Priority | L |
|--|--|--|--|---|---|---|---|
| Overall Condition | Poor | | | | | | |

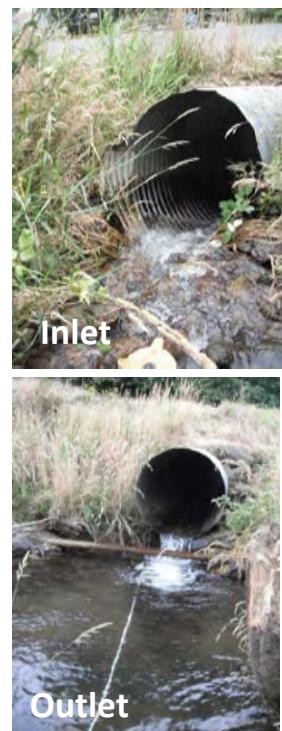
| LOCATION INFO | | | Culvert # | 987 | Priority | H |

| LOCATION INFO | | | Culvert # | 987 | Priority | H |
|---|---|---|---|---|---|---|
| Rustline Height (in) | 35 | | | | | |
| Overall Condition | Poor | | | | | |
| Notes: Configuration of culvert inlet apron and substrate created turbulent flows at inlet. One crossing occurred below this culvert. We were unable to access this crossing to complete an assessment. | | | | | | |

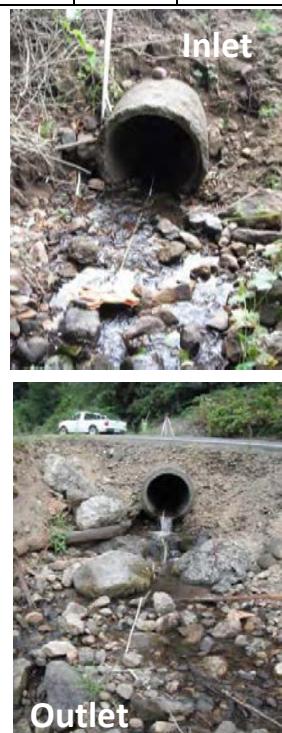
| LOCATION INFO | | | Culvert # | 999 | Priority | L |

| LOCATION INFO | | | Culvert # | 999 | Priority | L |
|--|---|---|---|---|---|---|
| Overall Condition | Poor | | | | | |
| Notes: Pipe barrel was not straight – its trajectory changed direction under the road bed. | | | | | | |

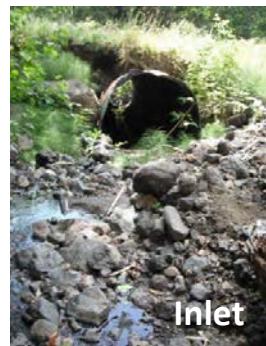
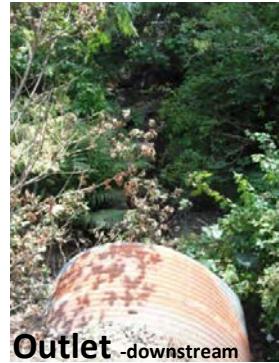
| LOCATION INFO | | | | Culvert # | 889 | Priority | L |
|---|---|---|---|---|---|---|---|
| Rustline Height (in) | 26 | | | | | | |
| Overall Condition | Critical | | | | | | |
| Notes: Pipe in extremely poor condition. Invert worn through nearly continuously from inlet to outlet, a seam was coming apart (resulting in deformation of barrel), and fill on outlet side badly eroding. Debris jamb on upstream side of culvert. Severity of fill erosion, prevented field crew from obtaining downstream channel measurements. As a result, we were unable to calculate perch height. However, the culvert did not appear to have a perched outlet. field crew observed small salmonids upstream of pipe. | | | | | | | |

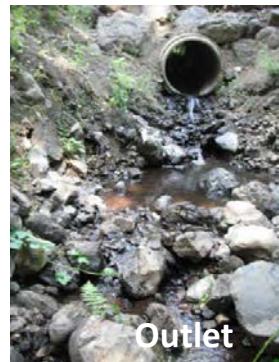
| LOCATION INFO | | | | Culvert # | 925 | Priority | L |

| LOCATION INFO | | | | Culvert # | 925 | Priority | L |
|---|---|---|---|---|---|---|---|
| Overall Condition | Fair | | | | | | |

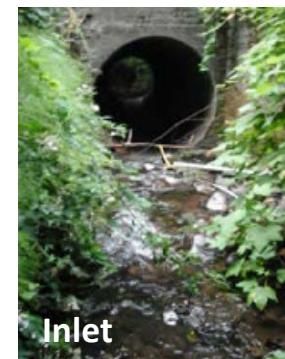
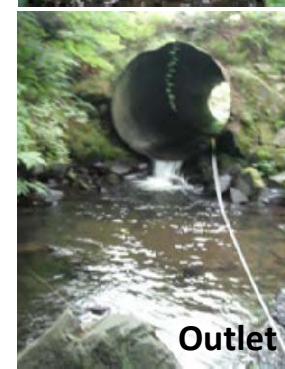
| LOCATION INFO | | | | Culvert # | 902 | Priority | H |
|---|---|---|---|---|---|---|---|
| Rustline Height (in) | 37 | | | | | | |
| Overall Condition | Poor | | | | | | |
| Notes: Several seams beginning to separate. One has separated across the invert and has resulted in an approximately 6 inch step within the barrel of the pipe. | | | | | | | |

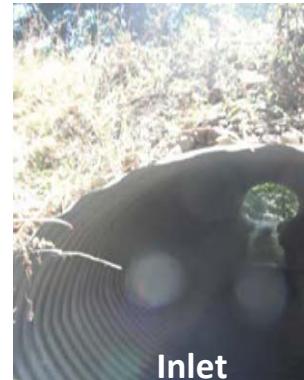
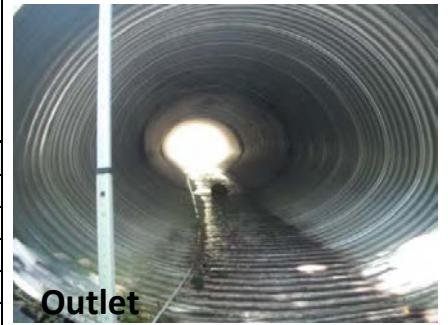
| LOCATION INFO | | | | Culvert # | 915 | Priority | H |

| LOCATION INFO | | | | Culvert # | 915 | Priority | H |
|--|---|---|---|---|---|---|---|
| Rustline Height (in) | 6 | | | | | | |
| Overall Condition | Fair | | | | | | |
| Notes: One seam separating, but repaired with a rubber strip. field crew noted that the strip appeared to seal the seam, but looked as if it "won't last long." Cascade over boulders at outlet. Culvert is appropriately sized, but apparently wasn't sufficiently countersunk. | | | | | | | |

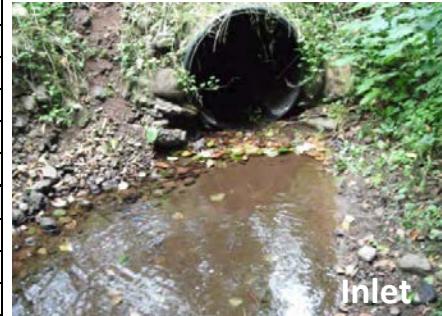
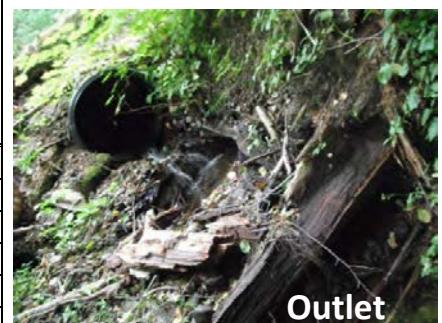
| LOCATION INFO | | | | Culvert # | 944 | Priority | L | | | | |

| LOCATION INFO | | | | Culvert # | 944 | Priority | L | | | | |
|--|---|---|---|---|---|---|---|--|--|--|--|
| Overall Condition | Good | | | | | | | | | | |
| Notes: Inlet perched at low flows. Pipe barrel bent under road bed. | | | | | | | | | | | |

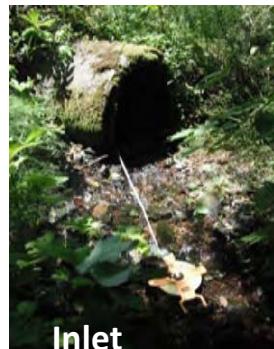
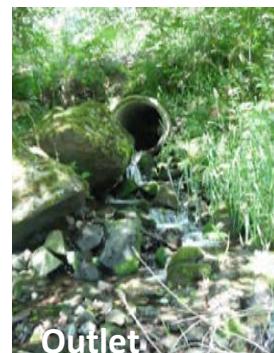
| LOCATION INFO | | | | Culvert # | 927 | Priority | L | | | | |

| LOCATION INFO | | | | Culvert # | 927 | Priority | L | | | | |
|---|---|---|---|---|---|---|---|--|--|--|--|
| Overall Condition | Poor | | | | | | | | | | |

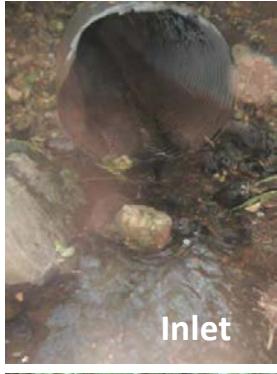
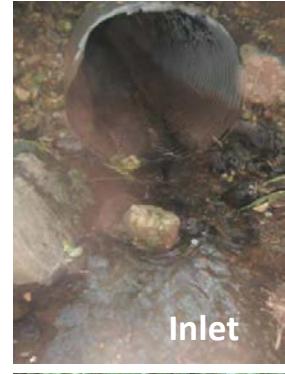
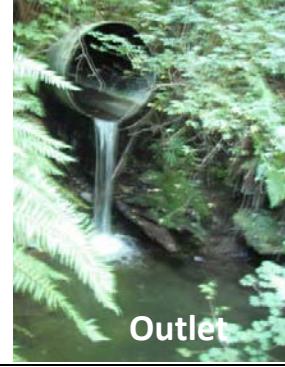
| LOCATION INFO | | Culvert # | 1010 | Priority | L | | |

| LOCATION INFO | | Culvert # | 1010 | Priority | L | | |
|---|---|---|---|---|---|--|--|
| Rustline Height (in) | 22 | | | | | | |
| Overall Condition | Critical | | | | | | |

Notes: Invert almost entirely rusted through from inlet to outlet. Remainder of pipe also very corroded and unstable.
