Kansas Creek Culverts, Wilson River Basin

BEAR CREEK AREA CULVERT

LOCATION INFO				Culvert #	723	Priority	L
Watershed		Wilson River

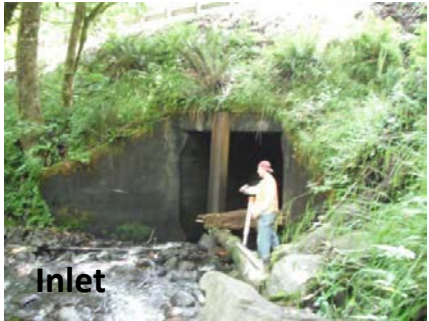
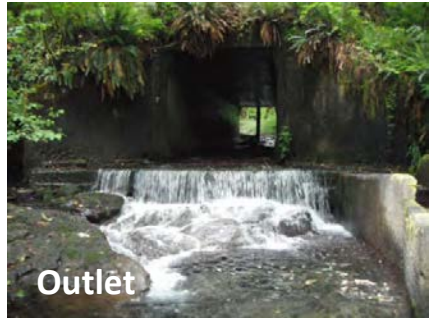
LOCATION INFO				Culvert #	667	Priority	H
Watershed		Wilson River

<p style="font-size: 24pt; font-weight: bold; margin-top: 0;">Outlet</p>			
Material	Concrete	Upstream Gradient (%)	7.0				
Length (ft)	94	Bankfull Width (ft)	16.9				
Width (in)	120	Bankfull:Culvert Ratio	0.6				
Height (in)	120	Water observed flowing from around outside of culvert on outlet side. Rubber baffles inside pipe. Many were damaged or missing.					
Outlet Perch (ft)	4.0						
Gradient (%)	5.2

Rustline Height (in)	N/A						
Overall Condition	Poor						
PRIORITIZATION ANALYSIS							
Upstream Habitat Length (mi)	2.0	Habitat Points	4				
Habitat Quality	Good	Habitat Quality Points	3				
Fish Species	Anad.	Fish Points	3				
Barrier Class	Red	Barrier Points	3				
		Prioritization Total Points	13				
<p>Notes: Outlet fish ladder substantially blocked with debris, in poor condition, and conveyed only a small fraction of the total stream flow.</p>

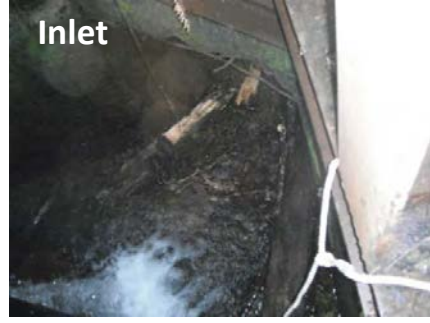
LOCATION INFO				Culvert #	584	Priority	M
Watershed		Wilson River

Fish Species	Anad.	Fish Points	3				
Barrier Class	Red	Barrier Points	3				
		Prioritization Total Points	10				
Notes: An approx. 5 ft wall of debris was trapped upstream of the trash rack and aggraded the upstream channel an equivalent amount. Water cascaded over debris wall. Additional loose woody debris was trapped against trash rack above stream bed.

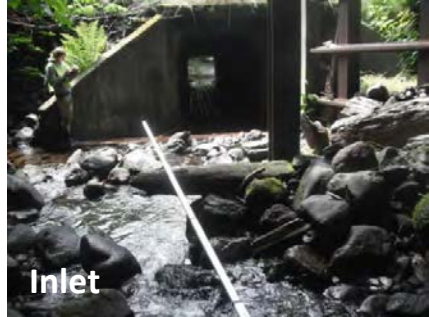
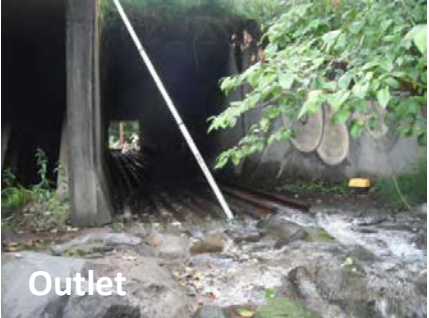
LOCATION INFO				Culvert #	199	Priority	H
Watershed		Wilson River

Shape	Box	Inlet Gradient (%)	42.7				
Material	Concrete	Upstream Gradient (%)	7.6				
Length (ft)	116	Bankfull Width (ft)	11.2				
Width (in)	96	Bankfull:Culvert Ratio	0.7				
Height (in)	96						
Outlet Perch (ft)	*Not measured	*Outlets directly into Wilson River. Unable to measure tailwater control, but at summer flows it cascades over 2-3 ft step into river.					
Gradient (%)	3.7						
Rustline Height (in)	N/A						
Overall Condition	Fair						
PRIORITIZATION ANALYSIS							
Upstream Habitat Length (mi)	1.1	Habitat Points	3

Habitat Quality	Good	Habitat Quality Points	3				
Fish Species	Anad.	Fish Points	3				
Barrier Class	Red	Barrier Points	3				
		Prioritization Total Points	12				
Notes: An I-beam across inlet creates an ~18 step. Culvert is paralleled by an attached fishway. However, at low flows this structure conveys insufficient flows to pass fish. Steps at either end of culvert are further impediments to passage.

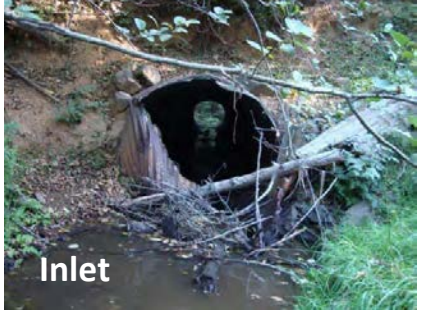
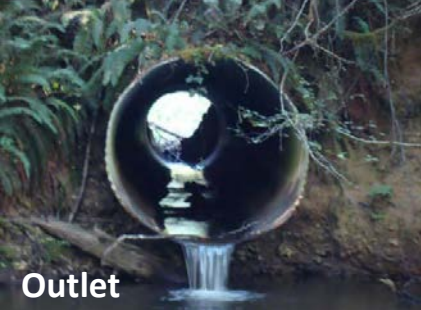
LOCATION INFO				Culvert #	231	Priority	H
Watershed		Wilson River

Upstream Habitat Length (mi)	3.3	Habitat Points	4				
Habitat Quality	Good	Habitat Quality Points	3				
Fish Species	Resident	Fish Points	2				
Barrier Class	Red	Barrier Points	3				
		Prioritization Total Points	12				
<p>Notes: Beaver dam gone in 2012, but small debris jam present. Inlet badly damaged and large holes on invert near inlet end of pipe.</p>

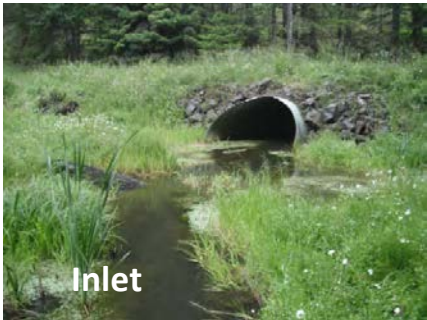
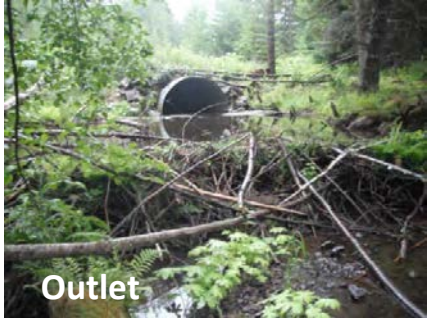
LOCATION INFO				Culvert #	299	Priority	L
Watershed		Wilson River

Barrier Class	Green	Barrier Points	1				
		Prioritization Total Points	7				
Notes: Large beaver dams just upstream and downstream of this pipe during summer 2011.

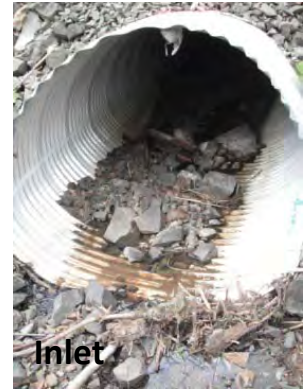
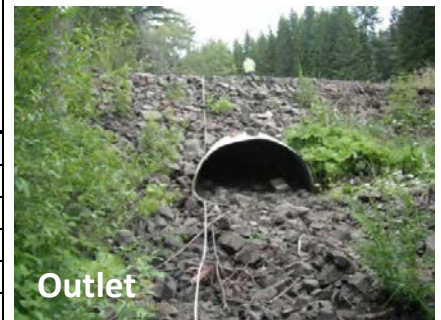
Overall Condition	Good						
PRIORITIZATION ANALYSIS							
Upstream Habitat Length (mi)		0.2	Habitat Points		1		
Habitat Quality		Fair	Habitat Quality Points		2		
Fish Species		Anad.	Fish Points		3		
Barrier Class		Red	Barrier Points		3		
			Prioritization Total Points		9		
<p>Notes: Log dam greatly restricting flows through pipe. Pipe outlets into riprap and water runs through this material before coming to the surface in the channel at the downstream end of this material. Tailwater control point was measured at the end of this placed material.</p>

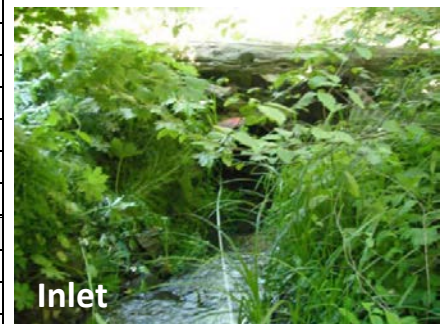
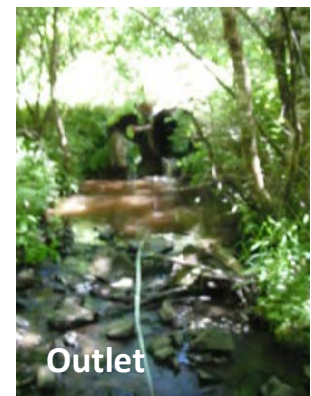
Habitat Quality		Good	Habitat Quality Points		3		
Fish Species		Anad.	Fish Points		3		
Barrier Class		Red	Barrier Points		3		
			Prioritization Total Points		11		
<p>Notes: Inlet was badly damaged, resulting in an ~12 inch cascade into the pipe</p>

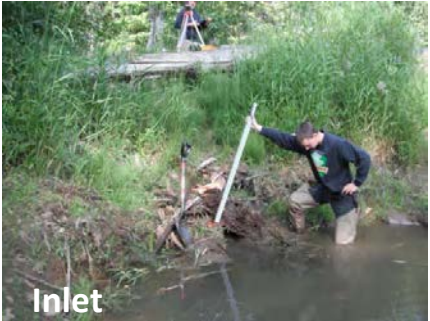
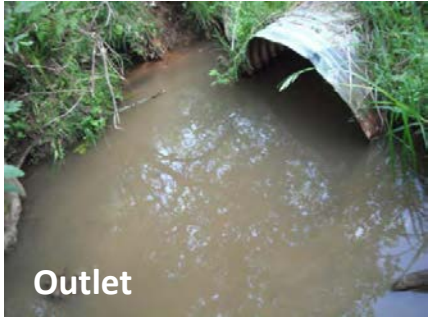
LOCATION INFO				Culvert #	176	Priority	M
Watershed		Wilson River

Habitat Quality	Good	Habitat Quality Points	3				
Fish Species	Anad.	Fish Points	3				
Barrier Class	Red	Barrier Points	3				
		Prioritization Total Points	10				
Notes: Pipe barrel deformed and invert highly corroded. Inlet nearly completely blocked with wood and sediment. *Series of beaver ponds along this stream. Inlet drains one of these ponds, and the culvert blockage noted below likely due to beaver activities.

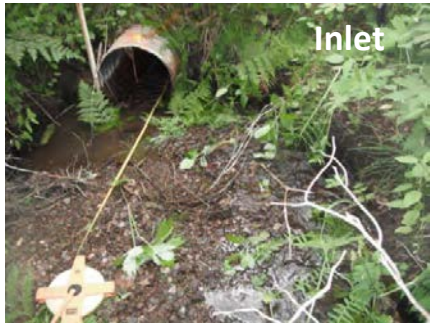
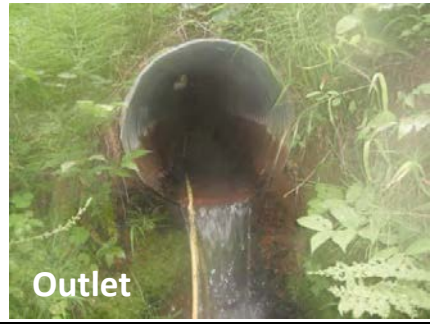
LOCATION INFO				Culvert #	246	Priority	L
Watershed		Wilson River

Outlet Perch (ft)	2.6						
Gradient (%)	4.2						
Rustline Height (in)	8						
Overall Condition	Poor						
PRIORITIZATION ANALYSIS							
Upstream Habitat Length (mi)	0.1	Habitat Points	1				
Habitat Quality	Poor	Habitat Quality Points	1				
Fish Species	Anad.	Fish Points	3

Barrier Class	Red	Barrier Points	3				
		Prioritization Total Points	8				
<p>Notes: This stream designated nonfish. However, it is a tributary to a known fishbearing stream and the lower portion appears to provide suitable habitat for fish. Thus, for this project we considered this stream as capable of supporting fish upstream to where it branches into two smaller headwater tributaries.</p>
