**Wilson River Basin
Culverts**

Wilson Basin Crossings

Wilson River Basin Clusters

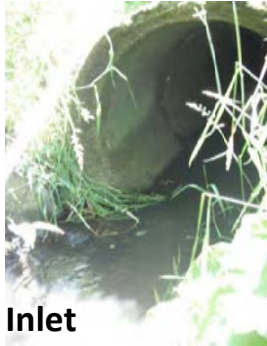
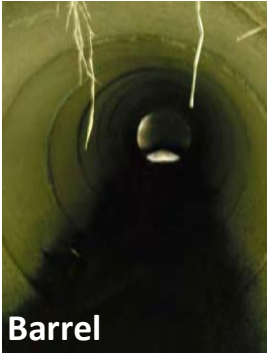
LOCATION INFO				Culvert #	792	Priority	H
Watershed		Wilson River

<p style="text-align: center;">Barrel</p>			
Stream Name		Juno Creek					
Township-Range-Section-1/4		T1S, R9W, Sec. 13, SE¼ of SE¼					
UTM Easting/Northing (Zone 10, NAD 1983)		433660/5036608					
Road Name		Boquist Road					
Road/Culvert Owner		Tillamook County					
Adjacent Landowners		L. & G. Edwards					
CULVERT INFO		CHANNEL INFO					
Shape	Circular	Inlet Gradient (%)	7.0				
Material	Concrete	Upstream Gradient (%)	4.0				
Length (ft)	Unable to measure	Bankfull Width (ft)	8.8				
Width (in)	48	Bankfull:Culvert Ratio	0.5				
Height (in)	48	This culvert has a tidegate on its outlet. It is visible in the barrel photo.					
Outlet Perch (ft)	Unable to measure						
Gradient (%)	6.0						
Rustline Height (in)	N/A						
Overall Condition	Fair						
PRIORITIZATION ANALYSIS							
Upstream Habitat Length (mi)	2.3	Habitat Points	4

Habitat Quality	Poor/Fair	Habitat Quality Points	1.5				
Fish Species	Anad.	Fish Points	3				
Barrier Class	Red	Barrier Points	3				
		Prioritization Total Points	11.5				
Notes: Culvert outlets into mainstem Wilson River. The reach between this pipe and 781 is poor quality habitat passing through agricultural land and a golf course. Above 781, conditions improve. The habitat quality score for this culvert reflects this dichotomy.

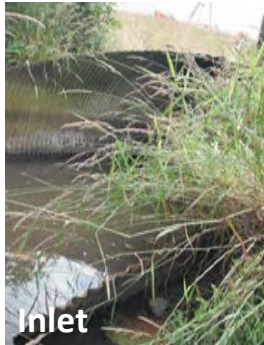
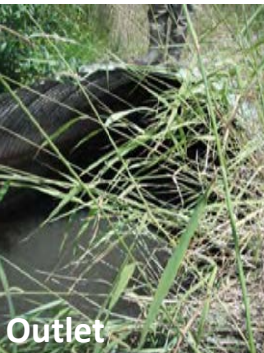
LOCATION INFO				Culvert #	781	Priority	NA
Watershed		Wilson River

<p style="text-align: center;">Outlet</p>			
Stream Name		Juno Creek					
Township-Range-Section-1/4		T1S, R9W, Sec. 18, NE¼ of SW¼					
UTM Easting/Northing (Zone 10, NAD 1983)		434655/5036763					
Road Name		Latimer Road					
Road/Culvert Owner		Tillamook County					
Adjacent Landowners		Tillamook Co., Victor Dairy, TCCA					
CULVERT INFO		CHANNEL INFO					
Shape	Circular	Inlet Gradient (%)	28.3				
Material	Corrugated metal	Upstream Gradient (%)	2.5				
Length (ft)	84	Bankfull Width (ft)	5.0				
Width (in)	108	Bankfull:Culvert Ratio	1.8				
Height (in)	108	This culvert has a tidegate on its outlet. It is visible in the barrel photo.					
Outlet Perch (ft)	0.1						
Gradient (%)	2.3						
Rustline Height (in)	48						
Overall Condition	Fair						
PRIORITIZATION ANALYSIS							
Upstream Habitat Length (mi)	1.6	Habitat Points	4

Habitat Quality	Fair	Habitat Quality Points	2				
Fish Species	Anad.	Fish Points	3				
Barrier Class	Green	Barrier Points	1				
		Prioritization Total Points	10				
Notes: Although the channel immediately upstream of this pipe is rather narrow, this is somewhat misleading because the upstream side of this pipe is a several acre wetland area with numerous small channels and other open water areas. As a result, the amount of water conveyed by this pipe is often greater than what one would expect from a 5 ft channel.

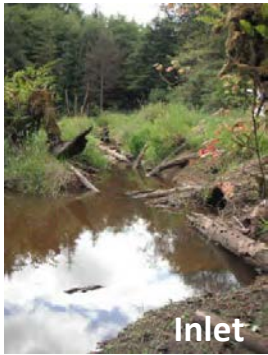
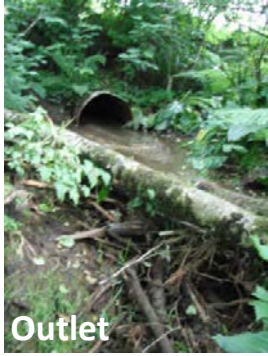
Shape	Circular	Inlet Gradient (%)	6.0				
Material	Corrugated metal	Upstream Gradient (%)	<1.0				
Length (ft)	50	Bankfull Width (ft)	N/A				
Width (in)	42	Bankfull:Culvert Ratio	N/A				
Height (in)	42	Culvert drains a large wetland with a complex channel system so no upstream bankfull measurements were obtained. However, pipe is clearly undersized.					
Outlet Perch (ft)	0.1						
Gradient (%)	3.2						
Rustline Height (in)	Entire pipe rusted						
Overall Condition	Poor						
PRIORITIZATION ANALYSIS							
Upstream Habitat Length (mi)	0.5	Habitat Points	1

Habitat Quality	Fair	Habitat Quality Points	2				
Fish Species	Anad.	Fish Points	3				
Barrier Class	Red	Barrier Points	3				
		Prioritization Total Points	9				
Notes:

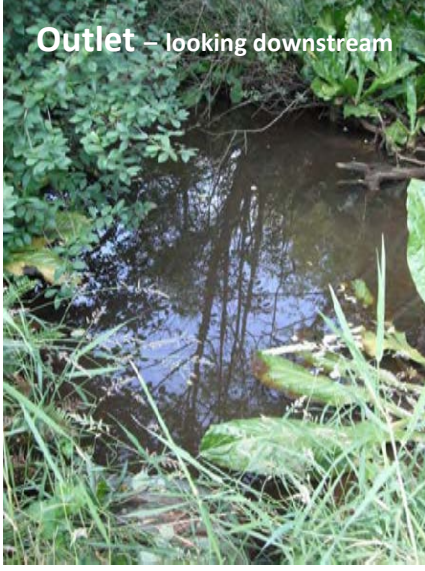
Shape	Circular	Inlet Gradient (%)	1.6				
Material	Corrugated metal	Upstream Gradient (%)	<1.0				
Length (ft)	29	Bankfull Width (ft)	4.6				
Width (in)	30	Bankfull:Culvert Ratio	0.6				
Height (in)	30	Large wetland complex on both sides of pipe.					
Outlet Perch (ft)	0.8						
Gradient (%)	6.1						
Rustline Height (in)	24						
Overall Condition	Critical						
PRIORITIZATION ANALYSIS							
Upstream Habitat Length (mi)	0.9	Habitat Points	1				
Habitat Quality	Fair(-)	Habitat Quality Points	2				
Fish Species	Anad.	Fish Points	3				
Barrier Class	Red	Barrier Points	3

Prioritization Total Points	9				
Notes: Large portions of the bottom of the pipe worn through.

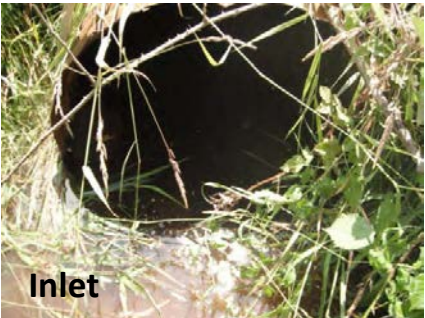
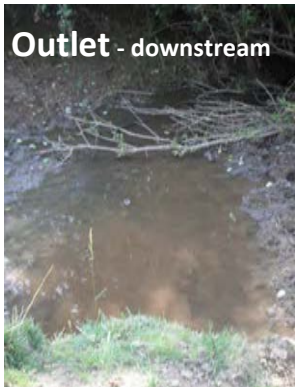
LOCATION INFO				Culvert #	5306	Priority	M
Watershed		Wilson River

<p>Outlet - downstream</p>			
Stream Name		Yankee Branch					
Township-Range-Section-1/4		T1S, R9W, Sec. 20, NE¼ of NW¼					
UTM Easting/Northing (Zone 10, NAD 1983)		436467/5036370					
Road Name		Latimer Road					
Road/Culvert Owner		Oregon Department of Forestry					
Adjacent Landowners		Oregon Department of Forestry					
CULVERT INFO		CHANNEL INFO					
Shape	Circular	Inlet Gradient (%)	21.6				
Material	Corrugated metal	Upstream Gradient (%)	1.1				
Length (ft)	87	Bankfull Width (ft)	3.8				
Width (in)	36	Bankfull:Culvert Ratio	0.8				
Height (in)	36						
Outlet Perch (ft)	None						
Gradient (%)	-1.0						
Rustline Height (in)	Entire pipe rusted						
Overall Condition	Fair						
PRIORITIZATION ANALYSIS							
Upstream Habitat Length (mi)	1.1	Habitat Points	3				
Habitat Quality	Fair	Habitat Quality Points	2				
Fish Species	Anad.	Fish Points	3

Barrier Class	Gray	Barrier Points	2				
		Prioritization Total Points	10				
<p>Notes: Outlet area heavily impacted by livestock use. A small overflow pipe was approx. 2 ft above this pipe. The overflow pipe appears to occasionally carry flows, suggesting that the main pipe is inadequately sized for fish passage and stream processes (despite being rated green by the barrier model). Based on this additional information, we rated this pipe a partial barrier to juvenile passage.</p>

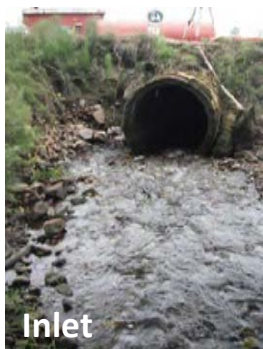
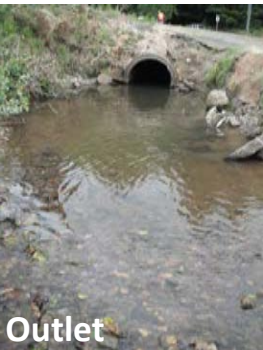
LOCATION INFO				Culvert #	814	Priority	H
Watershed		Wilson River

<p>Outlet</p>			
Stream Name		Beaver Creek					
Township-Range-Section-1/4		T1S, R9W, Sec. 16, SW¼ of SW¼					
UTM Easting/Northing (Zone 10, NAD 1983)		437528/5036405					
Road Name		Sollie Smith Road					
Road/Culvert Owner		Tillamook County					
Adjacent Landowners		D. Barker and L. Maynock					
CULVERT INFO		CHANNEL INFO					
Shape	Circular	Inlet Gradient (%)	19.6				
Material	Concrete	Upstream Gradient (%)	4.4				
Length (ft)	104	Bankfull Width (ft)	8.0				
Width (in)	48	Bankfull:Culvert Ratio	0.5				
Height (in)	48						
Outlet Perch (ft)	None						
Gradient (%)	2.6						
Rustline Height (in)	N/A						
Overall Condition	Fair						
PRIORITIZATION ANALYSIS							
Upstream Habitat Length (mi)	1.6	Habitat Points	4				
Habitat Quality	Fair	Habitat Quality Points	2				
Fish Species	Anad.	Fish Points	3				
Barrier Class	Gray	Barrier Points	2

Prioritization Total Points	11				
<p>Notes:</p>

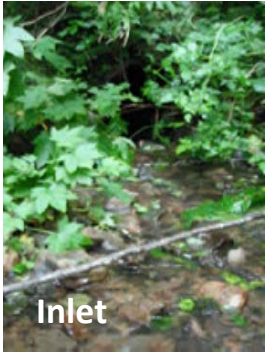
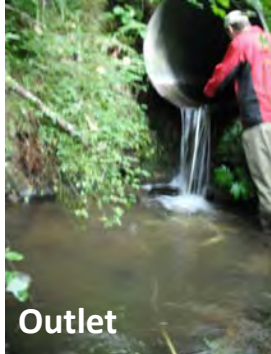
LOCATION INFO				Culvert #	735	Priority	L
Watershed		Wilson River

Stream Name		Unnamed tributary of Beaver Creek					
Township-Range-Section-1/4		T1S, R9W, Sec. 16, NW¼ of NE¼					
UTM Easting/Northing (Zone 10, NAD 1983)		437842/5037849					
Road Name		Beaver Creek Road					
Road/Culvert Owner		Oregon Department of Forestry					
Adjacent Landowners		Oregon Department of Forestry					
CULVERT INFO		CHANNEL INFO					
Shape	Circular	Inlet Gradient (%)	8.0				
Material	Corrugated metal	Upstream Gradient (%)	7.0				
Length (ft)	86	Bankfull Width (ft)	8.1				
Width (in)	42	Bankfull:Culvert Ratio	0.4				
Height (in)	42						
Outlet Perch (ft)	4.0						
Gradient (%)	11.0						
Rustline Height (in)	19						
Overall Condition	Poor						
PRIORITIZATION ANALYSIS							
Upstream Habitat Length (mi)	0.1	Habitat Points	1				
Habitat Quality	Poor	Habitat Quality Points	1				
Fish Species	Anad.	Fish Points	3

Barrier Class	Red	Barrier Points	3				
		Prioritization Total Points	8				
Notes:

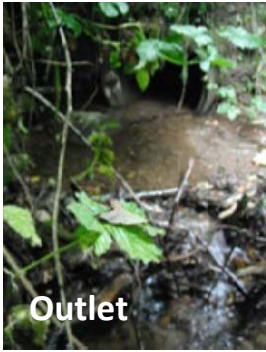
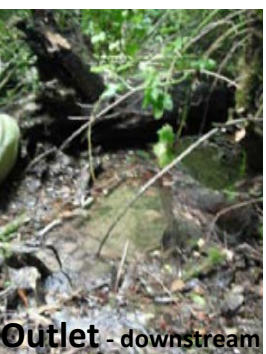
LOCATION INFO				Culvert #	803	Priority	L
Watershed		Wilson River

Stream Name		Unnamed tributary of Wilson River					
Township-Range-Section-1/4		T1S, R9W, Sec. 22, NE¼ of NW¼					
UTM Easting/Northing (Zone 10, NAD 1983)		439248/5036338					
Road Name		Sollie Smith Road					
Road/Culvert Owner		Tillamook County					
Adjacent Landowners		J. & G. Ficher					
CULVERT INFO		CHANNEL INFO					
Shape	Circular	Inlet Gradient (%)	13.0				
Material	Concrete	Upstream Gradient (%)	11.0				
Length (ft)	60	Bankfull Width (ft)	10.9				
Width (in)	36	Bankfull:Culvert Ratio	0.3				
Height (in)	36						
Outlet Perch (ft)	0.2						
Gradient (%)	14.0						
Rustline Height (in)	N/A						
Overall Condition	Fair						
PRIORITIZATION ANALYSIS							
Upstream Habitat Length (mi)	0.5	Habitat Points	1				
Habitat Quality	Poor	Habitat Quality Points	1				
Fish Species	Anad.	Fish Points	3				
Barrier Class	Red	Barrier Points	3

Prioritization Total Points	8				
Notes:

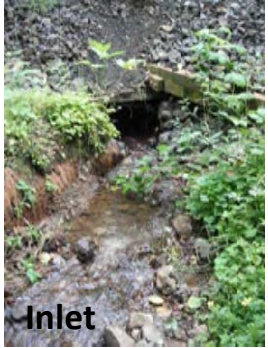
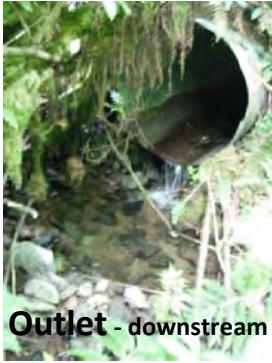
LOCATION INFO				Culvert #	788	Priority	L
Watershed		Wilson River

Shape	Circular	Inlet Gradient (%)	17.0				
Material	Corrugated metal	Upstream Gradient (%)	6.0				
Length (ft)	63	Bankfull Width (ft)	4.8				
Width (in)	24	Bankfull:Culvert Ratio	0.4				
Height (in)	24						
Outlet Perch (ft)	0.8						
Gradient (%)	7.0						
Rustline Height (in)	4						
Overall Condition	Poor						
PRIORITIZATION ANALYSIS							
Upstream Habitat Length (mi)	0.3	Habitat Points	1				
Habitat Quality	Poor	Habitat Quality Points	1				
Fish Species	Anad.	Fish Points	3				
Barrier Class	Red	Barrier Points	3

Prioritization Total Points	8				
Notes:

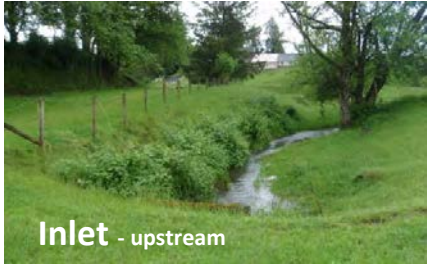
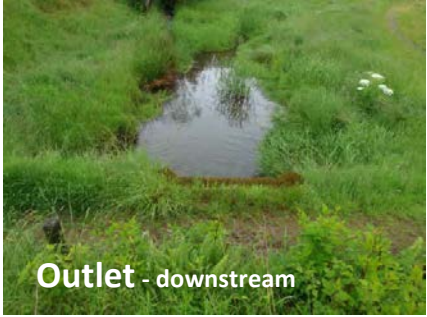
LOCATION INFO				Culvert #	898	Priority	?
Watershed		Wilson River

<p style="text-align: center; font-weight: bold;">Outlet - downstream</p>			
Shape	Box	Inlet Gradient (%)	unk				
Material	Concrete	Upstream Gradient (%)	unk				
Length (ft)	unknown	Bankfull Width (ft)	unk				
Width (in)	unknown	Bankfull:Culvert Ratio	unk				
Height (in)	unknown	Unable to access private property where inlet and outlet were located. As a result, no data was collected and only upstream and downstream photos were taken.					
Outlet Perch (ft)	unknown

Gradient (%)	unknown						
Rustline Height (in)	unknown						
Overall Condition	unknown						
PRIORITIZATION ANALYSIS							
Upstream Habitat Length (mi)	2.8	Habitat Points	4				
Habitat Quality	Poor(+)	Habitat Quality Points	1				
Fish Species	Anad.	Fish Points	3				
Barrier Class	Unk.	Barrier Points	?				
		Prioritization Total Points	8+				
Notes: Culvert appears to be an adequately sized concrete box. For analysis purposes, we assumed a partial barrier for Barrier Class Points.

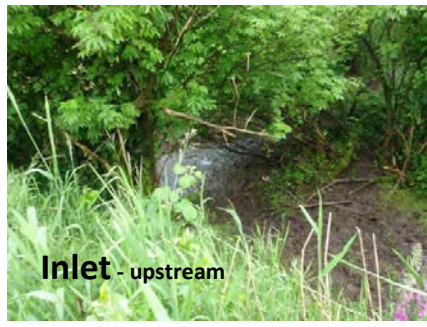
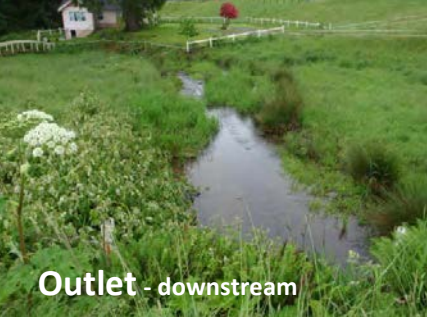
LOCATION INFO				Culvert #	900	Priority	?
Watershed		Wilson River

<p style="text-align: center; font-weight: bold;">Outlet - downstream</p>			
Shape	Circular	Inlet Gradient (%)	unk				
Material	Corrugated metal	Upstream Gradient (%)	unk				
Length (ft)	unknown	Bankfull Width (ft)	unk				
Width (in)	unknown	Bankfull:Culvert Ratio	unk				
Height (in)	unknown	Unable to access private property where inlet and outlet were located. As a result, no data was collected and only upstream and downstream photos were taken.					
Outlet Perch (ft)	unknown

Gradient (%)	unknown						
Rustline Height (in)	unknown						
Overall Condition	unknown						
PRIORITIZATION ANALYSIS							
Upstream Habitat Length (mi)	2.6	Habitat Points	4				
Habitat Quality	Poor(+)	Habitat Quality Points	1				
Fish Species	Anad.	Fish Points	3				
Barrier Class	Unk.	Barrier Points	?				
		Prioritization Total Points	8+				
Notes: Crossing 899 is located between 898 and 900. We were denied permission to access 899 and were unable to observe the crossing remotely.

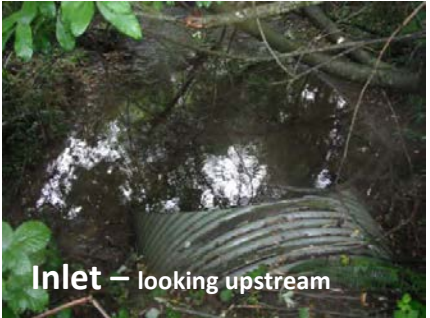
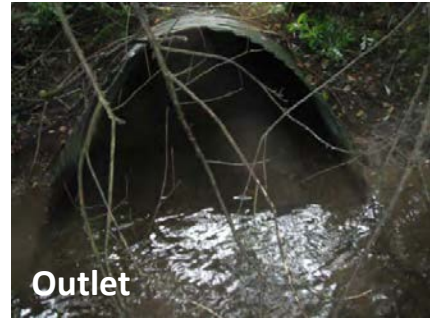
LOCATION INFO				Culvert #	901	Priority	M				
Watershed		Wilson River

Shape	Circular	Inlet Gradient (%)	5.5								
Material	Corrugated metal	Upstream Gradient (%)	5.5								
Length (ft)	70	Bankfull Width (ft)	7.0								
Width (in)	72	Bankfull:Culvert Ratio	0.9								
Height (in)	48*	*Couldn't find bottom of pipe under sediment.									
Outlet Perch (ft)	None										
Gradient (%)	3.5										
Rustline Height (in)	18										
Overall Condition	Fair										
PRIORITIZATION ANALYSIS											
Upstream Habitat Length (mi)	2.3	Habitat Points	4

Habitat Quality	Poor(+)	Habitat Quality Points	1								
Fish Species	Anad.	Fish Points	3								
Barrier Class	Gray	Barrier Points	2								
		Prioritization Total Points	10								
Notes: Culvert approximately 1/3 full of sediment.

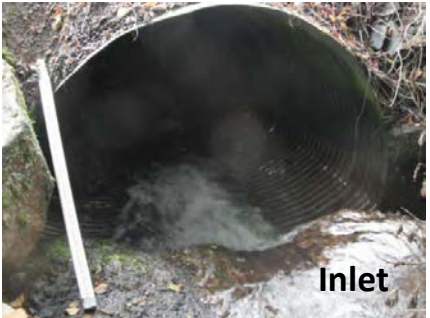
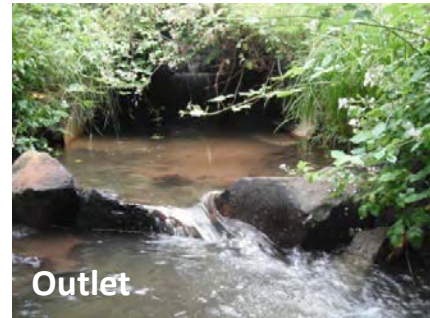
LOCATION INFO				Culvert #	910	Priority	H				
Watershed		Wilson River

Shape	Pipe arch	Inlet Gradient (%)	15.5								
Material	Corrugated metal	Upstream Gradient (%)	4.9								
Length (ft)	45	Bankfull Width (ft)	7.2								
Width (in)	96	Bankfull:Culvert Ratio	1.1								
Height (in)	72	A large slab of concrete was located in the stream channel at inlet. This resulted in an ~ 2 ft cascade into pipe.									
Outlet Perch (ft)	None										
Gradient (%)	6.7										
Rustline Height (in)	12										
Overall Condition	Fair										
PRIORITIZATION ANALYSIS

Upstream Habitat Length (mi)	1.8	Habitat Points	4								
Habitat Quality	Fair	Habitat Quality Points	2								
Fish Species	Anad.	Fish Points	3								
Barrier Class	Red	Barrier Points	3								
		Prioritization Total Points	12								
Notes: Barrier rating based on concrete blocking inlet and the steep pipe gradient and lack of natural substrate through pipe.

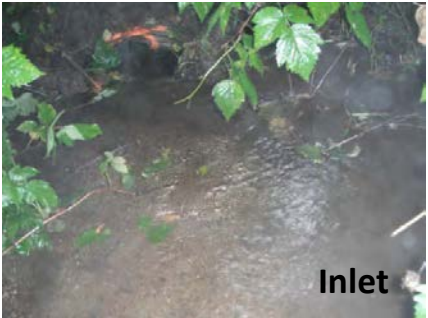
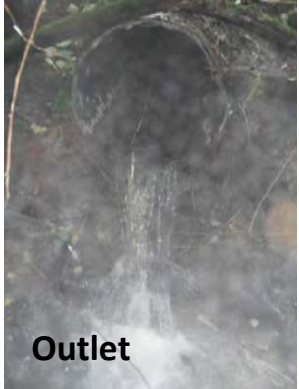
LOCATION INFO				Culvert #	877	Priority	L
Watershed		Wilson River

Shape	Circular	Inlet Gradient (%)	61.5				
Material	Corrugated metal	Upstream Gradient (%)	2.6				
Length (ft)	69	Bankfull Width (ft)	6.5				
Width (in)	36	Bankfull:Culvert Ratio	0.5				
Height (in)	36						
Outlet Perch (ft)	2.1						
Gradient (%)	4.4						
Rustline Height (in)	18						
Overall Condition	Poor						
PRIORITIZATION ANALYSIS							
Upstream Habitat Length (mi)	0.3	Habitat Points	1				
Habitat Quality	Fair(-)	Habitat Quality Points	2				
Fish Species	Anad.	Fish Points	3				
Barrier Class	Red	Barrier Points	3

Prioritization Total Points	9				
<p>Notes: Crossing 862 was located downstream of this crossing. We did not have permission to access 862 and could not adequately observe it from Highway 6 to determine what type of pipe occurs there, its condition, or its potential to impede passage.</p>

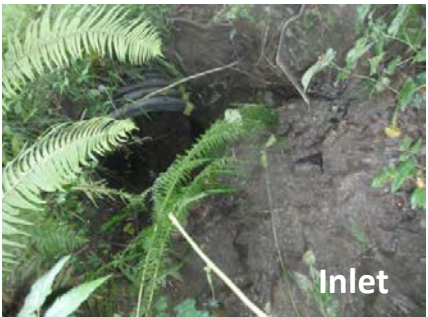
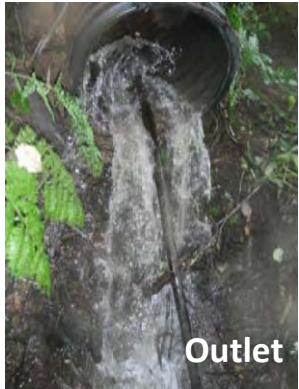
LOCATION INFO				Culvert #	881	Priority	L
Watershed		Wilson River

Shape	Circular	Inlet Gradient (%)	3.1				
Material	Plastic	Upstream Gradient (%)	4.1				
Length (ft)	34	Bankfull Width (ft)	5.1				
Width (in)	18	Bankfull:Culvert Ratio	0.3				
Height (in)	18						
Outlet Perch (ft)	5.7						
Gradient (%)	4.4						
Rustline Height (in)	18						
Overall Condition	Fair						
PRIORITIZATION ANALYSIS							
Upstream Habitat Length (mi)	0.1	Habitat Points	1				
Habitat Quality	Poor	Habitat Quality Points	1				
Fish Species	Anad.	Fish Points	3				
Barrier Class	Red	Barrier Points	3				
		Prioritization Total Points	8

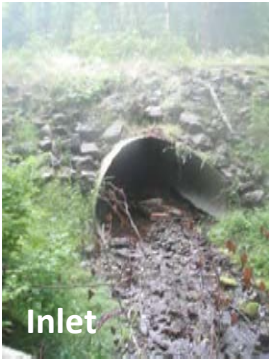
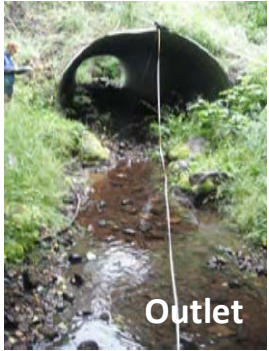
LOCATION INFO				Culvert #	465	Priority	NA
Watershed		Wilson River

Stream Name		Unnamed tributary of Little N. Fork Wilson River					
Township-Range-Section-1/4		T1N, R8W, Sec. 23, NW¼ of NW¼					
UTM Easting/Northing (Zone 10, NAD 1983)		450253/5045470					
Road Name		Kilchis Lookout Road					
Road/Culvert Owner		Oregon Department of Forestry					
Adjacent Landowners		Oregon Department of Forestry					
CULVERT INFO		CHANNEL INFO					
Shape	Pipe arch	Inlet Gradient (%)	3.1				
Material	Corrugated metal	Upstream Gradient (%)	6.2				
Length (ft)	74	Bankfull Width (ft)	8.3				
Width (in)	162	Bankfull:Culvert Ratio	1.6				
Height (in)	102						
Outlet Perch (ft)	None						
Gradient (%)	2.4						
Rustline Height (in)	10						
Overall Condition	Good						
PRIORITIZATION ANALYSIS							
Upstream Habitat Length (mi)	0.5	Habitat Points	1				
Habitat Quality	Fair	Habitat Quality Points	2				
Fish Species	Anad.	Fish Points	3

Barrier Class	Green	Barrier Points	1				
		Prioritization Total Points	7				
<p>Notes: It is possible that anadromous fish cannot make it to this point due to natural barriers. However, based on juvenile survey data, it appears that steelhead are capable of negotiating most known barriers below this point, so we elected to consider this reach as having anadromous potential.</p>

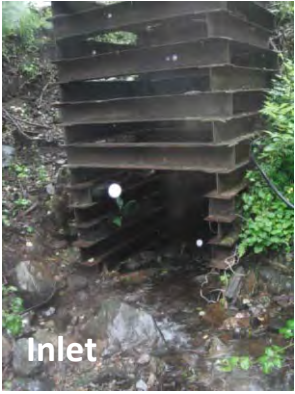
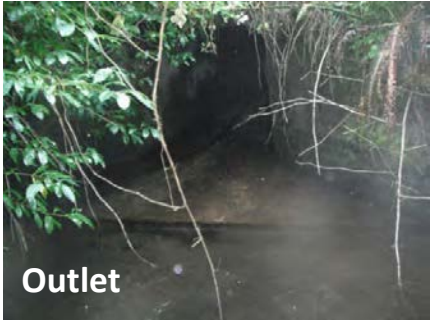
LOCATION INFO				Culvert #	775	Priority	M
Watershed		Wilson River

Shape	Box	Inlet Gradient (%)	7.0				
Material	Concrete	Upstream Gradient (%)	6.0				
Length (ft)	75	Bankfull Width (ft)	6.3				
Width (in)	60	Bankfull:Culvert Ratio	0.8				
Height (in)	60						
Outlet Perch (ft)	None						
Gradient (%)	5.0						
Rustline Height (in)	N/A						
Overall Condition	Fair						
PRIORITIZATION ANALYSIS							
Upstream Habitat Length (mi)	0.8	Habitat Points	2				
Habitat Quality	Fair	Habitat Quality Points	2				
Fish Species	Anad.	Fish Points	3

Barrier Class	Red	Barrier Points	3				
		Prioritization Total Points	10				
<p>Notes: Topography and obstacles precluded use of surveying level on this culvert. Unable to determine if outlet is perched. Trash rack at inlet. Culvert overly steep and lacks natural substrate.</p>

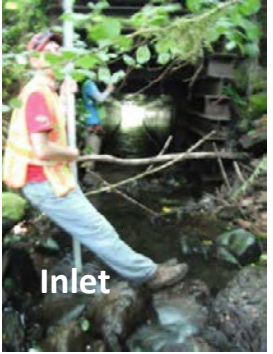
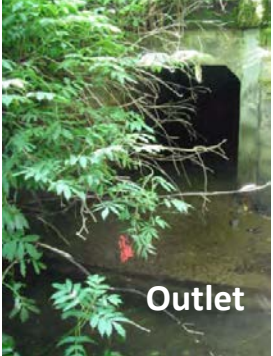
LOCATION INFO				Culvert #	760	Priority	M
Watershed		Wilson River

Shape	Box	Inlet Gradient (%)	12.0				
Material	Concrete	Upstream Gradient (%)	11.0				
Length (ft)	97	Bankfull Width (ft)	6.4				
Width (in)	60	Bankfull:Culvert Ratio	0.8				
Height (in)	60						
Outlet Perch (ft)	Unknown						
Gradient (%)	7.0						
Rustline Height (in)	N/A						
Overall Condition	Poor						
PRIORITIZATION ANALYSIS							
Upstream Habitat Length (mi)	1.0	Habitat Points	2				
Habitat Quality	Fair	Habitat Quality Points	2				
Fish Species	Anad.	Fish Points	3				
Barrier Class	Red	Barrier Points	3				
		Prioritization Total Points	10

<p>Notes: Topography and obstacles precluded use of surveying level on this culvert. Unable to determine if outlet is perched. Trash rack at inlet. Culvert overly steep and lacks natural substrate.</p>

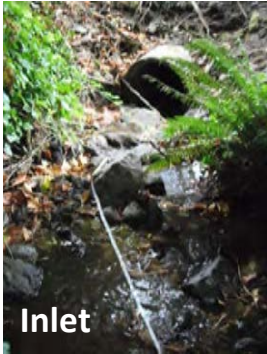
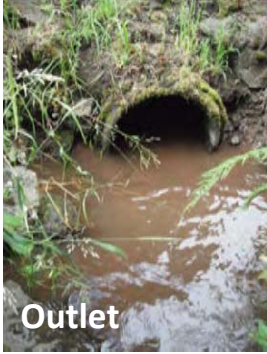
LOCATION INFO				Culvert #	722	Priority	L
Watershed		Wilson River

<p align="center">Outlet</p>			
Stream Name		Unnamed tributary of Wilson River					
Township-Range-Section-1/4		T1S, R8W, Sec. 8, SE¼ of NE¼					
UTM Easting/Northing (Zone 10, NAD 1983)		446487/5037891					
Road Name		Highway 6					
Road/Culvert Owner		Oregon Department of Transportation					
Adjacent Landowners		Wilson River Properties, LLC. and J. Vandyke					
CULVERT INFO		CHANNEL INFO					
Shape	Circular	Inlet Gradient (%)	9.8				
Material	Concrete	Upstream Gradient (%)	12.3				
Length (ft)	50	Bankfull Width (ft)	4.9				
Width (in)	24	Bankfull:Culvert Ratio	0.4				
Height (in)	24						
Outlet Perch (ft)	None						
Gradient (%)	4.8						
Rustline Height (in)	N/A						
Overall Condition	Fair						
PRIORITIZATION ANALYSIS							
Upstream Habitat Length (mi)	0.2	Habitat Points	1				
Habitat Quality	Poor	Habitat Quality Points	1

Fish Species	Anad.	Fish Points	3				
Barrier Class	Red	Barrier Points	3				
		Prioritization Total Points	8				
<p>Notes: Stream depicted as nonfish-modeled. However, technical review team suggested including this culvert in the analysis and ending fish use where stream gradient exceeds 15 percent grade.</p>

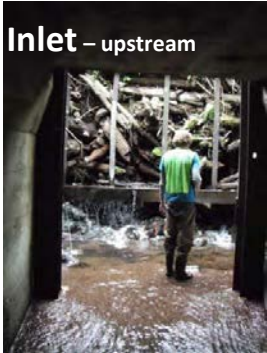
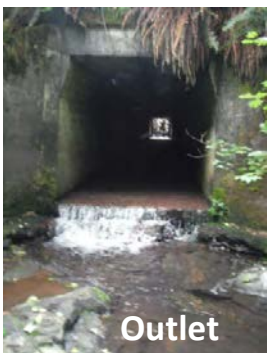
LOCATION INFO				Culvert #	713	Priority	M
Watershed		Wilson River

<p align="center">Outlet</p>			
Stream Name		Smith Creek					
Township-Range-Section-1/4		T1S, R8W, Sec. 9, SW¼ of NW¼					
UTM Easting/Northing (Zone 10, NAD 1983)		446846/5037955					
Road Name		Highway 6					
Road/Culvert Owner		Oregon Department of Transportation					
Adjacent Landowners		Stimson Lumber Company					
CULVERT INFO		CHANNEL INFO					
Shape	Box	Inlet Gradient (%)	Not measured				
Material	Concrete	Upstream Gradient (%)	4.0				
Length (ft)	143	Bankfull Width (ft)	6.2				
Width (in)	120	Bankfull:Culvert Ratio	1.6				
Height (in)	90						
Outlet Perch (ft)	~1.5	Use of surveying equipment precluded by terrain and obstacles.					
Gradient (%)	8.0						
Rustline Height (in)	N/A						
Overall Condition	Poor						
PRIORITIZATION ANALYSIS							
Upstream Habitat Length (mi)	0.6	Habitat Points	2

Habitat Quality	Fair	Habitat Quality Points	2				
Fish Species	Anad.	Fish Points	3				
Barrier Class	Red	Barrier Points	3				
		Prioritization Total Points	10				
<p>Notes: Water was observed entering the pipe from holes in the side walls and flowing around the outside of one of the wing walls at outlet. This suggests that water was flowing alongside the entire outer wall of the pipe. An approx. 20 ft wall of debris was trapped upstream of the trash rack and had aggraded the upstream channel an equivalent amount.</p>

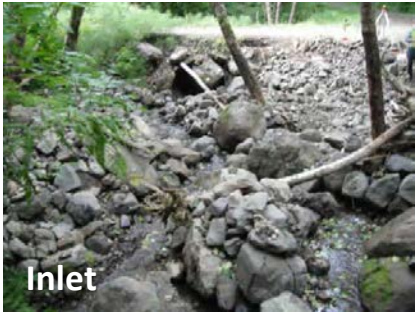
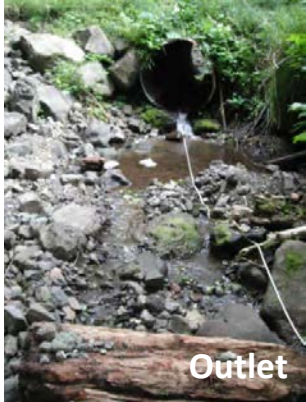
LOCATION INFO				Culvert #	693	Priority	L
Watershed		Wilson River

Stream Name		Smith Creek					
Township-Range-Section-1/4		T1S, R8W, Sec. 5, SE¼ of SE¼					
UTM Easting/Northing (Zone 10, NAD 1983)		446299/5038612					
Road Name		Smith Creek Road					
Road/Culvert Owner		Oregon Department of Forestry					
Adjacent Landowners		Oregon Department of Forestry					
CULVERT INFO		CHANNEL INFO					
Shape	Circular	Inlet Gradient (%)	12.8				
Material	Corrugated metal	Upstream Gradient (%)	11.2				
Length (ft)	27	Bankfull Width (ft)	4.5				
Width (in)	72	Bankfull:Culvert Ratio	1.3				
Height (in)	72						
Outlet Perch (ft)	2.7						
Gradient (%)	9.3						
Rustline Height (in)	12						
Overall Condition	Fair						
PRIORITIZATION ANALYSIS							
Upstream Habitat Length (mi)	0.3	Habitat Points	1				
Habitat Quality	Fair(-)	Habitat Quality Points	2				
Fish Species	Anad.	Fish Points	3				
Barrier Class	Red	Barrier Points	3

Prioritization Total Points	9				
Notes: Stream intermittently subterranean during survey (summer 2011). Depicted as nonfish. Technical team suggested including this culvert and stopping fish use where gradient exceeds 15 percent. Cutthroat observed in watered areas upstream of pipe during 2011 survey work.

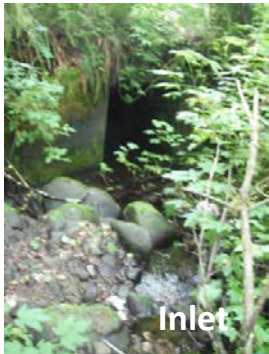
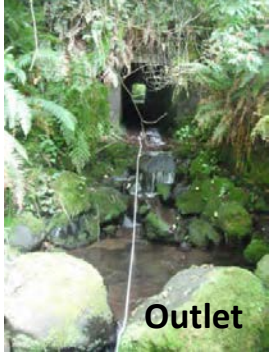
LOCATION INFO				Culvert #	696	Priority	L
Watershed		Wilson River

Stream Name		Fern Creek					
Township-Range-Section-1/4		T1S, R8W, Sec. 9, NE¼ of NW¼					
UTM Easting/Northing (Zone 10, NAD 1983)		447331/5038383					
Road Name		Highway 6					
Road/Culvert Owner		Oregon Department of Transportation					
Adjacent Landowners		R. & B. Stacks and DH Kim, LLC.					
CULVERT INFO		CHANNEL INFO					
Shape	Box	Inlet Gradient (%)	16.0				
Material	Concrete	Upstream Gradient (%)	9.5				
Length (ft)	100	Bankfull Width (ft)	6.6				
Width (in)	48	Bankfull:Culvert Ratio	0.6				
Height (in)	60						
Outlet Perch (ft)	~3.5	Use of surveying equipment precluded by terrain and obstacles.					
Gradient (%)	9.3						
Rustline Height (in)	12						
Overall Condition	Poor						
PRIORITIZATION ANALYSIS							
Upstream Habitat Length (mi)	0.5	Habitat Points	1				
Habitat Quality	Fair(-)	Habitat Quality Points	2				
Fish Species	Anad.	Fish Points	3

Barrier Class	Red	Barrier Points	3				
		Prioritization Total Points	9				
Notes: Outlet cascades over boulders and additional cascades over boulders are located a short distance downstream of outlet. Exposed rebar observed on invert of pipe.

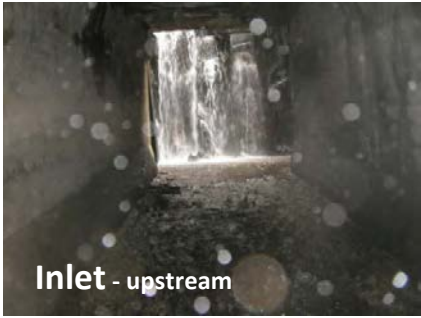
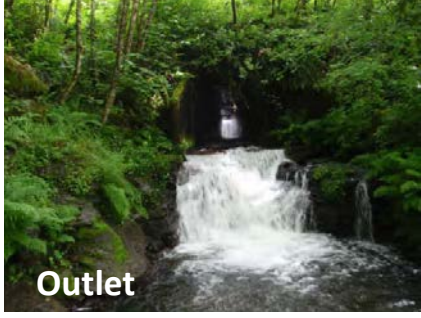
Shape	Box	Inlet Gradient (degrees)	90				
Material	Concrete	Upstream Gradient (%)	7.0				
Length (ft)	150	Bankfull Width (ft)	25.0				
Width (in)	126	Bankfull:Culvert Ratio	0.4				
Height (in)	120	Use of surveying equipment precluded by terrain and obstacles.					
Outlet Perch (ft)	~13.0						
Gradient (%)	8.0						
Rustline Height (in)	24						
Overall Condition	Poor						
PRIORITIZATION ANALYSIS							
Upstream Habitat Length (mi)	1.6	Habitat Points	4				
Habitat Quality	Good	Habitat Quality Points	3				
Fish Species	Anad.	Fish Points	3

Barrier Class	Red	Barrier Points	3				
		Prioritization Total Points	13				
Notes: An approx. 30 ft wall of debris occurred upstream of trash rack. Channel aggraded an equivalent amount. Culvert in very poor condition – wing walls detached and broken, rebar exposed along entire invert, top of pipe cracked and water leaking in through cracks, water pouring into culvert from holes in side walls, and water flowing out from around both sides of outlet.

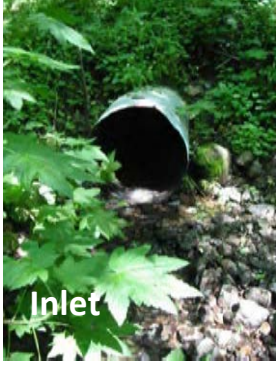
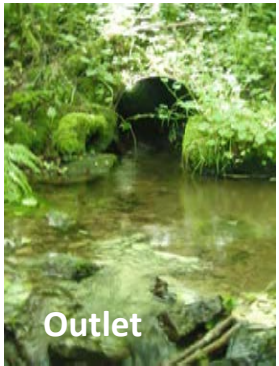
LOCATION INFO				Culvert #	762	Priority	L
Watershed		Wilson River

Shape	Circular	Inlet Gradient (%)	14.9				
Material	Corrugated metal	Upstream Gradient (%)	4.3				
Length (ft)	39	Bankfull Width (ft)	5.5				
Width (in)	30	Bankfull:Culvert Ratio	0.5				
Height (in)	30						
Outlet Perch (ft)	0.7						
Gradient (%)	6.5						
Rustline Height (in)	12						
Overall Condition	Good						
PRIORITIZATION ANALYSIS							
Upstream Habitat Length (mi)	0.1	Habitat Points	1				
Habitat Quality	Poor	Habitat Quality Points	1				
Fish Species	Resident	Fish Points	2

Barrier Class	Red	Barrier Points	3				
		Prioritization Total Points	7				
Notes:

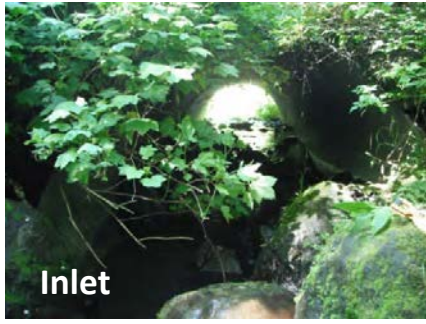
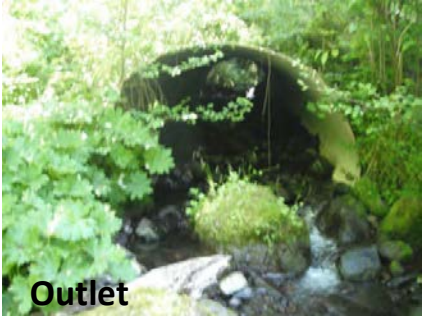
LOCATION INFO				Culvert #	799	Priority	L
Watershed		Wilson River

Shape	Circular	Inlet Gradient (%)	11.3				
Material	Corrugated metal	Upstream Gradient (%)	11.3				
Length (ft)	69	Bankfull Width (ft)	11.9				
Width (in)	156	Bankfull:Culvert Ratio	1.1				
Height (in)	108						
Outlet Perch (ft)	0.4						
Gradient (%)	1.6						
Rustline Height (in)	None						
Overall Condition	Fair						
PRIORITIZATION ANALYSIS							
Upstream Habitat Length (mi)	0.4	Habitat Points	1				
Habitat Quality	Poor	Habitat Quality Points	1				
Fish Species	Resident	Fish Points	2

Barrier Class	Red	Barrier Points	3				
		Prioritization Total Points	7				
Notes:

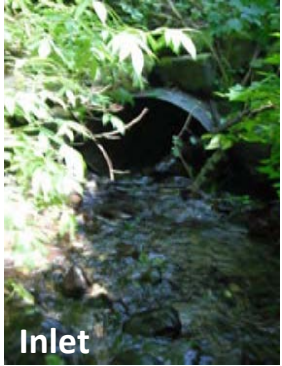
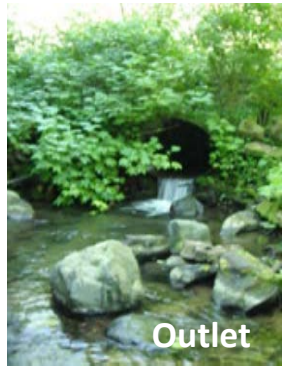
LOCATION INFO				Culvert #	798	Priority	L
Watershed		Wilson River

Stream Name		Kansas Creek					
Township-Range-Section-1/4		T1S, R8W, Sec. 14, SW¼ of NW¼					
UTM Easting/Northing (Zone 10, NAD 1983)		449687/5036465					
Road Name		Kansas Creek Road					
Road/Culvert Owner		Oregon Department of Forestry					
Adjacent Landowners		Oregon Department of Forestry					
CULVERT INFO		CHANNEL INFO					
Shape	Pipe arch	Inlet Gradient (%)	23.8				
Material	Corrugated metal	Upstream Gradient (%)	5.6				
Length (ft)	71	Bankfull Width (ft)	14.7				
Width (in)	66	Bankfull:Culvert Ratio	0.4				
Height (in)	42						
Outlet Perch (ft)	1.6						
Gradient (%)	3.1						
Rustline Height (in)	22						
Overall Condition	Fair						
PRIORITIZATION ANALYSIS

Upstream Habitat Length (mi)	0.4	Habitat Points	1				
Habitat Quality	Poor	Habitat Quality Points	1				
Fish Species	Resident	Fish Points	2				
Barrier Class	Red	Barrier Points	3

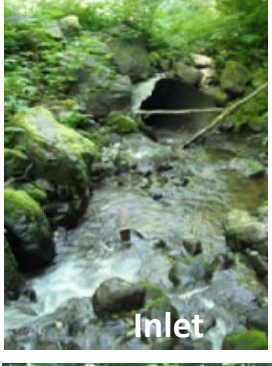
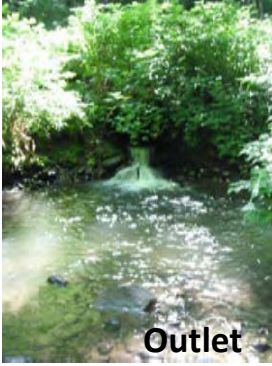
LOCATION INFO				Culvert #	822	Priority	L
Watershed		Wilson River

Stream Name		Kansas Creek					
Township-Range-Section-1/4		T1S, R8W, Sec. 14, SW¼ of NW¼					
UTM Easting/Northing (Zone 10, NAD 1983)		449858/5036361					
Road Name		Kansas Creek Road					
Road/Culvert Owner		Oregon Department of Forestry					
Adjacent Landowners		Oregon Department of Forestry					
CULVERT INFO		CHANNEL INFO					
Shape	Pipe arch	Inlet Gradient (%)	11.5				
Material	Corrugated metal	Upstream Gradient (%)	11.8				
Length (ft)	56	Bankfull Width (ft)	11.0				
Width (in)	55	Bankfull:Culvert Ratio	0.4				
Height (in)	41						
Outlet Perch (ft)	1.4						
Gradient (%)	9.9						
Rustline Height (in)	10						
Overall Condition	Fair						
PRIORITIZATION ANALYSIS

Upstream Habitat Length (mi)	0.3	Habitat Points	1				
Habitat Quality	Poor	Habitat Quality Points	1				
Fish Species	Resident	Fish Points	2				
Barrier Class	Red	Barrier Points	3

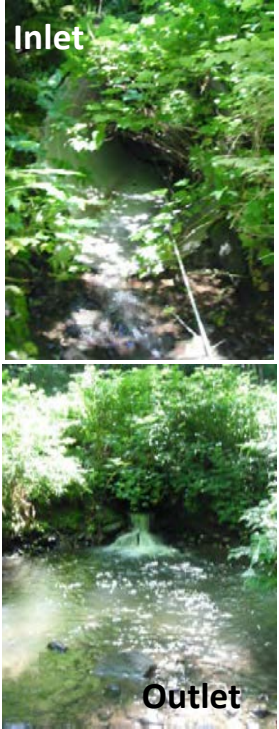
LOCATION INFO				Culvert #	823	Priority	L
Watershed		Wilson River

Stream Name		Kansas Creek					
Township-Range-Section-1/4		T1S, R8W, Sec. 14, NW¼ of SW¼					
UTM Easting/Northing (Zone 10, NAD 1983)		449997/5036035					
Road Name		Kansas Creek Road					
Road/Culvert Owner		Oregon Department of Forestry					
Adjacent Landowners		Oregon Department of Forestry					
CULVERT INFO		CHANNEL INFO					
Shape	Pipe arch	Inlet Gradient (%)	14.2				
Material	Circular	Upstream Gradient (%)	6.7				
Length (ft)	79	Bankfull Width (ft)	15.4				
Width (in)	90	Bankfull:Culvert Ratio	0.5				
Height (in)	90						
Outlet Perch (ft)	4.1						
Gradient (%)	4.2						
Rustline Height (in)	13						
Overall Condition	Poor						
PRIORITIZATION ANALYSIS							
Upstream Habitat Length (mi)	0.1	Habitat Points	1				
Habitat Quality	Poor	Habitat Quality Points	1				
Fish Species	Resident	Fish Points	2				
Barrier Class	Red	Barrier Points	3

Prioritization Total Points	7				
Notes: Seams in culvert were separating and water was flowing under pipe.
