# NESTUCCA / NESKOWIN WATERSHEDS

## CULVERT PRIORITIZATION AND ACTION PLAN FOR FISH PASSAGE

**Rachel Hoffman  
Environmental Project Manager  
Tillamook Estuaries Partnership**

**May 2006**

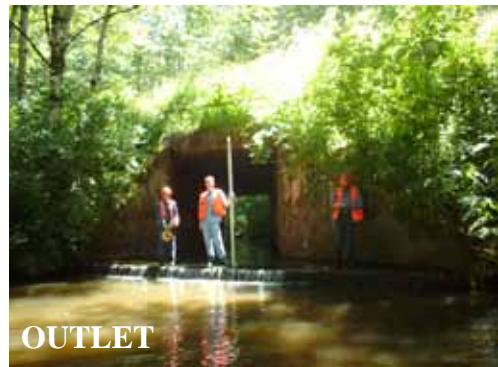
LOCATION INFO		CULVERT #	1129	PRIORITY	H
Watershed	Nestucca				
Stream Name	Nestucca River				
Township-Range-Section-1/4	3S – 6W – S15 – SW of NW				
UTM Easting / Northing	467208 / 5017400				
Road Name	3613 – Nestucca Access Road				
Road/Culvert Owner	BLM				
Adjacent Landowners	City of McMinnville				
CULVERT INFO		CHANNEL INFO			
Shape	Box	Inlet Gradient (%)	2.0		
Material	Concrete	Upstream Gradient (%)	2.0		
Length (ft)	91.5	Bankfull Width (ft)	22.0		
Width (in)	120.0	Bankfull Ratio	0.5		
Height (in)	120.0				
Outlet Drop (ft)	0.5				
Slope (%)	2.0				
PRIORITIZATION ANALYSIS					
Habitat Length	6.8 miles	(1) Habitat Pts	4		
Habitat Quality	good	(2) Habitat Quality Pts	3		
Fish Species	co stw ct	(3) Fish Pts	3		
Barrier Type	RED	(4) Barrier Pts	3		
		Prioritization Total Pts	<b>13</b>

**NOTES:** This culvert is located in Yamhill County. Wood baffles (4'x4's) have been placed in the culvert. BLM has completed an Environmental Assessment for replacement of this culvert (i.e. NEPA).

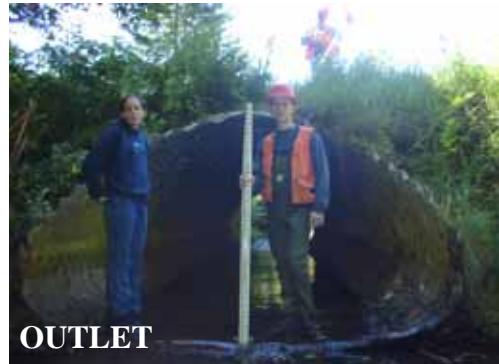
LOCATION INFO		CULVERT #	1157	PRIORITY	H
Watershed	Nestucca				
Stream Name	Walker Creek				
Township-Range-Section-1/4	3S – 6W – S15 – SE of SW				
UTM Easting / Northing	467477 / 5016513				
Road Name	3615.3 – A-B Road				
Road/Culvert Owner	BLM				
Adjacent Landowners	BLM				
CULVERT INFO		CHANNEL INFO			
Shape	Pipe arch	Inlet Gradient (%)	3.0		
Material	Corrugated metal	Upstream Gradient (%)	1.0		
Length (ft)	52.8	Bankfull Width (ft)	16.9		
Width (in)	78.0	Bankfull Ratio	0.5		
Height (in)	108.0				
Outlet Drop (ft)	0.0				
Slope (%)	1.0				
PRIORITIZATION ANALYSIS					
Habitat Length	5.7 miles	(1) Habitat Pts	4		
Habitat Quality	good	(2) Habitat Quality Pts	3		
Fish Species	co stw ct	(3) Fish Pts	3		
Barrier Type	GREY	(4) Barrier Pts	2		
		Prioritization Total Pts	12

NOTES: This culvert is located in Yamhill County. BLM has completed an Environmental Assessment for the replacement.

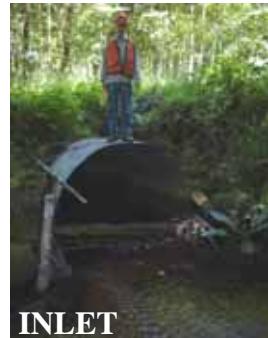
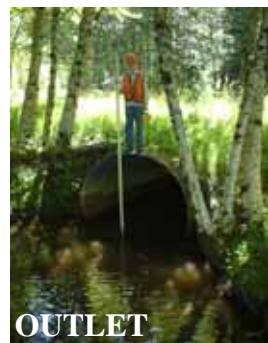
LOCATION INFO		CULVERT #	1174	PRIORITY	H
Watershed	Nestucca				
Stream Name	Walker Creek				
Township-Range-Section-1/4	3S – 6W – S22 – SW of NW				
UTM Easting / Northing	467407 / 5015715				
Road Name	3622.1				
Road/Culvert Owner	BLM				
Adjacent Landowners	BLM				
CULVERT INFO		CHANNEL INFO			
Shape	Pipe arch	Inlet Gradient (%)	8.0		
Material	Corrugated metal	Upstream Gradient (%)	2.0		
Length (ft)	50.6	Bankfull Width (ft)	17.0		
Width (in)	90.0	Bankfull Ratio	0.4		
Height (in)	69.0				
Outlet Drop (ft)	0.0				
Slope (%)	0.0				
PRIORITIZATION ANALYSIS					
Habitat Length	3.5 miles	(1) Habitat Pts	4		
Habitat Quality	good	(2) Habitat Quality Pts	3		
Fish Species	co stw ct	(3) Fish Pts	3		
Barrier Type	RED	(4) Barrier Pts	3		
		Prioritization Total Pts	13

NOTES: This culvert is located in Yamhill County. BLM has completed an Environmental Assessment for the replacement.

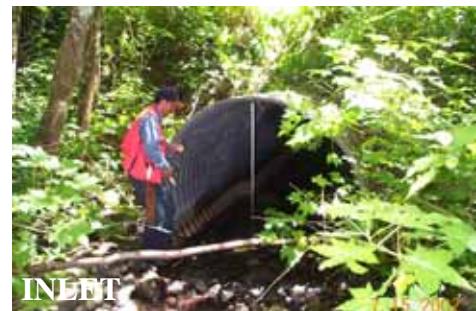
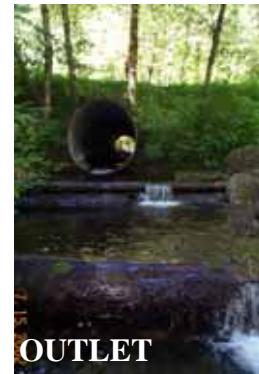
LOCATION INFO		CULVERT #	1192	PRIORITY	H
Watershed	Nestucca				
Stream Name	Fan Creek				
Township-Range-Section-1/4	3S – 7W – S24 – NE of SW				
UTM Easting / Northing	461059 / 5015442				
Road Name	3613 – Nestucca Access Road				
Road/Culvert Owner	BLM				
Adjacent Landowners	BLM				
CULVERT INFO		CHANNEL INFO			
Shape	Circular	Inlet Gradient (%)	6.0		
Material	Corrugated metal	Upstream Gradient (%)	4.0		
Length (ft)	79.0	Bankfull Width (ft)	16.0		
Width (in)	66.0	Bankfull Ratio	0.3		
Height (in)	66.0				
Outlet Drop (ft)	0.0				
Slope (%)	3.0				
PRIORITIZATION ANALYSIS					
Habitat Length	1.2 miles	(1) Habitat Pts	3		
Habitat Quality	fair	(2) Habitat Quality Pts	2		
Fish Species	co stw ct	(3) Fish Pts	3		
Barrier Type	RED	(4) Barrier Pts	3		
		Prioritization Total Pts	11

NOTES: In the 1980's, log weirs were placed below the outlet to facilitate fish access to the culvert. BLM has completed an Environmental Assessment for the replacement.

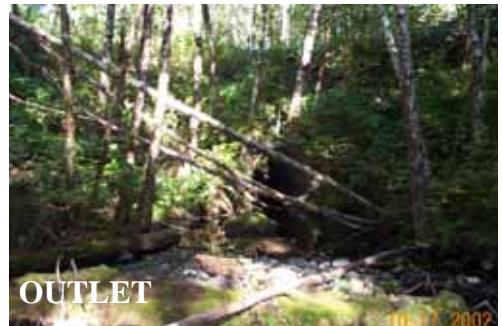
LOCATION INFO		CULVERT #	2012	PRIORITY	H
Watershed	Nestucca				
Stream Name	Fan Creek				
Township-Range-Section-1/4	3S – 7W – S24 – NE of SW				
UTM Easting / Northing	461029 / 5015573				
Road Name	3724 – Fan Creek Road				
Road/Culvert Owner	BLM				
Adjacent Landowners	BLM				
CULVERT INFO		CHANNEL INFO			
Shape	Circular	Inlet Gradient (%)	4.0		
Material	Corrugated metal	Upstream Gradient (%)	3.0		
Length (ft)	95.0	Bankfull Width (ft)	16.0		
Width (in)	84.0	Bankfull Ratio	0.4		
Height (in)	84.0				
Outlet Drop (ft)	0.0				
Slope (%)	3.0				
PRIORITIZATION ANALYSIS					
Habitat Length	1.1 miles	(1) Habitat Pts	3		
Habitat Quality	fair	(2) Habitat Quality Pts	2		
Fish Species	co stw ct	(3) Fish Pts	3		
Barrier Type	RED	(4) Barrier Pts	3		
		Prioritization Total Pts	11

NOTES: BLM has completed an Environmental Assessment for the replacement. This culvert appears to be a full barrier to coho as the last coho observed were in the outlet pool.

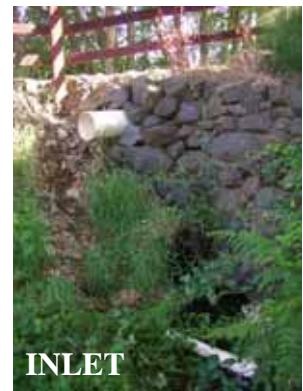
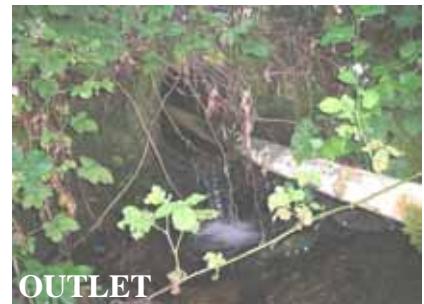
LOCATION INFO		CULVERT #	O3022	PRIORITY	M
Watershed	Nestucca				
Stream Name	Moon Creek tributary				
Township-Range-Section-1/4	3S – 8W – S29 – SW of NW				
UTM Easting / Northing	445050 / 5014075				
Road Name	863 – Moon Creek Road				
Road/Culvert Owner	Tillamook County				
Adjacent Landowners	William Slavens				
CULVERT INFO		CHANNEL INFO			
Shape	Circular	Inlet Gradient (%)	---		
Material	Concrete	Upstream Gradient (%)	6.0		
Length (ft)	60.0	Bankfull Width (ft)	---		
Width (in)	24.0	Bankfull Ratio	---		
Height (in)	24.0				
Outlet Drop (ft)	1.0				
Slope (%)	4.0				
PRIORITIZATION ANALYSIS					
Habitat Length	0.3 miles	(1) Habitat Pts	1		
Habitat Quality	poor	(2) Habitat Quality Pts	1		
Fish Species	ct	(3) Fish Pts	2		
Barrier Type	RED	(4) Barrier Pts	3		
		Prioritization Total Pts	7

NOTES: This culvert is broken in the middle and has a high failure risk.

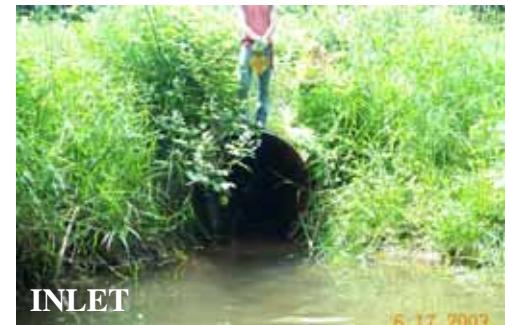
INLET

LOCATION INFO		CULVERT #	1083	PRIORITY	H
Watershed	Nestucca				
Stream Name	West Beaver Creek tributary				
Township-Range-Section-1/4	3S – 10W – S10 – NE of SE				
UTM Easting / Northing	430552 / 5018919				
Road Name	Unnamed				
Road/Culvert Owner	Green Diamond				
Adjacent Landowners	Green Diamond				
CULVERT INFO		CHANNEL INFO			
Shape	Circular	Inlet Gradient (%)	30.0		
Material	Corrugated metal	Upstream Gradient (%)	1.0		
Length (ft)	22.5	Bankfull Width (ft)	13.0		
Width (in)	66.0	Bankfull Ratio	0.4		
Height (in)	66.0				
Outlet Drop (ft)	0.9				
Slope (%)	2.0				
PRIORITIZATION ANALYSIS					
Habitat Length	2.0 miles	(1) Habitat Pts	4		
Habitat Quality	good	(2) Habitat Quality Pts	3		
Fish Species	co stw ct	(3) Fish Pts	3		
Barrier Type	RED	(4) Barrier Pts	3		
		Prioritization Total Pts	13

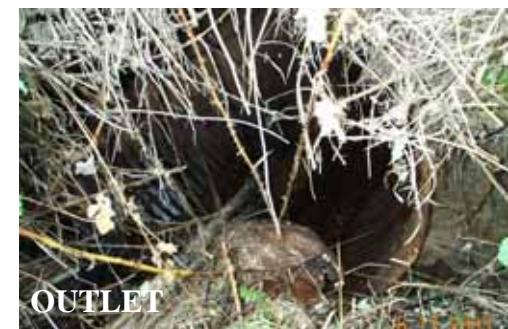
OUTLET

NOTES: This culvert is failing.

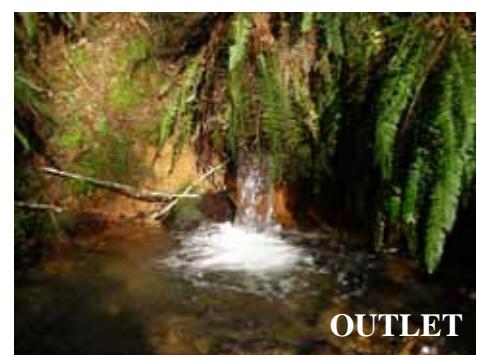
LOCATION INFO		CULVERT #	F3	PRIORITY	M
Watershed	Nestucca				
Stream Name	West Creek tributary				
Township-Range-Section-1/4	3S – 10W – S24 – NE of SE				
UTM Easting / Northing	433595 / 5015412				
Road Name	1004				
Road/Culvert Owner	USFS				
Adjacent Landowners	Forest Capital Partners LLC				
CULVERT INFO		CHANNEL INFO			
Shape	Circular	Inlet Gradient (%)	17.0		
Material	Corrugated metal	Upstream Gradient (%)	1.0		
Length (ft)	36.0	Bankfull Width (ft)	5.3		
Width (in)	24.0	Bankfull Ratio	0.4		
Height (in)	24.0				
Outlet Drop (ft)	1.9				
Slope (%)	2.0				
PRIORITIZATION ANALYSIS					
Habitat Length	0.2 miles	(1) Habitat Pts	1		
Habitat Quality	good	(2) Habitat Quality Pts	3		
Fish Species	co stw ct	(3) Fish Pts	3		
Barrier Type	RED	(4) Barrier Pts	3		
		Prioritization Total Pts	<b>10</b>		
NOTES: This culvert is failing and the inlet is partially blocked.

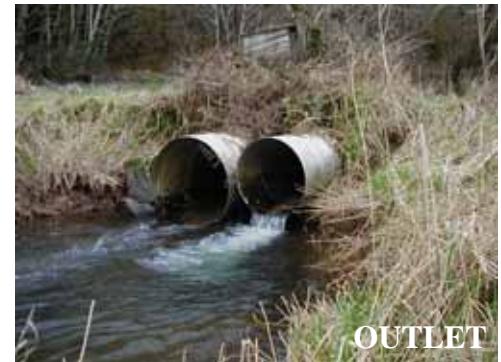
LOCATION INFO		CULVERT #	1724	PRIORITY	H
Watershed	Nestucca				
Stream Name	Alder Creek				
Township-Range-Section-1/4	5S – 9W – S17 – NE of SE				
UTM Easting / Northing	436671 / 4998039				
Road Name	Highway 22				
Road/Culvert Owner	ODOT				
Adjacent Landowners	Herbert Crew				
CULVERT INFO		CHANNEL INFO			
Shape	Circular	Inlet Gradient (%)	---		
Material	Corrugated metal	Upstream Gradient (%)	---		
Length (ft)	30.0	Bankfull Width (ft)	---		
Width (in)	36.0 & 48.0	Bankfull Ratio	---		
Height (in)	36.0 & 48.0				
Outlet Drop (ft)	0.5 & 0.0				
Slope (%)	---				
PRIORITIZATION ANALYSIS					
Habitat Length	0.3 miles	(1) Habitat Pts	1		
Habitat Quality	good	(2) Habitat Quality Pts	3		
Fish Species	co stw ct	(3) Fish Pts	3		
Barrier Type	RED	(4) Barrier Pts	3		
		Prioritization Total Pts	<b>10</b>

**NOTES:** This crossing has two side by side culverts, which equally divert streamflow in the winter (see picture). During the summer, flow is likely concentrated to the larger pipe.

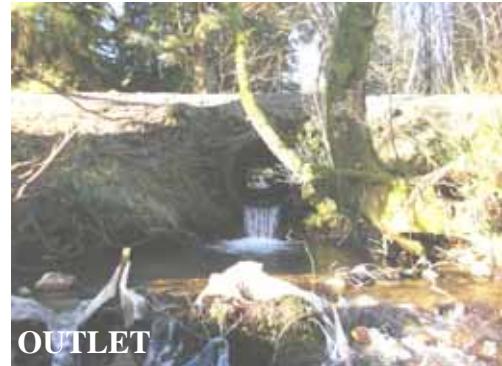
NOTES: A makeshift weir has been constructed just below the outlet.

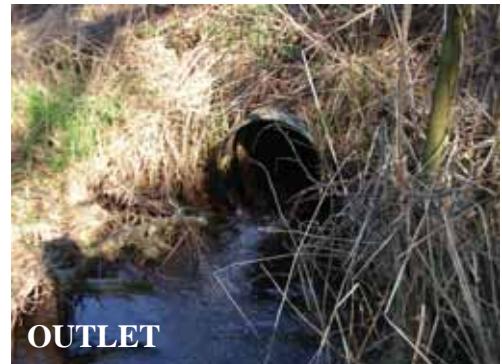
NOTES: Outlet has higher gradient than inlet. Culvert access is limited.
