Prepared for: Tillamook Estuaries Partnership (TEP)

# Burton-Fraser Road/Eckloff Road Upgrades *Alternatives Comparison*

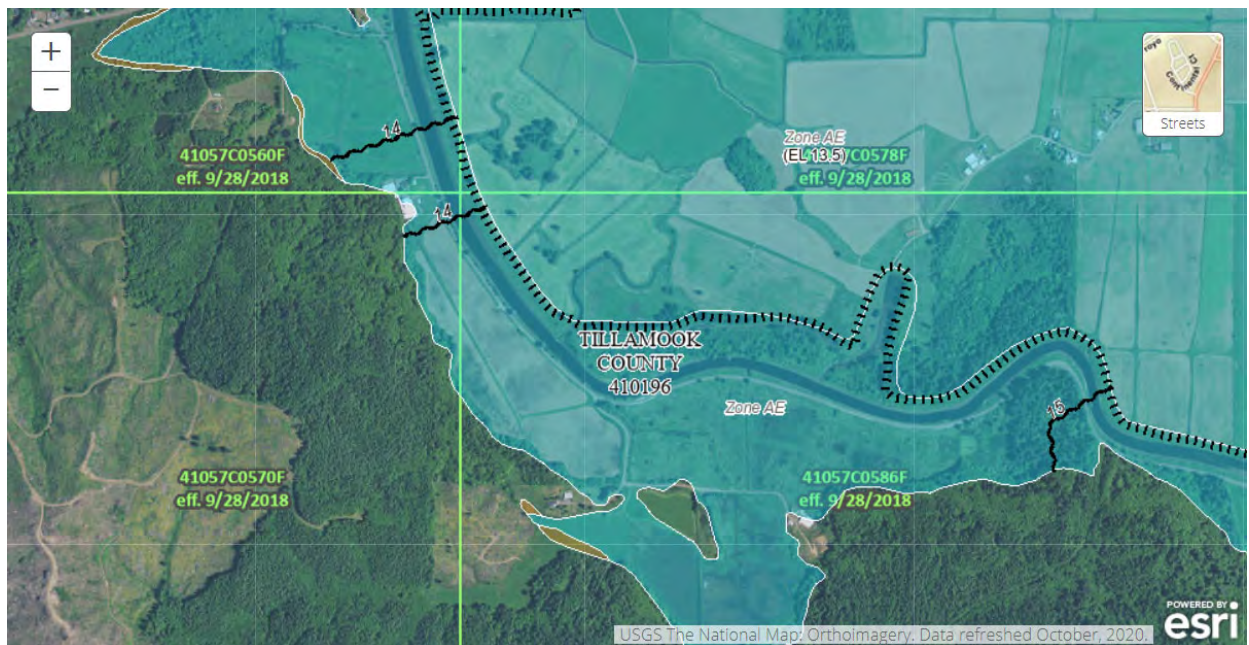
**Image 5:** FEMA Map showing Burton-Fraser Road within Zone AE (100-year floodplain), base flood elevation 14-15' NAVD88

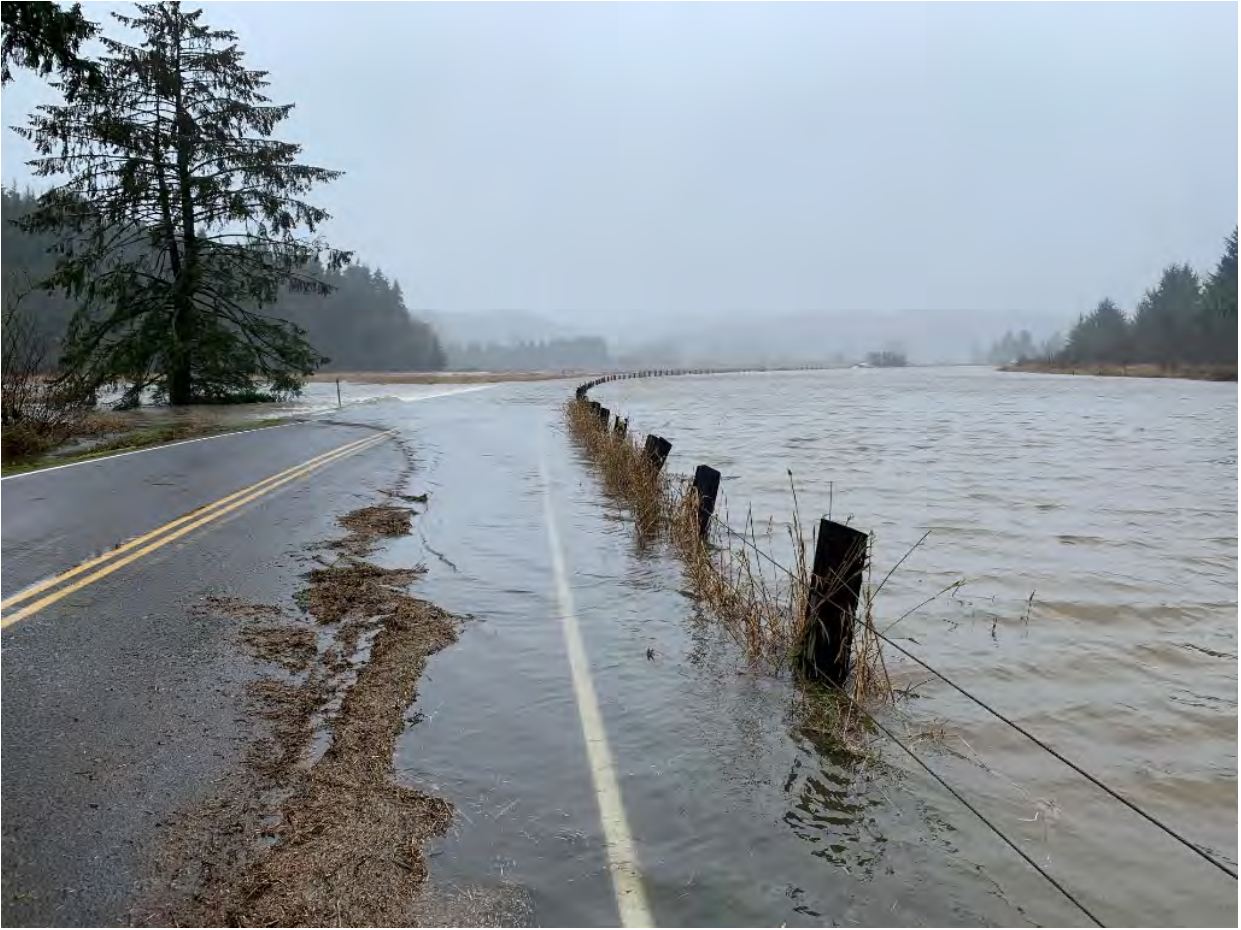
During overtopping events, water overflowing across the roadway has eroded the back/wetland side of the roadway embankment, creating abrupt edge conditions and threatening to undermine the edge of the roadway pavement (Images 6 and 7). To temporarily address the erosion on the back side of the

**Image 6:** *Burton-Fraser Road during flood conditions, eastern end of TRW site, January 12, 2021*

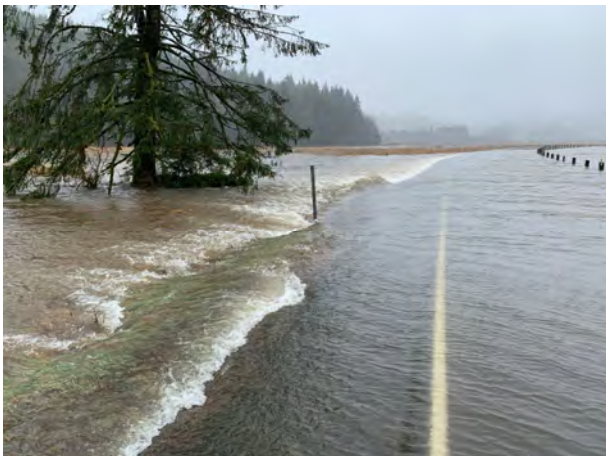
**Image 7:** *Burton-Fraser Road during flood conditions, eastern end of TRW site, January 12, 2021*

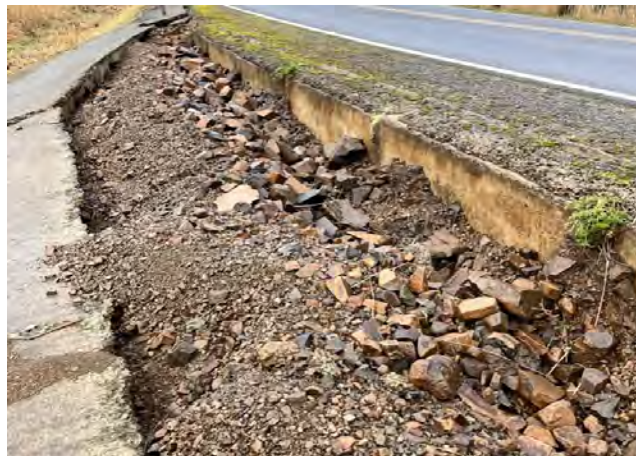
road, TCPW constructed scour protection aprons in six locations where water frequently overtops and flows across the roadway. The aprons were constructed in 2012 using a wire mesh-reinforced controlled density fill (CDF), a self-compacting, cementitious material. These scour protection measures are temporary and incomplete solutions for preventing ultimate failure of the roadway, and the aprons are showing significant deterioration the less than 10 years they have been in place (Images 8, 9, and 10).

During each overtopping event, water continues to erode and undermine these features, and significant changes have been observed in the past year alone. In several locations the edges of the CDF are failing, and two of the CDF aprons have been undermined and pushed away from the road's edge leaving an abrupt edge and additional safety hazard. The volume and velocity of water that crosses the road during overtopping is expected to eventually erode the CDF and adjacent embankments. It is likely that an overtopping event and/or culvert collapse could blow out the roadway embankment, rendering the road impassable.

**Image 8:** *Damaged CDF scour protection apron creating abrupt edge hazard*

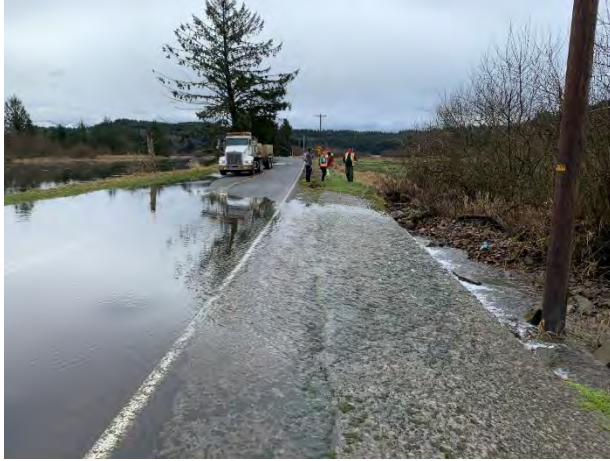
**Image 9:** CDF Apron with overflowing water during moderate high tide event, west of TRW (Silveira), January 27, 2021

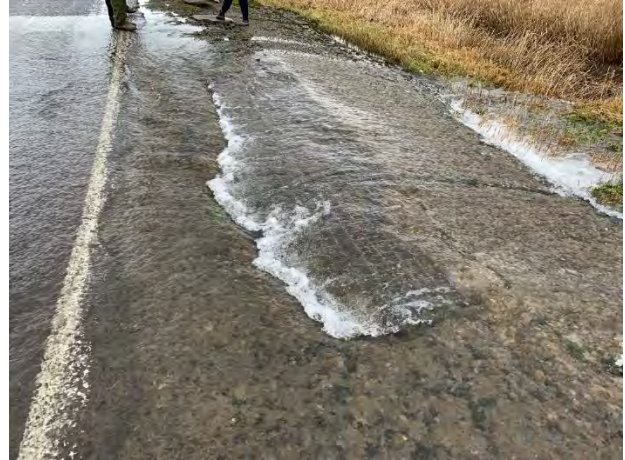
**Image 10:** CDF Apron with overflowing water during moderate high tide event along TRW, January 27, 2021

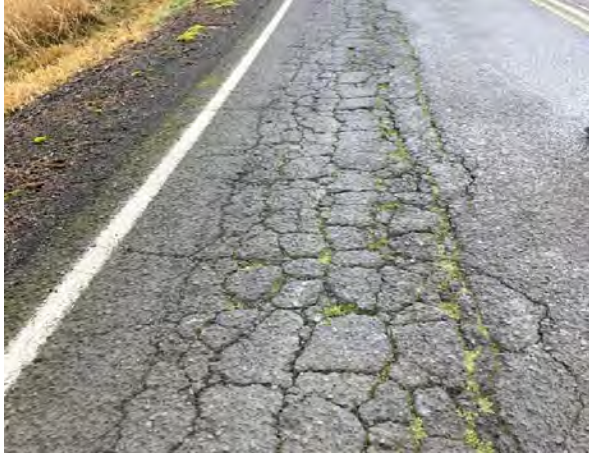
- Pavement failures including fracturing, crocodile cracking, and edge deterioration (Image 11),
- Uneven roadway surface and severe cross slopes due to settlement and sinking of the roadway (Image 12),
- Low points along the roadway where water overtops and flows across the roadway
- Deterioration and failure of the CDF aprons
- Missing or damaged segments of guardrail/cable barrier due to traffic accidents, rotted posts, and undermining (Images 13 and 14).
- Bank erosion and sloughing of the roadway embankment (Images 15 and 16),

**Image 11:** Crocodile cracking in pavement, a condition prevalent along Burton-Fraser Road due to underlying settlement

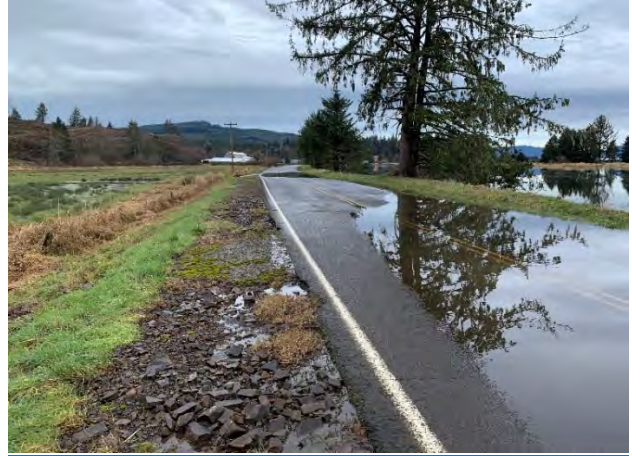
**Image 12:** Severe cross slope on Burton-Fraser Road due to non-uniform sinking of roadway

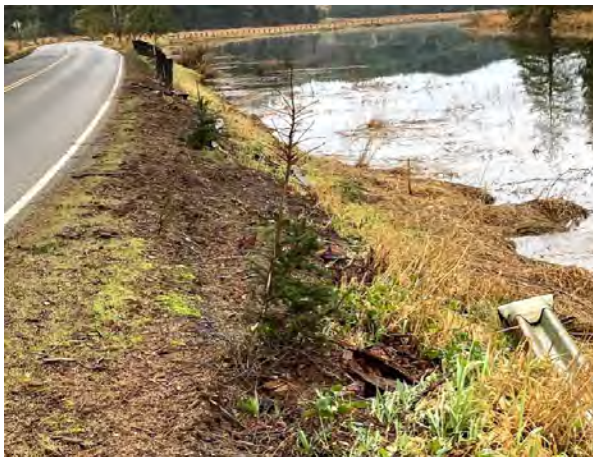
**Image 13:** Missing guard rail due to recent traffic accident

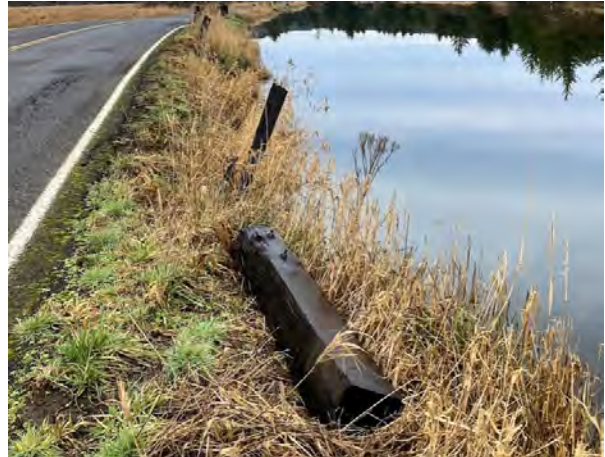
**Image 14:** Loss of cable barrier posts due to rotting and bank erosion

A complicated guard rail system would need to be designed and constructed, likely including deeper piles where the existing guardrail posts have become undermined due to bank erosion. Continued maintenance would be required to address road subsidence beyond normal road upkeep. A geotechnical analysis by Shannon & Wilson concluded that even if the road was raised, subsidence would continue due to the underlying geotechnical conditions.

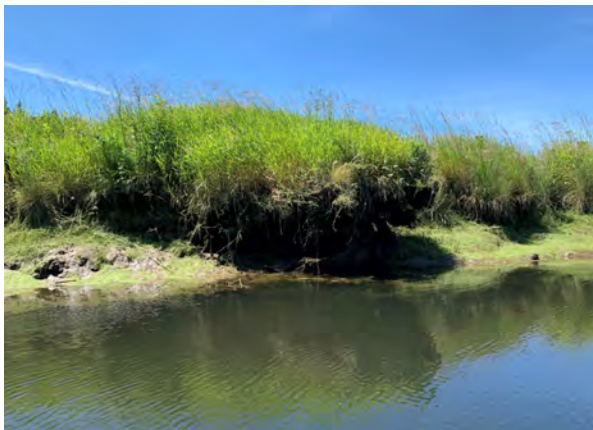
**Image 15:** Sloughing undercut bank at edge of roadway

Excavating to these depths would require dewatering of shallow groundwater and work-area isolation from the daily tide levels in the Tillamook River. Existing sloughing embankments would need to be repaired and stabilized using large rock and bioengineering bank stabilization measures to prevent future bank erosion and undermining. This would require in-water work in the Tillamook River and TRW wetlands, impacting waters and wetlands and requiring significant environmental permitting.

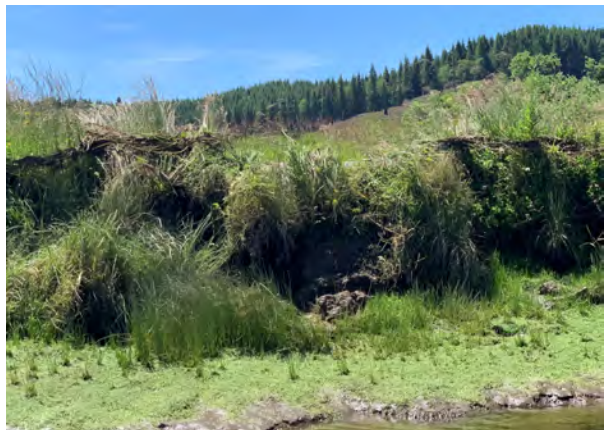
**Image 16:** Sloughing undercut bank at edge of roadway

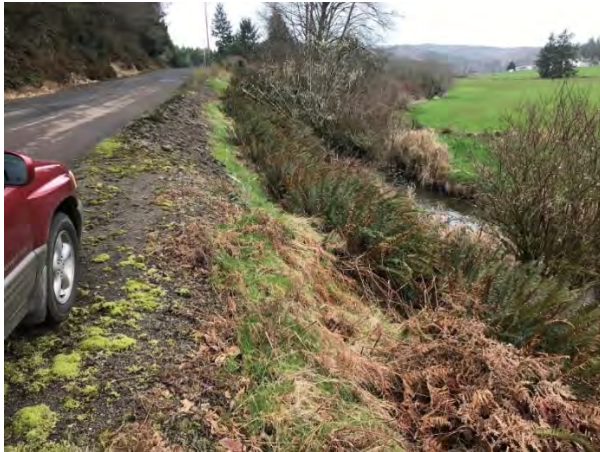
**Image 19:** Slumping section on eastern 1.5 miles of Eckloff Road

During a major earthquake, portions of Eckloff Road could become impassable due to landslides, but the slides could be cleared and transportation connection restored far faster than at Hwy 131 or Burton-Fraser Road. The existing slumping sections of roadway described at the east end are more vulnerable to failure resulting in hazards in their current state and should be repaired prior to significant traffic increases.

designing and constructing the new roadway. The eastern mile of Eckloff Road has some existing slumping sections that would need to be repaired through subgrade stabilization and repaving. Some slope stabilization, particularly downslope of the roadway towards Beaver Creek, may be required.

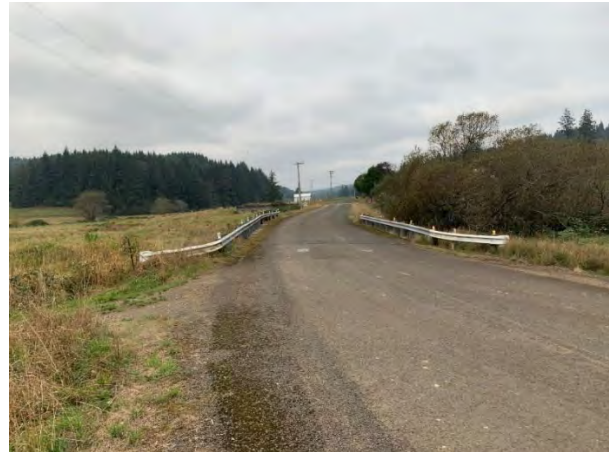
**Image 20:** Beaver Creek bridge on Eckloff Road, facing west

Although the current road is not regularly maintained by the County, access is not impacted during flood events. The FEMA 100-year floodplain extends up Beaver Creek where Eckloff Road crosses over on a bridge. The bridge deck elevation is approximately 22 feet (NAVD88) and is mapped just outside of the 100-year floodplain (Image 25). The Beaver Creek bridge is rated in good condition.

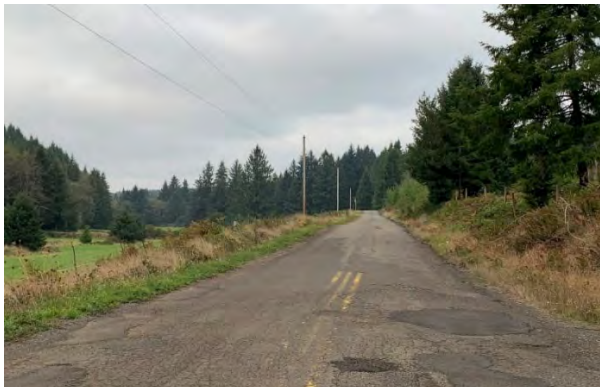
**Image 21:** West of Beaver Creek Bridge road condition degrades

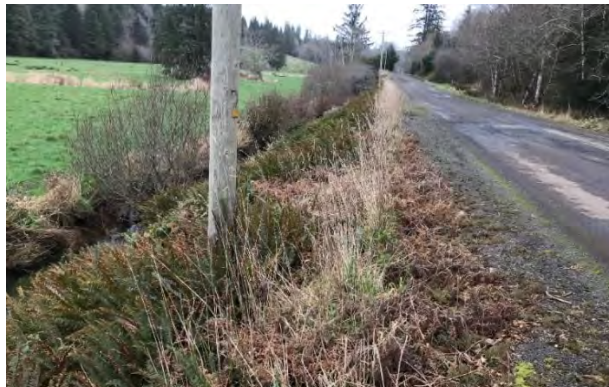
**Image 22:** Moving west road narrows and pavement fades to gravel and broken pavement surfacing

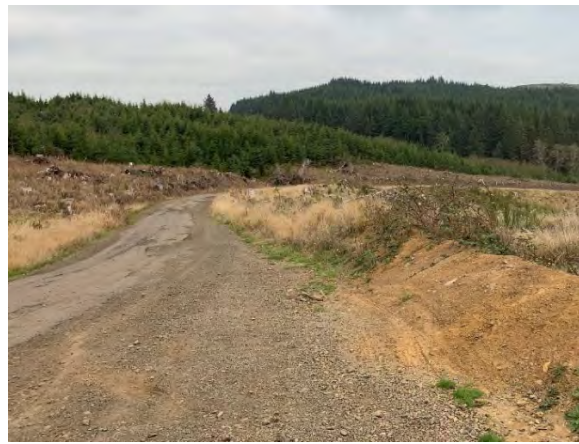
**Image 24:** Eastern ¾ miles of Eckloff Road rough forest road with steep grade, sharp curves

In addition to the structural conditions of the unimproved ¾ miles of road which pose a hazard to drivers, the intersection of Eckloff Road with Hwy 131 is located to the south of a vertical crest curve on Hwy 131, making difficult for southbound traffic on Hwy 131 to see vehicles turning south from Eckloff Road. An upgrade to Eckloff road should consider relocating this intersection to improve sight distances.

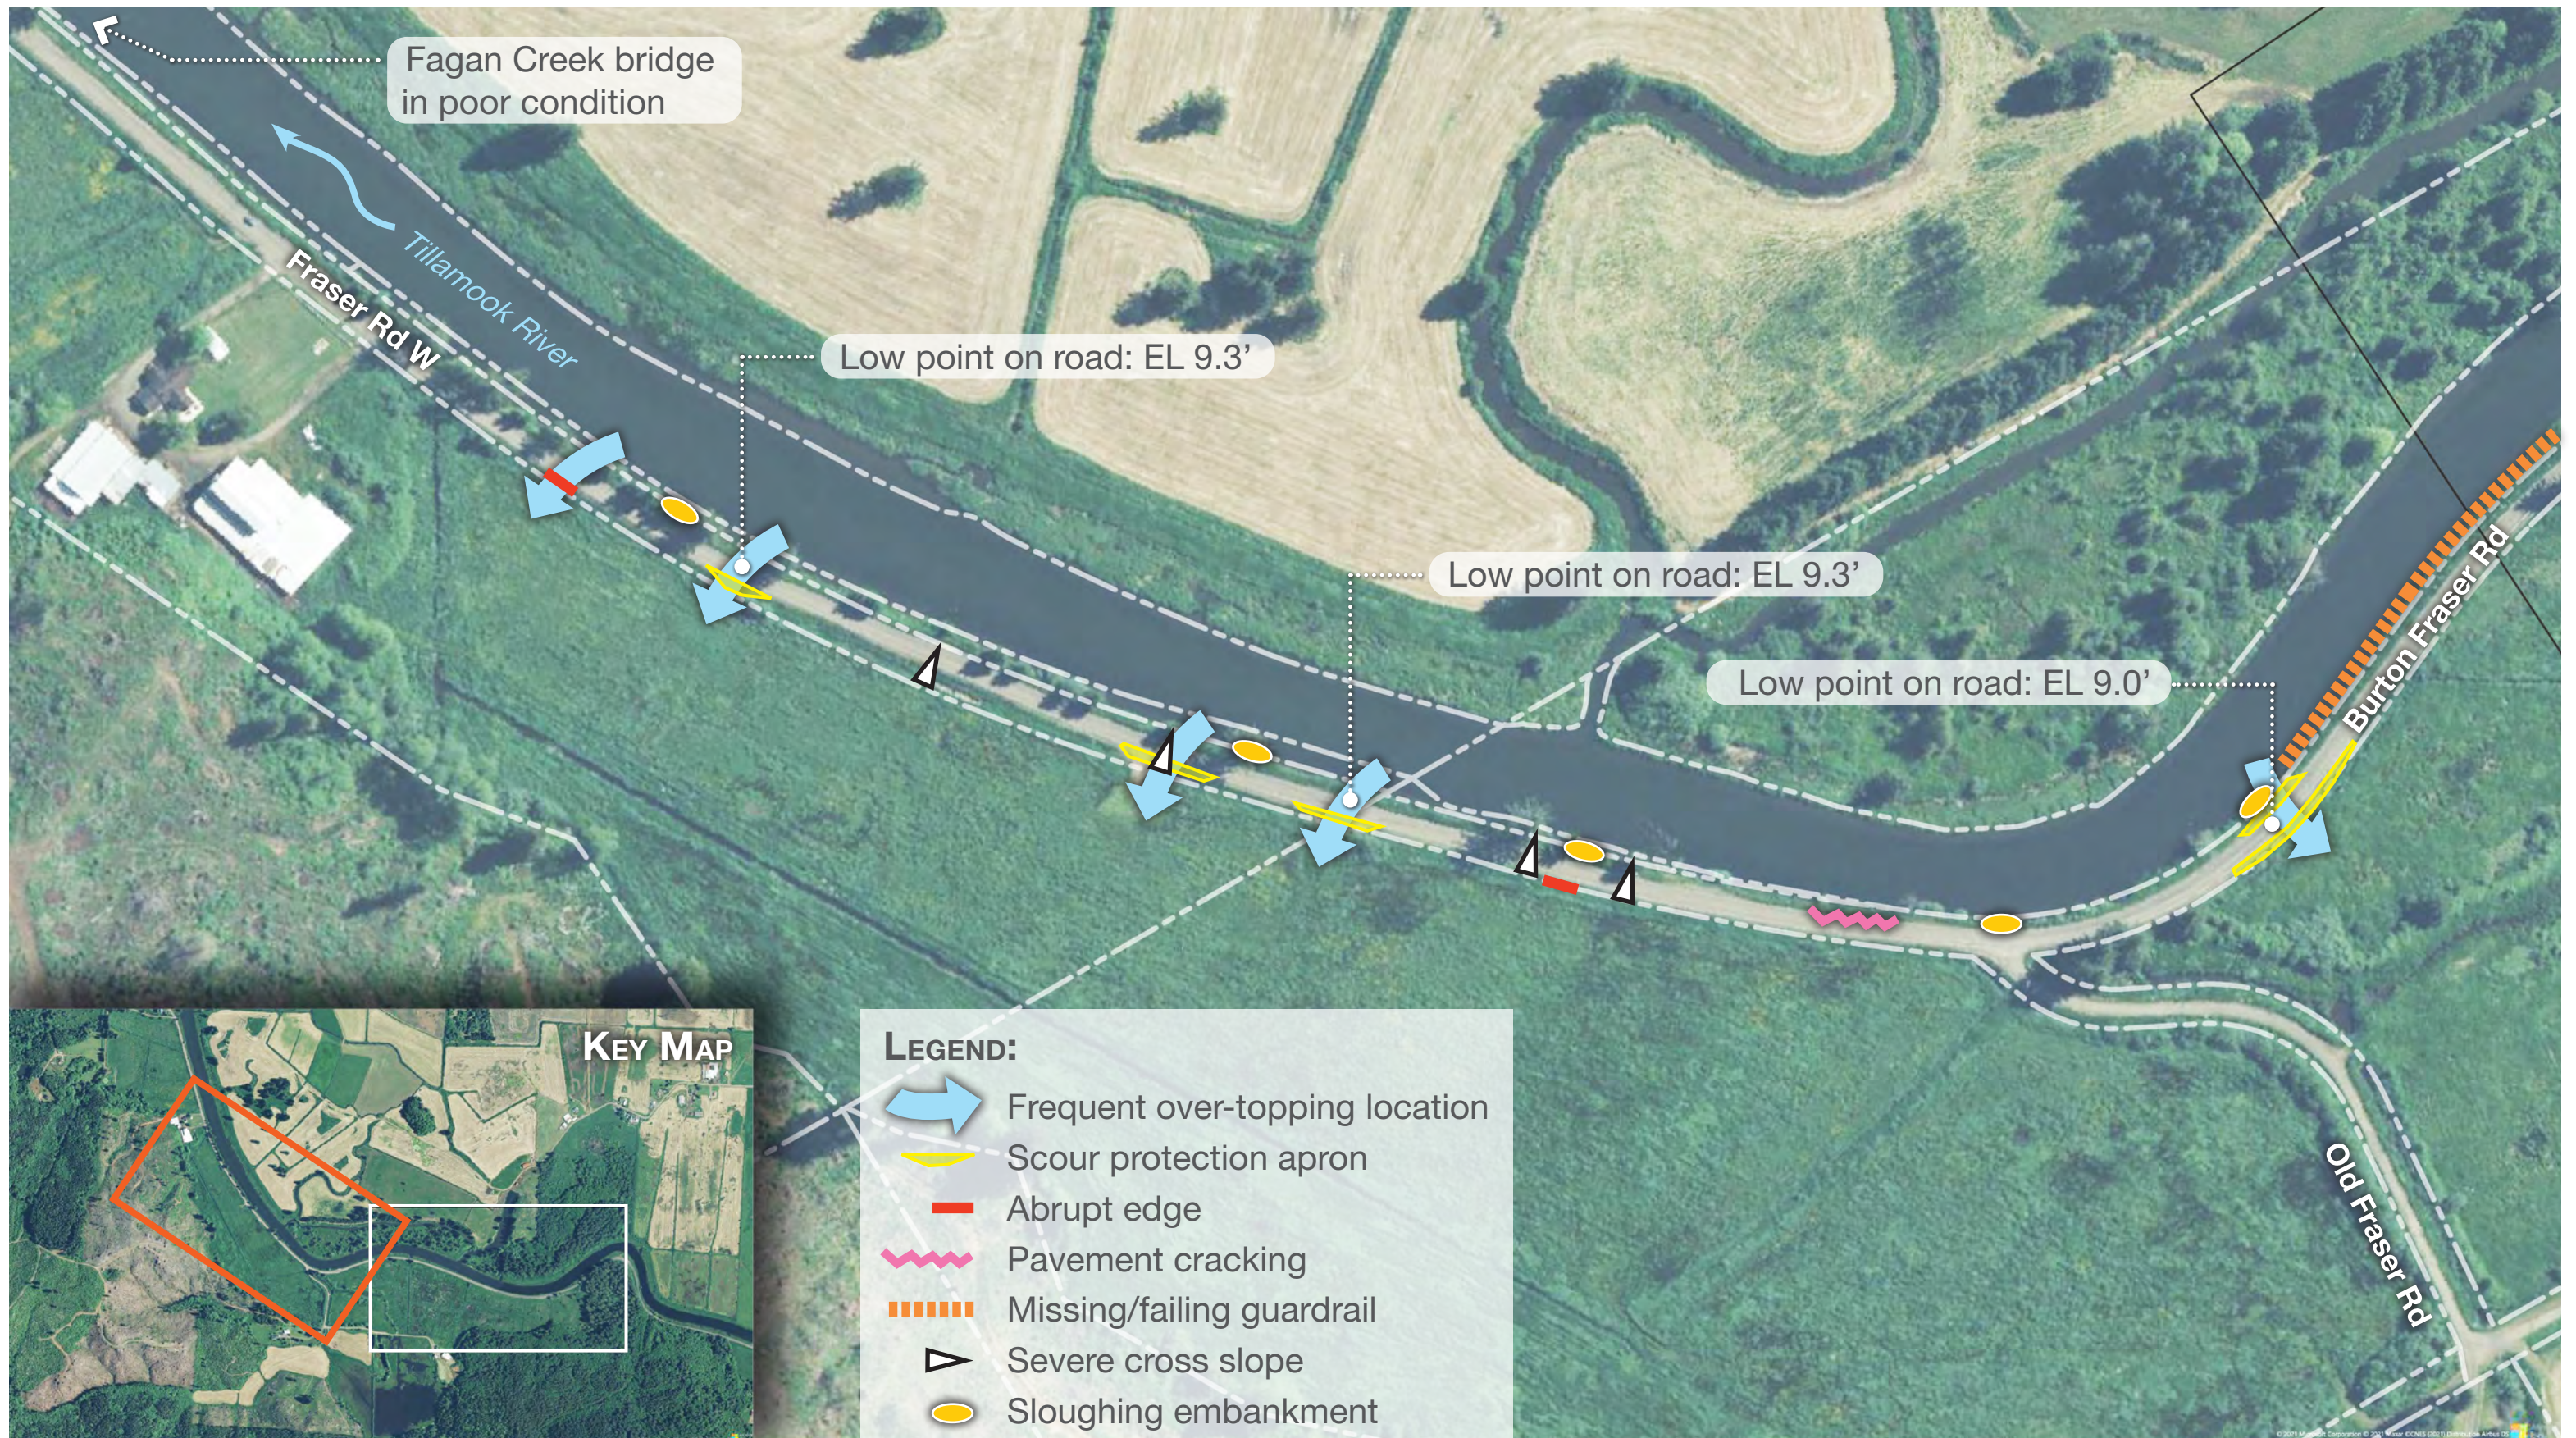
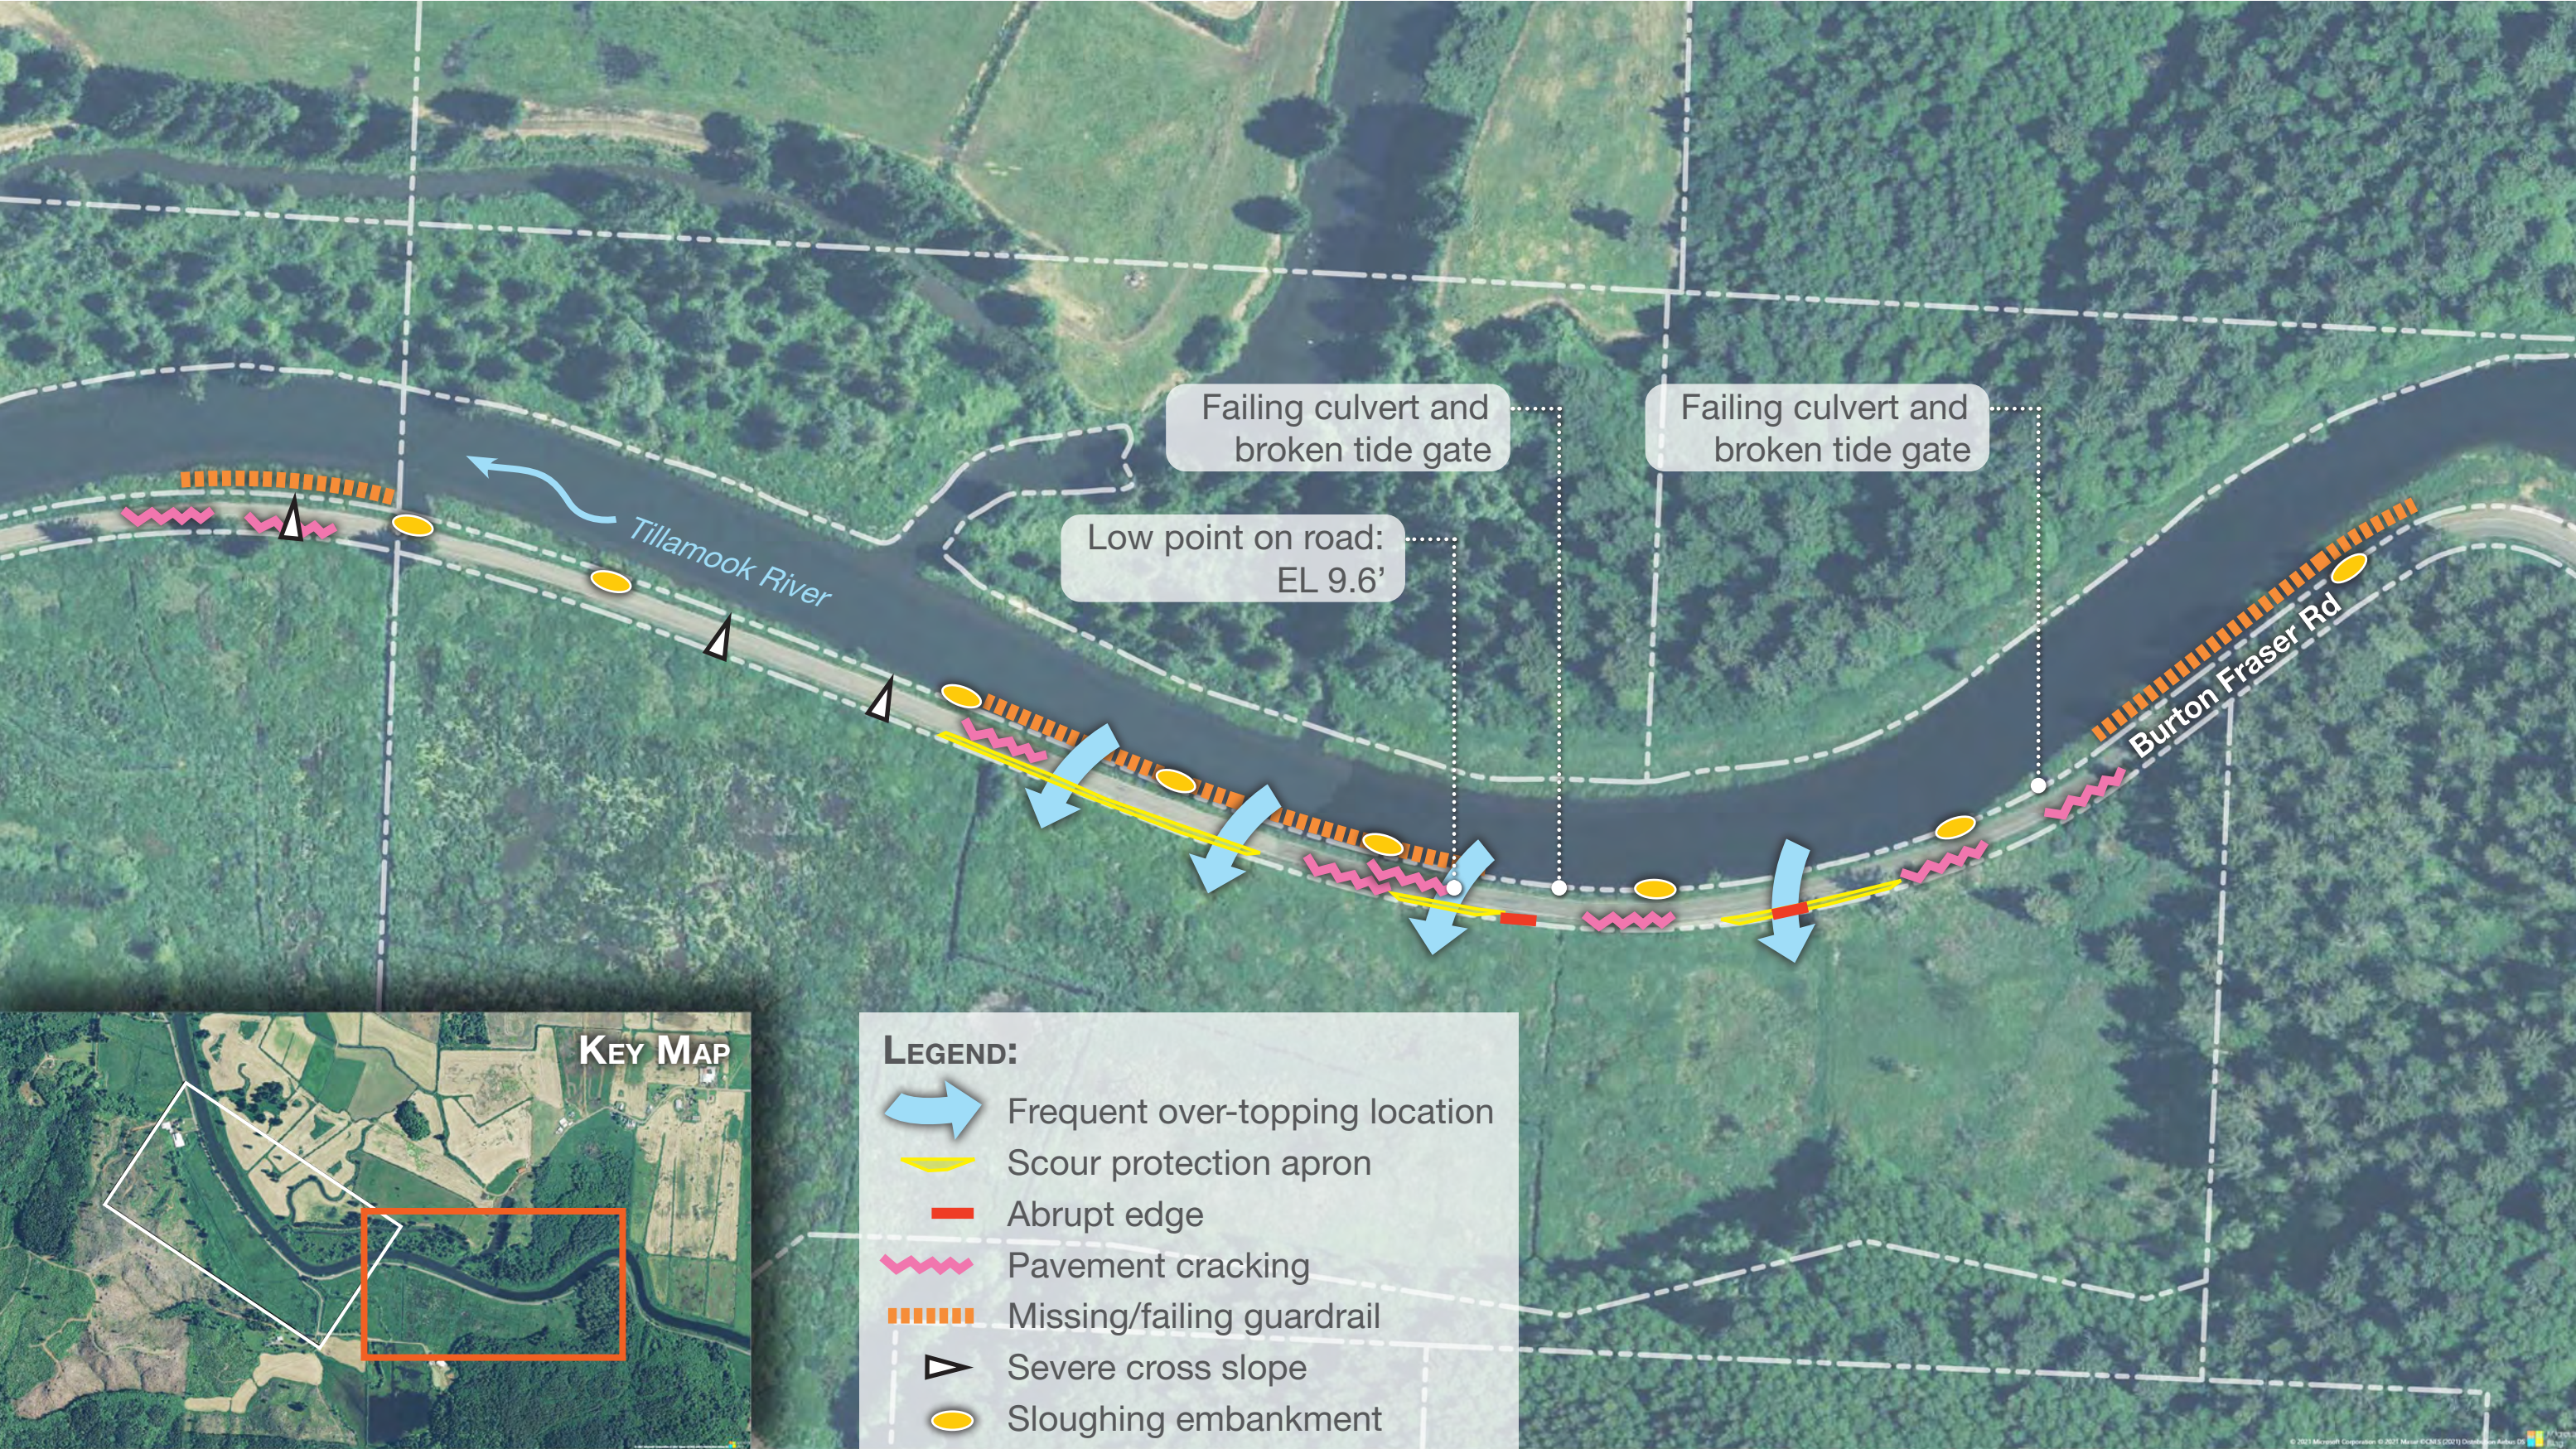
**FIGURE 6 | BURTON-FRASER ROAD DEFICIENCIES AND HAZARDS - EAST**

A summary of the current deficiencies and failing conditions of Burton-Fraser Road (**Figures 5 and 6**) include:
