# **PHASE I ENVIRONMENTAL SITE ASSESSMENT**

**JONES PROPERTY  
590 GOODSPEED ROAD N.  
TILLAMOOK, OREGON**

Project #1419.01  
September 28, 2015

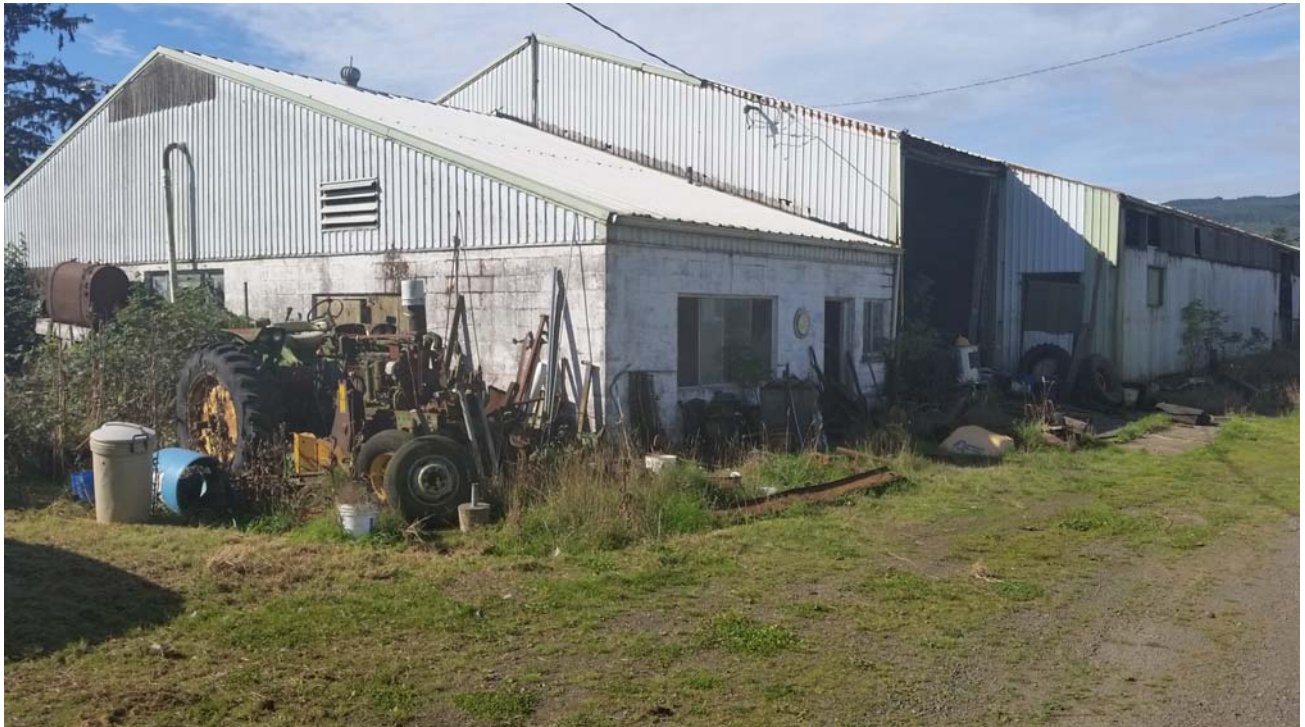
Dilapidated equipment, supplies and metal scraps are stored outside, on the north and east sides of the milking parlor (photographs #2, 3). The area was overgrown with grasses. No staining or other evidence of spills or dumping was observed in the area.

PHOTO 2: Items stored outside near former milking parlor.

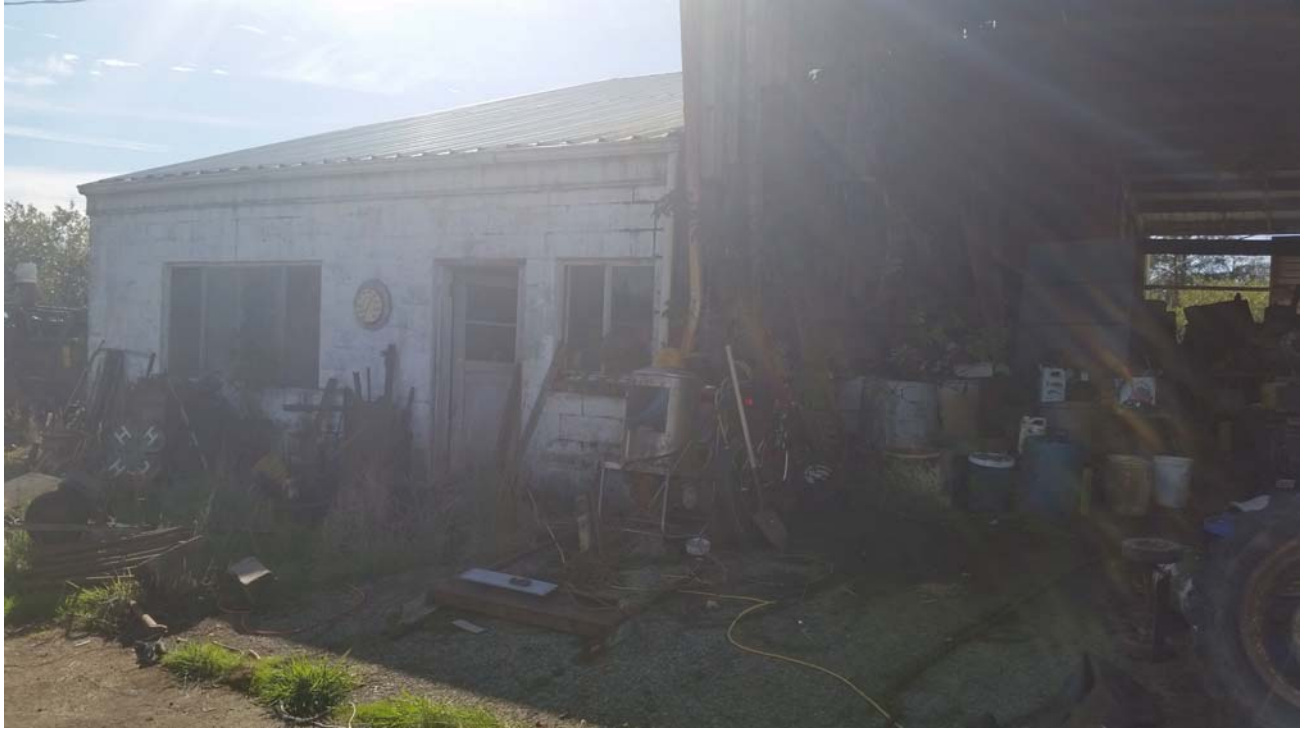
PHOTO 3: Items stored outside near east breezeway between former milking parlor and loading shed.

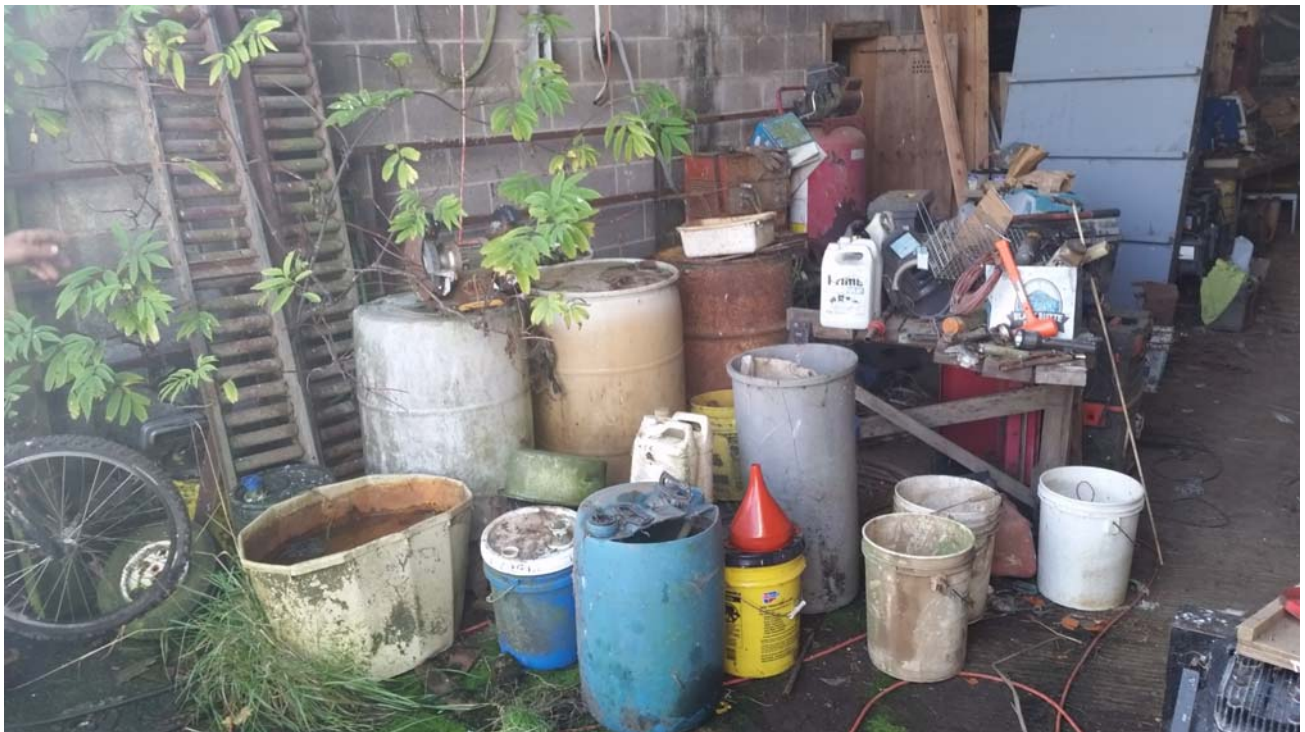
Various hazardous substances and petroleum products are stored on elevated surfaces and directly on the concrete floor. Hazardous substances include various substances related to vehicle maintenance such as motor oil (new and used), antifreeze, and paints, and five automobile batteries. The used motor oil was stored in two sealed 55-gallon drums (photo #4). Mr. Jones is in the process of transferring the used oil into 5-gallon containers since the local recycling facility does not accept used oil in 55-gallon drums.

PHOTO 4: Drums of used motor oil in east breezeway between loading shed and milking parlor.

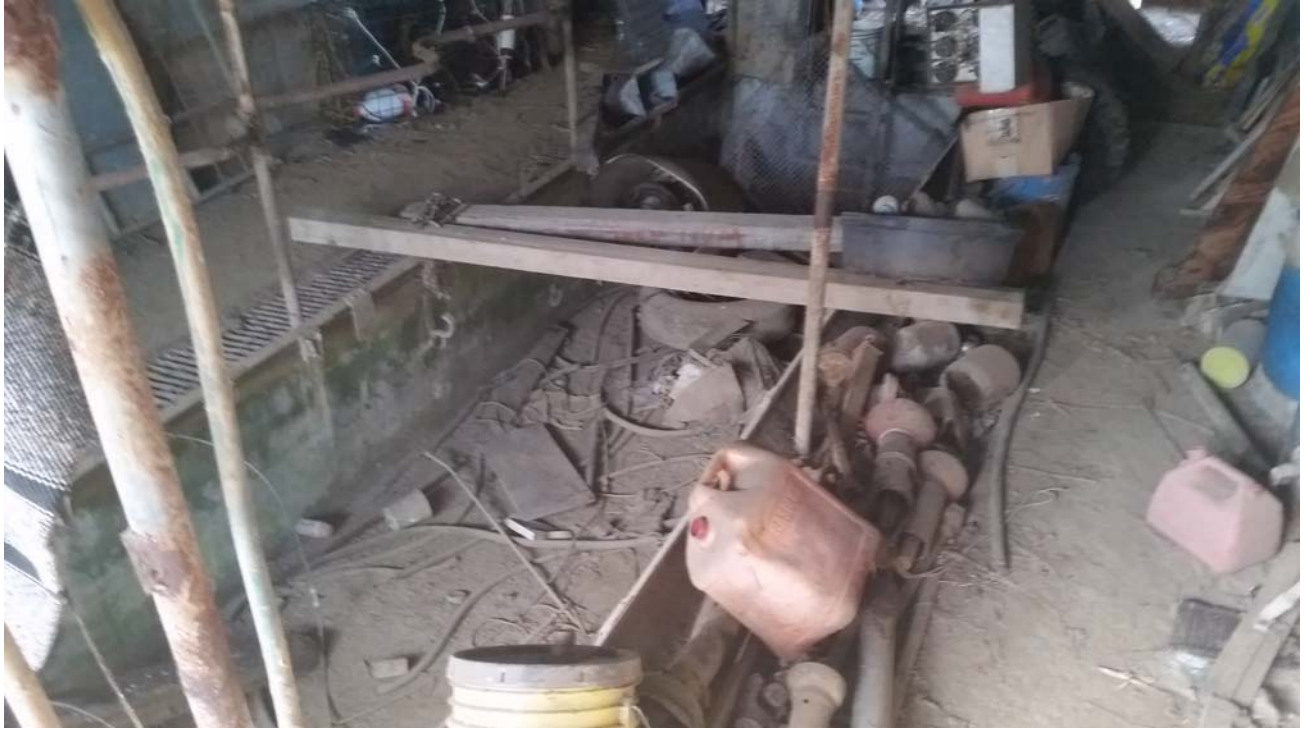
No floor drains, sumps or oil-water separators were observed on the subject property. A drain is located in the bottom of the milking pit that, according to Ron Jones, discharges to Hall Slough. Debris and stored items prevented direct observation of the floor drain.

- The concrete-lined pit in the milking parlor is where the milker stands while milking. A drain in the floor of the pit discharged into a sump west of the pit. Mr. Jones observed that, during periods of flooding when the water level in the slough was rising, water bubbled out of the sump, indicating that the sump is connected to the slough. Mr. Jones filled the sump with soil to prevent future flooding of the building.

PHOTO 7: Milking pit in milking parlor. Silt is from last flooding event.

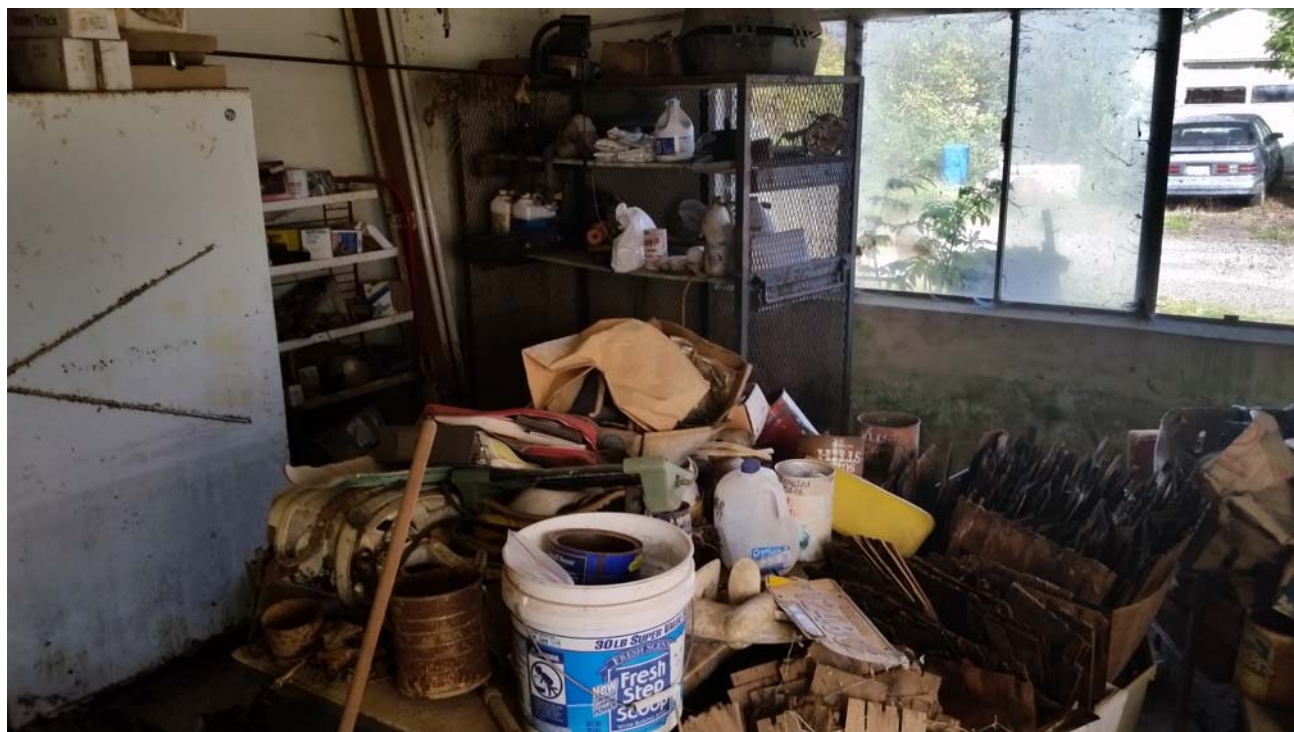
PHOTO 10: Miscellaneous items stored in former milk room.  
Silt and debris on floor are from most recent flooding event.

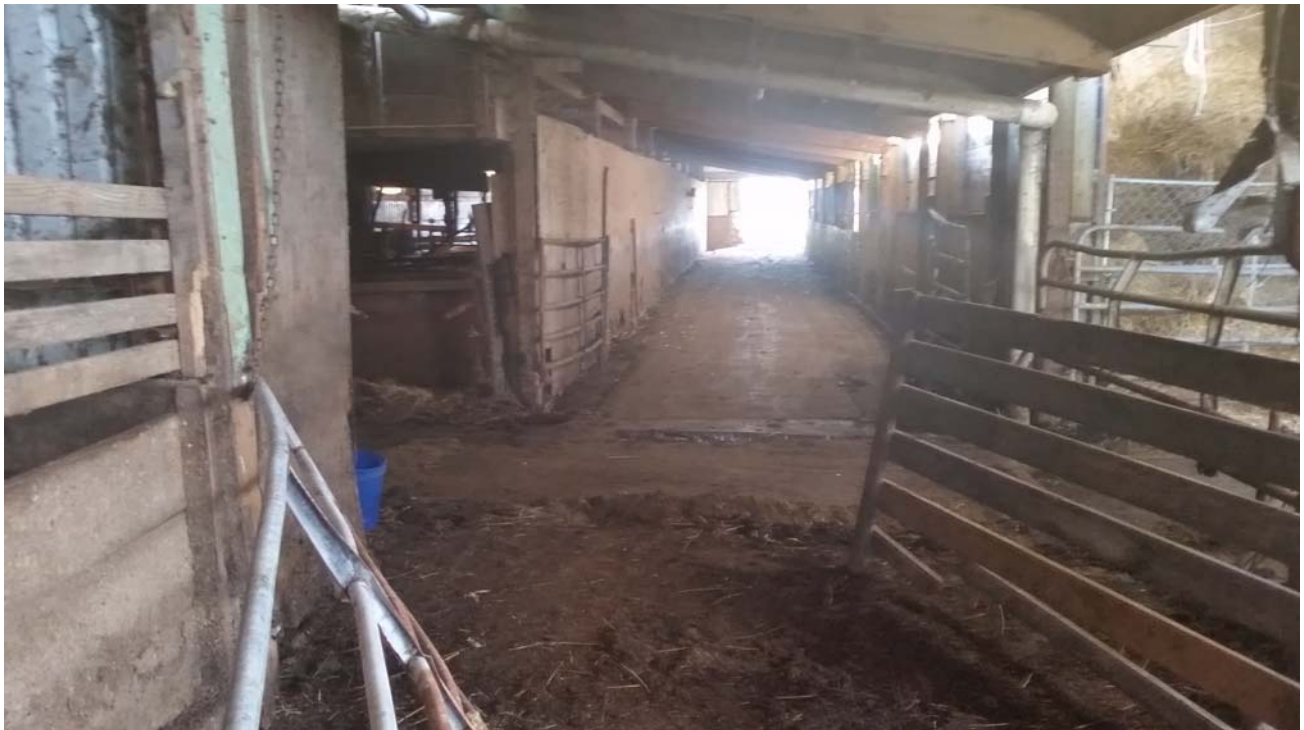
PHOTO 12: West breezeway in loafing shed.  
Underground liquid manure tanks are located beneath floor.

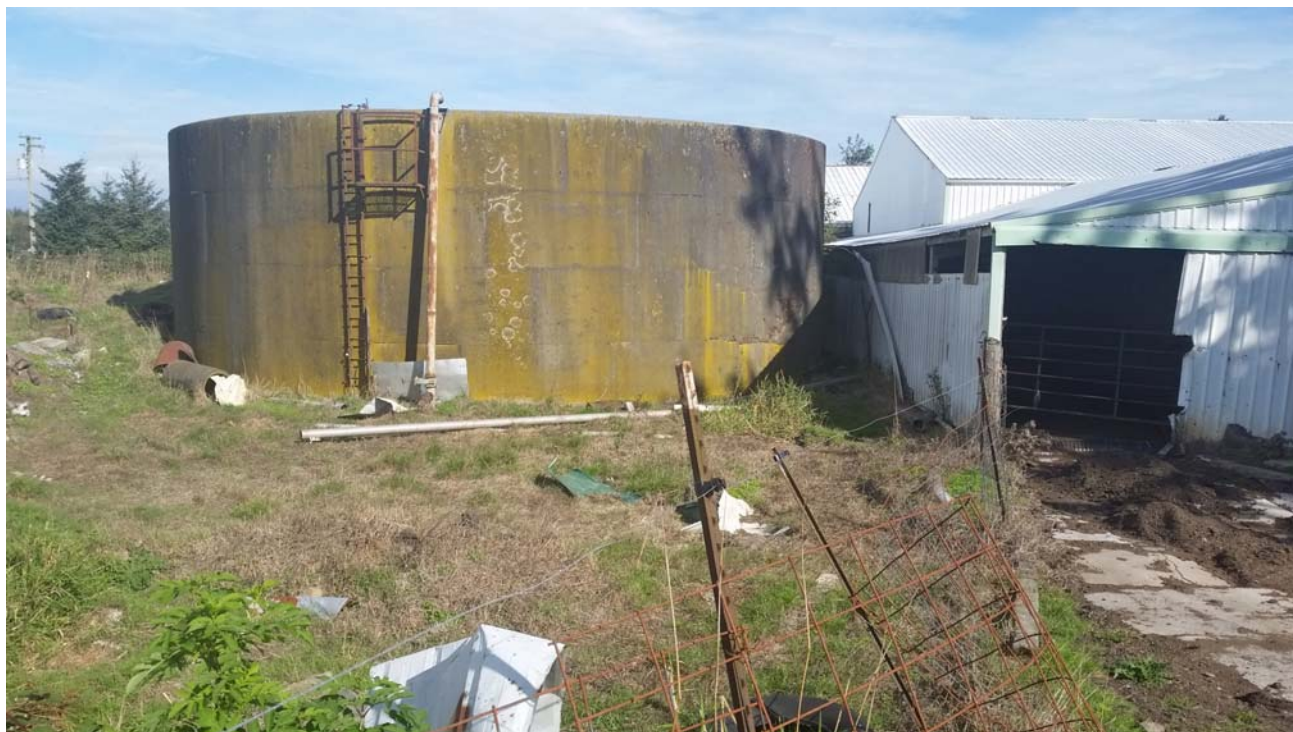
PHOTO 13: Above-ground liquid manure tank on southwest corner of loafing shed.

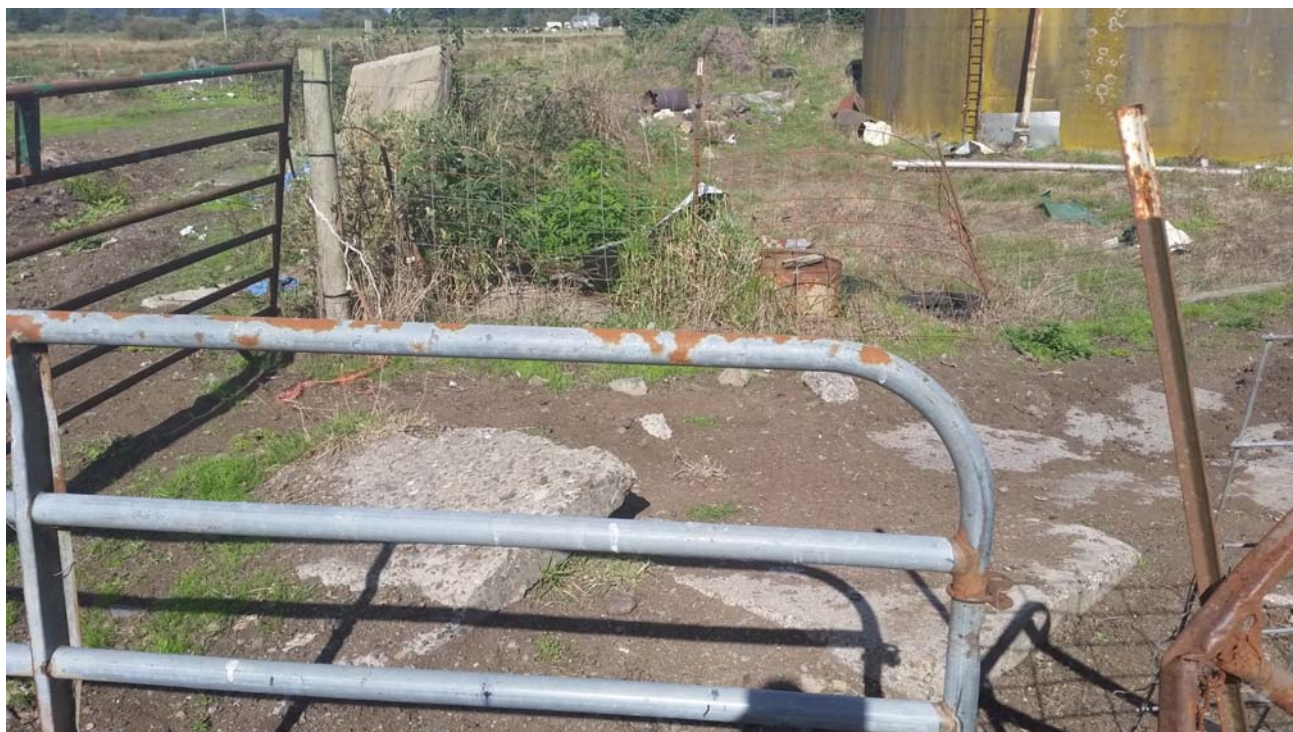
- The elevation of the area around the house and barns was raised with fill consisting of weathered asphalt, soil and controlled-density fill obtained from the widening of Highway 101 in 1997, scrap bricks from the demolition of a hotel in Tillamook, and scrap concrete from the replacement of a loading dock at a local creamery.
- The well located in the pasture was originally installed for irrigation. The well is currently not functional.
- The burn pile behind the house is used for burning general household and farm garbage (paper, wood, etc.). He has never dumped any petroleum products or hazardous substances in the burn pile.
- The original loafing building reportedly burned down in 1972 and was rebuilt.

PHOTO 14: Fill material south of farm buildings and manure tank. Concrete pieces were from demolition of loading dock at a local dairy.

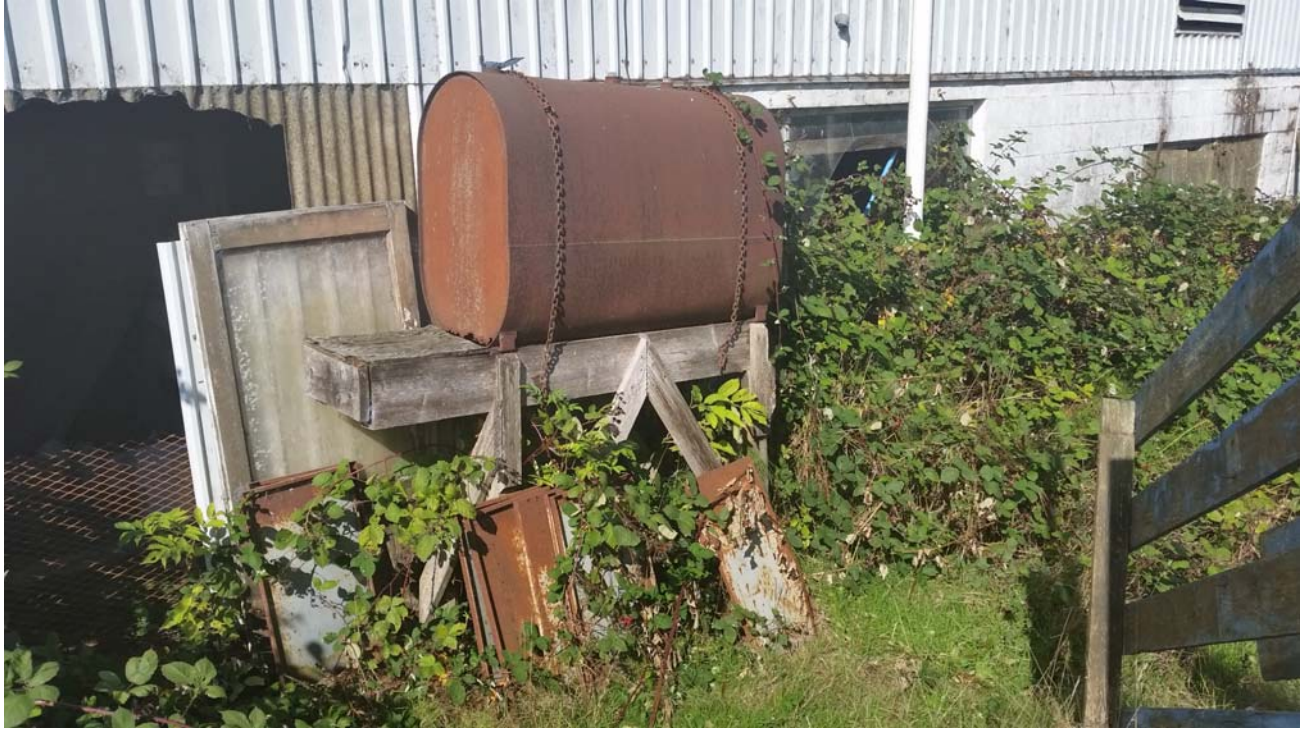
One 275-gallon above-ground storage tank was located on the east side of the milking parlor (photograph #15). The tank is empty and has not been used since Ron Jones purchased the property. A large corrosion hole was observed in the bottom of the tank. The ground beneath the tank exhibited no evidence of impacts by petroleum products.

PHOTO 15: Above-ground oil tank (empty) on east side of milking parlor.

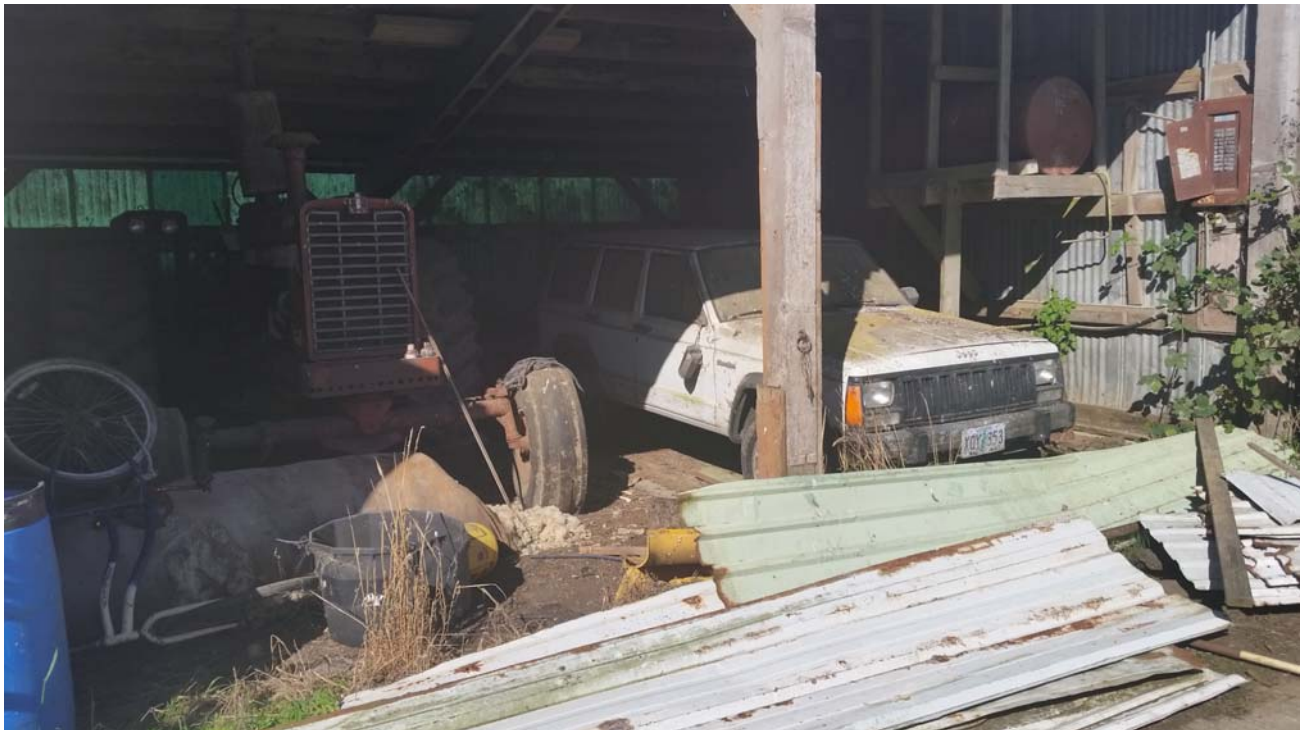
A small (150 gallon) above-ground motor fuel storage tank is located on the north end of the machine shed and is enclosed in a wooden frame suspended from the roof trusses (photograph #16). The tank was empty and there was no evidence of leakage or spillage of fuel from the tank.

PHOTO 16: Machine shed. Note empty oil tank mounted on rack attached to north wall.

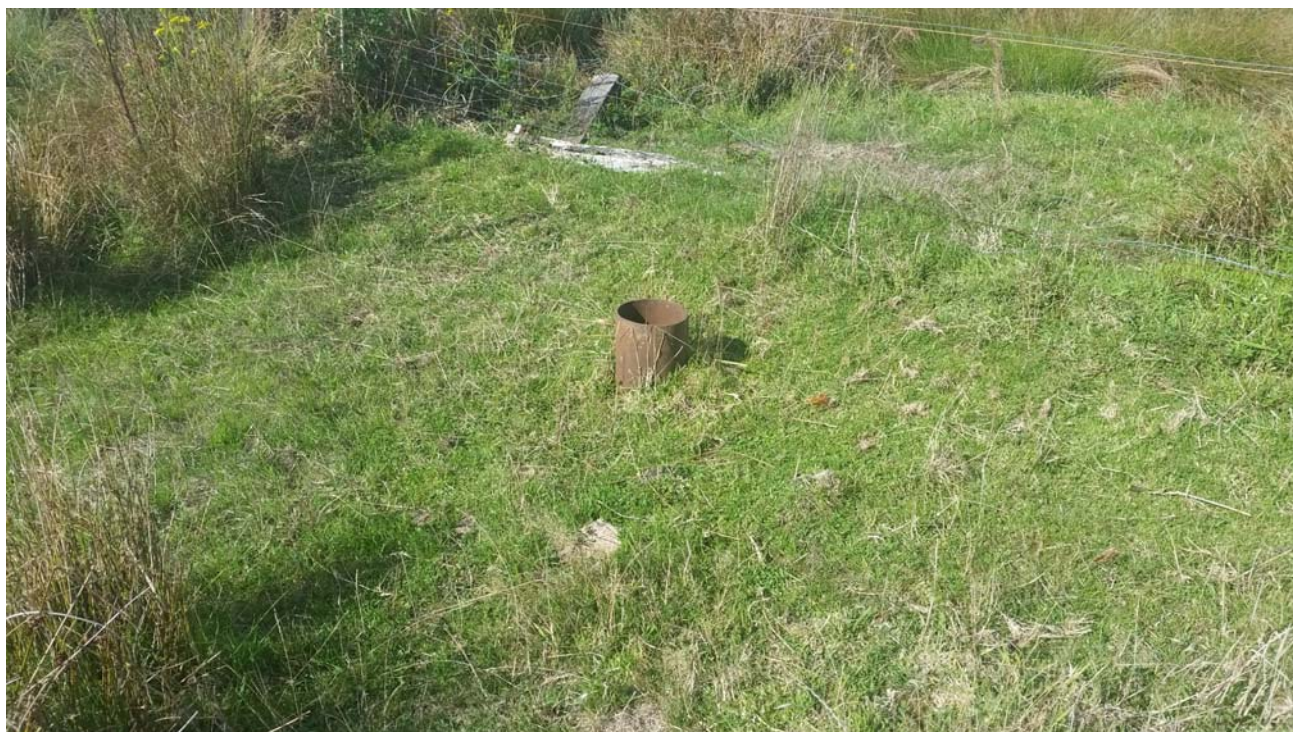
PHOTO 18: Steel casing for water well on tax lot 600, south of Goodspeed Road.

- An inactive water supply well consisting of an open steel casing is located in the pasture south of the farm buildings. **Recommendation:** If the well is not to be used, it should be permanently abandoned in accordance with Oregon Department of Water Resources rules. If the well may be used in the future, it should be temporarily abandoned by welding a steel cap or plate over the casing.
- Two underground liquid manure tanks (14,500 and 36,000 gallons) are located beneath the floor of the loafing shed. **Recommendation:** The manure tanks should be emptied and permanently decommissioned as part of the future decommissioning of the buildings.

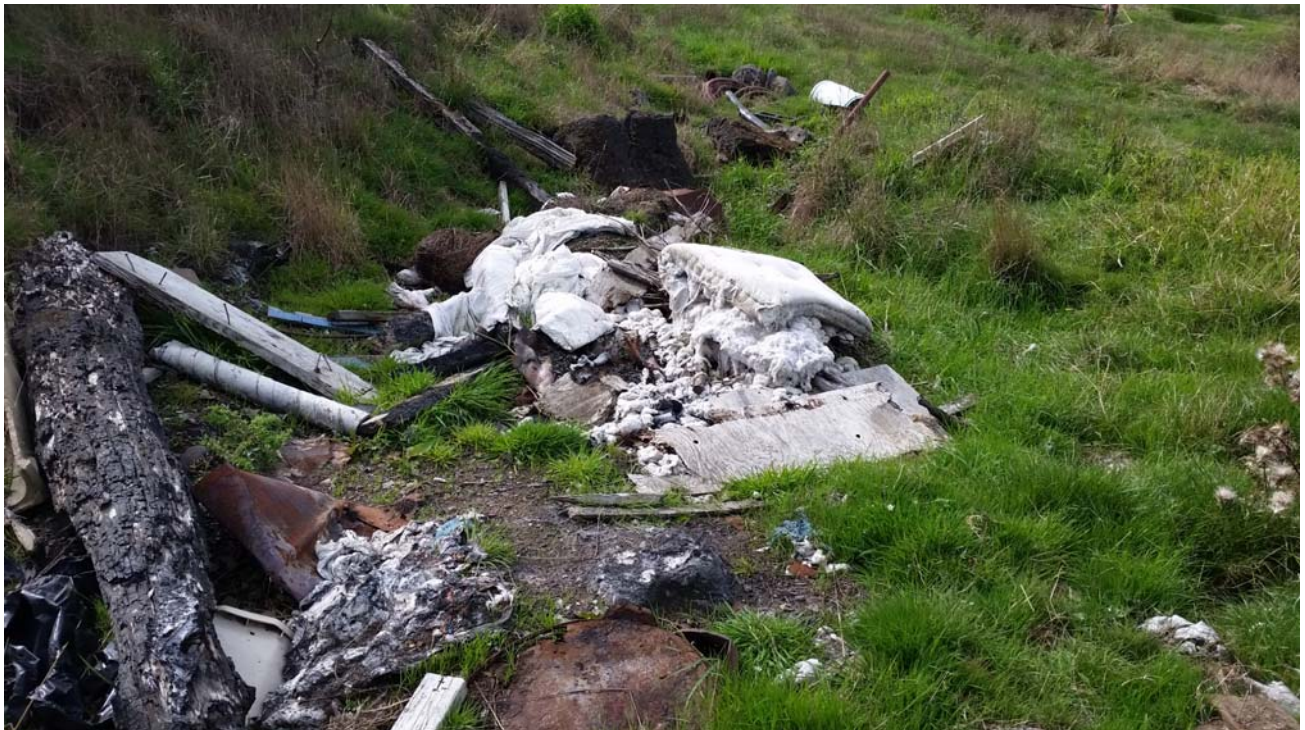
A small burn pile is located northwest of the house (photo #20). The pile contained ashes and unburned cardboard, plastic wrap, wood scraps and metal debris. According to Ron Jones, he only burns non-hazardous household and farm-related garbage. No evidence of hazardous substances was observed in the burn pile.

PHOTO 20: Burn pile northwest of house.

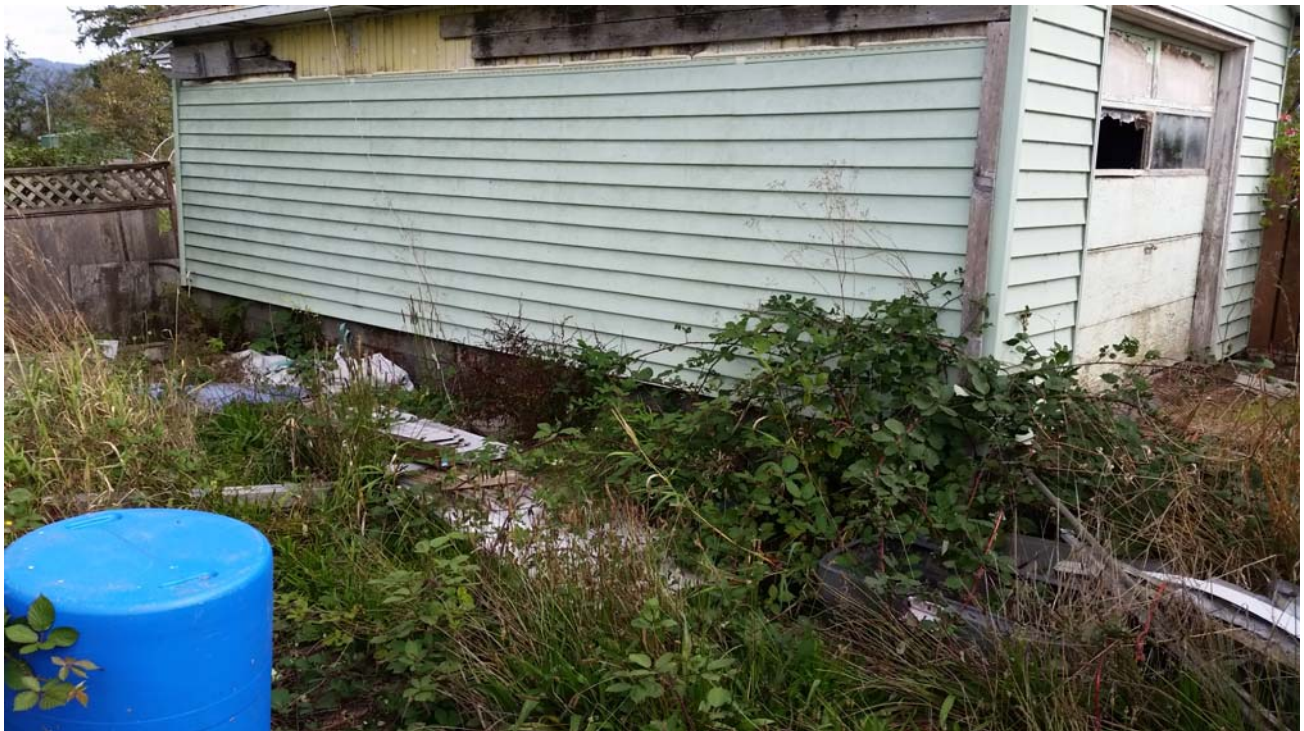
PHOTO 25: West side of garage where above-ground gasoline storage tank was reportedly located.
