## **Appendix A**

Graphs depicting water levels at Miami Wetlands from March 2008 through  
February 2017

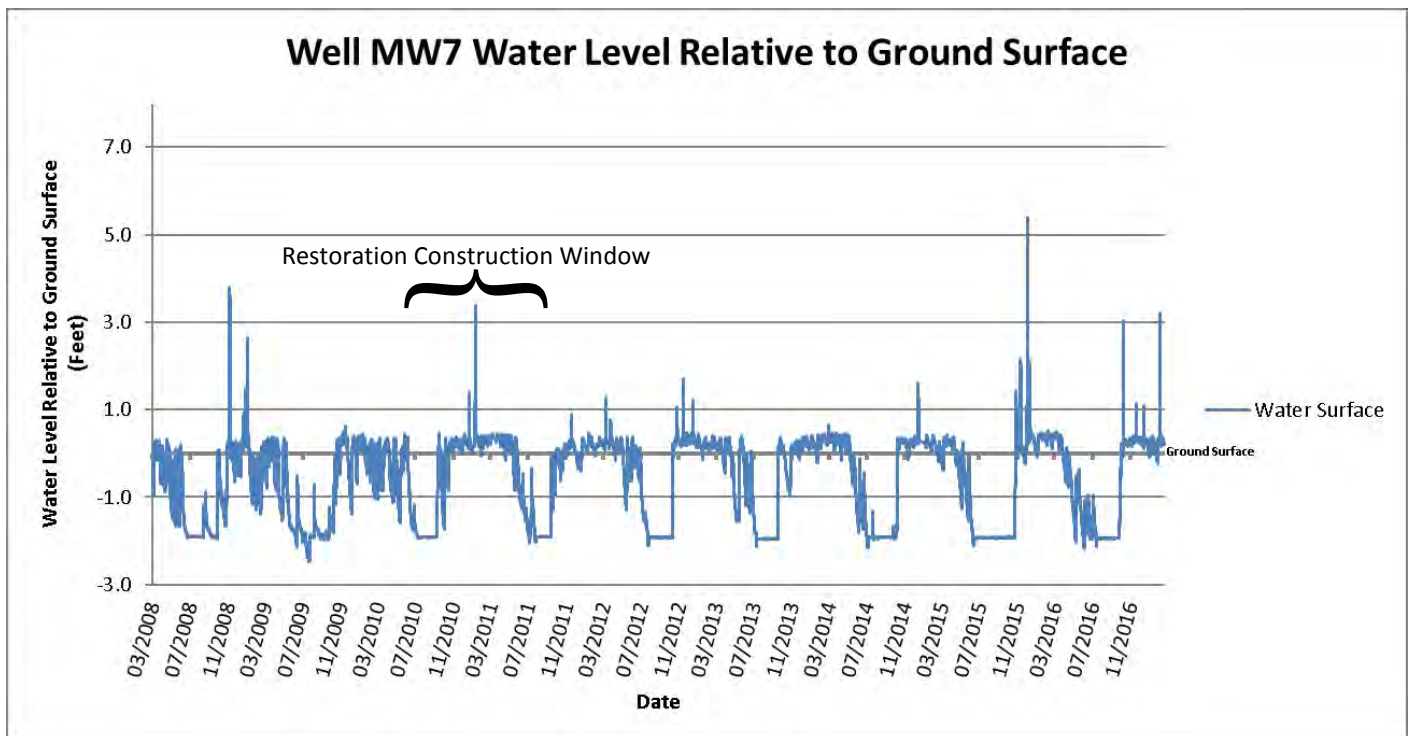
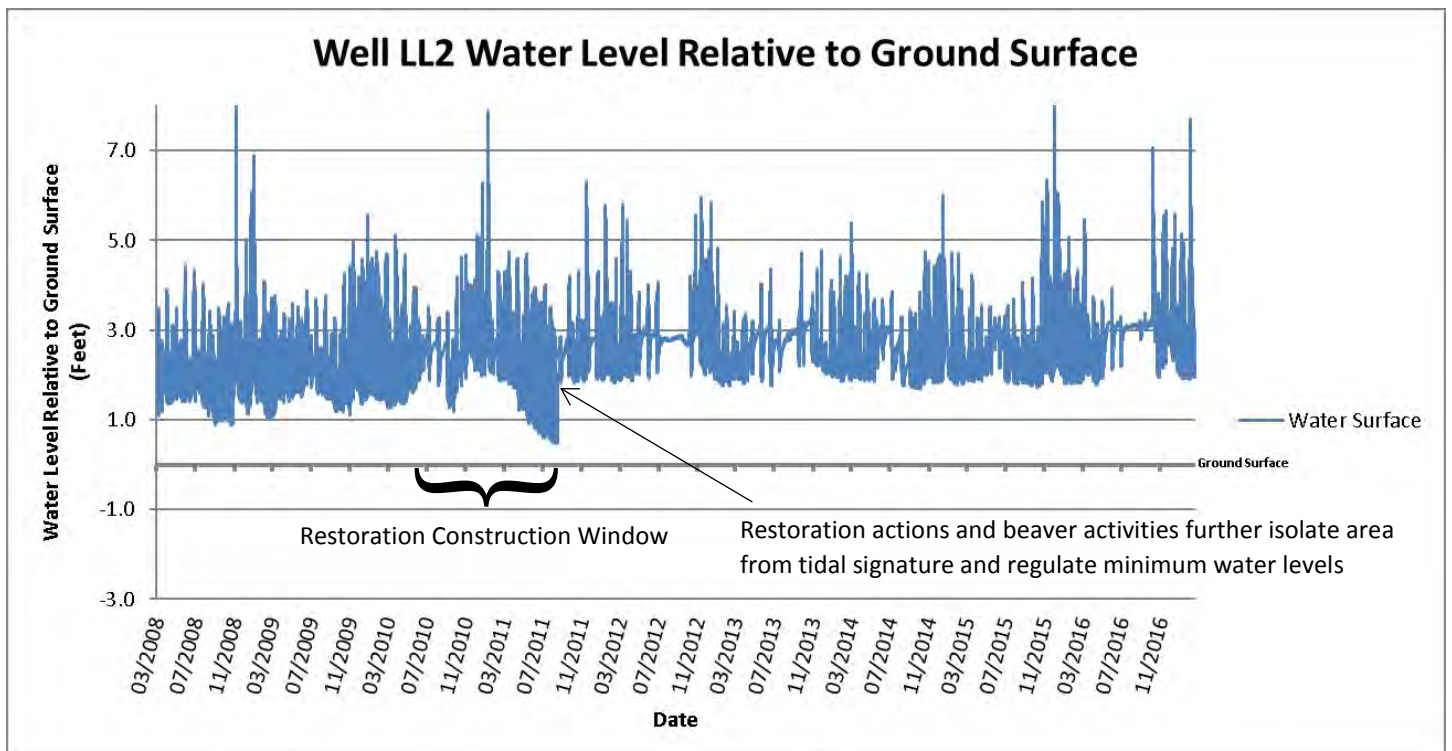
Figure A1. Water levels relative to ground surface for six groundwater and two in-channel wells at Miami Wetlands from March 2008 through February 2017. Discontinuous lines indicate data gaps.

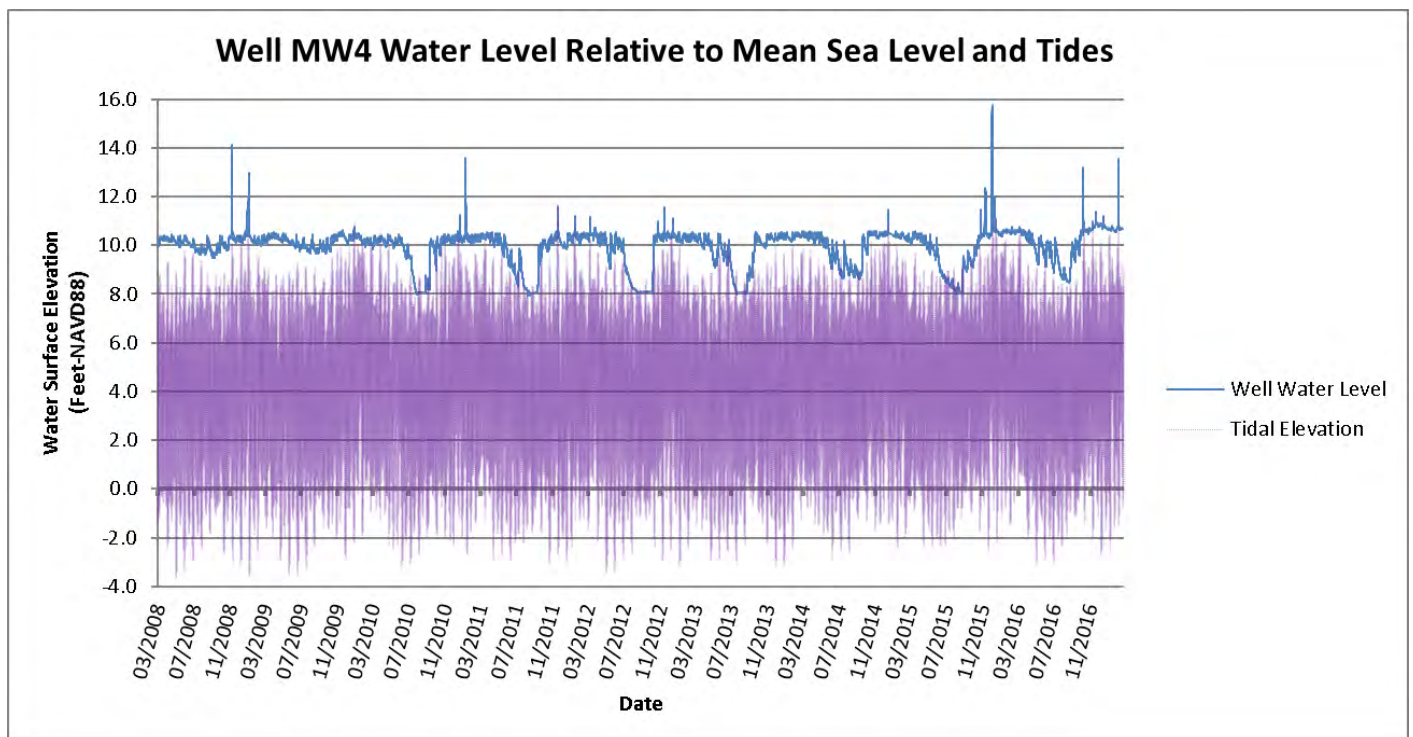
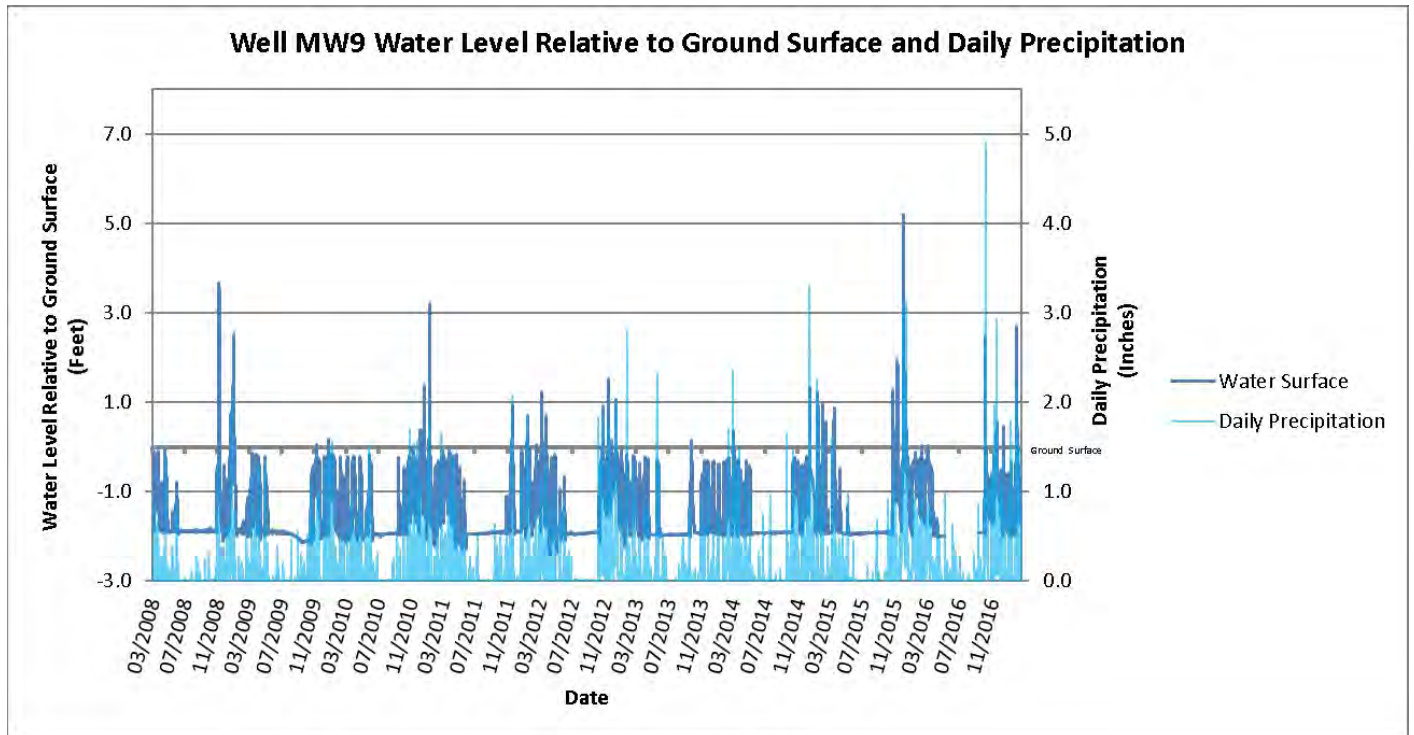
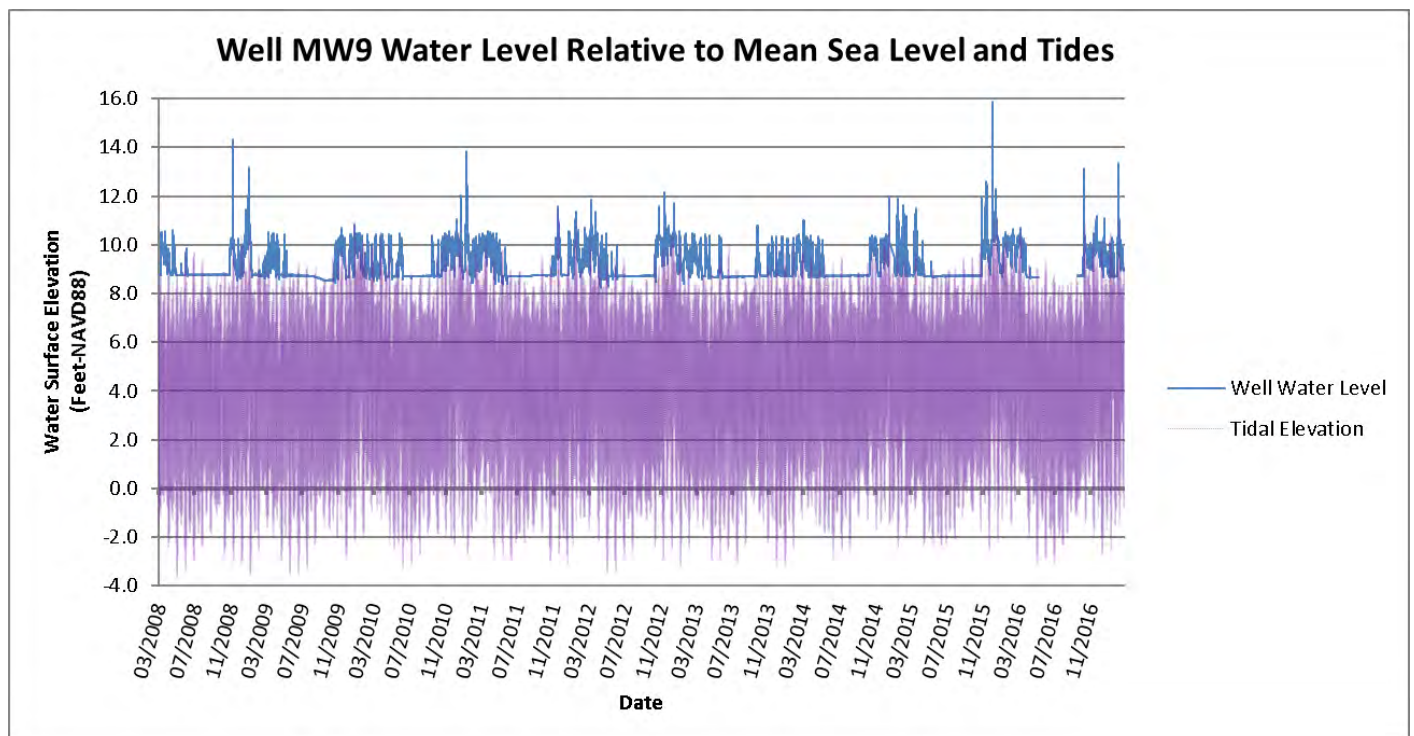
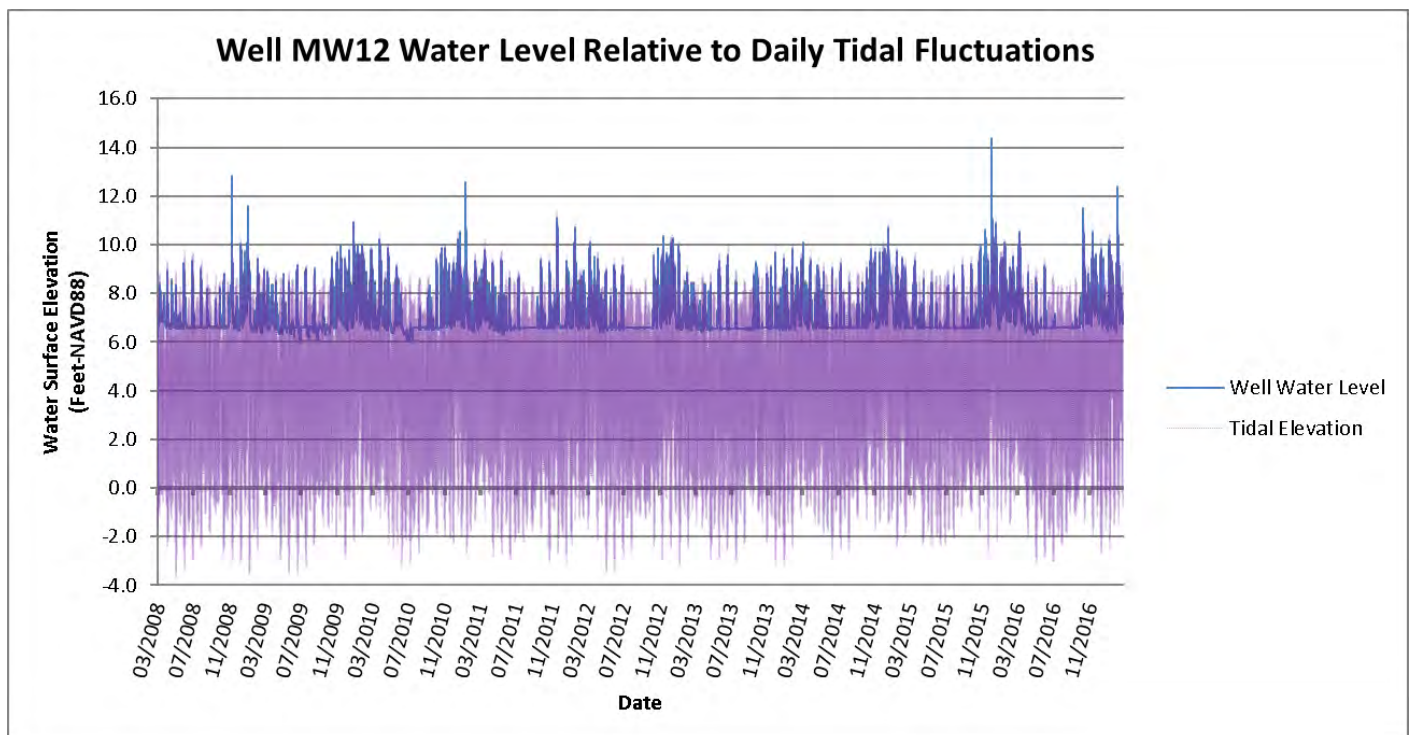
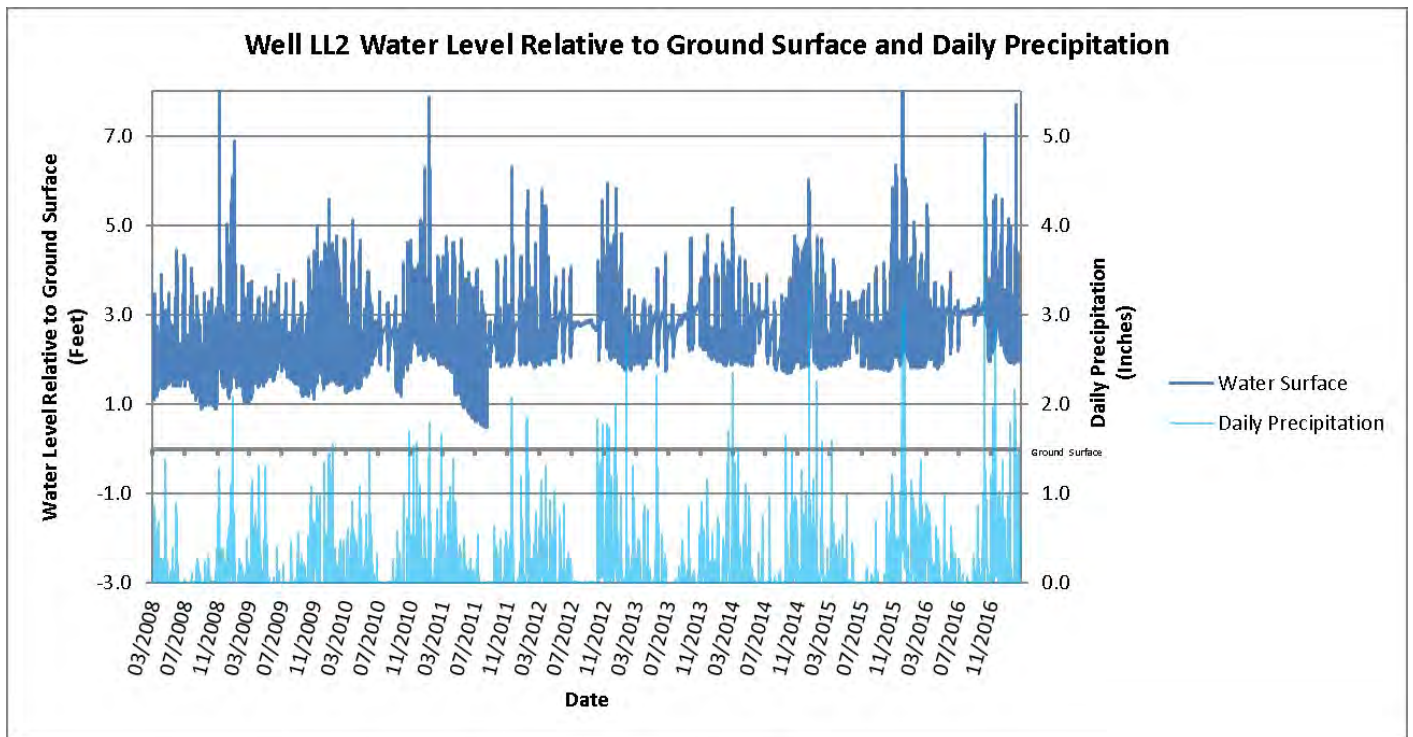
Figure A2. Water levels relative to ground surface and daily precipitation and water level relative to mean sea level and tides for six groundwater and two in-channel wells at Miami Wetlands from March 2008 through February 2017.

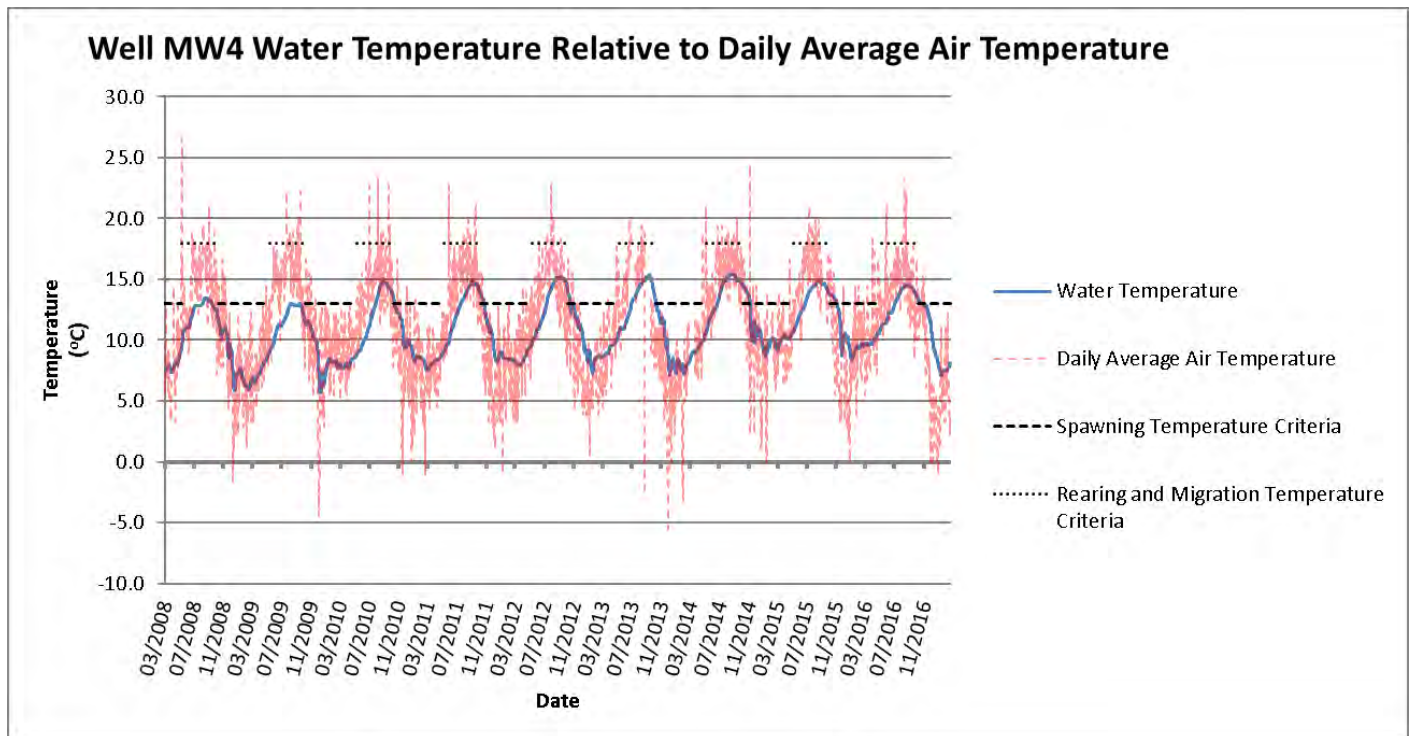
Figure B. Graphs depicting water temperatures in water level monitoring wells at Miami Wetlands from March 2008 through February 2017

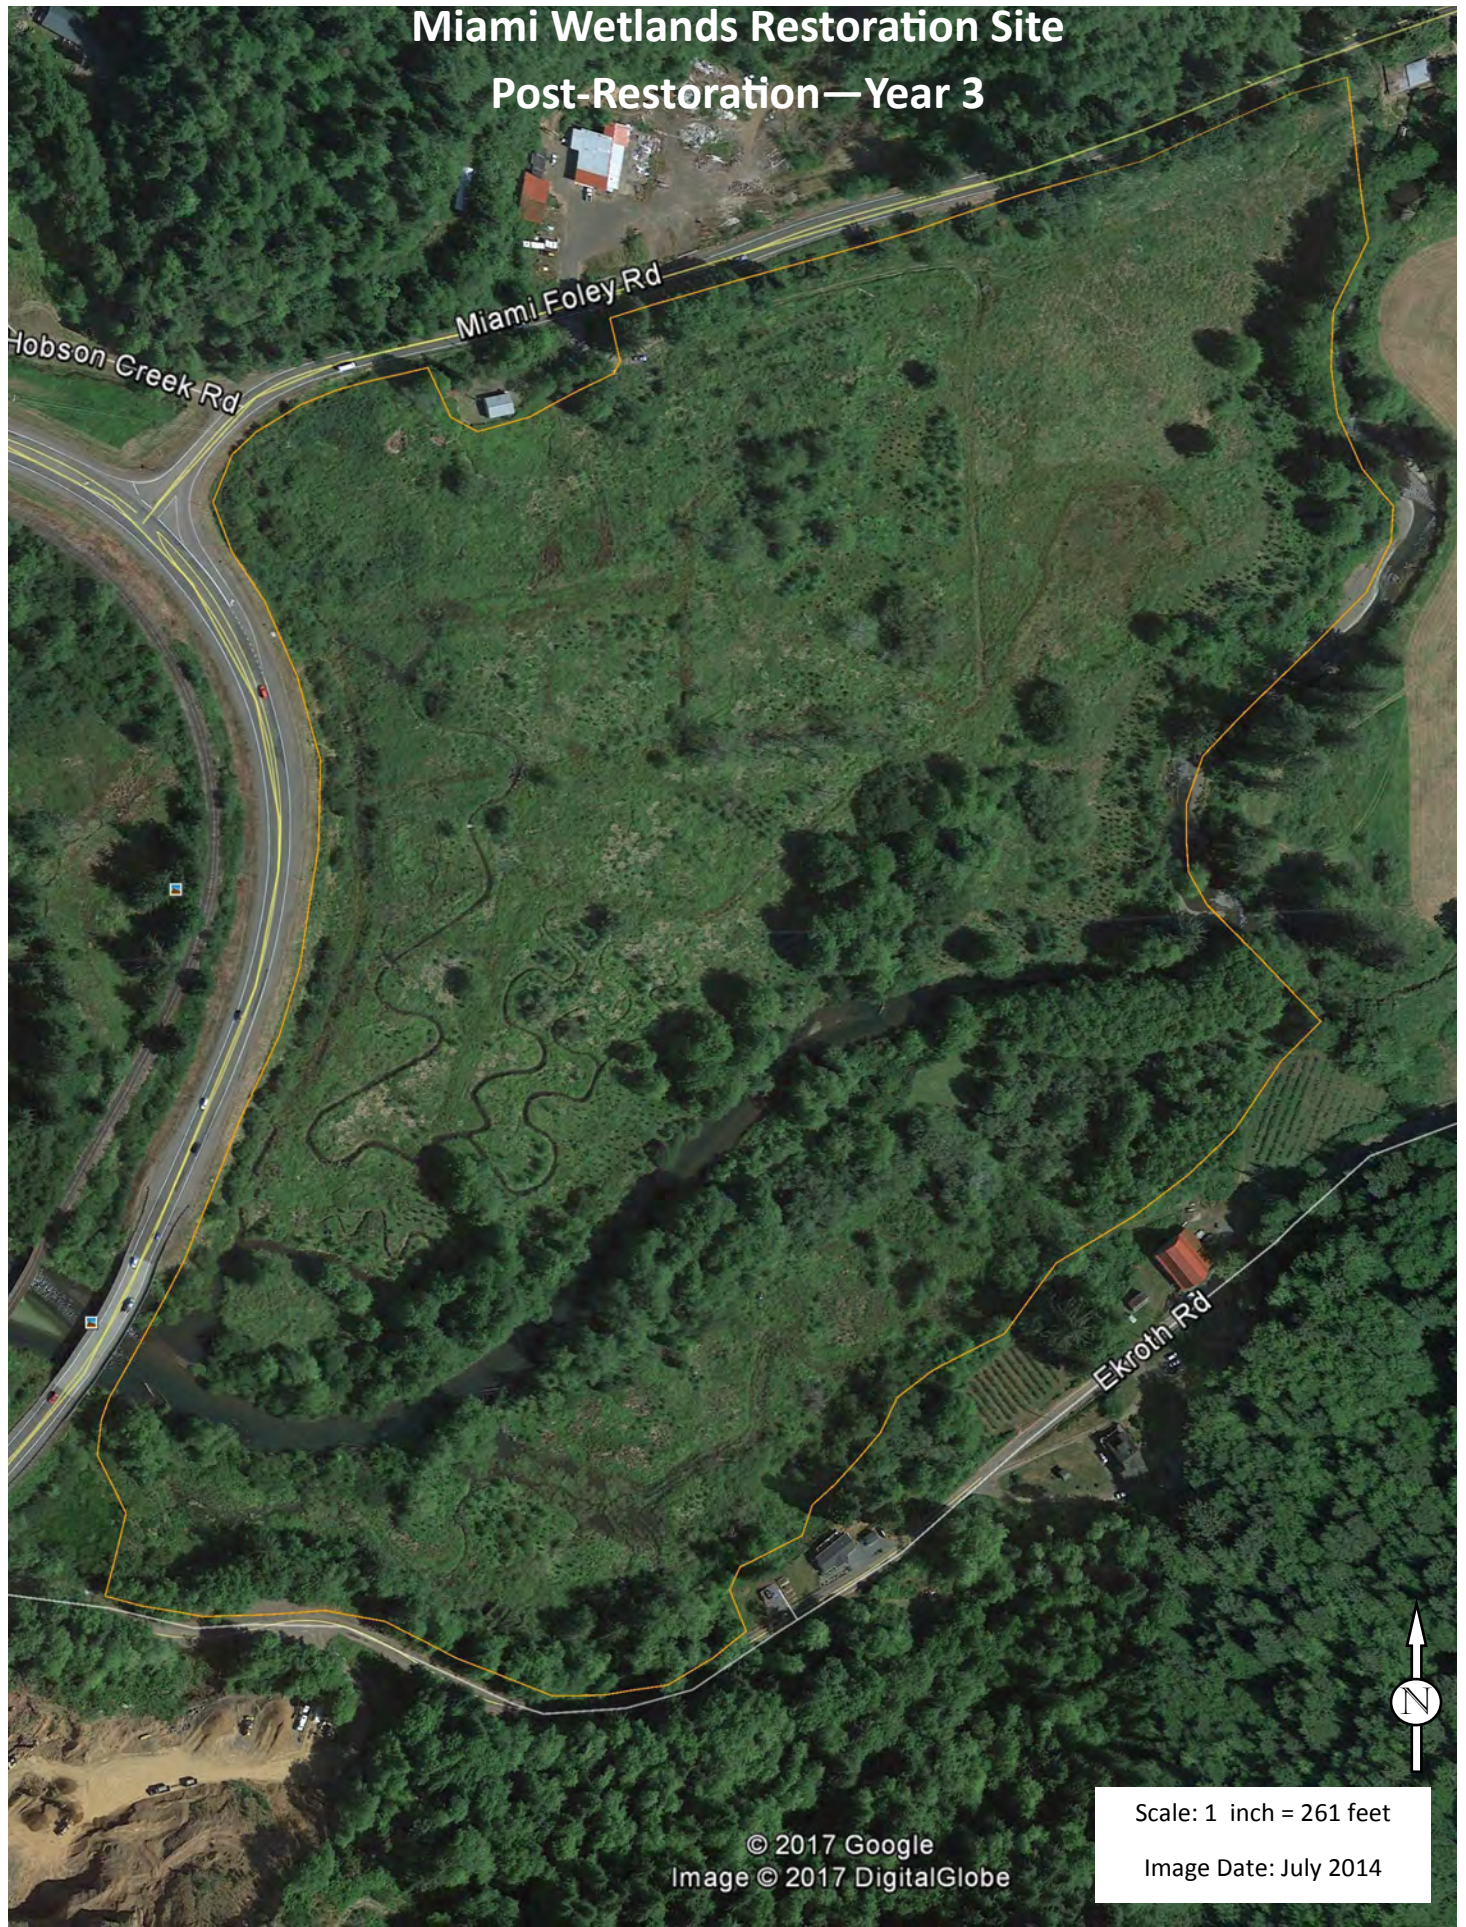
# Miami Wetlands Restoration Site

## Post-Restoration—Year 3

Image Date: July 2014

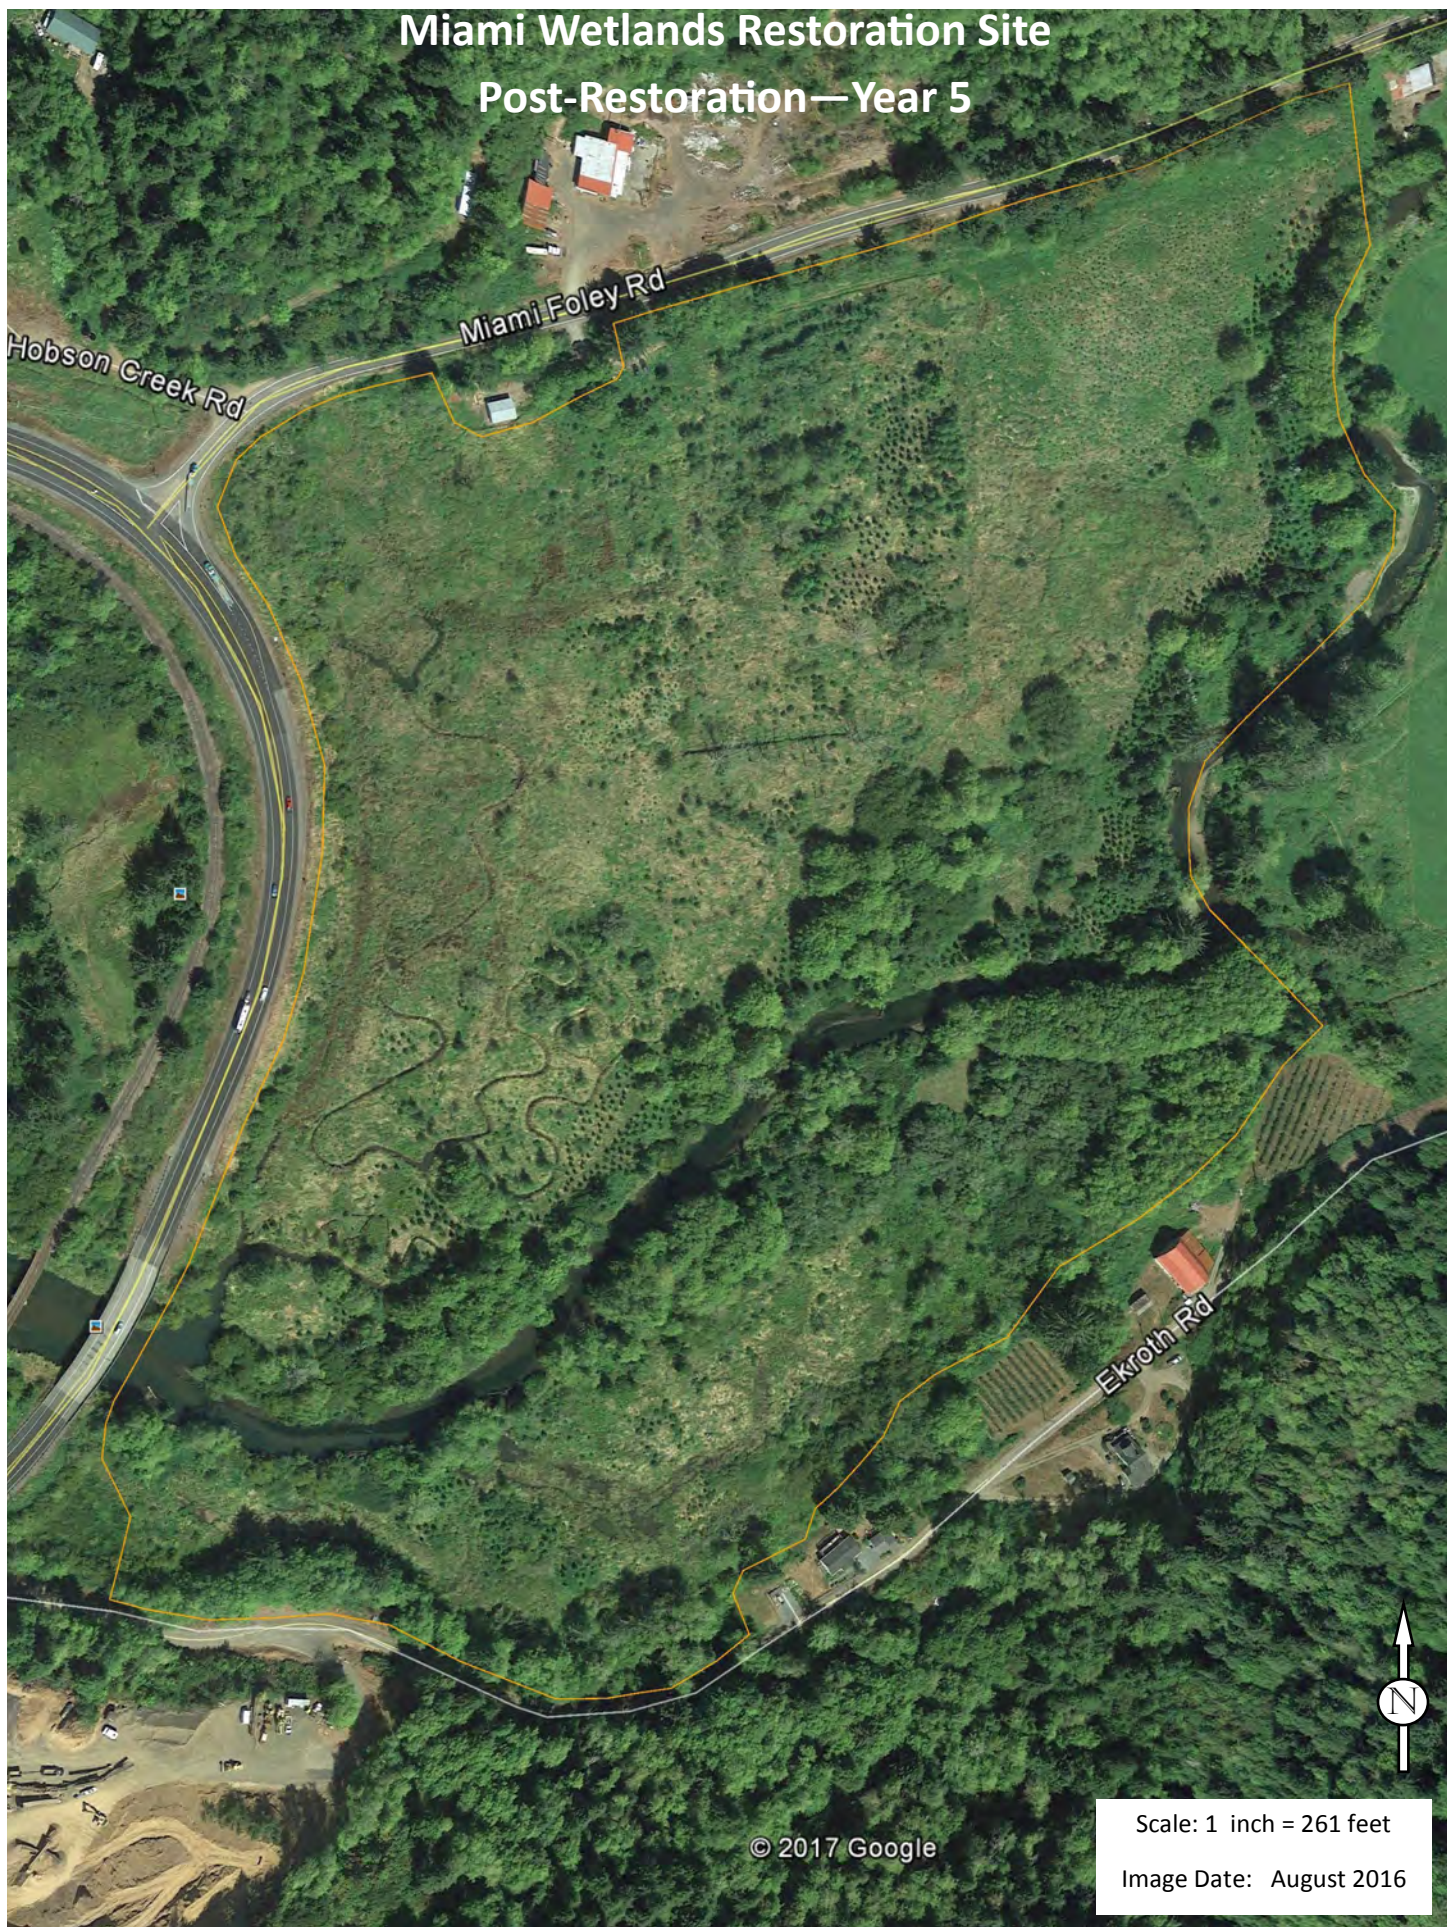
# Miami Wetlands Restoration Site

## Post-Restoration—Year 5

Scale: 1 inch = 261 feet  
Image Date: August 2016
