PATTERSON CREEK FISH PASSAGE FEASIBILITY AND CONCEPTUAL DESIGN STUDY

Feasibility and Conceptual Design Report

Client: Tillamook Estuaries Partnership (TEP)

Prepared by: Lower Columbia Engineering (LCE)

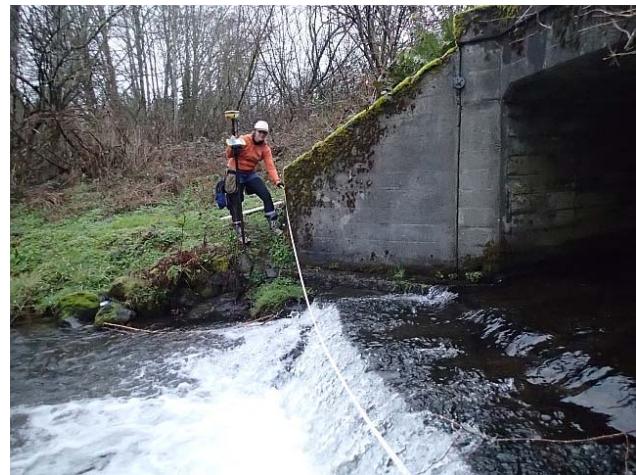
Figure 1: Locating culverts with GPS-RTK survey unit. Survey staff use a combination of methods including tapes and level rods.

An initial reconnaissance survey of crossings within Bay City was conducted on January 23, 2015. Culverts at Crossings 579 (4th Street), 578 (5th Street), 575 (7th Street), 5555 (8th Street), and 572 (9th Street) were photographed, structural dimensions measured, and water depths taken (for flow calculations). A GPS surveying unit (TOPCON Hiper II) was employed to collect location and elevation measurements of roads, utilities in proximity of crossings, survey benchmarks, and all culverts (Fig. 1). In RTK (real time kinematic) mode, the GPS survey unit is capable of reporting coordinates within 1cm (<0.5") relative horizontal location and 1.5cm (0.5") relative vertical location. A combination of known point measurements, static GPS calculations, and post processing were used to establish absolute locations in the UTM and the Oregon State Plane coordinate systems. GPS data was used to establish control points for total station surveys and stream profiles, to validate lidar data, and to reconcile field surveys with existing documentation.

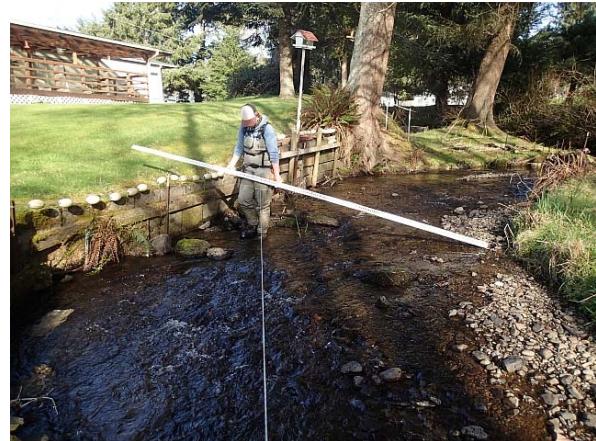
Figure 2: Stream survey of bed elevation and profile

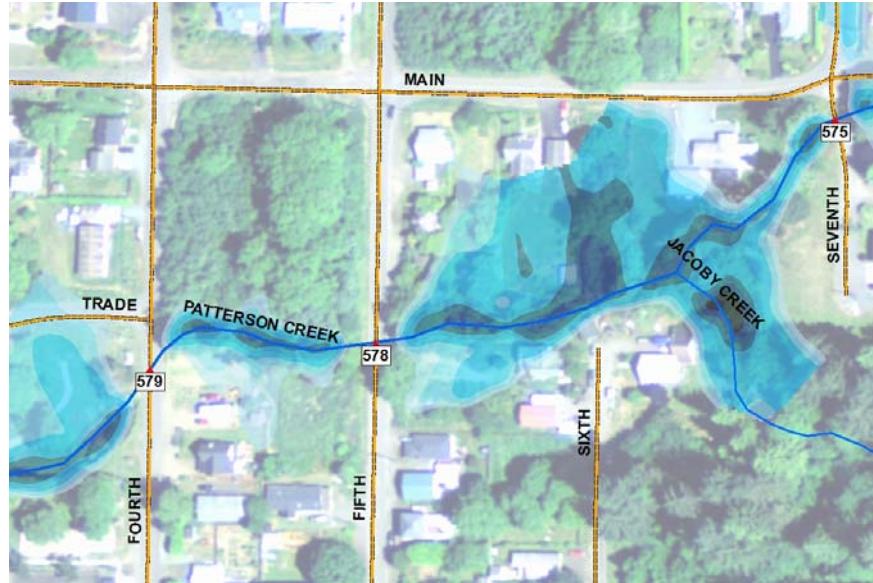
Figure 9: Reach 2-4. Altimetric model showing existing conditions. Field survey staff noted the area between Crossing 578 and confluence with Jacoby Creek is likely to flood adjacent to channel. This reach currently has multiple revetments and stream bank protections to prevent erosion. See Figures 10-12

Slope of the creek in this reach is 1% or less. The confluence with Jacoby Creek is located at the upstream end of Reach 4. Between 4th and 5th Streets, building lots have been condemned as unbuildable; however at least one buildable lot south of Patterson Creek is listed for sale. East of Crossing 578, residential structures are located directly adjacent to the creek on both north and south banks. Revetments and bank reinforcement have been built in several places near the confluence with Jacoby Creek. Between the

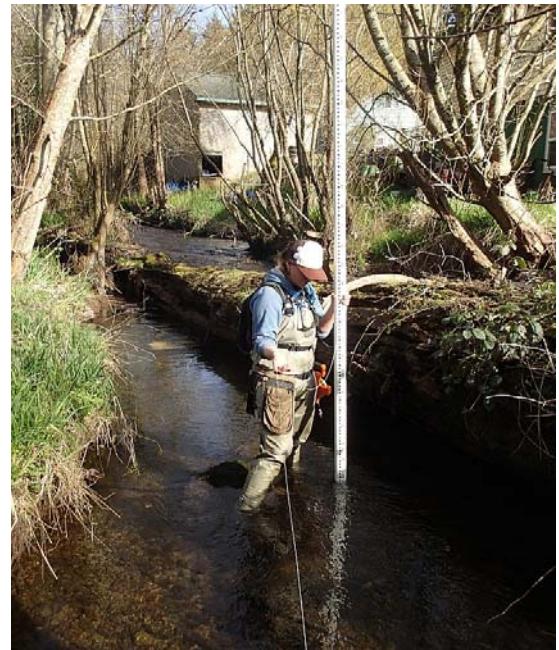
Figure 10: Large woody debris (several large conifer and hardwood logs) located between Crossing 578 and confluence of Patterson and Jacoby Creek

confluence and Crossing 578, large conifer logs and other woody debris have accumulated, and enough accumulated bedload to affect drainage. Notching in logs and revetments are evidence that constrained flow may be causing flooding and erosion upstream.

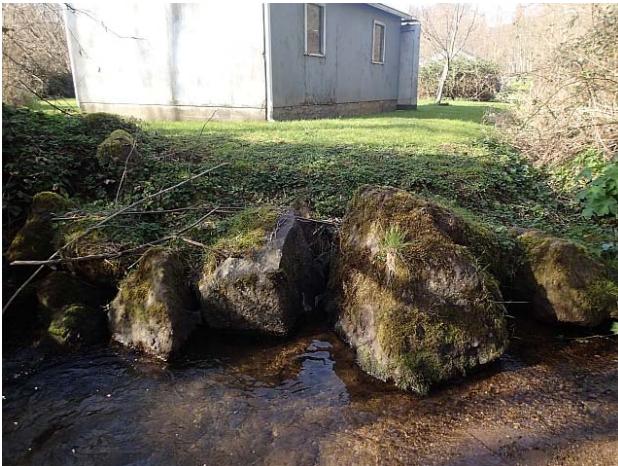
Figure 11: This reach currently has multiple revetments and stream bank protections to prevent erosion both above and below confluence with Jacoby Creek.

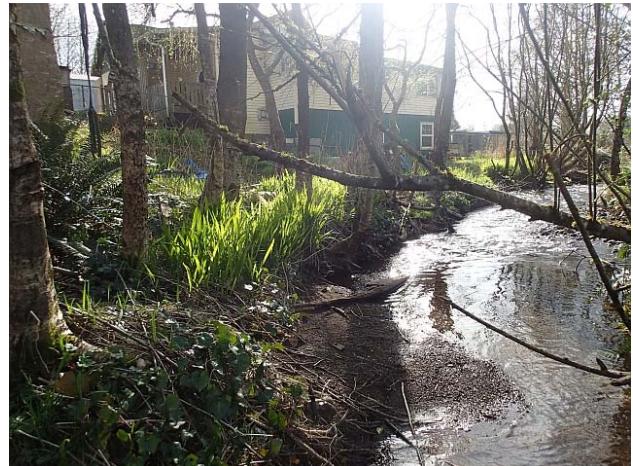
Figure 12: Several residential structures are located within one active channel width of the average high water line of Patterson Creek in Reach 4.

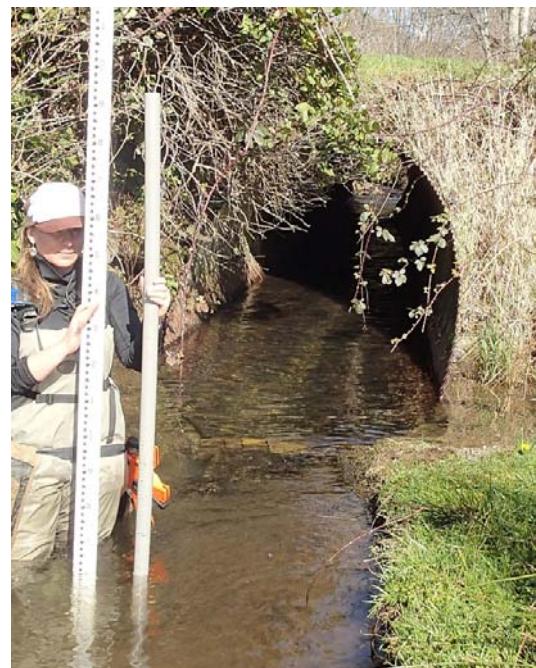
Figure 13: Crossing 579 (4th St.), looking upstream.

Patterson Creek crosses 4th Street via a 6' diameter corrugated metal pipe with mitered ends (91.5' length invert to invert) at a 60 degree skew to 4th Street. Concrete wing walls downstream are in poor condition, with a large concrete block (broken splash apron or wall abutment) located in the downstream pool. The upstream wing walls are completely overgrown, but appear to be badly eroded and possibly failed on north side. This culvert was flagged for replacement in the CoBC 2003 Storm Water Master Plan.

A 6" PVC water main crosses on the west edge of the road, and sewer main "I" terminates at south side, approximately 15' feet south of the culvert. The extreme skew and proximity of the sewer main were determining factors in the selection of a replacement structure.

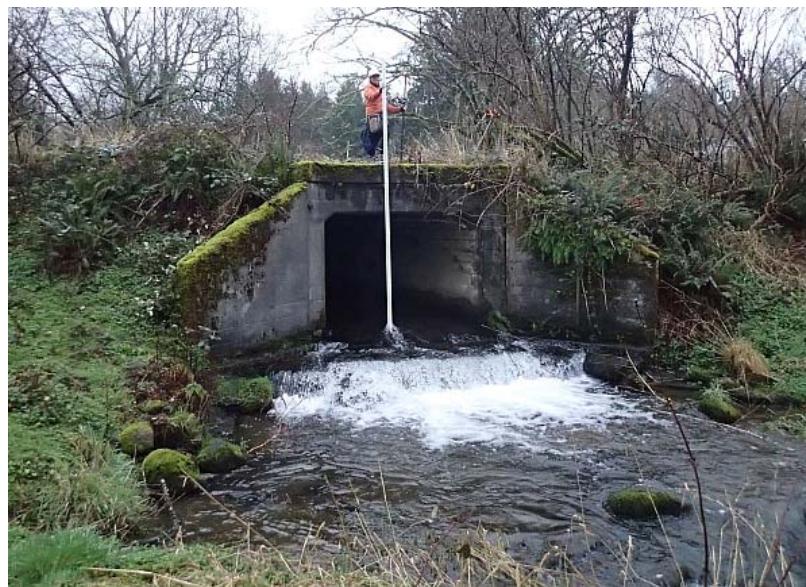
Figure 14: Concrete box culvert Crossing 578 (5th St.)

The box culvert at 5th Street is the first significant fish passage barrier on Patterson Creek. The outlet invert of the culvert is perched 2.5', and is a total barrier to juvenile salmonids. The shallow water depth in the concrete bottom culvert is a partial barrier to upstream migration by adult fish. The existing structure is a 6' x 8' x 72' concrete box culvert. The primary sewer conveyance from the north

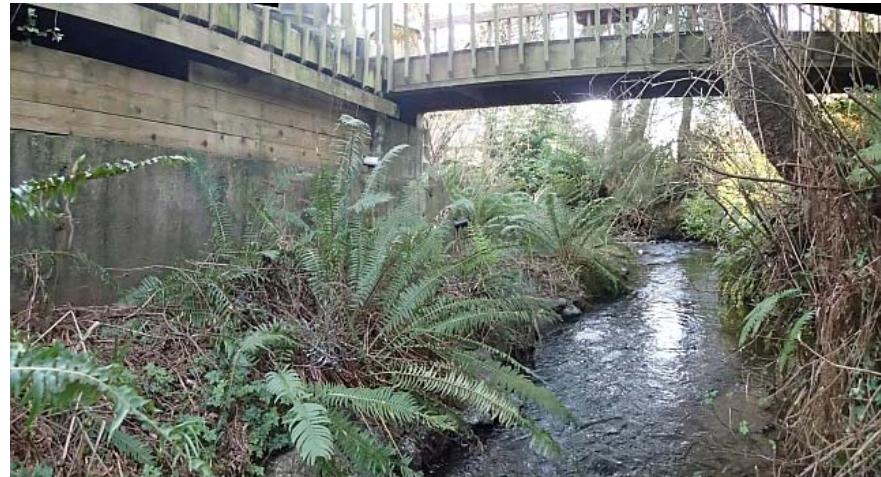
Figure 15: Residential development extends to the average high flow water level in Reach 5, limiting the potential to aggrade the channel as an approach to removing the fish passage barrier at the existing fish ladder, upstream approximately 200 feet.

Above the confluence with Jacoby Creek, Patterson Creek has been extensively modified to facilitate residential development close to the banks of both Patterson Creek and Jacoby Creek. The Patterson Creek channel has been straightened and deepened where it parallels Main Street (see Cross sections in

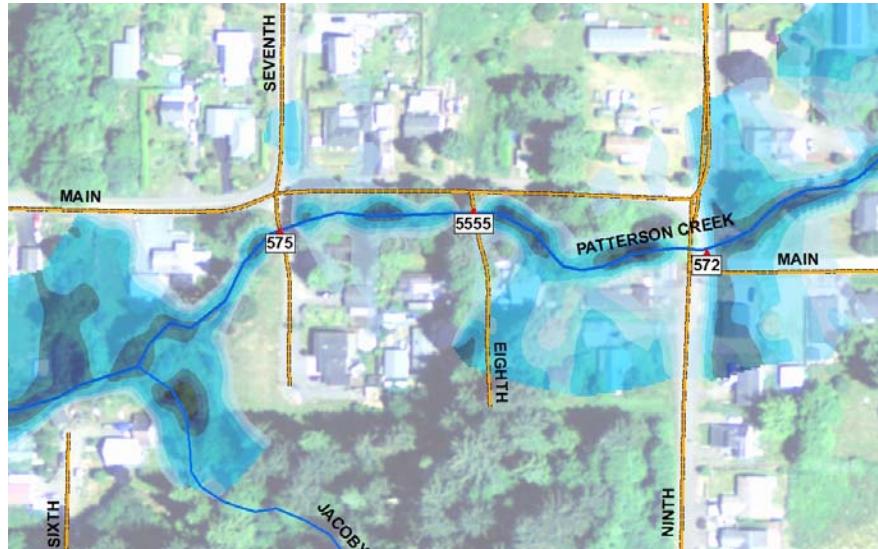
Figure 16: Existing conditions between 7th and 9th Streets, with altimetric elevations shown in blue. Structures located on the south side of Patterson Creek between 8th and 9th Streets are the most limiting constraints on vertical adjustments, coinciding with low lying areas south of Main Street. Residential developments east of 9th Street and south of Main Street (between Patterson and Jacoby Creek) are built on what was historically riparian floodplain.

Attachment C, Alternatives Analysis Figures, page 10). A deep scour pool and the perched, undersized culvert at 575 is a fish passage barrier to both adults and juveniles at most flow levels. The reach below the fish ladder is also deeply incised (in places nearly a 10' bank height and a 16' active channel width). Between 8th and 9th Streets, two private bridges cross the creek, and a foundation for a residence is built within the active channel width (Figure 15). Designs to improve fish passage in the area of the existing fish ladder require aggrading the channel, but are constrained by the height of adjacent low lying residential properties on

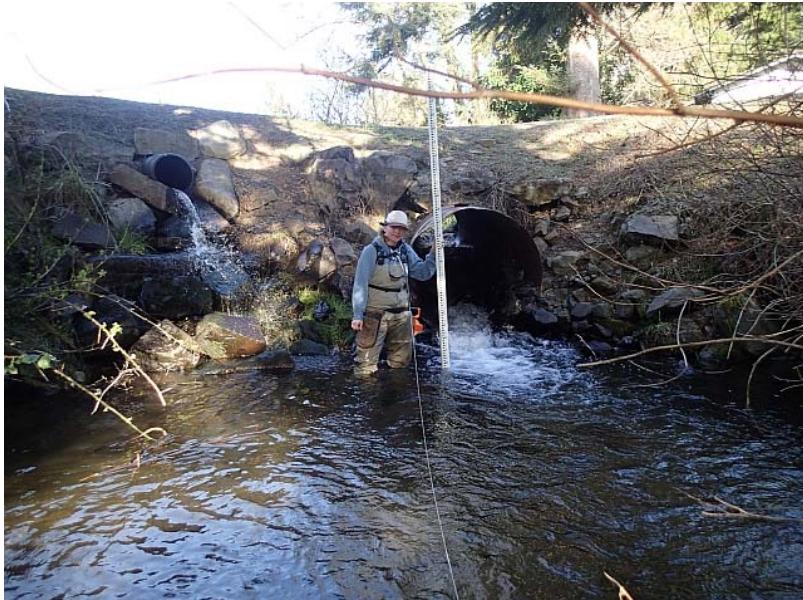
Figure 18: Crossing 575 (7th St.). The plastic culvert fed by the 7th Street drainage ditch can be seen on the left bank of the crossing fill. Downstream scour pool is 3' at deepest point.

A 16" corrugated plastic pipe outlet is located in the north face of the crossing fill, approximately 1' higher than Crossing 575, and connects across Main Street to a drainage ditch. A water service line is located in the crossing and connects to an 8" PVC main under Main St. The 8" sewer lateral F4 is shown in the sanitary sewer plans to be located directly below the existing culvert pipe.

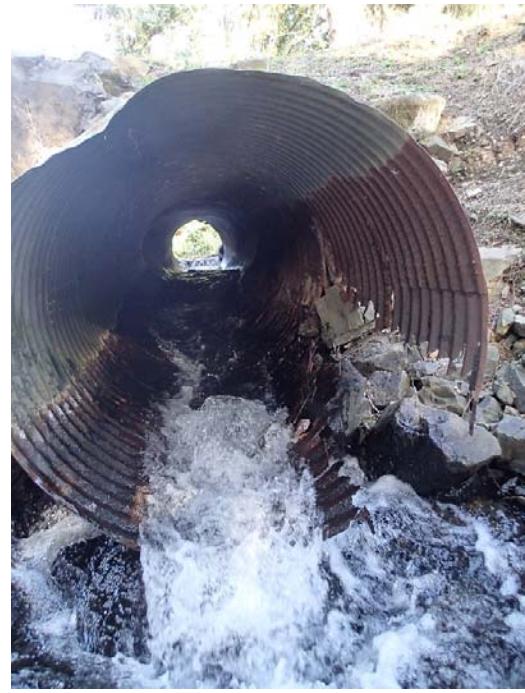
Figure 19: Outlet of Crossing 575, showing complete pipe failure. Scour has eroded below the pipe, which now projects above the pool below. Total perch height is 12" from water surface to outlet of pipe.

The 48" corrugated metal pipe is 36' in length at 7% pipe slope. It is undersized, is corroded along the entire length, and the pipe has completely failed at the outlet due to corrosion (Figure 19). The outlet is perched 1' from the low flow water surface (16" to rock bed), with a 3' deep scour pool. The steep slope, undersized and failed culvert pipe, and perch all prevent fish passage. Residents note that very few fish are seen past this point on Patterson Creek, and that significant numbers were seen in upstream pools in past decades.

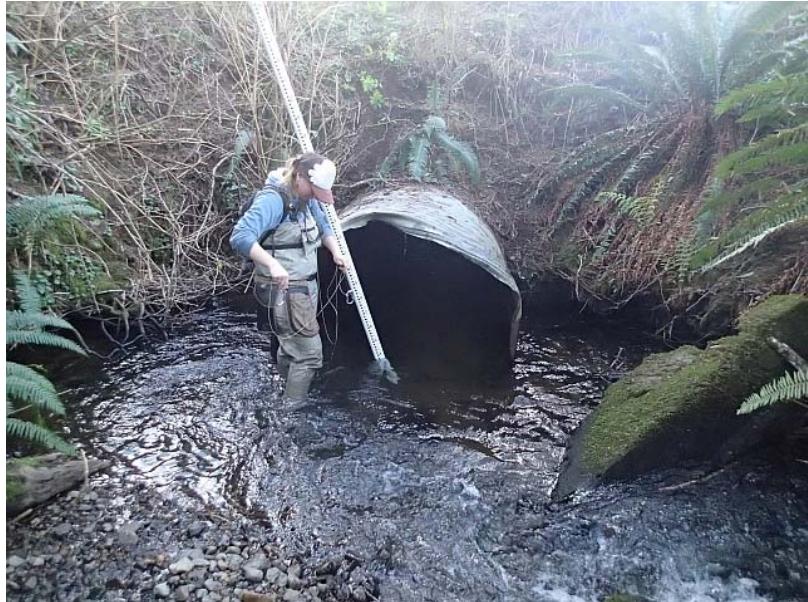
Figure 20: Crossing 5555 (8th St.)

Crossing 5555 provides access to 2-3 residences at 8th Street. The culvert is a 5' diameter, 40' long corrugated metal pipe. The pipe is undersized, and is partly embedded (approximately 12") at zero slope. Both ends are projecting and show damage from wear or during installation or maintenance. The stream thalweg is approximately 9 feet below the surrounding road surfaces, and becomes more deeply incised in the reach immediately upstream. A water service line is located in the crossing and connects to an 8" PVC main under Main St. The 8" sewer lateral F5 appears in plans to be resting directly in contact with the top of the culvert pipe. An overhead power line crosses Patterson Creek, with a power pole approximately 6' from the crossing at the northwest corner.

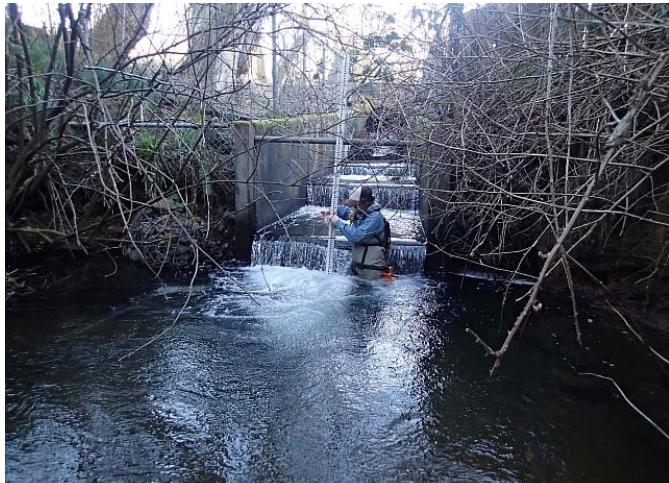
Figure 21: Outlet of fish ladder below Crossing 572 (9th St.)

The fish ladder and culvert are a total fish passage barrier in their current condition. The four cell ladder is in poor repair, with failed weir boards in at least two cells. The bottom three cells have accumulated gravel and fine sediment nearly to the depth of the weir boards at each cell outlet. At the outlet of the fish ladder, the bottom weir is perched 2' above the water surface of the scour pool. The depth of the outlet pool below the fish ladder is greater than 3' (at low flow); the depth is controlled by a downstream cobble riffle. Several residents indicated that fish historically collected below this crossing to pass upstream, but have not been seen in recent years

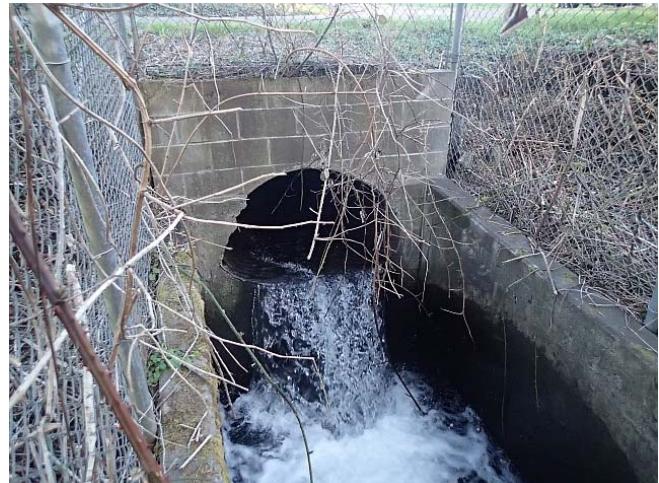
Figure 22: Crossing 572 (9th St.)

may reach the top cell due to the perch, high velocities within the pipe, and/or shallow depth at all flow conditions. The inlet of the pipe is constrained by vegetation, and Bay City Public Works staff indicated that maintenance at this culvert was required to prevent plugging with debris. Residents noted in later interviews that Patterson Creek overtops 9th street during a ten year recurrence interval flood event, even if the culvert is free of debris or obstructions. Residents also indicate that bedload has accumulated upstream since the construction of the fish ladder.

Sewer main F is located 2.8' underneath the culvert pipe. Man holes at either end of this crossing receive additional sewer laterals (F3 and F6), which constrain sewer elevations without extensive redesign (see discussion regarding *Bay City Infrastructure* below).

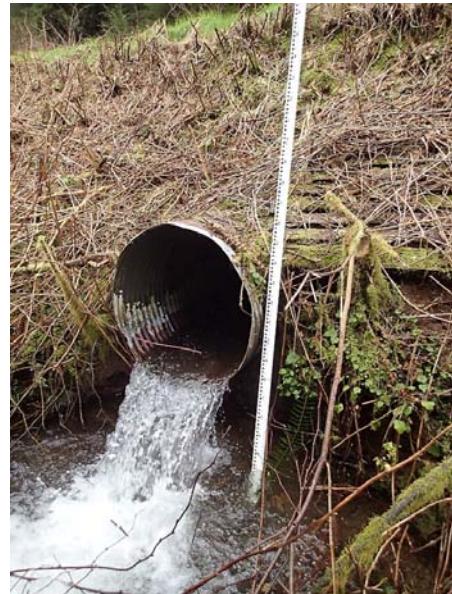
Figure 23: Crossing 542 (ODF/PP access Rd)

The main tributary of Patterson Creek passes through a 36" corrugated metal pipe, 36' long, which is in moderate condition. The culvert is undersized and perched 2.5' at downstream end, creating a total barrier to both adult and juvenile passage. Maintenance is required to prevent blockage by trapped debris and sediment (ODF staff). Another small culvert and drainage ditch at the northwest side of the crossing may require additional site grading.

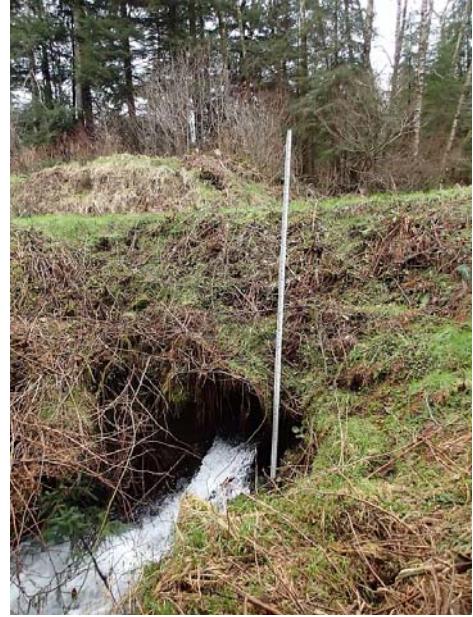
Figure 24: Crossing 543 (ODF/PP access Rd)

This crossing bridges a tributary of Patterson Creek, which is of equal size and drainage area to the main channel. The 42" diameter, 40' long corrugated metal pipe is undersized and perched 5' above the outlet pool, creating a total barrier to both adult and juvenile passage. This culvert also retains bedload and is a source of ongoing maintenance costs. Significant accumulation of bedload upstream is evident in the lidar profile and was also marked in the field survey.

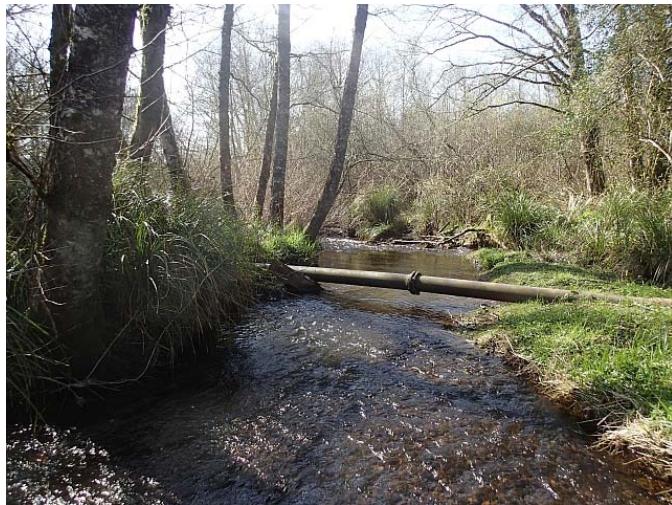
Figure 26: Exposed sewer main crossing Patterson Creek (Reach 1)

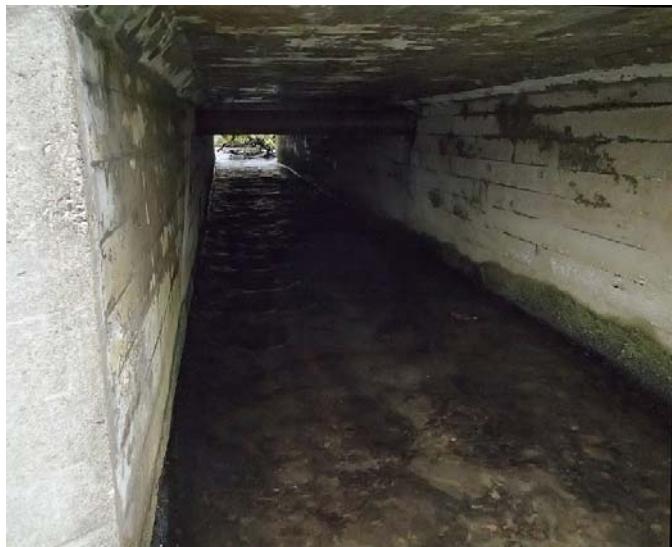
Figure 27: Exposed sewer main inside Crossing 578. Visible near top of box culvert

side of Bay City, a 10" sewer line (Main A), passes exposed through the culvert with approximately 4.75' of clearance beneath the cast iron pipe (see Figure 27). 8" PVC and 6" steel water mains cross on the east side of 5th street, and a hydrant is located north of the crossing. It was decided by project partners that upward adjustment of the stream channel elevation to eliminate the downstream perch is not feasible. The primary reason for this would be increased flooding risk at two buildable properties on the south side of Patterson Creek downstream of the crossing. Additionally, the exposed sewer main inside the box culvert is located at the top of the structure, by lowering the replacement structure it is possible to protect this pipe within the fill above a replacement culvert. Lots on the north side of Patterson Creek downstream are not buildable (DEQ assessment, see Tillamook Co. Assessor records) and may provide opportunities for habitat improvement and flood storage capacity.

At Crossing 578, there is an exposed sewer main inside the existing culvert (Figure 27). The proposed replacement culvert design retains the sewer main at the current elevation, and the replacement structure passes underneath (i.e., the sewer main will be buried in the fill- see Conceptual Design Drawings).
