Fluvial Geomorphic Analysis of the Tillamook Bay Basin Rivers

Prepared by Monte L. Pearson, Ph.D.

March 2002

Prepared for:
Portland District, US Army Corps of Engineers
and Tillamook County, Oregon
Contract Number: DACW57-99-D-0011-0006

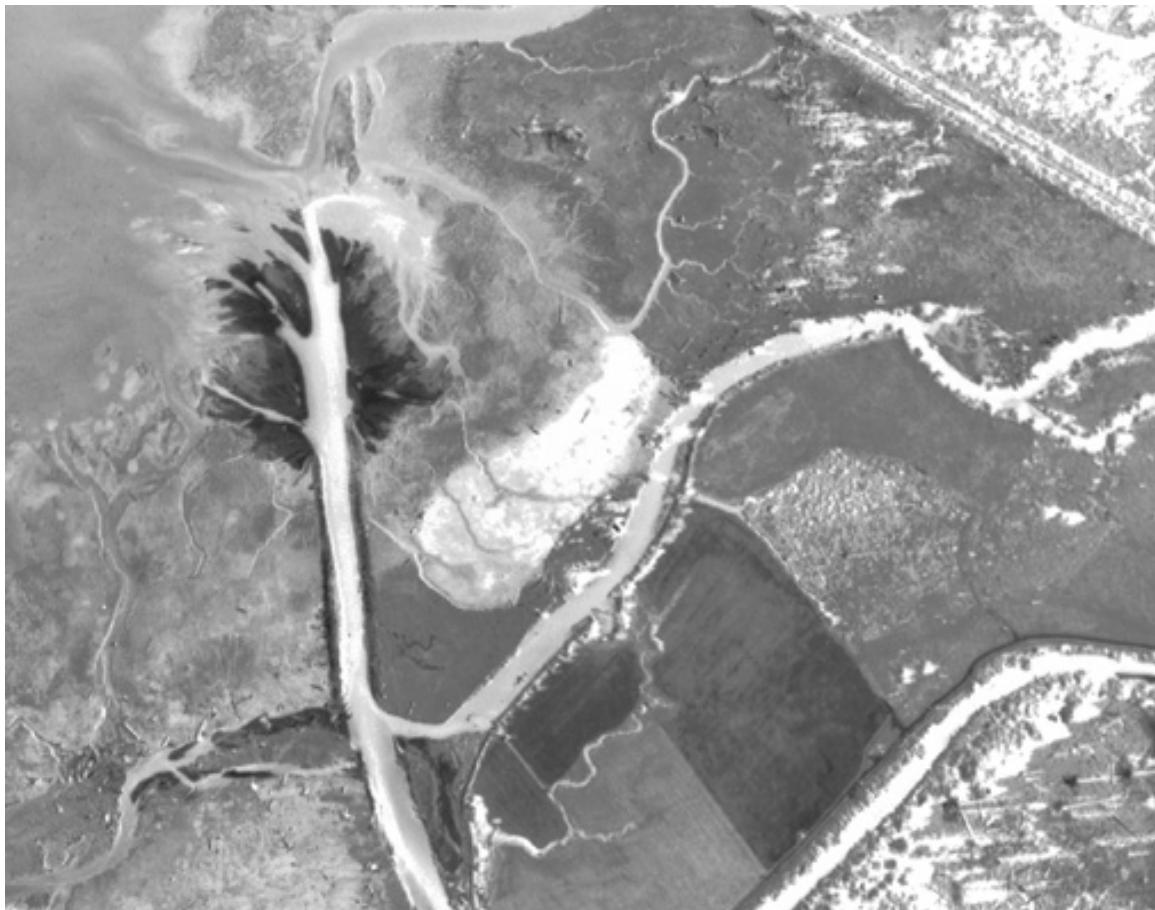
Photograph Number 1: Kilchis River 1939; River mile 0-1.

Large sediment deposit at the river – delta interface, it is still visible on the 2000 Photograph. The presents of the sedimentary element are an indication that recent sediment rates have slowed.

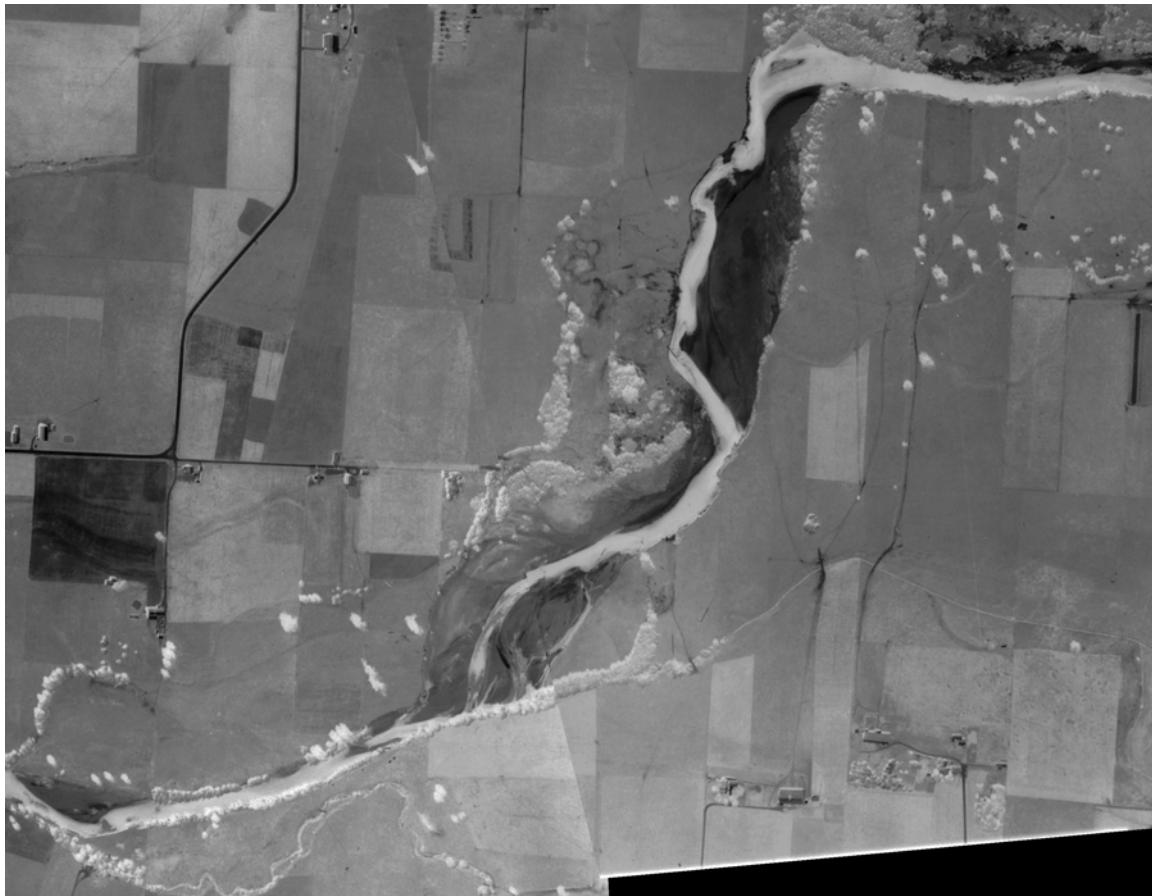
Photography Number 3: Trask River 1939; River mile 6 –7.

Extensive Gravel Bar complexes with limited riparian development. Gravel deposition occurring resulting in bed aggradation. High sediment loading associated with basin fire history

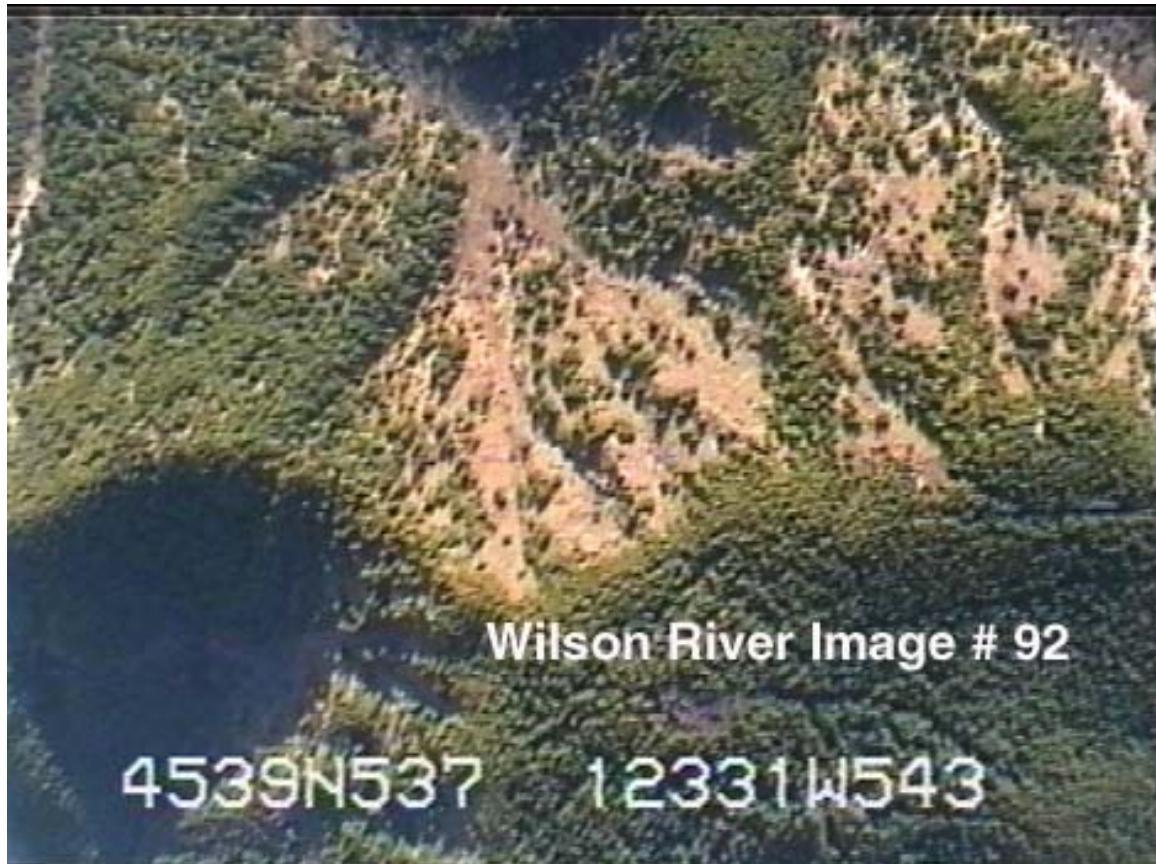
Photography Number 4: Wilson River November 1999.

Upper Basin Area; illustrating the slope Failures in the Upper Wilson Basin resulting from the November 1999 winter. (Wilson River Image 92)

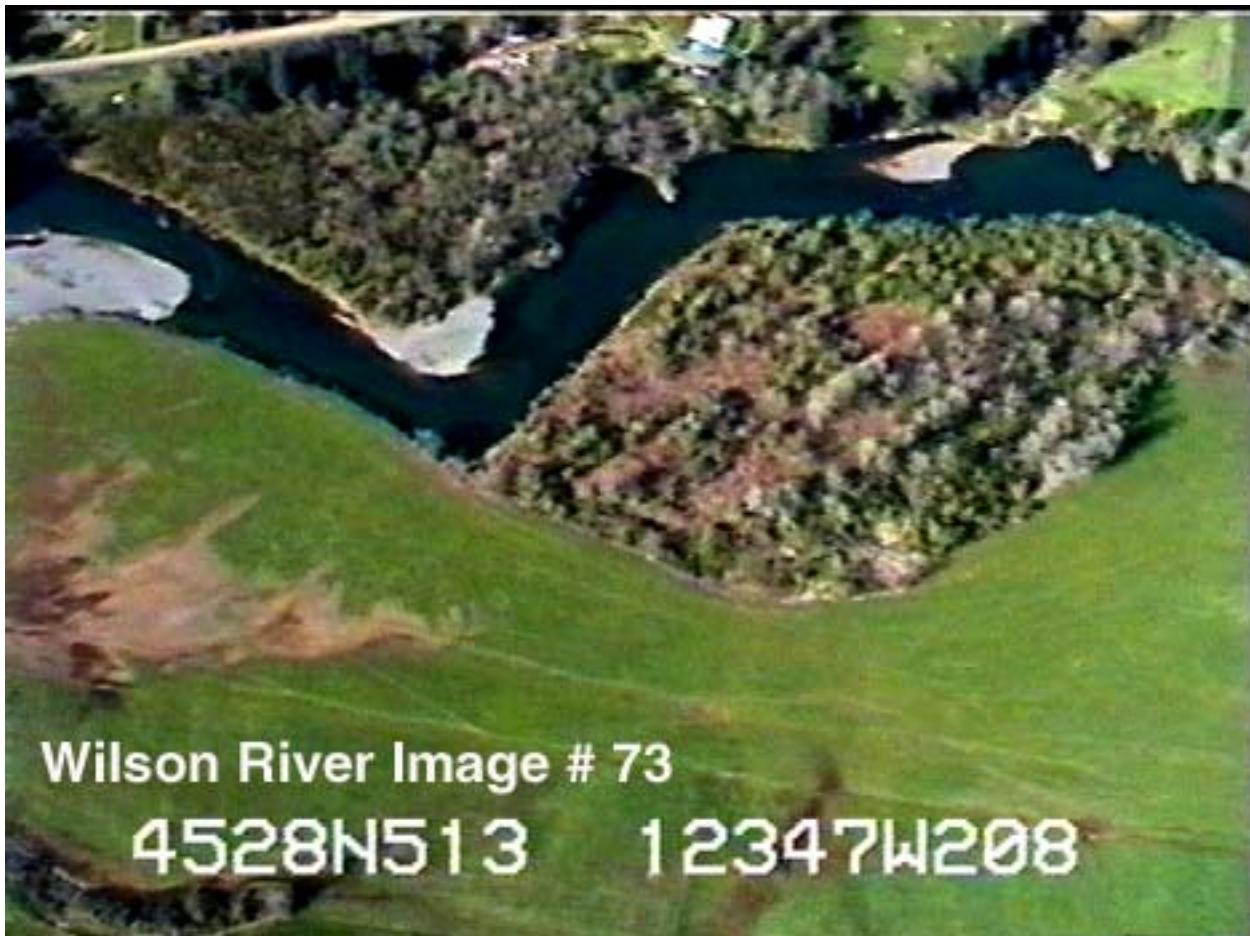
Photography Number 6: Wilson River November 1999, Middle Alluvial Plain.

Fine grain sediment deposited on agricultural land after flood event. Notice the large riparian zone and minor gravel bar complexes.
(Wilson River Image 73)

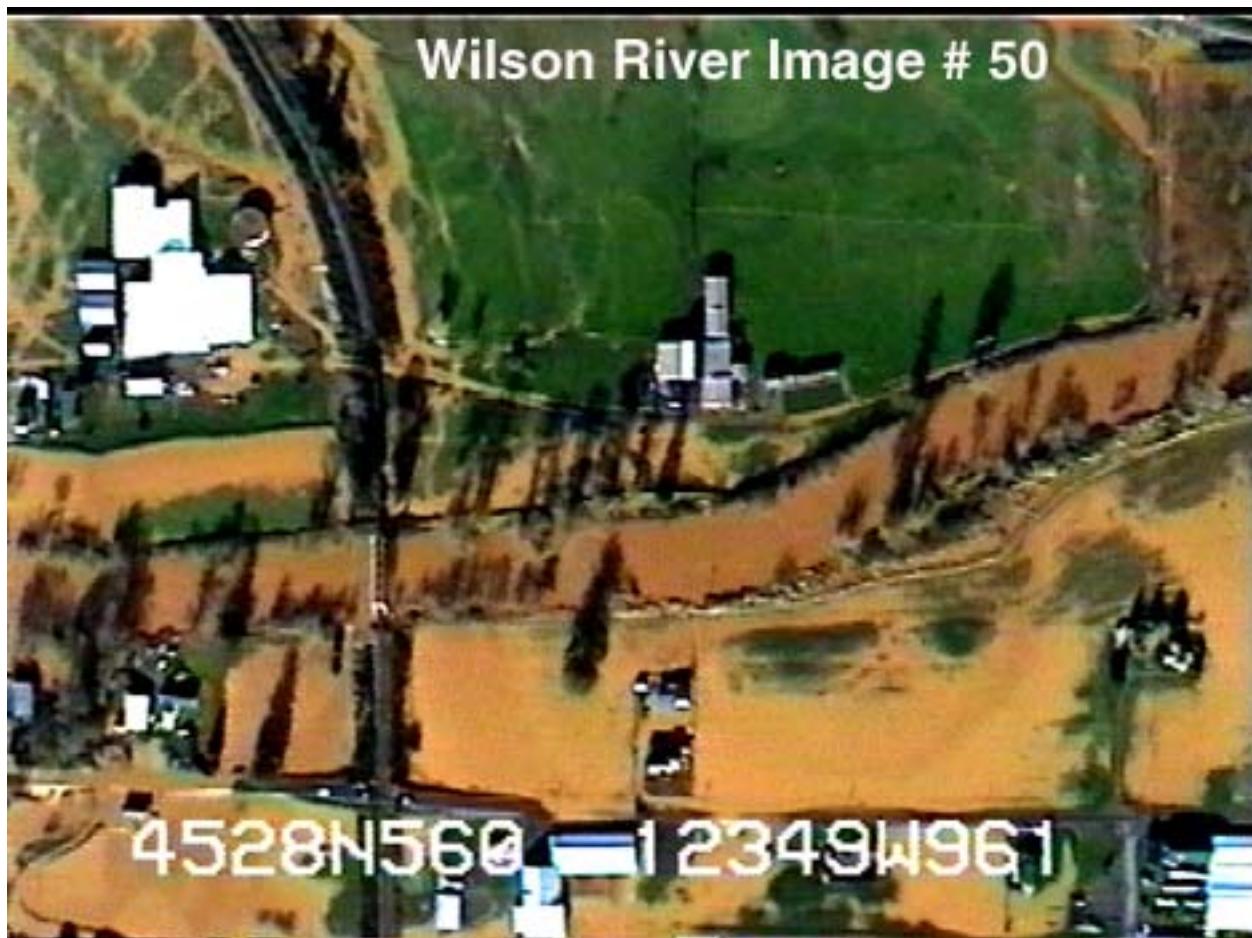
Photography Number 7: Wilson River.

Alluvial Plain at Flood Stage and Out of Channel Flow.
(Wilson River Image 50)

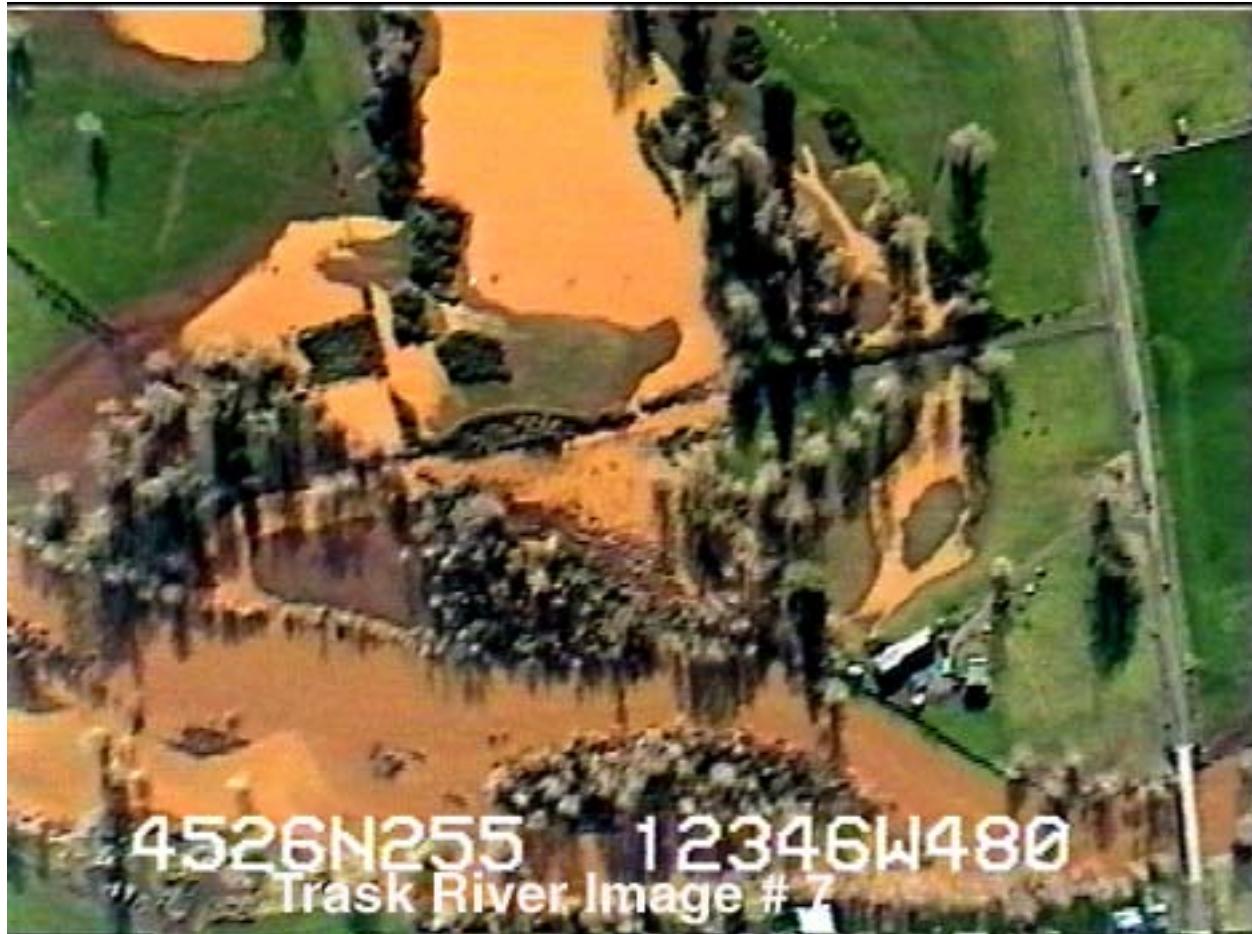
Photography Number 8: Trask River November 1999.

Lower Alluvial Plain at Flood Stage and Out of Channel Flow. (Trask River Image 7)
