Tillamook Estuaries Partnership

Patterson Creek Culverts Replacement Project: An Assessment of Potential In-Stream Enhancement Opportunities

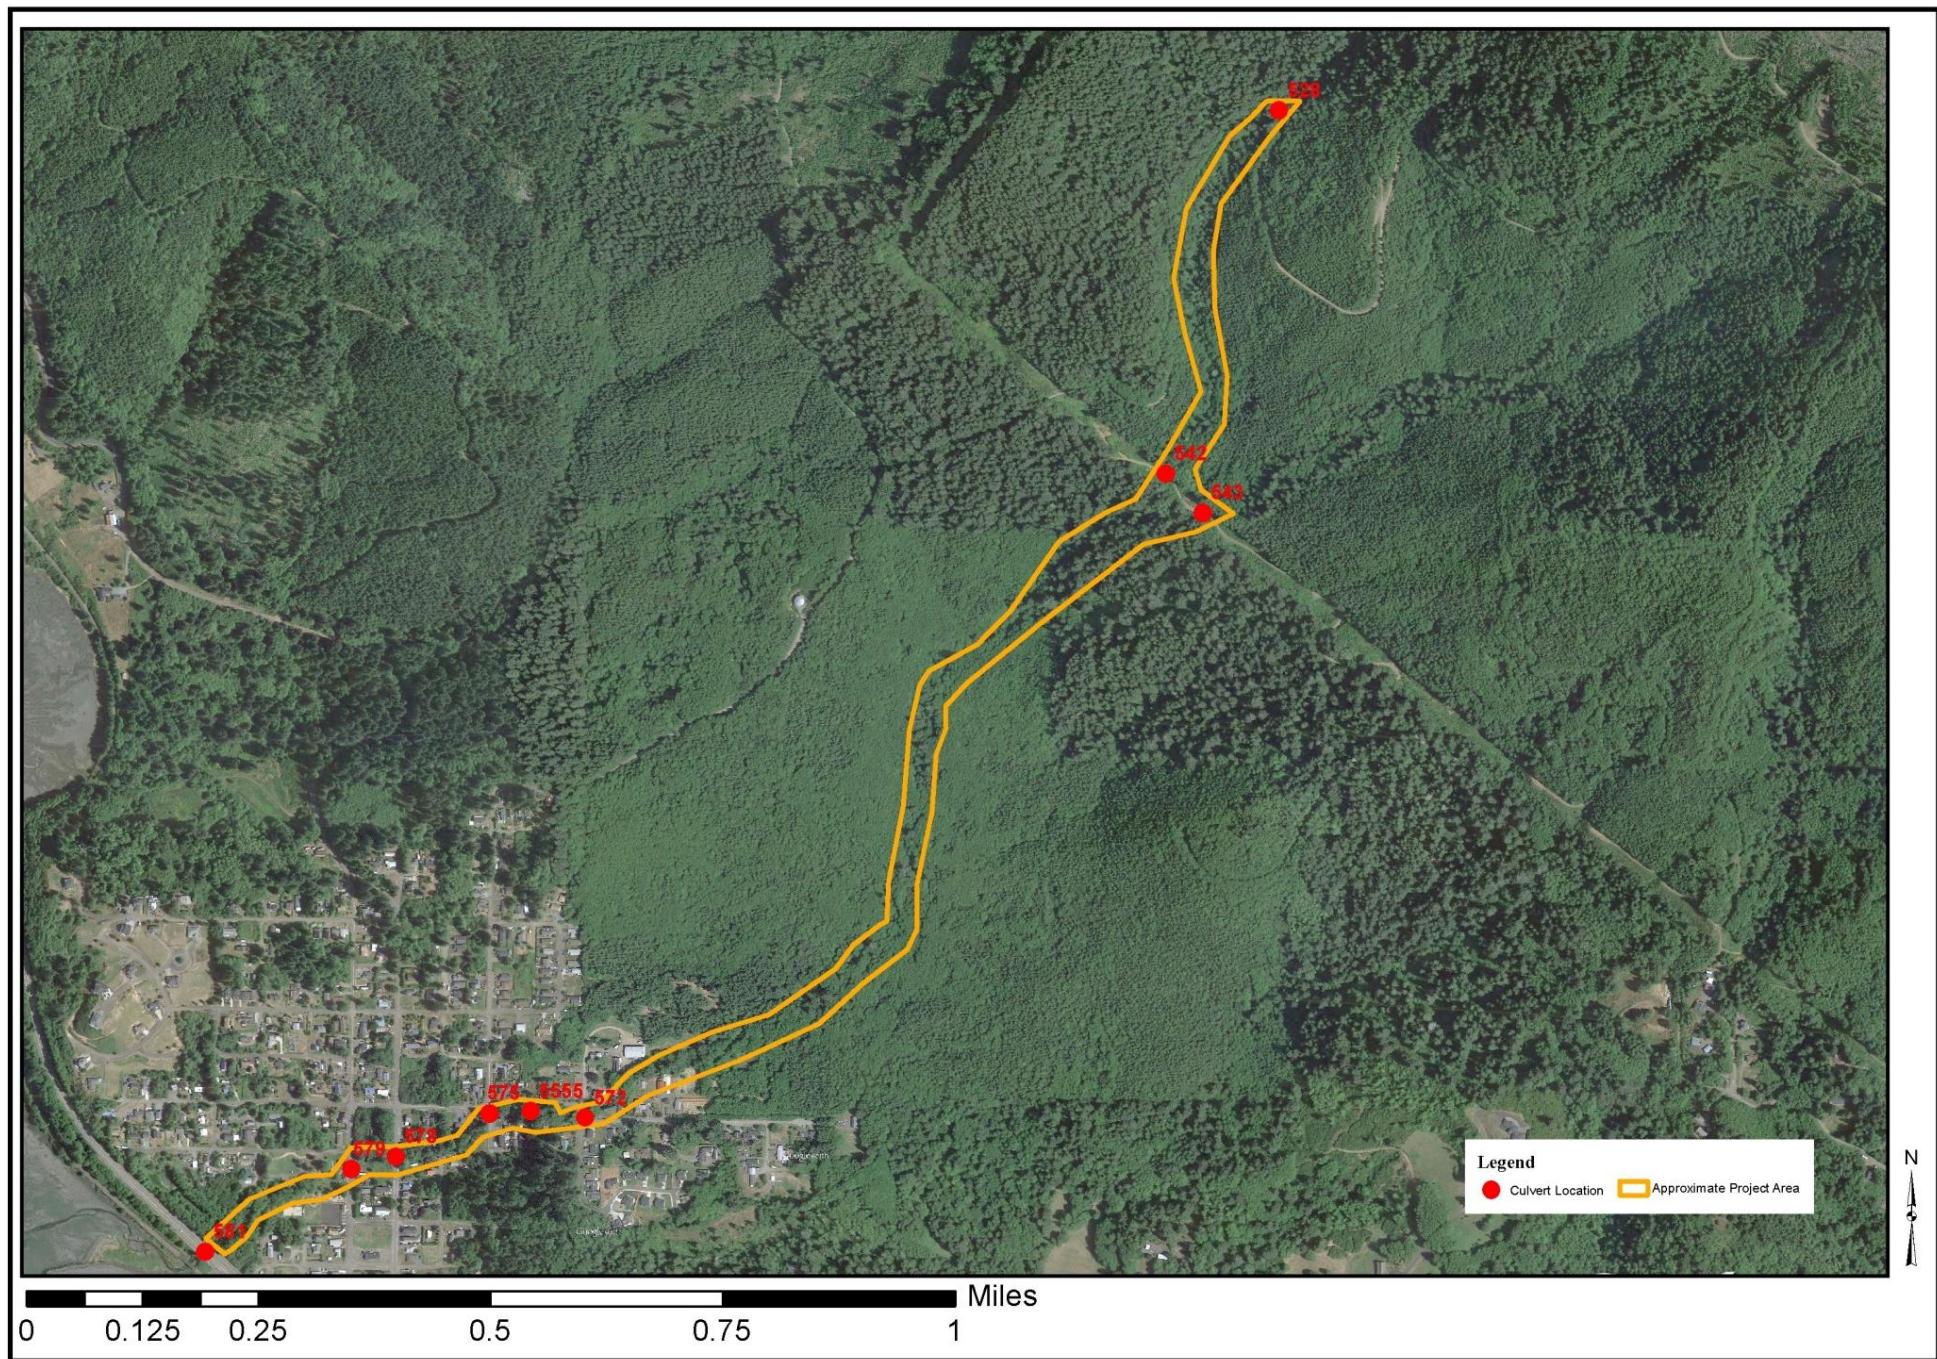
Figure 1 Aerial photograph depicting the locations of culverts along Patterson Creek and the approximate boundary of the Culverts Replacement Project, Tillamook County, Oregon.

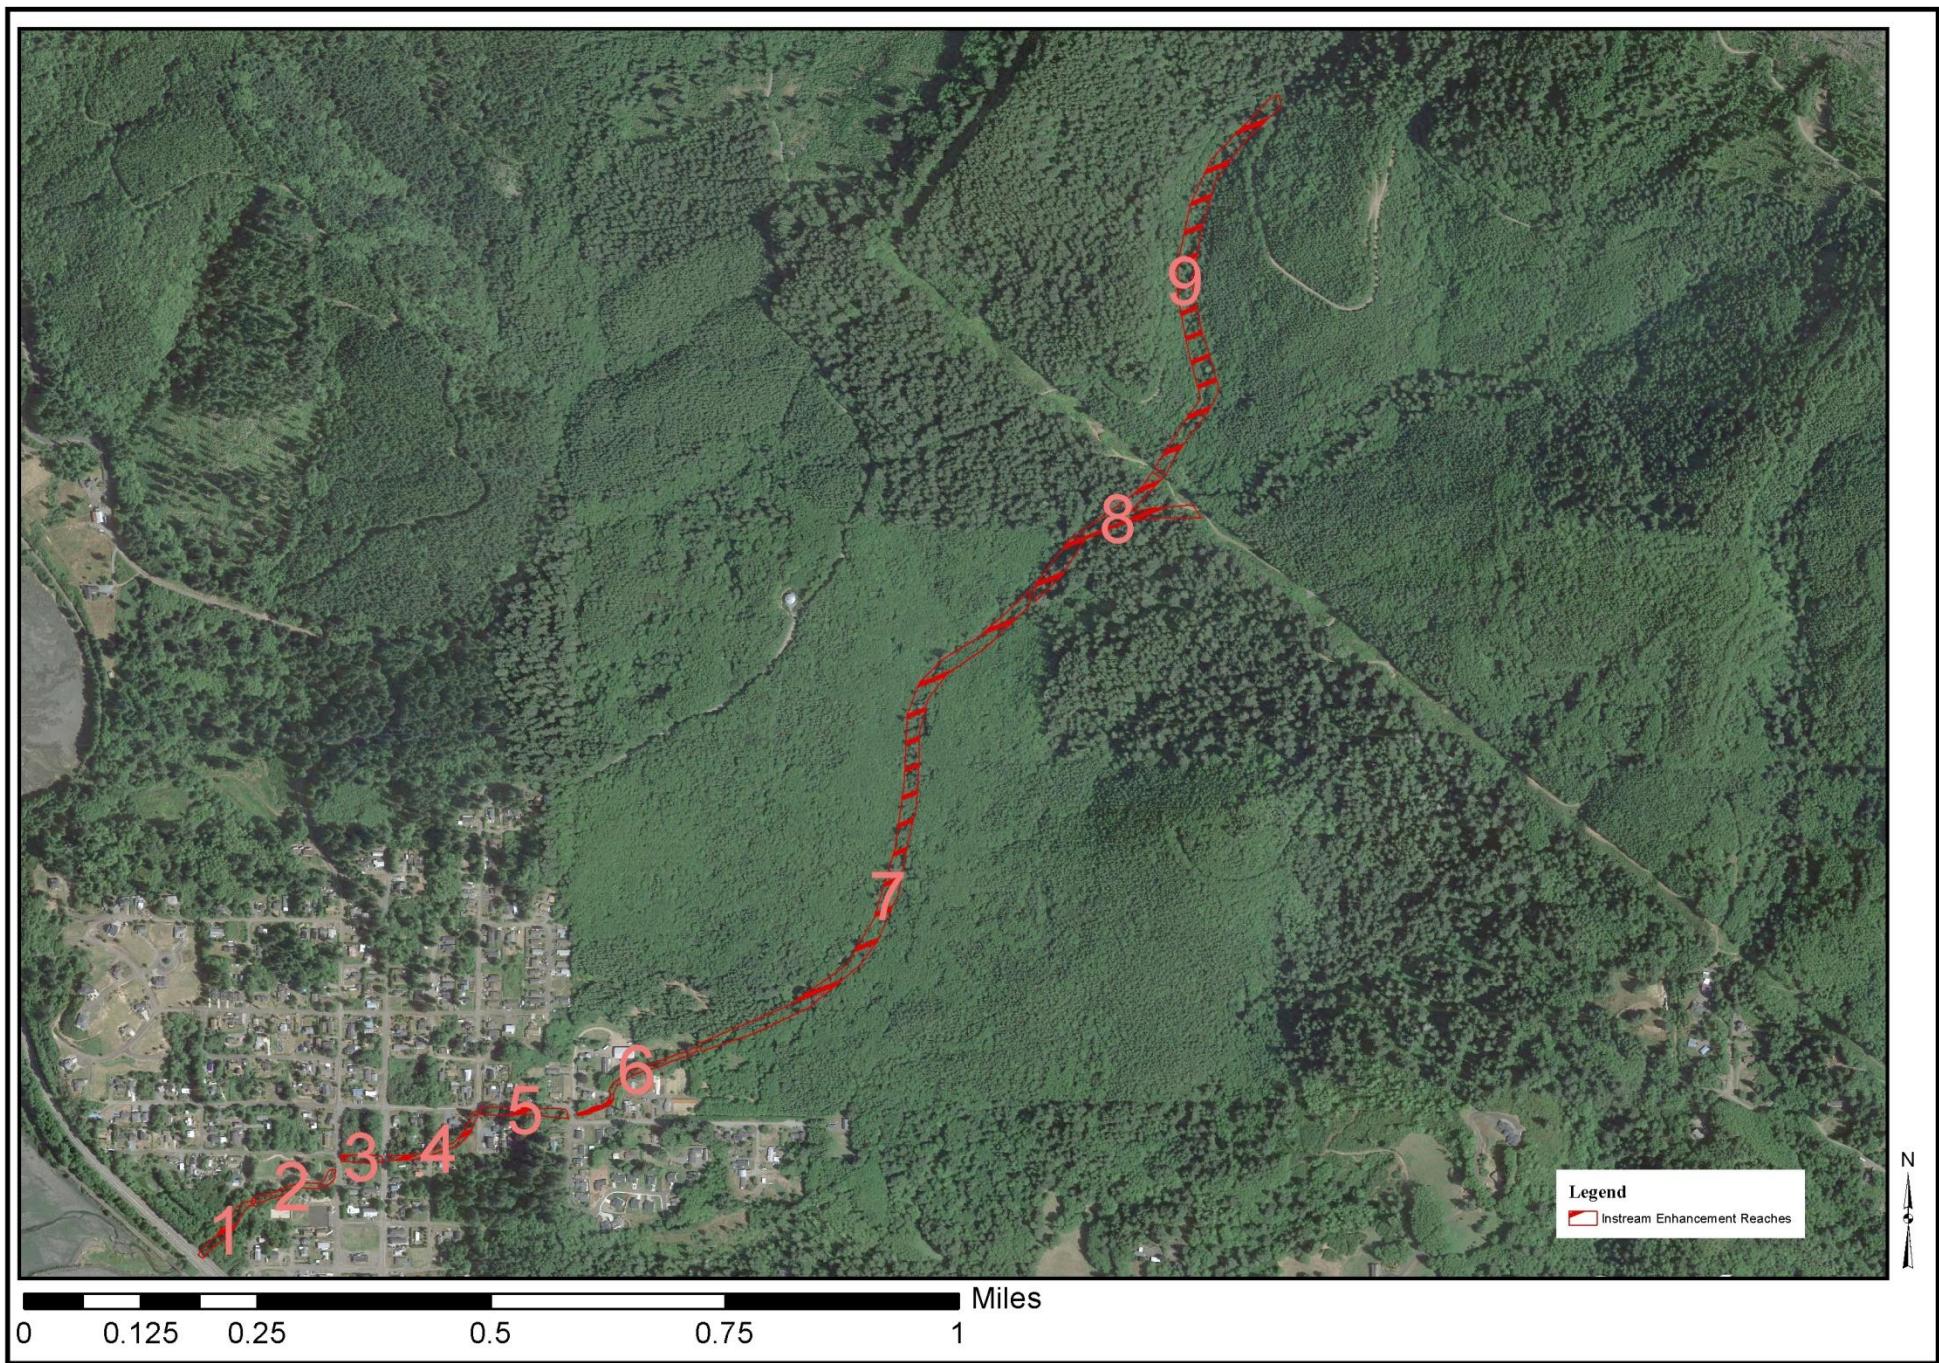
Figure 2. Aerial photograph depicting riparian enhancement planting evaluation reaches identified as part of the Patterson Creek Culverts Replacement Project, Tillamook County, Oregon.

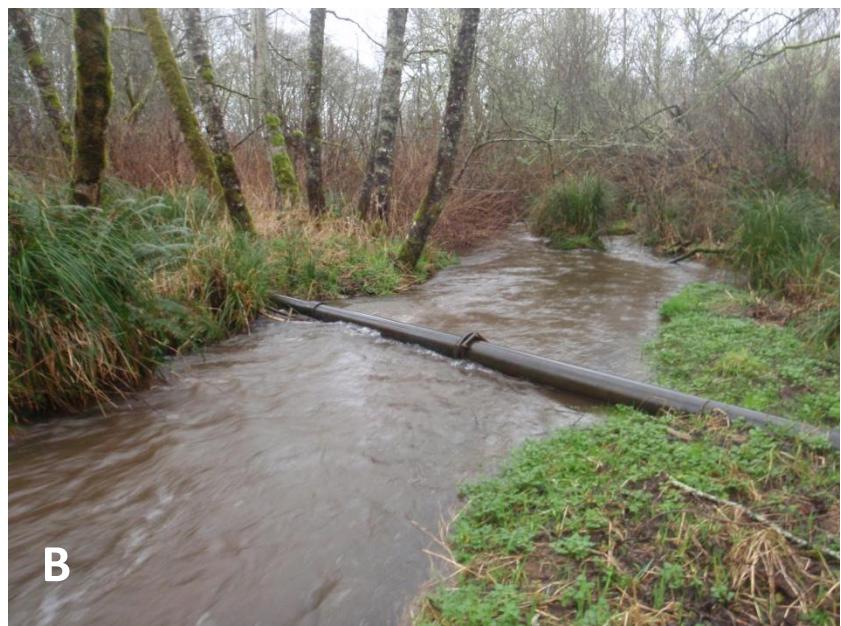
Reach 1

An approximately 10 inch diameter sewer mainline crosses the creek along this reach (Figure 3B). Where it crosses, the bottom of the pipe is at approximately bankfull elevation. On either side of the channel, the pipe runs just below the ground surface. It is within the floodplain for some distance on either side of the creek. To the south of the creek it appears to run somewhat parallel to the channel before leaving the floodplain (presumably running towards the Bay City wastewater treatment facility to the southwest).

- Embed and/ or reroute the city's sewer pipe that crosses the creek to alleviate stream flow interactions and the potential for catastrophic failure leading to a sewage release. Embedding the pipe would entail setting it below stream bed scour depth as determined from the stream profile and hydraulic analysis study work being done for this project.

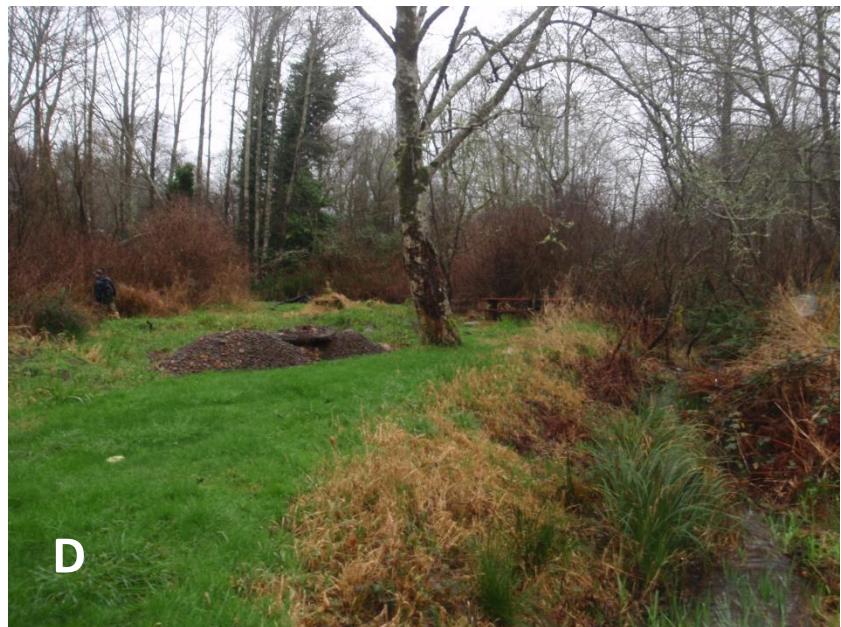
Reach 2

This reach is characterized by a low-gradient channel (1-2 percent) bounded by a mix of low terraces and somewhat higher terraces and gentle hill slopes. Floodplain connectivity is fair (but the floodplain is predominantly a manicured turf area), there are fair spawning gravels (although siltation appears to be a problem here too), bank erosion is variable (some areas are gently sloping and vegetated while others are steeply eroding -See Figure 3E) and there is no side channel development. One apparent storm drain culvert confluences with the creek along this reach, but there are no open channel tributaries. Riparian vegetation along this reach is dominated by turf grass and lacks the diversity and structure of healthy riparian environments (a few large senescent alders are scattered along this reach). Consequently, there is no in-stream large wood along this

reach and little opportunity for large wood recruitment here. There are a few large chunks of concrete in the channel that appear to be functioning as de facto boulders in that they are providing some much-needed in-stream structure.

- 1) The natural topography at the tributary junction located at the downstream end of this reach makes this an ideal location to create an off-channel habitat complex. Potential actions in this area could include limited excavation to increase water depth, installation of large woody debris and wetland and riparian vegetation plantings. See Figure 3D.

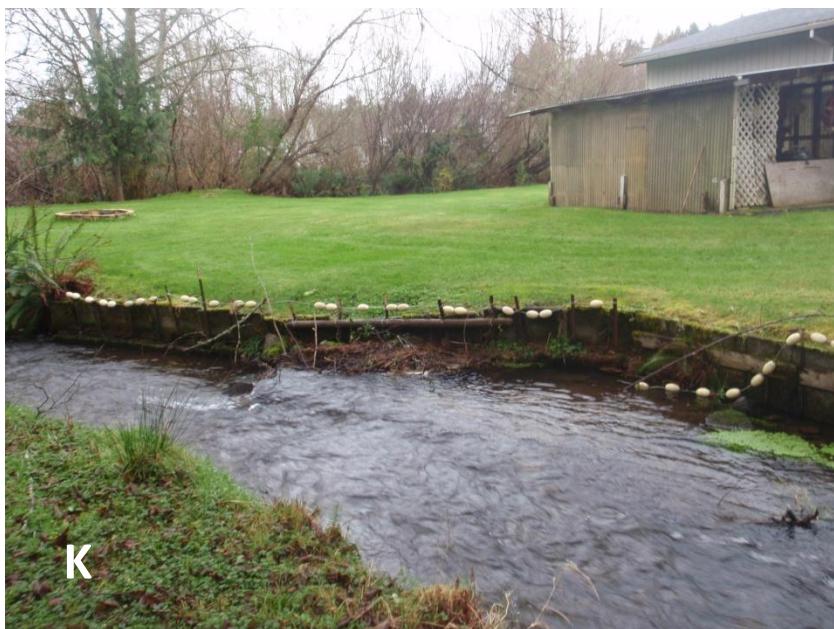
Reach 4

There has been some unusual bank protection work done along this reach incorporating small slabs of concrete, lumber and other materials, held in place by t-posts and rebar (see Figure 3K). This work appears to have been completed in an attempt to preserve the current configuration of the Patterson and Jacoby creeks confluence and to reduce erosion of upland property.

- 2) Just upstream of the current Patterson Creek / Jacoby Creek confluence there appears to be opportunity to reroute/ reconnect Patterson creek into a relic channel and restore natural channel meander, potentially eliminating bank erosion along the heavily rip-rapped/ manicured stream bank of the home perched above the north bank of Patterson Creek at this location. Moving the Patterson Creek channel into Jacoby creek at this location may also allow for riparian vegetation to establish along both sides of the stream channel rather than the current configuration where it occurs along only a single side.
