Appendix A

Graphs depicting water levels at Miami Wetlands from March 2008 through February 2017

Miami Wetlands Restoration Site

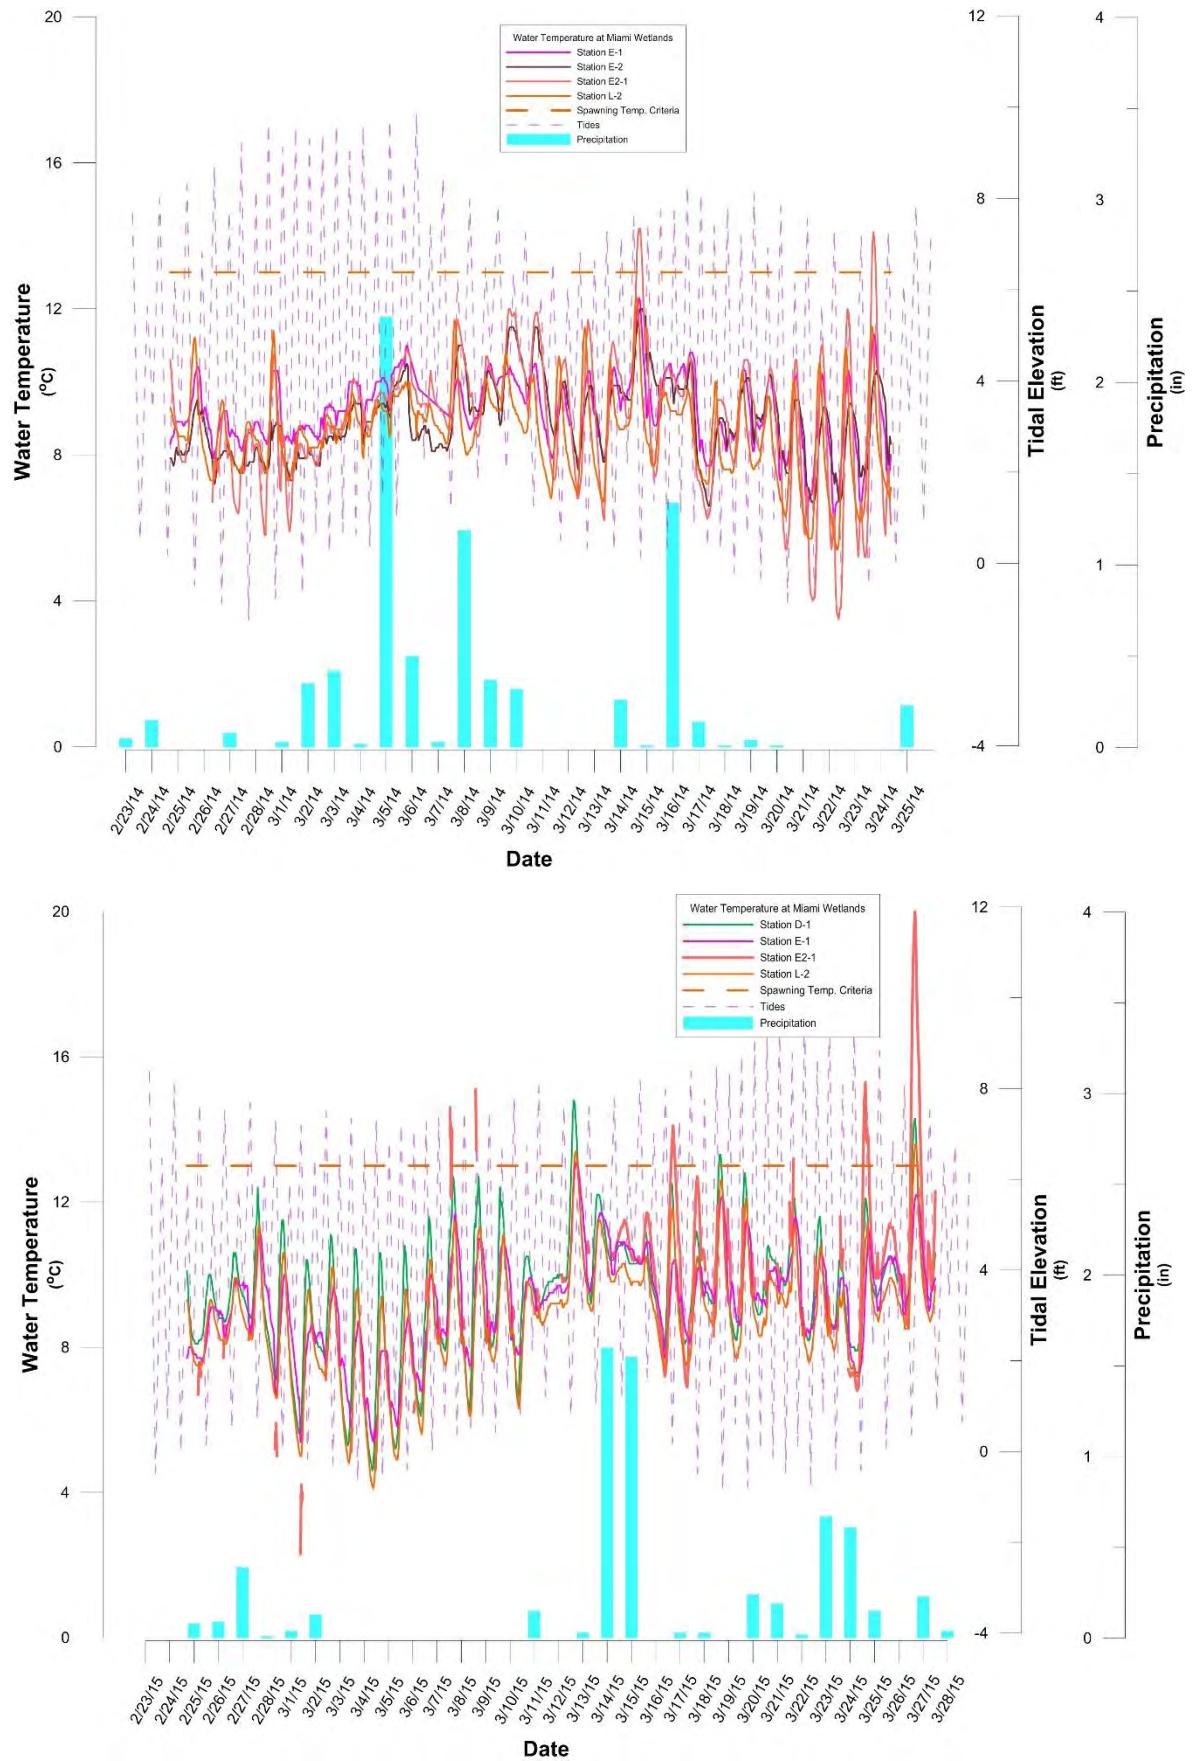
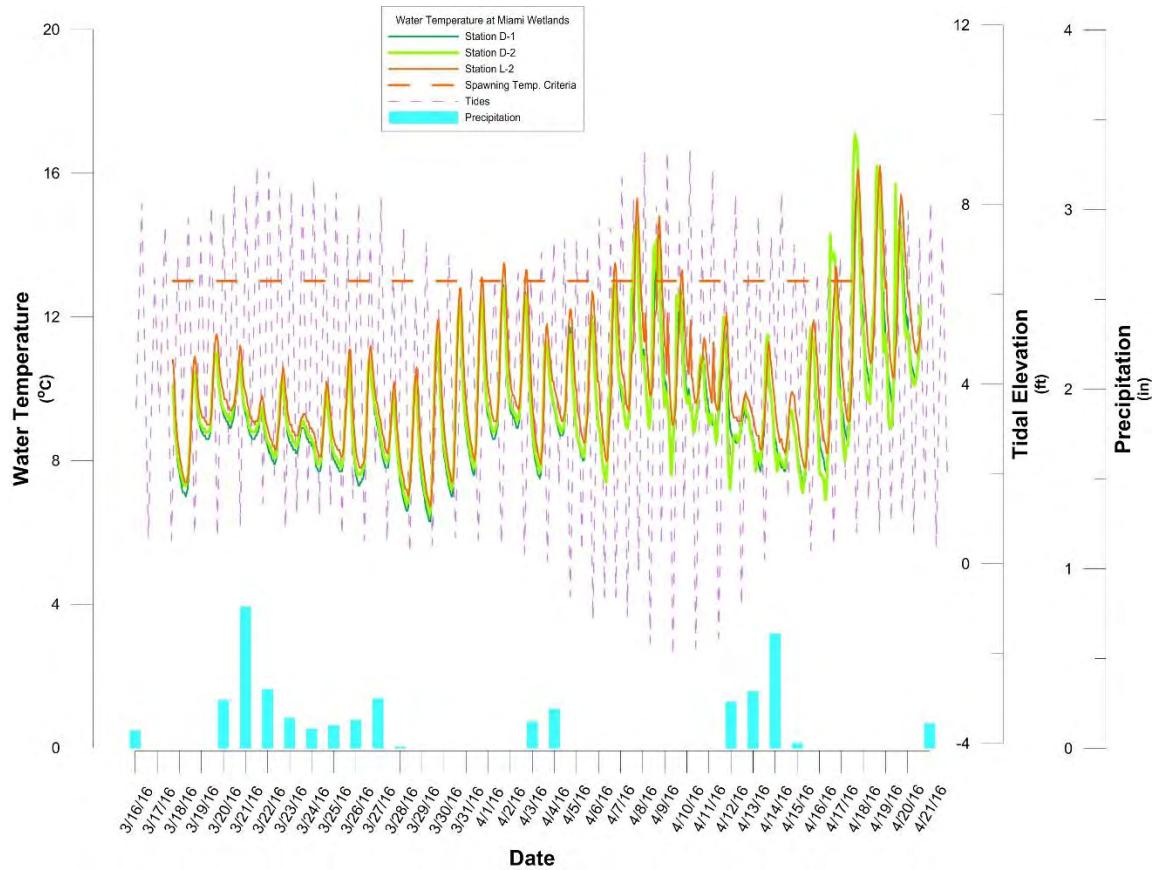
Figure C1. Graphs depicting post-restoration water temperatures in constructed channels at the Miami Wetlands during spring 2012-2016. Precipitation and tidal data also included. Discontinuous lines indicate missing data due to low water levels.

Figure C1. continued

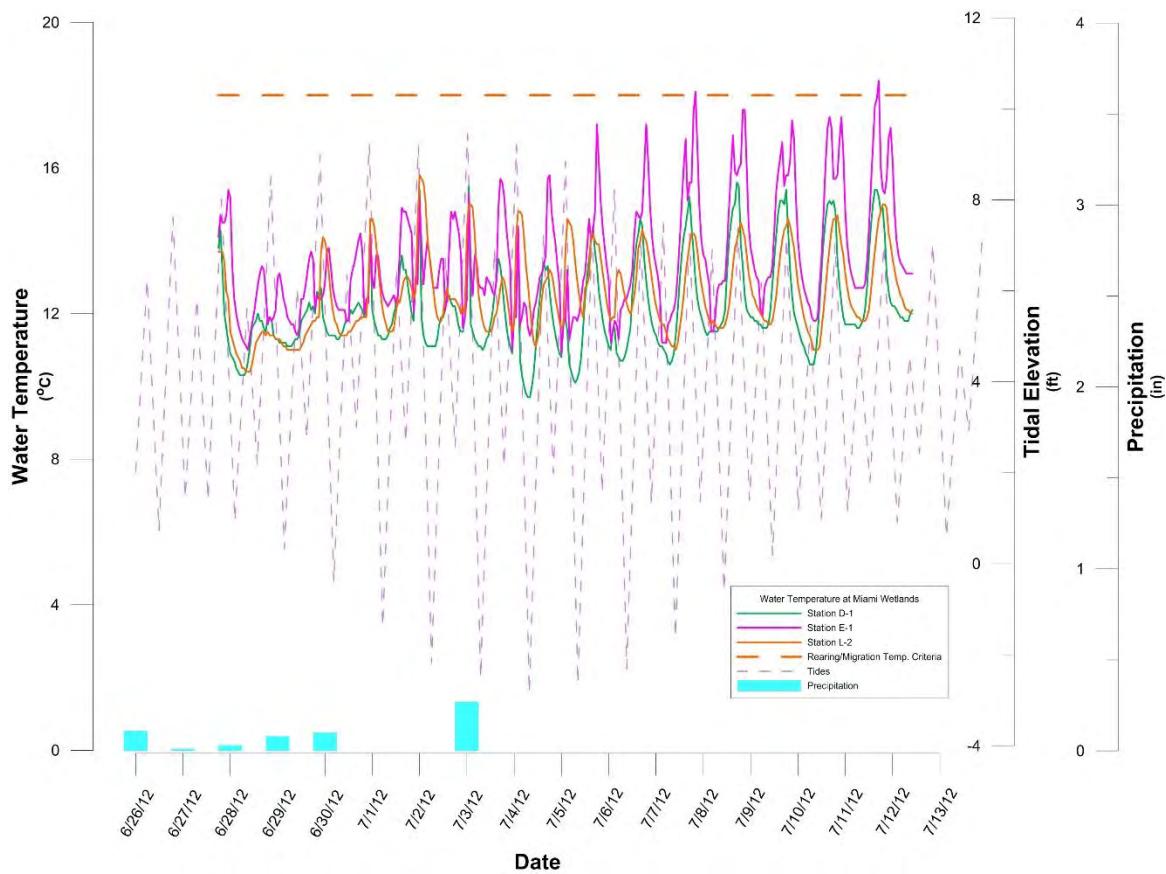
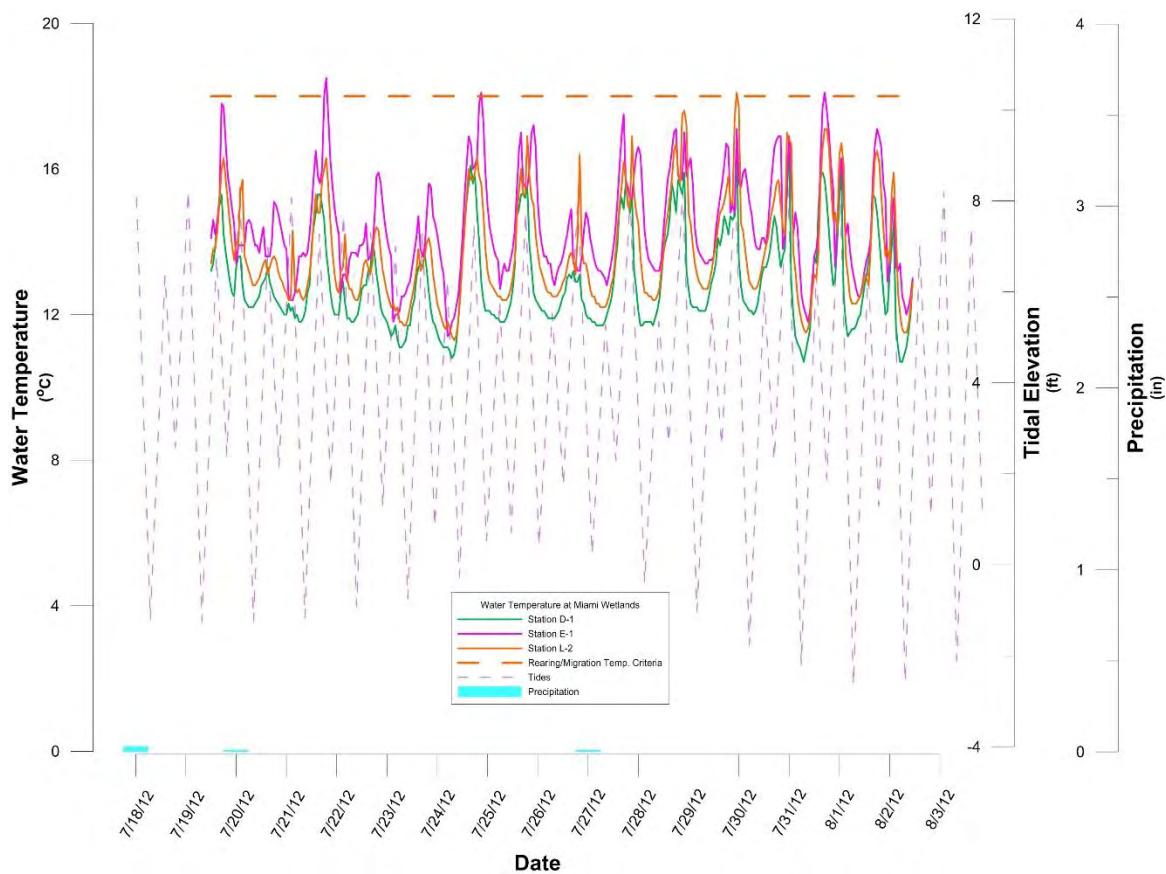
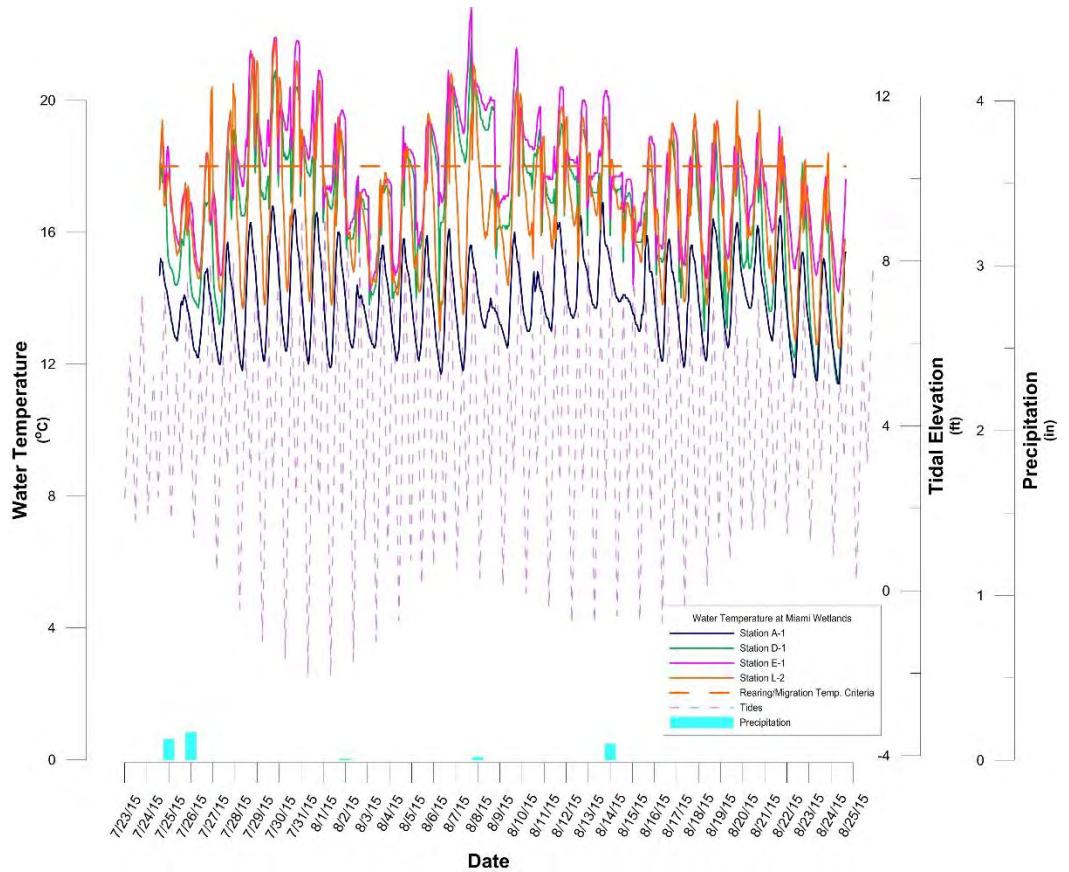
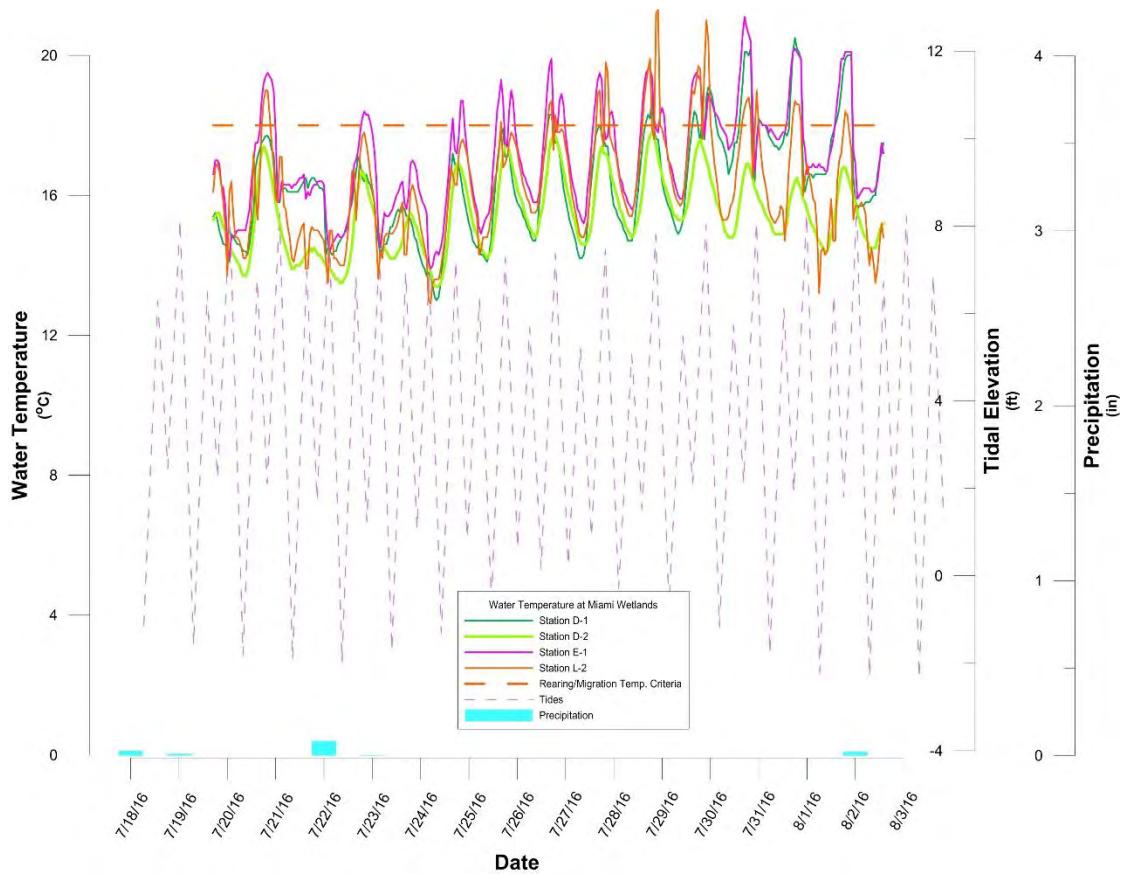
Figure C2. Graphs depicting post-restoration water temperatures in constructed channels at the Miami Wetlands during summer 2012-2016. Precipitation and tidal data also included. Discontinuous lines indicate missing data due to low water levels.

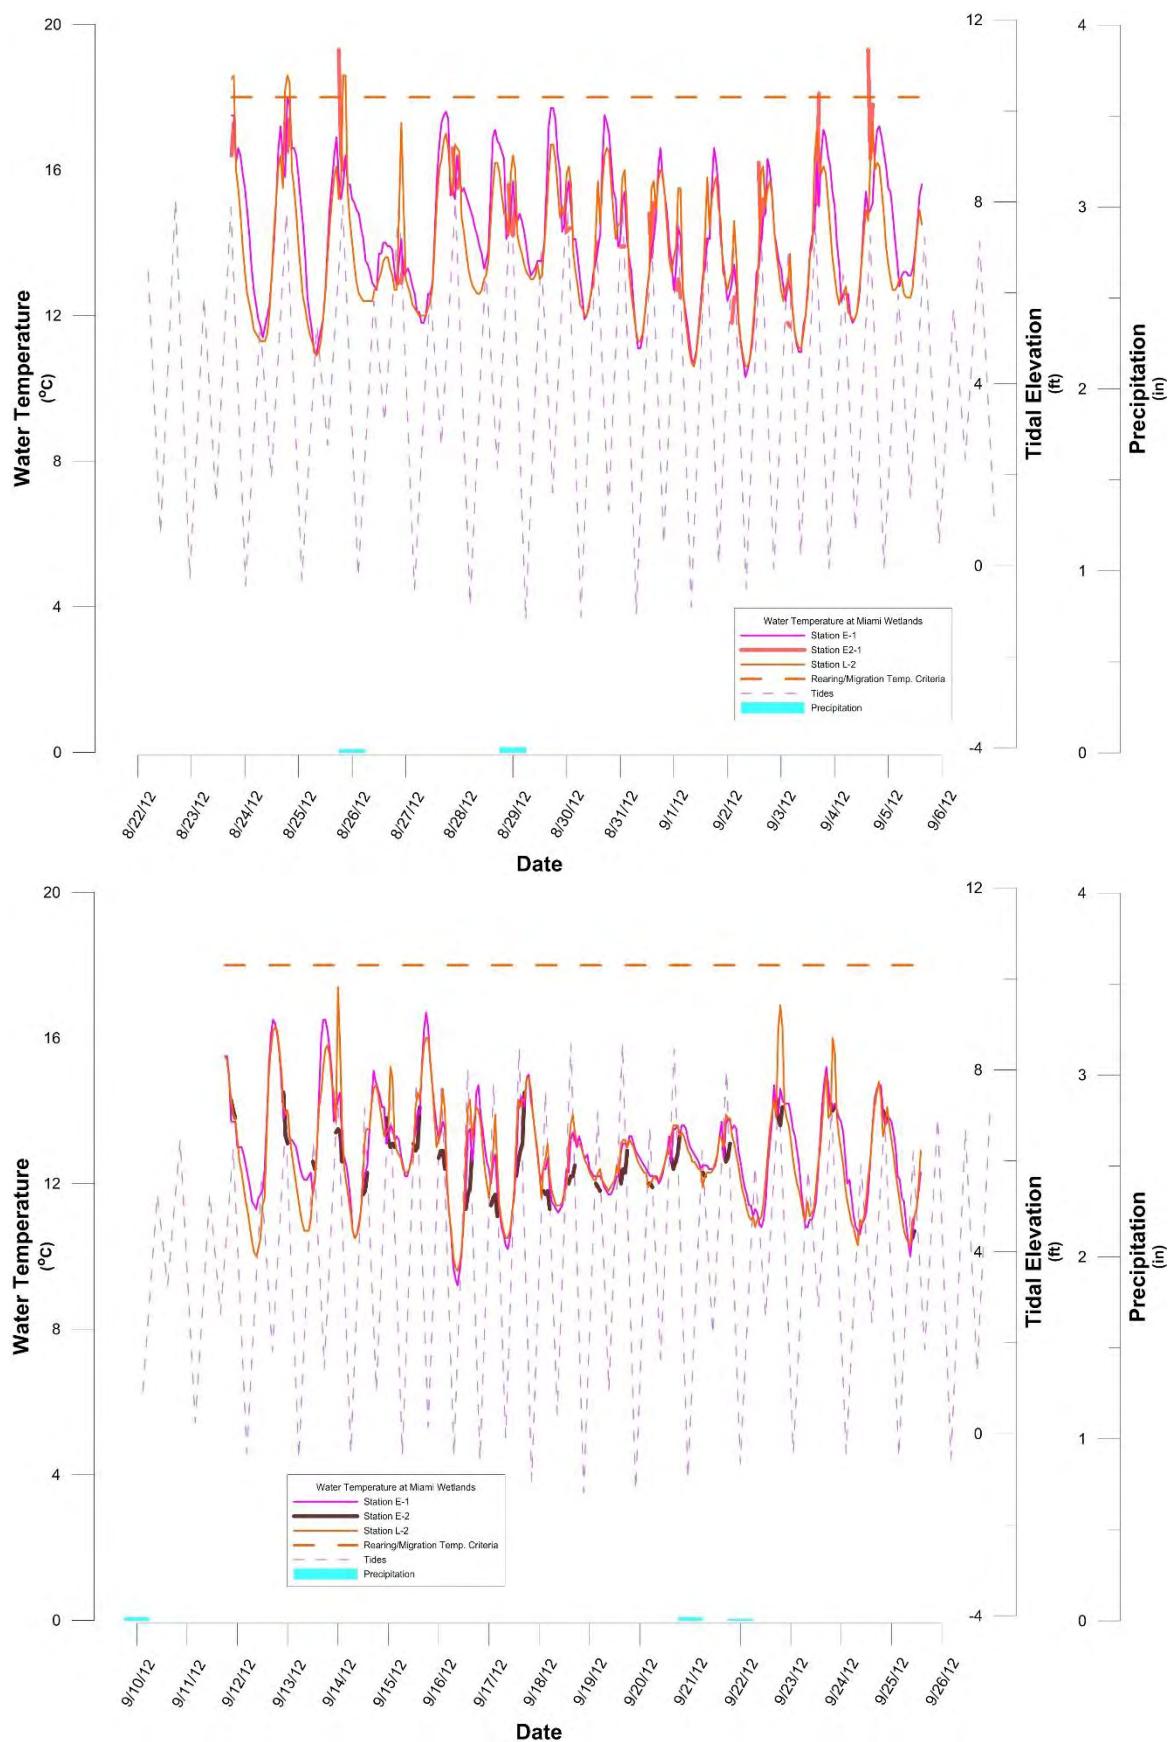
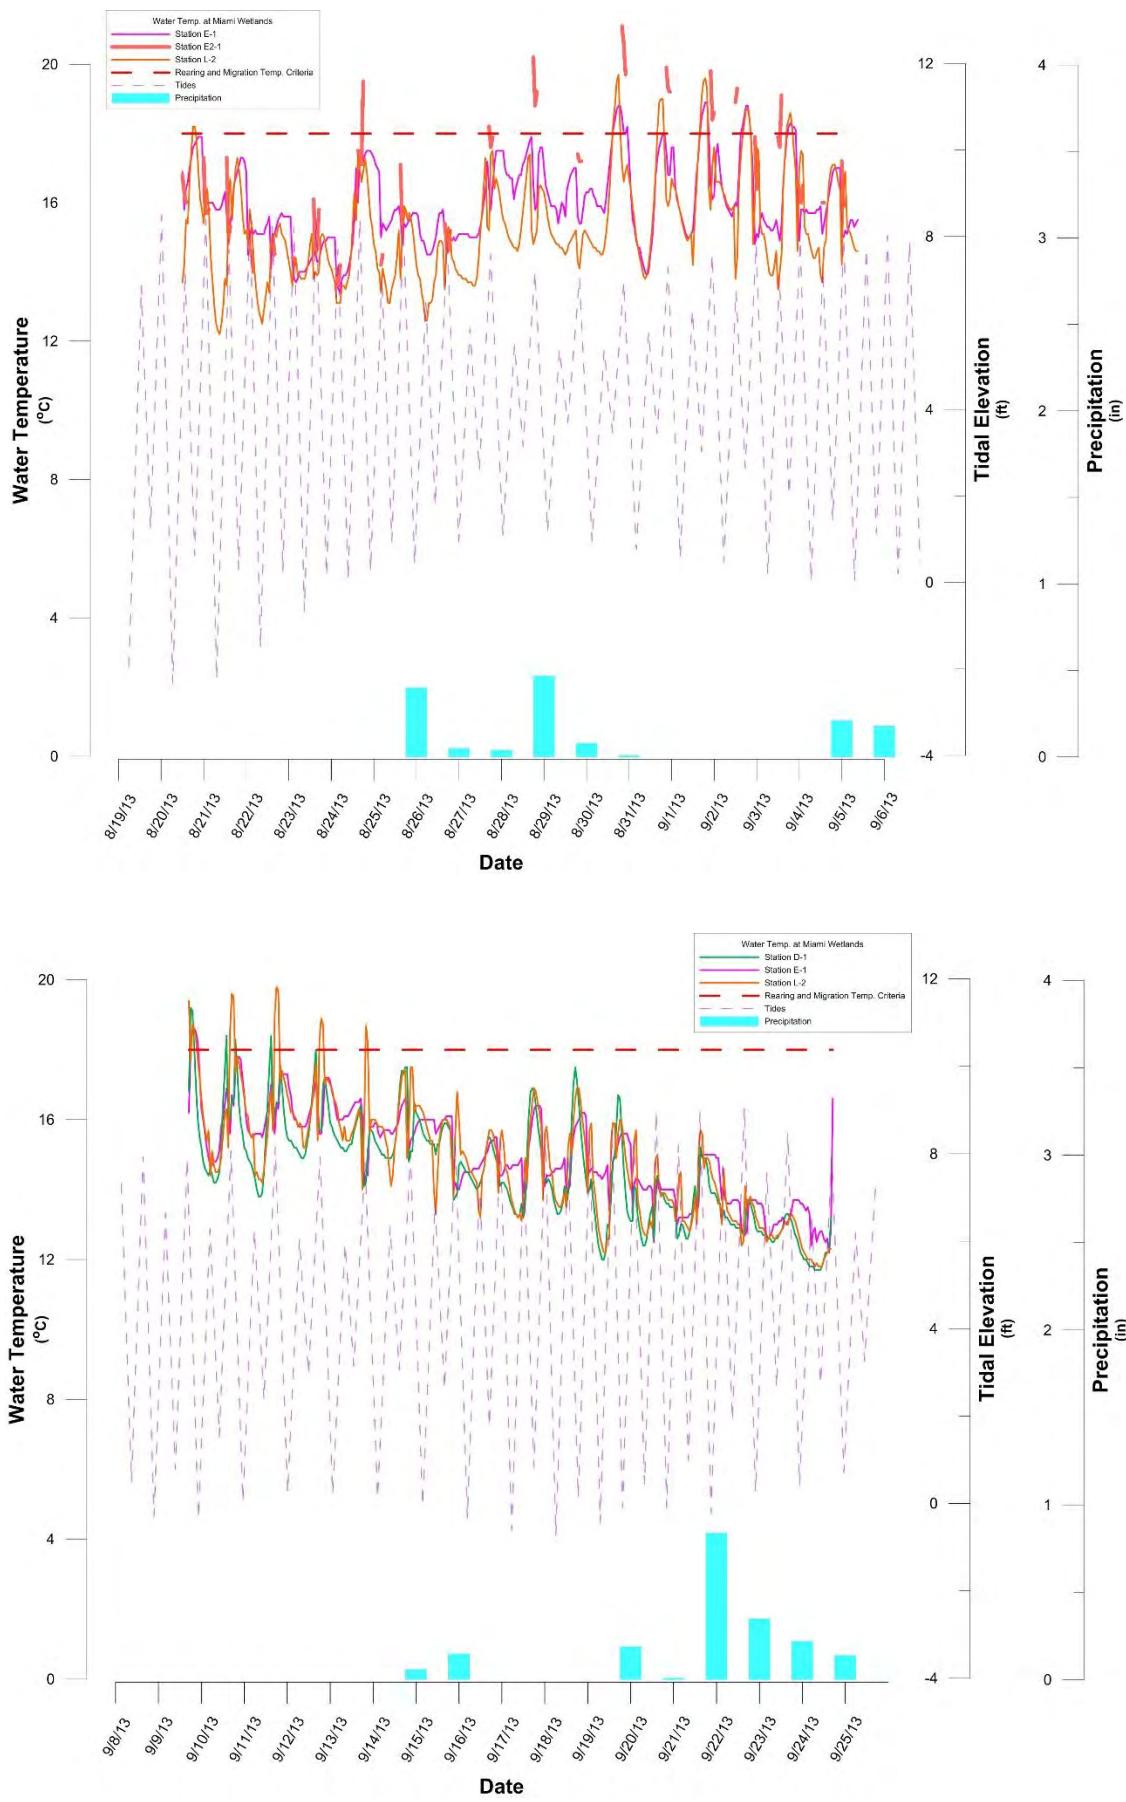
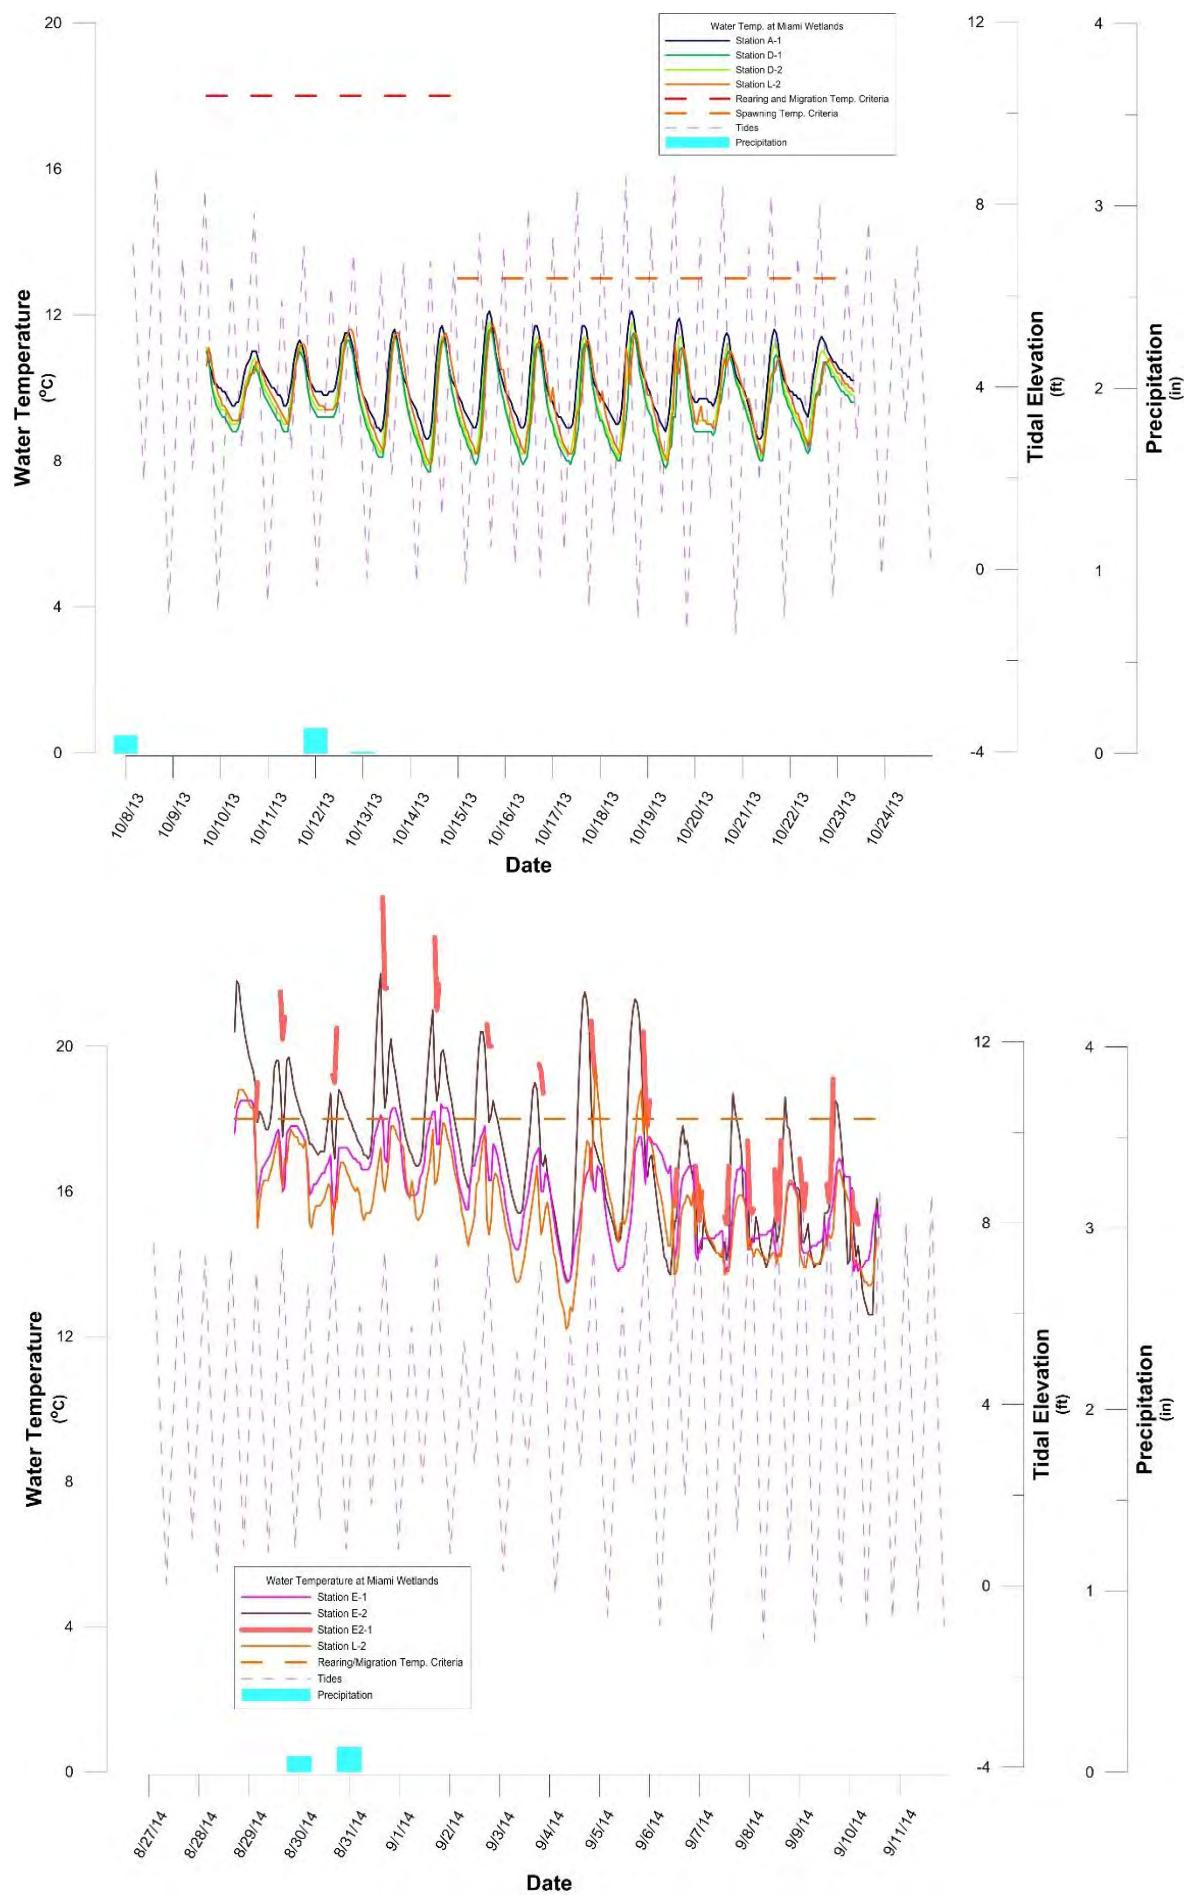
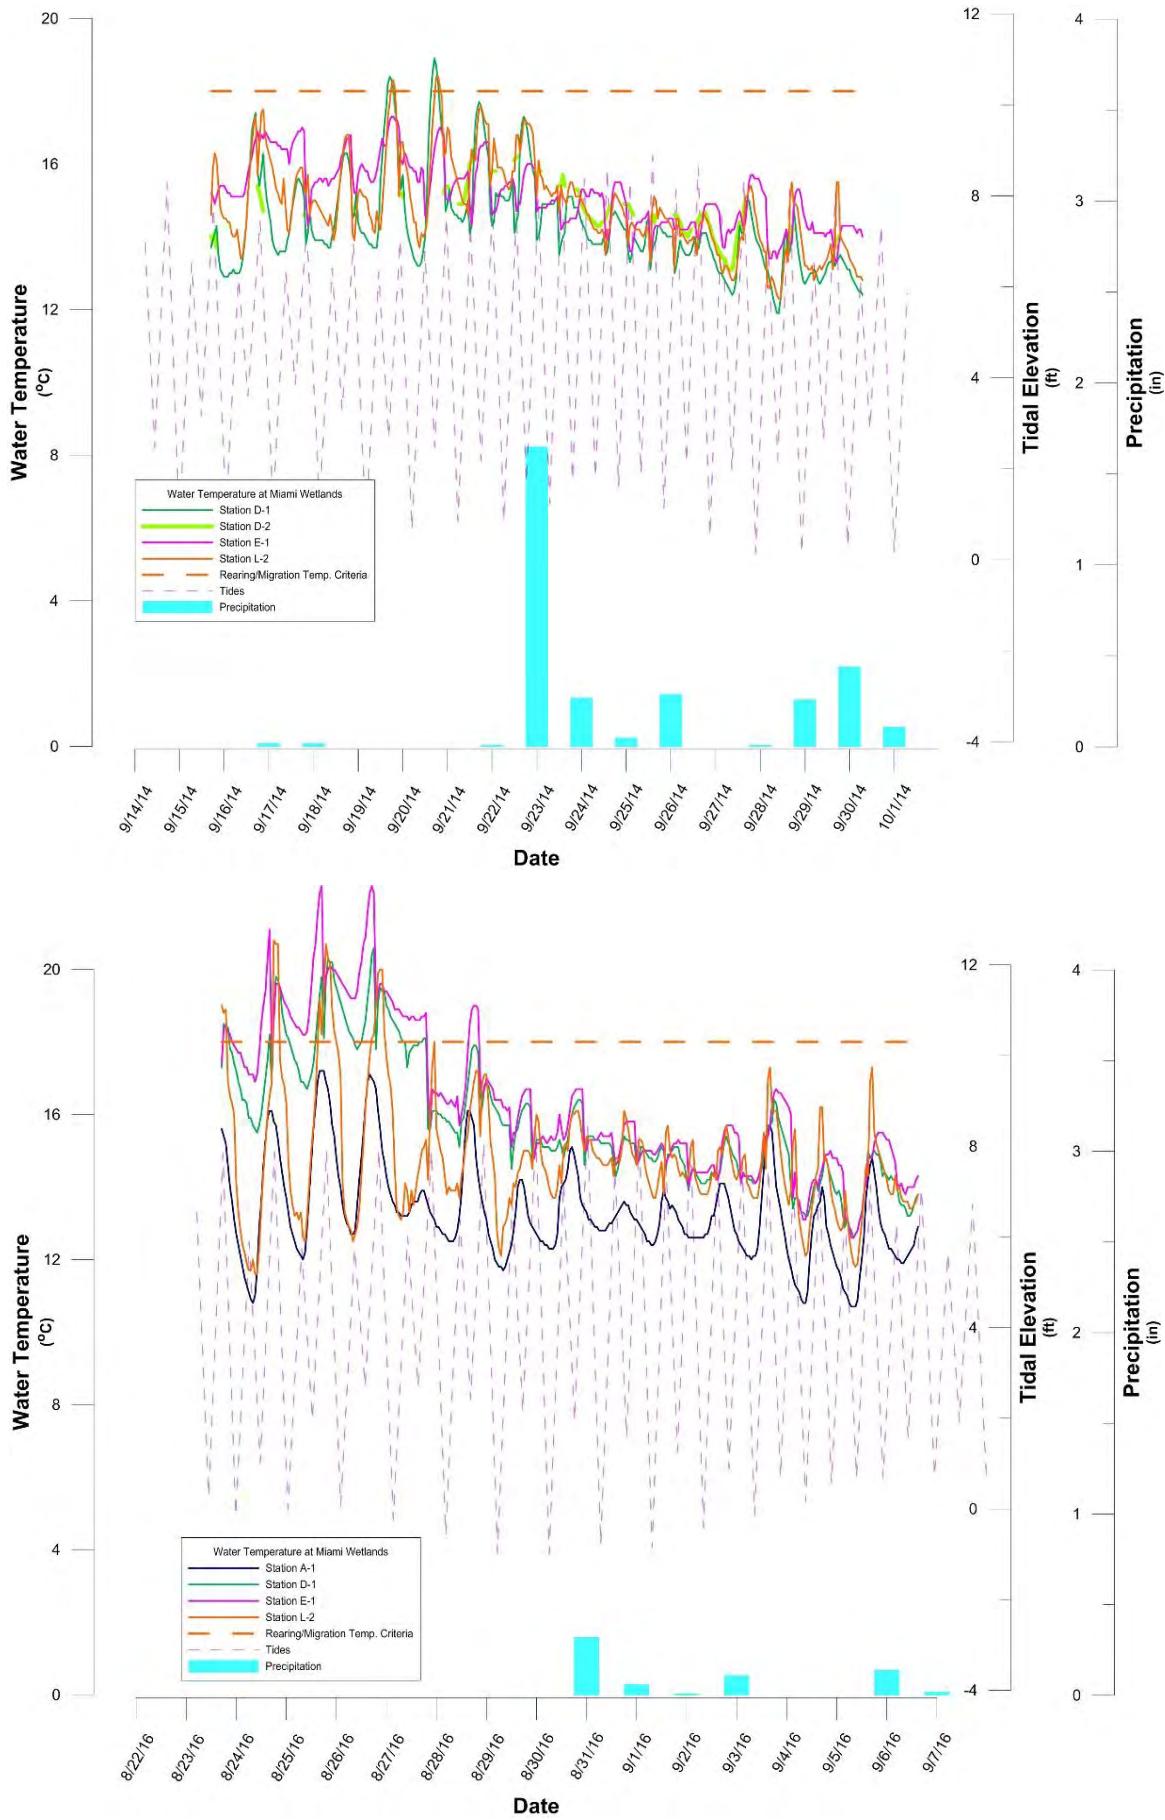
Figure C3. Graphs depicting post-restoration water temperatures in constructed channels at the Miami Wetlands during fall 2012-2016. Precipitation and tidal data also included. Discontinuous lines indicate missing data due to low water levels.

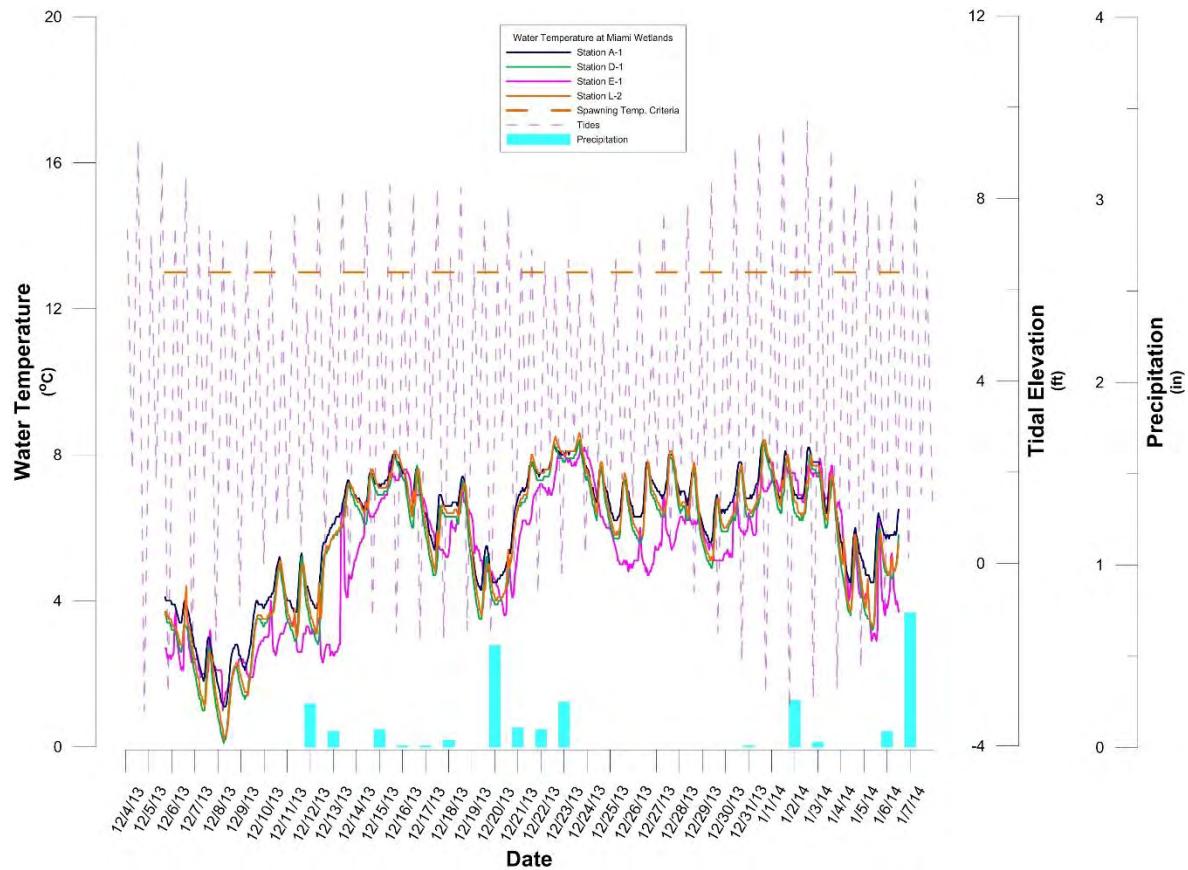
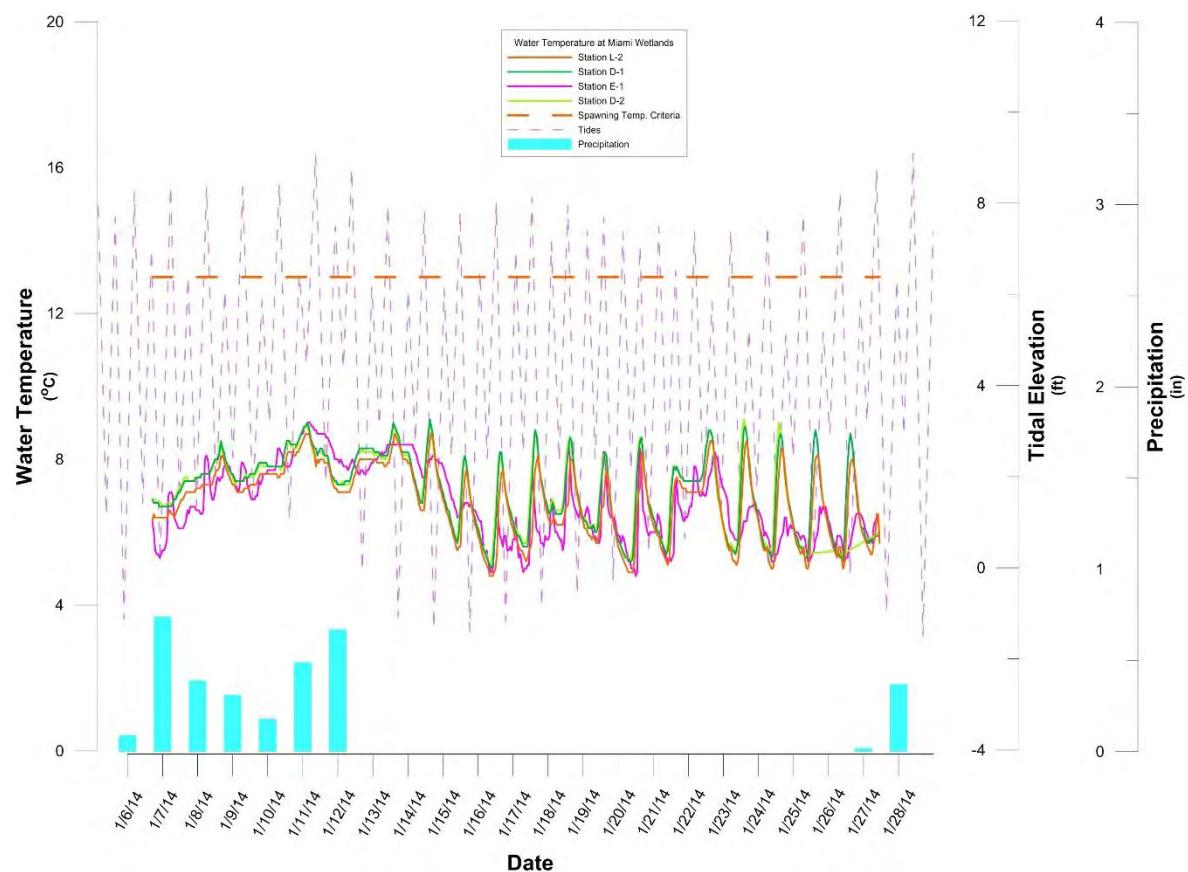
Figure C4. Graphs depicting post-restoration water temperatures in constructed channels at the Miami Wetlands during winter 2012-2016. Precipitation and tidal data also included. Discontinuous lines indicate missing data due to low water levels.

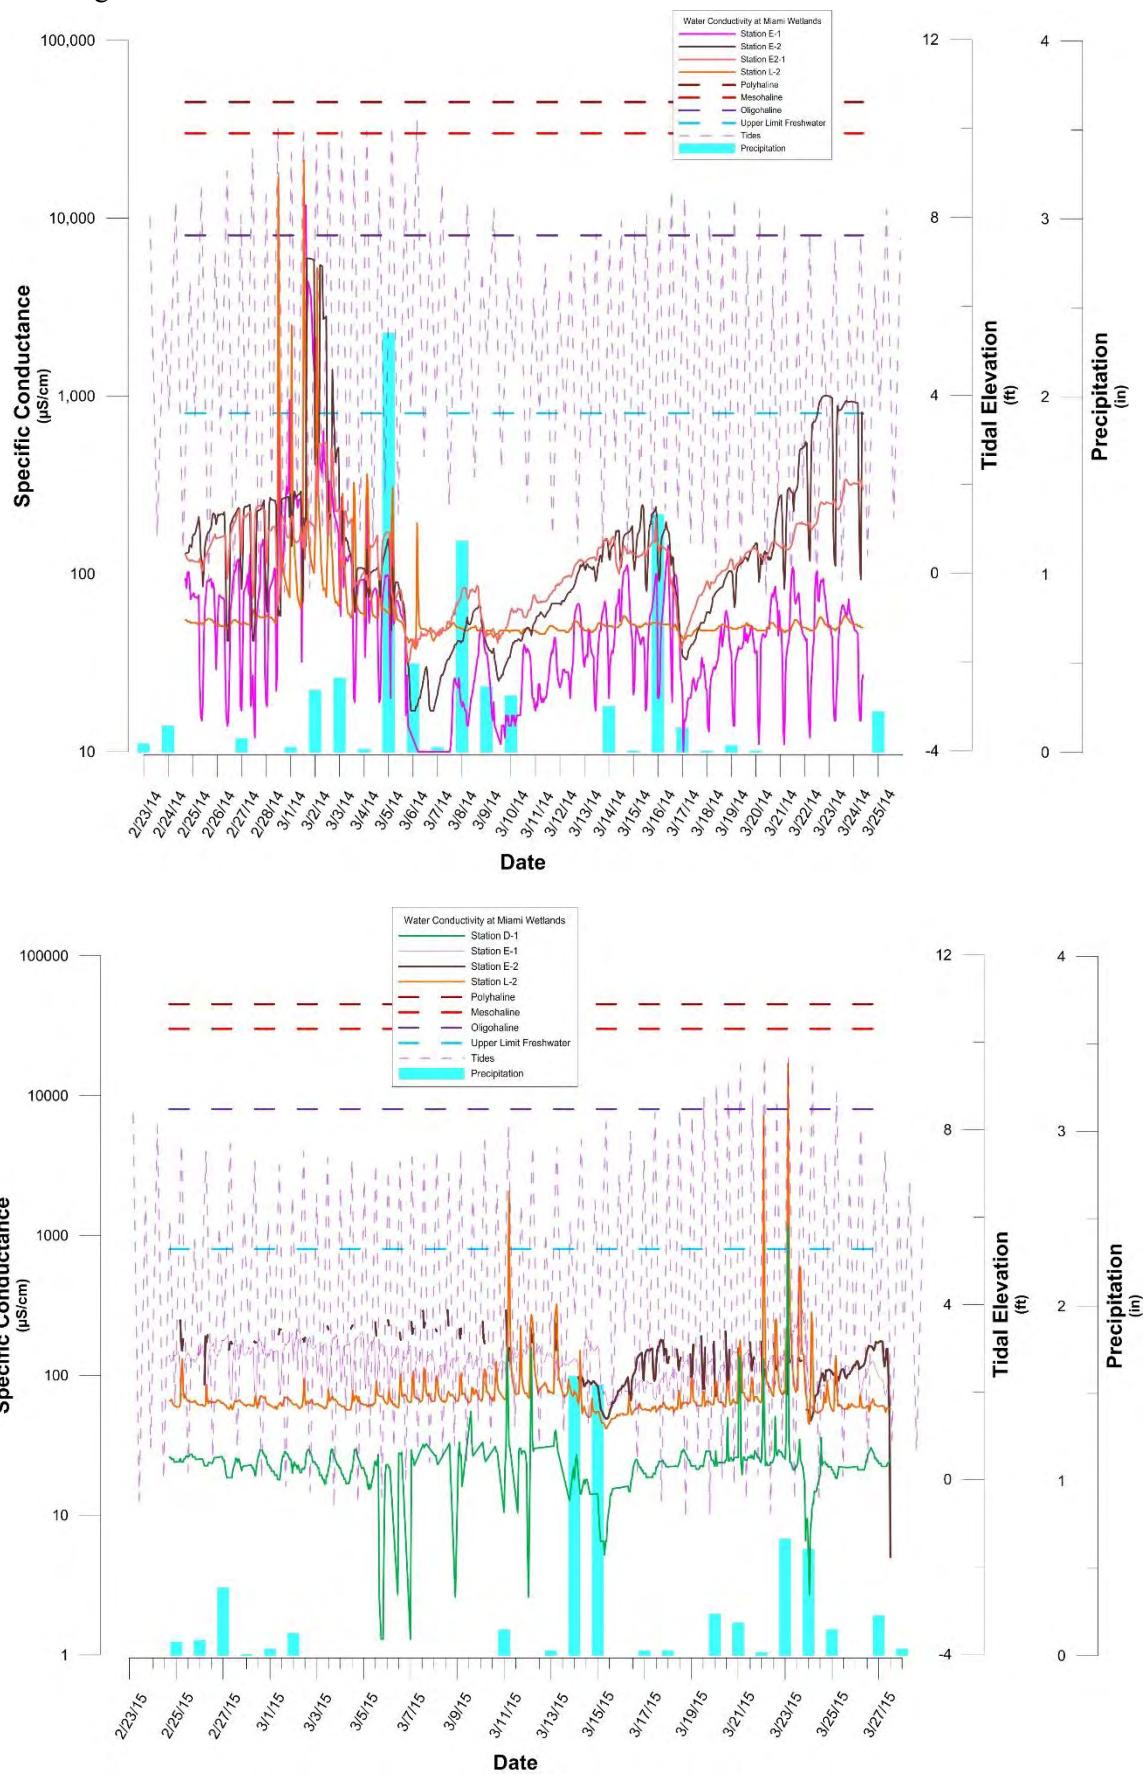
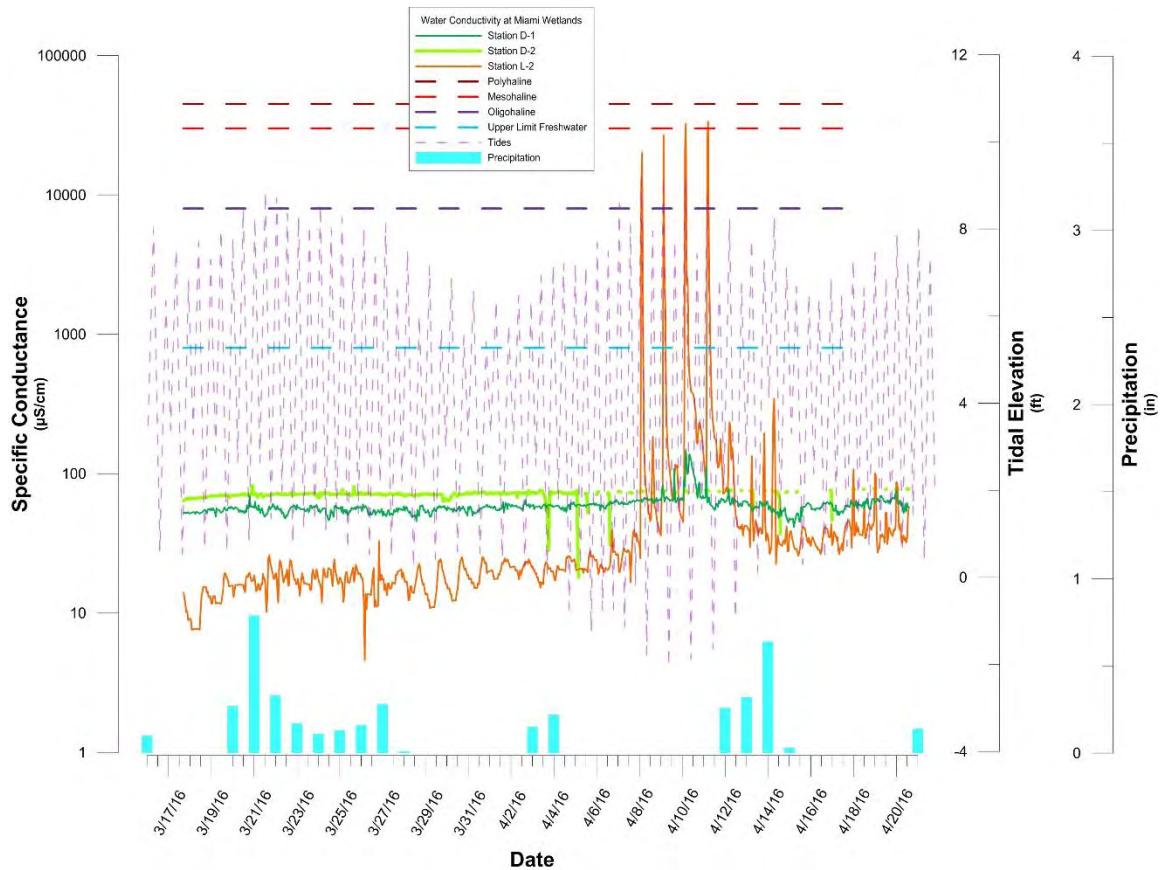
Figure D1. Graphs depicting post-restoration specific conductance levels in constructed channels at the Miami Wetlands during spring 2012-2016. Precipitation and tidal data also included. Discontinuous lines indicate missing data due to low water levels.
