Appendix A

Graphs depicting water levels at Miami Wetlands from March 2008 through February 2017

Miami Wetlands Restoration Site

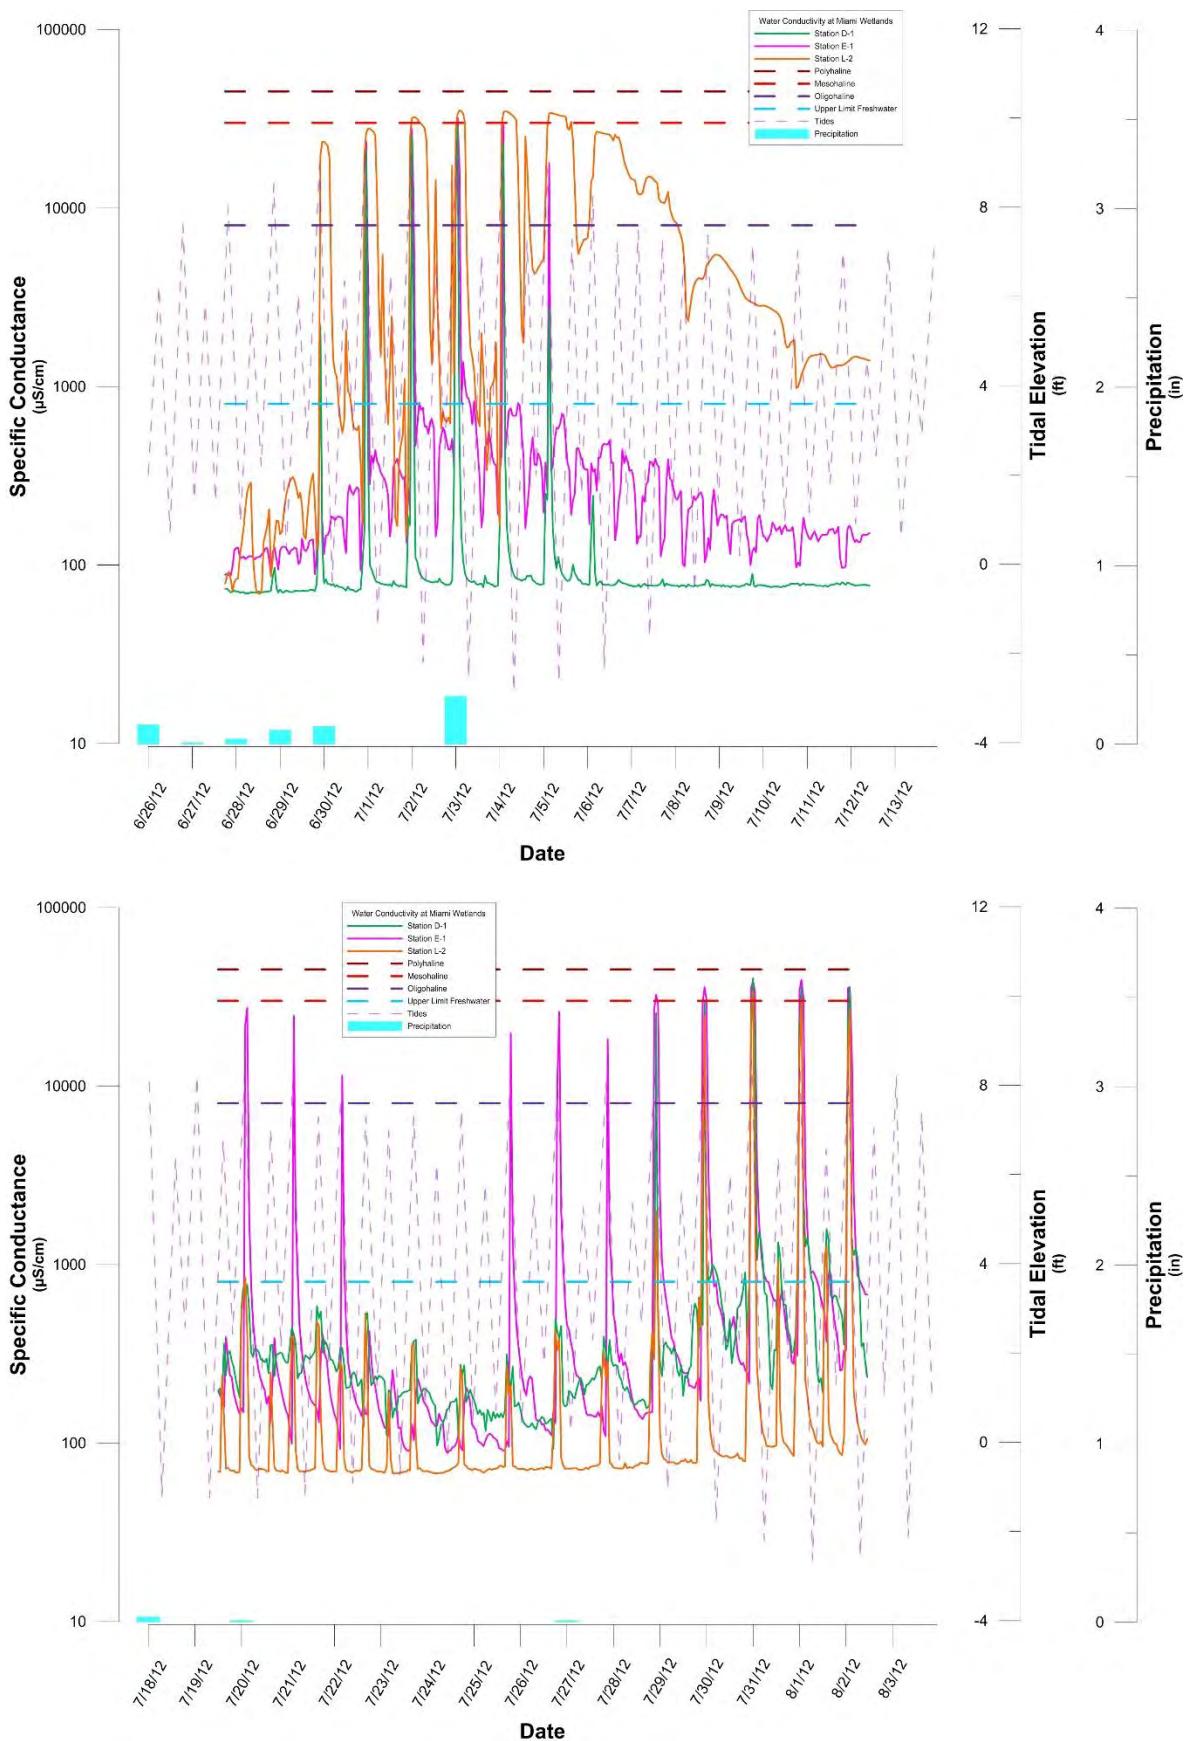
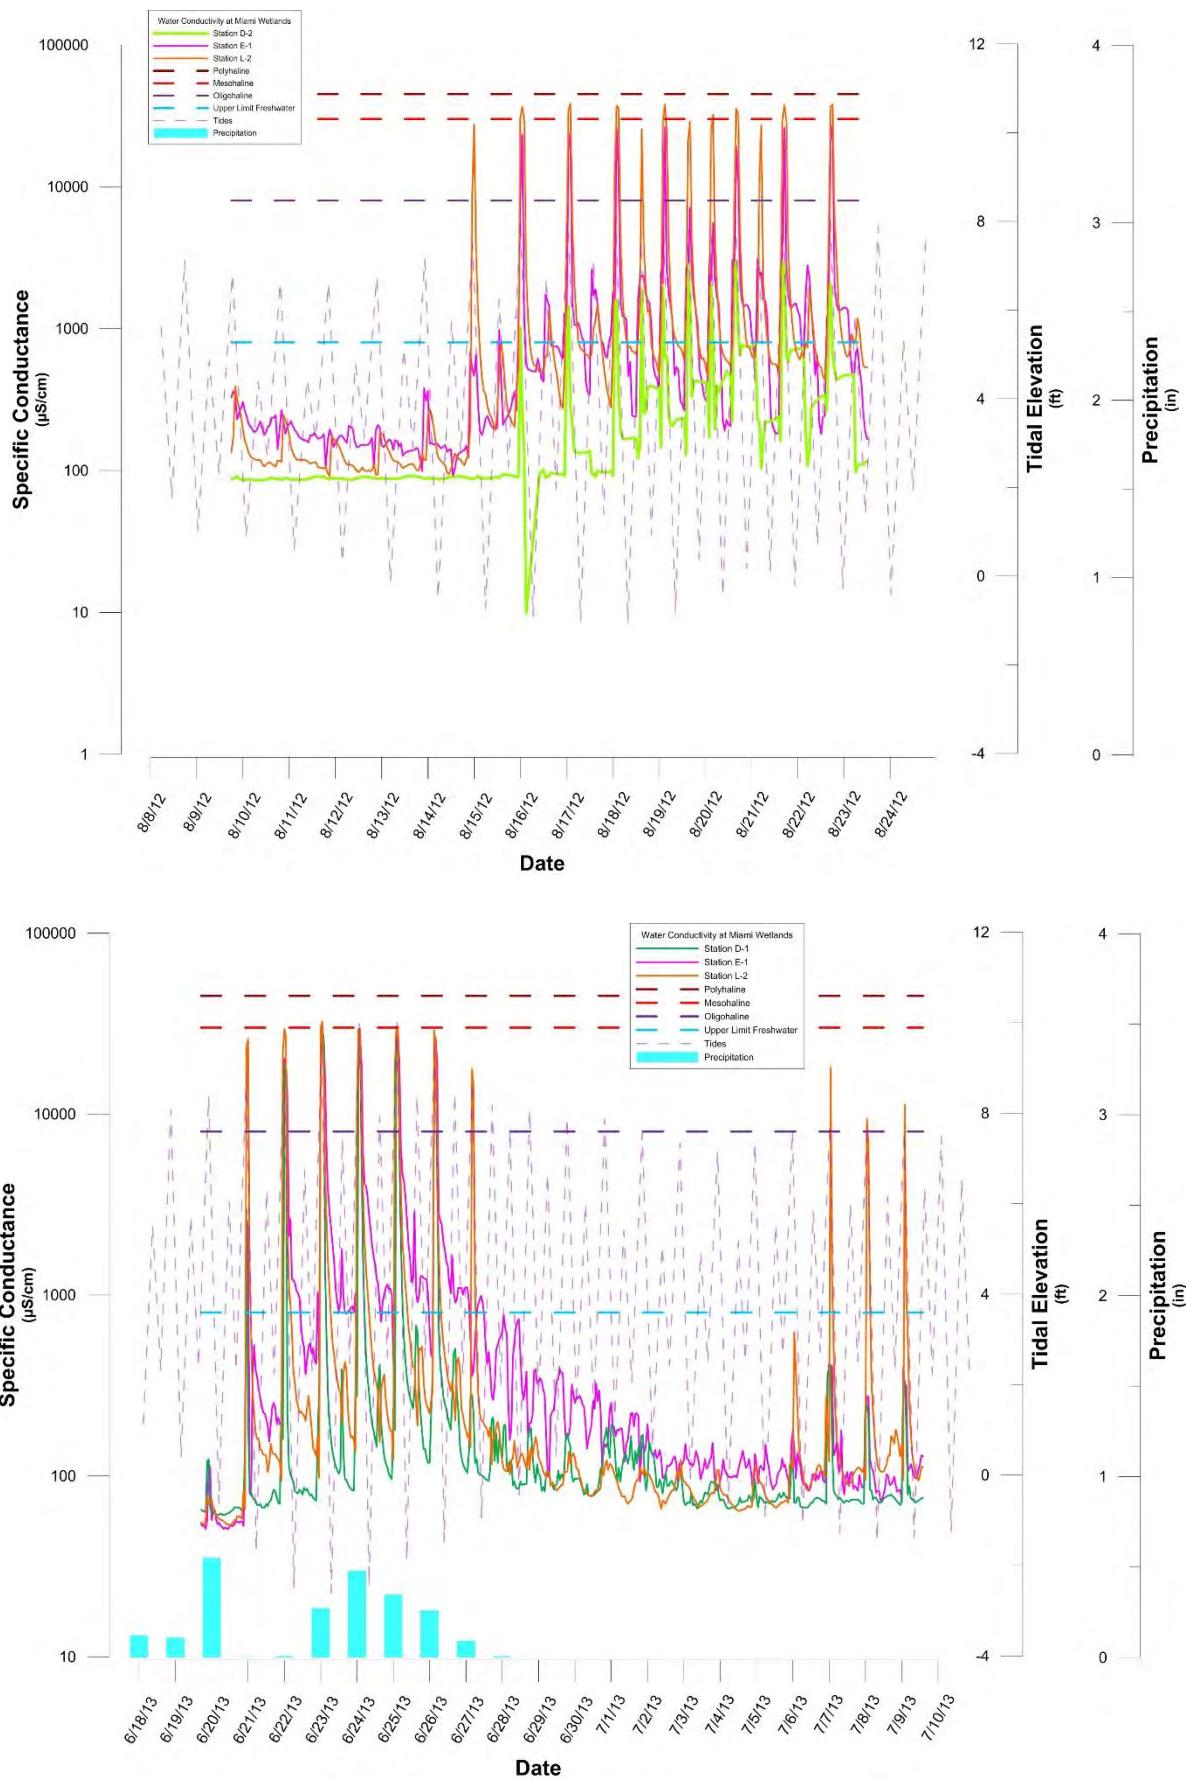
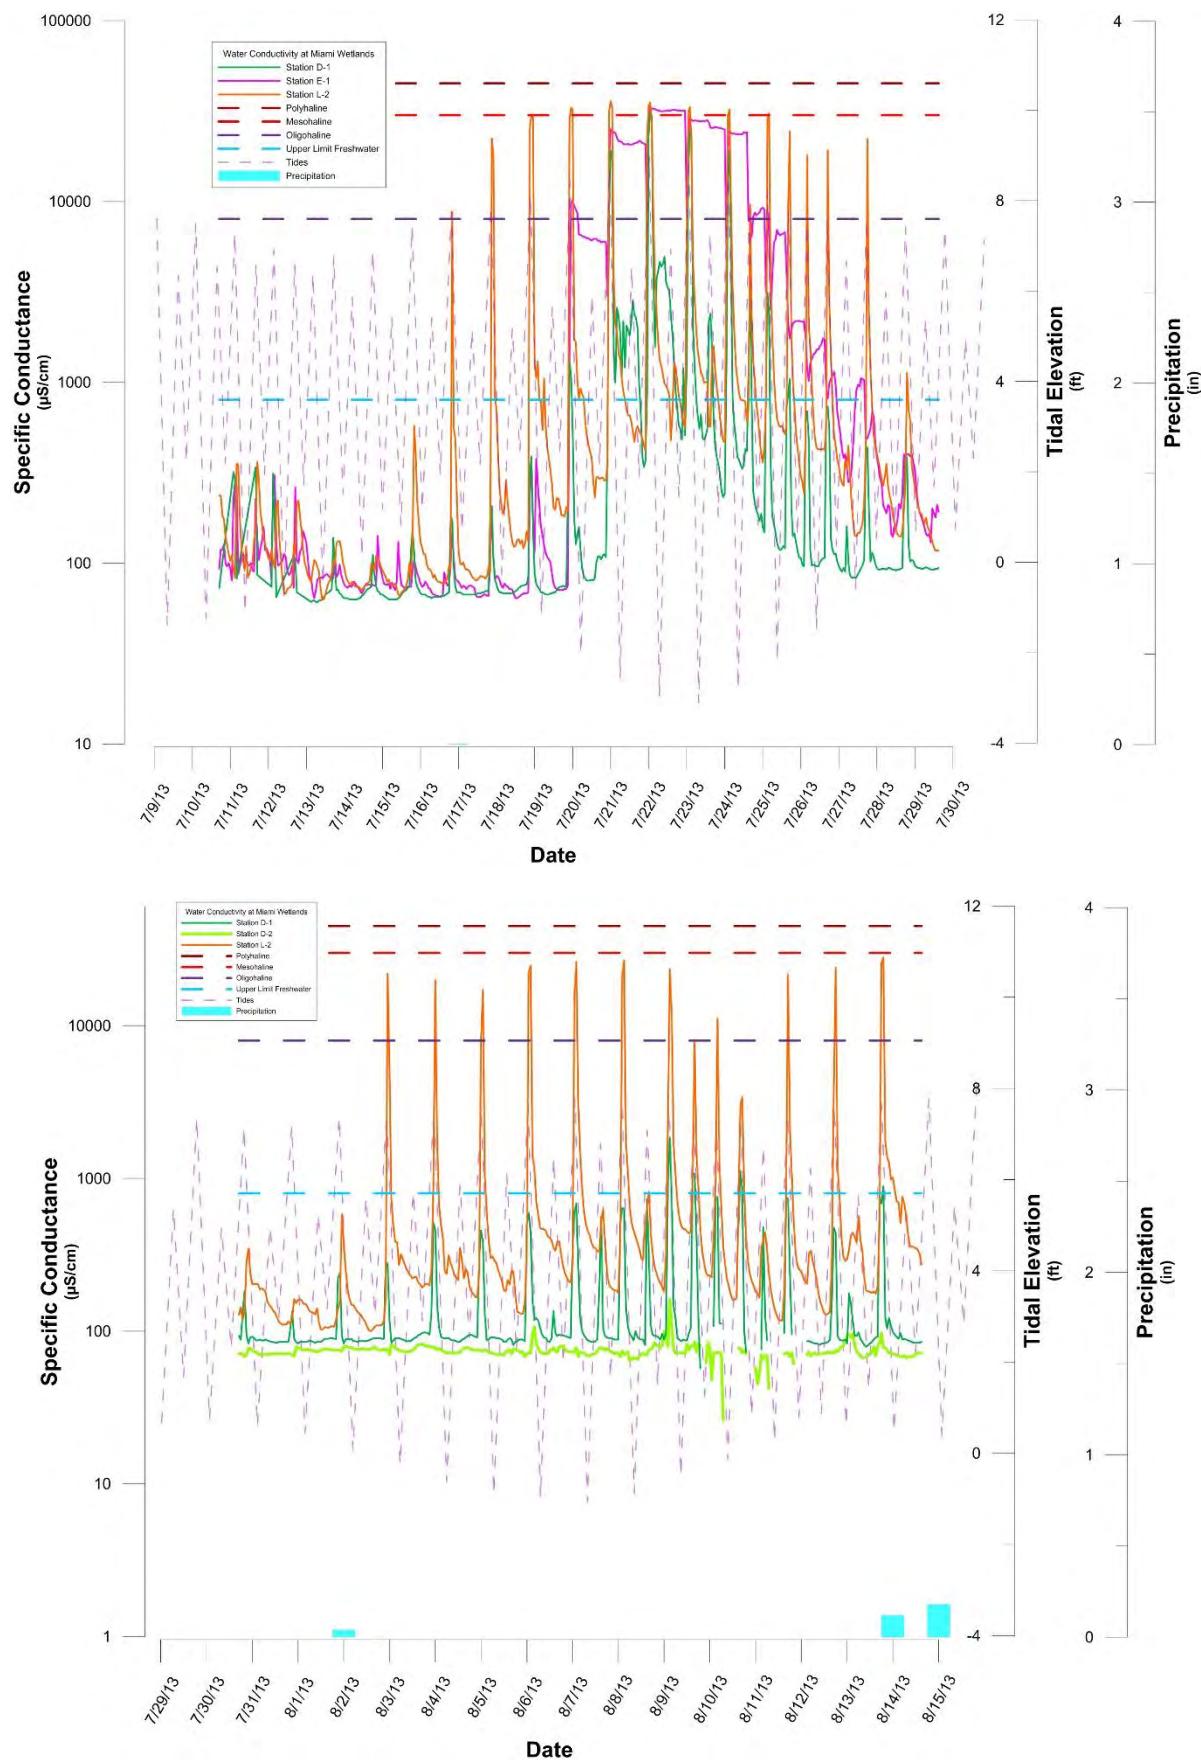
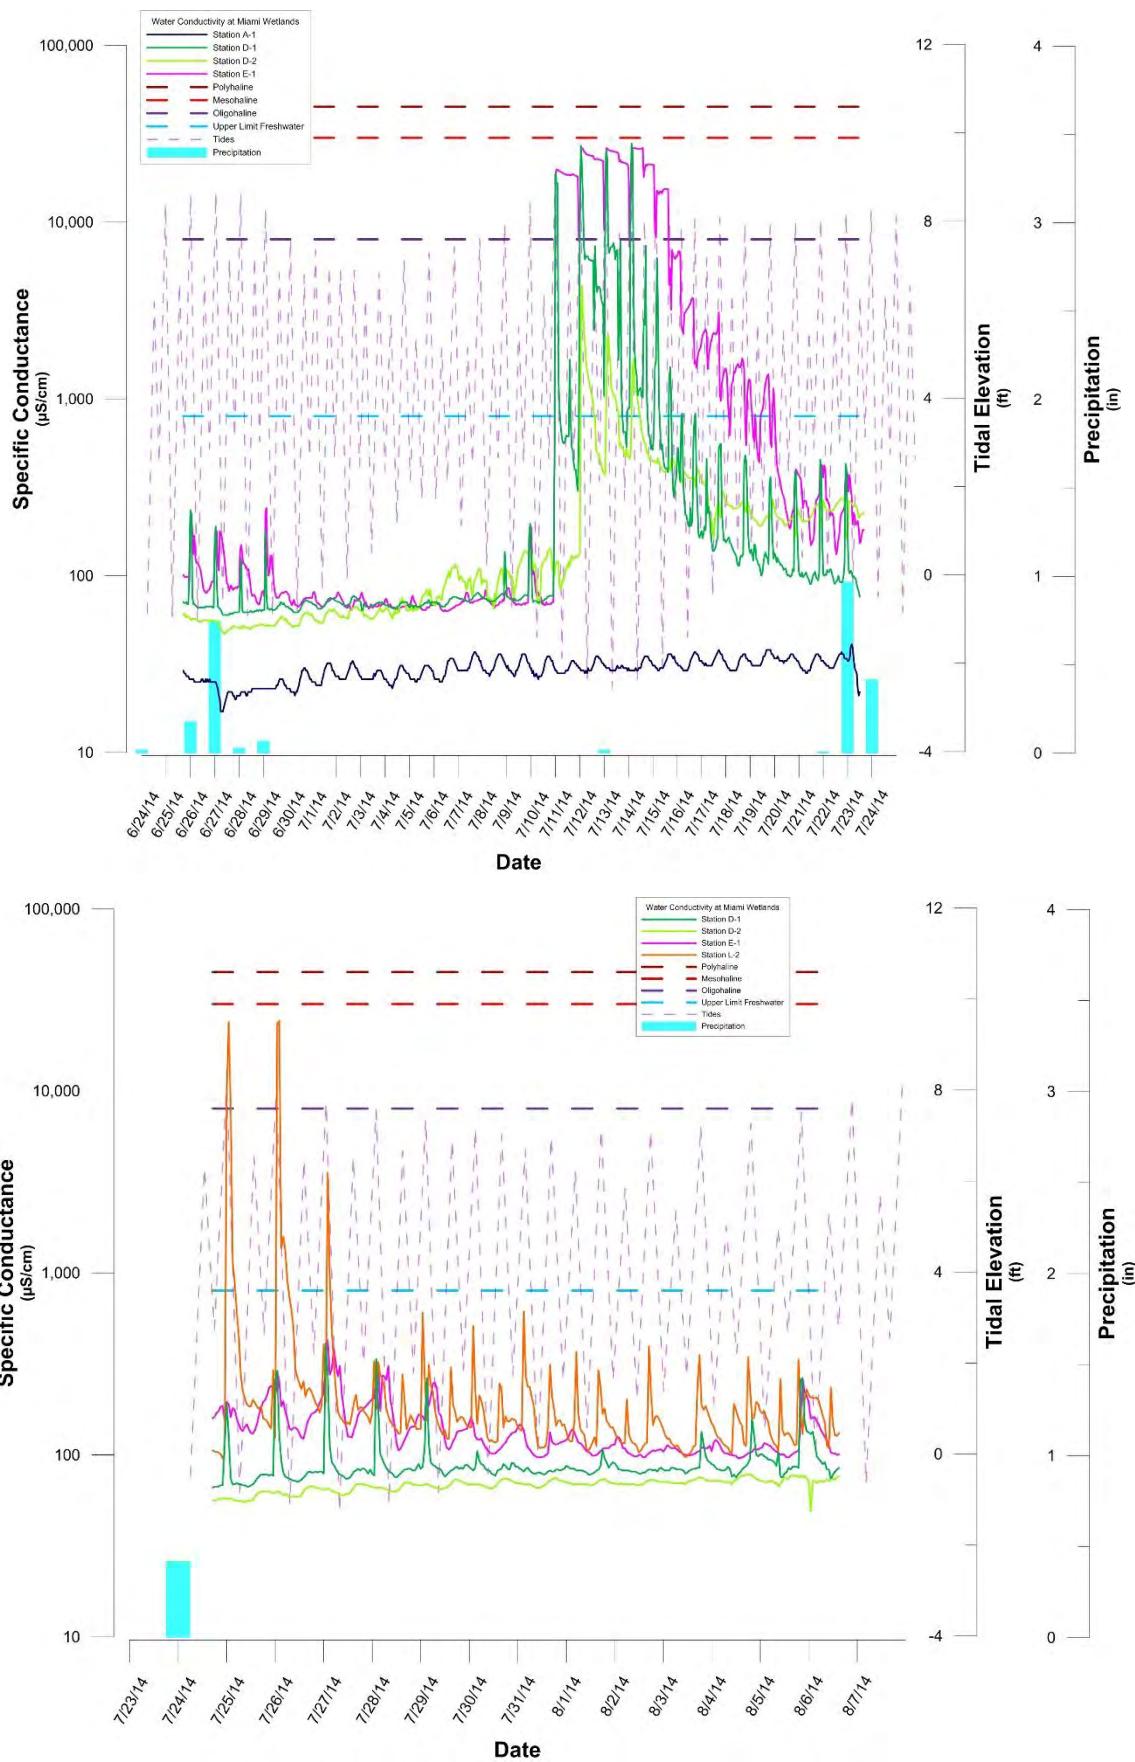
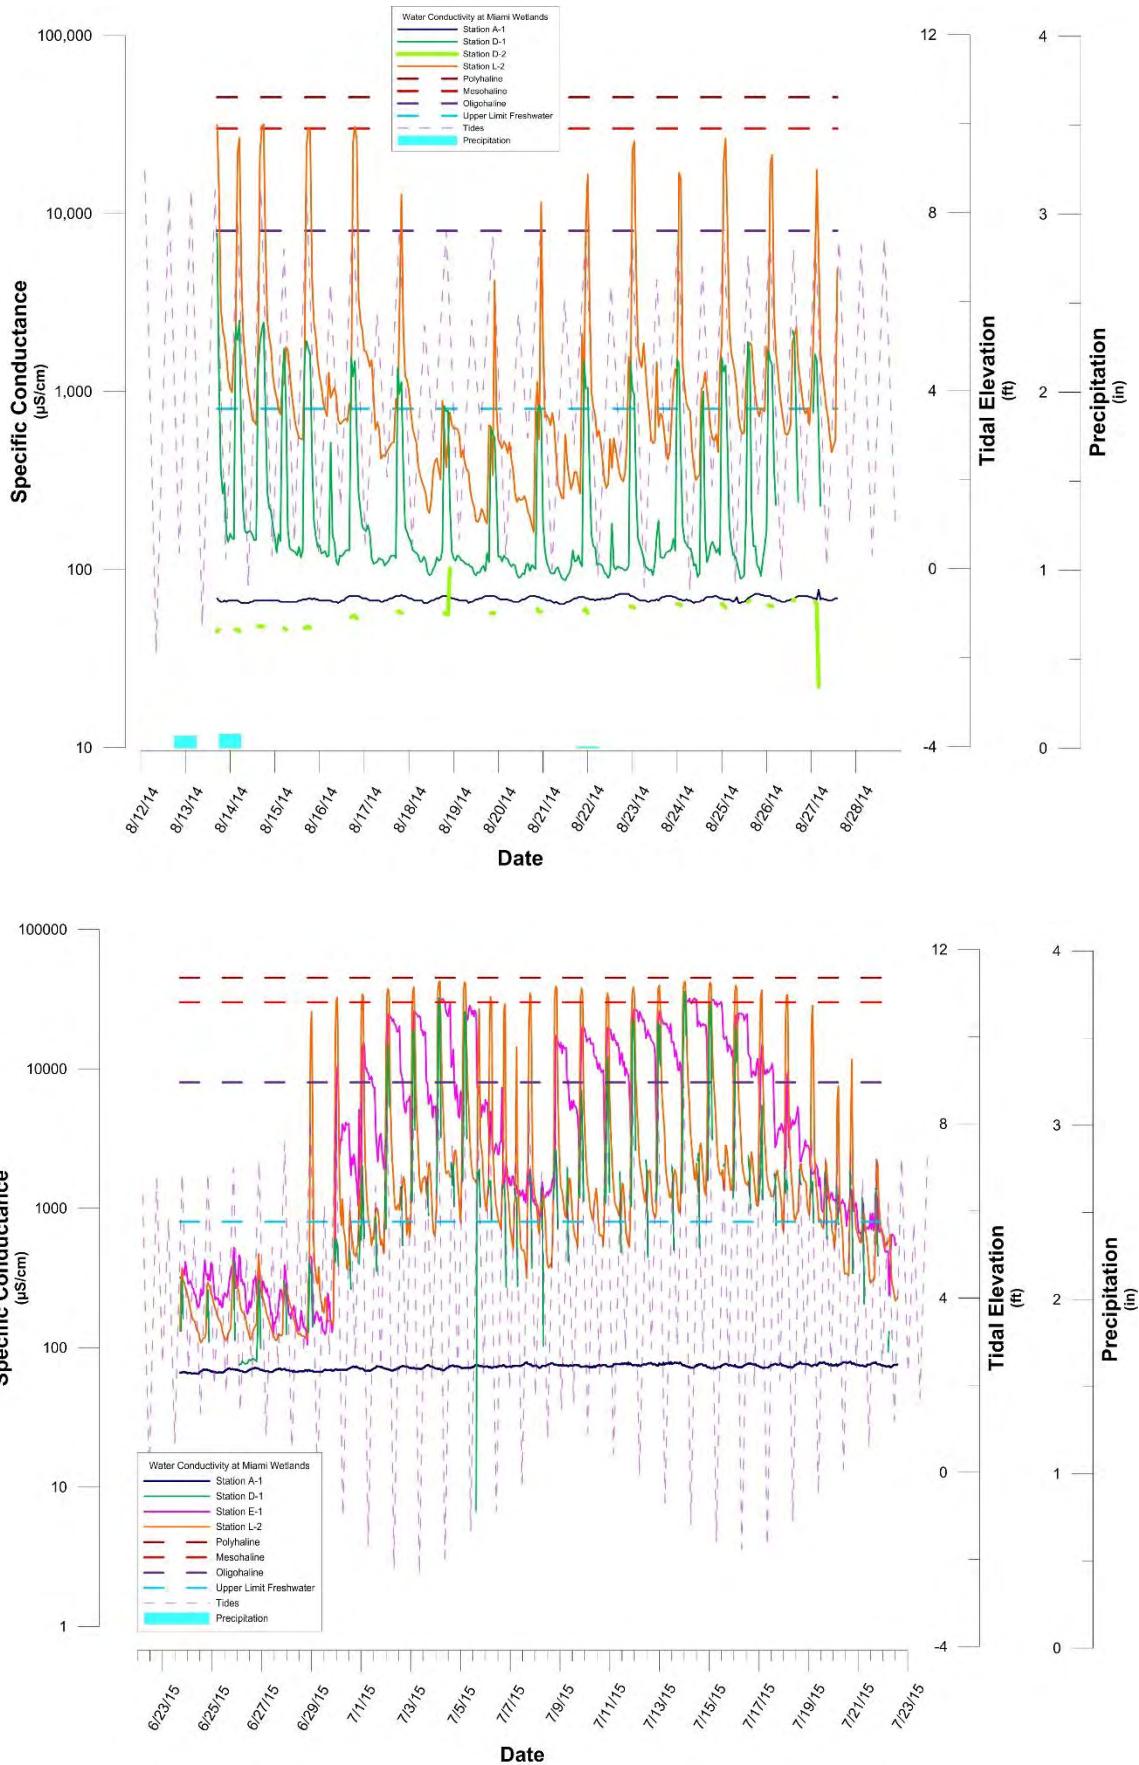
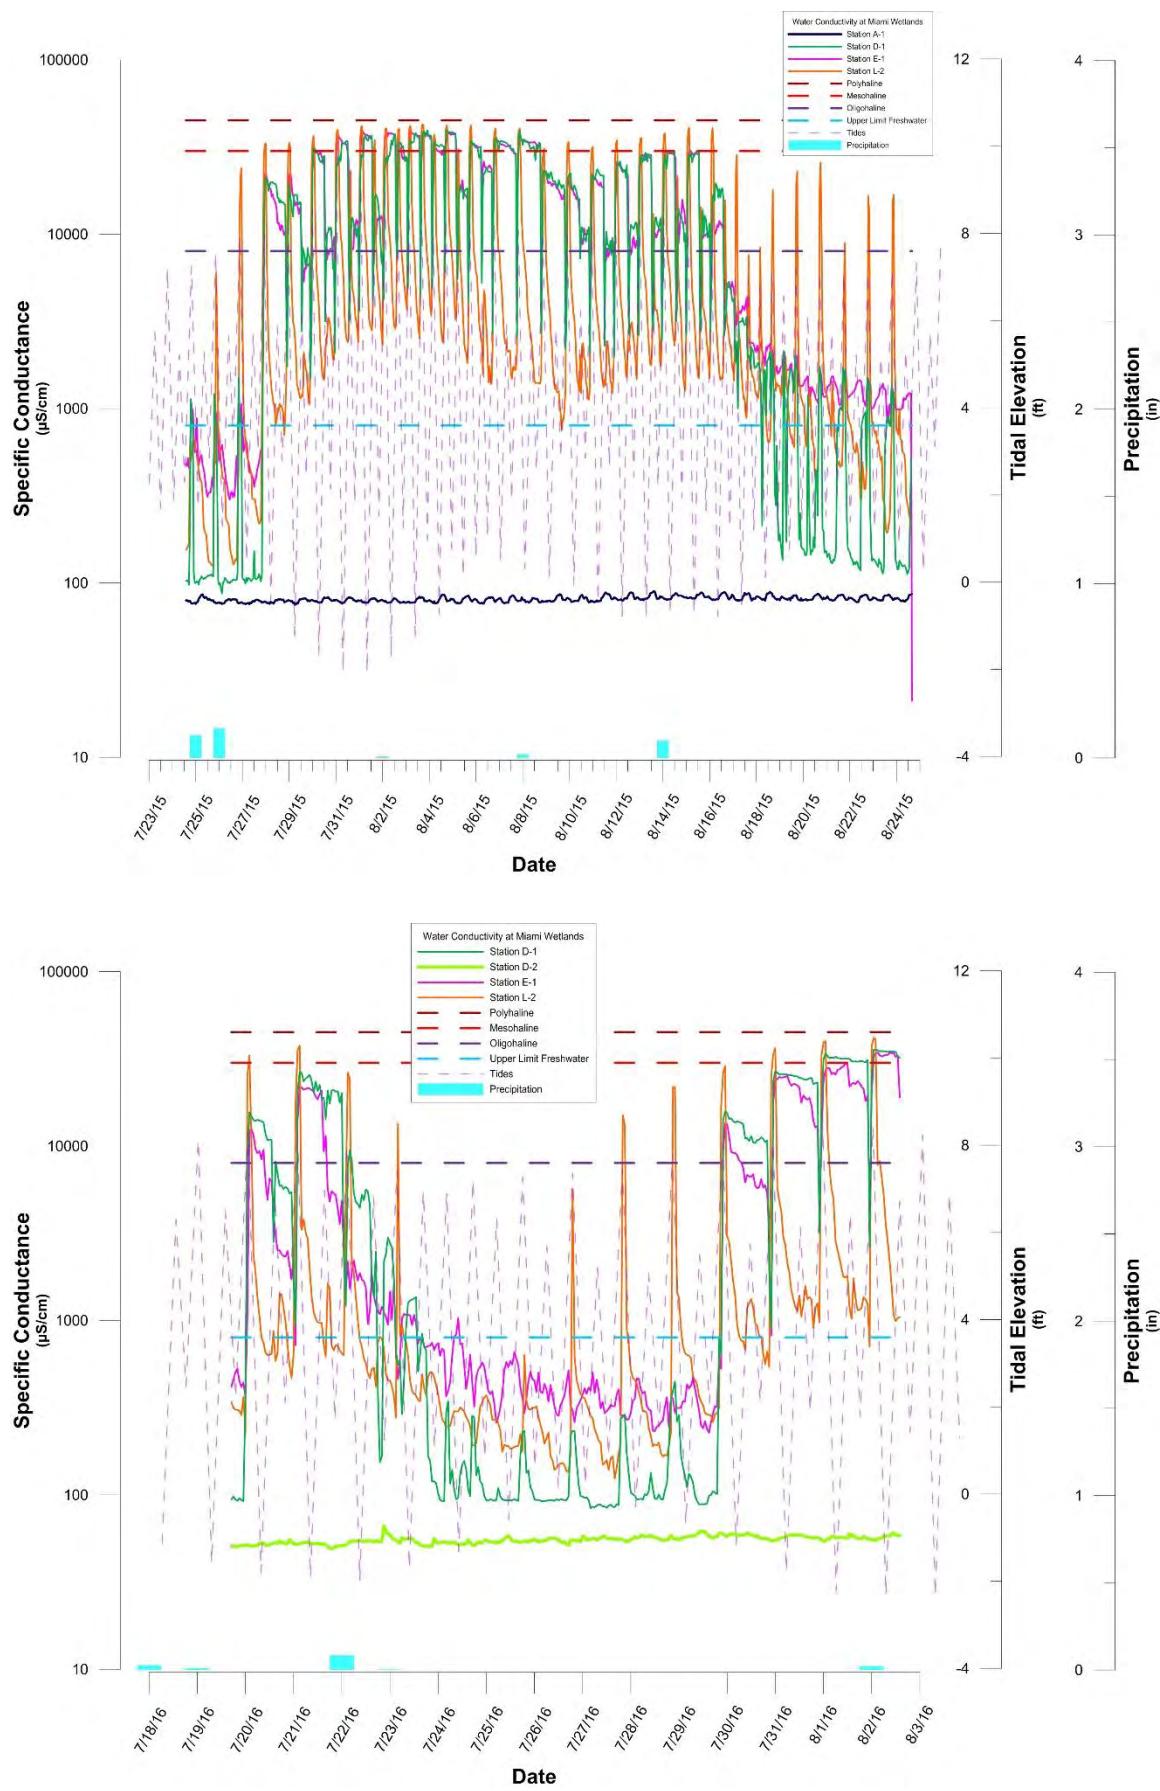
Figure D2. Graphs depicting post-restoration specific conductance levels in constructed channels at the Miami Wetlands during summer 2012-2016. Precipitation and tidal data also included. Discontinuous lines indicate missing data due to low water levels.

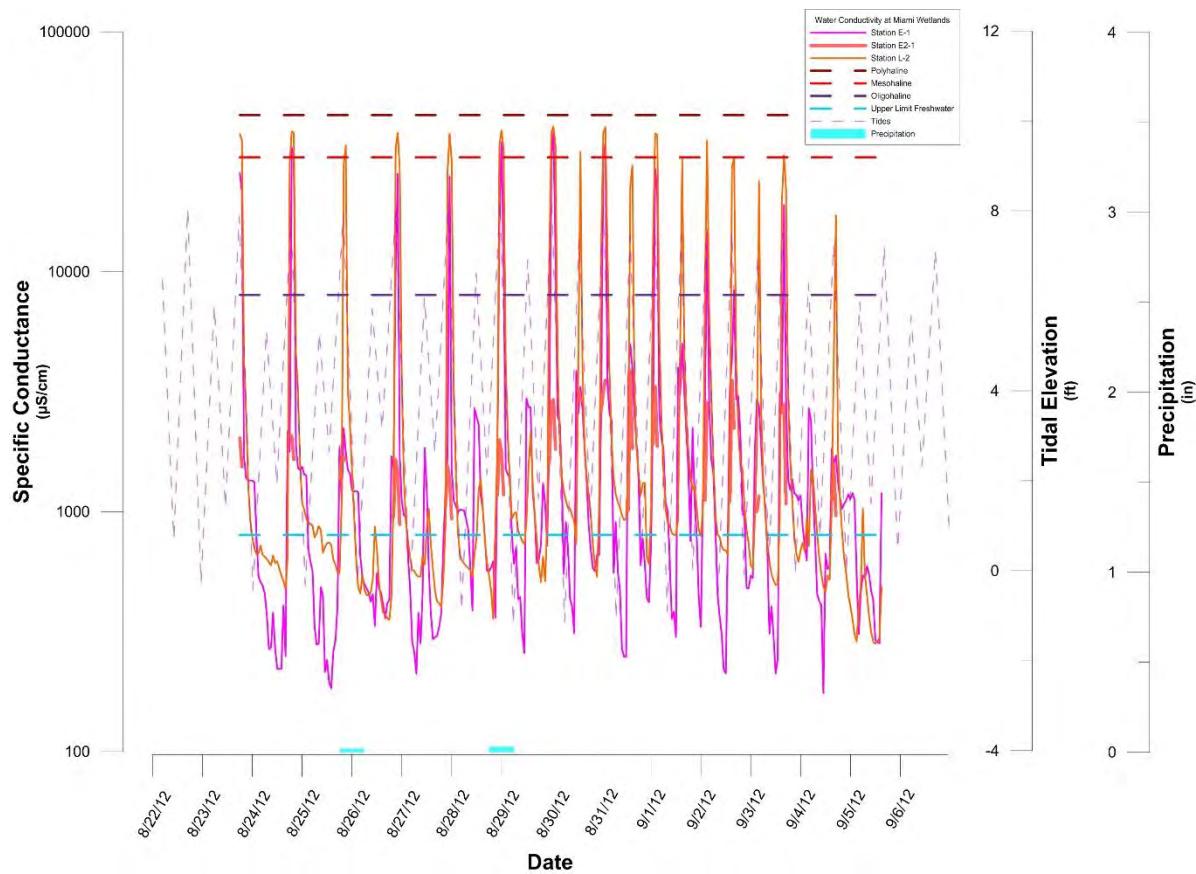
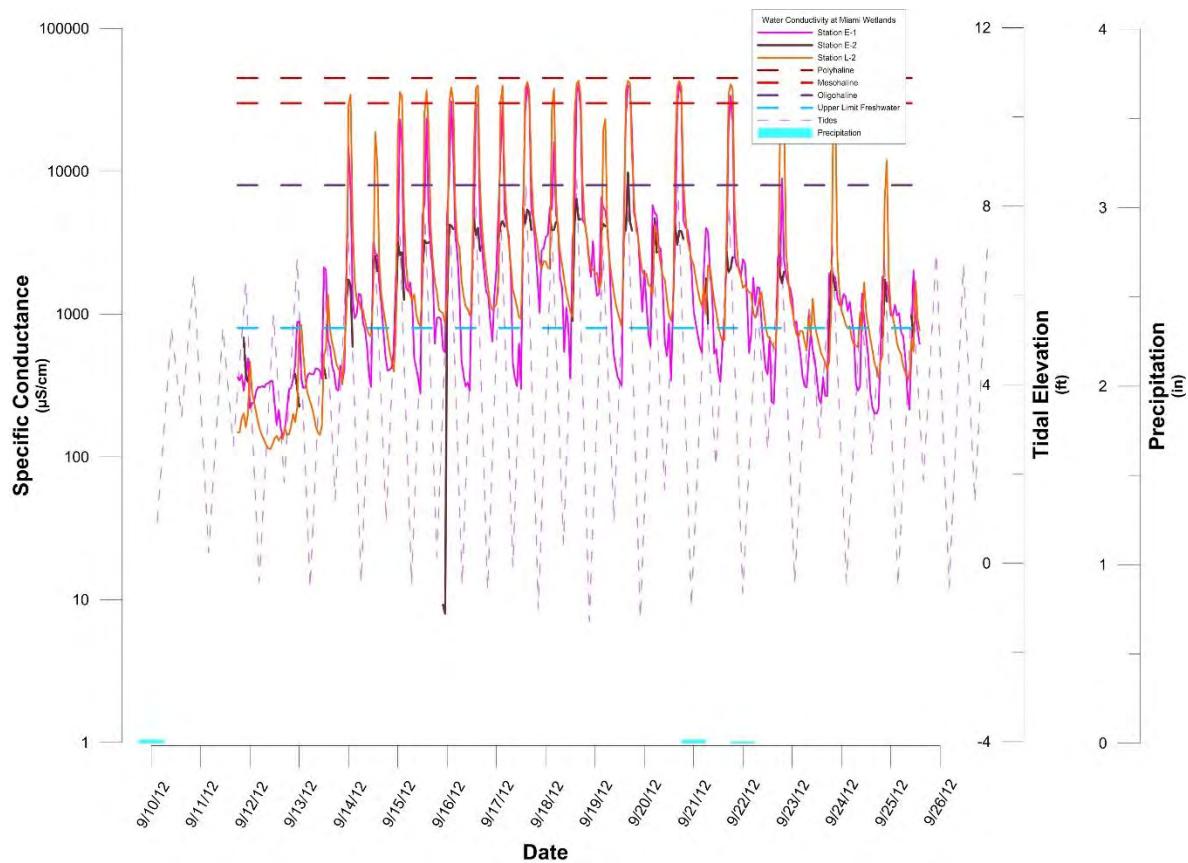
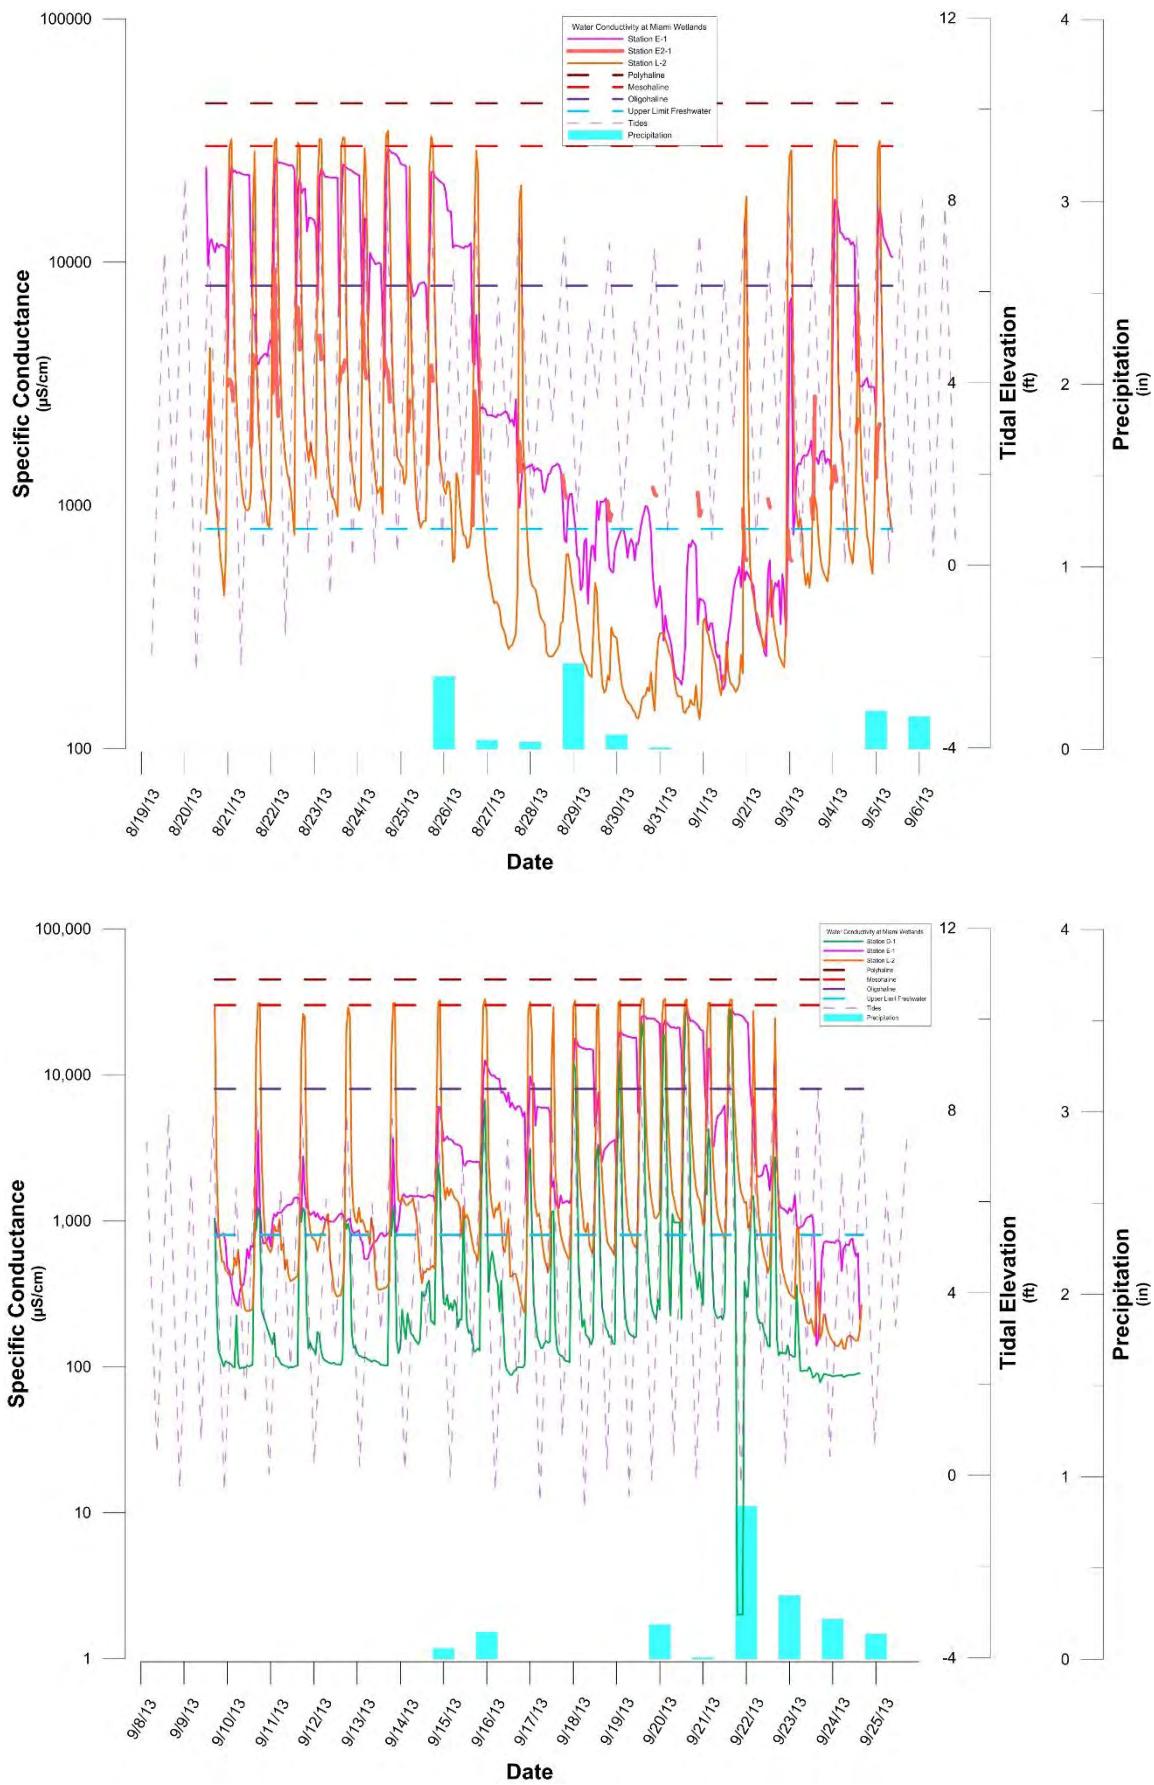
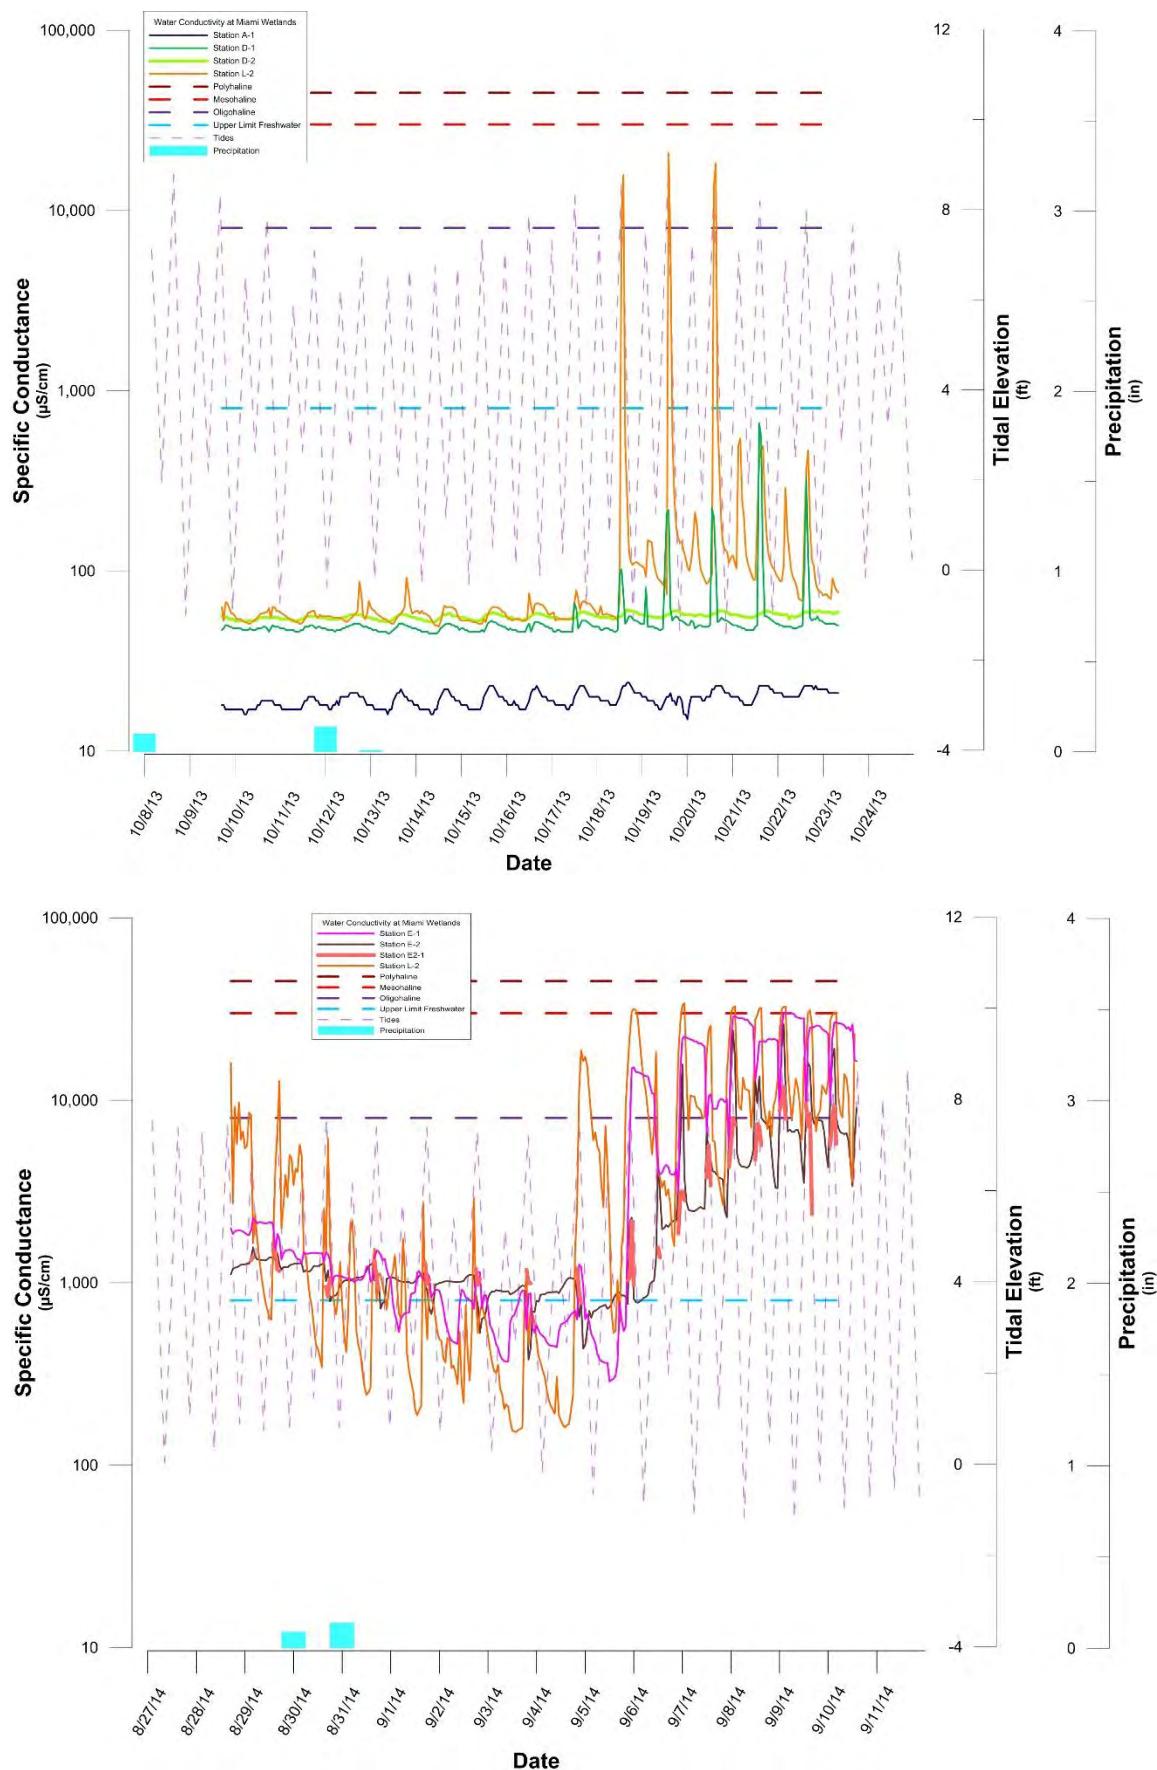
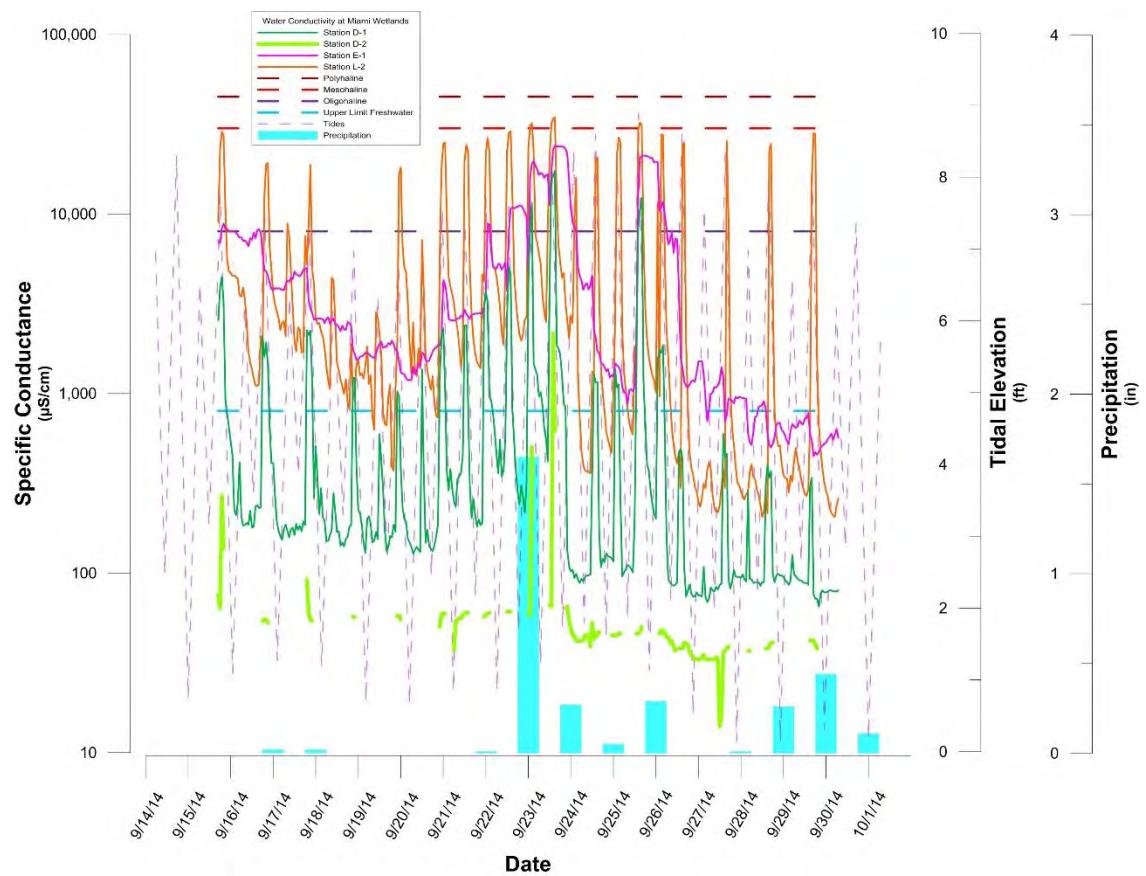
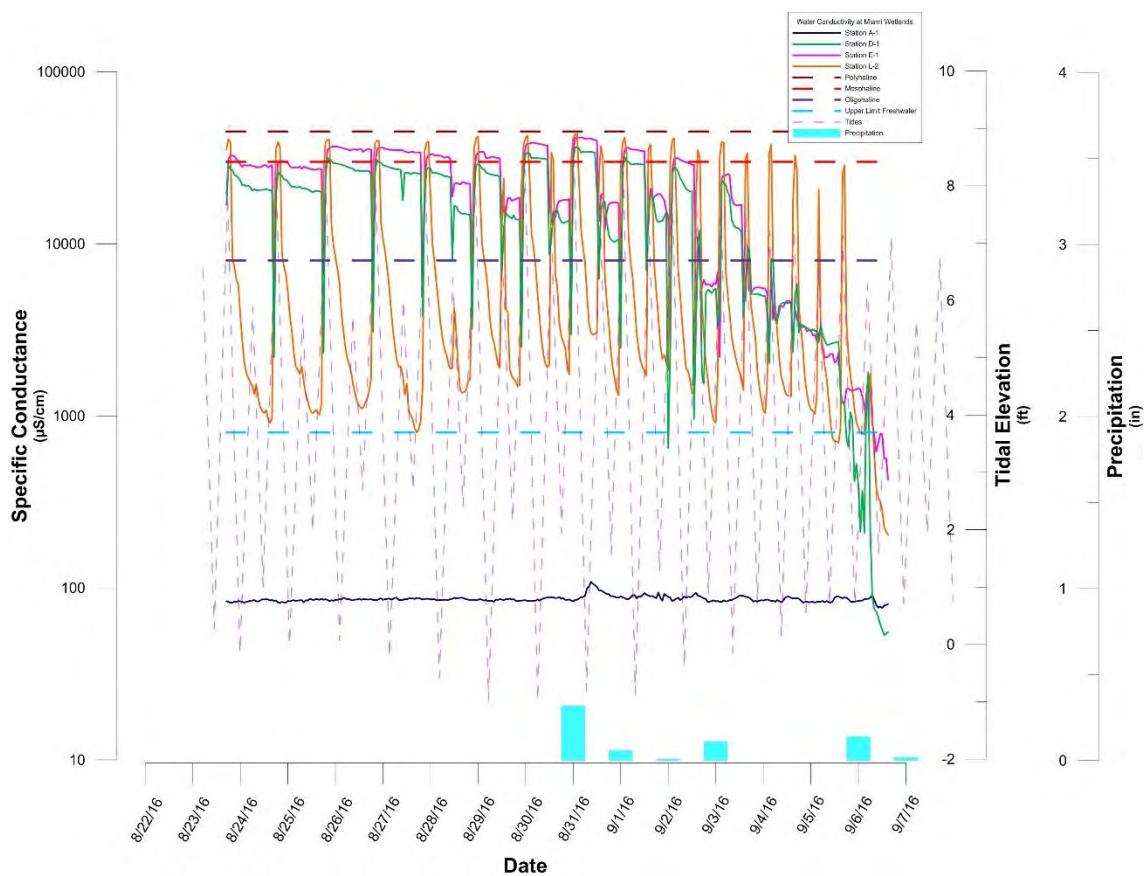
Figure D3. Graphs depicting post-restoration specific conductance levels in constructed channels at the Miami Wetlands during fall 2012-2016. Precipitation and tidal data also included. Discontinuous lines indicate missing data due to low water levels.

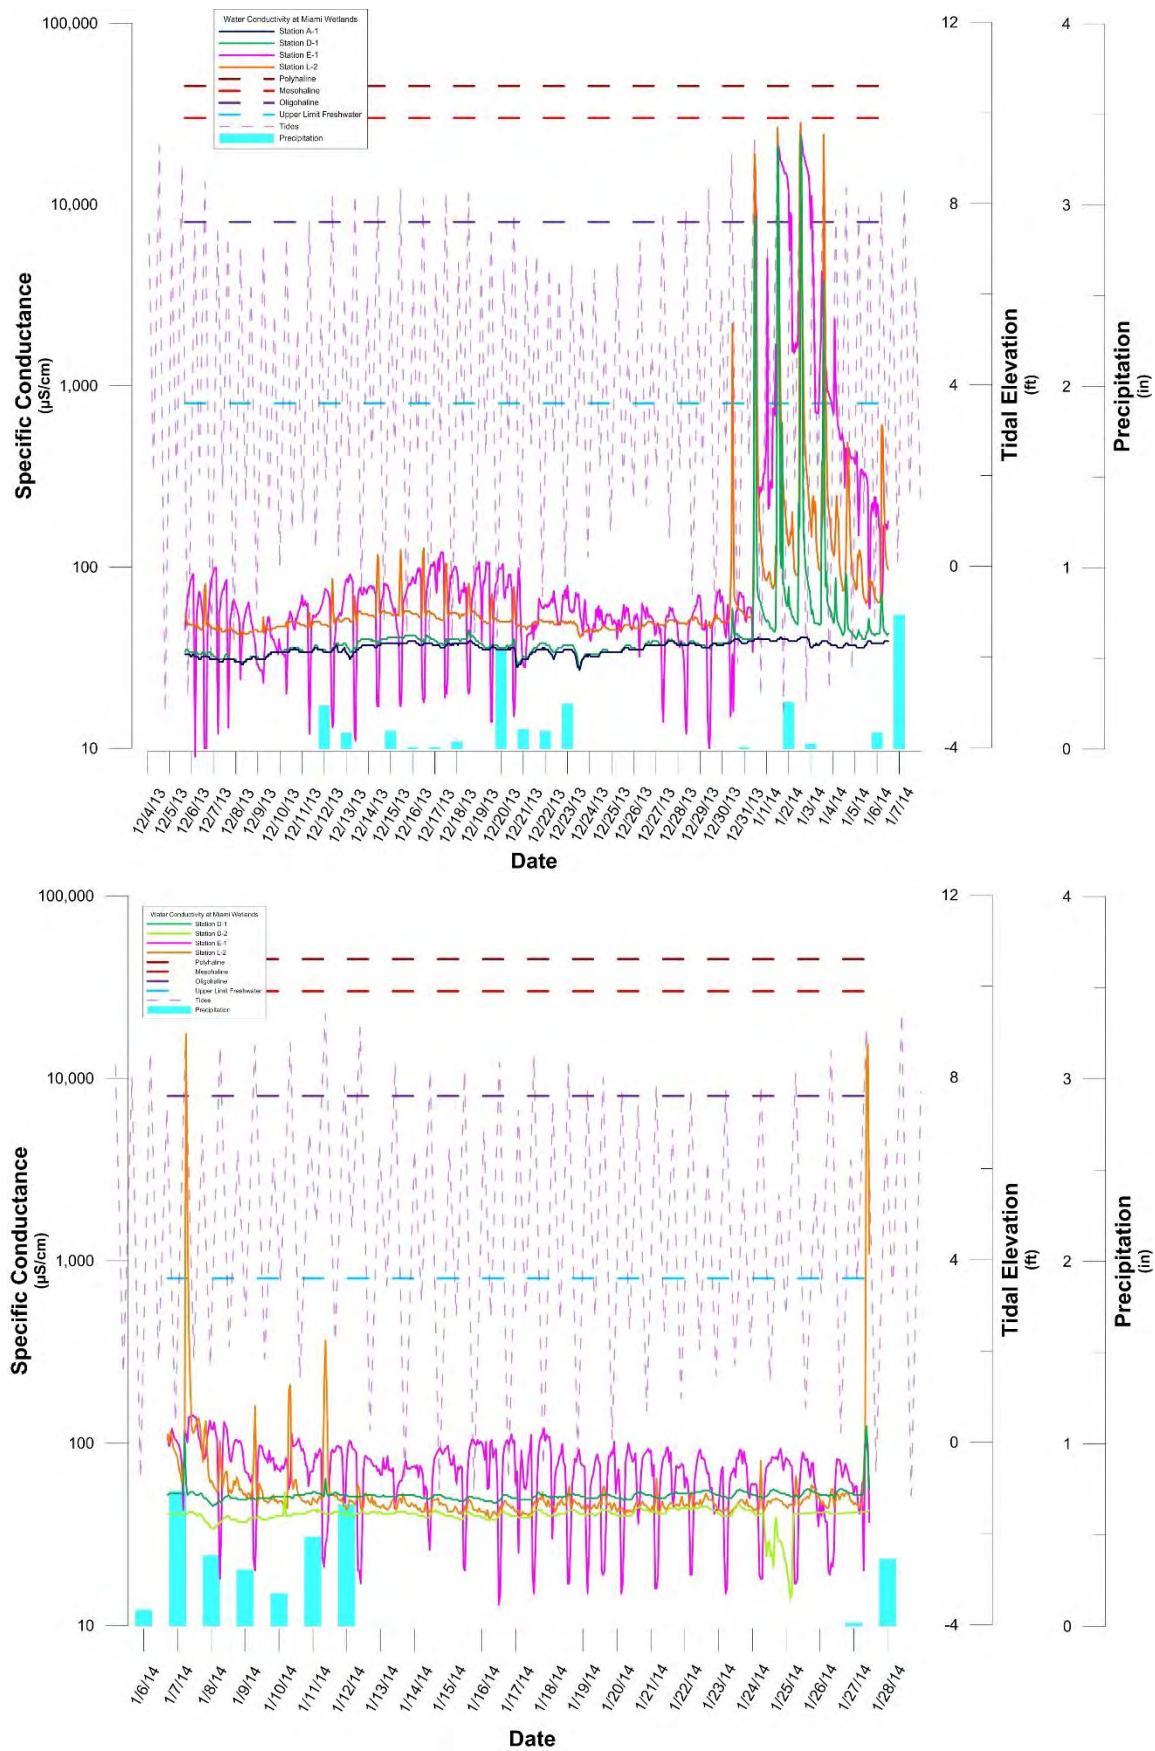
Figure D4. Graphs depicting post-restoration specific conductance levels in constructed channels at the Miami Wetlands during winter 2012-2016. Precipitation and tidal data also included. Discontinuous lines indicate missing data due to low water levels.
