Appendix A

Graphs depicting water levels at Miami Wetlands from March 2008 through February 2017

Miami Wetlands Restoration Site

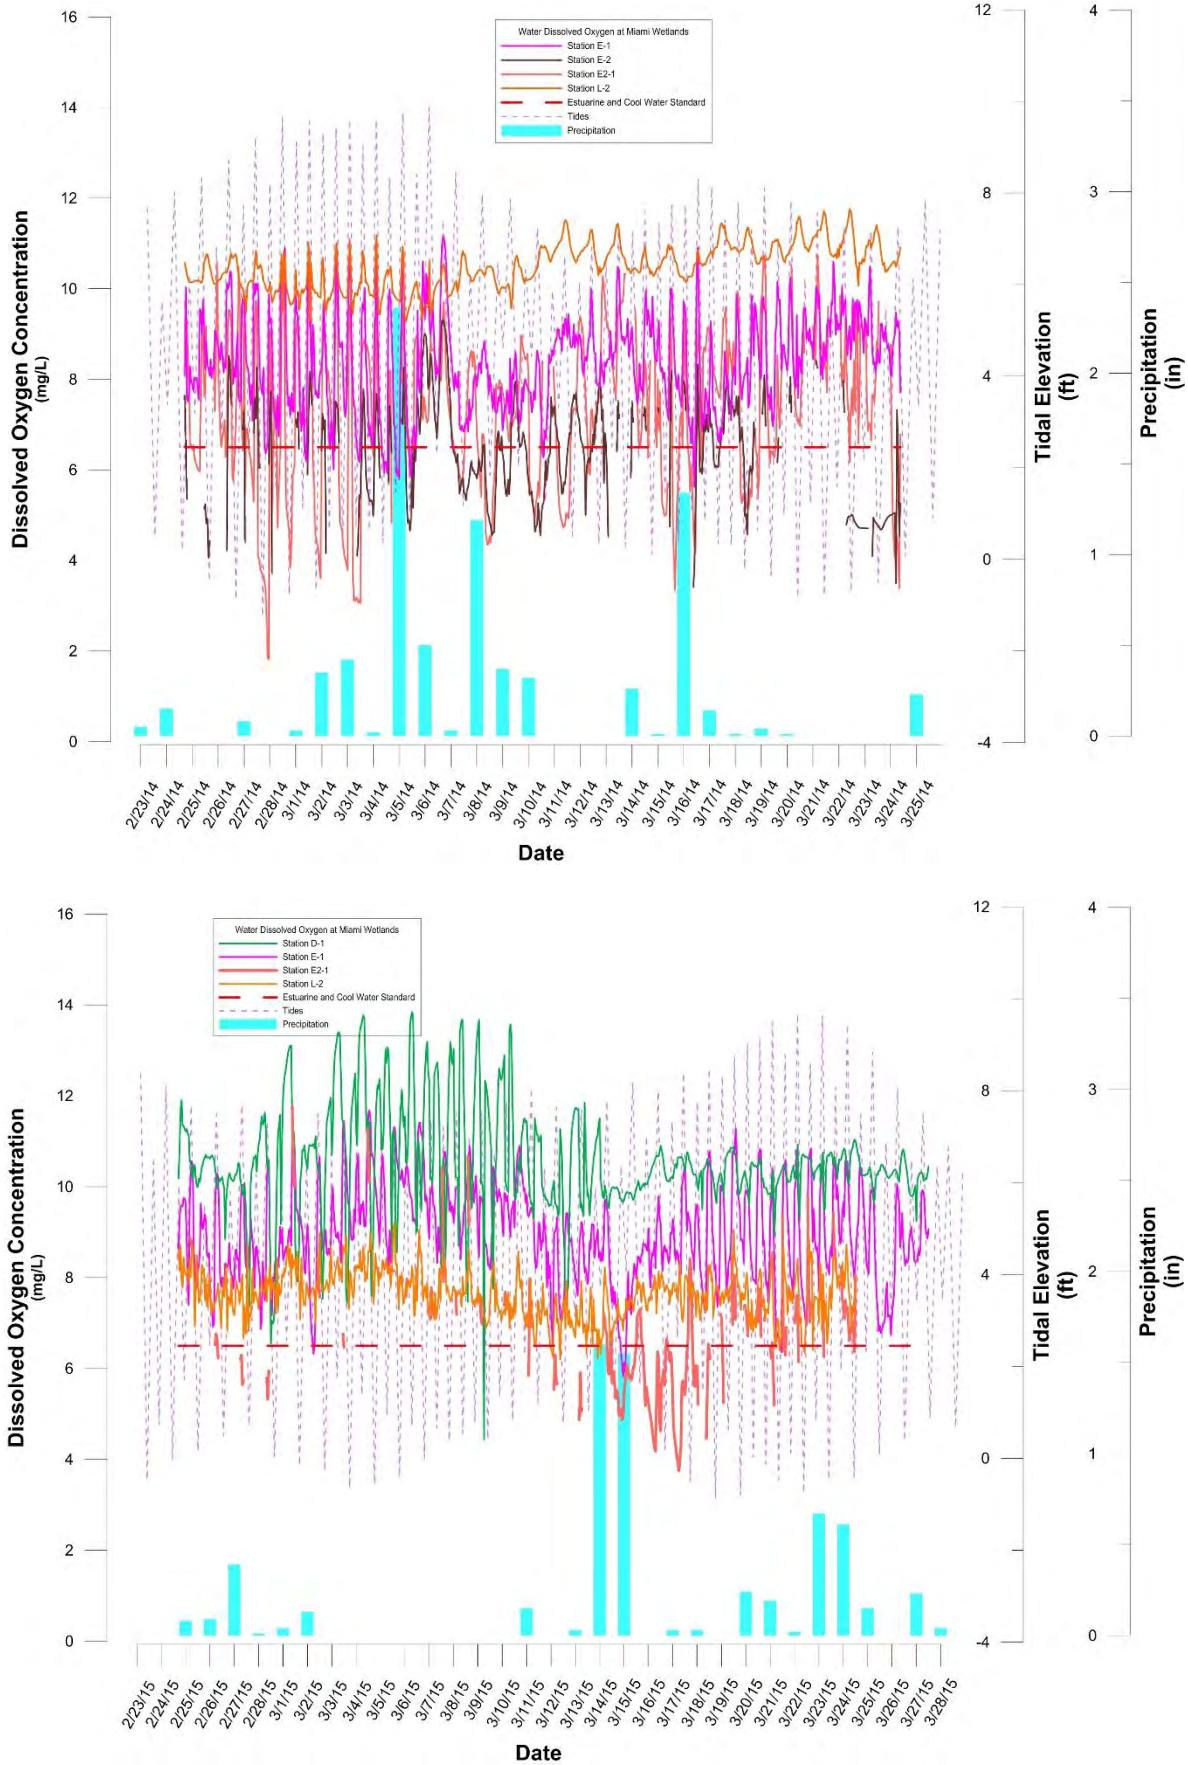
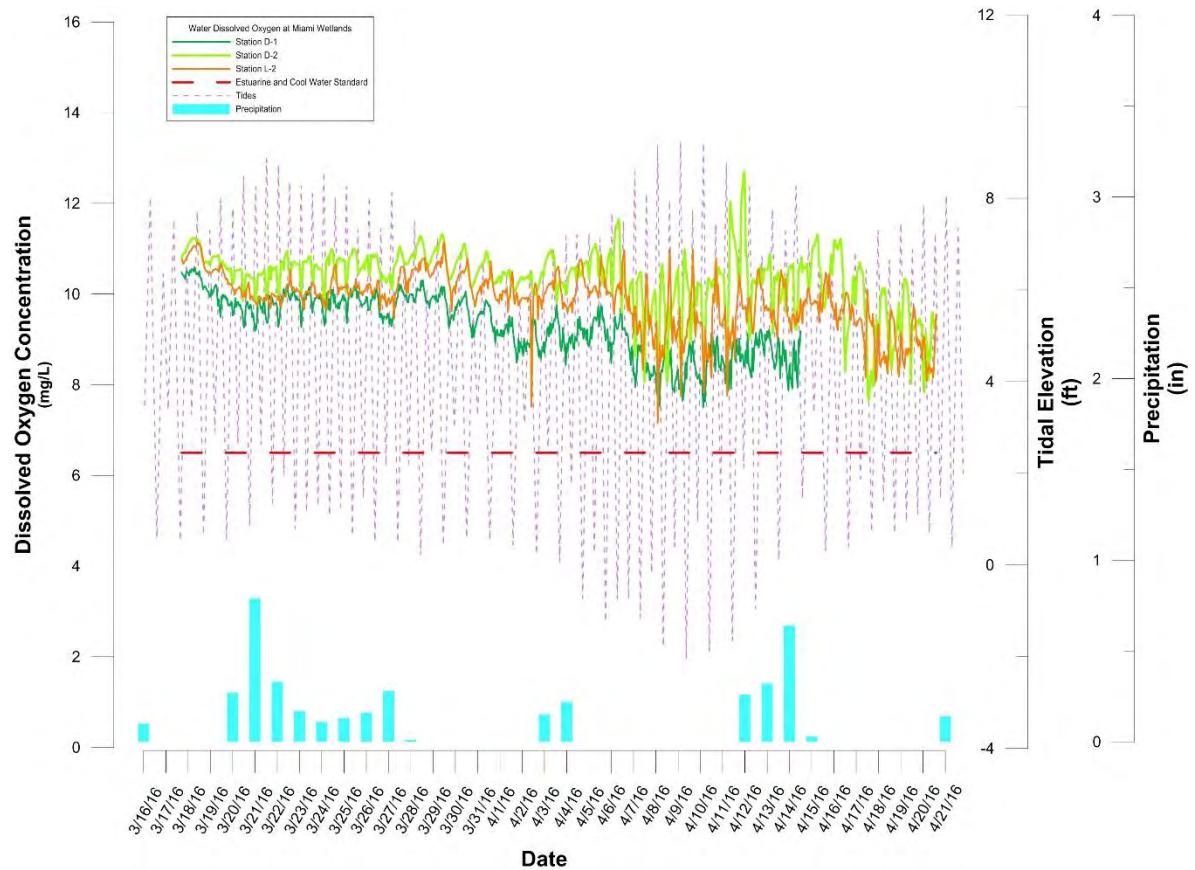
Figure E1. Graphs depicting post-restoration dissolved oxygen levels in constructed channels at the Miami Wetlands during spring 2012-2016. Precipitation and tidal data also included. Discontinuous lines indicate missing data due to low water levels.

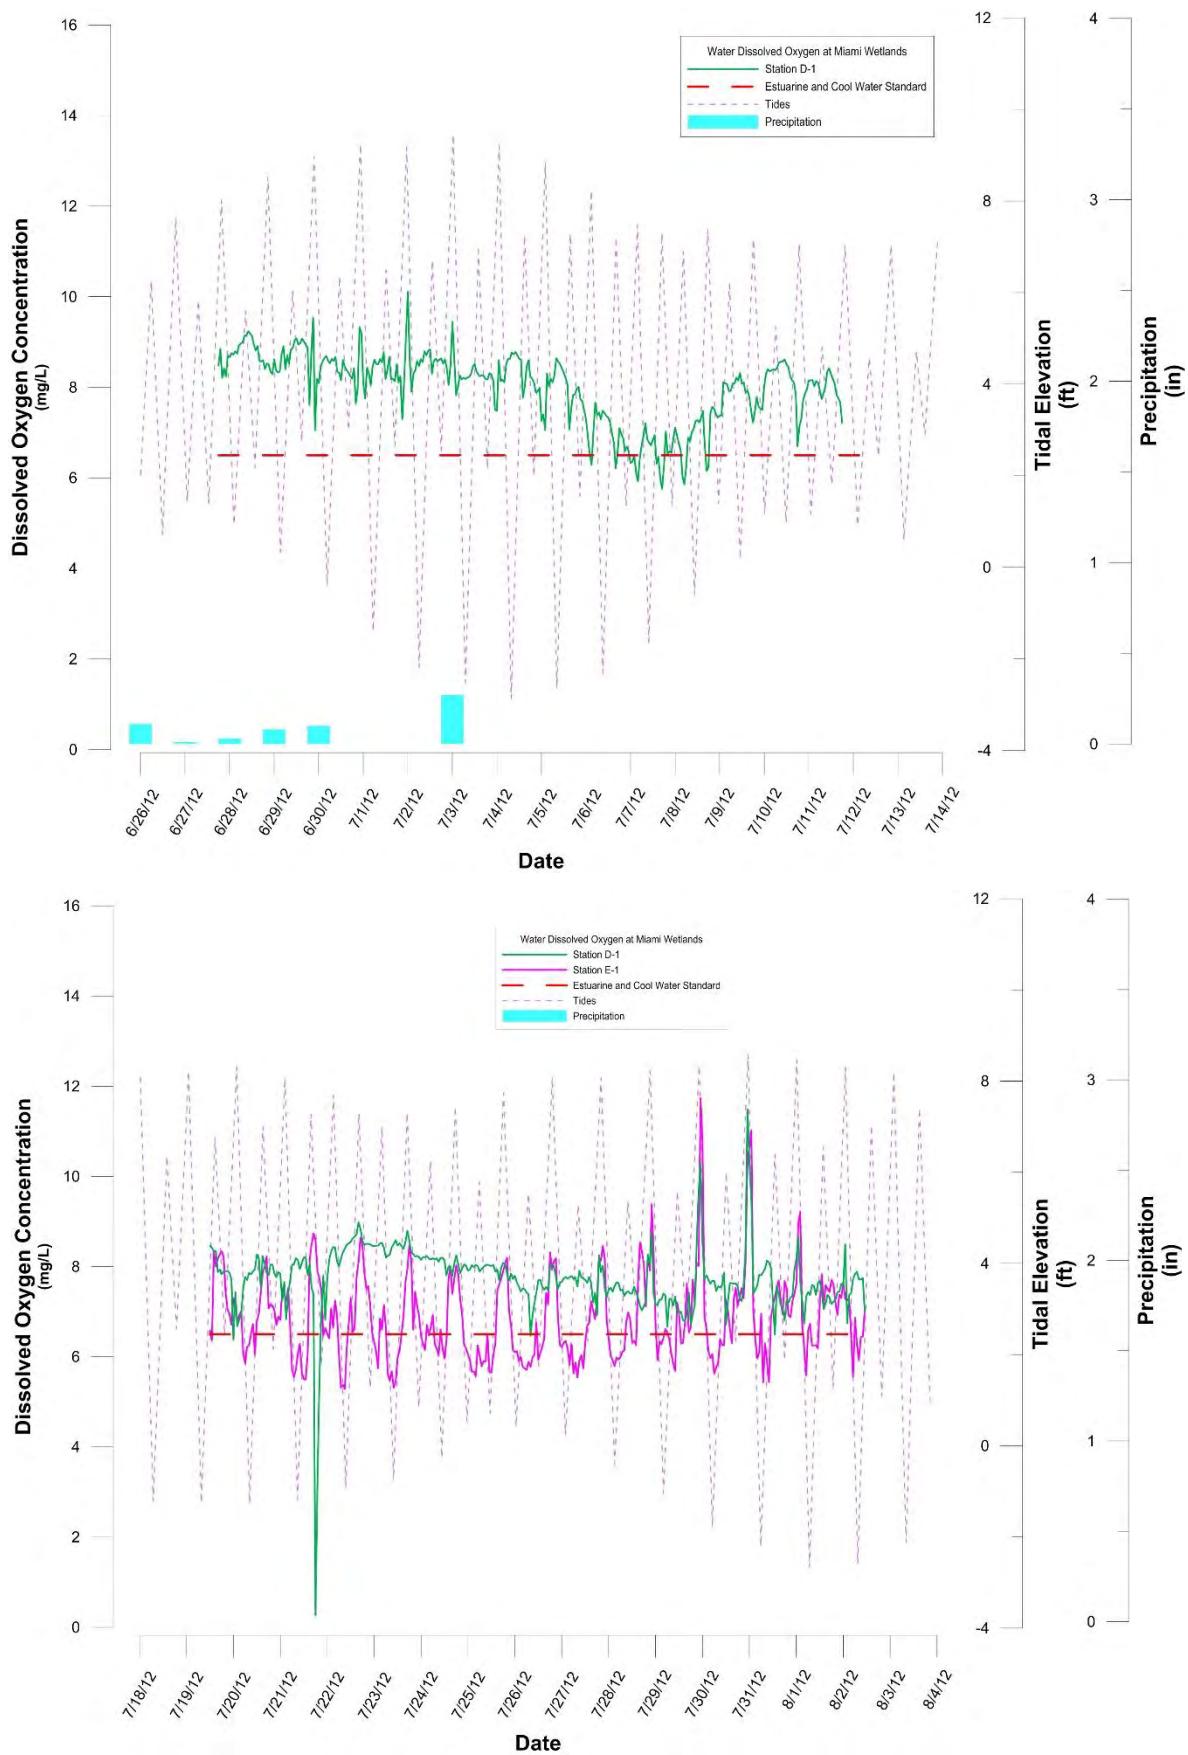
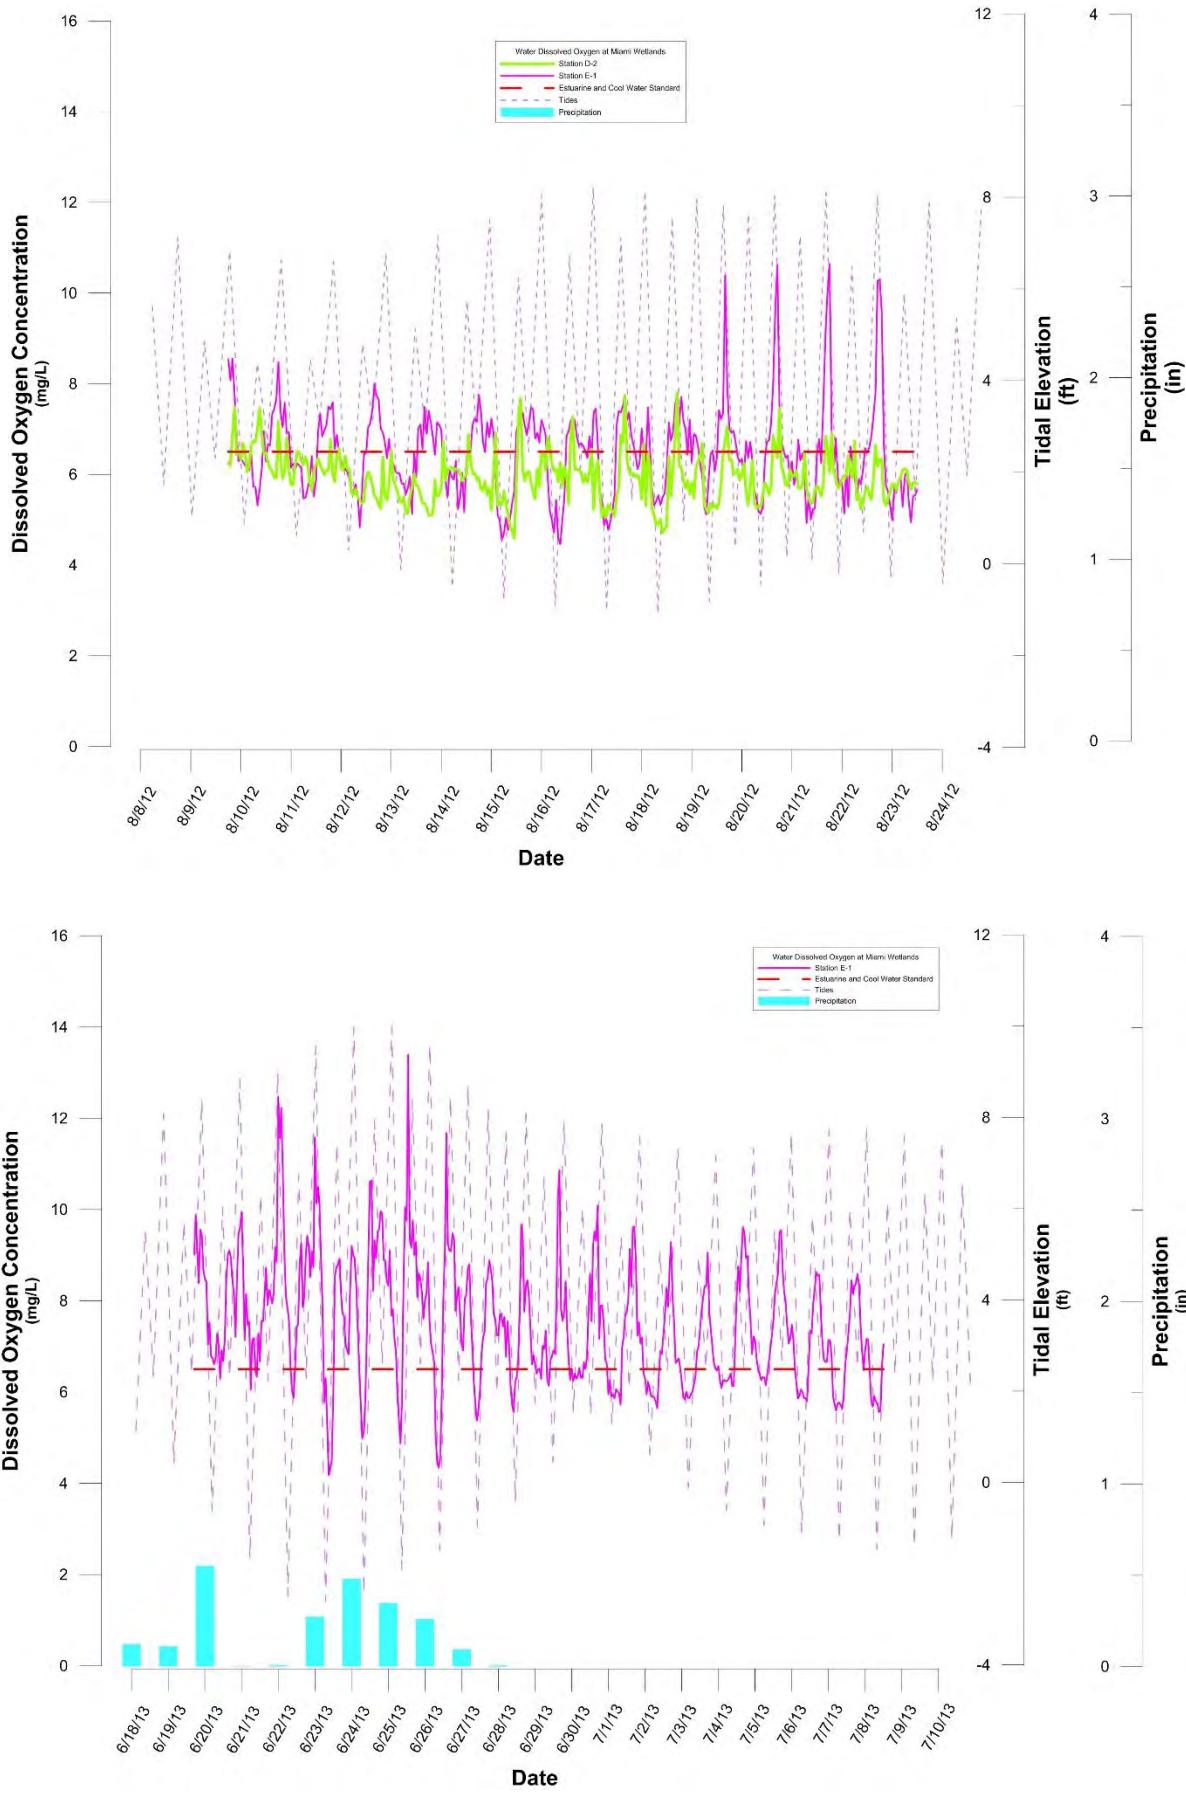
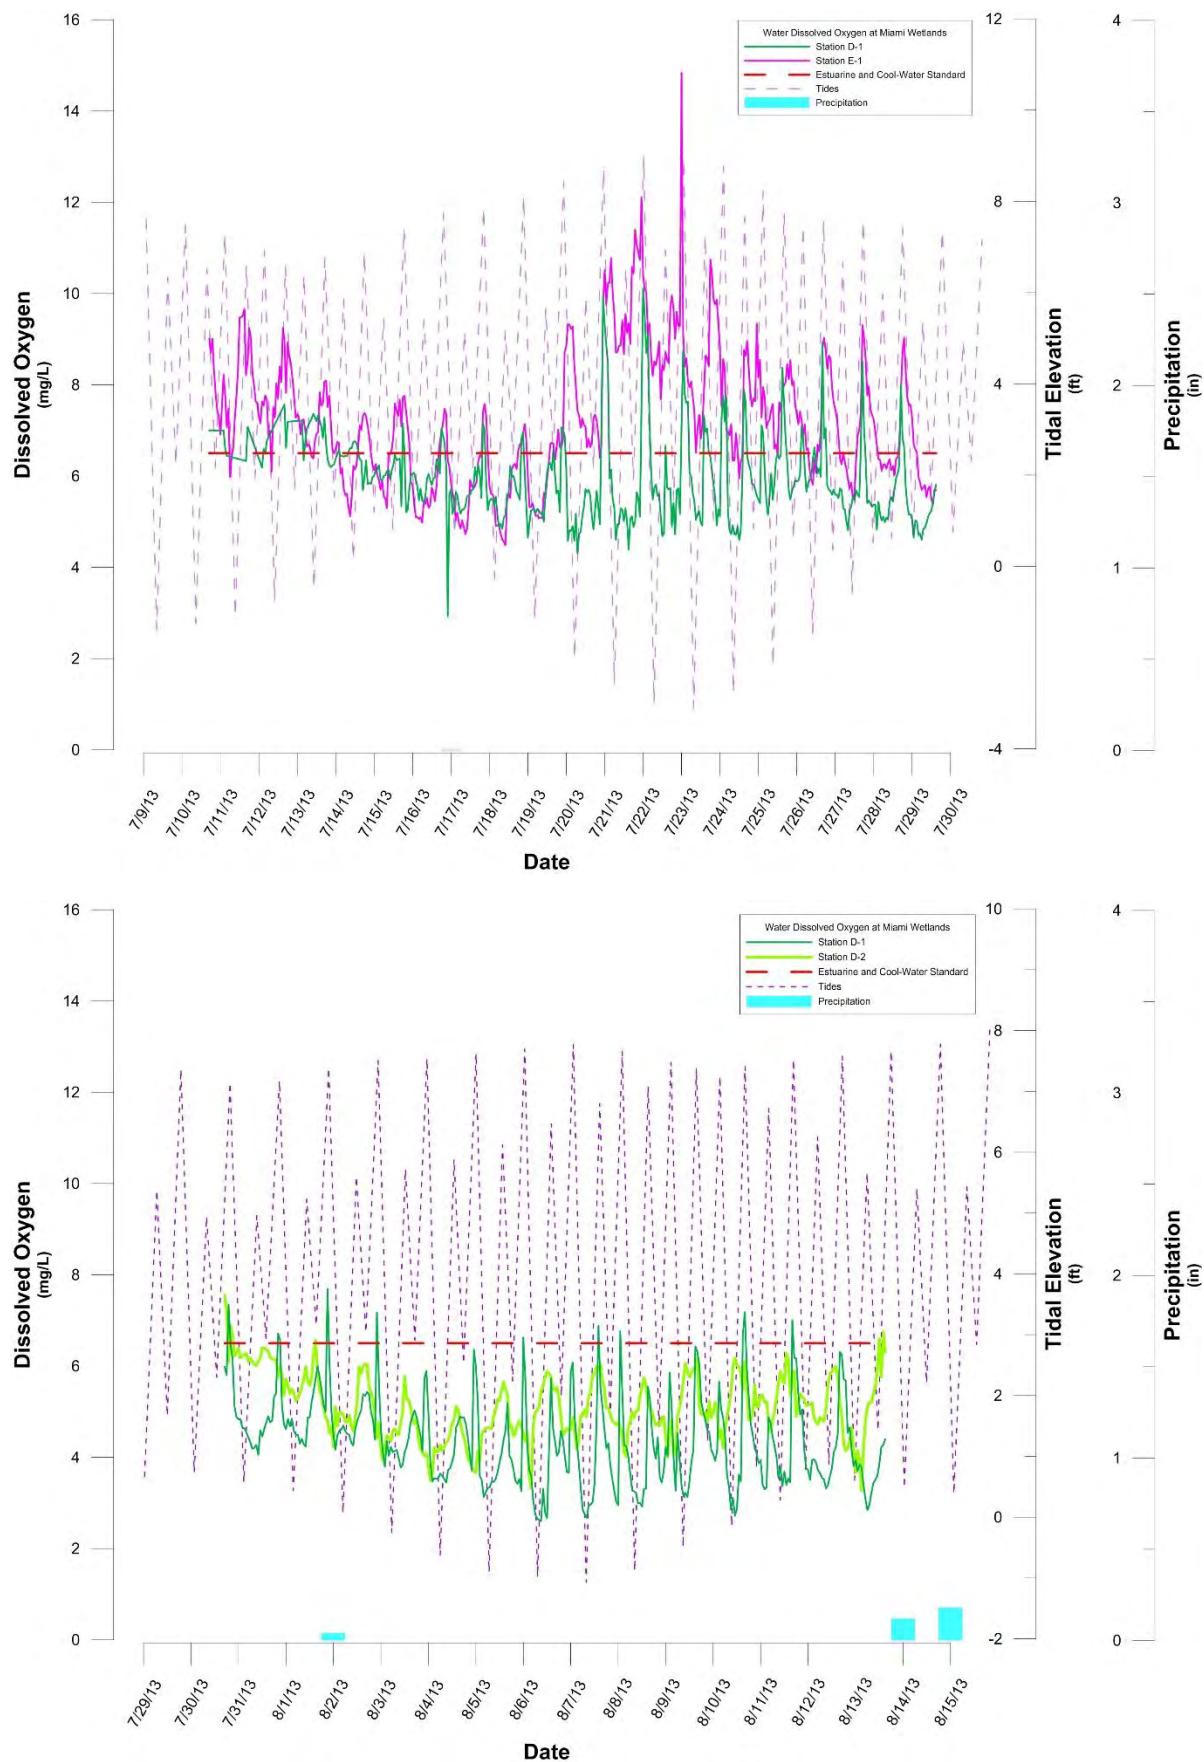
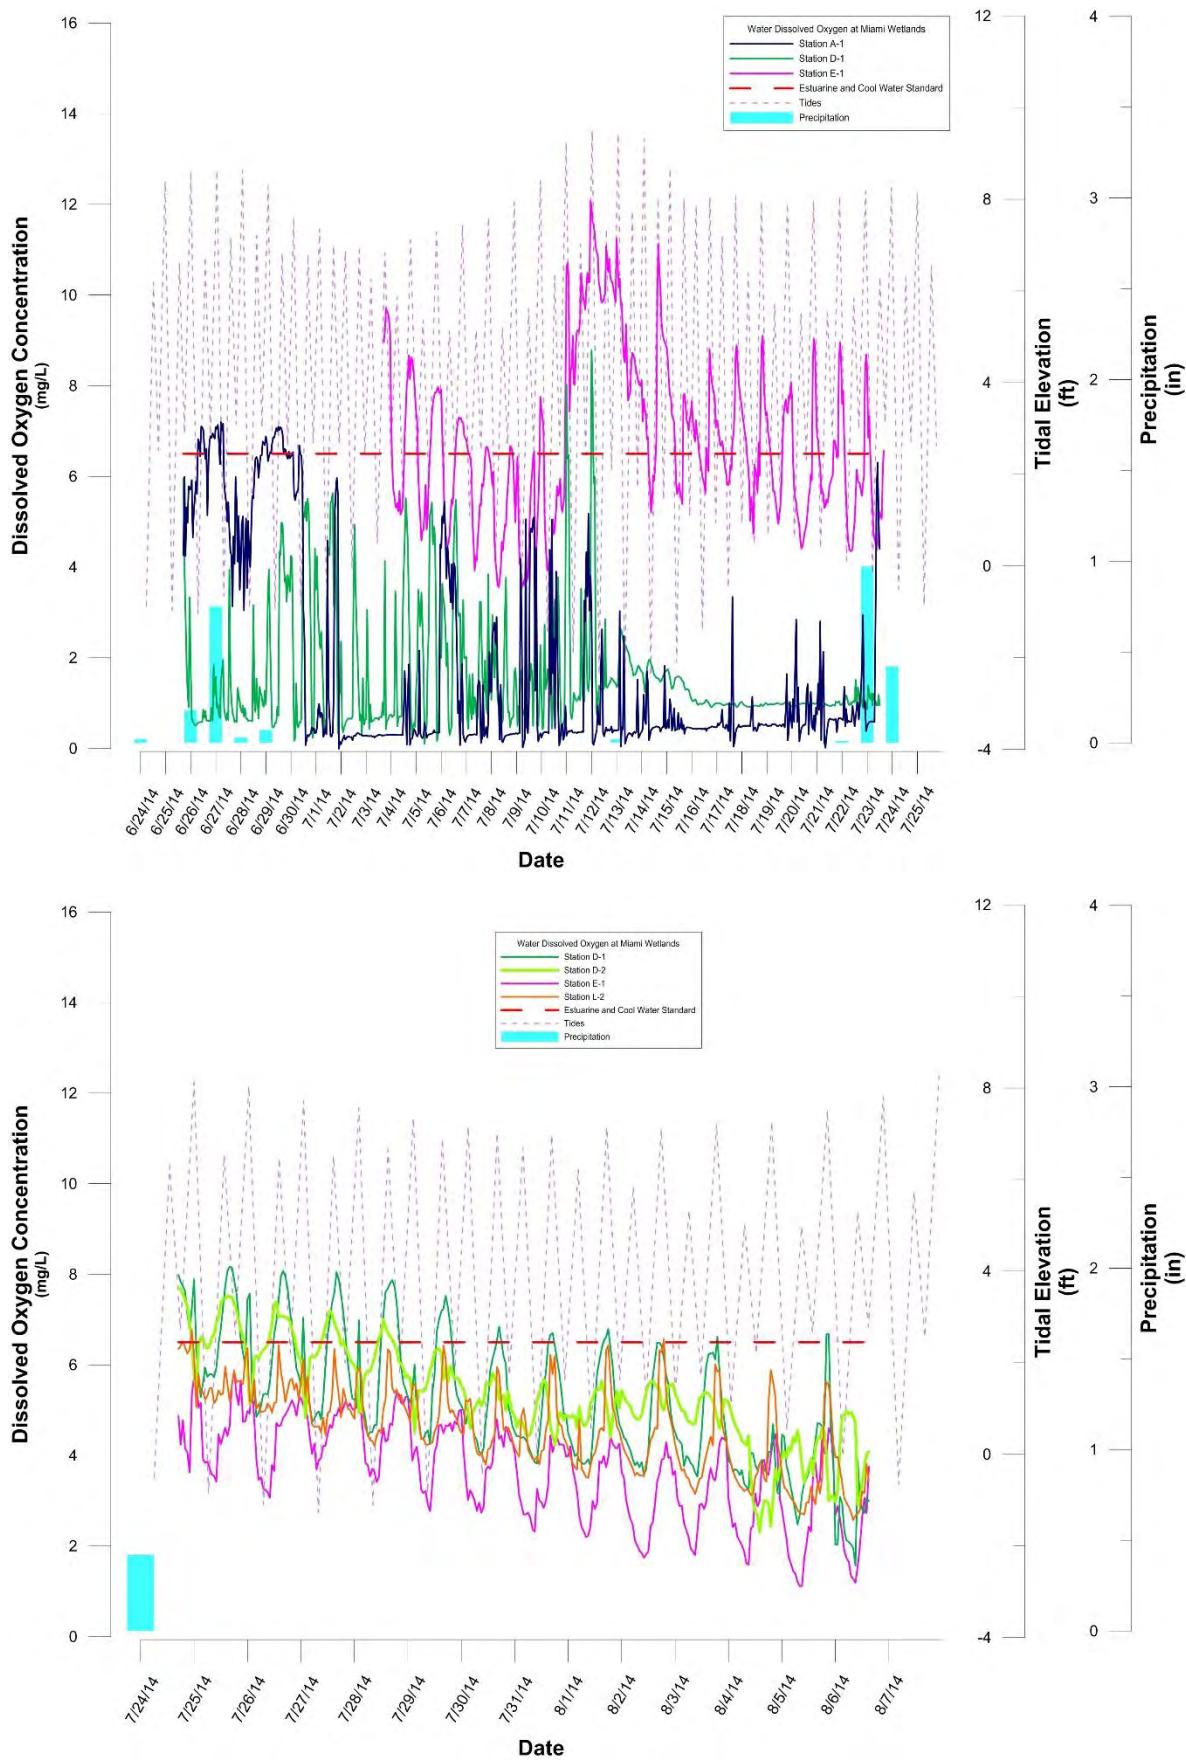
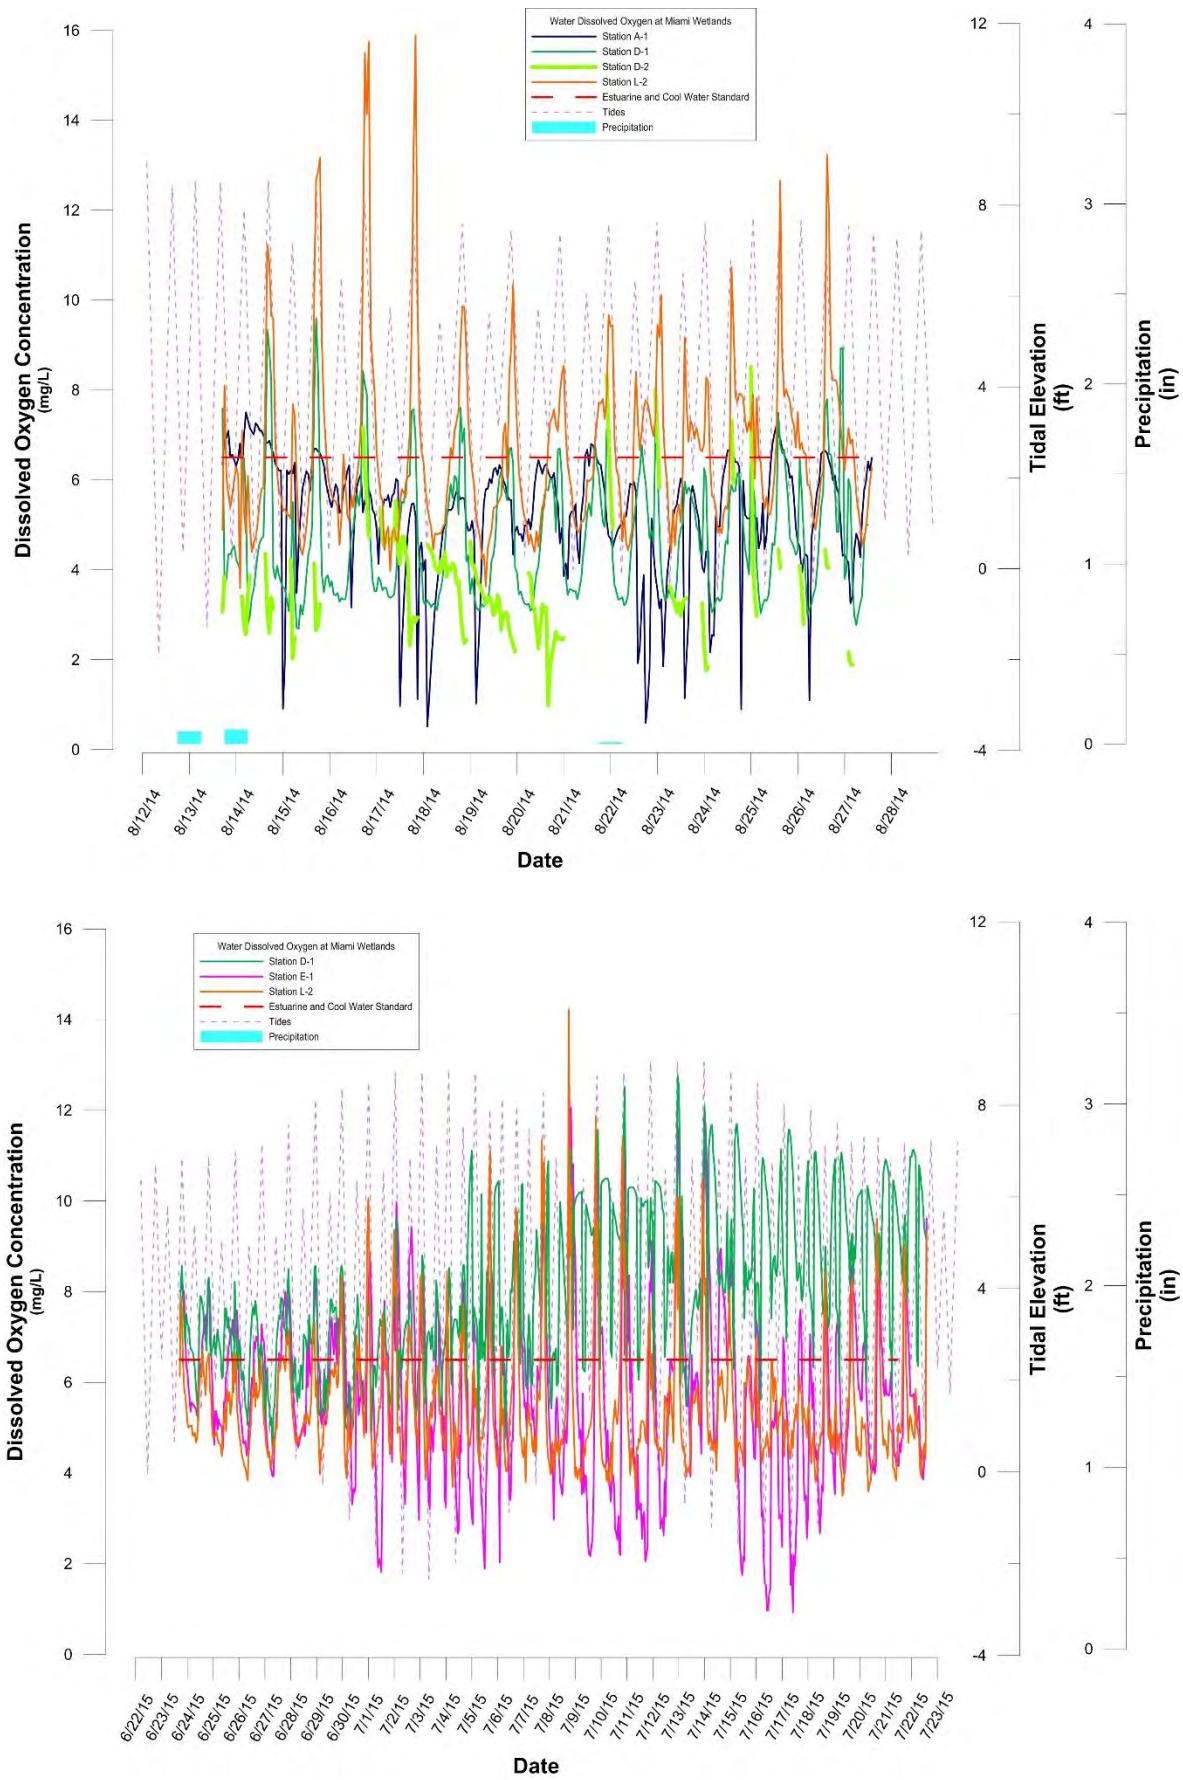
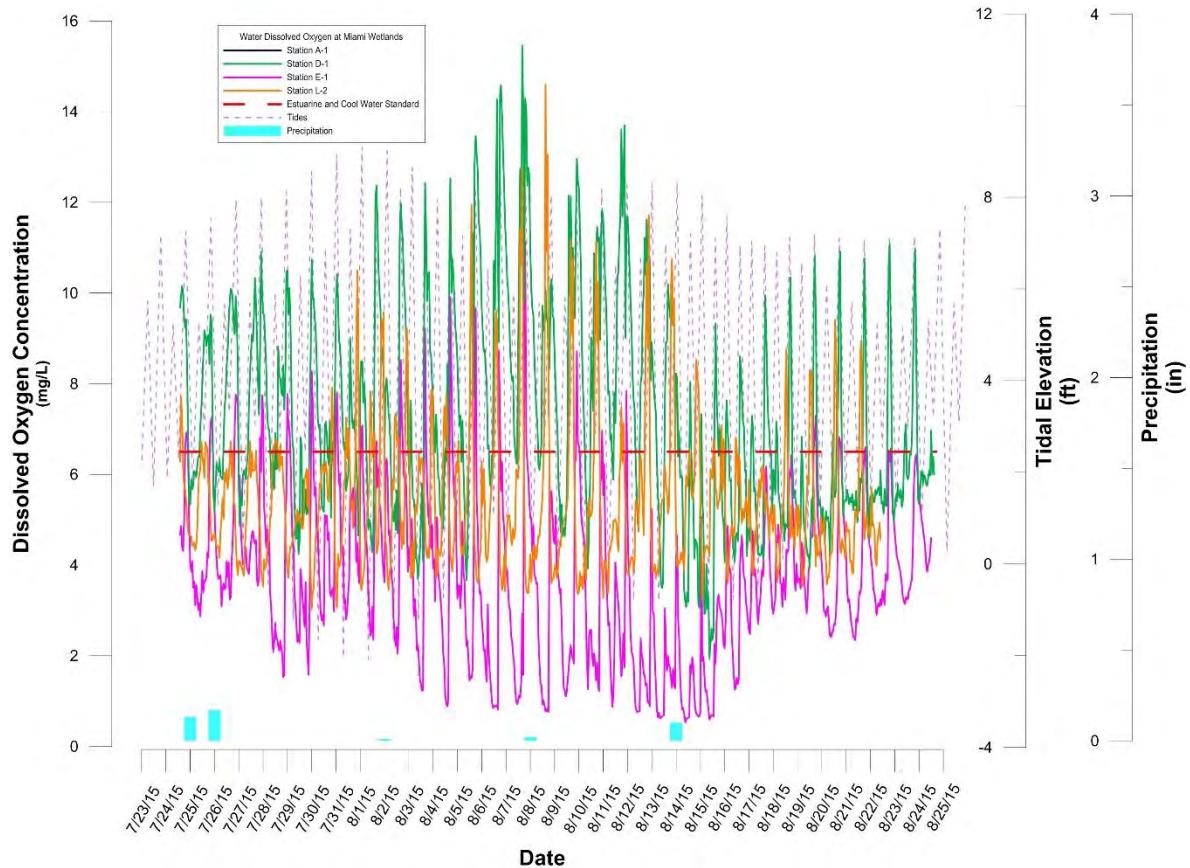
Figure E2. Graphs depicting post-restoration dissolved oxygen levels in constructed channels at the Miami Wetlands during summer 2012-2016. Precipitation and tidal data also included. Discontinuous lines indicate missing data due to low water levels.

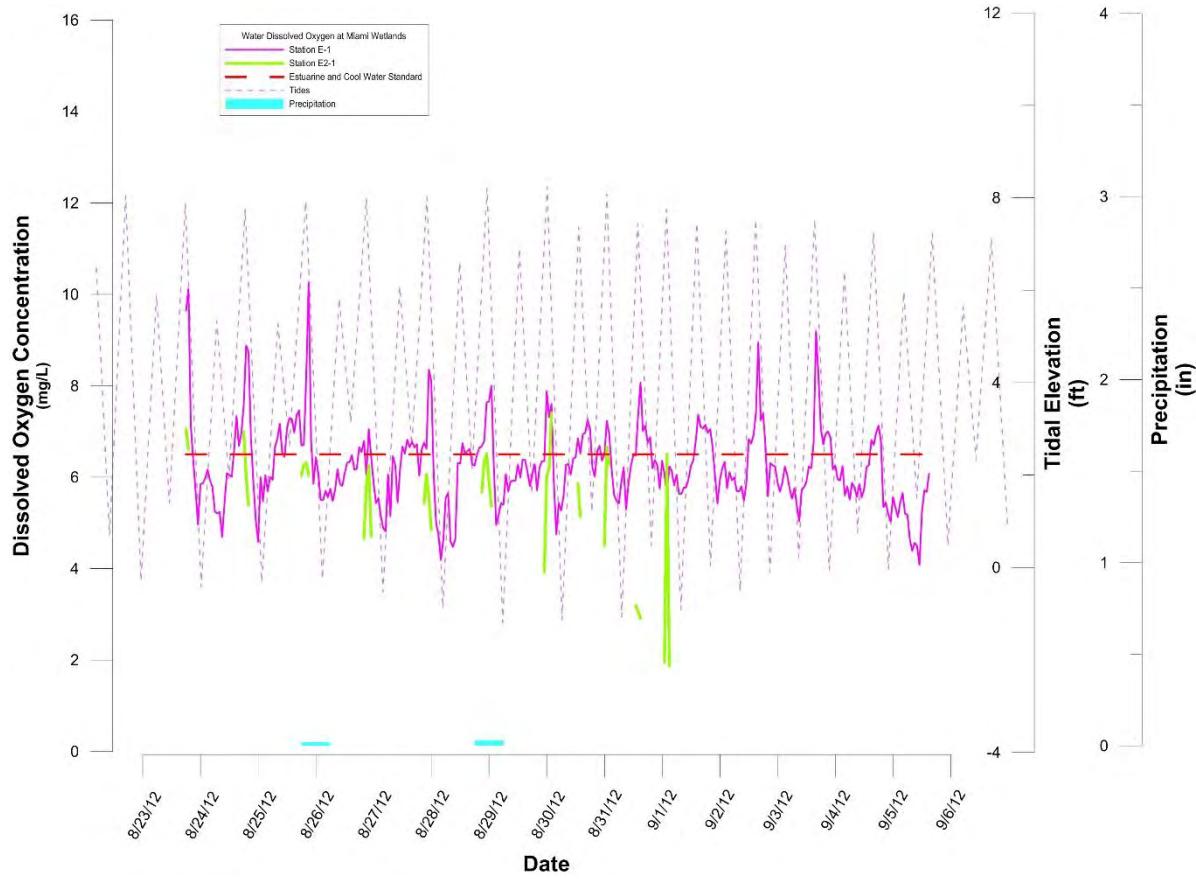
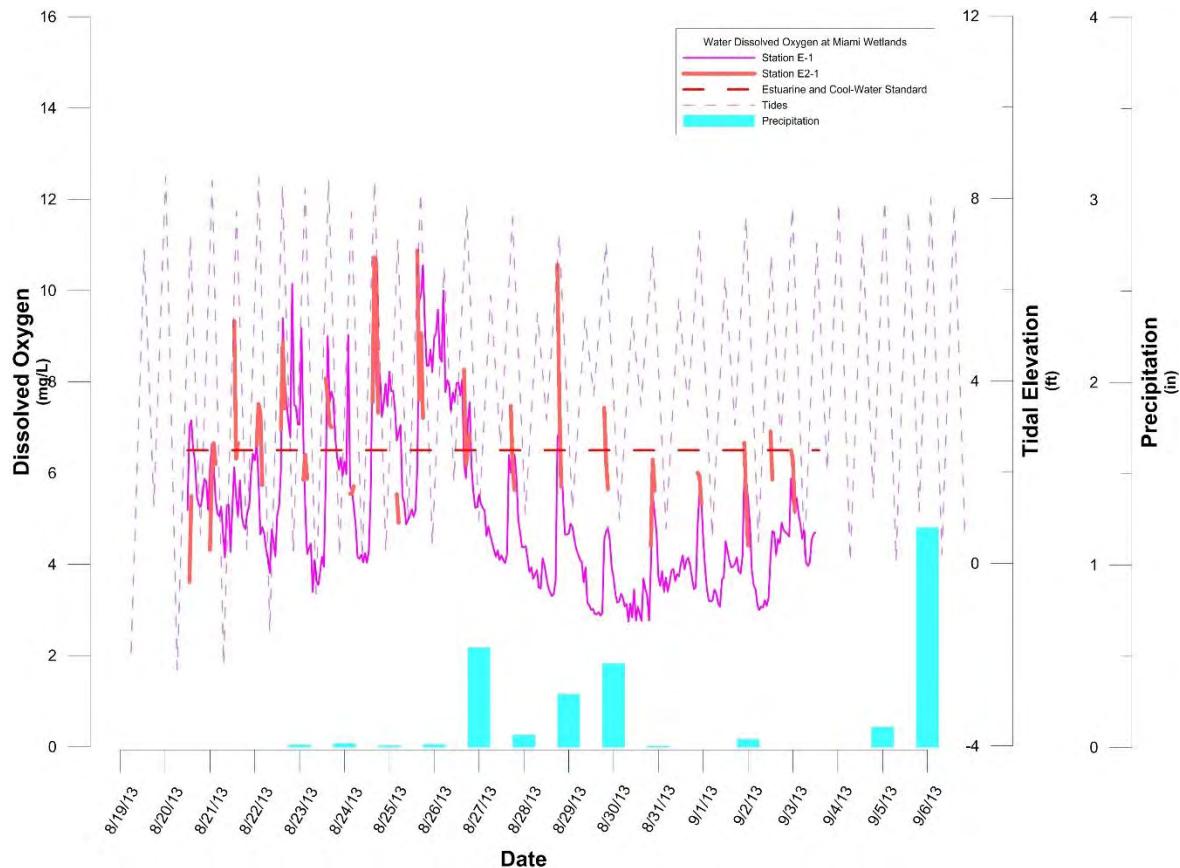
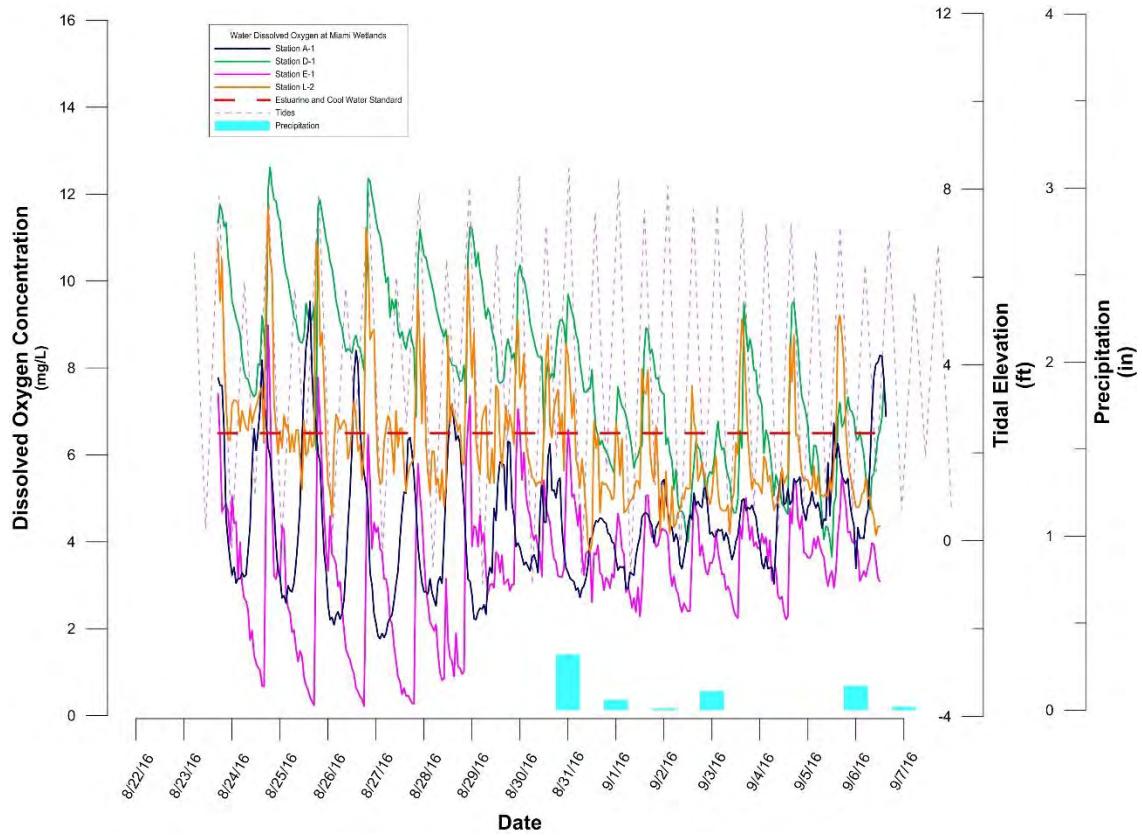
Figure E3. Graphs depicting post-restoration dissolved oxygen levels in constructed channels at the Miami Wetlands during fall 2012-2016. Precipitation and tidal data also included. Discontinuous lines indicate missing data due to low water levels.

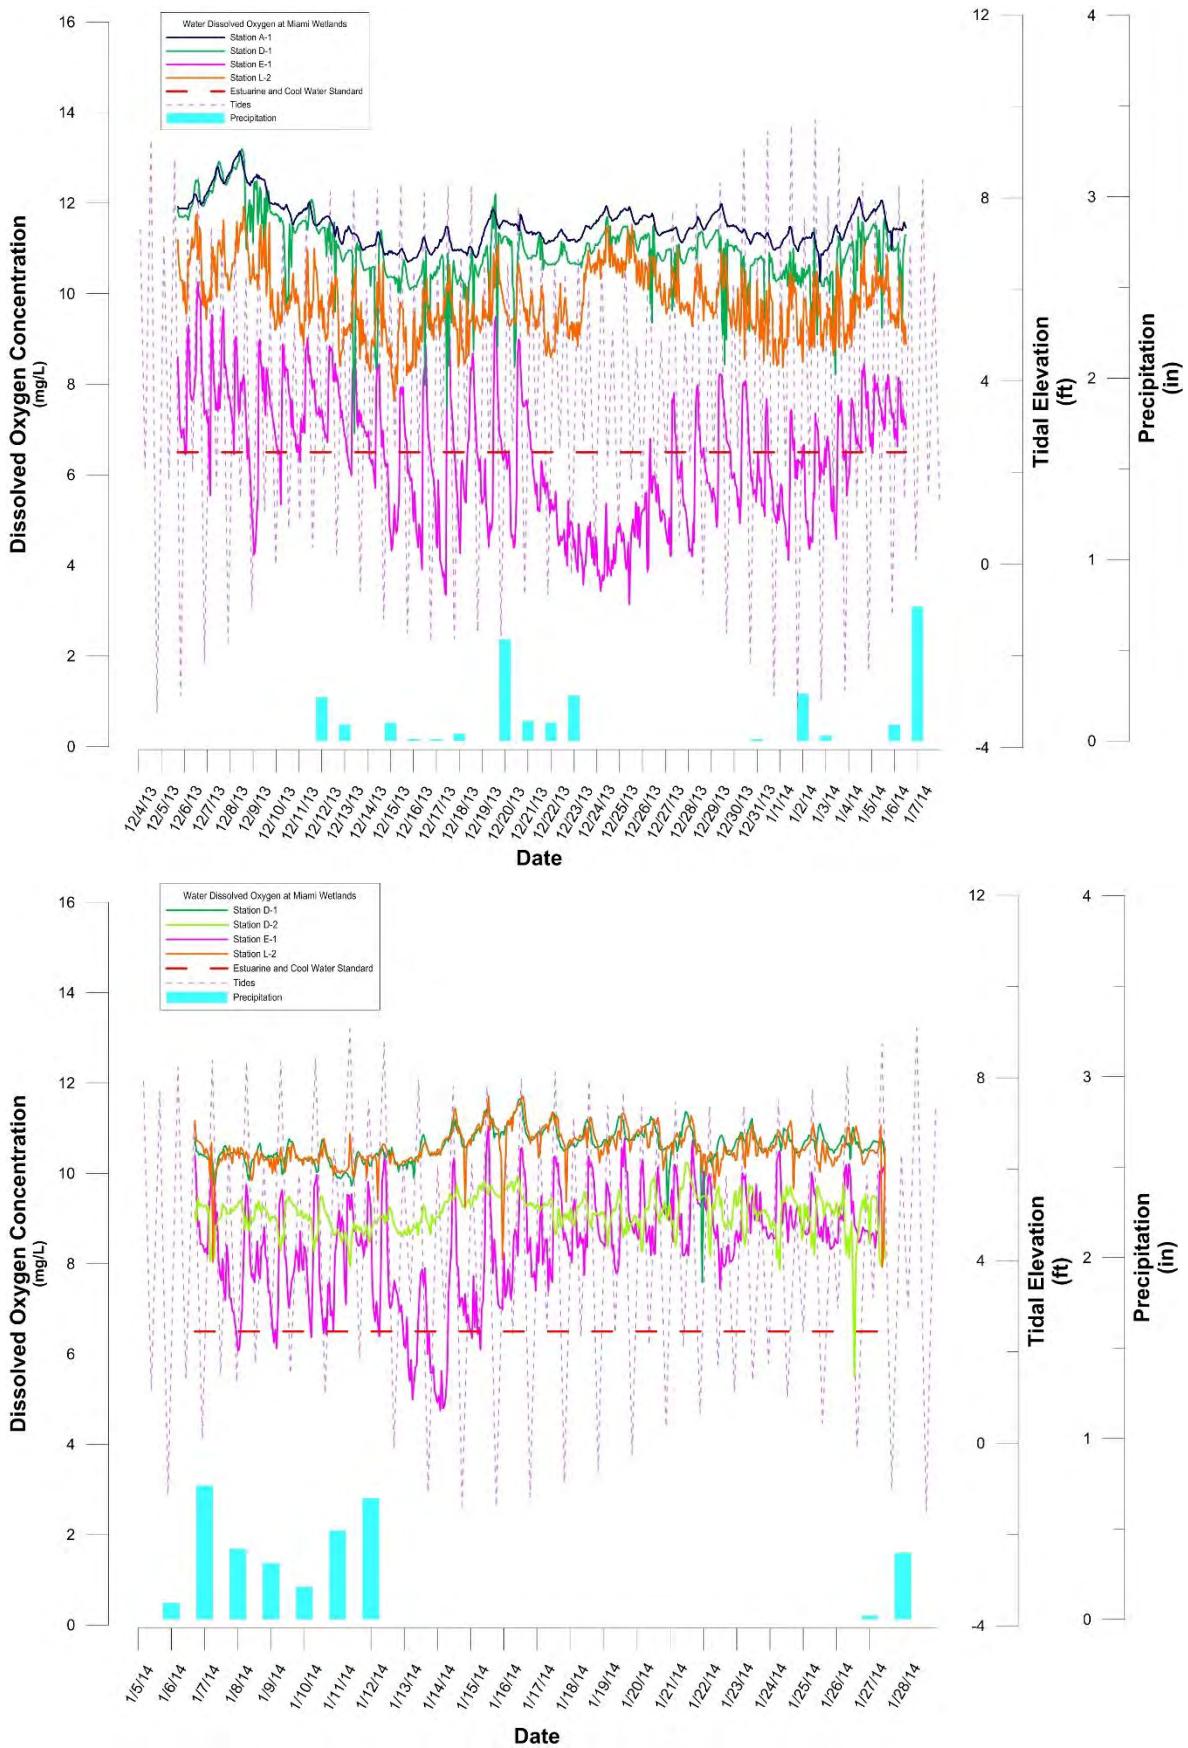
Figure E4. Graphs depicting post-restoration dissolved oxygen levels in constructed channels at the Miami Wetlands during winter 2012-2016. Precipitation and tidal data also included. Discontinuous lines indicate missing data due to low water levels.

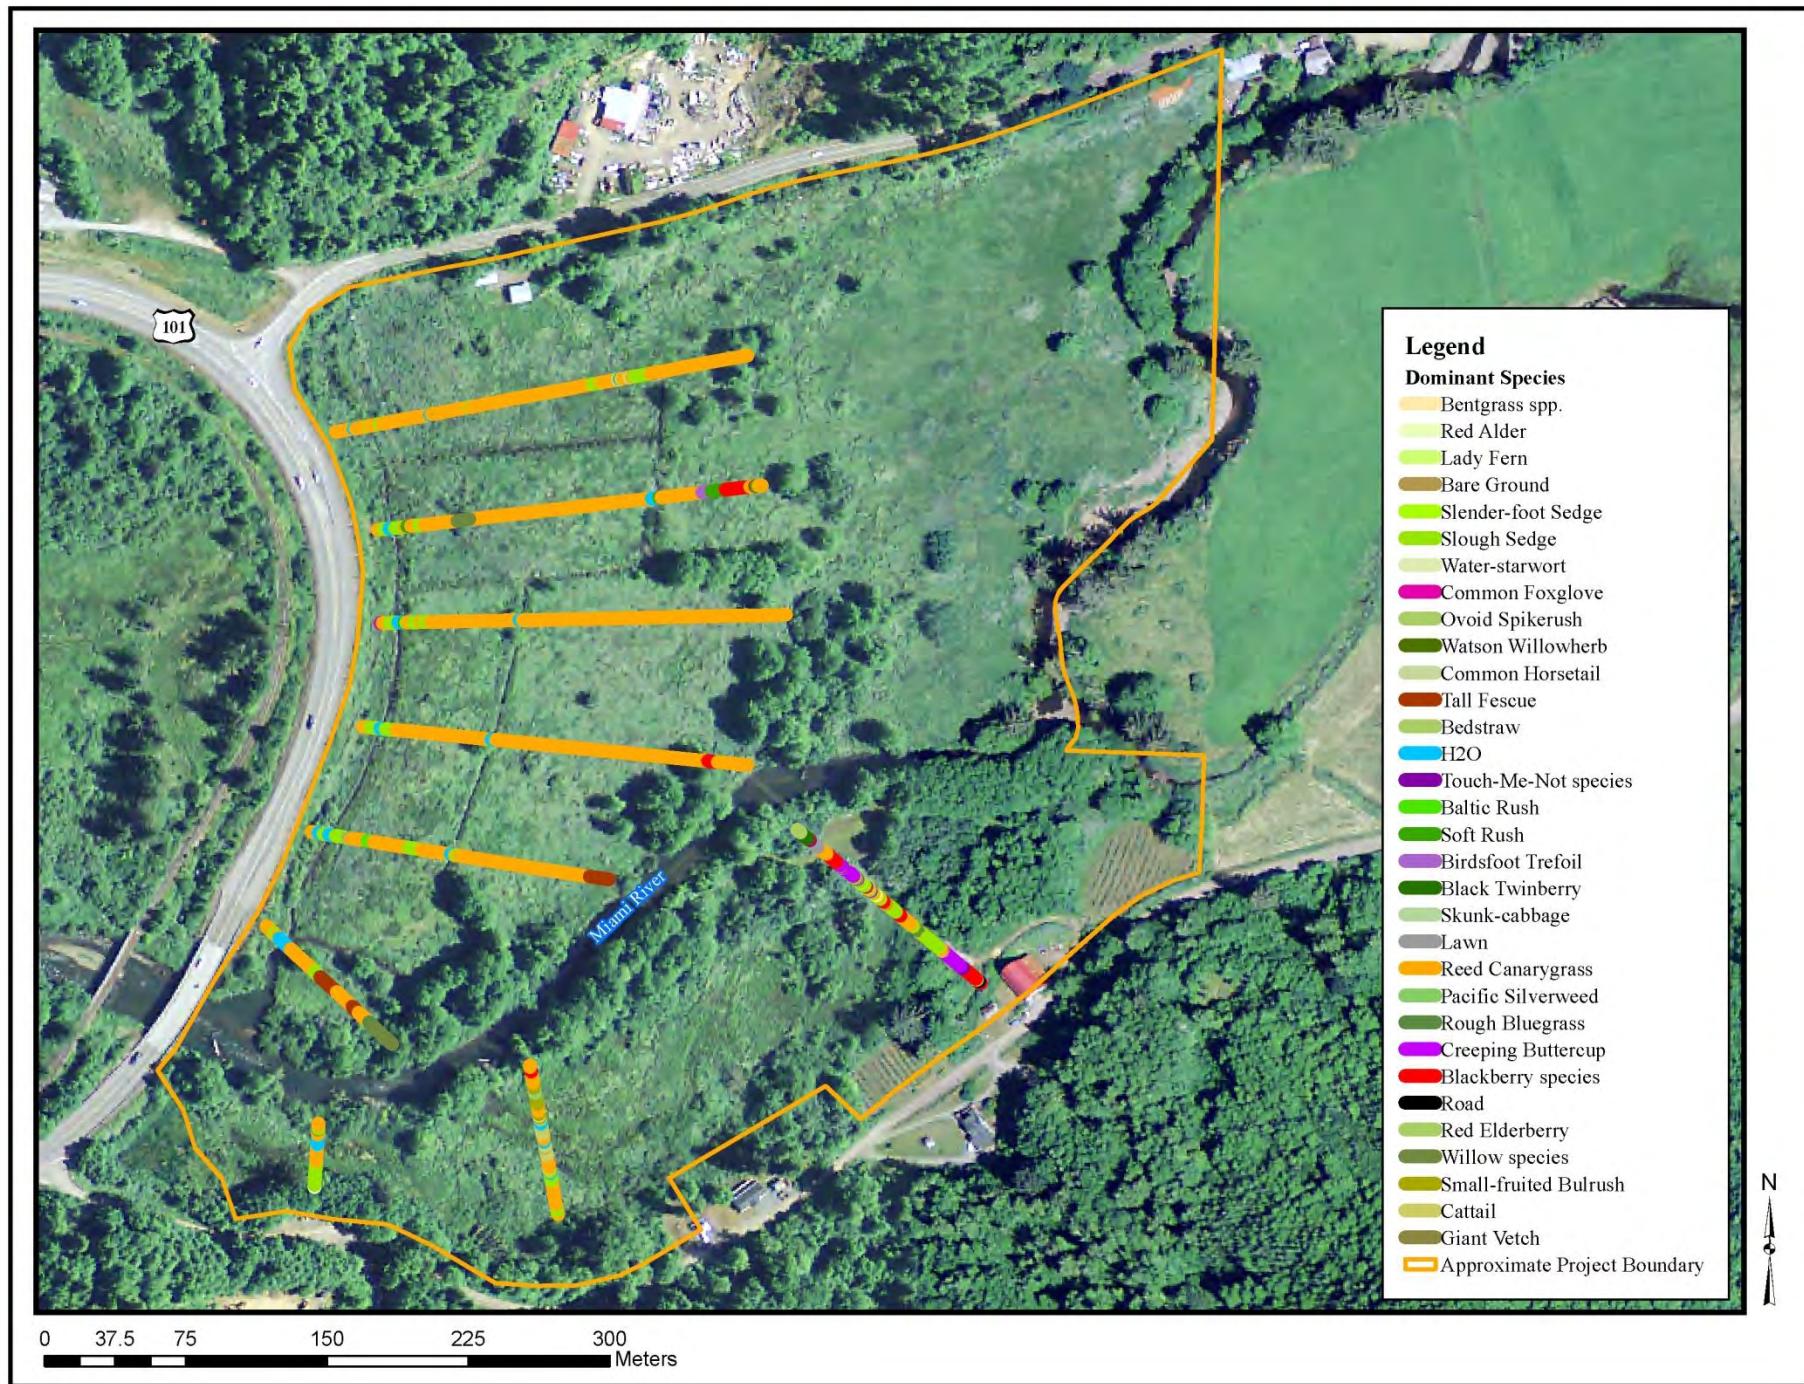
Figure I1. Aerial photograph of Miami Wetlands Restoration Project site with segmented polylines depicting 2010 pre-construction line intercept data. Non-native or invasive species are depicted in shades of red, purple and orange, while native species are greens. 2009 base image.
