Appendix A

Graphs depicting water levels at Miami Wetlands from March 2008 through February 2017

Miami Wetlands Restoration Site

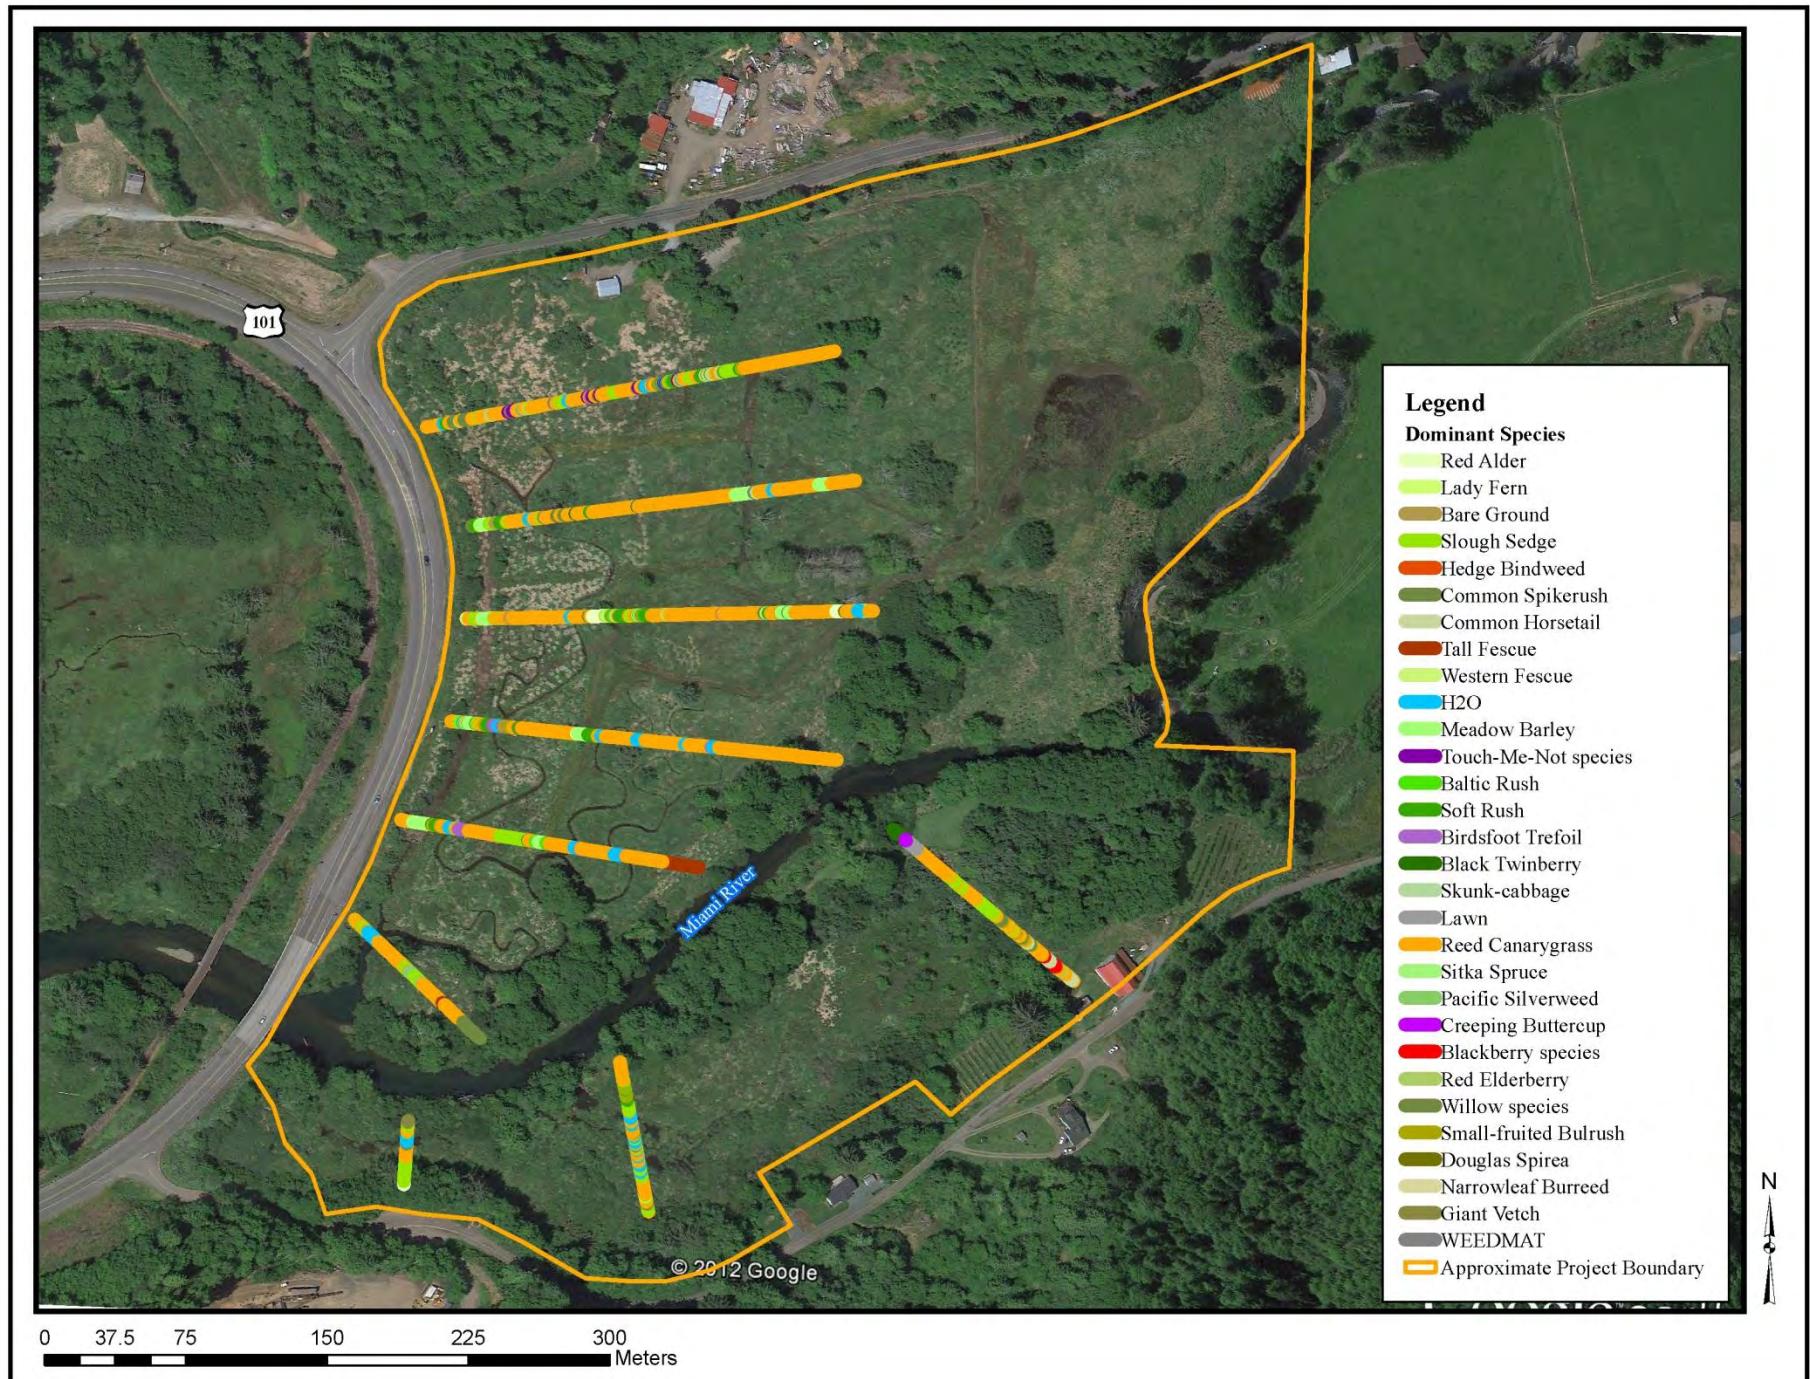
Figure I2. Aerial photograph of Miami Wetlands Restoration Project site with segmented polylines depicting 2012 post- construction line intercept data. Non-native or invasive species are depicted in shades of red, purple and orange, while native species are greens. 2012 base image.

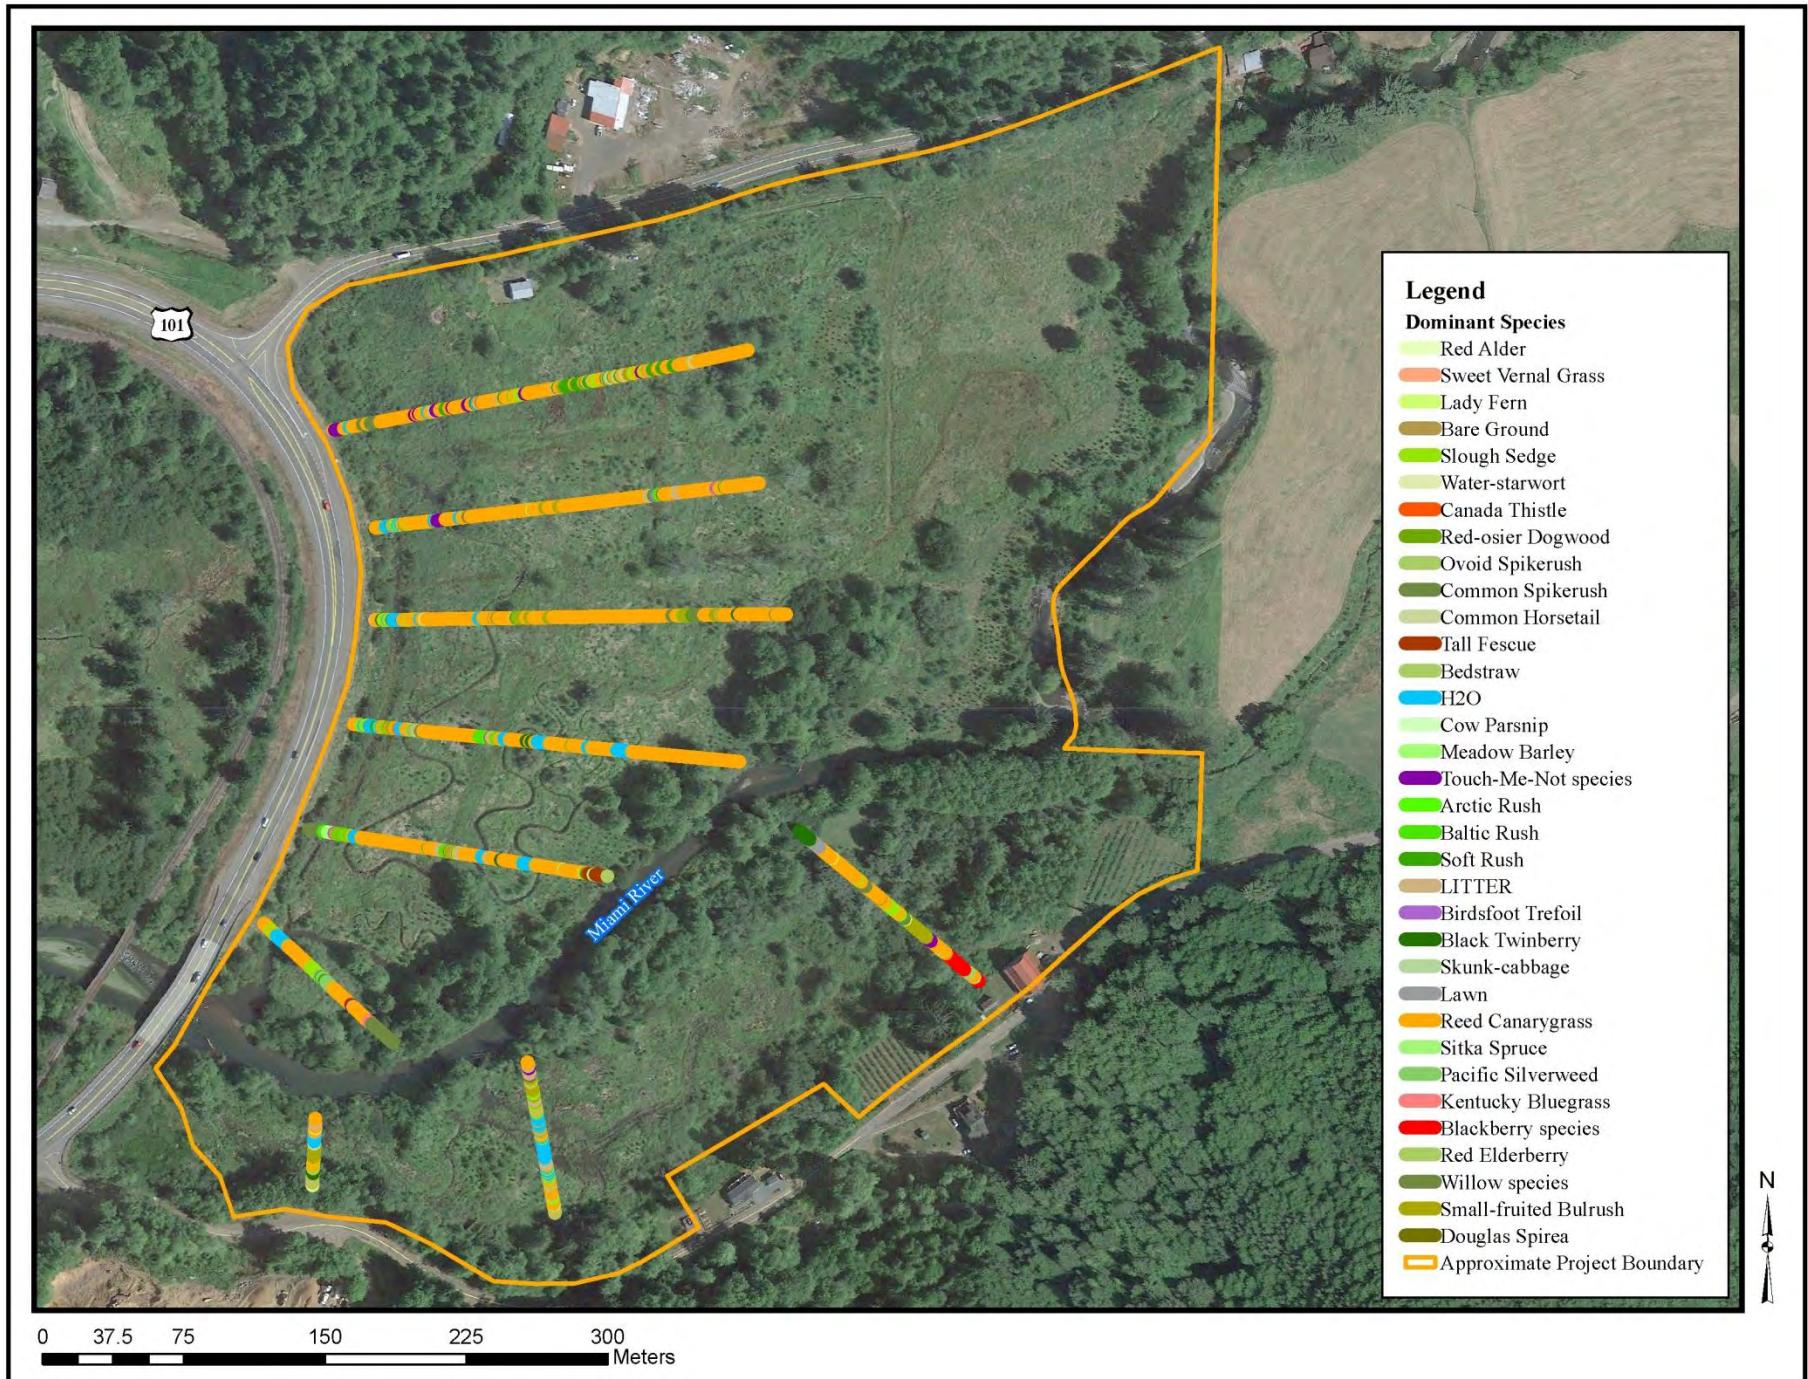
Figure I3. Aerial photograph of Miami Wetlands Restoration Project site with segmented polylines depicting 2014 post-construction line intercept data. Non-native or invasive species are depicted in shades of red, purple and orange, while native species are greens. 2014 base image.

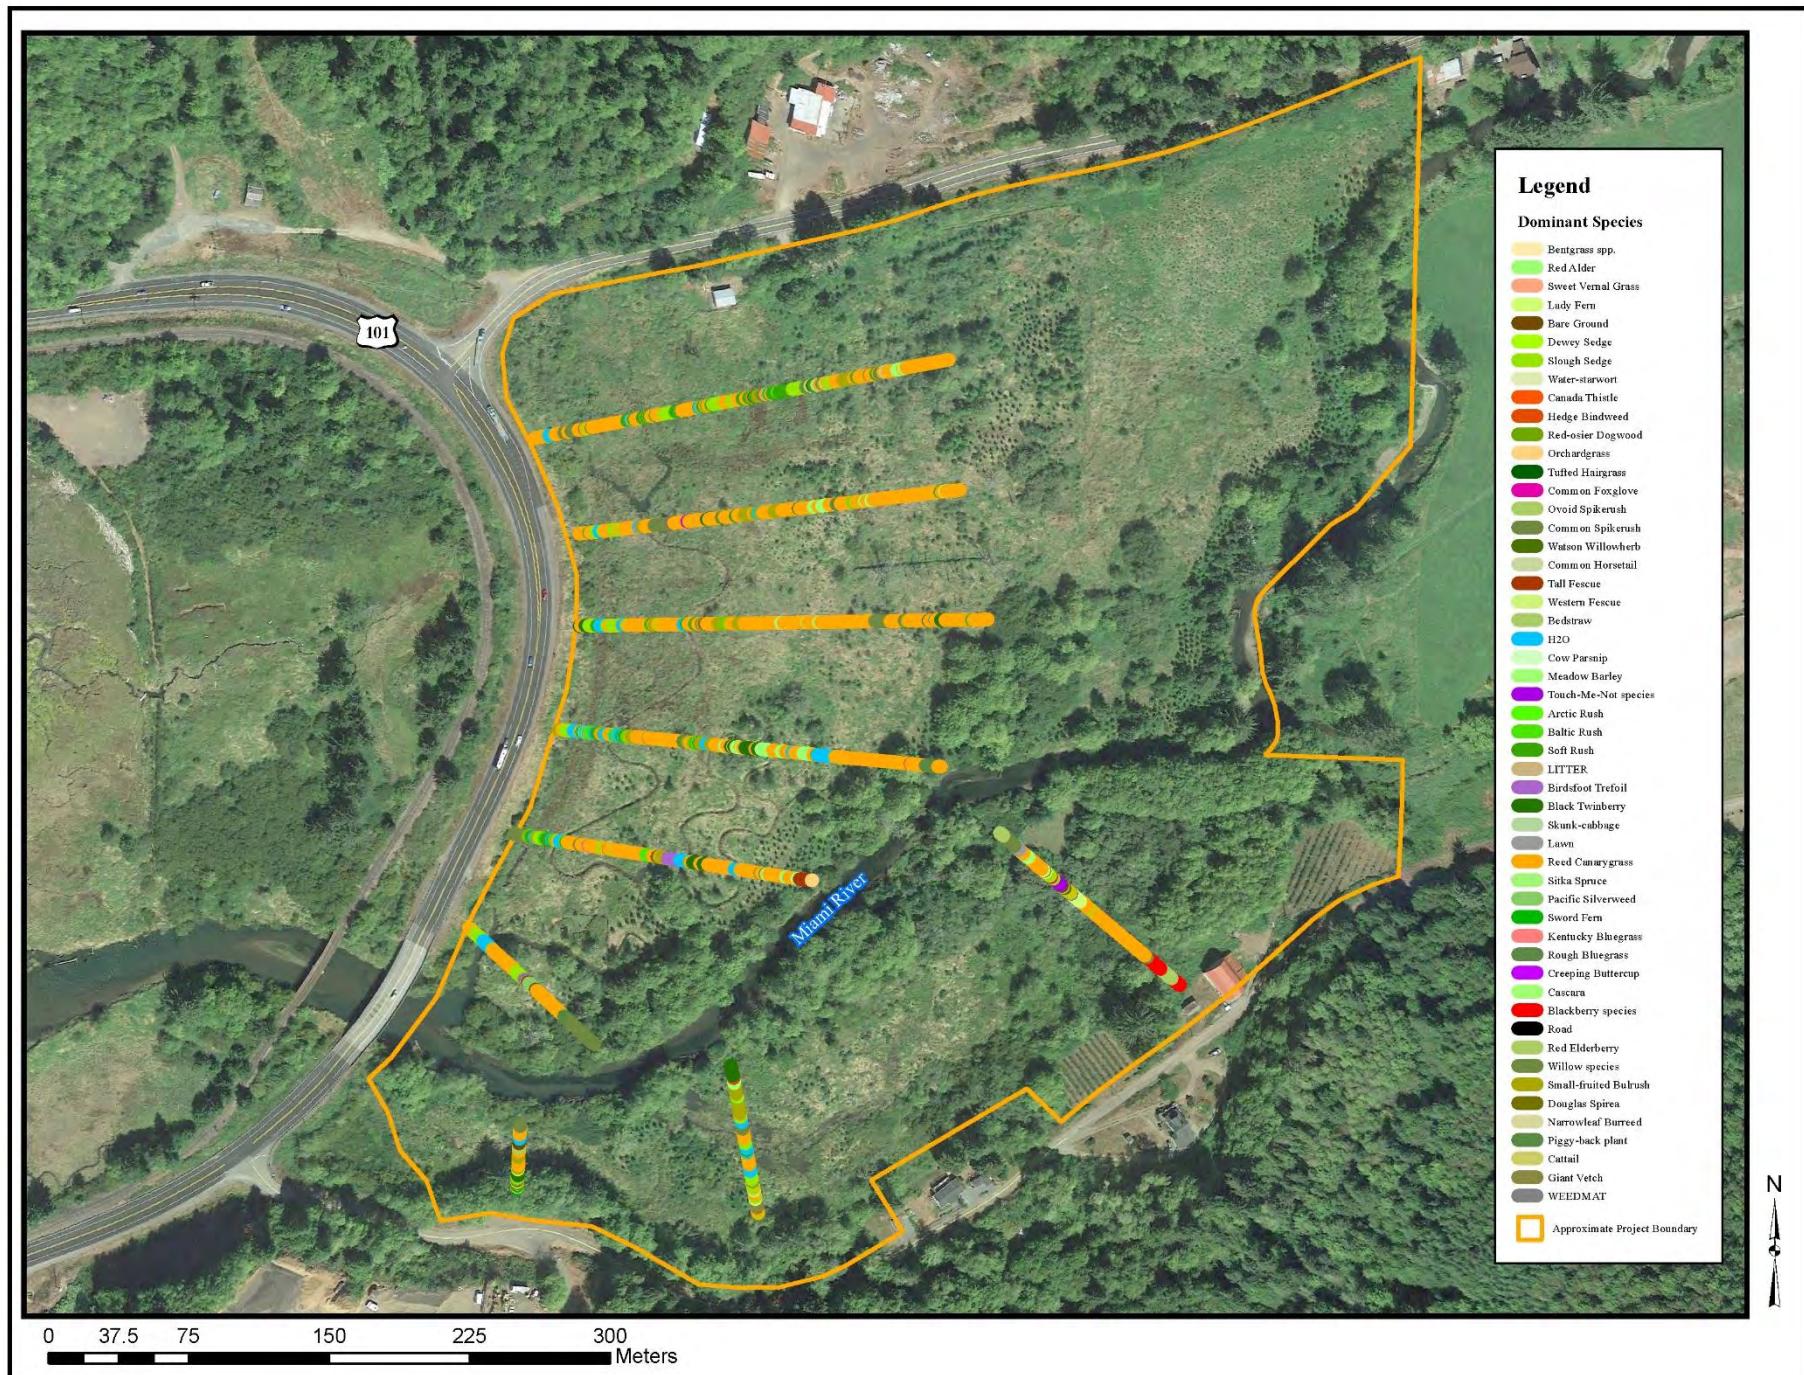
Figure I4. Aerial photograph of Miami Wetlands Restoration Project site with segmented polylines depicting 2016 post- construction line intercept data. Non-native or invasive species are depicted in shades of red, purple and orange, while native species are greens. 2016 base image.
