# Miami Wetlands Enhancement Project: Six-Year Post-Implementation Monitoring Report

**Tillamook  
Estuaries  
Partnership**

Prepared by  
Scott Jay Bailey, Project Manager  
Tillamook Estuaries Partnership  
613 Commercial Street  
Garibaldi, Oregon 97118  
503-322-2222  
**November 2017**

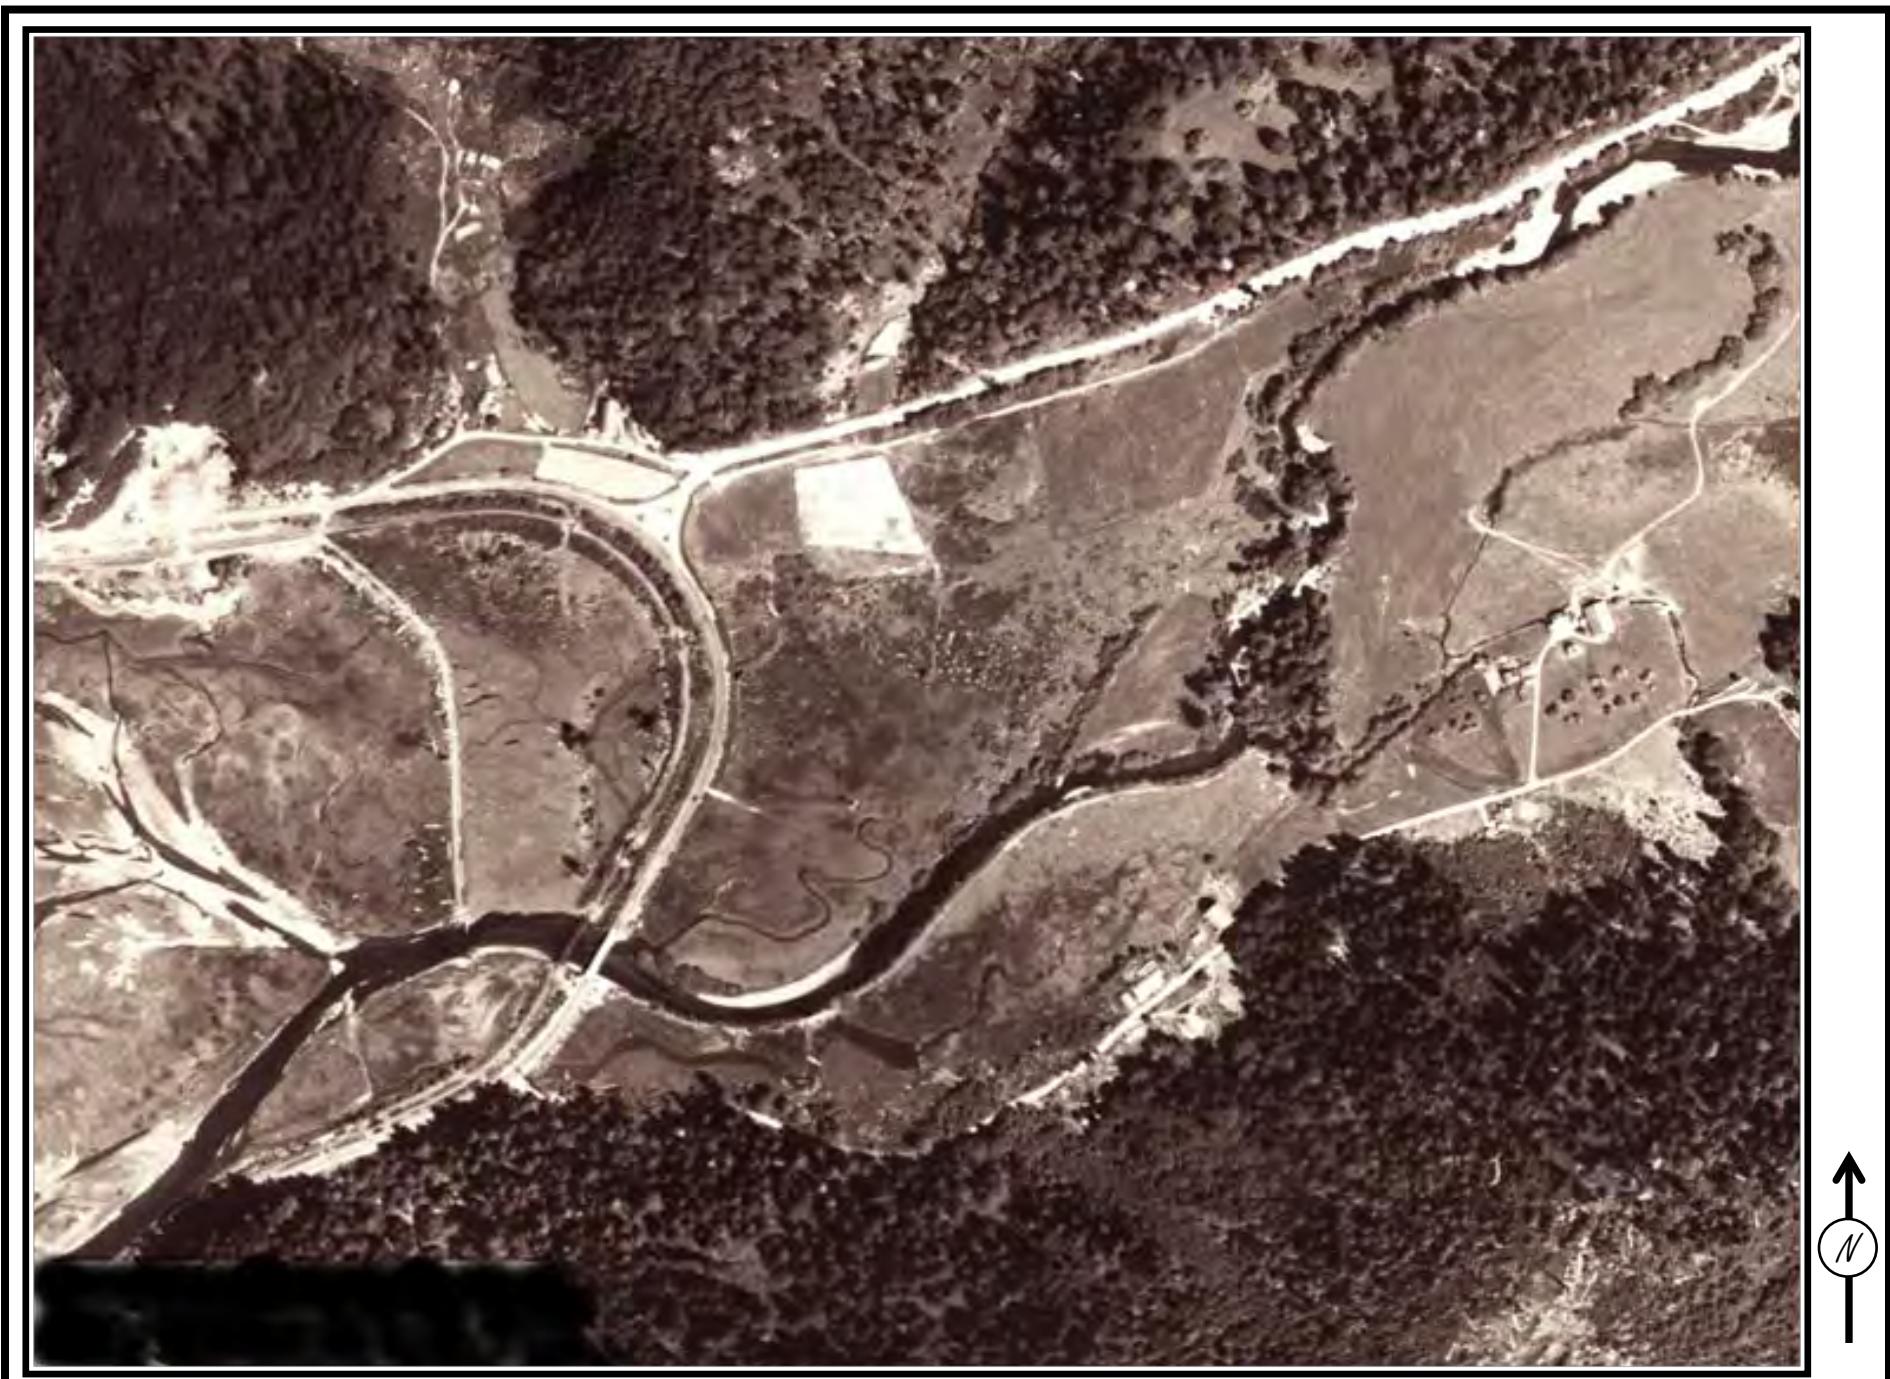
Figure 3. Historical aerial photograph of Miami Wetlands (ca. 1939). Note the U.S. Highway 101 and railroad rights-of-way, other road corridors and agricultural and residential development. Also note paucity of riparian vegetation along river. Photo not-to-scale.

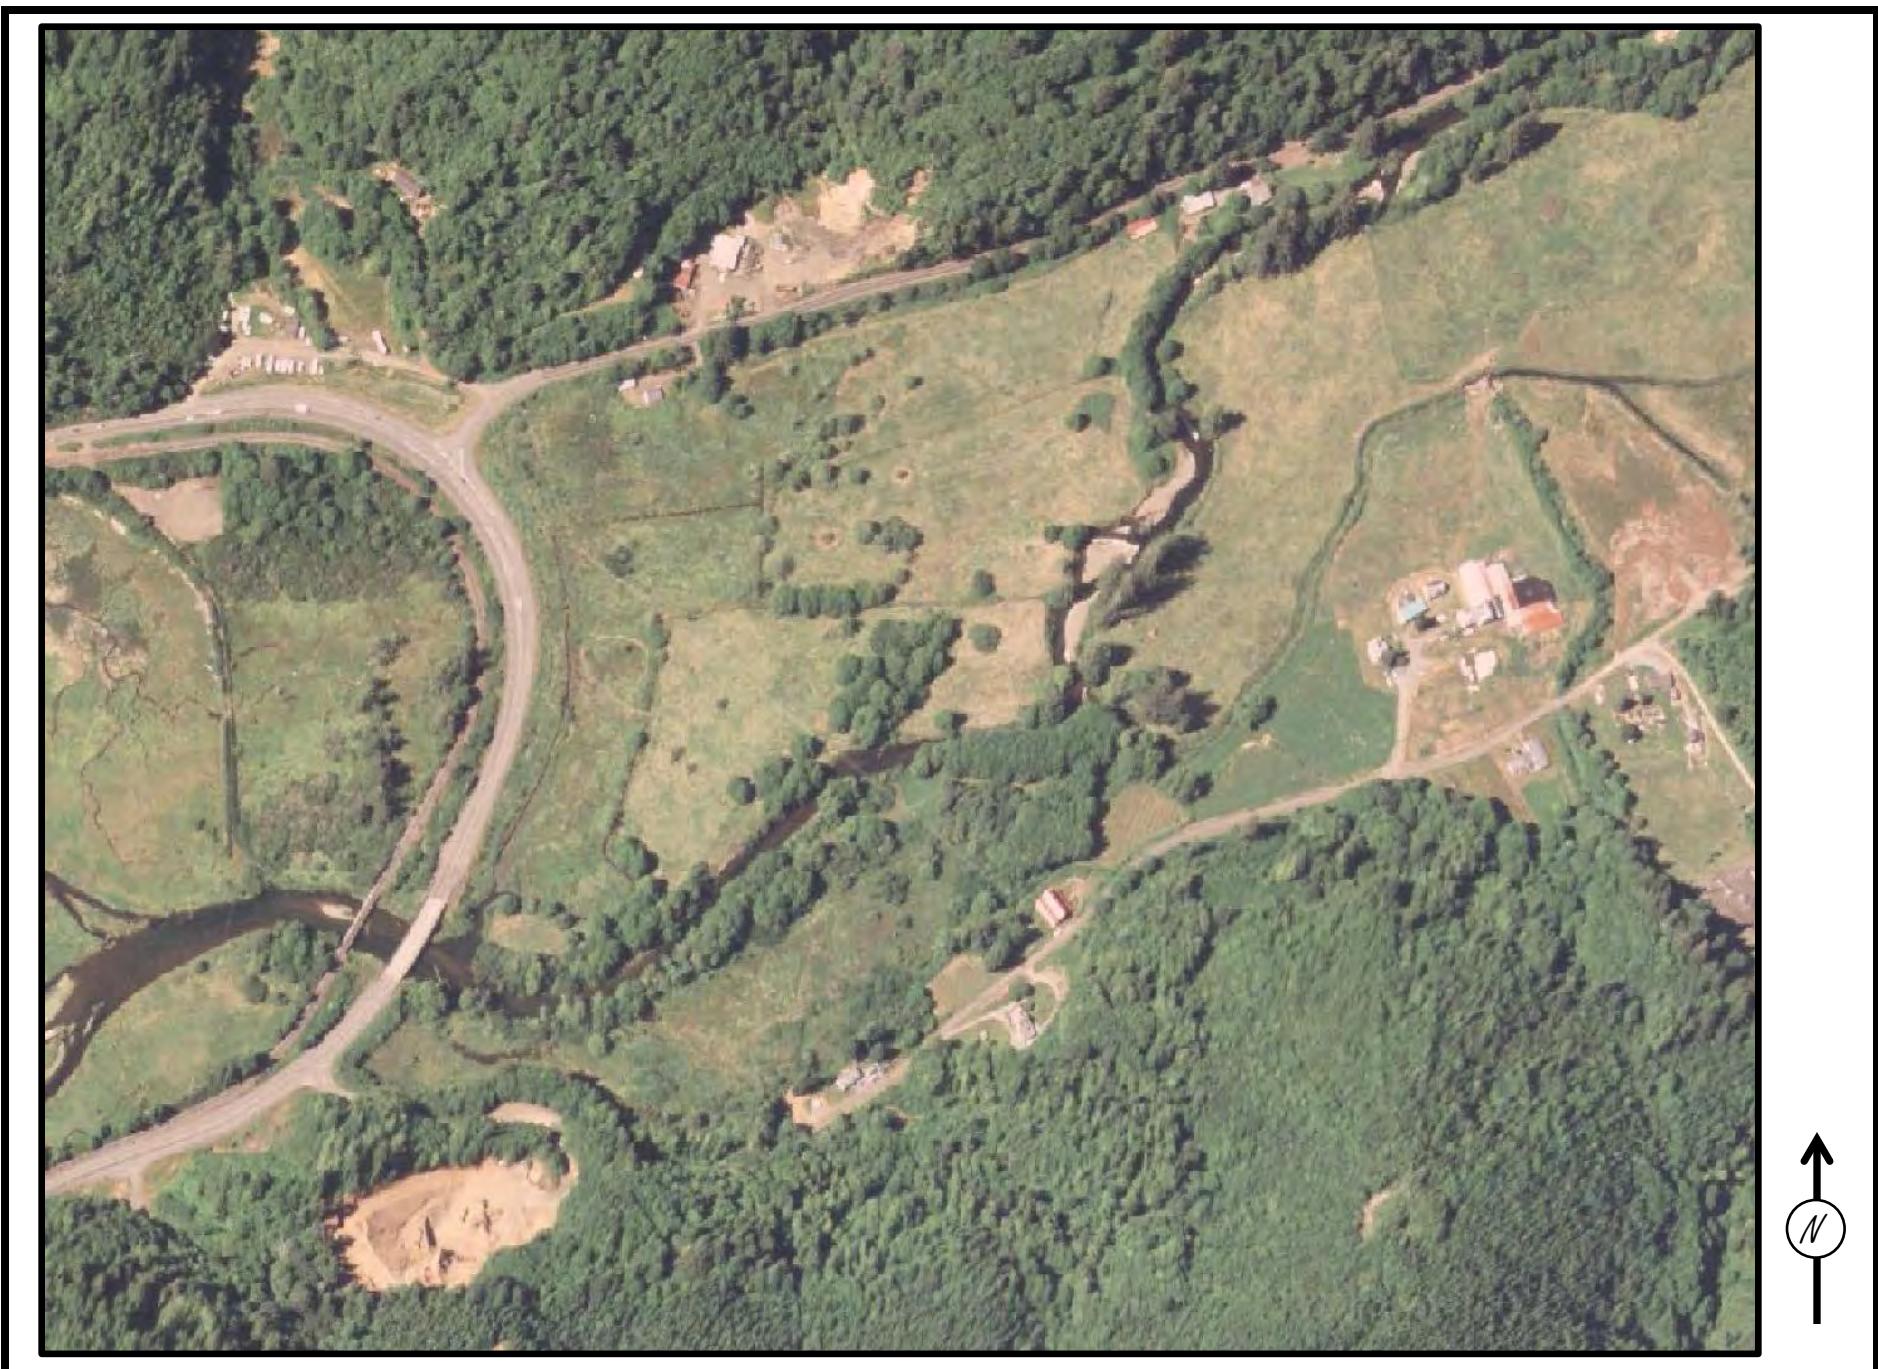
A more recent pre-project, aerial photo from 2005 is included as Figure 5. This photo depicts additional human alterations to the project area. Most notable are a network of drainage ditches, a house and detached garage on the TNC parcel and an overhead, utility corridor spanning the entire project area. Other changes from earlier conditions are also evident, including more riparian vegetation along the Miami River and reduced size and distinctiveness of the tidal channel and pond on the Crabb parcel (VAI [2008] speculated that this channel may have been widened and deepened to function as a log pond). We do not know exactly when the drainage ditch network was constructed. They are absent from the 1939 aerial, but are depicted on a 1985 U.S. Geological Survey topographic map of the area (Figure 2), so it is likely that they were constructed during the mid-1900's. Modern-looking, flexible, perforated, plastic drainpipes unearthed during the construction phase of the wetland enhancement project indicate that actions designed to facilitate drainage of the site continued into the latter 20<sup>th</sup> century. The Hobson-Struby channel paralleling Highway 101 is clearly evident in the 2005 photograph.

Figure 5. Pre-project aerial photograph of Miami Wetlands (ca. 2005). Note the two structures, the network of drainage ditches and the Hobson-Struby channel on the northern parcel. Also note the overhead utility corridor running southeast to northwest across the entire project area and the increase in riparian vegetation along the river as compared to Figure 3. Photo not-to-scale.
