Tillamook Estuaries Partnership

Volunteer Water Quality Monitoring Program

Bacteria Status and Trends Analysis

September 5th, 2018

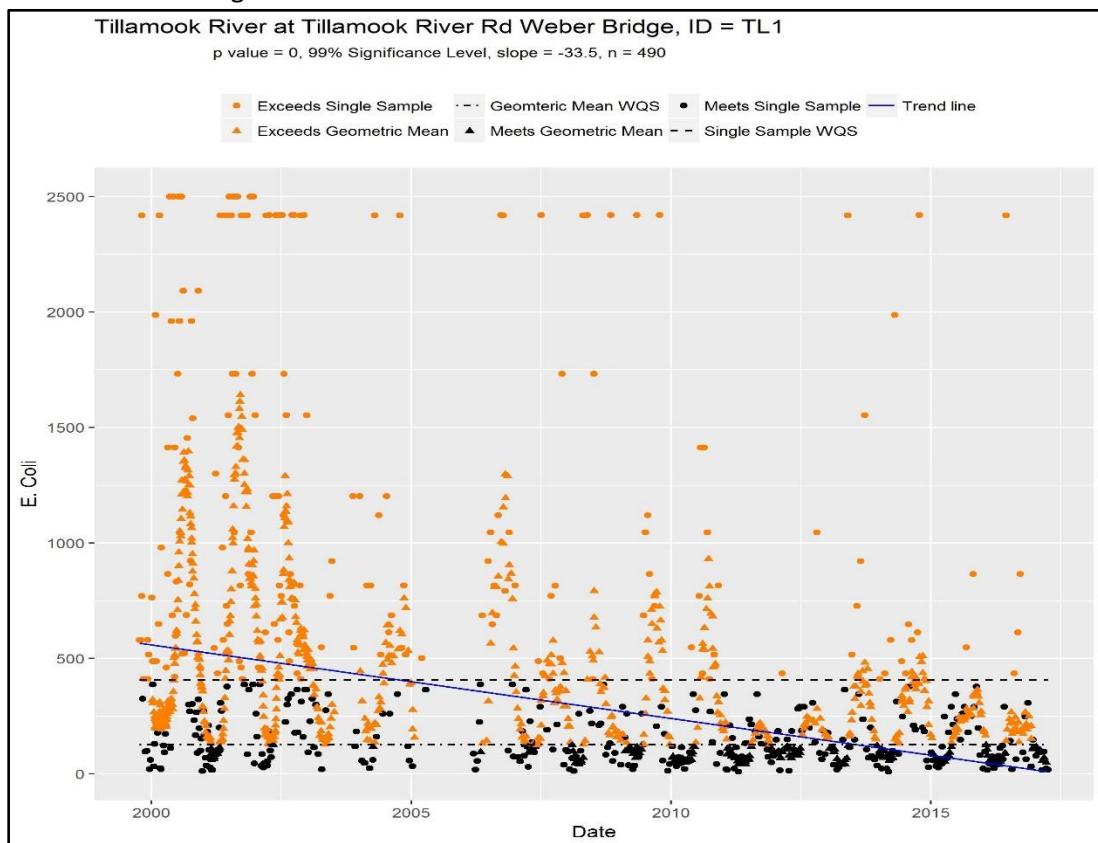
Figure 1. Seasonal Kendall analysis of bacteria concentration trends at Weber Bridge, Tillamook River (2000 – 2017)

Negative slope (-33.5) with 99% significance level indicates a statistically significant decrease in bacteria concentration, which means water quality is improving.

Once the status of a site is determined, DEQ uses “R” to conduct a Seasonal Kendall regression analyses on the entire bacteria concentration dataset available for each individual site (Figure 1). The data available for an individual site range from 1997 for sites on the Wilson River to as recently as 2013 for sites on the Sand Lake Estuary (Appendix B). The confidence interval for the trend analysis increases with the number of years of data included in the analysis. Generally, DEQ requires at least 8 years of

The Seasonal Kendall regression calculates slope, which indicates the change in bacteria concentration over time: a negative (positive) slope means the bacteria concentrations are decreasing (increasing) and water quality is improving (declining). Statistically significant bacteria trends ($\geq 80\%$ significance level) are represented by downward pointing (\downarrow) and upward pointing (\uparrow) arrows in an infographic to communicate results of the analysis (Figure 2). If the slope is less than 2 counts in either direction for a give site, the bacterial concentration is consider steady and is represented with a horizontal line (-). Season Kendall regression results by site are provided in Appendix C.

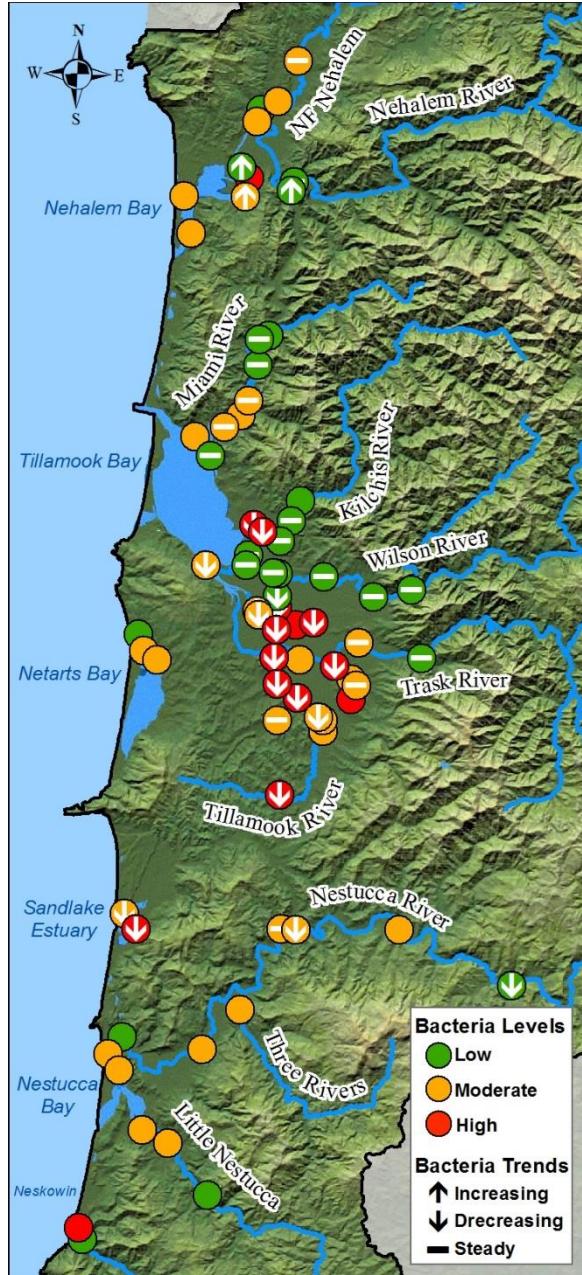
Figure 2. Bacteria levels and trends throughout Tillamook County.
