**US Army Corps
of Engineers®**
Portland District

Tillamook Bay and Estuary, Oregon General Investigation Feasibility Report

February 2005

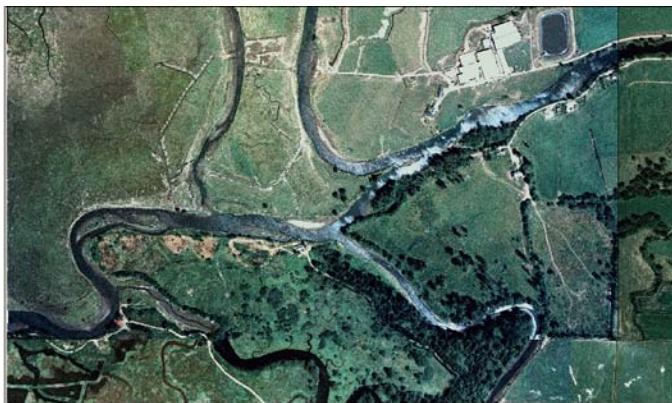
Figure 6. Diagram of Floodplain Mapping for Tillamook, Oregon

From the aerial photography, three-dimensional points were extracted.

From the three-dimensional points, a TIN was created.

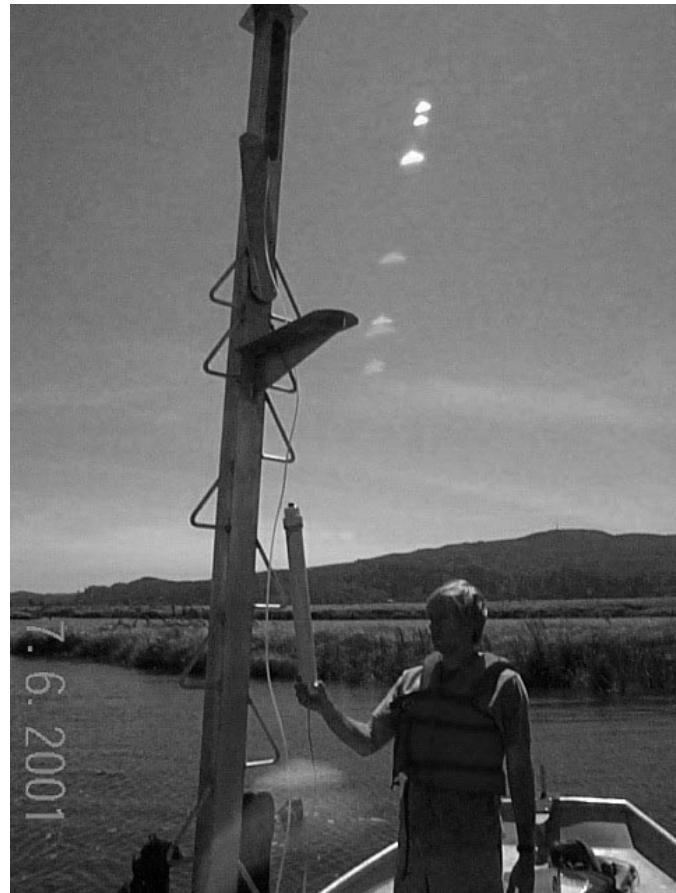
Figure 7. Tide Gauge on the Kilchis River at Kilchis Cove

Note logging device being held next to gauge housing.
Tidal range is approximately 10 feet at this location (Kilchis River at Kilchis Cove).

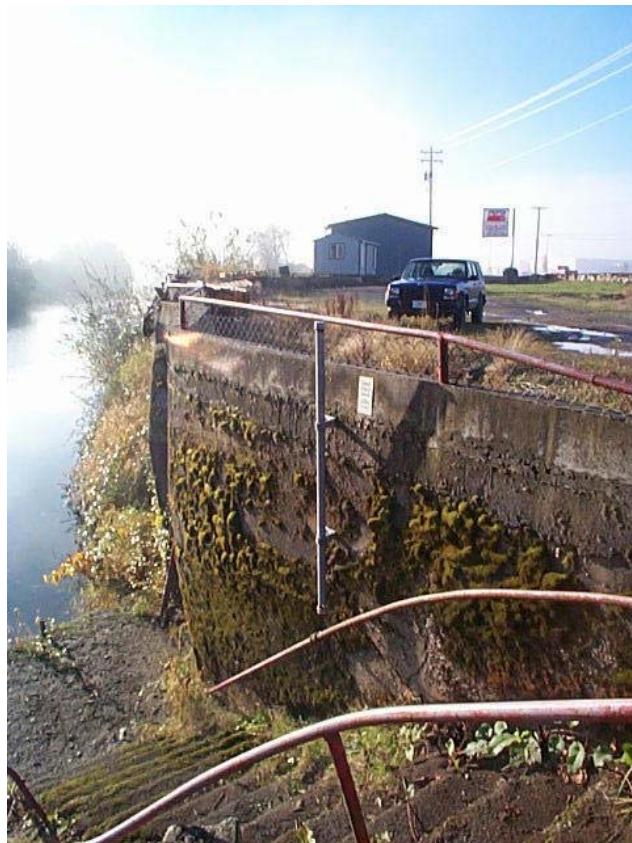
Figure 9. Crest Stage Gauge Located on the Lower Wilson River

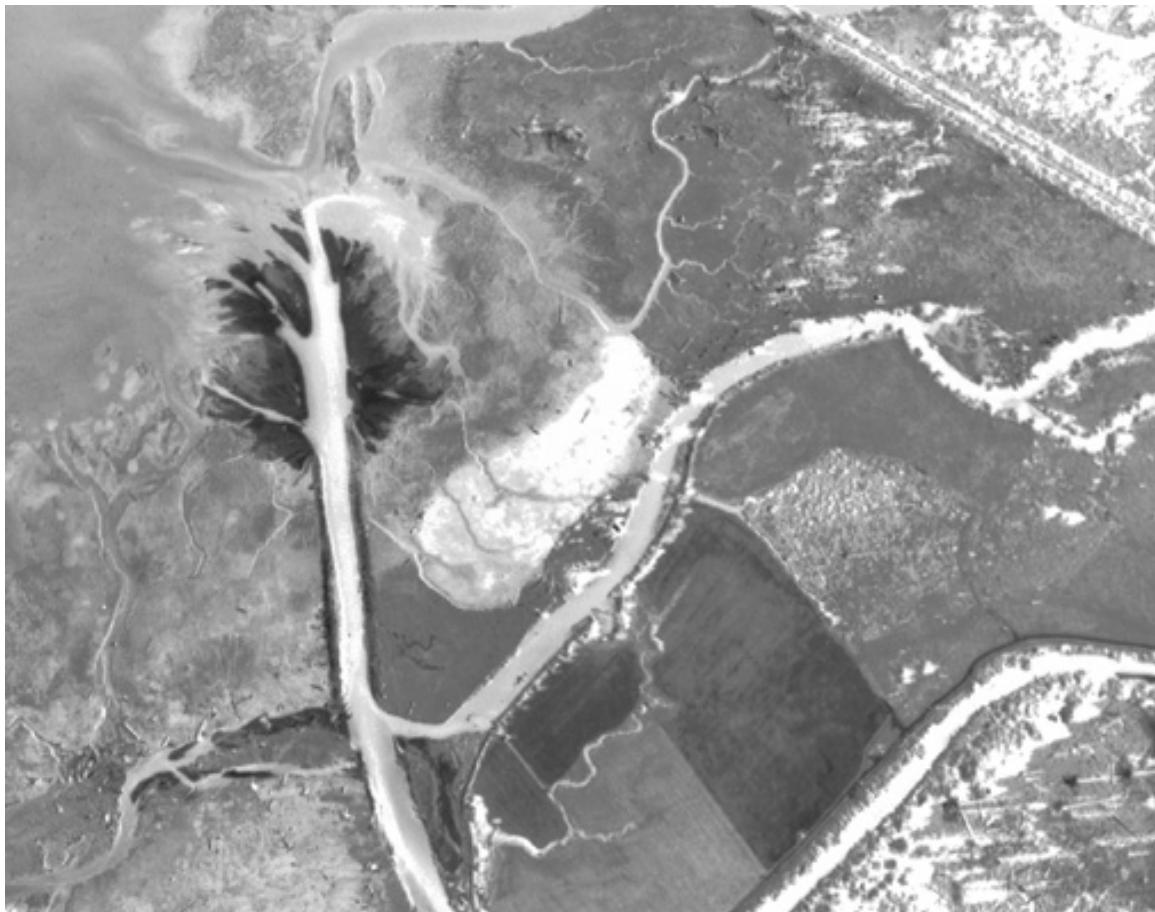
Photograph Number 1: Kilchis River 1939; River mile 0-1.

Large sediment deposit at the river – delta interface, it is still visible on the 2000 Photograph. The presents of the sedimentary element are an indication that recent sediment rates have slowed.

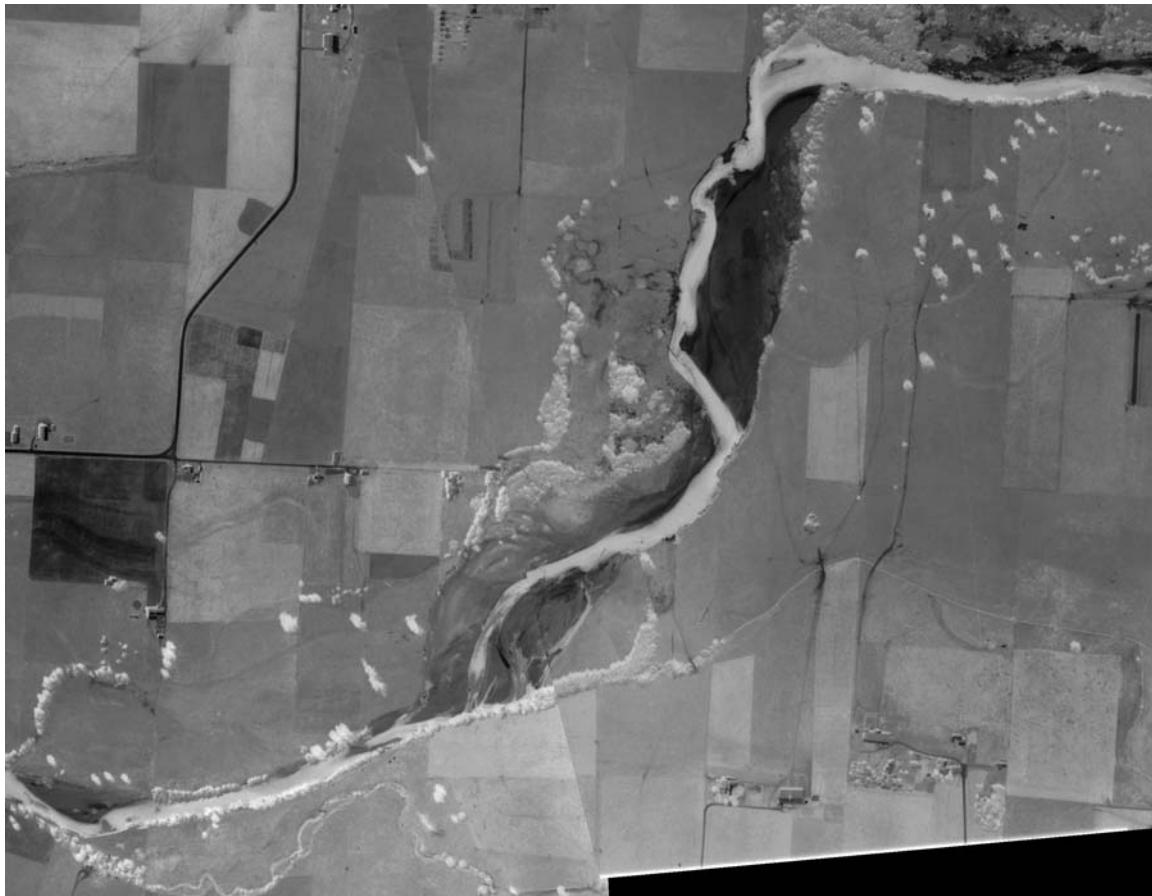
Photography Number 3: Trask River 1939; River mile 6 –7.

Extensive Gravel Bar complexes with limited riparian development. Gravel deposition occurring resulting in bed aggradation. High sediment loading associated with basin fire history

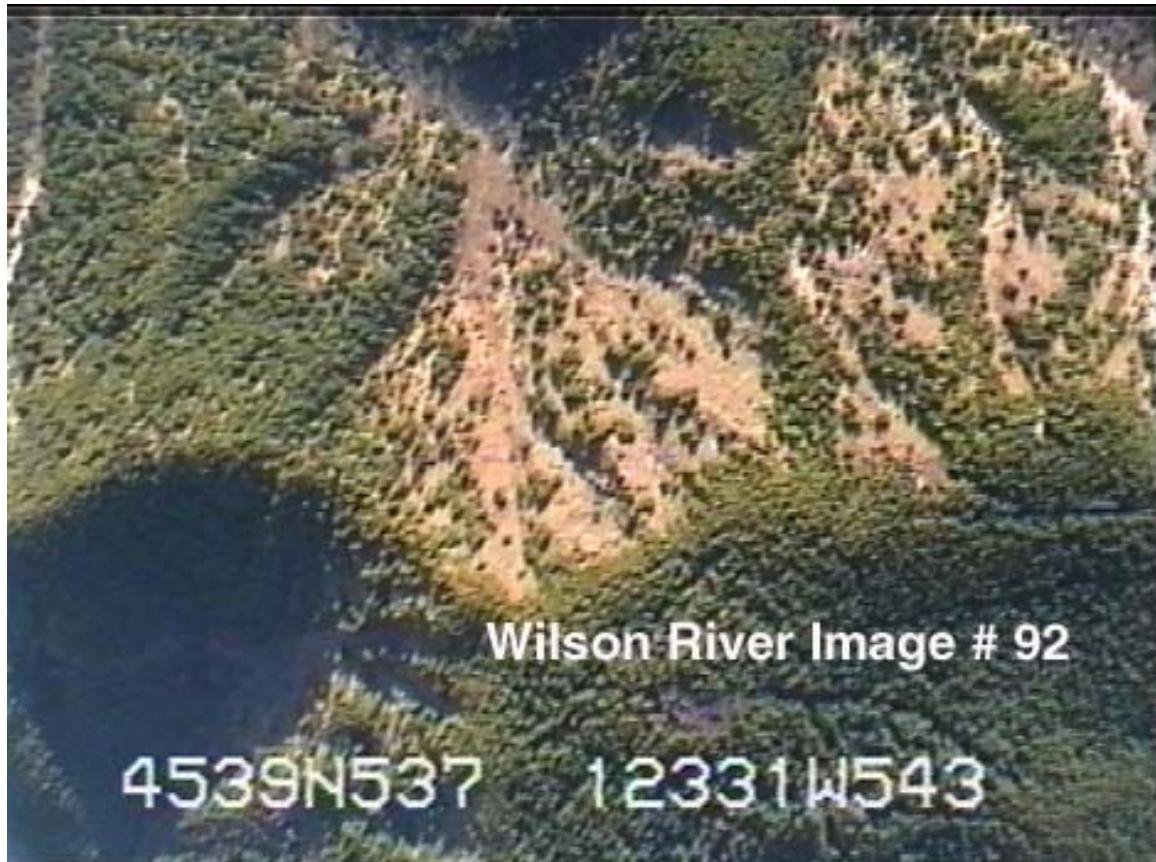
Photography Number 4: Wilson River November 1999.

Upper Basin Area; illustrating the slope Failures in the Upper Wilson Basin resulting from the November 1999 winter. (Wilson River Image 92)

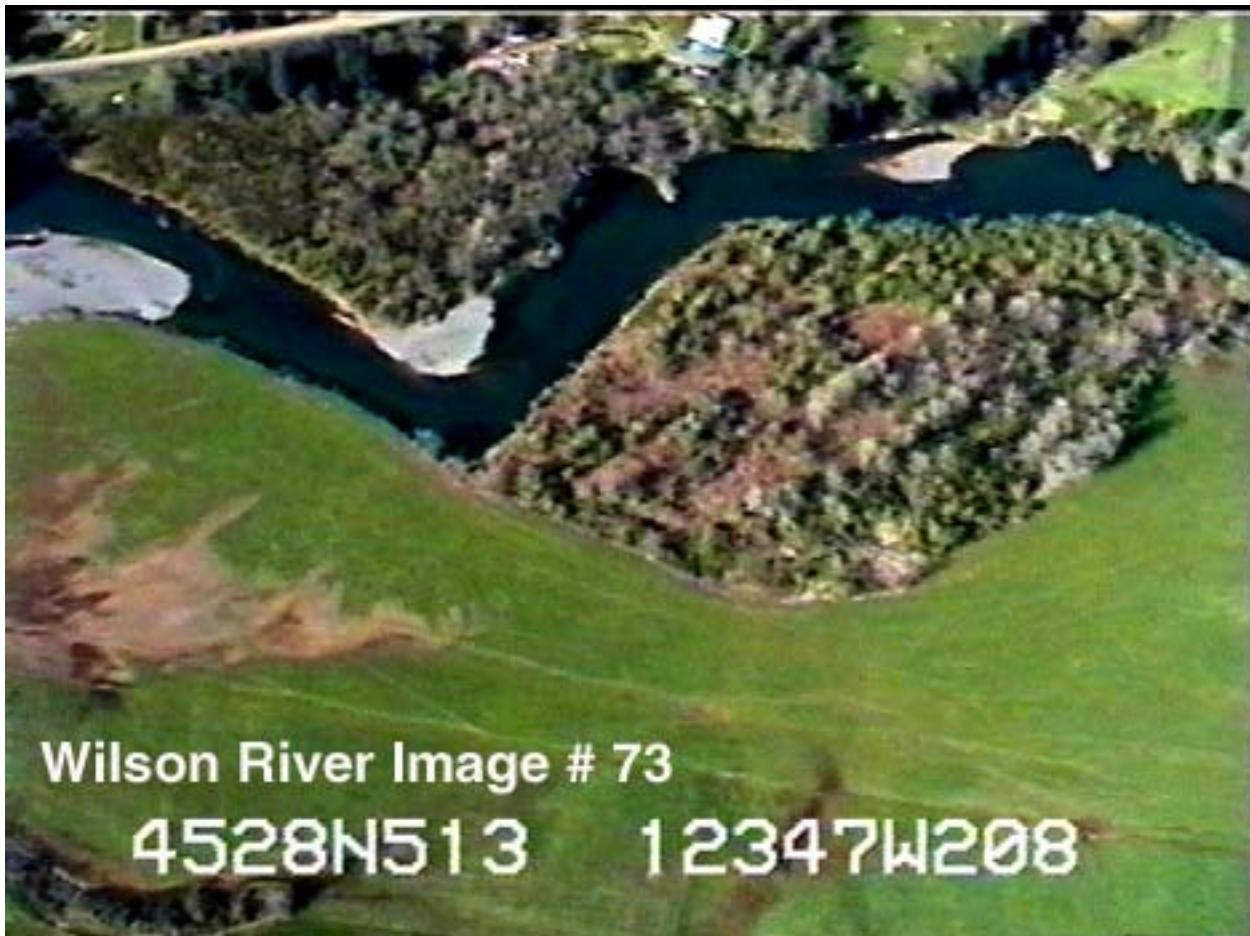
Photography Number 6: Wilson River November 1999, Middle Alluvial Plain.

Fine grain sediment deposited on agricultural land after flood event. Notice the large riparian zone and minor gravel bar complexes.
(Wilson River Image 73)

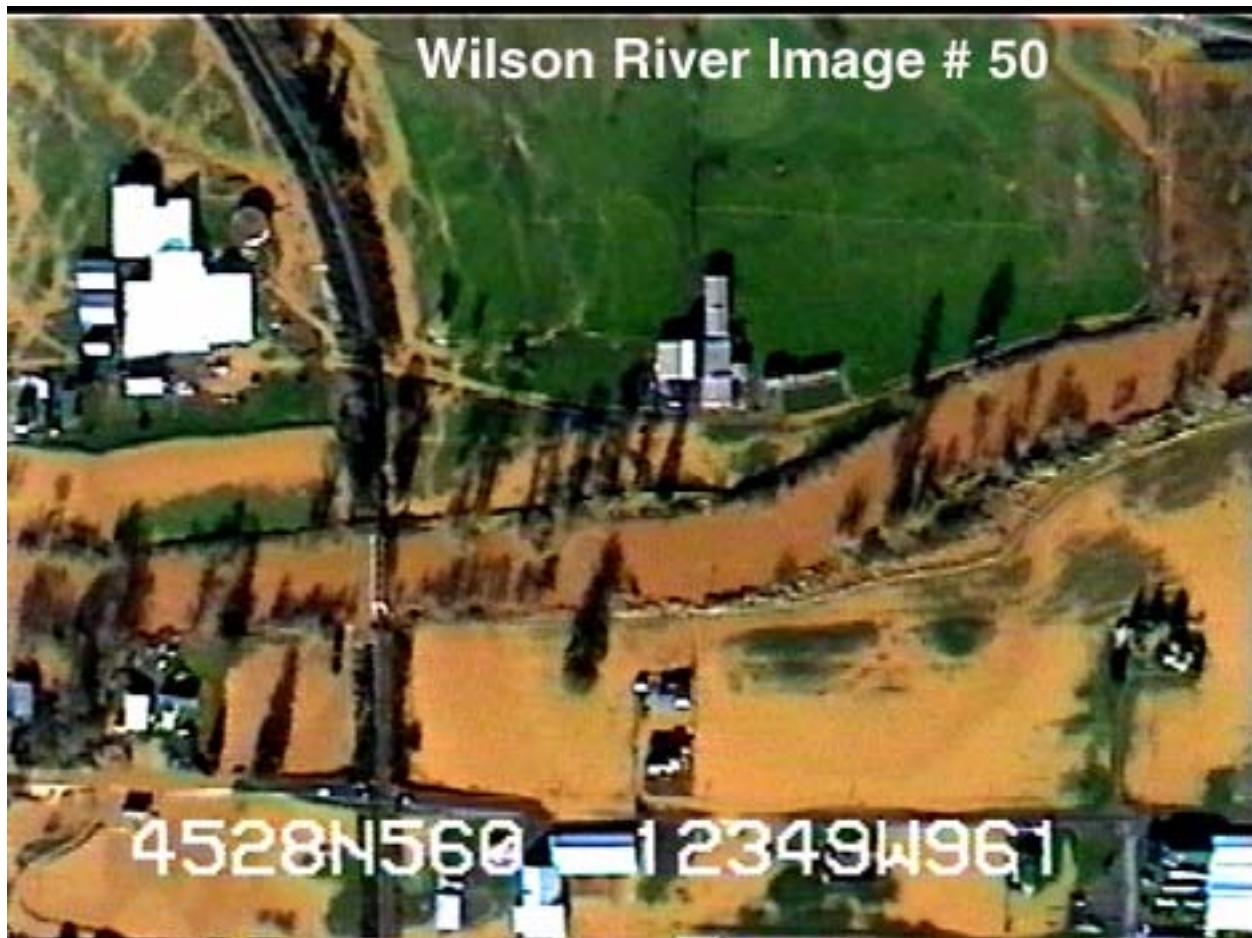
Photography Number 7: Wilson River.

Alluvial Plain at Flood Stage and Out of Channel Flow.
(Wilson River Image 50)

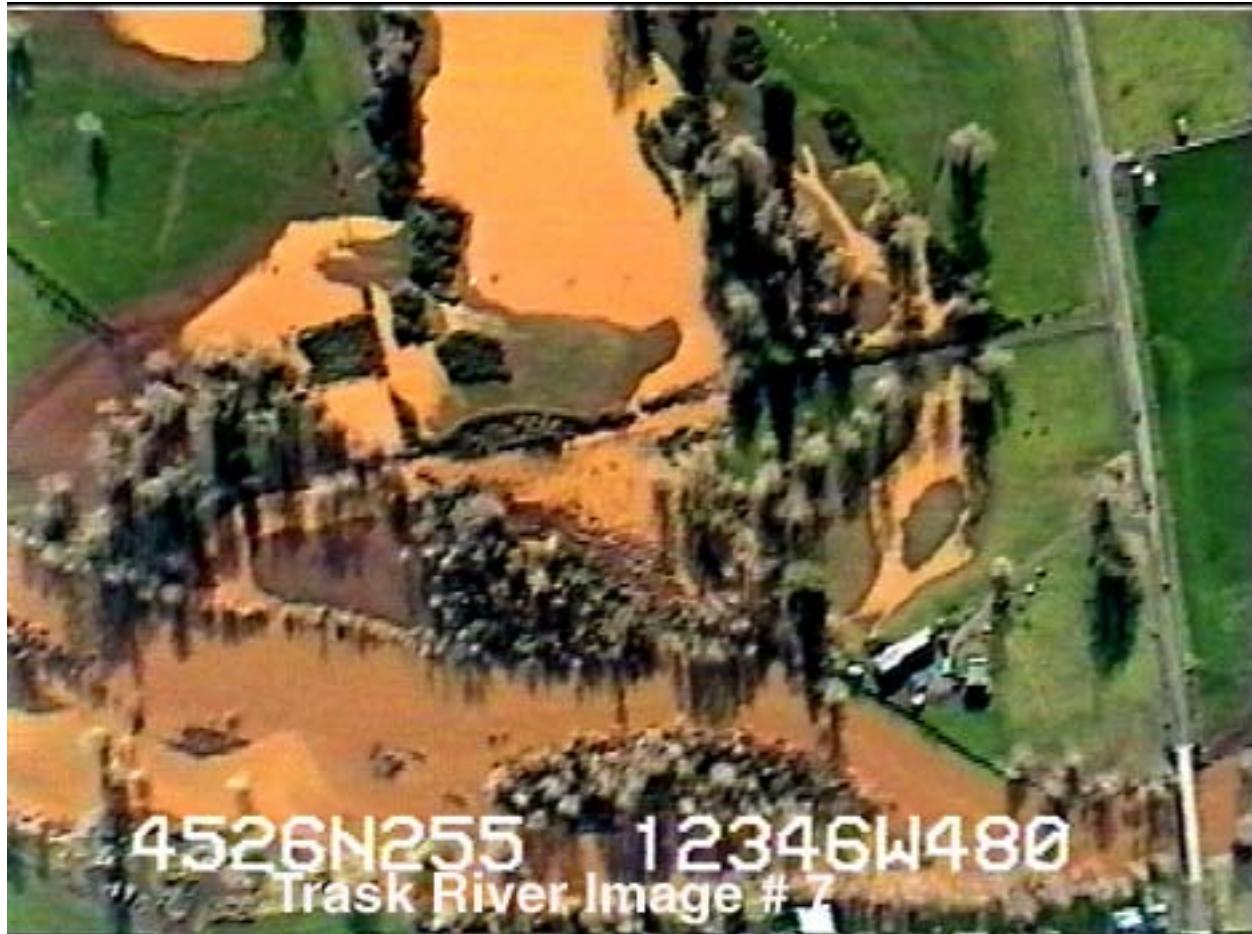
Photography Number 8: Trask River November 1999.

Lower Alluvial Plain at Flood Stage and Out of Channel Flow. (Trask River Image 7)

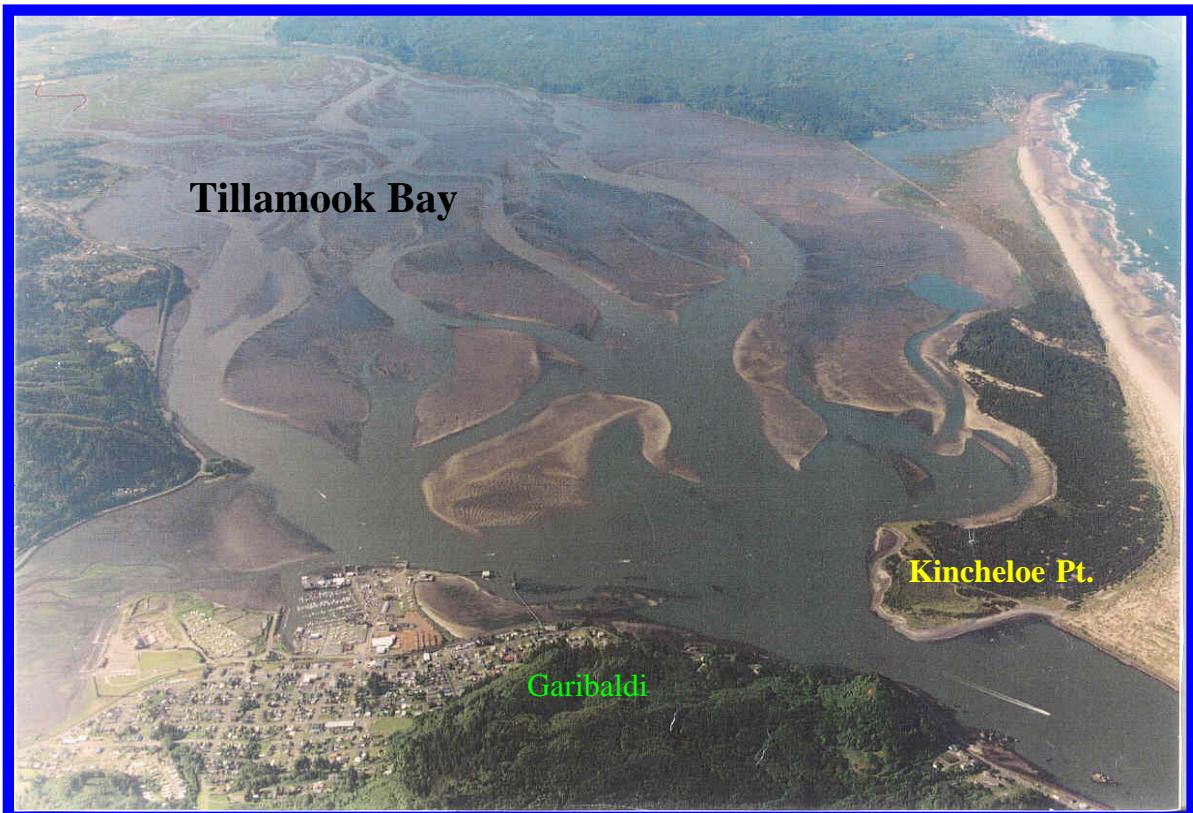
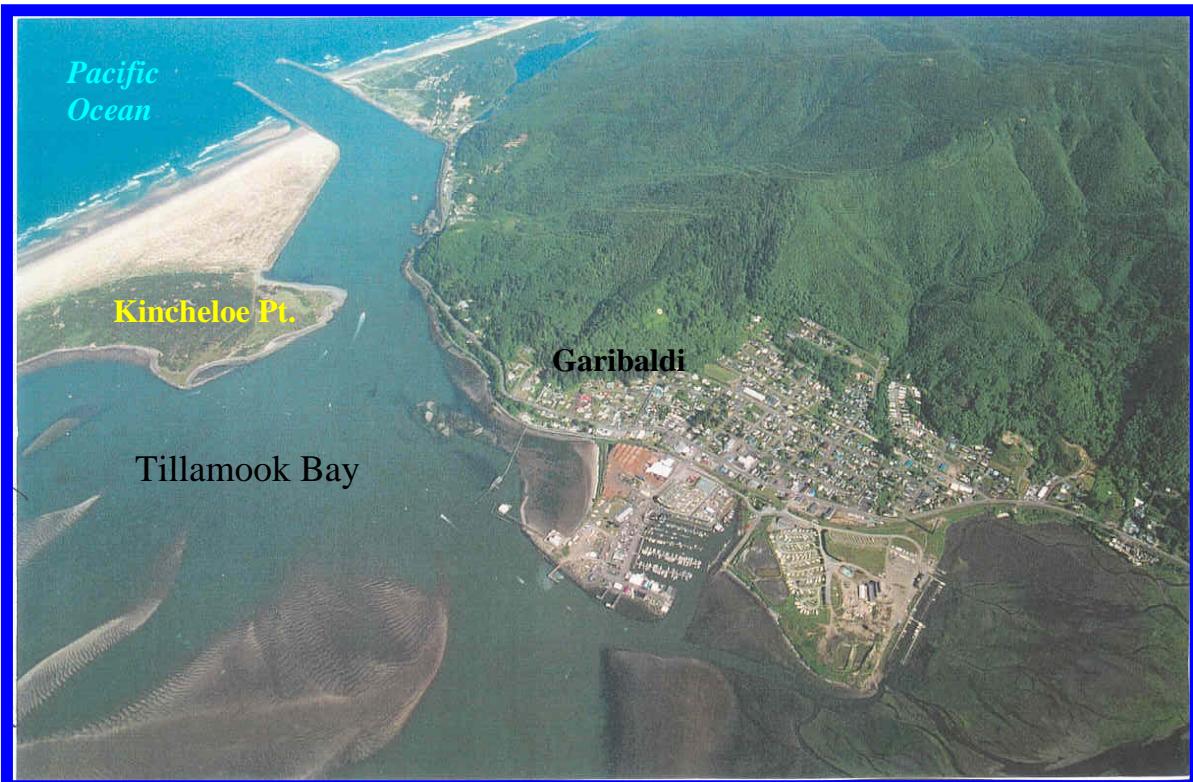
Figure 2. TOP. Aerial view at north end of Tillamook Bay at extreme low tide, view is to the south. Note broad expanse of interconnected tidal flats and network of incised tidal channels. All tidal flats are submerged during high tide. BOTTOM. Aerial view at north end of Tillamook Bay showing jettied channel connecting the bay to the Pacific Ocean, view is to the northwest. Note constricted area of entrance near Kincheloe Point. Photo date is 4 June 2000 and tide was -2 ft MLLW, courtesy Port of Garibaldi
