# Tillamook River Coho Restoration Strategy; Habitat Assessment and Limiting Factors Analysis

Data Analysis and Reporting Conducted by Demeter Design Inc.  
Habitat Data Prepared by Demeter Design Inc.  
Habitat Data Collected by Demeter Design Inc. and Bio-Surveys LLC.  
Production Modeling Prepared by Bio-Surveys LLC.  
Landslide Potential Analysis Conducted by Oregon Department of Forestry

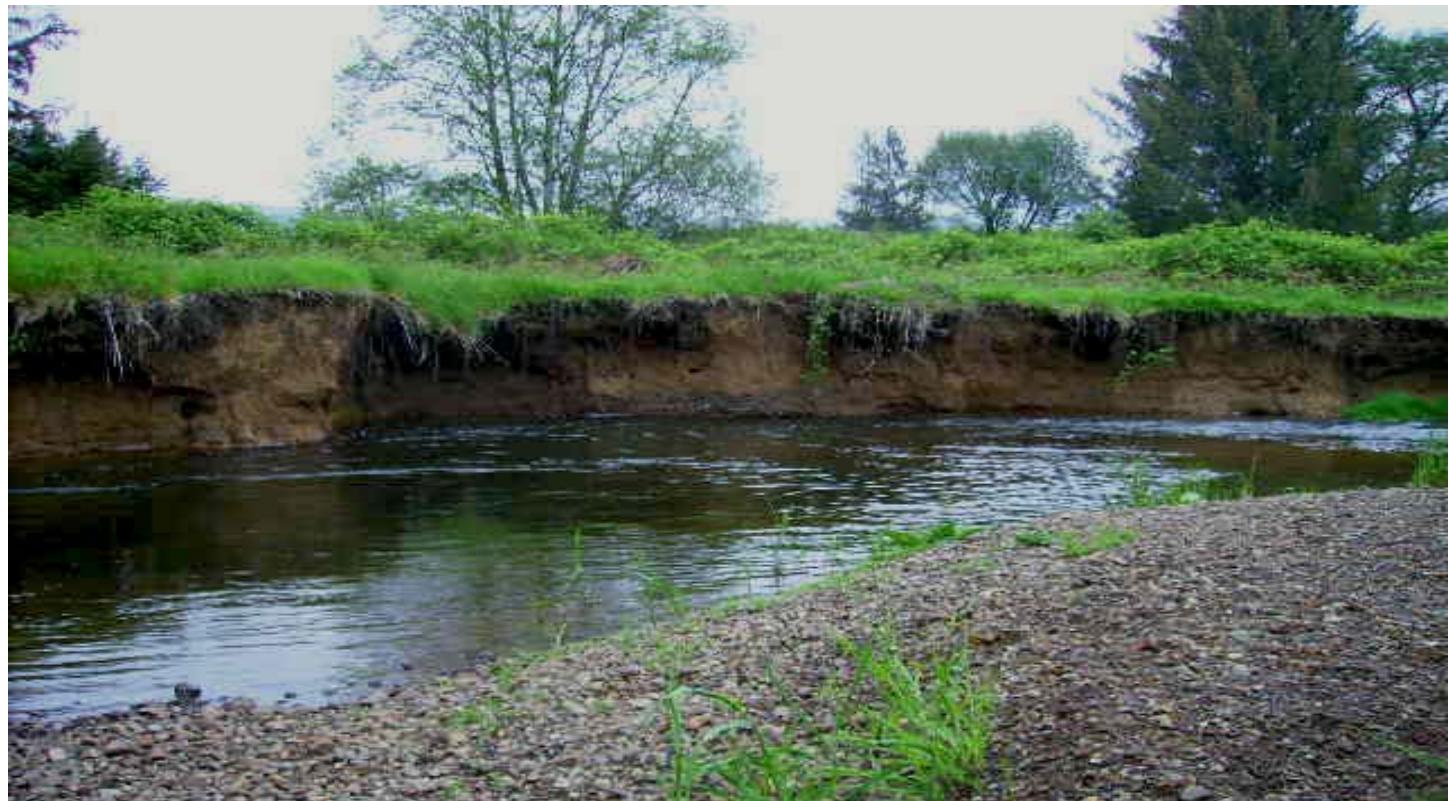
A low functioning anchor (1) occurs on the middle mainstem. This potential anchor has abundant gravels, no wood, minimal pools and is severely impacted by land-use. Although this reach provides 2/3 of the spawning gravels within the entire Tillamook River Watershed, Bio-Surveys disagreed with the classification of this section as an anchor.

A second low functioning anchor site (2) occurs between the confluence of Simmons Creek upstream to Fawcett Creek (~reach 5-8). Well sorted gravels are rare likely due to lack of LWD, but the potential for floodplain connection exists and gravels are present. Currently the channel is entrenched, and has poor to moderate riparian conditions (% Shade is well below benchmarks). The long term potential for restoration is very high in this section for multiple species including Chum, Steelhead, Chinook, and Lamprey. Although the % Pools is just above the low benchmark it is likely that given the low gradient and broad floodplain of the mainstem, historical pool volume would be much greater than the high benchmark. Current function is mixed with spawning habitat function high to moderate in reach 6 through half of reach 7 and low in reach 8. Summer rearing is low above reach 7 although the mixing action of the rapid in reach 7 could potentially mitigate some of the impacts of excess temperatures thus increasing summer rearing potential in reach 6 and the lower part of reach 7. Wood placement would increase rearing habitat through floodplain connectivity and would also sort gravels being delivered from Munson and Simmons creek. Existing pools would benefit from wood placement as well due to increased cover from predation, complexity, and hydraulic roughness. Summer juvenile rearing densities were lower in this anchor than in non-anchor sites in 2006 and 2007. One hypothesis for this is that surveyors observed juveniles migrating to cooler waters in 2005 while in 06/07 surveyors did not observe this migration due to timing. In other words, although all RBA surveys occurred before summer peak temperatures, the 2005 surveys may have occurred at the onset of increased summer temperatures.

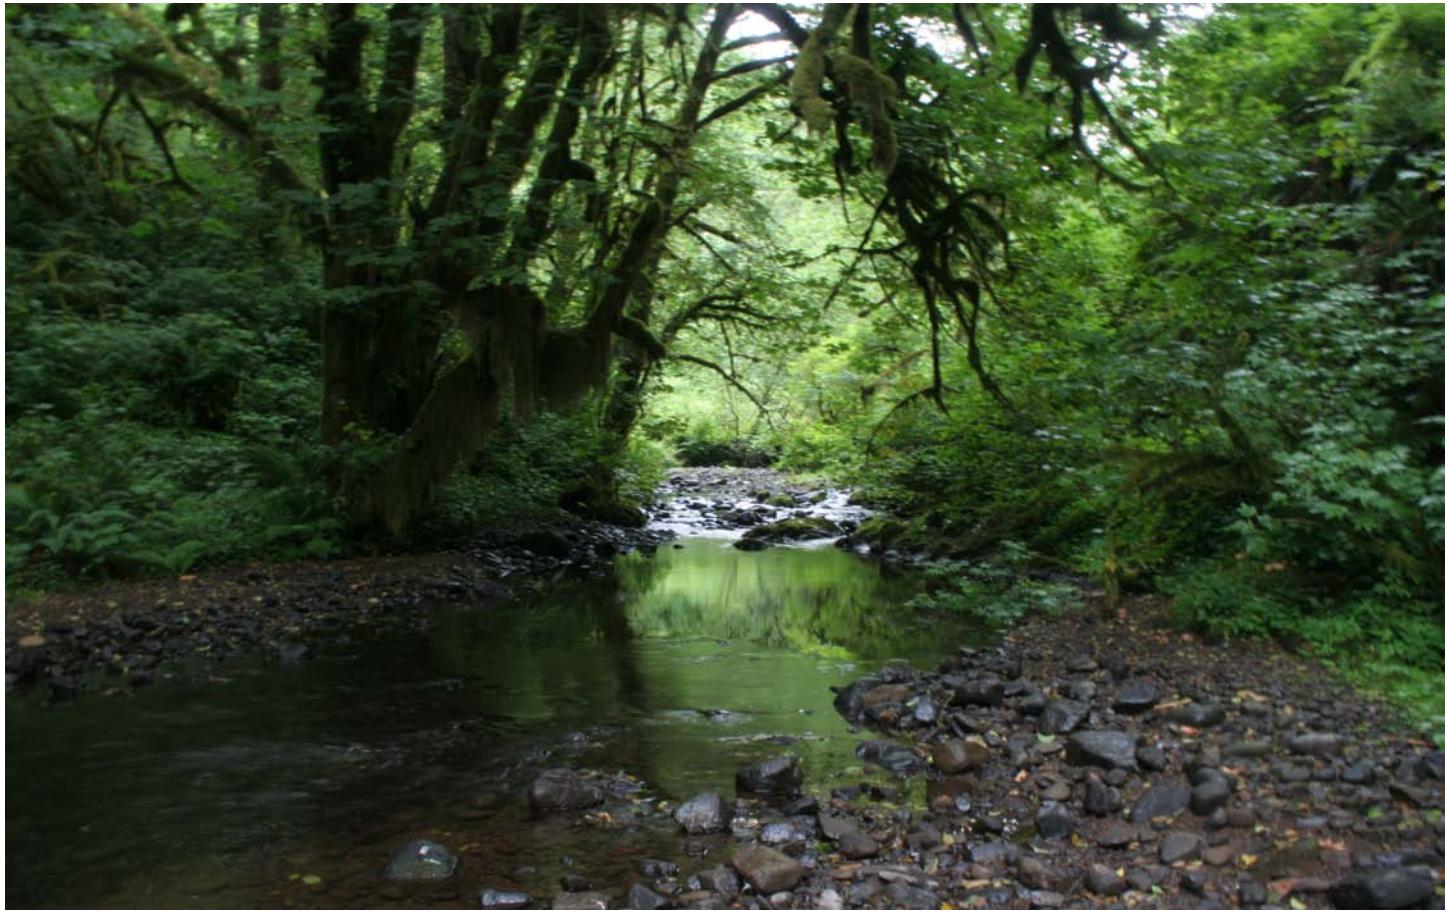
Map 3g - Fawcett Creek

Fawcett Creek has the potential to support a large Coho population but it is highly impacted by past and current land-use practices. The mouth of Fawcett Creek has the potential for excellent off channel habitat development by supplying the groundwater inputs needed to sustain alcoves or side channels. Additionally gravel deliveries from the upper basin, low gradients, and the potential for floodplain connection could result in spawning habitat were large wood placement to occur at the mouth. Fawcett Creek is always confined by terrace or hill-slope which, below a municipal water diversion, is largely a result of land-use practices. A debris flow during the winter of 2007/2008 resulted in the input of excess sands and fines reducing the quality of the minimally available spawning habitat. This debris flow appears to be the result of an improperly decommissioned road; undersized culverts were not removed and this appears to have changed the ground water regime which caused slumping and ultimately a landslide. Riparian conditions on Fawcett Creek are moderate and shade is minimal below the City of Tillamook water diversion. This municipal water diversion is antiquated and functions as a juvenile passage barrier with a 3' drop at low flow. Land-use impacts to the stream and riparian buffers were common downstream of the water diversion (e.g. LWD removal, degraded riparian vegetation, herbicide applications, and in one case a full spanning artificial dam which functions as a juvenile barrier). Changes to land-use practices and placement of LWD in conjunction with riparian work are needed to restore function to this section, although the potential remains for a future anchor habitat were this to occur. Upstream of the water diversion the potential for restoration effectiveness increases drastically. Although scour is still evident resistant outcrops prevent further downcutting and, in conjunction with abundant hill-slope delivery, has resulted in a more accessible floodplain than downstream of the diversion.

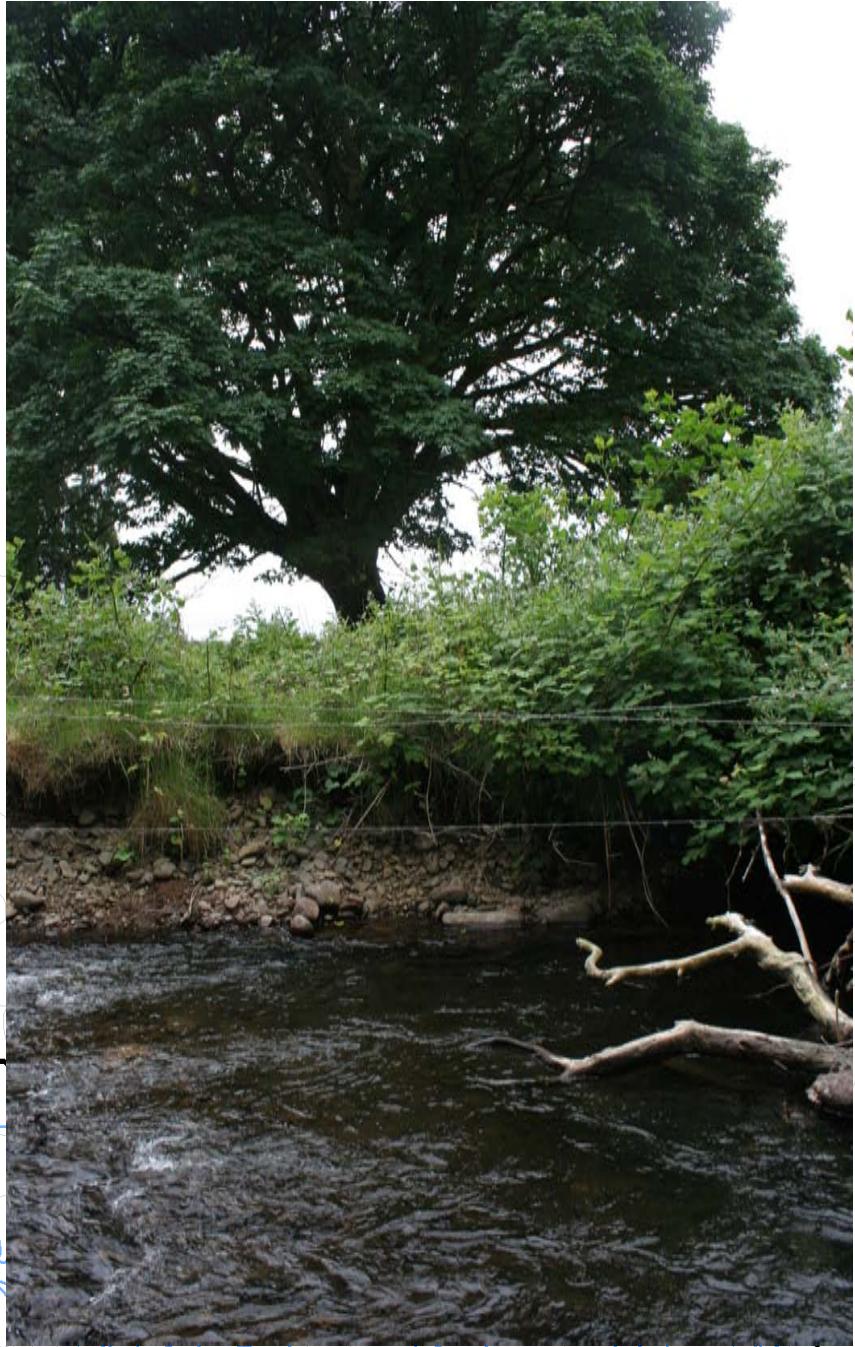
Map 3h - Simmons Creek

Simmons Creek is dominated by a cobble substrate and poorly sorted gravels, and is always confined by terraces and/or hill-slopes. The historic floodplain is very broad but the current channel is incised and contains minimal off channel habitat. Riparian condition is poor from the mouth to highway 101 exhibiting minimal future recruitment potential. A small spring fed tributary enters Simmons within 20 meters of the mouth. Field surveys suggest that historically the mouth of Simmons consisted of multiple braided channels and wetland habitat (much like the mouth of Killam Creek) but that channel entrenchment has created a simplified single channel. There is potential to restore function in this reach but riparian setbacks, large wood placement, and plantings would need to occur (which may be limited by land-use practices). Simmons passes through a properly sized concrete box culvert. A historical lumber mill was located immediately to the east of highway 101 (on both sides of the stream) but the property is currently rural residential. A remnant dike and settling pond is present on the north side of Simmons Creek. Landowner accounts indicate that small splash dams were built on Simmons Creek to clear debris that accumulated on a yearly basis. This is consistent with existing scour. The current lack of LWD in the system may also be a result of the limited LWD recruitment potential.

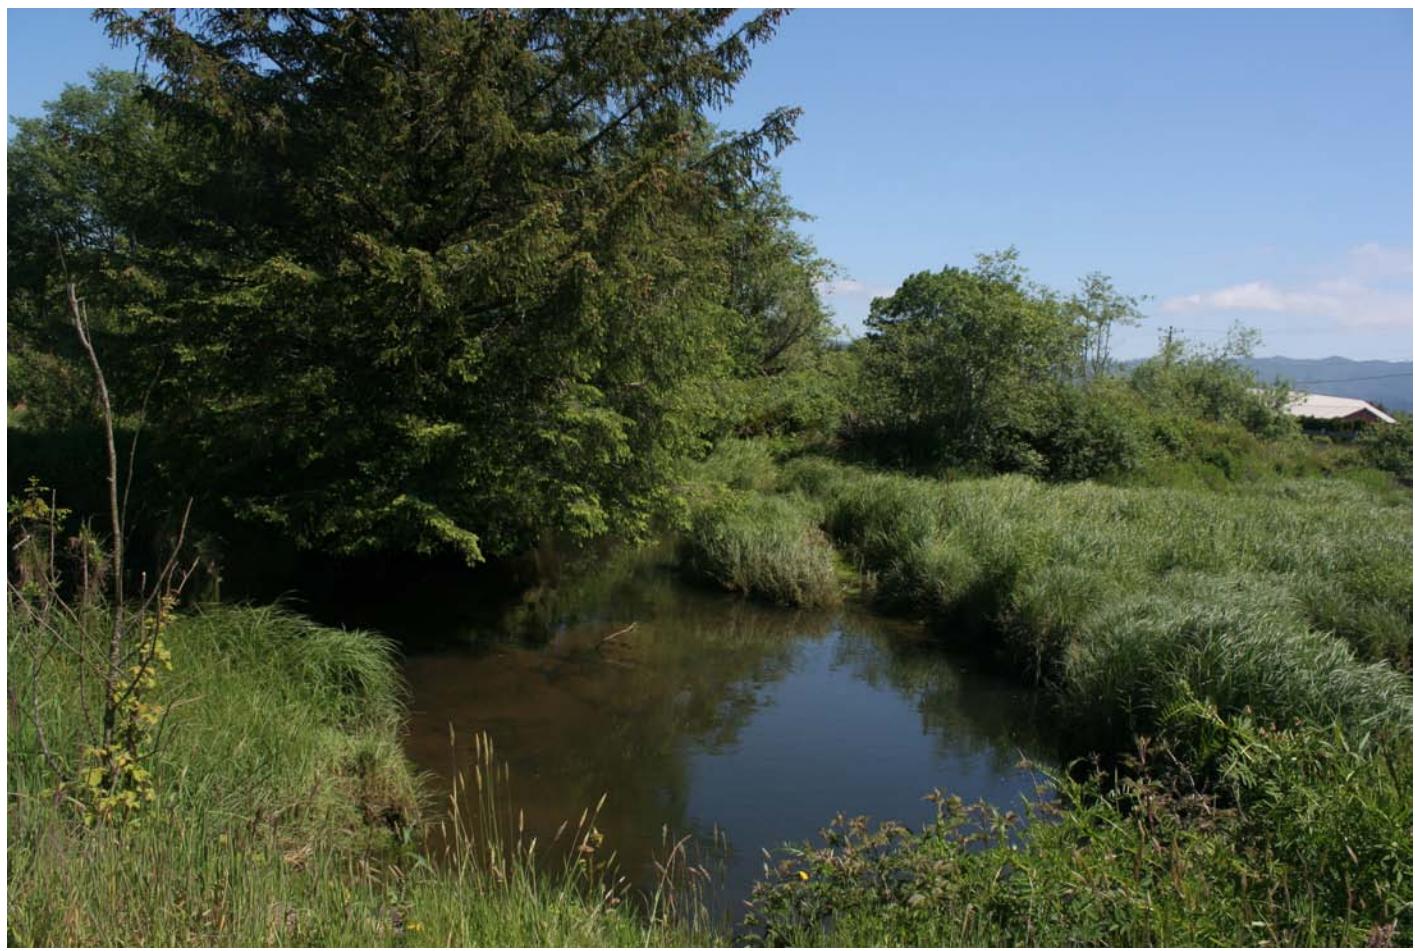
Map 3q - Esther and Tomlinson Creek

A series of levees and dikes have been constructed along lower Esther and Tomlinson to support historic and current agricultural uses. Both stream channels have been highly manipulated to force them into their current configuration. Historically, the channels flowed separately into a series of sloughs and tidal marshes adjacent to the Mainstem Tillamook. Currently Tomlinson has been rerouted to flow behind a road and dike to join Esther just before passing through a top hinged MTR tidegate. The tidegate is not functioning properly, and was observed to be completely closed despite >1m of stream height remaining between the upstream pasture and water level. This conclusion is supported by the erratic juvenile abundance data which show very few fish in 2005 & 2006, and a huge spike in 2007. Fish passage appears to be the primary issue for this stream complex. Tomlinson runs laterally along a dike, and passes through two culverts and skirts a county road (Cape Meares Loop) and agricultural field before entering industrial timberland. The first culvert is ~.65 m above the stream channel and constitutes a juvenile barrier. The second culvert is undersized and failing. The stream channel is small (~2 m active channel), generally entrenched, and lacks good riparian vegetation until it enters timberland. Despite this, the natural gradient and contributing geology (mostly volcanic) develop well sorted spawning gravels, and moderate quantities of simple pool habitat. Coho distribution ends at a bedrock falls shortly after the channel enters industrial timberland.
