# **Culvert Assessment and Prioritization Plan for Fish Passage in the Tillamook Bay Watershed, Tillamook County, Oregon – Version 1.1**

**Tillamook  
Estuaries  
Partnership**

**September 2012**

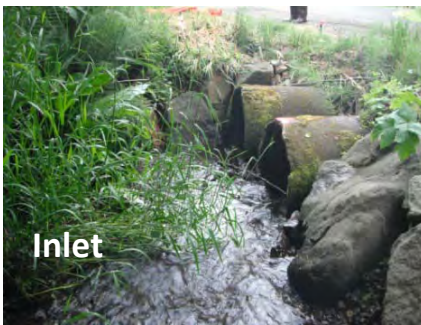
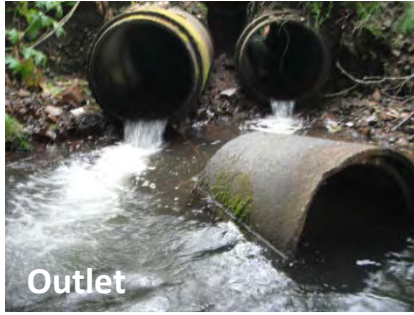
LOCATION INFO				Culvert #	629	Priority	H
Watershed				Kilchis River			
Stream Name				Vaughn Creek			
Township-Range-Section-1/4				T1S, R10W, Sec. 1, SW¼ of NE¼			
UTM Easting/Northing (Zone 10, NAD 1983)				433319/5040431			
Road Name				Doughty Road			
Road/Culvert Owner				Tillamook County			
Adjacent Landowners				R. Rasmussen and R. Carver			
CULVERT INFO		CHANNEL INFO					
Shape	Circular	Inlet Gradient (%)	8.7(7.4)				
Material	Concrete	Upstream Gradient (%)	1.0				
Length (ft)	35(31)	Bankfull Width (ft)	8.1				
Width (in)	29(29)	Bankfull:Culvert Ratio	0.6*				
Height (in)	29(29)						
Outlet Perch (ft)	0.1(0.2)						
Slope (%)	1.9(1.4)						
Rustline Height (in)	N/A						
Overall Condition	Poor						
PRIORITIZATION ANALYSIS							
Upstream Habitat Length (mi)	0.9	Habitat Points	2				
Habitat Quality	Fair(-)	Habitat Quality Points	2				
Fish Species	Anad.	Fish Points	3				
Barrier Type	Red	Barrier Points	3

Prioritization Total Points	10				
<b>Notes:</b> Twin concrete pipes at this crossing. * bankfull:culvert ratio based on combined pipe diameters. Water backed up at inlet and flowed over Doughty Road during most of the winter of 2011-12. This adversely affects road condition and water quality.

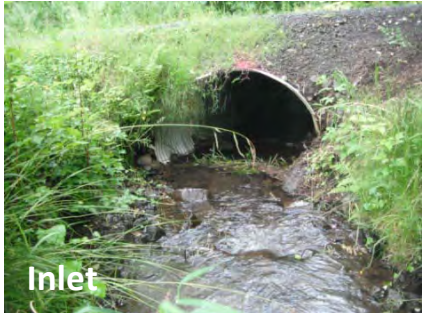
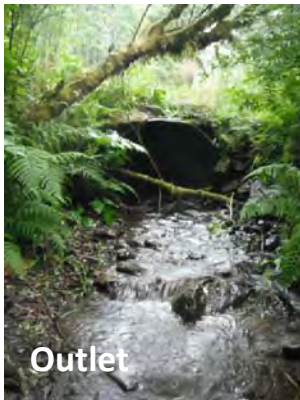
LOCATION INFO				Culvert #	621	Priority	H
Watershed			Kilchis River				
Stream Name			Vaughn Creek				
Township-Range-Section-1/4			T1S, R10W, Sec. 36, SW¼ of SE¼				
UTM Easting/Northing (Zone 10, NAD 1983)			433393/5040779				
Road Name			Private driveway off Pike Road				
Road/Culvert Owner			J. Bender				
Adjacent Landowners		J. Bender, M. & L. McClaskey, and R. & C. Watt					
CULVERT INFO			CHANNEL INFO				
Shape	Pipe arch		Inlet Gradient (%)	5.0			
Material	Corrugated metal		Upstream Gradient (%)	2.0			
Length (ft)	23		Bankfull Width (ft)	7.4			
Width (in)	74		Bankfull:Culvert Ratio	0.9			
Height (in)	52						
Outlet Perch (ft)	0.4						
Slope (%)	1.7						
Rustline Height (in)	3						
Overall Condition	Fair						
PRIORITIZATION ANALYSIS							
Upstream Habitat Length (mi)	0.7		Habitat Points	2			
Habitat Quality	Fair(-)		Habitat Quality Points	2			
Fish Species	Anad.		Fish Points	3			
Barrier Type	Red		Barrier Points	3

Prioritization Total Points	10			
<b>Notes:</b> Pipe 628 is between this pipe and 629. We did not have landowner permission to survey pipe 628, but it was likely a barrier culvert as well based on remote observation. The degree to which 628 may impede passage was unknown at the time of this report.

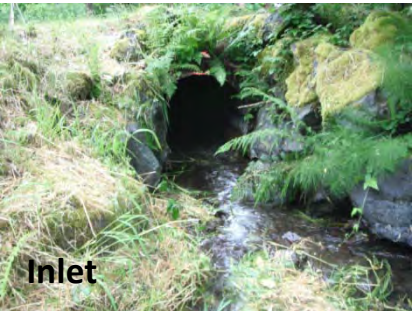
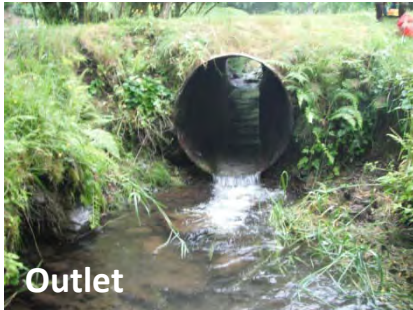
LOCATION INFO				Culvert #	620	Priority	H
Watershed		Kilchis River					
Stream Name		Vaughn Creek					
Township-Range-Section-1/4		T1S, R10W, Sec. 36, SW¼ of SE¼					
UTM Easting/Northing (Zone 10, NAD 1983)		433396/5040789					
Road Name		Private driveway off Pike Road					
Road/Culvert Owner		R. & C. Watt					
Adjacent Landowners		R. & C. Watt					
CULVERT INFO		CHANNEL INFO					
Shape	Circular	Inlet Gradient (%)	11.5				
Material	Corrugated metal	Upstream Gradient (%)	2.2				
Length (ft)	30	Bankfull Width (ft)	6.3				
Width (in)	48	Bankfull:Culvert Ratio	0.6				
Height (in)	48						
Outlet Perch (ft)	0.7						
Slope (%)	1.9						
Rustline Height (in)	19						
Overall Condition	Fair						
PRIORITIZATION ANALYSIS							
Upstream Habitat Length (mi)	0.7	Habitat Points	2				
Habitat Quality	Fair(-)	Habitat Quality Points	2				
Fish Species	Anad.	Fish Points	3				
Barrier Type	Red	Barrier Points	3				
		Prioritization Total Points	10

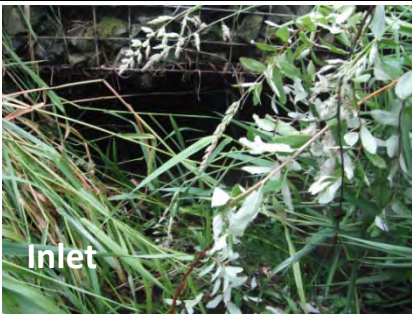
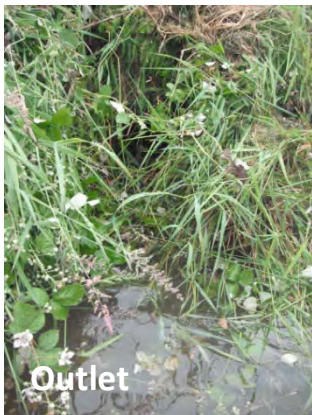
LOCATION INFO				Culvert #	673	Priority	L
Watershed				Kilchis River			
Stream Name				Hathaway Slough			
Township-Range-Section-1/4				T1S, R10W, Sec. 12, NW¼ of NE¼			
UTM Easting/Northing (Zone 10, NAD 1983)				433617/5039600			
Road Name				Alderbrook Road			
Road/Culvert Owner				Tillamook County			
Adjacent Landowners				T. Gienger, S. & E. Vermilyea, and J. Smith			
CULVERT INFO			CHANNEL INFO				
Shape	Circular	Inlet Gradient (%)	3.5				
Material	Concrete	Upstream Gradient (%)	<1.0				
Length (ft)	38	Bankfull Width (ft)	6.1				
Width (in)	24	Bankfull:Culvert Ratio	0.3				
Height (in)	24						
Outlet Perch (ft)	0.1						
Slope (%)	1.0						
Rustline Height (in)	N/A						
Overall Condition	Poor						
PRIORITIZATION ANALYSIS							
Upstream Habitat Length (mi)	0.3	Habitat Points	1				
Habitat Quality	Poor	Habitat Quality Points	1				
Fish Species	Anad.	Fish Points	3				
Barrier Type	Red	Barrier Points	3

**Notes:** Upstream listed as nonfish. However, although low-quality habitat, technical reviewers suggested that a short segment of the upstream west channel remains suitable for fish use if access issues are addressed.

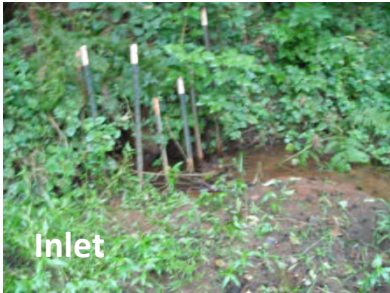
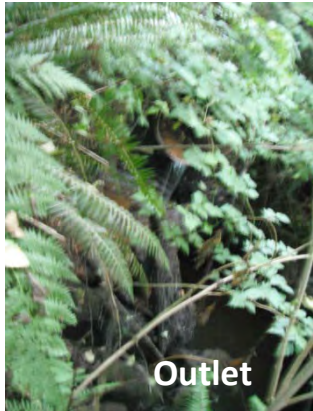
LOCATION INFO				Culvert #	674	Priority	M
Watershed		Kilchis River					
Stream Name		Unnamed tributary of Coal Creek					
Township-Range-Section-1/4		T1S, R9W, Sec. 8, NW¼ of SW¼					
UTM Easting/Northing (Zone 10, NAD 1983)		435604/5039169					
Road Name		Private road off of Curl Road					
Road/Culvert Owner		R. & K. Downs					
Adjacent Landowners		R. & K. Downs					
CULVERT INFO		CHANNEL INFO					
Shape	Circular	Inlet Gradient (%)	2.3				
Material	Corrugated metal	Upstream Gradient (%)	1.0				
Length (ft)	40	Bankfull Width (ft)	5.3				
Width (in)	30	Bankfull:Culvert Ratio	0.5				
Height (in)	30						
Outlet Perch (ft)	4.5						
Slope (%)	5.5						
Rustline Height (in)	24						
Overall Condition	Poor						
PRIORITIZATION ANALYSIS							
Upstream Habitat Length (mi)	0.2	Habitat Points	1				
Habitat Quality	Fair	Habitat Quality Points	2				
Fish Species	Anad.	Fish Points	3				
Barrier Type	Red	Barrier Points	3

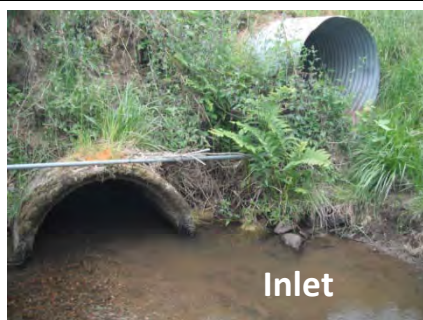
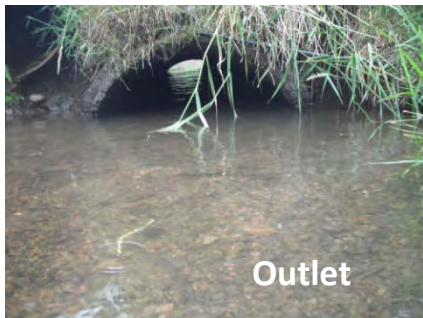
<b>Inlet</b>	
Shape	Circular	Inlet Gradient (%)	3.1				
Material	Concrete	Upstream Gradient (%)	3.1				
Length (ft)	38	Bankfull Width (ft)	4.6				
Width (in)	48	Bankfull:Culvert Ratio	0.9				
Height (in)	48	Two pipes at this location. One is an overflow pipe that conveys water only during high water events.					
Outlet Perch (ft)	None						
Slope (%)	1.4						
Rustline Height (in)	34						
Overall Condition	Fair						
PRIORITIZATION ANALYSIS

Habitat Quality	Fair	Habitat Quality Points	2				
Fish Species	Anad.	Fish Points	3				
Barrier Type	Gray	Barrier Points	2				
		Prioritization Total Points	11				
<b>Notes:</b> Barrel of concrete pipe is approximately 40 percent full of stream bed substrate.

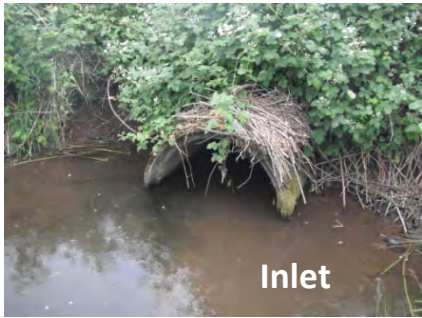
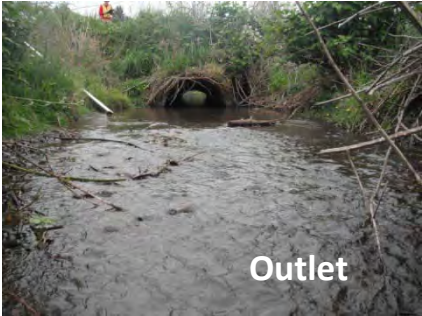
<div>Inlet</div>	
Shape	Circular	Inlet Gradient (%)	4.75				
Material	Concrete	Upstream Gradient (%)	0.2				
Length (ft)	40	Bankfull Width (ft)	6.0				
Width (in)	48	Bankfull:Culvert Ratio	0.7				
Height (in)	48						
Outlet Perch (ft)	None						
Slope (%)	-0.4						
Rustline Height (in)	n/a						
Overall Condition	Fair						
PRIORITIZATION ANALYSIS

<div>Outlet</div>	
Upstream Habitat Length (mi)	2.0	Habitat Points	4				
Habitat Quality	Fair	Habitat Quality Points	2				
Fish Species	Anad.	Fish Points	3				
Barrier Type	Gray	Barrier Points	2

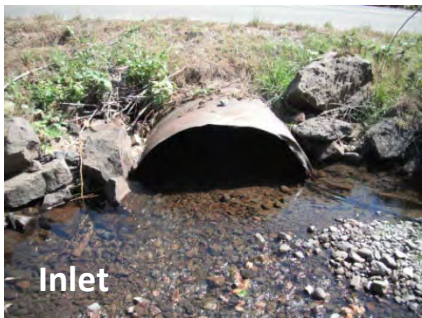
<b>Inlet</b>	
Shape	Circular	Inlet Gradient (%)	3.7				
Material	Corrugated metal	Upstream Gradient (%)	2.1				
Length (ft)	40	Bankfull Width (ft)	6.0				
Width (in)	66	Bankfull:Culvert Ratio	0.9				
Height (in)	66						
Outlet Perch (ft)	None						
Slope (%)	1.6						
Rustline Height (in)	n/a						
Overall Condition	Fair						
PRIORITIZATION ANALYSIS							
Upstream Habitat Length (mi)	1.7	Habitat Points	4				
Habitat Quality	Fair	Habitat Quality Points	2				
Fish Species	Anad.	Fish Points	3				
Barrier Type	Gray	Barrier Points	2				
		Prioritization Total Points	11

<b>Notes:</b> Barrel of pipe is approximately 50 percent filled with stream bed substrate. Crossing 641 immediately upstream of this crossing, is a livestock bridge.

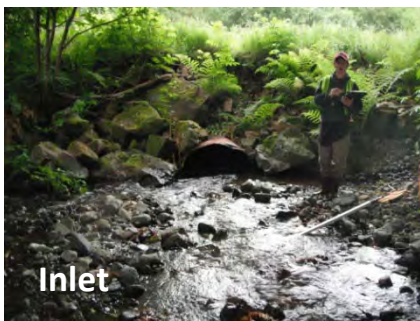
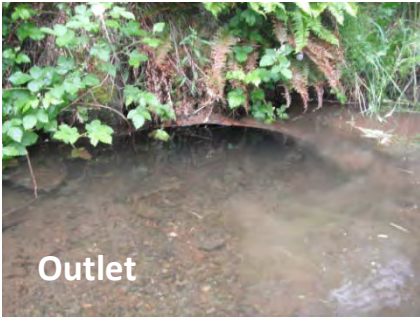
Inlet	
Shape	Circular	Inlet Gradient (%)	13.4				
Material	Corrugated metal	Upstream Gradient (%)	1.2				
Length (ft)	50	Bankfull Width (ft)	15.4				
Width (in)	54	Bankfull:Culvert Ratio	0.3				
Height (in)	54						
Outlet Perch (ft)	Outlet submerged						
Slope (%)	2.5						
Rustline Height (in)	Entire pipe rusted						
Overall Condition	Poor

Prioritization Total Points	10				
Notes: Barrel of pipe is approximately 60 percent filled with stream bed substrate.

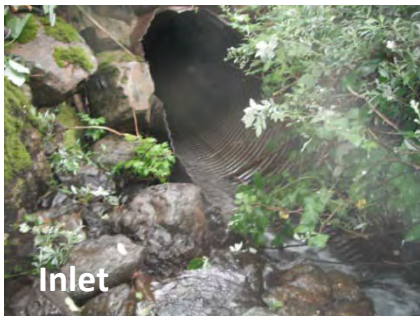
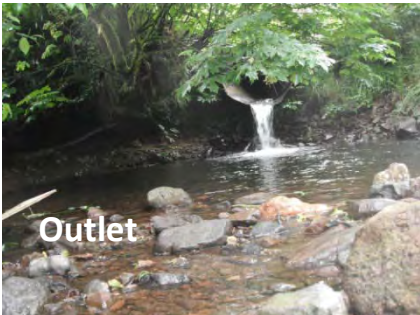
Adjacent Landowners		P. & M. Zweifel, Christensen Rock LLC					
CULVERT INFO		CHANNEL INFO					
Shape	Circular	Inlet Gradient (%)	13.3				
Material	Corrugated metal	Upstream Gradient (%)	3.5				
Length (ft)	41	Bankfull Width (ft)	12.8

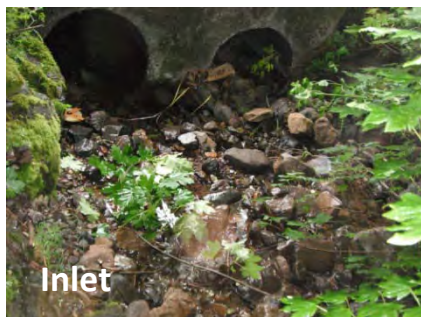
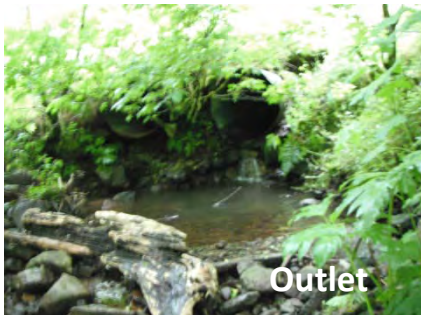
LOCATION INFO				Culvert #	589	Priority	L
Watershed		Kilchis River					
Stream Name		Thomas Creek					
Township-Range-Section-1/4		T1N, R9W, Sec. 32, SE¼ of SE¼					
UTM Easting/Northing (Zone 10, NAD 1983)		437077/5041645					
Road Name		Kilchis River Road					
Road/Culvert Owner		Tillamook County					
Adjacent Landowners		R. & S. Deloe, A. Bell					
CULVERT INFO		CHANNEL INFO					
Shape	Circular	Inlet Gradient (%)	24.0				
Material	Corrugated metal	Upstream Gradient (%)	8.1				
Length (ft)	43	Bankfull Width (ft)	12.6				
Width (in)	48	Bankfull:Culvert Ratio	0.6*				
Height (in)	48	Two pipes side-by-side at this crossing. This section includes information on the left pipe in inlet photo. This pipe appears to carry most flows through this crossing. Both pipes are 4 ft. circular CMP and both are perched.					
Outlet Perch (ft)	3.4						
Slope (%)	1.8						
Rustline Height (in)	Entire pipe rusted						
Overall Condition	Poor

PRIORITIZATION ANALYSIS							
Upstream Habitat Length (mi)	0.5	Habitat Points	1				
Habitat Quality	Poor(+)	Habitat Quality Points	1				
Fish Species	Anad.	Fish Points	3				
Barrier Type	Red	Barrier Points	3				
		Prioritization Total Points	8				
Notes: *used combined width of both pipes for this calculation. Right pipe appears to only flow periodically due to thalweg alignment and rocks blocking inlet.

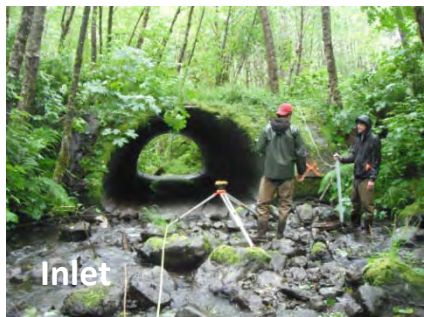
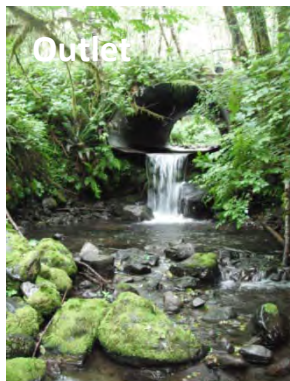
Shape	Pipe Arch	Inlet Gradient (%)	13.8				
Material	Corrugated metal	Upstream Gradient (%)	13.5				
Length (ft)	60	Bankfull Width (ft)	12.6				
Width (in)	156	Bankfull:Culvert Ratio	1.0				
Height (in)	108						
Outlet Perch (ft)	7.1						
Slope (%)	7.1						
Rustline Height (in)	18						
Overall Condition	Fair						
PRIORITIZATION ANALYSIS

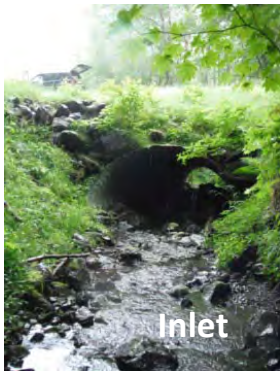
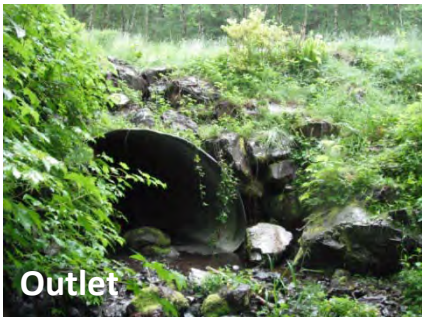
Shape	Pipe Arch	Inlet Gradient (%)	11.4				
Material	Corrugated metal	Upstream Gradient (%)	4.5				
Length (ft)	82	Bankfull Width (ft)	10.3				
Width (in)	144	Bankfull:Culvert Ratio	1.5				
Height (in)	90						
Outlet Perch (ft)	None						
Slope (%)	4.9						
Rustline Height (in)	N/A						
Overall Condition	Fair						
PRIORITIZATION ANALYSIS

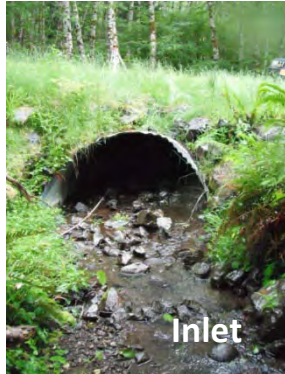
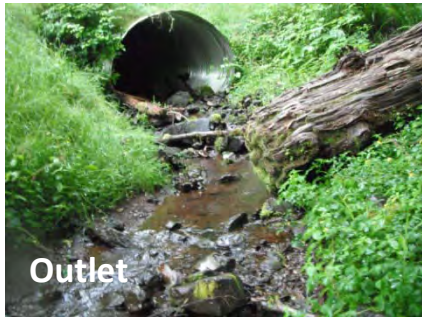
Shape	Pipe Arch	Inlet Gradient (%)	2.0				
Material	Corrugated metal	Upstream Gradient (%)	10.2				
Length (ft)	52	Bankfull Width (ft)	4.0				
Width (in)	96	Bankfull:Culvert Ratio	2.0				
Height (in)	72						
Outlet Perch (ft)	None						
Slope (%)	6.7						
Rustline Height (in)	6						
Overall Condition	Good						
PRIORITIZATION ANALYSIS

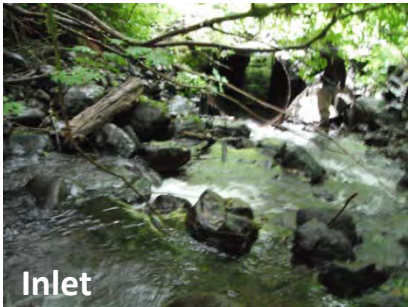
Shape	Circular	Inlet Gradient (%)	18.2				
Material	Corrugated metal	Upstream Gradient (%)	16.2				
Length (ft)	54	Bankfull Width (ft)	9.7				
Width (in)	66	Bankfull:Culvert Ratio	0.6				
Height (in)	66						
Outlet Perch (ft)	6.2						
Slope (%)	1.9						
Rustline Height (in)	42						
Overall Condition	Poor						
PRIORITIZATION ANALYSIS							
Upstream Habitat Length (mi)	0.1	Habitat Points	1				
Habitat Quality	Poor	Habitat Quality Points	1				
Fish Species	Anad.	Fish Points	3				
Barrier Class	Red	Barrier Points	3

Prioritization Total Points	8				
<b>Notes:</b> Although designated a nonfish stream, technical reviewers felt that a short reach of this stream would be suitable for fish use if passage were not prevented by this culvert.

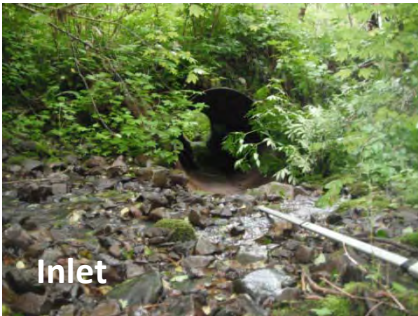
Inlet	
Shape	Circular	Inlet Gradient (%)	15.1				
Material	Corrugated metal	Upstream Gradient (%)	3.1				
Length (ft)	65	Bankfull Width (ft)	10.0				
Width (in)	66	Bankfull:Culvert Ratio	0.6				
Height (in)	66						
Outlet Perch (ft)	6.7						
Slope (%)	3.2						
Rustline Height (in)	30						
Overall Condition	Fair						
PRIORITIZATION ANALYSIS

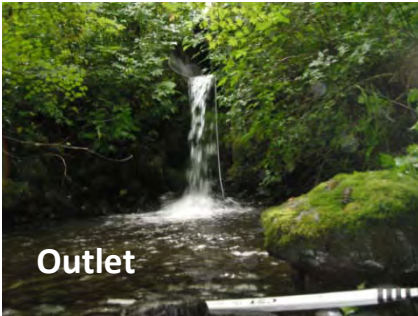
Outlet	
Upstream Habitat Length (mi)	0.5	Habitat Points	1				
Habitat Quality	Poor	Habitat Quality Points	1				
Fish Species	Anad.	Fish Points	3				
Barrier Type	Red	Barrier Points	3

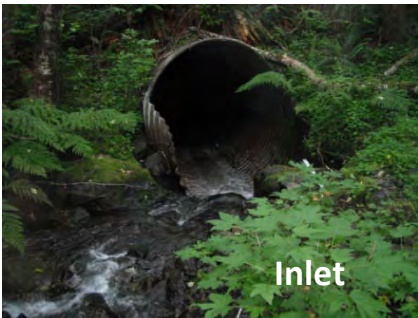
<b>Inlet</b>	
Shape	Circular	Inlet Gradient (%)	12.0				
Material	Corrugated metal	Upstream Gradient (%)	8.0				
Length (ft)	100	Bankfull Width (ft)	13.4				
Width (in)	84	Bankfull:Culvert Ratio	0.5				
Height (in)	96	Outlet cascades onto bedrock.					
Outlet Perch (ft)	4.5						
Slope (%)	7.0						
Rustline Height (in)	36						
Overall Condition	Poor						
PRIORITIZATION ANALYSIS

Fish Species	Anad.	Fish Points	3				
Barrier Type	Red	Barrier Points	3				
		Prioritization Total Points	11				
<b>Notes:</b> Water entering through holes in side of pipe. 4-6” holes in invert. Water flows under and alongside pipe. This pipe appears to sit on bedrock and it is unclear whether an accessible crossing can be created without considerable earthwork. Closer inspection of this location is in order.

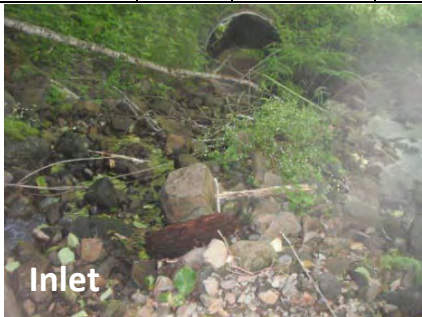
LOCATION INFO				Culvert #	120	Priority	L
Watershed		Kilchis River					
Stream Name		Tributary of Schroeder Creek					
Township-Range-Section-1/4		T2N, R8W, Sec. 30, NW¼ of SE¼					
UTM Easting/Northing (Zone 10, NAD 1983)		444731/5052521					
Road Name		Miami Divide Road					
Road/Culvert Owner		Oregon Department of Forestry					
Adjacent Landowners		Oregon Department of Forestry					
CULVERT INFO		CHANNEL INFO					
Shape	Circular	Inlet Gradient (%)	15.8				
Material	Corrugated Metal	Upstream Gradient (%)	6.9				
Length (ft)	46	Bankfull Width (ft)	4				
Width (in)	48	Bankfull:Culvert Ratio	1.0				
Height (in)	48						
Outlet Perch (ft)	9.8						
Slope (%)	6.8						
Rustline Height (in)	16						
Overall Condition	Fair						
PRIORITIZATION ANALYSIS							
Upstream Habitat Length (mi)	0.3	Habitat Points	1				
Habitat Quality	Poor	Habitat Quality Points	1				
Fish Species	Anad.	Fish Points	3				
Barrier Class	Red	Barrier Points	3

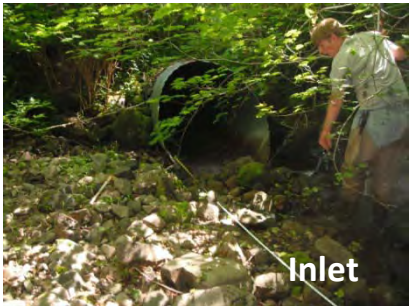
<div>Inlet</div>	
Shape	Circular	Inlet Gradient (%)	23.5				
Material	Corrugated Metal	Upstream Gradient (%)	5.3				
Length (ft)	51	Bankfull Width (ft)	8.2				
Width (in)	66	Bankfull:Culvert Ratio	0.7				
Height (in)	66						
Outlet Perch (ft)	0.1						
Slope (%)	7.1						
Rustline Height (in)	18						
Overall Condition	Good						
PRIORITIZATION ANALYSIS

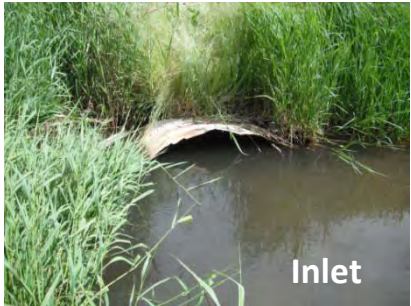
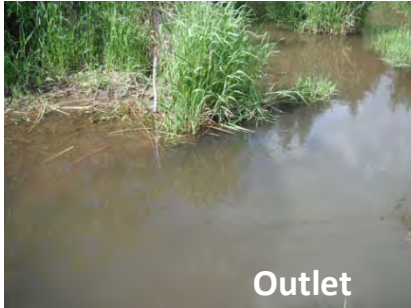
Adjacent Landowners		TNC, Tillamook County, and D. Schechter					
CULVERT INFO		CHANNEL INFO					
Shape	Pipe Arch	Inlet Gradient (%)	10.0				
Material	Corrugated metal	Upstream Gradient (%)	6.5				
Length (ft)	140	Bankfull Width (ft)	6.7

Width (in)	78	Bankfull:Culvert Ratio	1.0				
Height (in)	54	Condition unknown due to being submerged and full, but we suspect that the pipe is in poor condition based on the condition of the inlet and outlet.					
Outlet Perch (ft)	None						
Slope (%)	4.2						
Rustline Height (in)	unknown

Barrier Class	Gray	Barrier Points	2				
		Prioritization Total Points	9				
<b>Notes:</b> Culvert is almost entirely submerged under all flows. Beaver dams in the downstream wetland are likely the primary contributing factor. Upstream bankfull width impacted by adjacent land use which has largely constrained the channel.

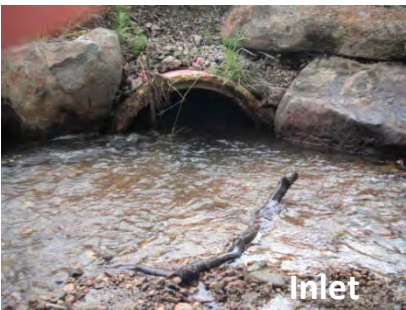
Inlet			
Shape	Circular	Inlet Gradient (%)	10.0				
Material	Concrete	Upstream Gradient (%)	1.8				
Length (ft)	26	Bankfull Width (ft)	6.1				
Width (in)	36	Bankfull:Culvert Ratio	0.5				
Height (in)	36						
Outlet Perch (ft)	None						
Slope (%)	-1.0						
Rustline Height (in)	N/A						
Overall Condition	Poor						
PRIORITIZATION ANALYSIS

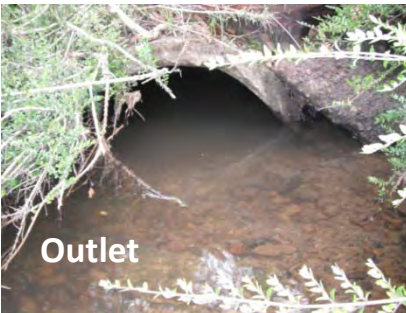
Outlet			
Upstream Habitat Length (mi)	0.9	Habitat Points	2				
Habitat Quality	Fair	Habitat Quality Points	2				
Fish Species	Anad.	Fish Points	3				
Barrier Class	Gray	Barrier Points	2				
		Prioritization Total Points	9

<b>Notes:</b> Pipe is approximately 1/3 full of stream bed substrate.

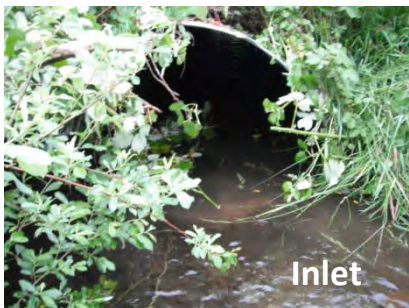
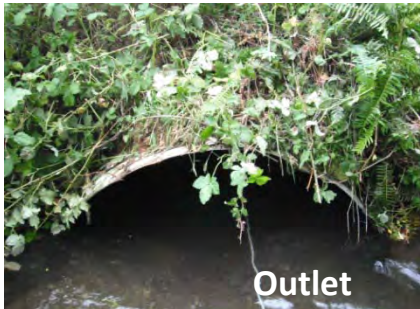
**Outlet**

LOCATION INFO				Culvert #	462	Priority	H
Watershed			Miami River				
Stream Name			Illingsworth Creek				
Township-Range-Section-1/4			T1N, R10W, Sec. 23, NW¼ of NW¼				
UTM Easting/Northing (Zone 10, NAD 1983)			431174/5045718				
Road Name			Ekroth Road				
Road/Culvert Owner			Tillamook County				
Adjacent Landowners		State of Oregon, F. Underhill, and T. & K. Roach					
CULVERT INFO			CHANNEL INFO				
Shape	Pipe Arch		Inlet Gradient (%)	7.0			
Material	Corrugated metal		Upstream Gradient (%)	0.6			
Length (ft)	37		Bankfull Width (ft)	13.2			
Width (in)	72		Bankfull:Culvert Ratio	0.5			
Height (in)	50						
Outlet Perch (ft)	None						
Slope (%)	0.1						
Rustline Height (in)	22						
Overall Condition	Fair						
PRIORITIZATION ANALYSIS							
Upstream Habitat Length (mi)	1.6		Habitat Points	4			
Habitat Quality	Good		Habitat Quality Points	3			
Fish Species	Anad.		Fish Points	3			
Barrier Class	Gray		Barrier Points	2

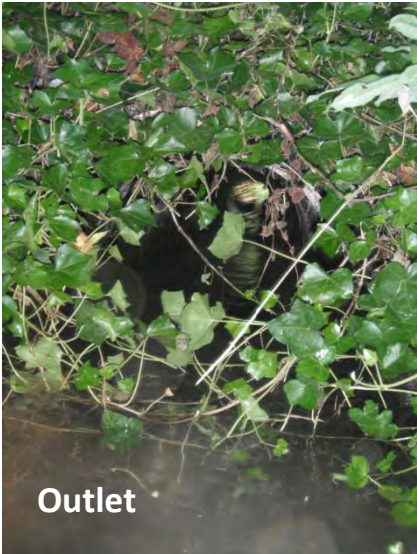
LOCATION INFO				Culvert #	352	Priority	H
Watershed		Miami River					
Stream Name		Waldron Creek					
Township-Range-Section-1/4		T1N, R10W, Sec. 11, SE¼ of NW¼					
UTM Easting/Northing (Zone 10, NAD 1983)		431665/5048197					
Road Name		Miami Foley Road					
Road/Culvert Owner		Tillamook County					
Adjacent Landowners		E. Waldron					
CULVERT INFO		CHANNEL INFO					
Shape	Circular	Inlet Gradient (%)	8.7				
Material	Concrete	Upstream Gradient (%)	3.4				
Length (ft)	52	Bankfull Width (ft)	8.5				
Width (in)	36	Bankfull:Culvert Ratio	0.4				
Height (in)	36						
Outlet Perch (ft)	None						
Slope (%)	2.5						
Rustline Height (in)	18						
Overall Condition	Fair						
PRIORITIZATION ANALYSIS							
Upstream Habitat Length (mi)	0.7	Habitat Points	2				
Habitat Quality	Fair	Habitat Quality Points	2				
Fish Species	Anad.	Fish Points	3				
Barrier Class	Red	Barrier Points	3				
		Prioritization Total Points	10

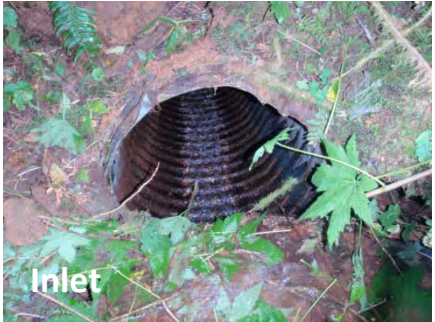
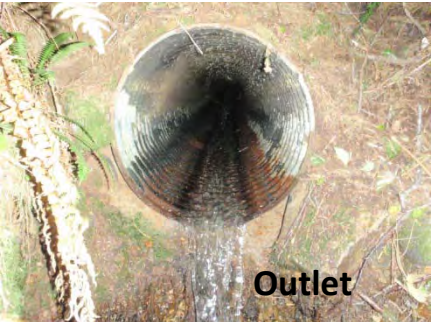
**Outlet**

LOCATION INFO				Culvert #	273	Priority	M
Watershed			Miami River				
Stream Name			Unnamed tributary of Minich Creek				
Township-Range-Section-1/4			T1N, R10W, Sec. 10, NE¼ of NE¼				
UTM Easting/Northing (Zone 10, NAD 1983)			430996/5048047				
Road Name			Minich Creek Road				
Road/Culvert Owner			Oregon Department of Forestry				
Adjacent Landowners		Stimson Lumber Company					
CULVERT INFO			CHANNEL INFO				
Shape	Circular		Inlet Gradient (%)	7.0			
Material	Corrugated metal		Upstream Gradient (%)	9.0			
Length (ft)	61		Bankfull Width (ft)	9.6			
Width (in)	24		Bankfull:Culvert Ratio	0.2			
Height (in)	24						
Outlet Perch (ft)	1.8						
Slope (%)	7.0						
Rustline Height (in)	14						
Overall Condition	Fair						
PRIORITIZATION ANALYSIS							
Upstream Habitat Length (mi)		0.2	Habitat Points		1		
Habitat Quality		Fair	Habitat Quality Points		2		
Fish Species		Anad.	Fish Points		3		
Barrier Class		Red	Barrier Points		3

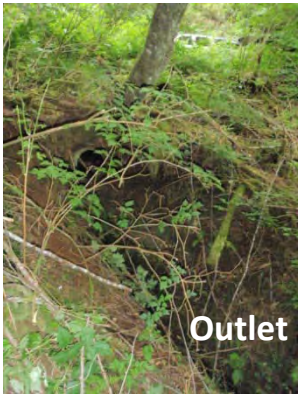
Inlet			
Stream Name		Miami River					
Township-Range-Section-1/4		Minich Creek					
UTM Easting/Northing (Zone 10, NAD 1983)		T1N, R11W, Sec. 10, SE¼ of NE¼					
Road Name		431133/5048601					
Road/Culvert Owner		Minich Creek Road					
Adjacent Landowners		Oregon Department of Forestry					
Overall Condition		Poor					
CULVERT INFO		CHANNEL INFO

Outlet			
Shape	Circular	Inlet Gradient (%)	2.0				
Material	Corrugated metal	Upstream Gradient (%)	2.5				
Length (ft)	68	Bankfull Width (ft)	6.6				
Width (in)	18	Bankfull:Culvert Ratio	0.2				
Height (in)	18						
Outlet Perch (ft)	6.8						
Slope (%)	7.0						
Rustline Height (in)	N/A						
PRIORITIZATION ANALYSIS							
Upstream Habitat Length (mi)	0.6	Habitat Points	2				
Habitat Quality	Fair	Habitat Quality Points	2				
Fish Species	Anad.	Fish Points	3				
Barrier Class	Red	Barrier Points	3				
		Prioritization Total Points	10

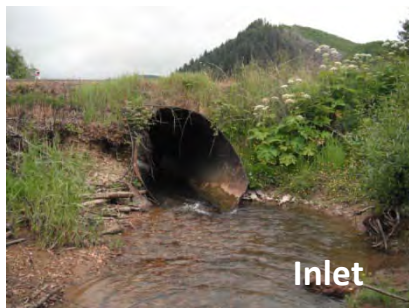
<b>Inlet</b>	
Shape	Circular	Inlet Gradient (%)	4.1				
Material	Corrugated metal	Upstream Gradient (%)	1.4				
Length (ft)	46	Bankfull Width (ft)	15.4				
Width (in)	96	Bankfull:Culvert Ratio	0.5				
Height (in)	96						
Outlet Perch (ft)	0.2*						
Slope (%)	1.0						
Rustline Height (in)	30						
Overall Condition	Poor						
PRIORITIZATION ANALYSIS

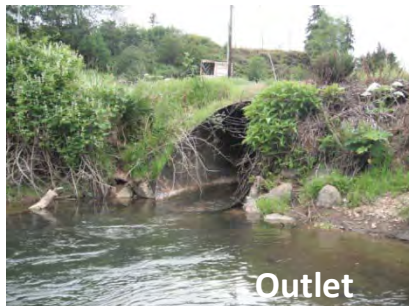
<b>Outlet</b>	
Upstream Habitat Length (mi)	6.2	Habitat Points	4				
Habitat Quality	Good	Habitat Quality Points	3				
Fish Species	Anad.	Fish Points	3				
Barrier Class	Gray	Barrier Points	2

Prioritization Total Points	12				
<b>Notes:</b> *Outlets into Miami River mainstem. Tailwater control point not measurable so perch height was estimated.

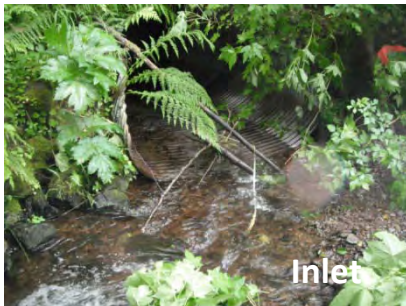
LOCATION INFO				Culvert #	138	Priority	H
Watershed			Miami River				
Stream Name			Prouty Creek				
Township-Range-Section-1/4			T2N, R10W, Sec. 36, NW¼ of NE¼				
UTM Easting/Northing (Zone 10, NAD 1983)			433364/5032149				
Road Name			Miami Forest River Road				
Road/Culvert Owner		Private Drive with Oregon Dept. of Forestry Easement					
Adjacent Landowners		State of Oregon and E. Frantz					
CULVERT INFO			CHANNEL INFO				
Shape	Pipe Arch		Inlet Gradient (%)	7.3			
Material	Corrugated metal		Upstream Gradient (%)	1.8			
Length (ft)	45		Bankfull Width (ft)	9.5			
Width (in)	110		Bankfull:Culvert Ratio	1.0			
Height (in)	82						
Outlet Perch (ft)	0.2						
Slope (%)	3.8						
Rustline Height (in)	18						
Overall Condition	Fair						
PRIORITIZATION ANALYSIS							
Upstream Habitat Length (mi)		1.1	Habitat Points	3			
Habitat Quality		Good	Habitat Quality Points	3			
Fish Species		Anad.	Fish Points	3			
Barrier Class		Red	Barrier Points	3

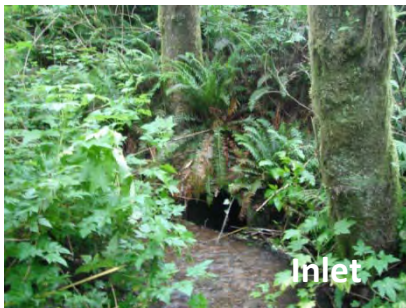
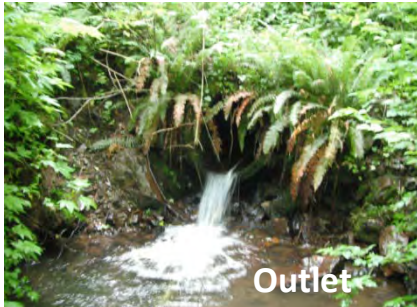
LOCATION INFO				Culvert #	126	Priority	M
Watershed		Miami River					
Stream Name		Carver Creek					
Township-Range-Section-1/4		T2N, R10W, Sec. 25, SE¼ of SW¼					
UTM Easting/Northing (Zone 10, NAD 1983)		433224/5052341					
Road Name		Miami Foley Road					
Road/Culvert Owner		Tillamook County					
Adjacent Landowners		N. Carver, W. Scholerman, W. Staben					
CULVERT INFO		CHANNEL INFO					
Shape	Circular	Inlet Gradient (%)	18.6				
Material	Concrete	Upstream Gradient (%)	4.2				
Length (ft)	91	Bankfull Width (ft)	7.4				
Width (in)	36	Bankfull:Culvert Ratio	0.4				
Height (in)	36						
Outlet Perch (ft)	2.2						
Slope (%)	3.1						
Rustline Height (in)	N/A						
Overall Condition	Poor						
PRIORITIZATION ANALYSIS							
Upstream Habitat Length (mi)	0.2	Habitat Points	1				
Habitat Quality	Fair	Habitat Quality Points	2				
Fish Species	Anad.	Fish Points	3				
Barrier Class	Red	Barrier Points	3				
		Prioritization Total Points	9

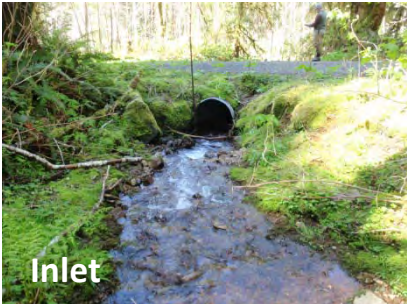
<b>Inlet</b>	
Shape	Circular	Inlet Gradient (%)	9.2				
Material	Corrugated metal	Upstream Gradient (%)	6.9				
Length (ft)	30	Bankfull Width (ft)	7.6				
Width (in)	36	Bankfull:Culvert Ratio	0.4				
Height (in)	36						
Outlet Perch (ft)	1.6						
Slope (%)	4.4						
Rustline Height (in)	14						
Overall Condition	Fair						
PRIORITIZATION ANALYSIS

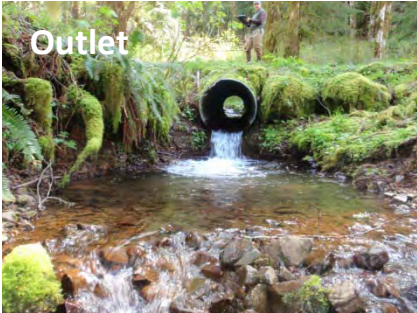
<b>Outlet</b>	
Upstream Habitat Length (mi)	0.1	Habitat Points	1				
Habitat Quality	Poor	Habitat Quality Points	1				
Fish Species	Anad.	Fish Points	3

Barrier Class	Red	Barrier Points	3				
		Prioritization Total Points	8				
Notes:

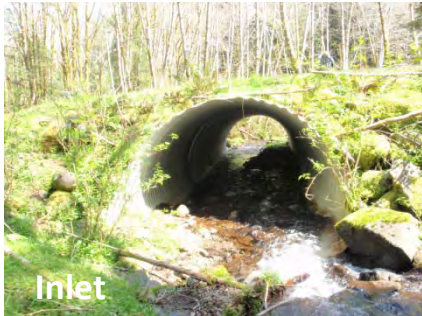
LOCATION INFO				Culvert #	93	Priority	NA
Watershed			Miami River				
Stream Name			Unnamed tributary to Miami River				
Township-Range-Section-1/4			T2N, R9W, Sec. 21, NW¼ of SW¼				
UTM Easting/Northing (Zone 10, NAD 1983)			438027/5054143				
Road Name			Miami Forest River Road				
Road/Culvert Owner			Oregon Dept. of Forestry				
Adjacent Landowners		Oregon Department of Forestry					
CULVERT INFO			CHANNEL INFO				
Shape	Pipe Arch		Inlet Gradient (%)	0.1			
Material	Corrugated metal		Upstream Gradient (%)	15.6			
Length (ft)	55		Bankfull Width (ft)	9.4			
Width (in)	120		Bankfull:Culvert Ratio	1.3			
Height (in)	96						
Outlet Perch (ft)	None						
Slope (%)	4.5						
Rustline Height (in)	N/A						
Overall Condition	Good						
PRIORITIZATION ANALYSIS							
Upstream Habitat Length (mi)	0.2		Habitat Points	1			
Habitat Quality	Poor		Habitat Quality Points	1			
Fish Species	Anad.		Fish Points	3			
Barrier Class	Green		Barrier Points	1

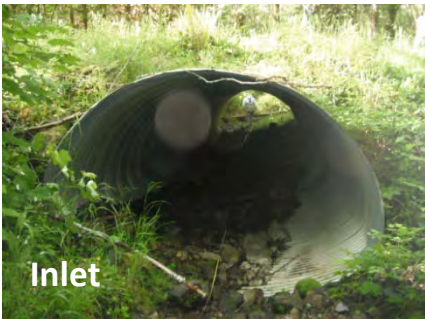
**Inlet**

LOCATION INFO				Culvert #	84	Priority	L
Watershed		Miami River					
Stream Name		Unnamed tributary to Miami River					
Township-Range-Section-1/4		T2N, R9W, Sec. 21, NW¼ of SW¼					
UTM Easting/Northing (Zone 10, NAD 1983)		439281/5054779					
Road Name		Miami Forest River Road					
Road/Culvert Owner		Oregon Dept. of Forestry					
Adjacent Landowners		Oregon Department of Forestry					
CULVERT INFO		CHANNEL INFO					
Shape	Pipe Arch	Inlet Gradient (%)	12.5				
Material	Corrugated metal	Upstream Gradient (%)	10.1				
Length (ft)	55	Bankfull Width (ft)	9.7				
Width (in)	120	Bankfull:Culvert Ratio	1.2				
Height (in)	96	Stream dry during summer 2011 site visit.					
Outlet Perch (ft)	10.3*						
Slope (%)	3.6						
Rustline Height (in)	N/A						
Overall Condition	Fair						
PRIORITIZATION ANALYSIS							
Upstream Habitat Length (mi)	0.2	Habitat Points	1				
Habitat Quality	Poor	Habitat Quality Points	1				
Fish Species	Anad.	Fish Points	3

Barrier Class	Red	Barrier Points	3				
		Prioritization Total Points	8				
<b>Notes:</b> *Stream cascades over steep boulders and cobbles into the mainstem Miami River shortly after exiting this culvert. Barrier class and outlet perch based on this fact.

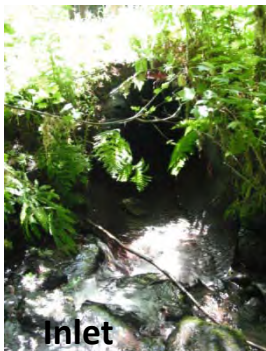
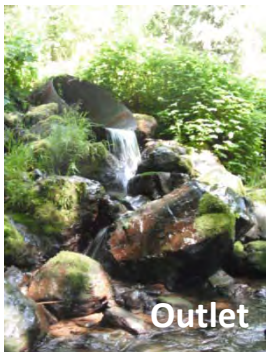
Shape	Circular	Inlet Gradient (%)	12.5				
Material	Corrugated metal	Upstream Gradient (%)	14.3				
Length (ft)	42	Bankfull Width (ft)	9.0				
Width (in)	60	Bankfull:Culvert Ratio	0.6				
Height (in)	60						
Outlet Perch (ft)	7.2						
Slope (%)	1.8						
Rustline Height (in)	24						
Overall Condition	Fair						
PRIORITIZATION ANALYSIS							
Upstream Habitat Length (mi)	0.1	Habitat Points	1				
Habitat Quality	Poor	Habitat Quality Points	1				
Fish Species	Anad.	Fish Points	3

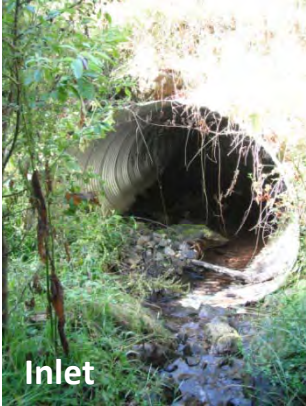
Inlet			
Stream Name		Unnamed tributary to Miami River					
Township-Range-Section-1/4		T2N, R9W, Sec. 21, NW¼ of SW¼					
UTM Easting/Northing (Zone 10, NAD 1983)		440590/5054528					
Road Name		Miami Forest River Road					
Road/Culvert Owner		Oregon Dept. of Forestry					
Adjacent Landowners		Oregon Department of Forestry					
CULVERT INFO		CHANNEL INFO					
Shape	Pipe Arch	Inlet Gradient (%)	34.1

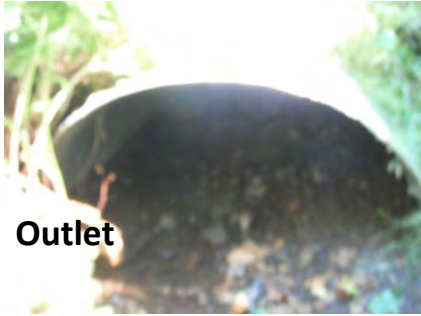
Outlet			
Material	Corrugated metal	Upstream Gradient (%)	19.4				
Length (ft)	61	Bankfull Width (ft)	5.2				
Width (in)	104	Bankfull:Culvert Ratio	1.7				
Height (in)	66						
Outlet Perch (ft)	0.4						
Slope (%)	3.3						
Rustline Height (in)	4						
Overall Condition	Good						
PRIORITIZATION ANALYSIS							
Upstream Habitat Length (mi)	0.1	Habitat Points	1				
Habitat Quality	Poor	Habitat Quality Points	1				
Fish Species	Anad.	Fish Points	3

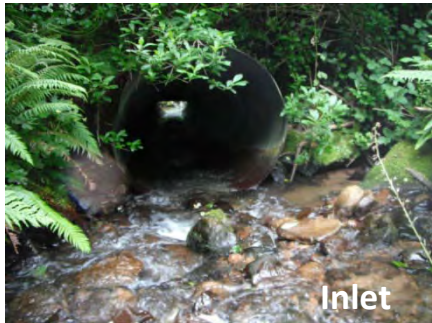
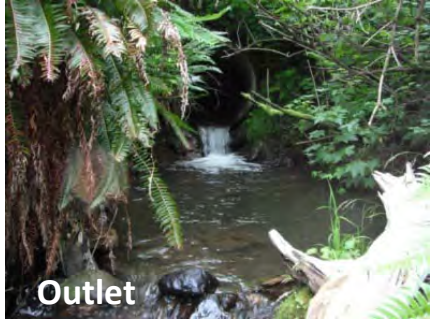
Shape	Box	Inlet Gradient (%)	13.4				
Material	Concrete	Upstream Gradient (%)	5.6				
Length (ft)	52	Bankfull Width (ft)	8.8				
Width (in)	56	Bankfull:Culvert Ratio	0.5				
Height (in)	56						
Outlet Perch (ft)	1.9						
Slope (%)	11.9						
Rustline Height (in)	22						
Overall Condition	Critical						
PRIORITIZATION ANALYSIS							
Upstream Habitat Length (mi)	0.9	Habitat Points	2				
Habitat Quality	Fair	Habitat Quality Points	2				
Fish Species	Anad.	Fish Points	3				
Barrier Type	Red	Barrier Points	3				
		Prioritization Total Points	10

<b>Notes:</b> Large holes in invert, pipe barrel is also deformed. Water running under pipe.

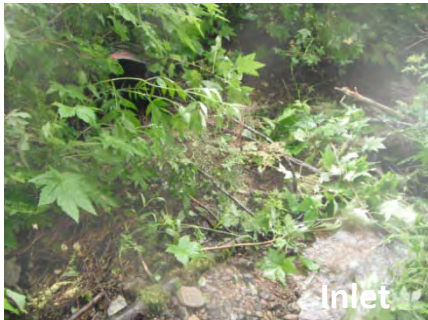
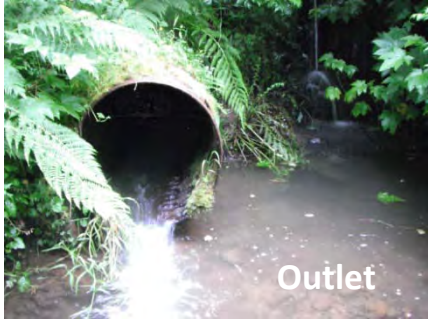
LOCATION INFO				Culvert #	413	Priority	M
Watershed		Tillamook Bay					
Stream Name		Smith Creek					
Township-Range-Section-1/4		T1N, R10W, Sec. 20, NE¼ of SE¼					
UTM Easting/Northing (Zone 10, NAD 1983)		427659/5046723					
Road Name		Barview Forest Road					
Road/Culvert Owner		Private Drive – ORM Timber					
Adjacent Landowners		ORM Timber					
CULVERT INFO		CHANNEL INFO					
Shape	Circular	Inlet Gradient (%)	12.0(N/A)				
Material	Corrugated metal	Upstream Gradient (%)	1.1				
Length (ft)	45(45)	Bankfull Width (ft)	10.1				
Width (in)	36(36)	Bankfull:Culvert Ratio	0.6*				
Height (in)	36(36)	Two pipes at this location. The outlet picture depicts pipe 2 in the foreground and the outfall of pipe 1 in the background (upper right corner of photo).					
Outlet Perch (ft)	7.5(0.8)						
Slope (%)	3.0(N/A)						
Rustline Height (in)	16(N/A)						
Overall Condition	Poor						
PRIORITIZATION ANALYSIS							
Upstream Habitat Length (mi)	0.3	Habitat Points	1

Habitat Quality	Fair	Habitat Quality Points	2				
Fish Species	Anad.	Fish Points	3				
Barrier Type	Red	Barrier Points	3				
		Prioritization Total Points	9				
<b>Notes:</b> *Bankfull:Culvert Ratio is based on both pipes. Both are 3 ft circular pipes and both were conveying flows during summer 2011 field visit. We were unable to locate the inlet for pipe 2 and it was unclear how flows were entering the pipe. Pipe 2 was perched 0.8 ft.

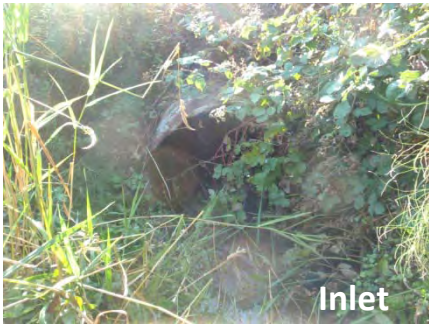
LOCATION INFO				Culvert #	5304	Priority	M
Watershed		Tillamook Bay					
Stream Name		School Creek					
Township-Range-Section-1/4		T1N, R10W, Sec. 20, SW¼ of NE¼					
UTM Easting/Northing (Zone 10, NAD 1983)		429112/5045771					
Road Name		Church Parking Lot					
Road/Culvert Owner		Private Drive					
Adjacent Landowners		Garibaldi Faith Church					
CULVERT INFO		CHANNEL INFO					
Shape	Circular	Inlet Gradient (%)	7.0				
Material	Corrugated Metal	Upstream Gradient (%)	4.0				
Length (ft)	125	Bankfull Width (ft)	8.0				
Width (in)	36	Bankfull:Culvert Ratio	0.4				
Height (in)	36	Natural substrate throughout pipe.					
Outlet Perch (ft)	None						
Slope (%)	1.0						
Rustline Height (in)	18						
Overall Condition	Poor						
PRIORITIZATION ANALYSIS							
Upstream Habitat Length (mi)	0.7	Habitat Points	2				
Habitat Quality	Poor	Habitat Quality Points	1				
Fish Species	Anad.	Fish Points	3				
Barrier Type	Red	Barrier Points	3

Prioritization Total Points	9				
<b>Notes:</b> Barrel of pipe is deformed. In addition, the outlet is wider (42 inch width) and a different shape than the inlet (it is a pipe arch). Two different pipes may have been joined to allow construction of the church parking lot. Barrier rating based on BFW:Culvert ratio, but during low flows (e.g., when we observed the pipe during summer 2012) it appears that juvenile fish could pass through the culvert.

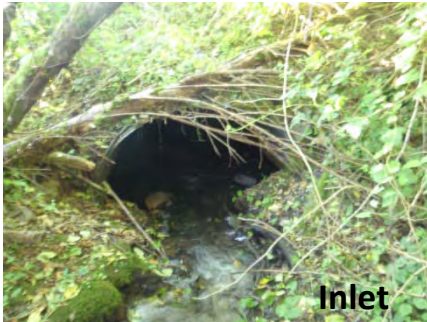
LOCATION INFO				Culvert #	452	Priority	L
Watershed			Tillamook Bay				
Stream Name			School Creek				
Township-Range-Section-1/4			T1N, R10W, Sec. 20, SW¼ of NE¼				
UTM Easting/Northing (Zone 10, NAD 1983)			429064/5045799				
Road Name			Driftwood Avenue, Garibaldi				
Road/Culvert Owner			Private Drive				
Adjacent Landowners		J.&D. McGeever, B. Merrill, Garibaldi Faith Church					
CULVERT INFO			CHANNEL INFO				
Shape	Pipe Arch		Inlet Gradient (%)	8.0			
Material	Corrugated Metal		Upstream Gradient (%)	5.0			
Length (ft)	82		Bankfull Width (ft)	9.5			
Width (in)	96		Bankfull:Culvert Ratio	0.8			
Height (in)	48		Natural substrate through entire pipe.				
Outlet Perch (ft)	None						
Slope (%)	3.0						
Rustline Height (in)	6						
Overall Condition	Fair						
PRIORITIZATION ANALYSIS							
Upstream Habitat Length (mi)	0.7		Habitat Points	2			
Habitat Quality	Poor		Habitat Quality Points	1			
Fish Species	Anad.		Fish Points	3

Barrier Type	Gray		Barrier Points	2			
			Prioritization Total Points	8			
Notes:

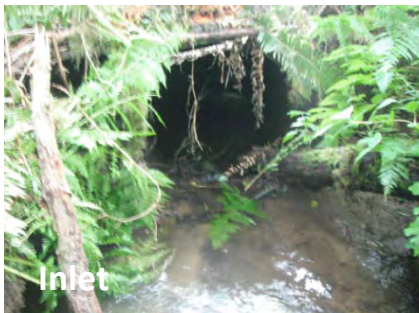
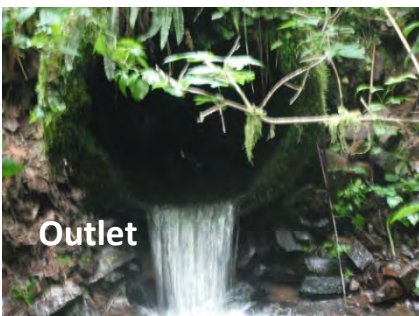
Shape	Circular	Inlet Gradient (%)	1.4				
Material	Concrete	Upstream Gradient (%)	0.4				
Length (ft)	55	Bankfull Width (ft)	3.6				
Width (in)	36	Bankfull:Culvert Ratio	0.8				
Height (in)	36						
Outlet Perch (ft)	1.5						
Slope (%)	1.8						
Rustline Height (in)	N/A						
Overall Condition	Poor						
PRIORITIZATION ANALYSIS

Upstream Habitat Length (mi)	0.4	Habitat Points	1				
Habitat Quality	Fair	Habitat Quality Points	2				
Fish Species	Anad.	Fish Points	3				
Barrier Type	Red	Barrier Points	3				
		Prioritization Total Points	9

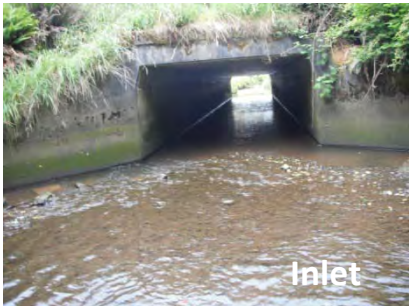
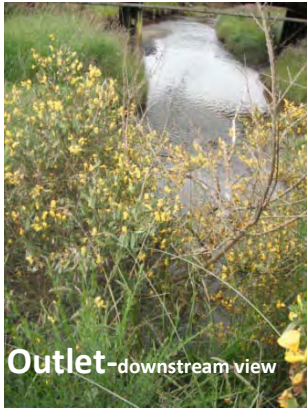
Adjacent Landowners		ODOT, Port of Garibaldi					
CULVERT INFO		CHANNEL INFO					
Shape	Box	Inlet Gradient (%)	0.1				
Material	Concrete	Upstream Gradient (%)	0.2				
Length (ft)	105	Bankfull Width (ft)	22.0				
Width (in)	96	Bankfull:Culvert Ratio	0.4				
Height (in)	96						
Outlet Perch (ft)	None						
Slope (%)	0.2						
Rustline Height (in)	48						
Overall Condition	Fair						
PRIORITIZATION ANALYSIS							
Upstream Habitat Length (mi)	3.8	Habitat Points	4				
Habitat Quality	Fair(-)	Habitat Quality Points	2				
Fish Species	Anad.	Fish Points	3				
Barrier Class	Gray	Barrier Points	2

Prioritization Total Points	11				
<b>Notes:</b> Although classified as Gray, this culvert likely passes fish under most conditions. Classification is based on BFW:Width Ratio, but because culvert is tidally influence and completely backwatered under most conditions, it seems likely that passage is rarely inhibited by this crossing. That being said, the culvert is undersized and almost certainly impairs tidal processes.

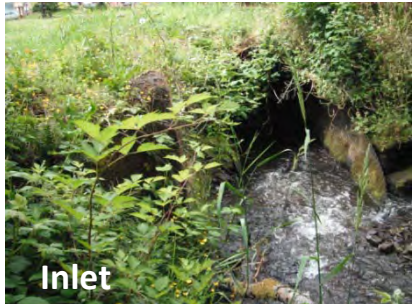
<b>Inlet</b>	
Shape	Circular	Inlet Gradient (%)	7.6				
Material	Corrugated Metal	Upstream Gradient (%)	1.9				
Length (ft)	97	Bankfull Width (ft)	11.4				
Width (in)	72	Bankfull:Culvert Ratio	0.5				
Height (in)	72						
Outlet Perch (ft)	None						
Slope (%)	1.6						
Rustline Height (in)	33						
Overall Condition	Fair						
PRIORITIZATION ANALYSIS

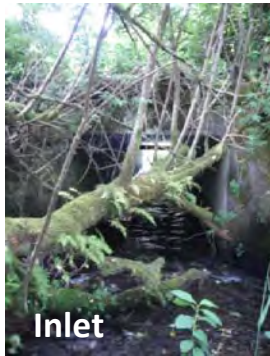
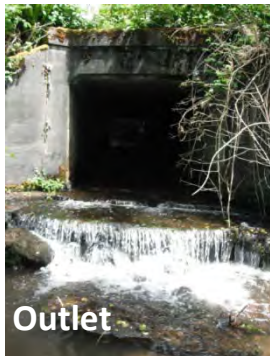
LOCATION INFO				Culvert #	578	Priority	H
Watershed		Tillamook Bay					
Stream Name		Patterson Creek					
Township-Range-Section-1/4		T1N, R10W, Sec. 35, SE¼ of NW¼					
UTM Easting/Northing (Zone 10, NAD 1983)		430568/5041806					
Road Name		5 <sup>th</sup> Street					
Road/Culvert Owner		City of Bay City					
Adjacent Landowners		A & E. Troyer, A. Harris, J. Fullan					
CULVERT INFO		CHANNEL INFO

<b>Outlet</b>	
Shape	Box	Inlet Gradient (%)	4.2				
Material	Concrete	Upstream Gradient (%)	10				
Length (ft)	71	Bankfull Width (ft)	15.0				
Width (in)	96	Bankfull:Culvert Ratio	0.5				
Height (in)	72						
Outlet Perch (ft)	1.8						
Slope (%)	0.5						
Rustline Height (in)	24						
Overall Condition	Fair						
PRIORITIZATION ANALYSIS							
Upstream Habitat Length (mi)	3.6	Habitat Points	4				
Habitat Quality	Fair(-)	Habitat Quality Points	2				
Fish Species	Anad.	Fish Points	3				
Barrier Class	Red	Barrier Points	3

Prioritization Total Points	12				
Notes:

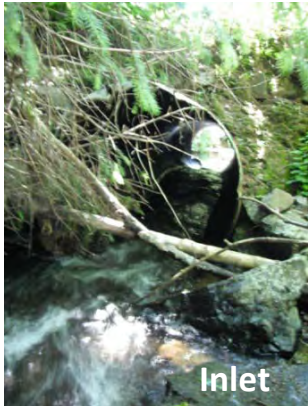
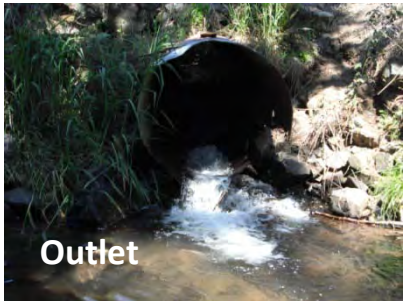
LOCATION INFO				Culvert #	575	Priority	H
Watershed		Tillamook Bay					
Stream Name		Patterson Creek					
Township-Range-Section-1/4		T1N, R10W, Sec. 35, SE¼ of NW¼					
UTM Easting/Northing (Zone 10, NAD 1983)		430727/5041881					
Road Name		Unnamed drive off Main Ave.					
Road/Culvert Owner		City of Bay City					
Adjacent Landowners		D. Buxton, R. & S. Blodget					
CULVERT INFO		CHANNEL INFO

<b>Inlet</b>	
Shape	Circular	Inlet Gradient (%)	2.8				
Material	Corrugated metal	Upstream Gradient (%)	2.2				
Length (ft)	36	Bankfull Width (ft)	11.6				
Width (in)	60	Bankfull:Culvert Ratio	0.4				
Height (in)	60						
Outlet Perch (ft)	0.8						
Slope (%)	3.4						
Rustline Height (in)	18						
Overall Condition	Critical						
PRIORITIZATION ANALYSIS

<b>Outlet</b>	
Upstream Habitat Length (mi)	2.3	Habitat Points	4				
Habitat Quality	Fair(-)	Habitat Quality Points	2				
Fish Species	Anad.	Fish Points	3

Barrier Type	Red	Barrier Points	3				
		Prioritization Total Points	12				
Notes: Bottom and side of culvert completely worn through.

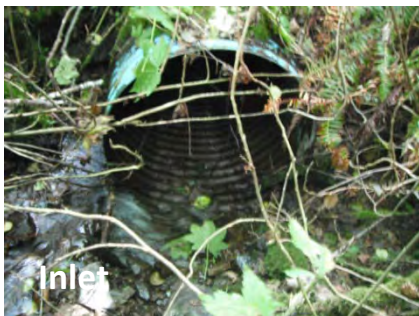
LOCATION INFO				Culvert #	528	Priority	L
Watershed				Tillamook Bay			
Stream Name				Patterson Creek			
Township-Range-Section-1/4				T1N, R10W, Sec. 26, NW¼ of SE¼			
UTM Easting/Northing (Zone 10, NAD 1983)				432101/5043624			
Road Name				Patterson Creek Road			
Road/Culvert Owner				Oregon Department of Forestry			
Adjacent Landowners				Oregon Department of Forestry			
CULVERT INFO		CHANNEL INFO

Shape	Circular	Inlet Gradient (%)	4.0				
Material	Corrugated metal	Upstream Gradient (%)	3.5				
Length (ft)	74	Bankfull Width (ft)	6.9				
Width (in)	36	Bankfull:Culvert Ratio	0.4				
Height (in)	36						
Outlet Perch (ft)	2.2						
Slope (%)	2.0						
Rustline Height (in)	16						
Overall Condition	Poor						
PRIORITIZATION ANALYSIS				 			
Upstream Habitat Length (mi)	0.1	Habitat Points	1				
Habitat Quality	Poor	Habitat Quality Points	1				
Fish Species	Anad.	Fish Points	3				
Barrier Type	Red	Barrier Points	3

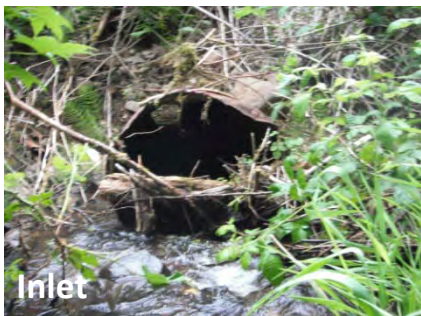
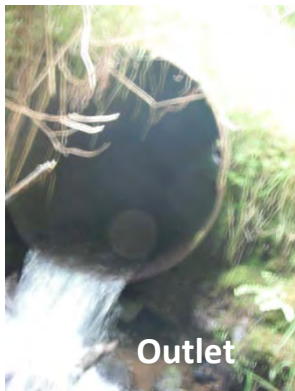
LOCATION INFO				Culvert #	543	Priority	M
Watershed		Tillamook Bay					
Stream Name		Unnamed tributary to Patterson Creek					
Township-Range-Section-1/4		T1N, R10W, Sec. 25, NW¼ of SE¼					
UTM Easting/Northing (Zone 10, NAD 1983)		431979/5042920					
Road Name		Unnamed Forest Road					
Road/Culvert Owner		Oregon Department of Forestry					
Adjacent Landowners		Oregon Department of Forestry					
CULVERT INFO		CHANNEL INFO					
Shape	Circular	Inlet Gradient (%)	66.3				
Material	Corrugated metal	Upstream Gradient (%)	7.3				
Length (ft)	41	Bankfull Width (ft)	5.7				
Width (in)	42	Bankfull:Culvert Ratio	0.6				
Height (in)	42						
Outlet Perch (ft)	3.1						
Slope (%)	4.2						
Rustline Height (in)	23						
Overall Condition	Poor						
PRIORITIZATION ANALYSIS							
Upstream Habitat Length (mi)	0.4	Habitat Points	1				
Habitat Quality	Fair	Habitat Quality Points	2				
Fish Species	Anad.	Fish Points	3				
Barrier Type	Red	Barrier Points	3

Prioritization Total Points	9				
Notes: Large amount of debris in inlet.

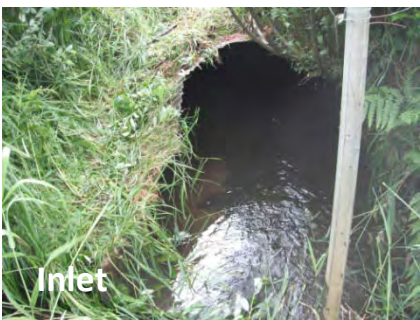
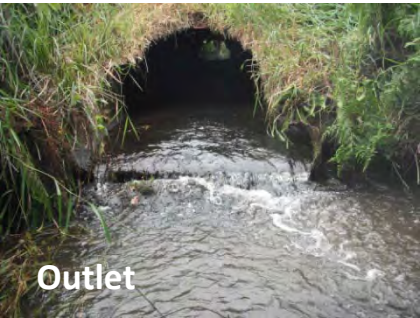
LOCATION INFO				Culvert #	647	Priority	H
Watershed		Kilchis River					
Stream Name		Doty Creek					
Township-Range-Section-1/4		T1S, R10W, Sec. 2, SW¼ of SE¼					
UTM Easting/Northing (Zone 10, NAD 1983)		431728/5039890					
Road Name		Highway 101					
Road/Culvert Owner		Oregon Department of Transportation					
Adjacent Landowners		M. Farrington, F. & L. Adkins					
CULVERT INFO		CHANNEL INFO

Shape	Pipe Arch	Inlet Gradient (%)			2.7		
Material	Corrugated metal	Upstream Gradient (%)			13.2		
Length (ft)	75	Bankfull Width (ft)			5.8		
Width (in)	66	Bankfull:Culvert Ratio			0.9		
Height (in)	36						
Outlet Perch (ft)	0.5						
Slope (%)	0.7						
Rustline Height (in)	10						
Overall Condition	Fair						
PRIORITIZATION ANALYSIS

Upstream Habitat Length (mi)	1.7	Habitat Points			4		
Habitat Quality	Fair	Habitat Quality Points			2		
Fish Species	Anad.	Fish Points			3		
Barrier Type	Red	Barrier Points			3

Prioritization Total Points			12		
Notes: Integrated apron on outlet.

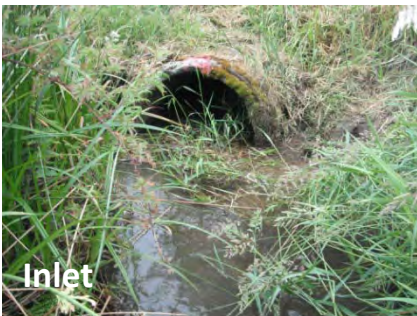
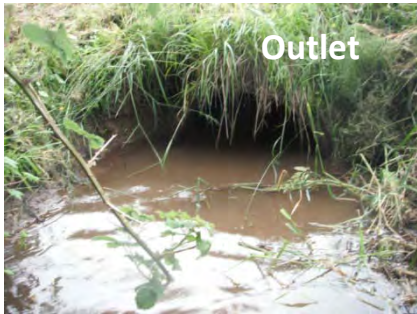
LOCATION INFO				Culvert #	637	Priority	H
Watershed			Kilchis River				
Stream Name			Doty Creek				
Township-Range-Section-1/4			T1S, R10W, Sec. 2, SE¼ of SE¼				
UTM Easting/Northing (Zone 10, NAD 1983)			432147/5040015				
Road Name			Alderbrook Loop Road				
Road/Culvert Owner			Tillamook County				
Adjacent Landowners		L.&C. Oswald, D.&C. Phillips, and J. Johnson					
CULVERT INFO			CHANNEL INFO				
Shape	Circular		Inlet Gradient (%)	13.6			
Material	Concrete		Upstream Gradient (%)	0.15			
Length (ft)	41		Bankfull Width (ft)	6.8			
Width (in)	36		Bankfull:Culvert Ratio	0.4			
Height (in)	36						
Outlet Perch (ft)	0.1						
Slope (%)	0.1						
Rustline Height (in)	N/A						
Overall Condition	Fair						
PRIORITIZATION ANALYSIS							
Upstream Habitat Length (mi)	1.4		Habitat Points	3			
Habitat Quality	Fair		Habitat Quality Points	2			
Fish Species	Anad.		Fish Points	3			
Barrier Type	Gray		Barrier Points	2

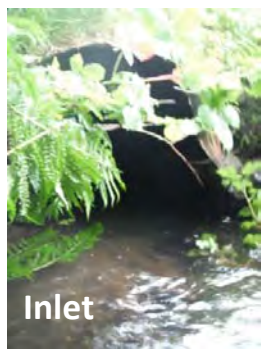
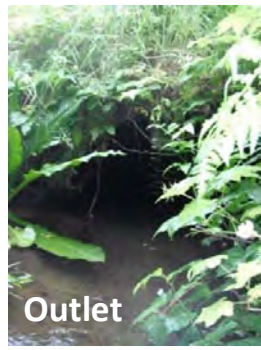
LOCATION INFO				Culvert #	613	Priority	M
Watershed			Tillamook Bay				
Stream Name			Doty Creek				
Township-Range-Section-1/4			T1S, R10W, Sec. 1, NW¼ of NW¼				
UTM Easting/Northing (Zone 10, NAD 1983)			432729/5040868				
Road Name			Doughty Road				
Road/Culvert Owner			Tillamook County				
Adjacent Landowners		R. Rasmussen, Alderbrook Hills, W.&D. Collum					
CULVERT INFO			CHANNEL INFO				
Shape	Circular		Inlet Gradient (%)	10.8			
Material	Corrugated metal		Upstream Gradient (%)	3.5			
Length (ft)	36		Bankfull Width (ft)	6.5			
Width (in)	46		Bankfull:Culvert Ratio	0.6			
Height (in)	46						
Outlet Perch (ft)	None						
Slope (%)	-1.1						
Rustline Height (in)	17						
Overall Condition	Fair						
PRIORITIZATION ANALYSIS							
Upstream Habitat Length (mi)	0.7		Habitat Points	2			
Habitat Quality	Fair		Habitat Quality Points	2			
Fish Species	Anad.		Fish Points	3			
Barrier Type	Gray		Barrier Points	2

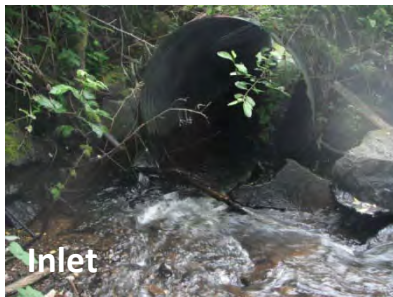
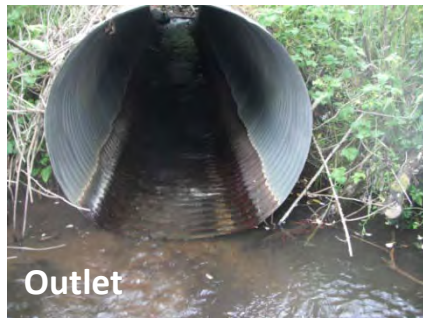
LOCATION INFO				Culvert #	605	Priority	M
Watershed		Tillamook Bay					
Stream Name		Doty Creek					
Township-Range-Section-1/4		T1N, R10W, Sec. 36, SE¼ of SW¼					
UTM Easting/Northing (Zone 10, NAD 1983)		432768/5041048					
Road Name		Private Drive off Doughty Road					
Road/Culvert Owner		Oregon Department of Forestry					
Adjacent Landowners		Oregon Department of Forestry					
CULVERT INFO		CHANNEL INFO					
Shape	Circular	Inlet Gradient (%)	12.0				
Material	Corrugated metal	Upstream Gradient (%)	0.58				
Length (ft)	31	Bankfull Width (ft)	7.6				
Width (in)	48	Bankfull:Culvert Ratio	0.5				
Height (in)	48						
Outlet Perch (ft)	None						
Slope (%)	3.4						
Rustline Height (in)	20.4						
Overall Condition	Fair						
PRIORITIZATION ANALYSIS							
Upstream Habitat Length (mi)	0.5	Habitat Points	1				
Habitat Quality	Fair	Habitat Quality Points	2				
Fish Species	Anad.	Fish Points	3				
Barrier Type	Red	Barrier Points	3

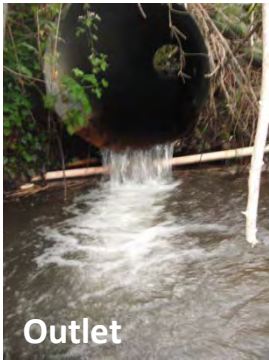
LOCATION INFO				Culvert #	599	Priority	M
Watershed		Tillamook Bay					
Stream Name		Doty Creek					
Township-Range-Section-1/4		T1N, R10W, Sec. 36, SE¼ of SW¼					
UTM Easting/Northing (Zone 10, NAD 1983)		432833/5041204					
Road Name		Timberline Drive					
Road/Culvert Owner		J.&S. Smith					
Adjacent Landowners		J.&S. Smith and P. Early					
CULVERT INFO		CHANNEL INFO

Shape	Circular	Inlet Gradient (%)	18.1				
Material	Corrugated metal	Upstream Gradient (%)	3.1				
Length (ft)	40	Bankfull Width (ft)	9.0				
Width (in)	48	Bankfull:Culvert Ratio	0.4				
Height (in)	48						
Outlet Perch (ft)	0.9						
Slope (%)	1.2						
Rustline Height (in)	18						
Overall Condition	Good						
PRIORITIZATION ANALYSIS
