# **Culvert Assessment and Prioritization Plan for Fish Passage in the Tillamook Bay Watershed, Tillamook County, Oregon – Version 1.1**

**Tillamook  
Estuaries  
Partnership**

**September 2012**

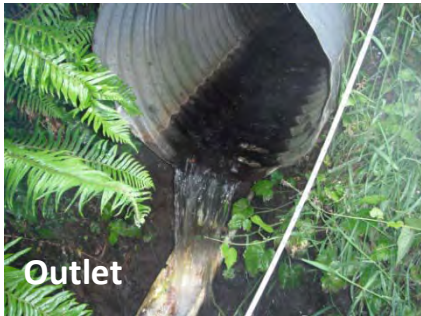
LOCATION INFO				Culvert #	593	Priority	
Watershed		Tillamook Bay					
Stream Name		Doty Creek					
Township-Range-Section-1/4		T1N, R10W, Sec. 36, SE¼ of NW¼					
UTM Easting/Northing (Zone 10, NAD 1983)		432915/5041390					
Road Name		Private drive off Willowbrook Drive					
Road/Culvert Owner		Alderbrook Hills Road & Maintenance					
Adjacent Landowners		E.&K. Heuberger, B. Germond					
CULVERT INFO		CHANNEL INFO

Shape	Circular	Inlet Gradient (%)	5.6				
Material	Corrugated metal	Upstream Gradient (%)	1.9				
Length (ft)	44	Bankfull Width (ft)	5.2				
Width (in)	24	Bankfull:Culvert Ratio	0.4				
Height (in)	24						
Outlet Perch (ft)	4.2						
Slope (%)	6.3						
Rustline Height (in)	unknown						
Overall Condition	Fair						
PRIORITIZATION ANALYSIS

Barrier Type	Red	Barrier Points	3				
		Prioritization Total Points	9				
Notes: Small PVC “apron” on outlet

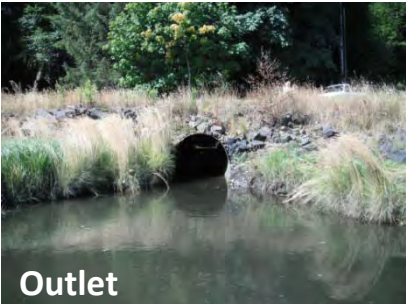
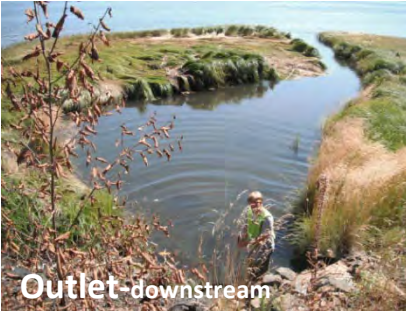
LOCATION INFO				Culvert #	725	Priority	L
Watershed		Tillamook Bay

<p>Outlet-downstream</p>			
Adjacent Landowners		J. A. Johnson					
CULVERT INFO		CHANNEL INFO					
Shape	Circular	Inlet Gradient (%)	1.8				
Material	Corrugated metal	Upstream Gradient (%)	3.7				
Length (ft)	52	Bankfull Width (ft)	6.7				
Width (in)	72	Bankfull:Culvert Ratio	0.9				
Height (in)	72						
Outlet Perch (ft)	Not measurable						
Slope (%)	2.8						
Rustline Height (in)	30						
Overall Condition	Poor						
PRIORITIZATION ANALYSIS							
Upstream Habitat Length (mi)	0.4	Habitat Points	1				
Habitat Quality	Fair	Habitat Quality Points	2				
Fish Species	Anad.	Fish Points	3

Barrier Class	Gray	Barrier Points	2				
		Prioritization Total Points	8				
Notes: Outlets directly into bay.

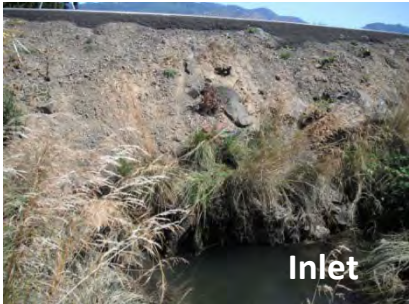
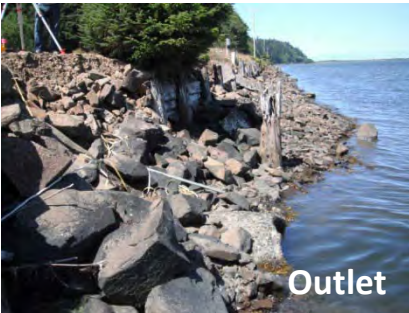
LOCATION INFO				Culvert #	702	Priority	M
Watershed		Tillamook Bay					
Stream Name		Unnamed tributary at McCoy Cove					
Township-Range-Section-1/4		T1S, R10W, Sec. 9, SE¼ of SW¼					
UTM Easting/Northing (Zone 10, NAD 1983)		428043/5038123					
Road Name		Bayocean Road					
Road/Culvert Owner		Tillamook County					
Adjacent Landowners		J. A. Johnson					
CULVERT INFO		CHANNEL INFO

Shape	Circular	Inlet Gradient (%)	1.0				
Material	Concrete	Upstream Gradient (%)	0.5				
Length (ft)	48	Bankfull Width (ft)	9.3				
Width (in)	48	Bankfull:Culvert Ratio	0.4				
Height (in)	48						
Outlet Perch (ft)	Not measurable						
Slope (%)	0.2						
Rustline Height (in)	34						
Overall Condition	Fair						
PRIORITIZATION ANALYSIS

Prioritization Total Points	9				
Notes: Outlets directly into bay.

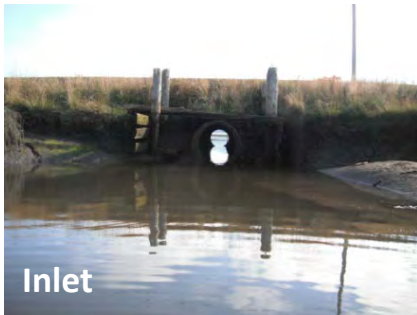
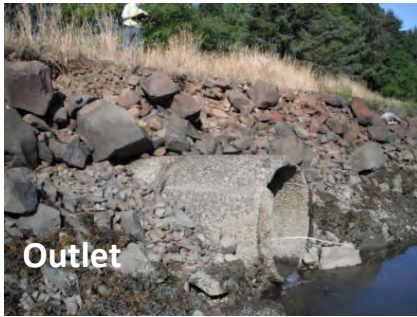
LOCATION INFO				Culvert #	689	Priority	H
Watershed		Tillamook Bay					
Stream Name		Flower Pot Creek					
Township-Range-Section-1/4		T1S, R10W, Sec. 8, SW¼ of SE¼					
UTM Easting/Northing (Zone 10, NAD 1983)		427301/5038583					
Road Name		Bayocean Road					
Road/Culvert Owner		Tillamook County					
Adjacent Landowners		Tillamook County					
CULVERT INFO		CHANNEL INFO

Inlet	
Shape	Circular	Inlet Gradient (%)	0.2				
Material	Concrete	Upstream Gradient (%)	0.5				
Length (ft)	56	Bankfull Width (ft)	12.7				
Width (in)	48	Bankfull:Culvert Ratio	0.3				
Height (in)	48						
Outlet Perch (ft)	Not measurable						
Slope (%)	0.7						
Rustline Height (in)	36						
Overall Condition	Fair						
PRIORITIZATION ANALYSIS

Prioritization Total Points	10				
Notes: Outlets directly into bay.

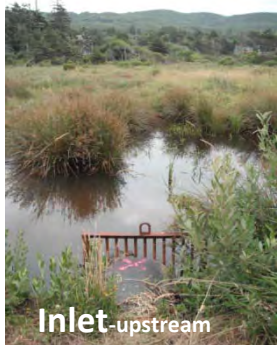
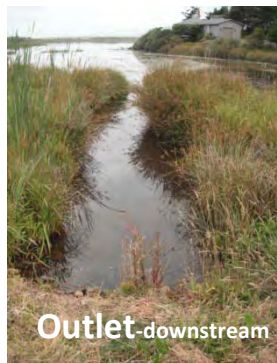
LOCATION INFO				Culvert #	675	Priority	L
Watershed		Tillamook Bay					
Stream Name		Coleman Creek					
Township-Range-Section-1/4		T1S, R10W, Sec. 7, SE¼ of NW¼					
UTM Easting/Northing (Zone 10, NAD 1983)		425267/5039131					
Road Name		5 <sup>th</sup> Street					
Road/Culvert Owner		Tillamook County					
Adjacent Landowners		Tillamook County					
CULVERT INFO		CHANNEL INFO					
Shape	Circular	Inlet Gradient (%)	---				
Material	Plastic	Upstream Gradient (%)	---				
Length (ft)	50	Bankfull Width (ft)	---				
Width (in)	42	Bankfull:Culvert Ratio	---				
Height (in)	42	--- = Not Measurable					
Outlet Perch (ft)	Not measurable						
Slope (%)	6.1						
Rustline Height (in)	Unknown						
Overall Condition	Fair						
PRIORITIZATION ANALYSIS							
Upstream Habitat Length (mi)	1.0	Habitat Points	2				
Habitat Quality	Fair	Habitat Quality Points	2				
Fish Species	Resident	Fish Points	2				
Barrier Class	Gray	Barrier Points	2

Prioritization Total Points	8				
Notes: Outlets directly into Cape Meares Lake.

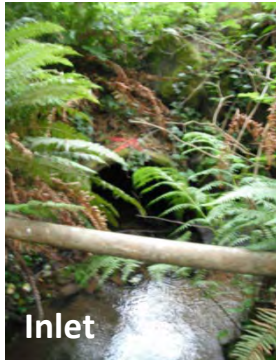
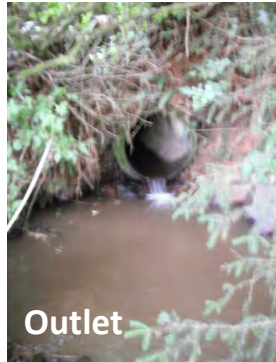
LOCATION INFO				Culvert #	686	Priority	M		
Watershed		Tillamook Bay							
Stream Name		Coleman Creek							
Township-Range-Section-1/4		T1S, R10W, Sec. 7, NW¼ of SE¼							
UTM Easting/Northing (Zone 10, NAD 1983)		425312/5038726							
Road Name		Pacific Avenue							
Road/Culvert Owner		Cape Meares							
Adjacent Landowners		C.&S. Overstreet and C. Friedman							
CULVERT INFO		CHANNEL INFO

Shape	Circular	Inlet Gradient (%)	14.1						
Material	Concrete	Upstream Gradient (%)	7.3						
Length (ft)	39	Bankfull Width (ft)	6.4						
Width (in)	36	Bankfull:Culvert Ratio	0.5						
Height (in)	36								
Outlet Perch (ft)	2.1								
Slope (%)	3.1								
Rustline Height (in)	6								
Overall Condition	Fair								
PRIORITIZATION ANALYSIS									
Upstream Habitat Length (mi)	0.7	Habitat Points	2						
Habitat Quality	Fair	Habitat Quality Points	2						
Fish Species	Resident	Fish Points	2

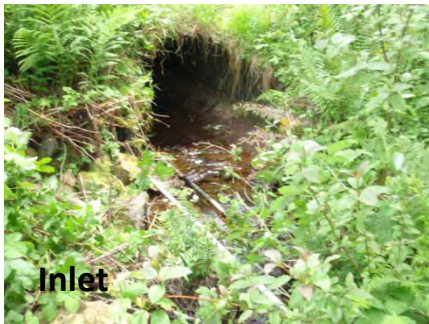
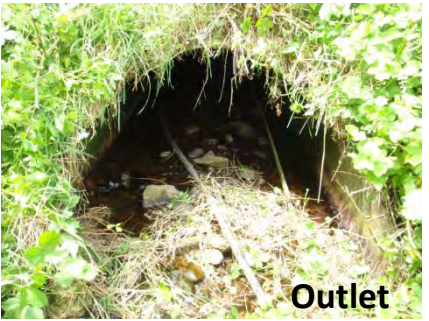
LOCATION INFO				Culvert #	848	Priority	L
Watershed				Tillamook River			
Stream Name				Memaloose Creek			
Township-Range-Section-1/4				T1S, R10W, Sec. 22, NE¼ of SE¼			
UTM Easting/Northing (Zone 10, NAD 1983)				430623/5035363			
Road Name				Bayocean Road			
Road/Culvert Owner				Tillamook County			
Adjacent Landowners				H. Hinck, T. Holgate, and R. Biggs			
CULVERT INFO			CHANNEL INFO				
Shape	Pipe arch and Box			Inlet Gradient (%)	1.8		
Material	Corrugated metal & Concrete			Upstream Gradient (%)	5.4		
Length (ft)	48			Bankfull Width (ft)	6.3		
Width (in)	66			Culvert:Bankfull Ratio	0.9		
Height (in)	42						
Outlet Perch (ft)	0.3						
Slope (%)	1.2						
Rustline Height (in)	18						
Overall Condition	Poor						
PRIORITIZATION ANALYSIS							
Upstream Habitat Length (mi)	0.5		Habitat Points	1			
Habitat Quality	Fair		Habitat Quality Points	2			
Fish Species	Anad.		Fish Points	3			
Barrier Class	Red		Barrier Points	3

Prioritization Total Points	9			
<b>Notes:</b> Mixed construction crossing: inlet and outlet were corrugated metal pipe arches and central portion of crossing was a concrete box. Dimensions above are for the pipe arch portions.

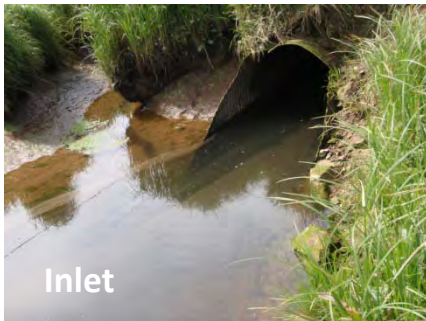
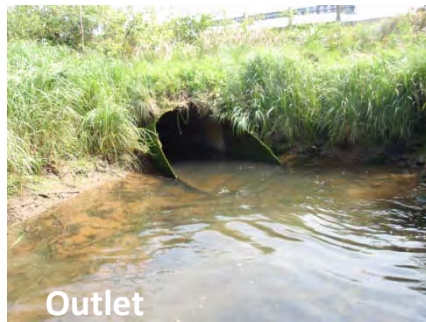
LOCATION INFO				Culvert #	908	Priority	H
Watershed		Tillamook River					
Stream Name		Tomlinson/Esther Creek					
Township-Range-Section-1/4		T1S, R10W, Sec. 26, NE¼ of SW¼					
UTM Easting/Northing (Zone 10, NAD 1983)		431197/5033781					
Road Name		Highway 131					
Road/Culvert Owner		Oregon Department of Transportation					
Adjacent Landowners		P. & S. Reeder					
CULVERT INFO		CHANNEL INFO				<div>

</div>	
Shape	Circular	Inlet Gradient (%)	1.5				
Material	Corrugated metal	Upstream Gradient (%)	1.5				
Length (ft)	155	Bankfull Width (ft)	17.1				
Width (in)	66	Culvert:Bankfull Ratio	0.3				
Height (in)	78	Seam separation and culvert barrel deformation noted. Also, there was a dike and system of tidegates that was not surveyed as part of this study approximately 100 m upstream of this culvert.					
Outlet Perch (ft)	None						
Slope (%)	1.0						
Rustline Height (in)	Entirely rusted

Overall Condition	Poor						
PRIORITIZATION ANALYSIS							
Upstream Habitat Length (mi)	3.9	Habitat Points	4				
Habitat Quality	Good	Habitat Quality Points	3				
Fish Species	Anad.	Fish Points	3				
Barrier Class	Gray	Barrier Points	2				
		Prioritization Total Points	12				
<b>Notes:</b> Classification is based on BFW:Width Ratio. Because culvert is tidally influenced and completely backwatered under most conditions, it seems likely that passage is rarely inhibited by this crossing. However, the culvert is undersized and almost certainly impairs tidal processes.

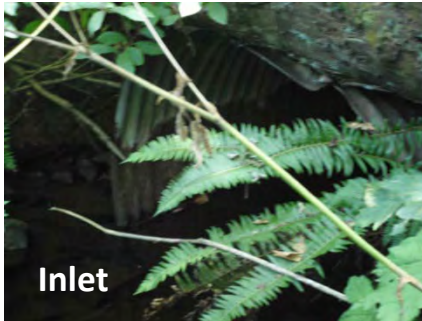
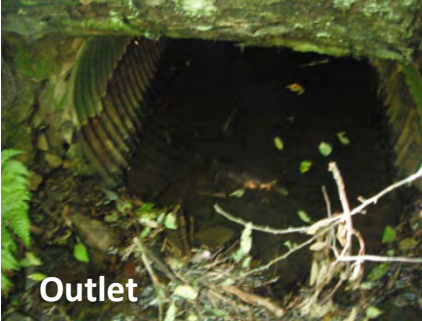
Upstream Habitat Length (mi)	0.5	Habitat Points		1			
Habitat Quality	Good	Habitat Quality Points		3			
Fish Species	Anad.	Fish Points		3			
Barrier Class	Red	Barrier Points		3			
		Prioritization Total Points		10

**Notes:** Based on review of RBA data, it appears that a second pipe also occurs along this stream that we were unable to survey. That report indicates that that pipe was perched >1.0 ft and impassable for juvenile fish.

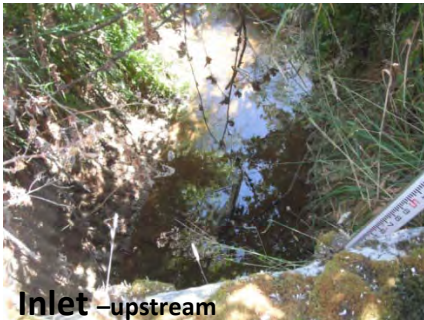
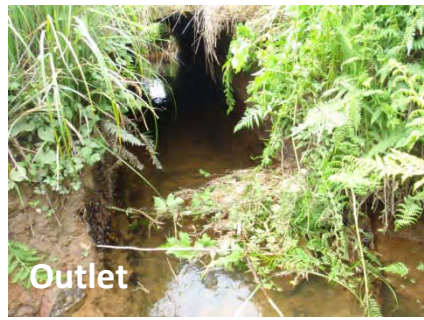
LOCATION INFO				Culvert #	931	Priority	H
Watershed		Tillamook River					
Stream Name		Esther Creek					
Township-Range-Section-1/4		T1S, R10W, Sec. 26, SW¼ of SW¼					
UTM Easting/Northing (Zone 10, NAD 1983)		430928/503563					
Road Name		Tomlinson Road					
Road/Culvert Owner		Tillamook County					
Adjacent Landowners		R. Peterson					
CULVERT INFO		CHANNEL INFO

<b>Inlet</b> –upstream	
Shape	Circular	Inlet Gradient (%)*	1.0				
Material	Corrugated metal	Upstream Gradient (%)*	1.0				
Length (ft)	25	Bankfull Width (ft)*	6.0				
Width (in)	60	Culvert:Bankfull Ratio*	0.8				
Height (in)	60	*Unable to access area upstream of culvert for these measurements. Measurements used to report these fields were visual estimates.					
Outlet Perch (ft)	0.1						
Slope (%)	1.2						
Rustline Height (in)	48						
Overall Condition	Poor						
PRIORITIZATION ANALYSIS

Habitat Quality	Good	Habitat Quality Points	3				
Fish Species	Anad.	Fish Points	3				
Barrier Class	Gray	Barrier Points	2				
		Prioritization Total Points	12				
<b>Notes:</b> A substantial portion of this stream flows through pastures and has highly impaired riparian habitats. Nervertheless, this system is well-used by juvenile salmonids.

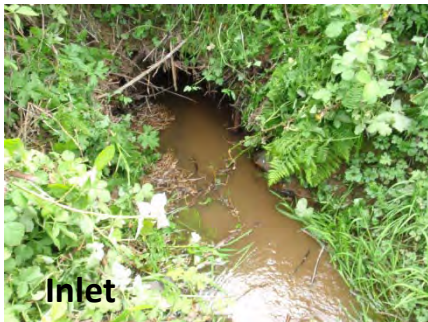
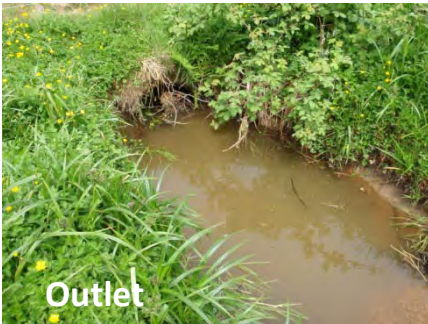
LOCATION INFO				Culvert #	932	Priority	H
Watershed		Tillamook River					
Stream Name		Unnamed tributary of Esther Creek					
Township-Range-Section-1/4		T1S, R10W, Sec. 26, NW¼ of SW¼					
UTM Easting/Northing (Zone 10, NAD 1983)		430845/5033558					
Road Name		Private Drive off Tomlinson Road					
Road/Culvert Owner		Tillamook County					
Adjacent Landowners		R. Peterson					
CULVERT INFO		CHANNEL INFO

<b>Inlet</b>	
Shape	Circular	Inlet Gradient (%)	8.8				
Material	Concrete	Upstream Gradient (%)	4.6				
Length (ft)	34	Bankfull Width (ft)	4.5				
Width (in)	30	Culvert:Bankfull Ratio	0.6				
Height (in)	30						
Outlet Perch (ft)	None						
Slope (%)	-0.4						
Rustline Height (in)	12						
Overall Condition	Fair						
PRIORITIZATION ANALYSIS

Barrier Class	Gray	Barrier Points	2				
		Prioritization Total Points	10				
<b>Notes:</b> A portion of this stream flows through pastures and has highly impaired riparian habitats.

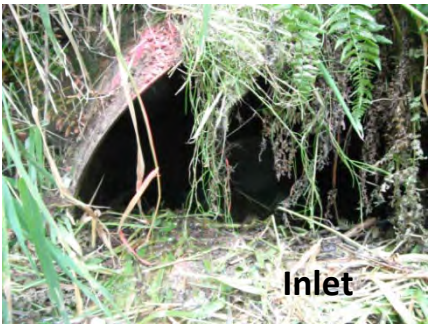
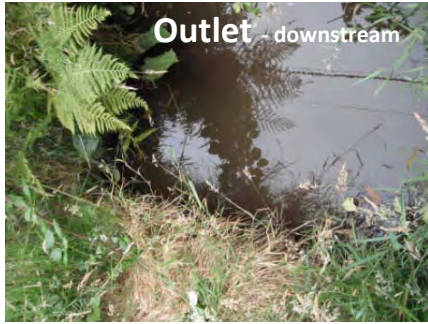
LOCATION INFO				Culvert #	985	Priority	L
Watershed			Tillamook River				
Stream Name			Unnamed tributary of Fagan Creek (Trib. A)				
Township-Range-Section-1/4			T1S, R10W, Sec. 34, NE¼ of SW¼				
UTM Easting/Northing (Zone 10, NAD 1983)			429888/5032065				
Road Name			Highway 131 (Netarts Highway)				
Road/Culvert Owner			Oregon Department of Transportation				
Adjacent Landowners			K. & M. Oleman and D. & T. Johnson				
CULVERT INFO			CHANNEL INFO				
Shape		Circular	Inlet Gradient (%)		0.5		
Material	Concrete/Corrugated Metal		Upstream Gradient (%)		4.5		
Length (ft)		104	Bankfull Width (ft)		4.7		
Width (in)		48	Culvert:Bankfull Ratio		0.9		
Height (in)		48					
Outlet Perch (ft)		0.3					
Slope (%)		3.9					
Rustline Height (in)		48					
Overall Condition		Fair					
PRIORITIZATION ANALYSIS							
Upstream Habitat Length (mi)		0.3	Habitat Points		1		
Habitat Quality		Fair	Habitat Quality Points		2		
Fish Species		Anad.	Fish Points		3

Barrier Class		Red	Barrier Points		3		
			Prioritization Total Points		9

**Notes:** Inlet is a circular metal pipe that is approximately 75% blocked by sediment. Outlet was mostly submerged and concrete. The pipes appear to connect at a manhole near the intersection of Hwy 131 and a private drive. These two pipes appear to run approximately perpendicular to one another. Length of pipe estimated. In May 2012, we observed spawning Western Brook Lamprey immediately above this culvert.

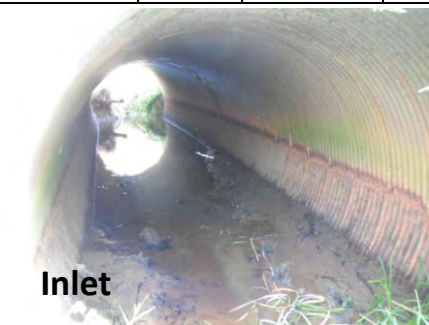
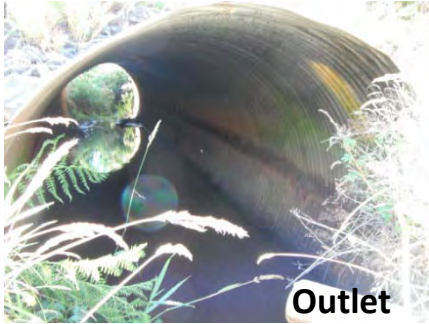
LOCATION INFO				Culvert #	1102	Priority	NA
Watershed		Tillamook River					
Stream Name		Unnamed tributary to Beaver Creek (Trib. C)					
Township-Range-Section-1/4		T2S, R10W, Sec. 11, NW¼ of NW¼					
UTM Easting/Northing (Zone 10, NAD 1983)		431060/5029663					
Road Name		Private Drive off Eckloff Road					
Road/Culvert Owner		F. Johnston					
Adjacent Landowners		F. Johnston					
CULVERT INFO		CHANNEL INFO

<b>Inlet</b>	
Shape	Circular	Inlet Gradient (%)	9.8				
Material	Corrugated metal	Upstream Gradient (%)	1.0				
Length (ft)	40	Bankfull Width (ft)	4.5				
Width (in)	90	Culvert:Bankfull Ratio	1.7				
Height (in)	90						
Outlet Perch (ft)	None						
Slope (%)	-1.2						
Rustline Height (in)	42						
Overall Condition	Poor

Barrier Class	Green	Barrier Points	1				
		Prioritization Total Points	10				
<b>Notes:</b> Although, based on most factors, this culvert does not appear to be a barrier; it is included here due to its poor condition assessment which indicates it should be replaced in the near future.

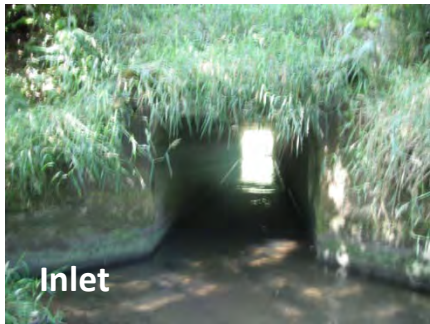
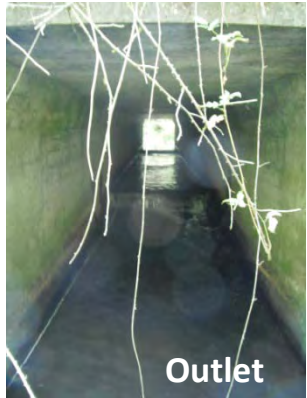
LOCATION INFO				Culvert #	1234	Priority	H
Watershed		Tillamook River					
Stream Name		Killam Creek					
Township-Range-Section-1/4		T2S, R9W, Sec. 16, NW¼ of SW¼					
UTM Easting/Northing (Zone 10, NAD 1983)		437142/5022712					
Road Name		Highway 101					
Road/Culvert Owner		Oregon Department of Transportation					
Adjacent Landowners		G. Stevens and Stimson Lumber Co.					
CULVERT INFO		CHANNEL INFO

Inlet	
Shape	Box	Inlet Gradient (%)	2.4				
Material	Concrete	Upstream Gradient (%)	2.8				
Length (ft)	109	Bankfull Width (ft)	11.2				
Width (in)	96	Culvert:Bankfull Ratio	0.7				
Height (in)	96	Three ~1ft baffles inside pipe. Also includes a fish ladder where culvert outlets into Tillamook River mainstem. Ladder has two ~3ft sills. An ~1ft jump is required to clear each sill and enter the culvert.					
Outlet Perch (ft)	4.4						
Slope (%)	0.4						
Rustline Height (in)	36						
Overall Condition	Fair

Outlet	
Upstream Habitat Length (mi)	10.8	Habitat Points	4				
Habitat Quality	Good	Habitat Quality Points	3				
Fish Species	Anad.	Fish Points	3				
Barrier Class	Red	Barrier Points	3				
		Prioritization Total Points	13				
<b>Notes:</b> Perch based on elevation difference between outlet invert and outlet pool tailwater control point below fish ladder. Fish surveys indicate that adults are able to pass this culvert, but the ladder is clearly a barrier to juvenile passage.

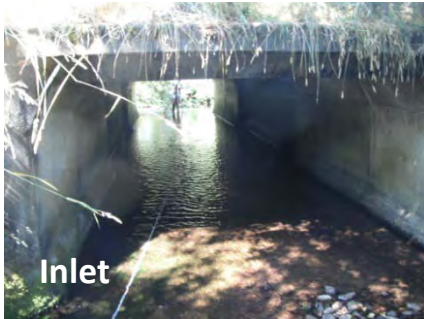
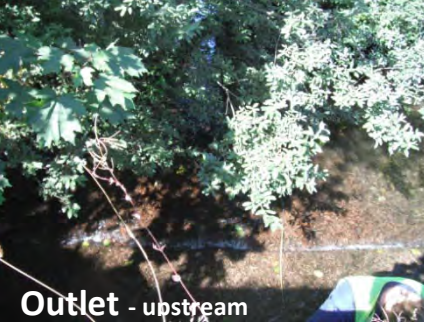
LOCATION INFO				Culvert #	1381	Priority	H
Watershed				Tillamook River			
Stream Name				Munson Creek			
Township-Range-Section-1/4				T2S, R9W, Sec. 28, SW¼ of NW¼			
UTM Easting/Northing (Zone 10, NAD 1983)				437008/5024593			
Road Name				Highway 101			
Road/Culvert Owner				Oregon Department of Transportation			
Adjacent Landowners				J. & J. Sheldon and T. & S. Marlin			
CULVERT INFO		CHANNEL INFO					
Shape	Box	Inlet Gradient (%)	1.4

<p>Inlet</p>			
Material	Concrete	Upstream Gradient (%)	2.4				
Length (ft)	69	Bankfull Width (ft)	14.1				
Width (in)	144	Culvert:Bankfull Ratio	0.9				
Height (in)	72						
Outlet Perch (ft)	1.0						
Slope (%)	0.1						
Rustline Height (in)	21						
Overall Condition	Fair

Barrier Class	Red	Barrier Points	3				
		Prioritization Total Points	13				
<b>Notes:</b> Rating based on perch and laminar flows across pipe invert (no natural substrate on culvert invert).

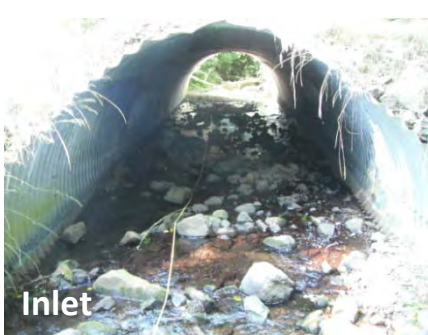
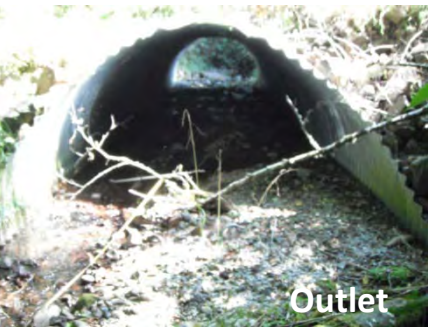
LOCATION INFO				Culvert #	1404	Priority	H
Watershed		Tillamook River					
Stream Name		Munson Creek					
Township-Range-Section-1/4		T2S, R9W, Sec. 27, SW¼ of SW¼					
UTM Easting/Northing (Zone 10, NAD 1983)		438611/5023756					
Road Name		Munson Creek Road					
Road/Culvert Owner		Tillamook County					
Adjacent Landowners		Stimson Lumber Co.					
CULVERT INFO		CHANNEL INFO					
Shape	Open bottom arch	Inlet Gradient (%)	19.3				
Material	Concrete	Upstream Gradient (%)	7.8				
Length (ft)	61	Bankfull Width (ft)	11.4				
Width (in)	156	Culvert:Bankfull Ratio	1.2				
Height (in)	90						
Outlet Perch (ft)	0.2						
Slope (%)	4.2						
Rustline Height (in)	12						
Overall Condition	Fair						
PRIORITIZATION ANALYSIS							
Upstream Habitat Length (mi)	1.4	Habitat Points	3				
Habitat Quality	Good	Habitat Quality Points	3				
Fish Species	Anad.	Fish Points	3				
Barrier Class	Green	Barrier Points	1				
		Prioritization Total Points	10

Notes: A crossing we were unable to access to survey was located approximately ¼ mile upstream of this crossing.

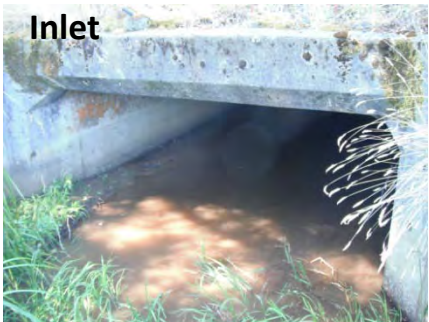
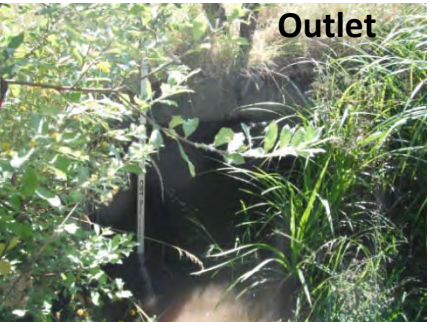
LOCATION INFO				Culvert #	1401	Priority	NA
Watershed		Tillamook River					
Stream Name		Pleasant Valley Creek					
Township-Range-Section-1/4		T2S, R9W, Sec. 28, SW¼ of SW¼					
UTM Easting/Northing (Zone 10, NAD 1983)		437013/5023817					
Road Name		Highway 101					
Road/Culvert Owner		Oregon Department of Transportation					
Adjacent Landowners		M. Upshaw and P. Myers					
CULVERT INFO		CHANNEL INFO				<div>Inlet</div>

Shape	Box	Inlet Gradient (%)	7.4				
Material	Concrete	Upstream Gradient (%)					
Length (ft)	80	Bankfull Width (ft)	~8.0				
Width (in)	96	Culvert:Bankfull Ratio	1.0				
Height (in)	60	No upstream access. Upstream gradient and bankfull width not measurable.					
Outlet Perch (ft)	0.3						
Slope (%)	0.5						
Rustline Height (in)	21						
Overall Condition	Fair						
PRIORITIZATION ANALYSIS							
Upstream Habitat Length (mi)	1.1	Habitat Points	3				
Habitat Quality	Good	Habitat Quality Points	3

Fish Species	Anad.	Fish Points	3				
Barrier Class	Green	Barrier Points	1				
		Prioritization Total Points	10				
Notes: A crossing we were unable to access to survey was located approximately ¼ mile upstream of this crossing.

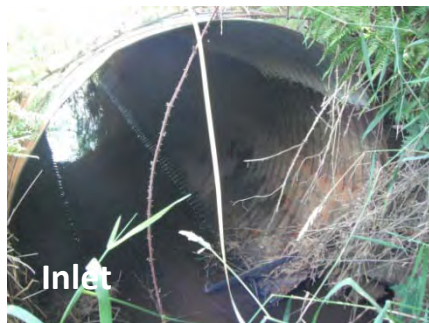
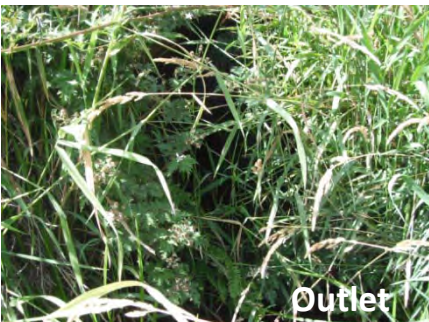
LOCATION INFO				Culvert #	1438	Priority	H
Watershed		Tillamook River					
Stream Name		Unnamed tributary of Tillamook River (Trib. E)					
Township-Range-Section-1/4		T2S, R9W, Sec. 31, SE¼ of NW¼					
UTM Easting/Northing (Zone 10, NAD 1983)		434395/5022847					
Road Name		Private Drive off Yellow Fir Road					
Road/Culvert Owner		Tillamook County					
Adjacent Landowners		M. Walker					
CULVERT INFO		CHANNEL INFO

Shape	Circular	Inlet Gradient (%)	-3.2				
Material	Corrugated metal	Upstream Gradient (%)	1.8				
Length (ft)	17	Bankfull Width (ft)	8.9				
Width (in)	60	Culvert:Bankfull Ratio	0.6				
Height (in)	60						
Outlet Perch (ft)	None						
Slope (%)	1.6						
Rustline Height (in)	48						
Overall Condition	Critical						
PRIORITIZATION ANALYSIS

Barrier Class	Gray	Barrier Points	2				
		Prioritization Total Points	12				
Notes: Invert and sides very corroded. Numerous holes in pipe noted.

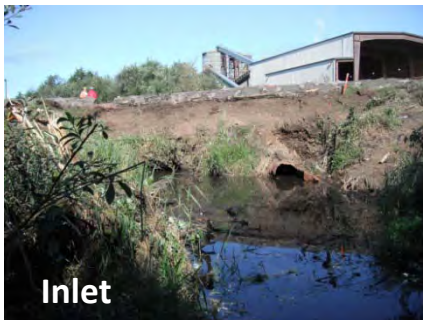
<b>Inlet</b>	
Shape	Circular	Inlet Gradient (%)	3.0				
Material	Corrugated metal	Upstream Gradient (%)	2.0				
Length (ft)	41	Bankfull Width (ft)	12.5				
Width (in)	60(48)	Bankfull:Culvert Ratio	0.7*				
Height (in)	60 (48)						
Outlet Perch (ft)	0.6 (none)						
Slope (%)	1.5(0.1)						
Rustline Height (in)	entirely rusted						
Overall Condition	Critical						
PRIORITIZATION ANALYSIS							
Upstream Habitat Length (mi)	3.1	Habitat Points	4				
Habitat Quality	Poor	Habitat Quality Points	1				
Fish Species	Anad.	Fish Points	3

Barrier Class	Red	Barrier Points	3				
		Prioritization Total Points	11				
Notes: Dual pipes at this location. *Based on combined inlet widths. Both inlets very damaged.

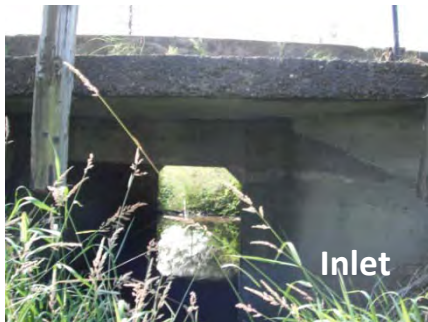
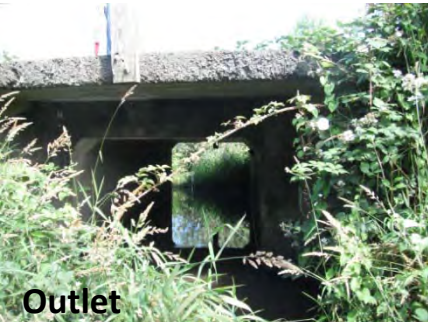
Notes: Continuous stream substrate through culvert.

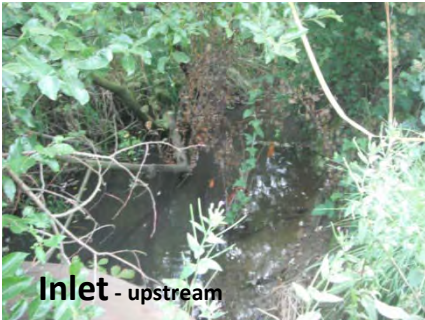
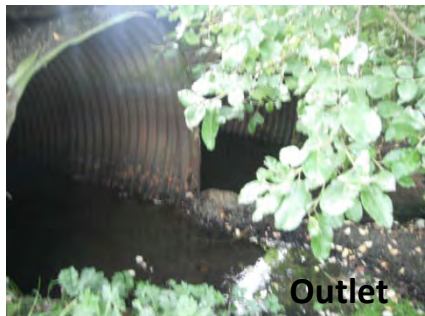
Shape	Circular	Inlet Gradient (%)	1.9(1.3)				
Material	Corrugated metal	Upstream Gradient (%)	0.9				
Length (ft)	20	Bankfull Width (ft)	10.0				
Width (in)	48(48)	Bankfull:Culvert Ratio	0.8*				
Height (in)	48(48)

Outlet Perch (ft)	None						
Slope (%)	5.8(4.6)						
Rustline Height (in)	entirely rusted						
Overall Condition	Poor						
PRIORITIZATION ANALYSIS							
Upstream Habitat Length (mi)	2.7	Habitat Points			4		
Habitat Quality	Poor	Habitat Quality Points			1		
Fish Species	Anad.	Fish Points			3

Barrier Class	Red	Barrier Points			3		
		Prioritization Total Points			11		
Notes: Dual pipes at this location. *Based on combined inlet widths.

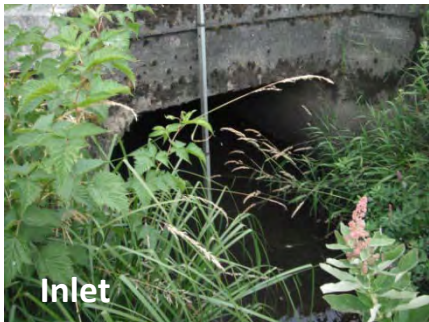
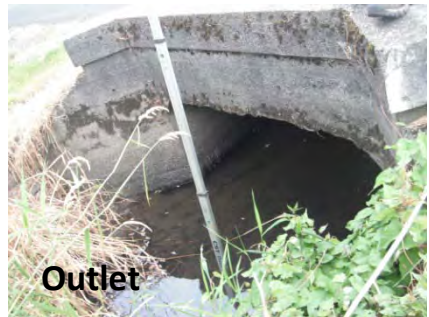
Prioritization Total Points	10				
<b>Notes:</b> Continuous stream substrate through culvert.

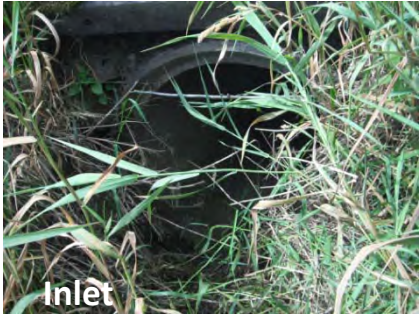
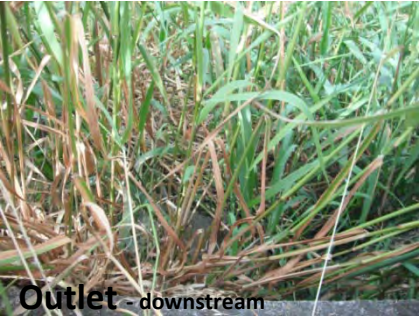
CULVERT INFO		CHANNEL INFO					
Shape	Circular	Inlet Gradient (%)	10.0				
Material	Concrete (Corrugated metal)	Upstream Gradient (%)	0.7				
Length (ft)	34	Bankfull Width (ft)	8.3				
Width (in)	36(42)	Bankfull:Culvert Ratio	0.8*				
Height (in)	36(42)						
Outlet Perch (ft)	None						
Slope (%)	2.9(1.6)						
Rustline Height (in)	N/A(20)						
Overall Condition	Fair(Poor)						
PRIORITIZATION ANALYSIS							
Upstream Habitat Length (mi)	1.0	Habitat Points	2				
Habitat Quality	Poor	Habitat Quality Points	1				
Fish Species	Anad.	Fish Points	3

Barrier Class	Red	Barrier Points	3				
		Prioritization Total Points	9				
<b>Notes:</b> Dual pipes at this crossing. *Bankfull:Culvert Ratio based on combined width of pipes. Channel was dry during summer 2011 site visit.

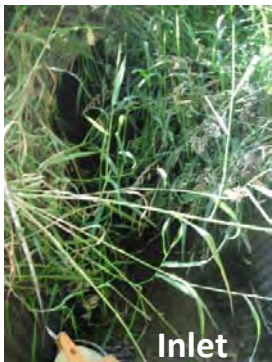
Inlet

Prioritization Total Points	12				
Notes: Pipe is in very poor condition. Invert worn through along a considerable portion of the pipe.

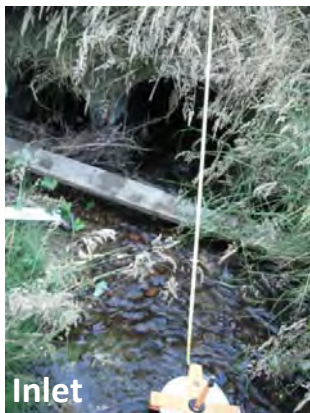
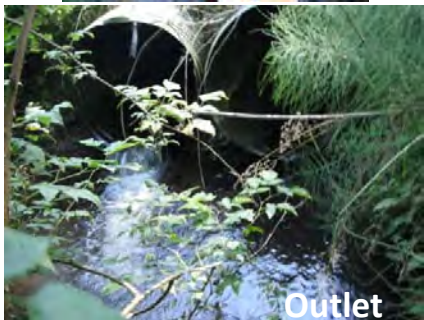
Inlet	
Shape	Circular	Inlet Gradient (%)	10.6				
Material	Corrugated metal	Upstream Gradient (%)	2.4				
Length (ft)	27	Bankfull Width (ft)	6.4				
Width (in)	29(29)	Bankfull:Culvert Ratio	0.8*				
Height (in)	29(29)	*Bankfull:Culvert Ratio based on combined width of both pipes.					
Outlet Perch (ft)	0.4(0.4)						
Slope (%)	1.0(1.1)						
Rustline Height (in)	13(17)						
Overall Condition	Poor

Fish Species	Anad.	Fish Points	3				
Barrier Class	Red	Barrier Points	3				
		Prioritization Total Points	12				
Notes: Two pipes at this location.

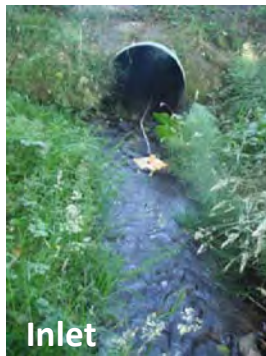
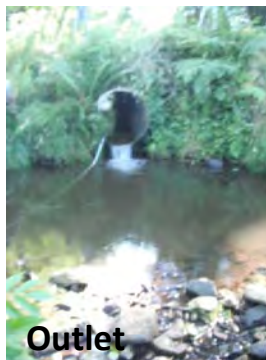
Outlet	
Shape	Circular	Inlet Gradient (%)	13.6				
Material	Corrugated metal	Upstream Gradient (%)	5.3				
Length (ft)	27	Bankfull Width (ft)	6.3				
Width (in)	37	Bankfull:Culvert Ratio	0.5				
Height (in)	37						
Outlet Perch (ft)	0.8						
Slope (%)	2.4						
Rustline Height (in)	23						
Overall Condition	Poor						
PRIORITIZATION ANALYSIS							
Upstream Habitat Length (mi)	1.9	Habitat Points				4	
Habitat Quality	Fair(+)	Habitat Quality Points				2	
Fish Species	Anad.	Fish Points				3	
Barrier Class	Red	Barrier Points				3

Prioritization Total Points				12	
<b>Notes:</b> Two pipes at this location. The second was a 19 in dia. CMP that was located ~4 ft to one side of the main pipe and ~2ft higher elevation. Because this pipe likely only conveys flows during very high flows, it was not used for the Bankfull:Culvert ratio.

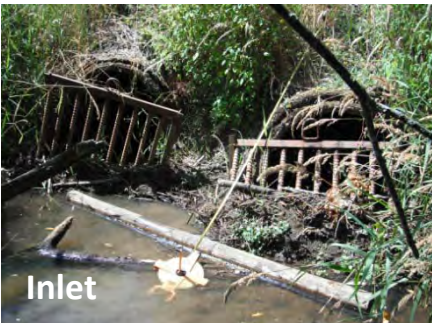
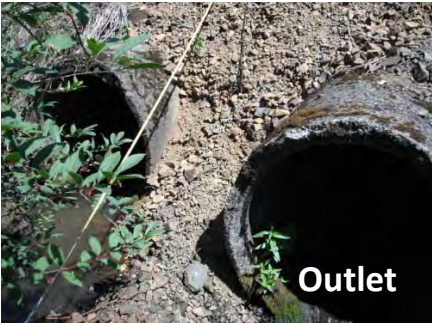
Shape	Circular	Inlet Gradient (%)	7.8(6.1)				
Material	Concrete	Upstream Gradient (%)	14.5				
Length (ft)	43	Bankfull Width (ft)	14.6				
Width (in)	36(36)	Bankfull:Culvert Ratio	0.4*				
Height (in)	36(36)	*Bankfull:Culvert ratio based on combined width of both pipes.					
Outlet Perch (ft)	0.4(0.1)						
Slope (%)	0.9(1.3)						
Rustline Height (in)	N/A						
Overall Condition	Fair

Habitat Quality	Poor	Habitat Quality Points	1				
Fish Species	Anad.	Fish Points	3				
Barrier Class	Red	Barrier Points	3				
		Prioritization Total Points	11				
Notes: Dual pipes at this location. Trash rack at inlet had not been maintained and had a considerable amount of debris built up.

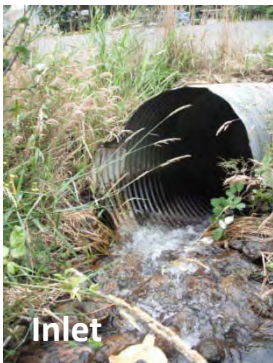
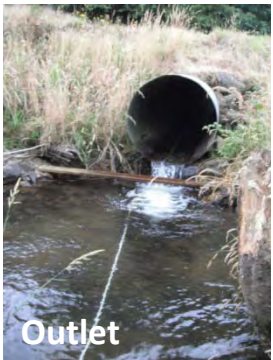
Shape	Circular	Inlet Gradient (%)	1.0				
Material	Corrugated metal	Upstream Gradient (%)	5.6				
Length (ft)	50	Bankfull Width (ft)	7.7				
Width (in)	53	Bankfull:Culvert Ratio	0.6				
Height (in)	53						
Outlet Perch (ft)	1.0						
Slope (%)	5.6						
Rustline Height (in)	35						
Overall Condition	Poor						
PRIORITIZATION ANALYSIS							
Upstream Habitat Length (mi)	1.7	Habitat Points	4				
Habitat Quality	Fair	Habitat Quality Points	2				
Fish Species	Anad.	Fish Points	3				
Barrier Class	Red	Barrier Points	3

Prioritization Total Points	12				
<b>Notes:</b> Configuration of culvert inlet apron and substrate created turbulent flows at inlet. One crossing occurred below this culvert. We were unable to access this crossing to complete an assessment.

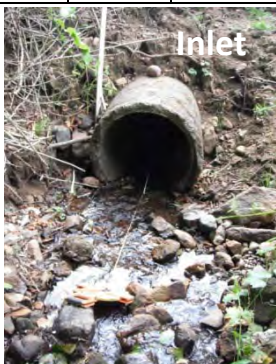
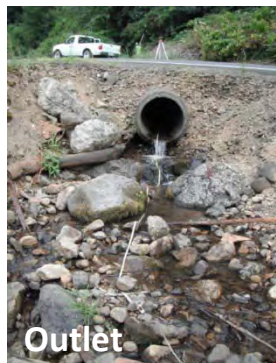
Prioritization Total Points	9				
Notes: Pipe barrel was not straight – its trajectory changed direction under the road bed.

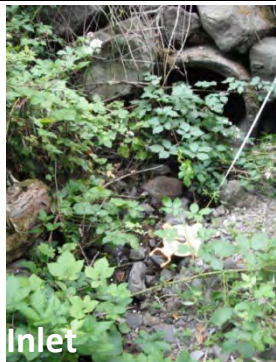
LOCATION INFO				Culvert #	903	Priority	L
Watershed		Trask River

Stream Name		Unnamed tributary of Trask River					
Township-Range-Section-1/4		T1S, R8W, Sec. 27, NW¼ of NE¼					
UTM Easting/Northing (Zone 10, NAD 1983)		449111/5033866					
Road Name		Trask River Road					
Road/Culvert Owner		Tillamook County					
Adjacent Landowners		J. & D. Bedford, D. Stout and J. & S. Smith					
CULVERT INFO		CHANNEL INFO					
Shape	Circular	Inlet Gradient (%)	13.8				
Material	Concrete	Upstream Gradient (%)	8.4				
Length (ft)	56	Bankfull Width (ft)	7.8				
Width (in)	36	Bankfull:Culvert Ratio	0.4				
Height (in)	36						
Outlet Perch (ft)	1.9						
Slope (%)	4.9						
Rustline Height (in)	N/A						
Overall Condition	Fair						
PRIORITIZATION ANALYSIS							
Upstream Habitat Length (mi)	0.4	Habitat Points	1				
Habitat Quality	Poor	Habitat Quality Points	1				
Fish Species	Anad.	Fish Points	3				
Barrier Class	Red	Barrier Points	3

Prioritization Total Points	8				
<b>Notes:</b> Another culvert is located several feet lateral to this pipe. It appears that that metal pipe was abandoned in place, because it looks to have been deliberately plugged and the upstream channel course appears to have been re-directed into the concrete culvert reported above.

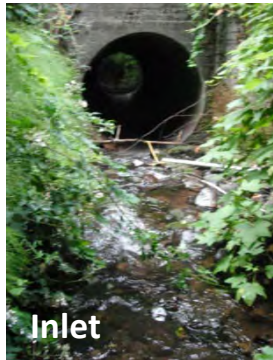
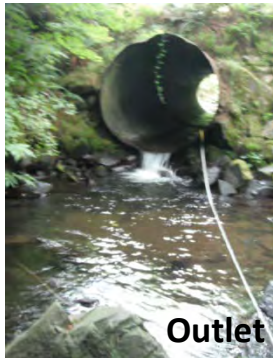
Shape	Circular	Inlet Gradient (%)	8.5				
Material	Corrugated metal	Upstream Gradient (%)	4.3				
Length (ft)	46	Bankfull Width (ft)	10.8				
Width (in)	84	Bankfull:Culvert Ratio	0.7				
Height (in)	84						
Outlet Perch (ft)	1.1						
Slope (%)	5.5						
Rustline Height (in)	37						
Overall Condition	Poor						
PRIORITIZATION ANALYSIS							
Upstream Habitat Length (mi)	1.5	Habitat Points	3				
Habitat Quality	Good	Habitat Quality Points	3				
Fish Species	Anad.	Fish Points	3				
Barrier Class	Red	Barrier Points	3

Prioritization Total Points	12				
<b>Notes:</b> Several seams beginning to separate. One has separated across the invert and has resulted in an approximately 6 inch step within the barrel of the pipe.

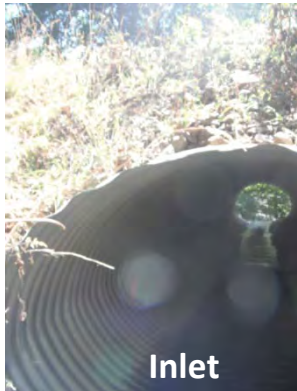
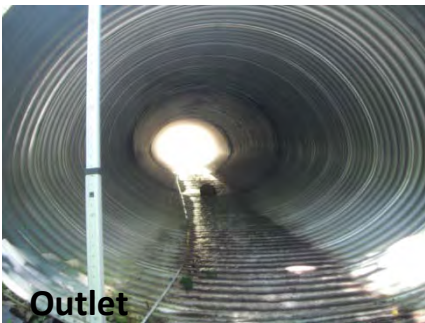
Inlet	
Shape	Pipe arch	Inlet Gradient (%)	5.2				
Material	Corrugated metal	Upstream Gradient (%)	3.0				
Length (ft)	59	Bankfull Width (ft)	5.0				
Width (in)	91	Bankfull:Culvert Ratio	1.5				
Height (in)	68						
Outlet Perch (ft)	2.9						
Slope (%)	0.2						
Rustline Height (in)	6						
Overall Condition	Fair						
PRIORITIZATION ANALYSIS

Outlet	
Upstream Habitat Length (mi)	0.8	Habitat Points	2				
Habitat Quality	Fair	Habitat Quality Points	2				
Fish Species	Anad.	Fish Points	3				
Barrier Class	Red	Barrier Points	3

Prioritization Total Points	10				
<b>Notes:</b> One seam separating, but repaired with a rubber strip. field crew noted that the strip appeared to seal the seam, but looked as if it “won’t last long.” Cascade over boulders at outlet. Culvert is appropriately sized, but apparently wasn’t sufficiently countersunk.

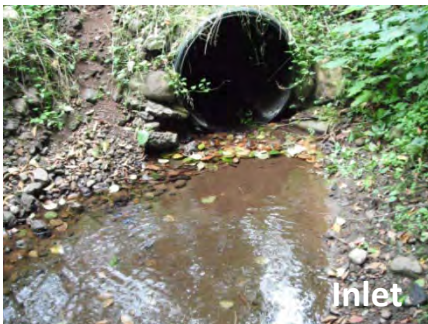
Material	Plastic		Upstream Gradient (%)	11.0			
Length (ft)	30		Bankfull Width (ft)	2.5			
Width (in)	36		Bankfull:Culvert Ratio	1.2			
Height (in)	36		*Topography precluded use of surveying level to obtain longitudinal profile data.				
Outlet Perch (ft)	~3.0*						
Slope (%)	4.0						
Rustline Height (in)	N/A						
Overall Condition	Good						
PRIORITIZATION ANALYSIS							
Upstream Habitat Length (mi)	0.1		Habitat Points	1			
Habitat Quality	Poor		Habitat Quality Points	1

Fish Species	Anad.		Fish Points	3			
Barrier Class	Red		Barrier Points	3			
			Prioritization Total Points	8			
Notes: Inlet perched at low flows. Pipe barrel bent under road bed.

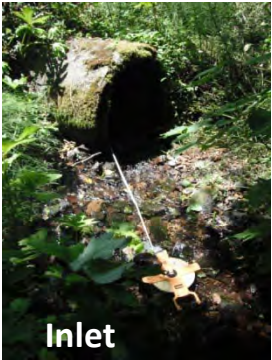
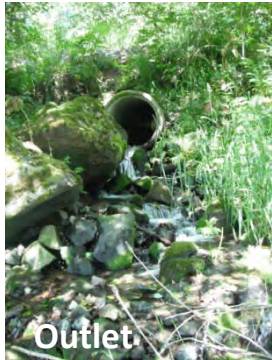
<b>Outlet</b>	
Shape	Circular	Inlet Gradient (%)	21.1				
Material	Concrete	Upstream Gradient (%)	4.7				
Length (ft)	44	Bankfull Width (ft)	4.5				
Width (in)	36	Bankfull:Culvert Ratio	0.7				
Height (in)	36						
Outlet Perch (ft)	0.6						
Slope (%)	9.2						
Rustline Height (in)	n/a						
Overall Condition	Poor						
PRIORITIZATION ANALYSIS							
Upstream Habitat Length (mi)	0.1	Habitat Points	1				
Habitat Quality	Poor	Habitat Quality Points	1				
Fish Species	Anad.	Fish Points	3				
Barrier Class	Red	Barrier Points	3

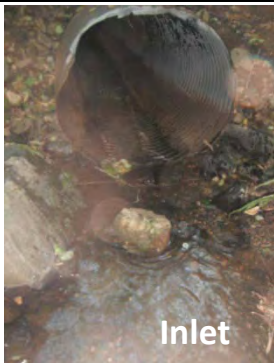
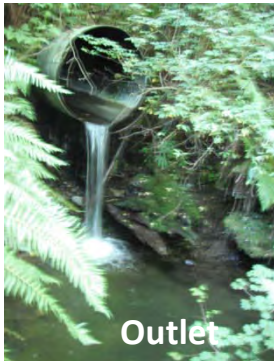
<b>Inlet</b>	
Shape	Circular	Inlet Gradient (%)	1.8				
Material	Corrugated metal	Upstream Gradient (%)	12.5				
Length (ft)	64	Bankfull Width (ft)	9.0				
Width (in)	48	Bankfull:Culvert Ratio	0.5				
Height (in)	48						
Outlet Perch (ft)	4.5						
Slope (%)	3.0						
Rustline Height (in)	22						
Overall Condition	Critical						
PRIORITIZATION ANALYSIS

<b>Outlet</b>	
Upstream Habitat Length (mi)	0.1	Habitat Points	1				
Habitat Quality	Poor	Habitat Quality Points	1				
Fish Species	Anad.	Fish Points	3

Barrier Class	Red	Barrier Points	3				
		Prioritization Total Points	8				
<b>Notes:</b> Invert almost entirely rusted through from inlet to outlet. Remainder of pipe also very corroded and unstable.

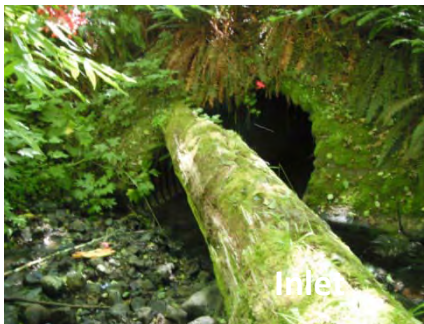
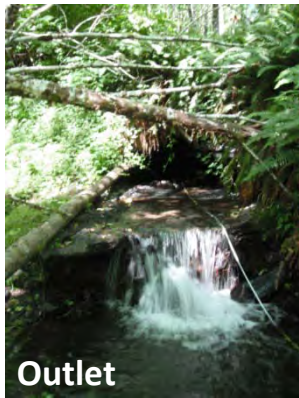
Prioritization Total Points	11				
<b>Notes:</b> Inlet was partially blocked by large log during summer 2011. It is our understanding that ODF intends to block this road and replace this culvert with a small bridge to facilitate foot and motorcycle traffic.

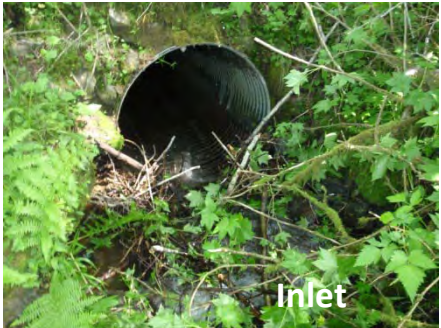
LOCATION INFO				Culvert #	1402	Priority	H
Watershed		Trask River

Inlet			
Stream Name		Unnamed tributary of South Fork Trask River					
Township-Range-Section-1/4		T2S, R8W, Sec. 25, NE¼ of SE¼					
UTM Easting/Northing (Zone 10, NAD 1983)		452161/5023649					
Road Name		South Fork Trask Road					
Road/Culvert Owner		Stimson Lumber Co.					
Adjacent Landowners		Stimson Lumber Co.					
CULVERT INFO		CHANNEL INFO					
Shape	Circular	Inlet Gradient (%)	21.3

Outlet			
Material	Corrugated metal	Upstream Gradient (%)	4.1				
Length (ft)	45	Bankfull Width (ft)	8.0				
Width (in)	48	Bankfull:Culvert Ratio	0.5				
Height (in)	48						
Outlet Perch (ft)	None						
Slope (%)	6.2						
Rustline Height (in)	16						
Overall Condition	Poor						
PRIORITIZATION ANALYSIS							
Upstream Habitat Length (mi)	0.7	Habitat Points	2				
Habitat Quality	Good	Habitat Quality Points	3				
Fish Species	Anad.	Fish Points	3

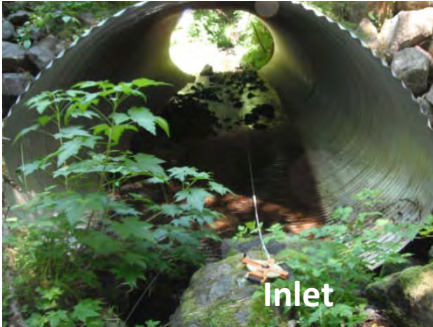
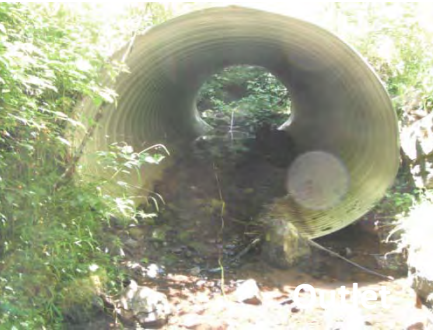
**Notes:** Water flowing under inlet invert. Culvert is appropriately sized, but apparently wasn't sufficiently countersunk when initially installed (which allows a portion of stream flow to run under pipe. Boulders at inlet also appear to have ability to impede passage.

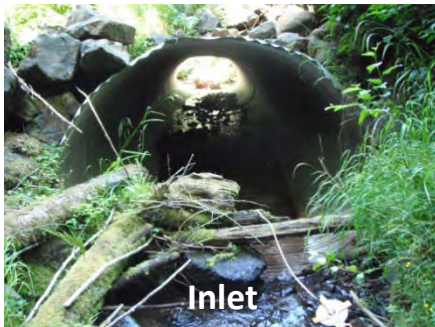
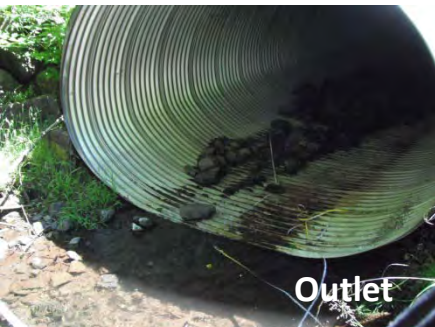
Prioritization Total Points	9				
<b>Notes:</b> Inlet substantially blocked by wood and boulders. Outlet end becoming undercut. Culvert is appropriately sized, but apparently wasn't sufficiently countersunk when initially installed.

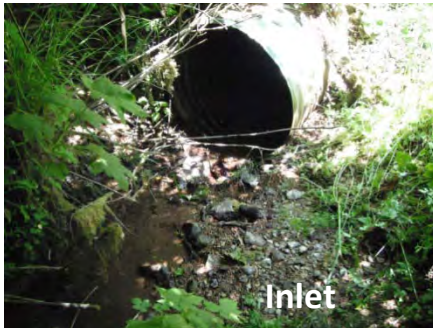
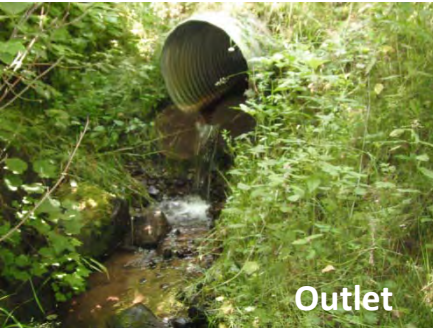
Prioritization Total Points	9				
<b>Notes:</b> Stream listed as Nonfish. However, field crew thought it looked suitable, it is low-gradient, and it is a tributary to a good-quality stream so we elected to include this pipe in our assessment.

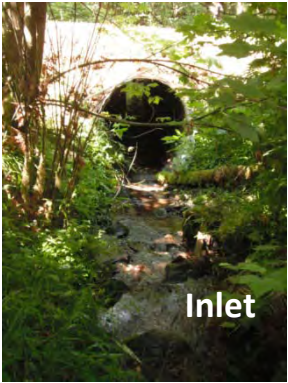
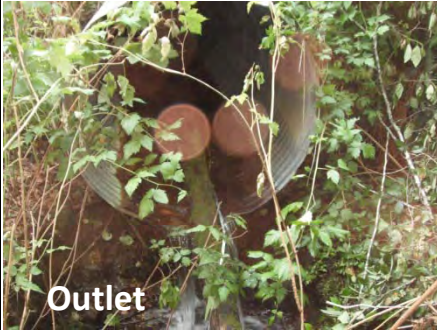
Shape	Circular	Inlet Gradient (%)	1.3				
Material	Corrugated metal	Upstream Gradient (%)	3.6				
Length (ft)	50	Bankfull Width (ft)	4.9				
Width (in)	54	Bankfull:Culvert Ratio	0.9				
Height (in)	54						
Outlet Perch (ft)	2.3						
Slope (%)	2.3						
Rustline Height (in)	12						
Overall Condition	Fair						
PRIORITIZATION ANALYSIS

Upstream Habitat Length (mi)	0.3	Habitat Points	1				
Habitat Quality	Fair	Habitat Quality Points	2				
Fish Species	Anad.	Fish Points	3

Barrier Class	Red	Barrier Points	3				
		Prioritization Total Points	9				
<b>Notes:</b> Stream listed as Nonfish. However, field crew thought it looked suitable, it is low-gradient, it has a moderate intrinsic potential rating, and it is a tributary to a good-quality stream so we elected to include this pipe in our assessment.

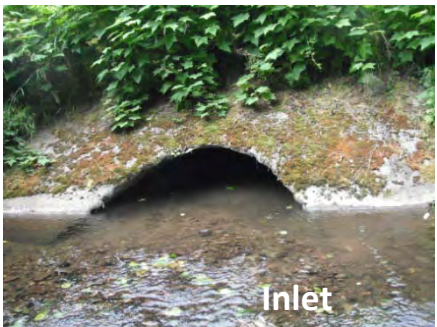
LOCATION INFO				Culvert #	1476	Priority	NA
Watershed		Trask River

Stream Name		Headquarters Camp Creek					
Township-Range-Section-1/4		T2S, R7W, Sec. 34, NE¼ of NW¼					
UTM Easting/Northing (Zone 10, NAD 1983)		457836/5022036					
Road Name		East Fork Road					
Road/Culvert Owner		Oregon Department of Forestry					
Adjacent Landowners		Oregon Department of Forestry					
CULVERT INFO		CHANNEL INFO					
Shape	Open bottomed arch	Inlet Gradient (%)	27.2

Material	Corrugated metal	Upstream Gradient (%)	5.5				
Length (ft)	50	Bankfull Width (ft)	9.1				
Width (in)	114	Bankfull:Culvert Ratio	1.0				
Height (in)	48						
Outlet Perch (ft)	None						
Slope (%)	0						
Rustline Height (in)	30						
Overall Condition	Fair						
PRIORITIZATION ANALYSIS							
Upstream Habitat Length (mi)	1.6	Habitat Points	4				
Habitat Quality	Good	Habitat Quality Points	3				
Fish Species	Anad.	Fish Points	3				
Barrier Class	Green	Barrier Points	1

Prioritization Total Points	11				
Notes: Extensive pooling on both side of pipe.

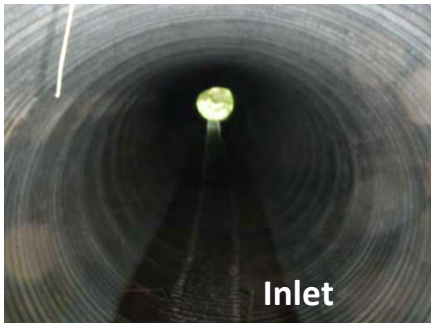
Prioritization Total Points	8			
<b>Notes:</b> Above this culvert stream listed as Nonfish. However, field crew thought it looked suitable, the stream has suitable gradient for fish use and it is mapped as suitable for coho spawning. As a result, we included this pipe in our assessment.

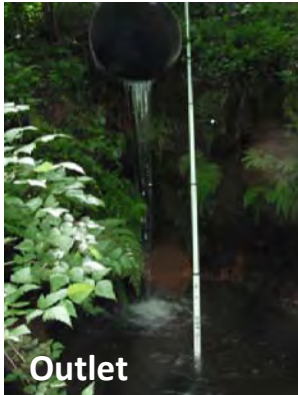
<b>Outlet</b>	
Habitat Quality	Poor	Habitat Quality Points				1		
Fish Species	Anad.	Fish Points				3

<b>Inlet</b>		
Shape	Circular	Inlet Gradient (%)						7.5
Material	Corrugated metal	Upstream Gradient (%)						0.5
Length (ft)	67	Bankfull Width (ft)						4.9
Width (in)	36	Bankfull:Culvert Ratio						0.6
Height (in)	36							
Outlet Perch (ft)	6.6							
Slope (%)	1.4							
Rustline Height (in)	20							
Overall Condition	Poor							
PRIORITIZATION ANALYSIS								
Upstream Habitat Length (mi)	0.1	Habitat Points				1

Barrier Class	Red	Barrier Points				3		
		Prioritization Total Points				8		
<b>Notes:</b> Above this culvert stream listed as Nonfish. However, field crew thought it looked suitable in the field and the reach is low-gradient. As a result, we included this pipe in our assessment.

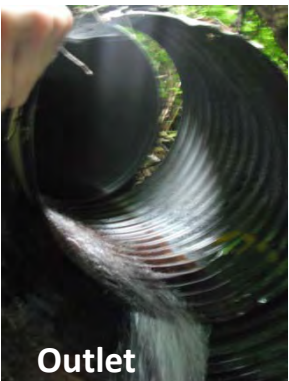
<b>Outlet</b>

<b>Inlet</b>			
Shape	Circular	Inlet Gradient (%)	4.0				
Material	Corrugated metal	Upstream Gradient (%)	12.5				
Length (ft)	55	Bankfull Width (ft)	3.4				
Width (in)	30	Bankfull:Culvert Ratio	0.9				
Height (in)	30	Topography and obstructions precluded the use of surveying equipment to obtain longitudinal profile data.					
Outlet Perch (ft)	1.0 to 1.5						
Slope (%)	5.0						
Rustline Height (in)	13						
Overall Condition	Fair						
PRIORITIZATION ANALYSIS							
Upstream Habitat Length (mi)	0.5	Habitat Points	1

Habitat Quality	Poor	Habitat Quality Points	1				
Fish Species	Anad.	Fish Points	3				
Barrier Class	Red	Barrier Points	3				
		Prioritization Total Points	8

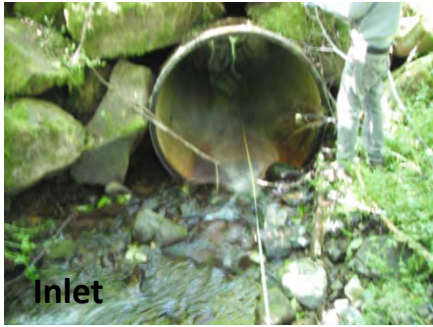
<p style="font-weight: bold; font-size: 1.2em;">Inlet</p>			
Stream Name		Pothole Creek					
Township-Range-Section-1/4		T1S, R7W, Sec. 23, SW¼ of SW¼					
UTM Easting/Northing (Zone 10, NAD 1983)		459224/5024799					
Road Name		Murphy Camp Road					
Road/Culvert Owner		Oregon Department of Forestry

<p style="font-weight: bold; font-size: 1.2em;">Outlet</p>			
Adjacent Landowners		Oregon Department of Forestry					
CULVERT INFO		CHANNEL INFO					
Shape	Circular	Inlet Gradient (%)	11.5				
Material	steel lined with plastic	Upstream Gradient (%)	5.1				
Length (ft)	53	Bankfull Width (ft)	9.3				
Width (in)	60	Bankfull:Culvert Ratio	0.5				
Height (in)	60						
Outlet Perch (ft)	1.3						
Slope (%)	6.6						
Rustline Height (in)	N/A						
Overall Condition	Fair						
PRIORITIZATION ANALYSIS							
Upstream Habitat Length (mi)	0.4	Habitat Points	2

Habitat Quality	Good	Habitat Quality Points	3				
Fish Species	Anad.	Fish Points	3				
Barrier Class	Red	Barrier Points	3				
		Prioritization Total Points	11				
Notes:

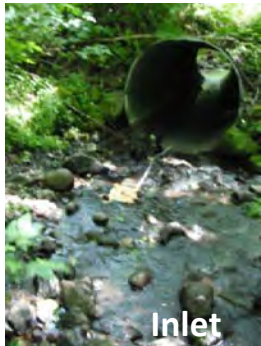
LOCATION INFO				Culvert #	1099	Priority	H
Watershed			Trask River				
Stream Name			Unnamed tributary to Bark Shanty Creek				
Township-Range-Section-1/4			T2S, R7W, Sec. 3, NE¼ of SE¼				
UTM Easting/Northing (Zone 10, NAD 1983)			458843/5029888				
Road Name			Bark Shanty Road				
Road/Culvert Owner			Oregon Department of Forestry				
Adjacent Landowners		Oregon Department of Forestry					
CULVERT INFO			CHANNEL INFO				
Shape	Circular		Inlet Gradient (%)		17.5		
Material	Corrugated metal		Upstream Gradient (%)		9.5		
Length (ft)	40		Bankfull Width (ft)		11.6		
Width (in)	66		Bankfull:Culvert Ratio		0.5		
Height (in)	66						
Outlet Perch (ft)	1.4						
Slope (%)	9.2						
Rustline Height (in)	19						
Overall Condition	Fair						
PRIORITIZATION ANALYSIS							
Upstream Habitat Length (mi)		0.6	Habitat Points		2		
Habitat Quality		Fair	Habitat Quality Points		2		
Fish Species		Anad.	Fish Points		3		
Barrier Class		Red	Barrier Points		3

Prioritization Total Points		10		
Notes:

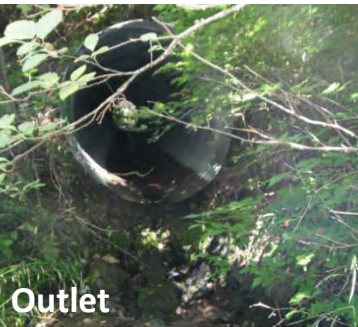
Shape	Circular	Inlet Gradient (%)			28.3		
Material	Corrugated metal	Upstream Gradient (%)			4.0		
Length (ft)	72	Bankfull Width (ft)			4.3		
Width (in)	50	Bankfull:Culvert Ratio			1.0		
Height (in)	50						
Outlet Perch (ft)	4.3						
Slope (%)	6.4						
Rustline Height (in)	14						
Overall Condition	Fair						
PRIORITIZATION ANALYSIS							
Upstream Habitat Length (mi)	0.1	Habitat Points			1

Habitat Quality	Poor	Habitat Quality Points			1		
Fish Species	Anad.	Fish Points			3		
Barrier Class	Red	Barrier Points			3

Prioritization Total Points			8		
Notes: Stream channel dry during summer 2011 survey effort.

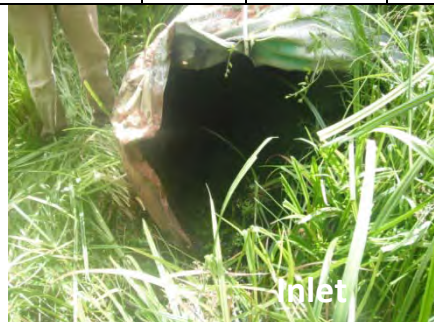
Shape	Circular	Inlet Gradient (%)	2.0				
Material	Corrugated metal	Upstream Gradient (%)	10.2				
Length (ft)	100	Bankfull Width (ft)	5.0				
Width (in)	42	Bankfull:Culvert Ratio	0.7				
Height (in)	42	Topography precluded use of survey equipment to collect longitudinal profile data					
Outlet Perch (ft)	3.0						
Slope (%)	12.0						
Rustline Height (in)	14						
Overall Condition	Poor						
PRIORITIZATION ANALYSIS

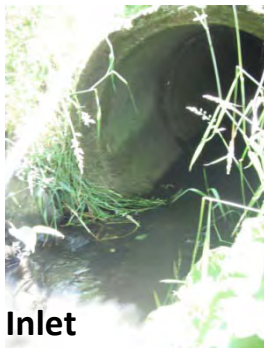
<b>Inlet</b>

Fish Species	Anad.	Fish Points	3				
Barrier Class	Red	Barrier Points	3				
		Prioritization Total Points	11.5				
<b>Notes:</b> Culvert outlets into mainstem Wilson River. The reach between this pipe and 781 is poor quality habitat passing through agricultural land and a golf course. Above 781, conditions improve. The habitat quality score for this culvert reflects this dichotomy.

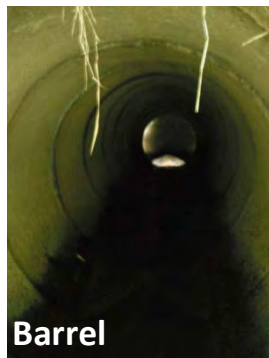
<b>Barrel</b>	
Shape	Circular	Inlet Gradient (%)	7.0				
Material	Concrete	Upstream Gradient (%)	4.0				
Length (ft)	Unable to measure	Bankfull Width (ft)	8.8				
Width (in)	48	Bankfull:Culvert Ratio	0.5				
Height (in)	48	This culvert has a tidegate on its outlet. It is visible in the barrel photo.					
Outlet Perch (ft)	Unable to measure						
Gradient (%)	6.0						
Rustline Height (in)	N/A						
Overall Condition	Fair						
PRIORITIZATION ANALYSIS							
Upstream Habitat Length (mi)	2.3	Habitat Points	4				
Habitat Quality	Poor/Fair	Habitat Quality Points	1.5

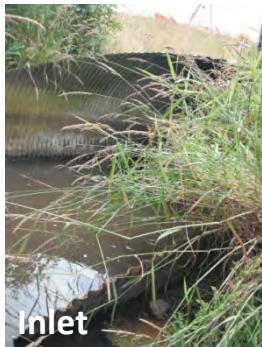
Inlet</div> <div>

Outlet</div>			
Shape	Circular	Inlet Gradient (%)	28.3				
Material	Corrugated metal	Upstream Gradient (%)	2.5				
Length (ft)	84	Bankfull Width (ft)	5.0				
Width (in)	108	Bankfull:Culvert Ratio	1.8				
Height (in)	108						
Outlet Perch (ft)	0.1						
Gradient (%)	2.3						
Rustline Height (in)	48						
Overall Condition	Fair						
PRIORITIZATION ANALYSIS							
Upstream Habitat Length (mi)	1.6	Habitat Points	4				
Habitat Quality	Fair	Habitat Quality Points	2				
Fish Species	Anad.	Fish Points	3

Barrier Class	Green	Barrier Points	1				
		Prioritization Total Points	10				
<b>Notes:</b> Although the channel immediately upstream of this pipe is rather narrow, this is somewhat misleading because the upstream side of this pipe is a several acre wetland area with numerous small channels and other open water areas. As a result, the amount of water conveyed by this pipe is often greater than what one would expect from a 5 ft channel.
