# **Culvert Assessment and Prioritization Plan for Fish Passage in the Tillamook Bay Watershed, Tillamook County, Oregon – Version 1.1**

**Tillamook  
Estuaries  
Partnership**

**September 2012**

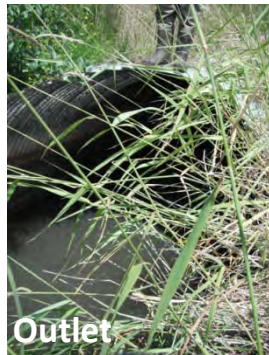
Outlet</div>			
Shape	Circular	Inlet Gradient (%)	28.3				
Material	Corrugated metal	Upstream Gradient (%)	2.5				
Length (ft)	84	Bankfull Width (ft)	5.0				
Width (in)	108	Bankfull:Culvert Ratio	1.8				
Height (in)	108						
Outlet Perch (ft)	0.1						
Gradient (%)	2.3						
Rustline Height (in)	48						
Overall Condition	Fair						
PRIORITIZATION ANALYSIS							
Upstream Habitat Length (mi)	1.6	Habitat Points	4				
Habitat Quality	Fair	Habitat Quality Points	2				
Fish Species	Anad.	Fish Points	3

Barrier Class	Green	Barrier Points	1				
		Prioritization Total Points	10				
<b>Notes:</b> Although the channel immediately upstream of this pipe is rather narrow, this is somewhat misleading because the upstream side of this pipe is a several acre wetland area with numerous small channels and other open water areas. As a result, the amount of water conveyed by this pipe is often greater than what one would expect from a 5 ft channel.

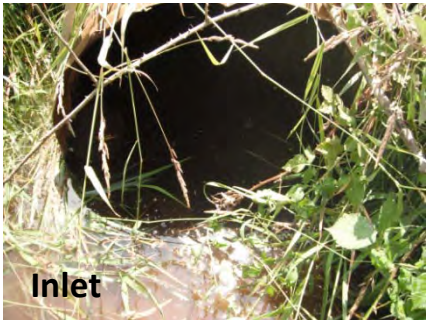
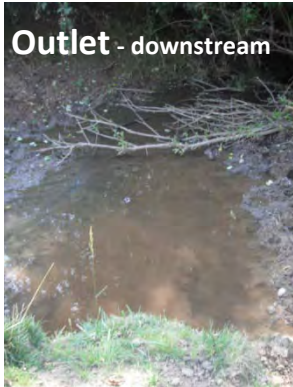
<b>Inlet</b>

<b>Outlet - downstream</b>	
Shape	Circular	Inlet Gradient (%)	21.6				
Material	Corrugated metal	Upstream Gradient (%)	1.1				
Length (ft)	87	Bankfull Width (ft)	3.8				
Width (in)	36	Bankfull:Culvert Ratio	0.8				
Height (in)	36						
Outlet Perch (ft)	None						
Gradient (%)	-1.0						
Rustline Height (in)	Entire pipe rusted						
Overall Condition	Fair						
PRIORITIZATION ANALYSIS							
Upstream Habitat Length (mi)	1.1	Habitat Points	3				
Habitat Quality	Fair	Habitat Quality Points	2

Fish Species	Anad.	Fish Points	3				
Barrier Class	Gray	Barrier Points	2				
		Prioritization Total Points	10				
<b>Notes:</b> Outlet area heavily impacted by livestock use. A small overflow pipe was approx. 2 ft above this pipe. The overflow pipe appears to occasionally carry flows, suggesting that the main pipe is inadequately sized for fish passage and stream processes (despite being rated green by the barrier model). Based on this additional information, we rated this pipe a partial barrier to juvenile passage.

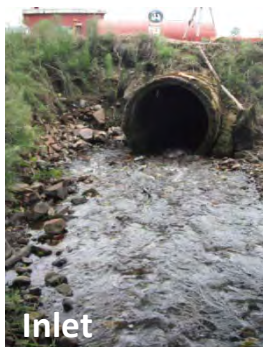
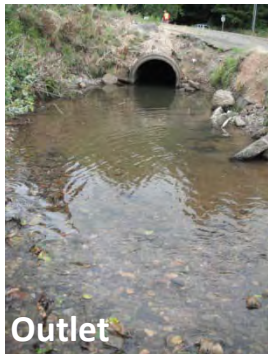
<b>Inlet</b>	
Shape	Circular	Inlet Gradient (%)	19.6				
Material	Concrete	Upstream Gradient (%)	4.4				
Length (ft)	104	Bankfull Width (ft)	8.0				
Width (in)	48	Bankfull:Culvert Ratio	0.5				
Height (in)	48						
Outlet Perch (ft)	None						
Gradient (%)	2.6						
Rustline Height (in)	N/A						
Overall Condition	Fair						
PRIORITIZATION ANALYSIS

<b>Outlet</b>	
Upstream Habitat Length (mi)	1.6	Habitat Points	4				
Habitat Quality	Fair	Habitat Quality Points	2				
Fish Species	Anad.	Fish Points	3				
Barrier Class	Gray	Barrier Points	2

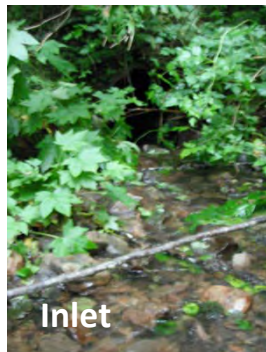
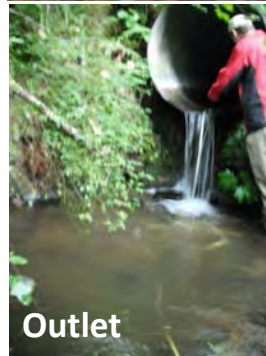
Inlet</div> <div>

Outlet</div>	
Shape	Circular	Inlet Gradient (%)	8.0				
Material	Corrugated metal	Upstream Gradient (%)	7.0				
Length (ft)	86	Bankfull Width (ft)	8.1				
Width (in)	42	Bankfull:Culvert Ratio	0.4				
Height (in)	42						
Outlet Perch (ft)	4.0						
Gradient (%)	11.0						
Rustline Height (in)	19						
Overall Condition	Poor						
PRIORITIZATION ANALYSIS							
Upstream Habitat Length (mi)	0.1	Habitat Points	1				
Habitat Quality	Poor	Habitat Quality Points	1

Fish Species	Anad.	Fish Points	3				
Barrier Class	Red	Barrier Points	3				
		Prioritization Total Points	8				
Notes:

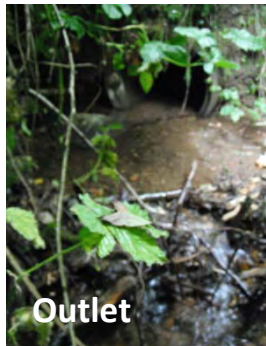
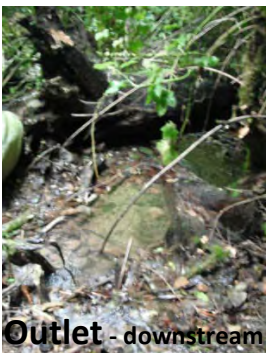
<b>Outlet</b>

<b>Outlet - downstream</b>	
Shape	Circular	Inlet Gradient (%)	13.0				
Material	Concrete	Upstream Gradient (%)	11.0				
Length (ft)	60	Bankfull Width (ft)	10.9				
Width (in)	36	Bankfull:Culvert Ratio	0.3				
Height (in)	36						
Outlet Perch (ft)	0.2						
Gradient (%)	14.0						
Rustline Height (in)	N/A						
Overall Condition	Fair						
PRIORITIZATION ANALYSIS							
Upstream Habitat Length (mi)	0.5	Habitat Points	1				
Habitat Quality	Poor	Habitat Quality Points	1				
Fish Species	Anad.	Fish Points	3

Barrier Class	Red	Barrier Points	3				
		Prioritization Total Points	8				
Notes:

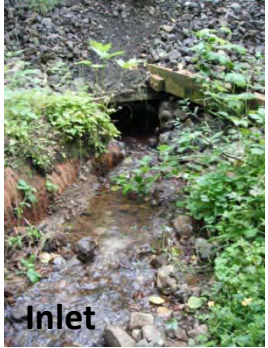
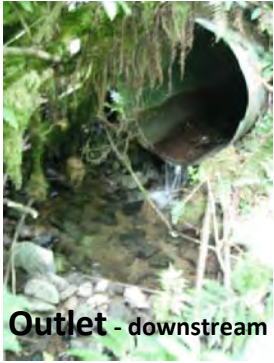
Inlet			
Stream Name		Unnamed tributary of Wilson River					
Township-Range-Section-1/4		T1S, R9W, Sec. 22, NE¼ of NW¼					
UTM Easting/Northing (Zone 10, NAD 1983)		439249/5036600					
Road Name		Sollie Smith Road					
Road/Culvert Owner		Shirhar Farms					
Adjacent Landowners		Shirhar Farms					
CULVERT INFO		CHANNEL INFO					
Shape	Circular	Inlet Gradient (%)	17.0				
Material	Corrugated metal	Upstream Gradient (%)	6.0				
Length (ft)	63	Bankfull Width (ft)	4.8				
Width (in)	24	Bankfull:Culvert Ratio	0.4				
Height (in)	24						
Outlet Perch (ft)	0.8						
Gradient (%)	7.0						
Rustline Height (in)	4						
Overall Condition	Poor						
PRIORITIZATION ANALYSIS

Outlet - downstream			
Upstream Habitat Length (mi)	0.3	Habitat Points	1				
Habitat Quality	Poor	Habitat Quality Points	1				
Fish Species	Anad.	Fish Points	3				
Barrier Class	Red	Barrier Points	3

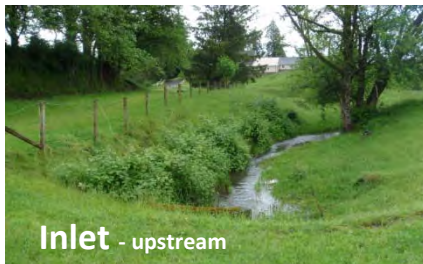
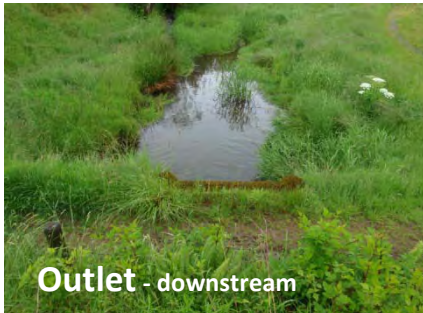
<p>Inlet - upstream</p>		
Shape	Box	Inlet Gradient (%)						unk
Material	Concrete	Upstream Gradient (%)						unk
Length (ft)	unknown	Bankfull Width (ft)						unk
Width (in)	unknown	Bankfull:Culvert Ratio						unk
Height (in)	unknown	Unable to access private property where inlet and outlet were located. As a result, no data was collected and only upstream and downstream photos were taken.						
Outlet Perch (ft)	unknown							
Gradient (%)	unknown							
Rustline Height (in)	unknown							
Overall Condition	unknown

<p>Outlet - downstream</p>	
Upstream Habitat Length (mi)	2.8	Habitat Points				4		
Habitat Quality	Poor(+)	Habitat Quality Points				1		
Fish Species	Anad.	Fish Points				3		
Barrier Class	Unk.	Barrier Points				?		
		Prioritization Total Points				8+		
<b>Notes:</b> Culvert appears to be an adequately sized concrete box. For analysis purposes, we assumed a partial barrier for Barrier Class Points.

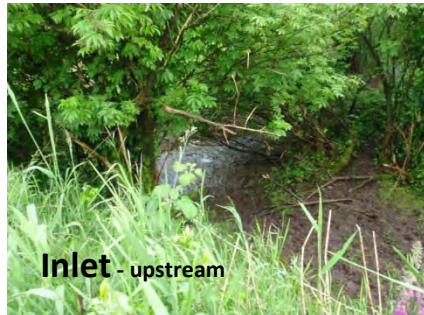
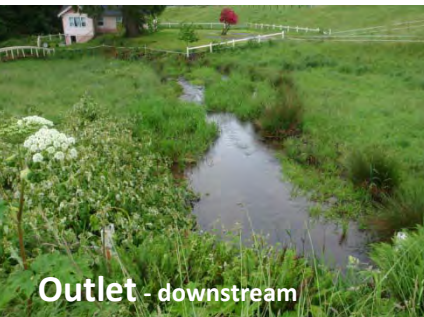
<p><b>Outlet</b> - downstream</p>			
Adjacent Landowners		V. Lucas and D. Lucas					
CULVERT INFO		CHANNEL INFO					
Shape	Circular	Inlet Gradient (%)	unk				
Material	Corrugated metal	Upstream Gradient (%)	unk				
Length (ft)	unknown	Bankfull Width (ft)	unk	<p>Unable to access private property where inlet and outlet were located. As a result, no data was collected and only upstream and downstream photos were taken.</p>			
Width (in)	unknown	Bankfull:Culvert Ratio	unk				
Height (in)	unknown						
Outlet Perch (ft)	unknown						
Gradient (%)	unknown						
Rustline Height (in)	unknown

Overall Condition	unknown						
PRIORITIZATION ANALYSIS							
Upstream Habitat Length (mi)	2.6	Habitat Points	4				
Habitat Quality	Poor(+)	Habitat Quality Points	1				
Fish Species	Anad.	Fish Points	3				
Barrier Class	Unk.	Barrier Points	?				
		Prioritization Total Points	8+				
<p><b>Notes:</b> Crossing 899 is located between 898 and 900. We were denied permission to access 899 and were unable to observe the crossing remotely.</p>

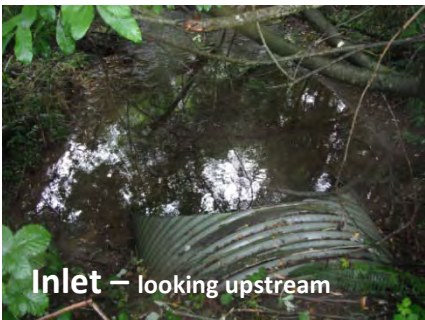
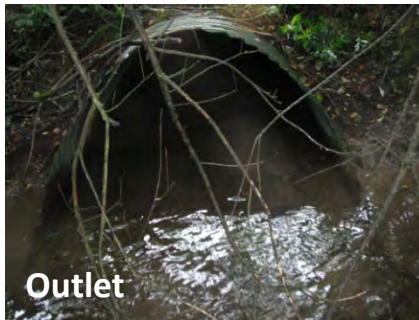
<b>Outlet</b>	
Upstream Habitat Length (mi)	2.3	Habitat Points	4				
Habitat Quality	Poor(+)	Habitat Quality Points	1

<b>Inlet</b> – looking upstream	
Shape	Circular	Inlet Gradient (%)	5.5				
Material	Corrugated metal	Upstream Gradient (%)	5.5				
Length (ft)	70	Bankfull Width (ft)	7.0				
Width (in)	72	Bankfull:Culvert Ratio	0.9				
Height (in)	48*	*Couldn't find bottom of pipe under sediment.					
Outlet Perch (ft)	None						
Gradient (%)	3.5						
Rustline Height (in)	18						
Overall Condition	Fair						
PRIORITIZATION ANALYSIS

Fish Species	Anad.	Fish Points	3				
Barrier Class	Gray	Barrier Points	2				
		Prioritization Total Points	10				
Notes: Culvert approximately 1/3 full of sediment.

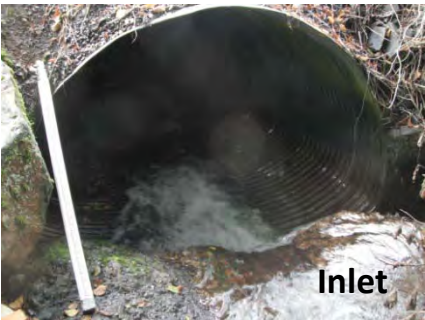
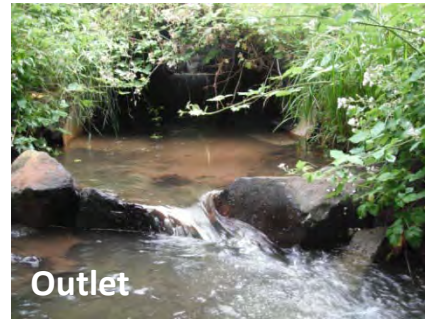
Adjacent Landowners		E. & W. Meyer, J. Main, R. & D. Steel					
CULVERT INFO		CHANNEL INFO					
Shape	Pipe arch	Inlet Gradient (%)	15.5				
Material	Corrugated metal	Upstream Gradient (%)	4.9				
Length (ft)	45	Bankfull Width (ft)	7.2	<p>A large slab of concrete was located in the stream channel at inlet. This resulted in an ~ 2 ft cascade into pipe.</p>			
Width (in)	96	Bankfull:Culvert Ratio	1.1				
Height (in)	72						
Outlet Perch (ft)	None						
Gradient (%)	6.7						
Rustline Height (in)	12						
Overall Condition	Fair						
PRIORITIZATION ANALYSIS							
Upstream Habitat Length (mi)	1.8	Habitat Points	4

Habitat Quality	Fair	Habitat Quality Points	2				
Fish Species	Anad.	Fish Points	3				
Barrier Class	Red	Barrier Points	3				
		Prioritization Total Points	12				
<p><b>Notes:</b> Barrier rating based on concrete blocking inlet and the steep pipe gradient and lack of natural substrate through pipe.</p>

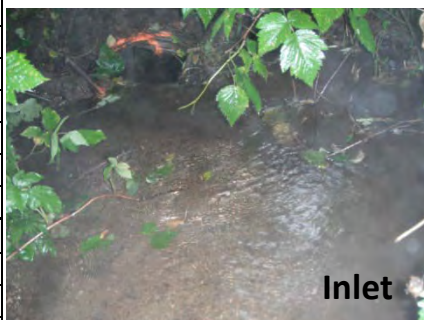
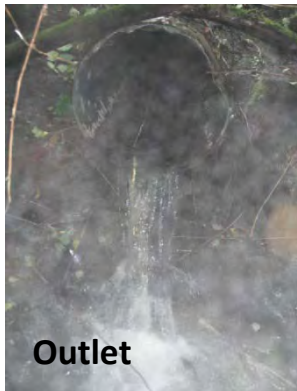
<b>Inlet</b>	
Shape	Circular	Inlet Gradient (%)	61.5				
Material	Corrugated metal	Upstream Gradient (%)	2.6				
Length (ft)	69	Bankfull Width (ft)	6.5				
Width (in)	36	Bankfull:Culvert Ratio	0.5				
Height (in)	36						
Outlet Perch (ft)	2.1						
Gradient (%)	4.4						
Rustline Height (in)	18						
Overall Condition	Poor						
PRIORITIZATION ANALYSIS

Barrier Class	Red	Barrier Points	3				
		Prioritization Total Points	9				
<b>Notes:</b> Crossing 862 was located downstream of this crossing. We did not have permission to access 862 and could not adequately observe it from Highway 6 to determine what type of pipe occurs there, its condition, or its potential to impede passage.

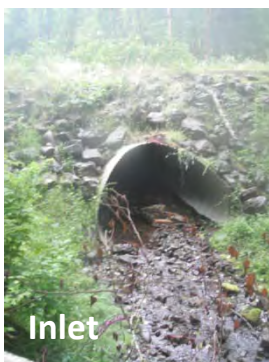
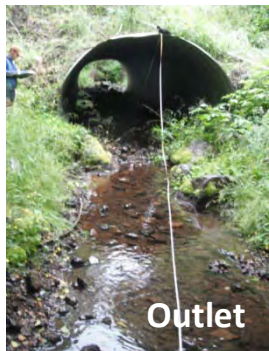
Inlet

Barrier Class	Green	Barrier Points	1				
		Prioritization Total Points	7				
<b>Notes:</b> It is possible that anadromous fish cannot make it to this point due to natural barriers. However, based on juvenile survey data, it appears that steelhead are capable of negotiating most known barriers below this point, so we elected to consider this reach as having anadromous potential.

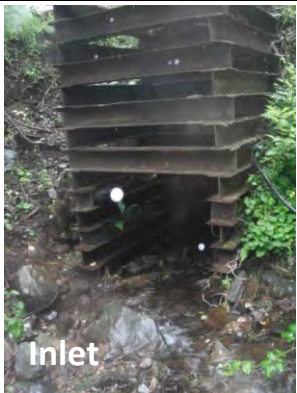
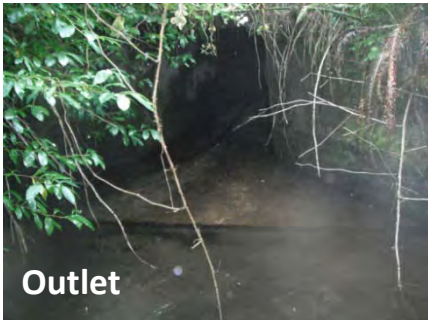
Shape	Box	Inlet Gradient (%)			7.0		
Material	Concrete	Upstream Gradient (%)			6.0		
Length (ft)	75	Bankfull Width (ft)			6.3		
Width (in)	60	Bankfull:Culvert Ratio			0.8		
Height (in)	60						
Outlet Perch (ft)	None						
Gradient (%)	5.0						
Rustline Height (in)	N/A						
Overall Condition	Fair						
PRIORITIZATION ANALYSIS

Barrier Class	Red	Barrier Points			3		
		Prioritization Total Points			10		
<b>Notes:</b> Topography and obstacles precluded use of surveying level on this culvert. Unable to determine if outlet is perched. Trash rack at inlet. Culvert overly steep and lacks natural substrate.

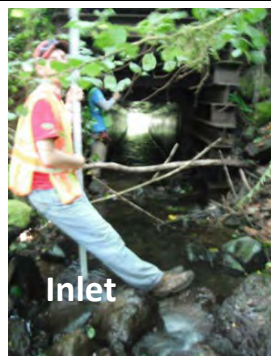
<b>Inlet</b>

<b>Outlet</b>	
Shape	Box	Inlet Gradient (%)	12.0				
Material	Concrete	Upstream Gradient (%)	11.0				
Length (ft)	97	Bankfull Width (ft)	6.4				
Width (in)	60	Bankfull:Culvert Ratio	0.8				
Height (in)	60						
Outlet Perch (ft)	Unknown						
Gradient (%)	7.0						
Rustline Height (in)	N/A						
Overall Condition	Poor						
PRIORITIZATION ANALYSIS							
Upstream Habitat Length (mi)	1.0	Habitat Points	2				
Habitat Quality	Fair	Habitat Quality Points	2				
Fish Species	Anad.	Fish Points	3				
Barrier Class	Red	Barrier Points	3

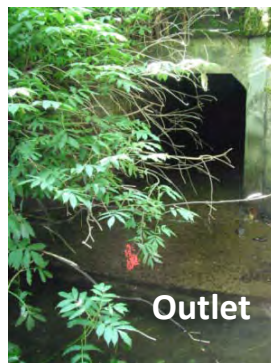
Prioritization Total Points	10				
<b>Notes:</b> Topography and obstacles precluded use of surveying level on this culvert. Unable to determine if outlet is perched. Trash rack at inlet. Culvert overly steep and lacks natural substrate.

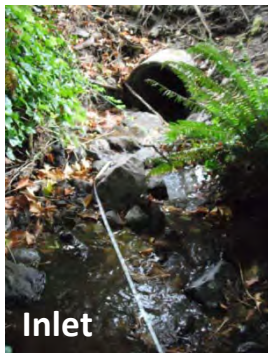
LOCATION INFO				Culvert #	722	Priority	L
Watershed		Wilson River					
Stream Name		Unnamed tributary of Wilson River					
Township-Range-Section-1/4		T1S, R8W, Sec. 8, SE¼ of NE¼					
UTM Easting/Northing (Zone 10, NAD 1983)		446487/5037891					
Road Name		Highway 6					
Road/Culvert Owner		Oregon Department of Transportation					
Adjacent Landowners		Wilson River Properties, LLC. and J. Vandyke					
CULVERT INFO		CHANNEL INFO					
Shape	Circular	Inlet Gradient (%)	9.8				
Material	Concrete	Upstream Gradient (%)	12.3				
Length (ft)	50	Bankfull Width (ft)	4.9				
Width (in)	24	Bankfull:Culvert Ratio	0.4				
Height (in)	24						
Outlet Perch (ft)	None						
Gradient (%)	4.8						
Rustline Height (in)	N/A						
Overall Condition	Fair						
PRIORITIZATION ANALYSIS							
Upstream Habitat Length (mi)	0.2	Habitat Points	1				
Habitat Quality	Poor	Habitat Quality Points	1				
Fish Species	Anad.	Fish Points	3				
Barrier Class	Red	Barrier Points	3

Prioritization Total Points	8				
<b>Notes:</b> Stream depicted as nonfish-modeled. However, technical review team suggested including this culvert in the analysis and ending fish use where stream gradient exceeds 15 percent grade.

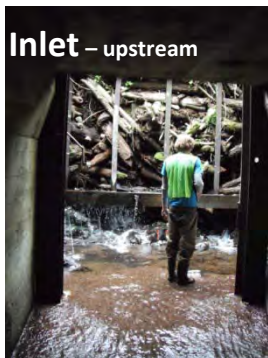
Inlet – upstream

LOCATION INFO				Culvert #	713	Priority	M
Watershed		Wilson River					
Stream Name		Smith Creek					
Township-Range-Section-1/4		T1S, R8W, Sec. 9, SW¼ of NW¼					
UTM Easting/Northing (Zone 10, NAD 1983)		446846/5037955					
Road Name		Highway 6					
Road/Culvert Owner		Oregon Department of Transportation					
Adjacent Landowners		Stimson Lumber Company					
CULVERT INFO		CHANNEL INFO					
Shape	Box	Inlet Gradient (%)		Not measured			
Material	Concrete	Upstream Gradient (%)		4.0			
Length (ft)	143	Bankfull Width (ft)		6.2			
Width (in)	120	Bankfull:Culvert Ratio		1.6			
Height (in)	90	Use of surveying equipment precluded by terrain and obstacles.					
Outlet Perch (ft)	~1.5						
Gradient (%)	8.0						
Rustline Height (in)	N/A						
Overall Condition	Poor						
PRIORITIZATION ANALYSIS							
Upstream Habitat Length (mi)		0.6	Habitat Points		2		
Habitat Quality		Fair	Habitat Quality Points		2		
Fish Species		Anad.	Fish Points		3

Barrier Class		Red	Barrier Points		3		
			Prioritization Total Points		10		
<b>Notes:</b> Water was observed entering the pipe from holes in the side walls and flowing around the outside of one of the wing walls at outlet. This suggests that water was flowing alongside the entire outer wall of the pipe. An approx. 20 ft wall of debris was trapped upstream of the trash rack and had aggraded the upstream channel an equivalent amount.

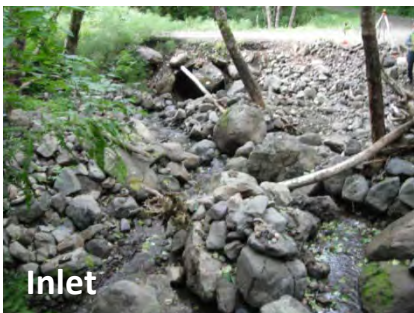
Inlet		
Shape	Circular	Inlet Gradient (%)						12.8
Material	Corrugated metal	Upstream Gradient (%)						11.2
Length (ft)	27	Bankfull Width (ft)						4.5
Width (in)	72	Bankfull:Culvert Ratio						1.3
Height (in)	72							
Outlet Perch (ft)	2.7							
Gradient (%)	9.3							
Rustline Height (in)	12							
Overall Condition	Fair							
PRIORITIZATION ANALYSIS

Barrier Class	Red	Barrier Points				3		
		Prioritization Total Points				9		
<b>Notes:</b> Stream intermittently subterranean during survey (summer 2011). Depicted as nonfish. Technical team suggested including this culvert and stopping fish use where gradient exceeds 15 percent. Cutthroat observed in watered areas upstream of pipe during 2011 survey work.

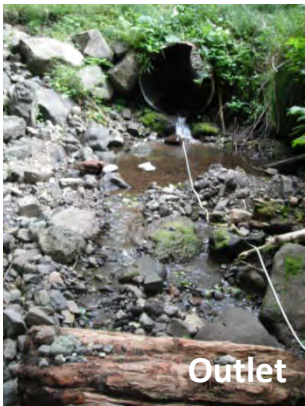
Outlet	
Upstream Habitat Length (mi)	0.3	Habitat Points				1		
Habitat Quality	Fair(-)	Habitat Quality Points				2		
Fish Species	Anad.	Fish Points				3

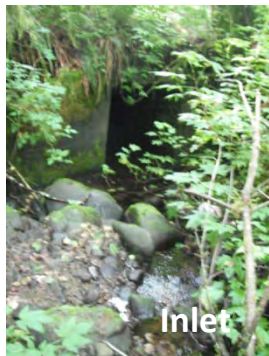
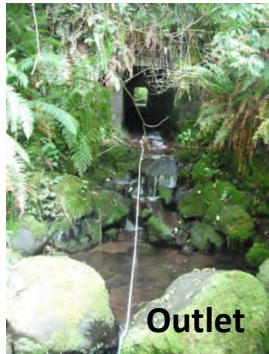
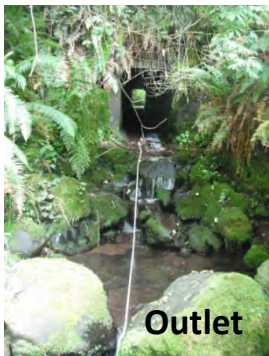
**Outlet**

Shape	Box	Inlet Gradient (%)	16.0				
Material	Concrete	Upstream Gradient (%)	9.5				
Length (ft)	100	Bankfull Width (ft)	6.6				
Width (in)	48	Bankfull:Culvert Ratio	0.6				
Height (in)	60	Use of surveying equipment precluded by terrain and obstacles.					
Outlet Perch (ft)	~3.5						
Gradient (%)	9.3						
Rustline Height (in)	12						
Overall Condition	Poor						
PRIORITIZATION ANALYSIS							
Upstream Habitat Length (mi)	0.5	Habitat Points	1				
Habitat Quality	Fair(-)	Habitat Quality Points	2				
Fish Species	Anad.	Fish Points	3

Barrier Class	Red	Barrier Points	3				
		Prioritization Total Points	9				
<b>Notes:</b> Outlet cascades over boulders and additional cascades over boulders are located a short distance downstream of outlet. Exposed rebar observed on invert of pipe.

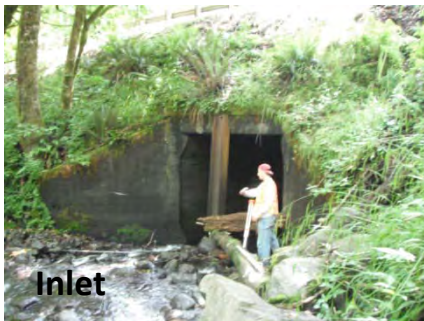
Shape	Box	Inlet Gradient (%)	15.7				
Material	Concrete	Upstream Gradient (%)	7.0				
Length (ft)	94	Bankfull Width (ft)	16.9				
Width (in)	120	Bankfull:Culvert Ratio	0.6				
Height (in)	120	Water observed flowing from around outside of culvert on outlet side. Rubber baffles inside pipe. Many were damaged or missing.					
Outlet Perch (ft)	4.0						
Gradient (%)	5.2						
Rustline Height (in)	N/A						
Overall Condition	Poor						
PRIORITIZATION ANALYSIS

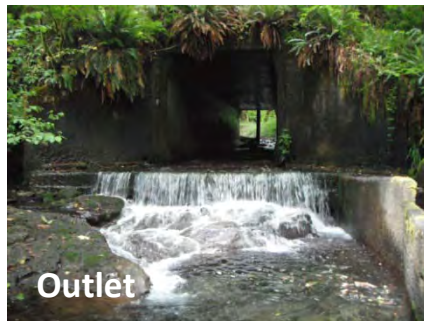
Habitat Quality	Good	Habitat Quality Points	3				
Fish Species	Anad.	Fish Points	3				
Barrier Class	Red	Barrier Points	3				
		Prioritization Total Points	13				
Notes: Outlet fish ladder substantially blocked with debris, in poor condition, and conveyed only a small fraction of the total stream flow.

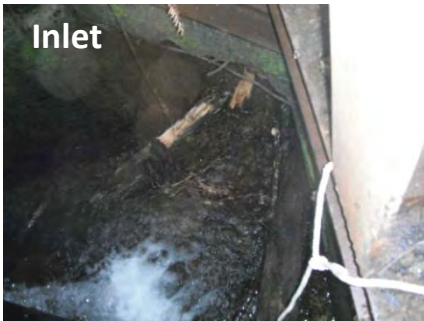
Inlet

Fish Species	Anad.	Fish Points	3				
Barrier Class	Red	Barrier Points	3				
		Prioritization Total Points	10				
<b>Notes:</b> An approx. 5 ft wall of debris was trapped upstream of the trash rack and aggraded the upstream channel an equivalent amount. Water cascaded over debris wall. Additional loose woody debris was trapped against trash rack above stream bed.

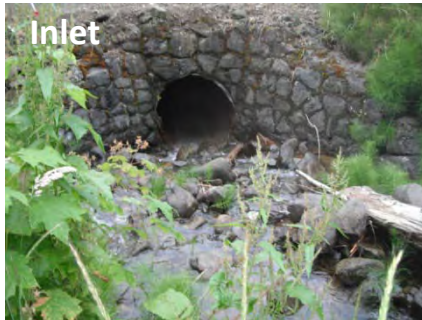
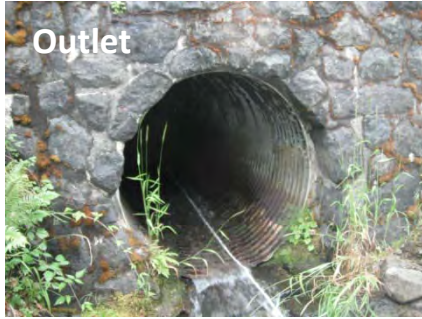
Adjacent Landowners		Oregon Department of Forestry					
CULVERT INFO		CHANNEL INFO					
Shape	Circular	Inlet Gradient (%)	26.5				
Material	Corrugated metal	Upstream Gradient (%)	15.5				
Length (ft)	51	Bankfull Width (ft)	6.7				
Width (in)	54	Bankfull:Culvert Ratio	0.7				
Height (in)	54						
Outlet Perch (ft)	1.1						
Gradient (%)	10.8						
Rustline Height (in)	30						
Overall Condition	Fair						
PRIORITIZATION ANALYSIS							
Upstream Habitat Length (mi)	0.7	Habitat Points	2				
Habitat Quality	Fair	Habitat Quality Points	2				
Fish Species	Anad.	Fish Points	3				
Barrier Class	Red	Barrier Points	3

Prioritization Total Points	10				
<p><b>Notes:</b> This culvert has rock headwalls and wingwalls that may have been constructed by the Civilian Conservation Corps. The Oregon State Historical Preservation Office should be consulted regarding these features. Replacement of this culvert will likely require compliance with applicable cultural resources protection laws.</p>

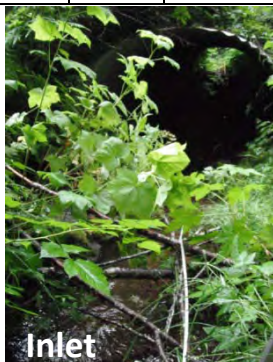
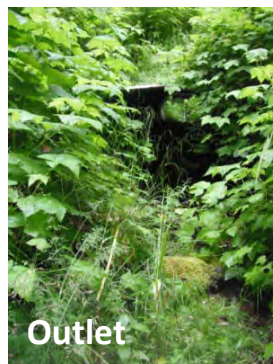
Shape	Pipe arch	Inlet Gradient (%)	2.5				
Material	Corrugated metal	Upstream Gradient (%)	5.4				
Length (ft)	45	Bankfull Width (ft)	6.2				
Width (in)	100	Bankfull:Culvert Ratio	1.4				
Height (in)	68						
Outlet Perch (ft)	1.0						
Gradient (%)	1.8						
Rustline Height (in)	None						
Overall Condition	Fair						
PRIORITIZATION ANALYSIS

Barrier Class	Red	Barrier Points	3				
		Prioritization Total Points	9				
Notes:

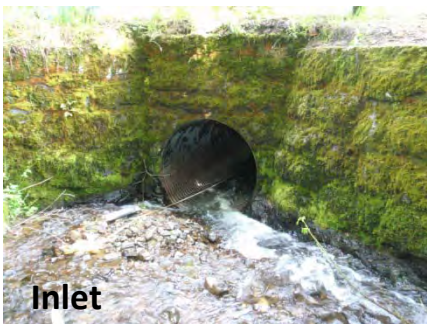
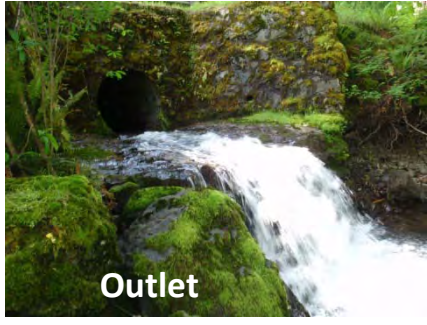
Fish Species	Anad.	Fish Points	3				
Barrier Class	Red	Barrier Points	3				
		Prioritization Total Points	11				
<p><b>Notes:</b> This culvert has rock headwalls, wingwalls, and an outlet apron that may have been constructed by the Civilian Conservation Corps. The Oregon State Historical Preservation Office should be consulted regarding these features. Replacement of this culvert will likely require compliance with applicable cultural resources protection laws.</p>

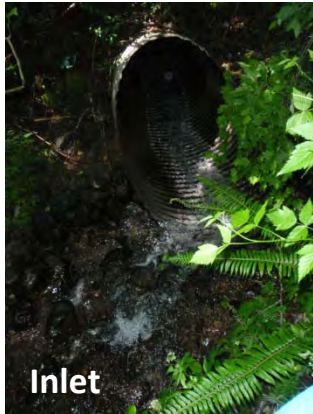
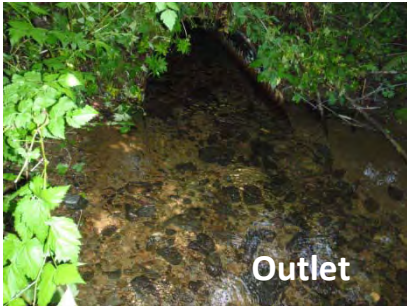
<b>Inlet</b>	
Shape	Circular	Inlet Gradient (%)	14.0				
Material	Corrugated metal	Upstream Gradient (%)	3.0				
Length (ft)	100	Bankfull Width (ft)	4.3				
Width (in)	42	Bankfull:Culvert Ratio	0.8				
Height (in)	42	Use of surveying equipment precluded by terrain and obstacles.					
Outlet Perch (ft)	1.1						
Gradient (%)	5.0						
Rustline Height (in)	26						
Overall Condition	Fair						
PRIORITIZATION ANALYSIS

Fish Species	Anad.	Fish Points	3				
Barrier Class	Red	Barrier Points	3				
		Prioritization Total Points	11				
<b>Notes:</b> Tech. team noted that, based on their experience, an unidentified barrier culvert occurs on a utility Right-of-Way across private land approximately 0.1 miles upstream of this crossing.

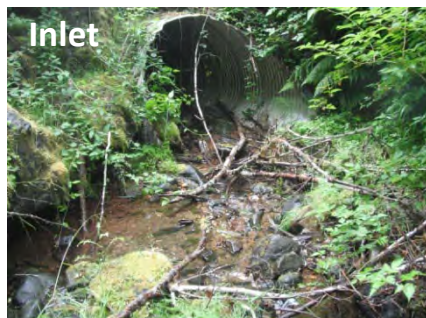
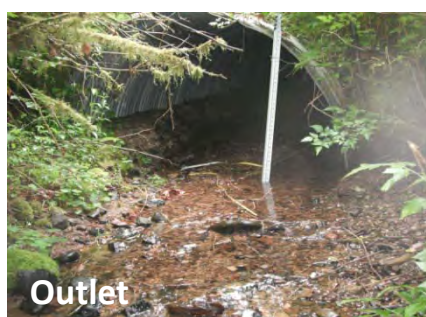
Barrier Class	Gray	Barrier Points	2				
		Prioritization Total Points	8				
Notes: Barrier class based on culvert slope being greater than + 1 percent of stream gradient.

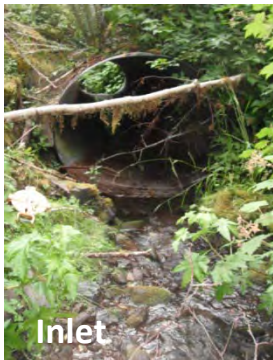
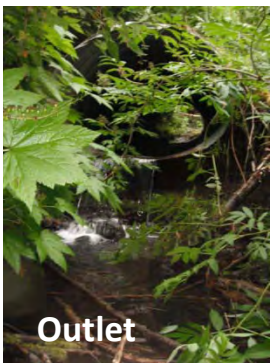
<b>Outlet</b></div>			
Stream Name		Wilson River					
Township-Range-Section-1/4		Moore Creek					
Township-Range-Section-1/4		T1N, R7W, Sec. 2, SW¼ of SE¼					
UTM Easting/Northing (Zone 10, NAD 1983)		460473/5049046					
Road Name		East Ben Smith Road					
Road/Culvert Owner		Oregon Department of Forestry					
Adjacent Landowners		Oregon Department of Forestry					
CULVERT INFO		CHANNEL INFO					
Shape	Pipe arch	Inlet Gradient (%)	9.7				
Material	Corrugated metal	Upstream Gradient (%)	7.5				
Length (ft)	43	Bankfull Width (ft)	6.1				
Width (in)	78	Bankfull:Culvert Ratio	1.1				
Height (in)	60						
Outlet Perch (ft)	2.6						
Gradient (%)	3.5						
Rustline Height (in)	19						
Overall Condition	Poor						
PRIORITIZATION ANALYSIS							
Upstream Habitat Length (mi)	0.2	Habitat Points	1				
Habitat Quality	Fair	Habitat Quality Points	2

Fish Species	Anad.	Fish Points	3				
Barrier Class	Red	Barrier Points	3				
		Prioritization Total Points	9				
Notes:

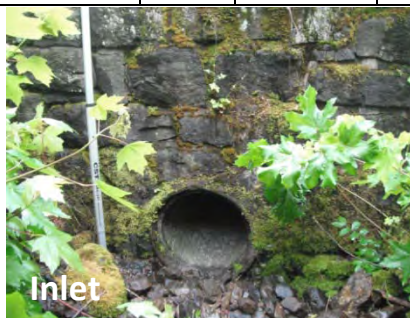
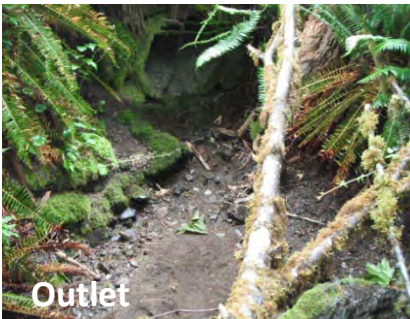
Shape	Circular	Inlet Gradient (%)	14.0				
Material	Concrete	Upstream Gradient (%)	12.0				
Length (ft)	80	Bankfull Width (ft)	6.1				
Width (in)	24	Bankfull:Culvert Ratio	0.3				
Height (in)	24						
Outlet Perch (ft)	1.0						
Gradient (%)	9.0						
Rustline Height (in)	N/A						
Overall Condition	Poor						
PRIORITIZATION ANALYSIS

Prioritization Total Points	9				
<b>Notes:</b> Stream dry during summer 2011 site visit. This culvert has rock headwalls that may have been constructed by the Civilian Conservation Corps. The Oregon State Historical Preservation Office should be consulted regarding these features. Replacement of this culvert will likely require compliance with applicable cultural resources protection laws.

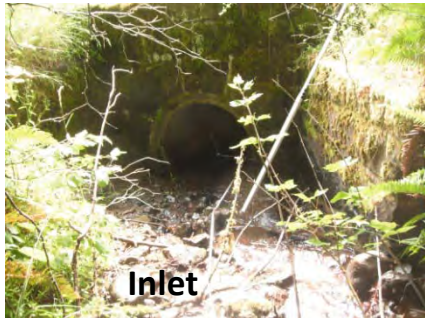
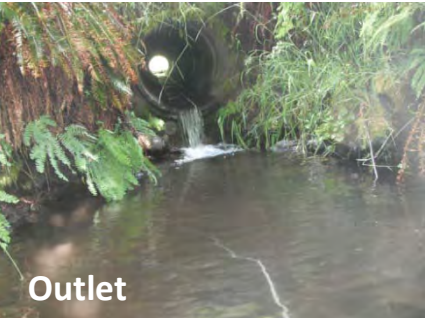
<b>Inlet</b>	
Shape	Circular	Inlet Gradient (%)	20.5				
Material	Concrete	Upstream Gradient (%)	6.3				
Length (ft)	61	Bankfull Width (ft)	7.2				
Width (in)	36	Bankfull:Culvert Ratio	0.4				
Height (in)	36						
Outlet Perch (ft)	1.8						
Gradient (%)	4.3						
Rustline Height (in)	N/A						
Overall Condition	Fair						
PRIORITIZATION ANALYSIS

Barrier Class	Red	Barrier Points	3				
		Prioritization Total Points	9				
Notes:

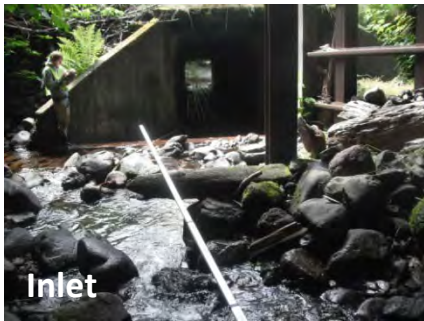
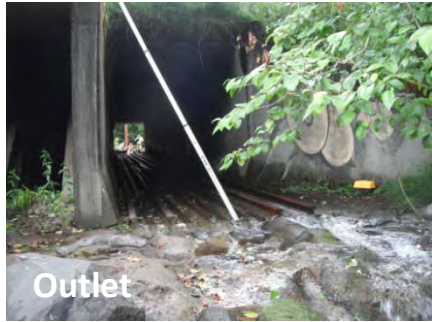
Shape	Box	Inlet Gradient (%)	42.7				
Material	Concrete	Upstream Gradient (%)	7.6				
Length (ft)	116	Bankfull Width (ft)	11.2				
Width (in)	96	Bankfull:Culvert Ratio	0.7				
Height (in)	96	*Outlets directly into Wilson River. Unable to measure tailwater control, but at summer flows it cascades over 2-3 ft step into river.					
Outlet Perch (ft)	*Not measured						
Gradient (%)	3.7						
Rustline Height (in)	N/A						
Overall Condition	Fair						
PRIORITIZATION ANALYSIS

Habitat Quality	Good	Habitat Quality Points	3				
Fish Species	Anad.	Fish Points	3				
Barrier Class	Red	Barrier Points	3				
		Prioritization Total Points	12				
<b>Notes:</b> An I-beam across inlet creates an ~18 step. Culvert is paralleled by an attached fishway. However, at low flows this structure conveys insufficient flows to pass fish. Steps at either end of culvert are further impediments to passage.

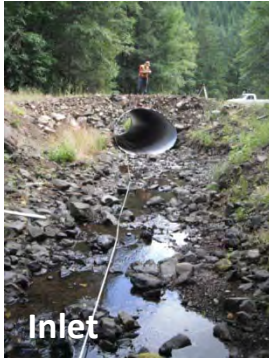
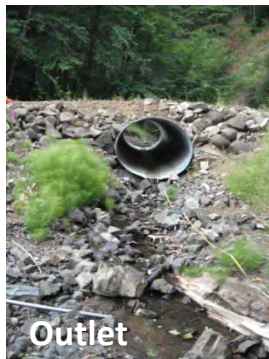
Outlet</div>	
Shape	Pipe arch	Inlet Gradient (%)		5.1			
Material	Corrugated metal	Upstream Gradient (%)		4.0			
Length (ft)	43	Bankfull Width (ft)		9.2			
Width (in)	94	Bankfull:Culvert Ratio		0.9			
Height (in)	72						
Outlet Perch (ft)	2.2						
Gradient (%)	4.5						
Rustline Height (in)	6						
Overall Condition	Good						
PRIORITIZATION ANALYSIS							
Upstream Habitat Length (mi)		0.2	Habitat Points		1		
Habitat Quality		Fair	Habitat Quality Points		2

Fish Species		Anad.	Fish Points		3		
Barrier Class		Red	Barrier Points		3		
			Prioritization Total Points		9		
Notes:

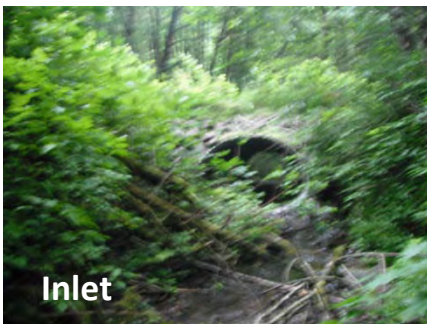
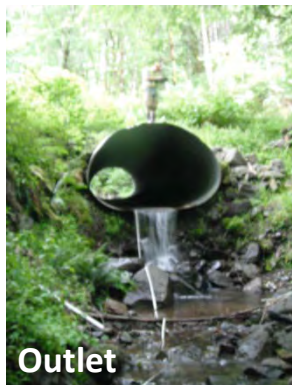
<b>Inlet</b>	
Shape	Pipe arch	Inlet Gradient (%)	5.2				
Material	Corrugated metal	Upstream Gradient (%)	6.5				
Length (ft)	67	Bankfull Width (ft)	11.1				
Width (in)	126	Bankfull:Culvert Ratio	0.9				
Height (in)	86						
Outlet Perch (ft)	4.3						
Gradient (%)	9.2						
Rustline Height (in)	4						
Overall Condition	Fair						
PRIORITIZATION ANALYSIS

Barrier Class	Red	Barrier Points	3				
		Prioritization Total Points	8				
Notes:

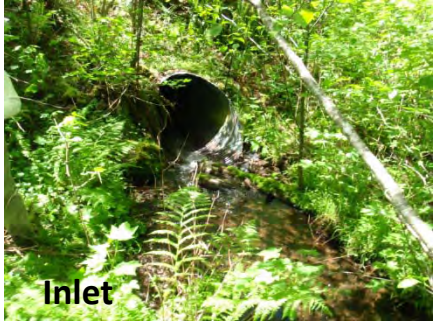
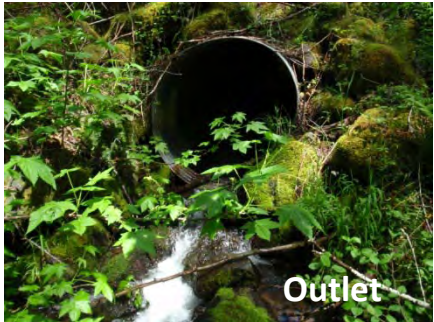
<p>Outlet</p>			
Adjacent Landowners		Oregon Department of Forestry					
CULVERT INFO		CHANNEL INFO					
Shape	Circular	Inlet Gradient (%)	12.0				
Material	Corrugated metal	Upstream Gradient (%)	18.0				
Length (ft)	67	Bankfull Width (ft)	11.2				
Width (in)	57	Bankfull:Culvert Ratio	0.4				
Height (in)	57						
Outlet Perch (ft)	None						
Gradient (%)	6.0						
Rustline Height (in)	-						
Overall Condition	Good						
PRIORITIZATION ANALYSIS							
Upstream Habitat Length (mi)	0.1	Habitat Points	1				
Habitat Quality	Poor	Habitat Quality Points	1				
Fish Species	Anad.	Fish Points	3

Barrier Class	Red	Barrier Points	3				
		Prioritization Total Points	8				
Notes:

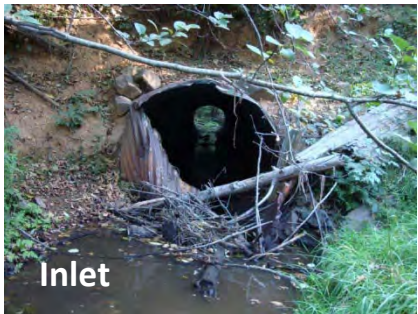
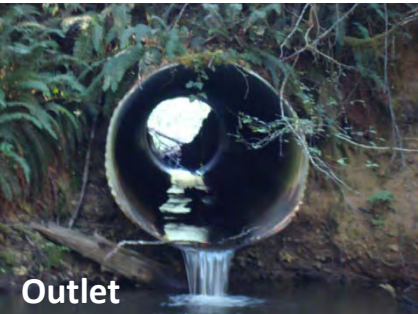
Material	Corrugated metal	Upstream Gradient (%)	5.0				
Length (ft)	80	Bankfull Width (ft)	14.3				
Width (in)	76	Bankfull:Culvert Ratio	0.4				
Height (in)	76	Crossing approx 250 ft upstream of University Falls, a complete passage barrier. Beaver dam blocking inlet in summer 2011, creating large wetland above culvert. 2012 photos.					
Outlet Perch (ft)	1.5						
Gradient (%)	1.0						
Rustline Height (in)	24						
Overall Condition	Poor						
PRIORITIZATION ANALYSIS

Upstream Habitat Length (mi)	3.3	Habitat Points	4				
Habitat Quality	Good	Habitat Quality Points	3				
Fish Species	Resident	Fish Points	2				
Barrier Class	Red	Barrier Points	3				
		Prioritization Total Points	12				
<b>Notes:</b> Beaver dam gone in 2012, but small debris jam present. Inlet badly damaged and large holes on invert near inlet end of pipe.

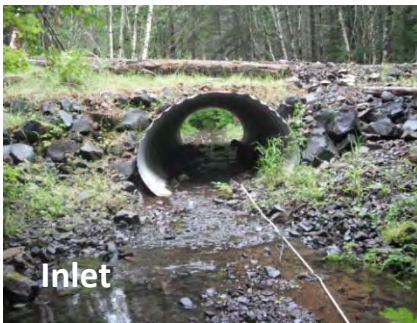
LOCATION INFO				Culvert #	265	Priority	L
Watershed		Wilson River					
Stream Name		Elliot Creek					
Township-Range-Section-1/4		T1N R6W, Sec. 2, SE¼ of SE¼					
UTM Easting/Northing (Zone 10, NAD 1983)		470043/5049124					
Road Name		Unnamed off Beaver Dam Road					
Road/Culvert Owner		Oregon Department of Forestry					
Adjacent Landowners		Oregon Department of Forestry					
CULVERT INFO		CHANNEL INFO					
Shape	Pipe arch	Inlet Gradient (%)	5.2				
Material	Corrugated metal	Upstream Gradient (%)	6.2				
Length (ft)	41	Bankfull Width (ft)	8.0				
Width (in)	102	Bankfull:Culvert Ratio	1.1				
Height (in)	72						
Outlet Perch (ft)	0.2						
Gradient (%)	2.6						
Rustline Height (in)	5						
Overall Condition	Good						
PRIORITIZATION ANALYSIS							
Upstream Habitat Length (mi)	1.2	Habitat Points	3				
Habitat Quality	Good	Habitat Quality Points	3				
Fish Species	Resident	Fish Points	2				
Barrier Class	Green	Barrier Points	1

Prioritization Total Points	9				
Notes:

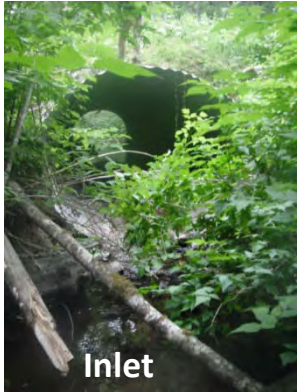
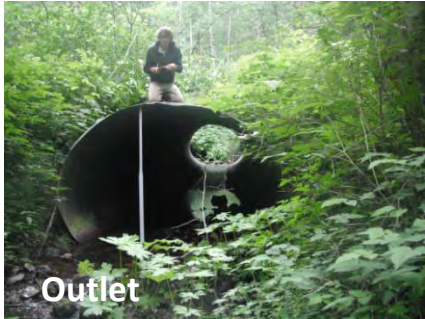
LOCATION INFO				Culvert #	266	Priority	M
Watershed				Wilson River			
Stream Name				Elliot Creek			
Township-Range-Section-1/4				T1N R6W, Sec. 1, SW¼ of SW¼			
UTM Easting/Northing (Zone 10, NAD 1983)				470343/5049056			
Road Name				Beaver Dam Road			
Road/Culvert Owner				Oregon Department of Forestry			
Adjacent Landowners				Oregon Department of Forestry			
CULVERT INFO		CHANNEL INFO					
Shape	Pipe arch	Inlet Gradient (%)	2.4				
Material	Corrugated metal	Upstream Gradient (%)	5.2				
Length (ft)	66	Bankfull Width (ft)	9.8				
Width (in)	120	Bankfull:Culvert Ratio	1.0				
Height (in)	96						
Outlet Perch (ft)	1.1						
Gradient (%)	2.7						
Rustline Height (in)	9						
Overall Condition	Poor						
PRIORITIZATION ANALYSIS							
Upstream Habitat Length (mi)	1.0	Habitat Points	2				
Habitat Quality	Good	Habitat Quality Points	3				
Fish Species	Resident	Fish Points	2				
Barrier Class	Red	Barrier Points	3

Prioritization Total Points	10				
Notes:

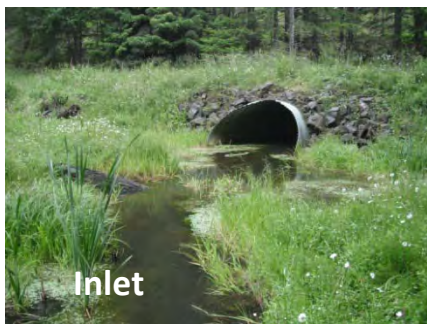
<b>Inlet</b>	
Shape	Pipe arch	Inlet Gradient (%)	1.1				
Material	Corrugated metal	Upstream Gradient (%)	0.7				
Length (ft)	56	Bankfull Width (ft)	12.2				
Width (in)	126	Bankfull:Culvert Ratio	0.9				
Height (in)	90						
Outlet Perch (ft)	0.1						
Gradient (%)	0.5						
Rustline Height (in)	26						
Overall Condition	Fair						
PRIORITIZATION ANALYSIS

Barrier Class	Green	Barrier Points	1				
		Prioritization Total Points	7				
<b>Notes:</b> Large beaver dams just upstream and downstream of this pipe during summer 2011.

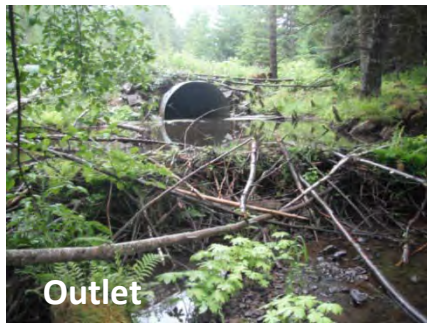
<b>Outlet</b>	
Upstream Habitat Length (mi)	0.5	Habitat Points	1				
Habitat Quality	Good	Habitat Quality Points	3				
Fish Species	Resident	Fish Points	2

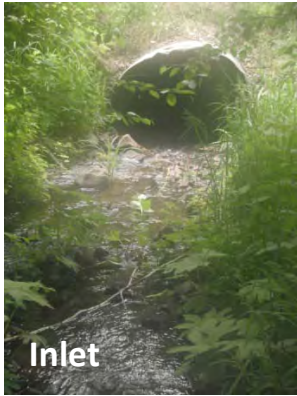
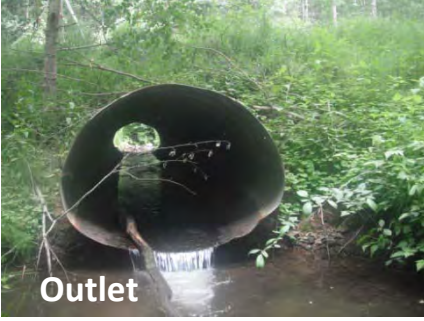
Shape	Pipe arch	Inlet Gradient (%)	4.8				
Material	Corrugated metal	Upstream Gradient (%)	5.1				
Length (ft)	50	Bankfull Width (ft)	10.6				
Width (in)	76	Bankfull:Culvert Ratio	0.6				
Height (in)	54						
Outlet Perch (ft)	0.6						
Gradient (%)	0.6						
Rustline Height (in)	12						
Overall Condition	Poor						
PRIORITIZATION ANALYSIS							
Upstream Habitat Length (mi)	1.7	Habitat Points	4				
Habitat Quality	Good	Habitat Quality Points	3				
Fish Species	Anad.	Fish Points	3				
Barrier Class	Red	Barrier Points	3

Prioritization Total Points	13				
Notes:

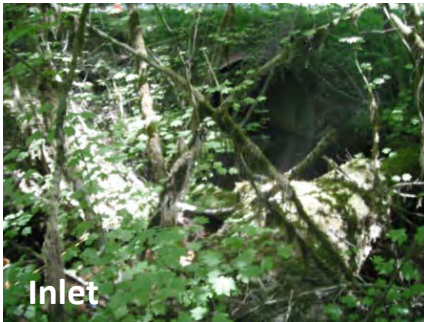
Inlet	
Shape	Pipe arch	Inlet Gradient (%)	-8.6				
Material	Corrugated metal	Upstream Gradient (%)	0.5				
Length (ft)	54	Bankfull Width (ft)	7.8				
Width (in)	94	Bankfull:Culvert Ratio	1.0				
Height (in)	60	Crew couldn't find invert of pipe below substrate, but it appears to be a pipe arch and not an open-bottomed arch.					
Outlet Perch (ft)	None						
Gradient (%)	1.8						
Rustline Height (in)	12						
Overall Condition	Good						
PRIORITIZATION ANALYSIS

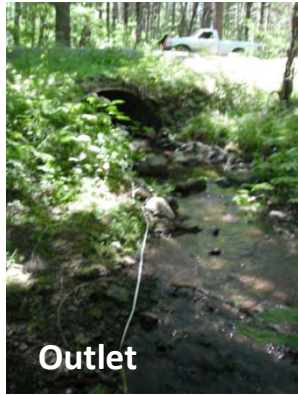
Outlet	
Upstream Habitat Length (mi)	0.8	Habitat Points	2

Habitat Quality	Good	Habitat Quality Points	3				
Fish Species	Anad.	Fish Points	3				
Barrier Class	Gray	Barrier Points	3				
		Prioritization Total Points	11				
Notes:

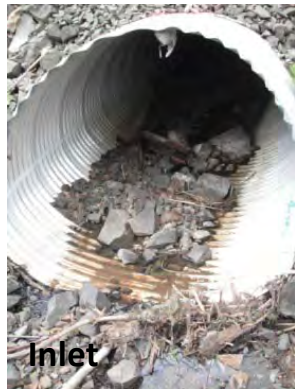
Inlet

**Notes:** Log dam greatly restricting flows through pipe. Pipe outlets into riprap and water runs through this material before coming to the surface in the channel at the downstream end of this material. Tailwater control point was measured at the end of this placed material.

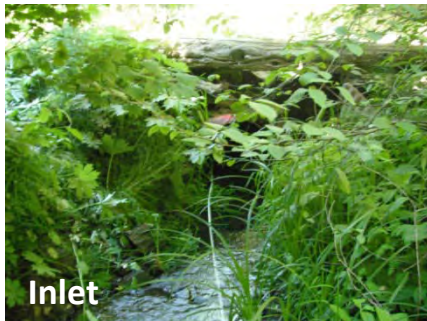
<b>Inlet</b>	
Shape	Circular	Inlet Gradient (%)		5.2			
Material	Corrugated metal	Upstream Gradient (%)		2.8			
Length (ft)	29	Bankfull Width (ft)		5.1			
Width (in)	36	Bankfull:Culvert Ratio		0.6			
Height (in)	36	According to ODF staff, this pipe is scheduled to be replaced in preparation for an upcoming timber sale.					
Outlet Perch (ft)	1.3						
Gradient (%)	2.3						
Rustline Height (in)	10						
Overall Condition	Poor						
PRIORITIZATION ANALYSIS

Upstream Habitat Length (mi)		0.6	Habitat Points		2		
Habitat Quality		Good	Habitat Quality Points		3		
Fish Species		Anad.	Fish Points		3		
Barrier Class		Red	Barrier Points		3		
			Prioritization Total Points		11		
<b>Notes:</b> Inlet was badly damaged, resulting in an ~12 inch cascade into the pipe

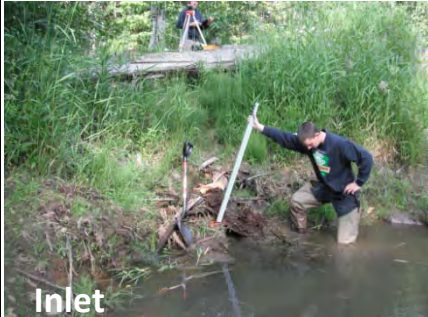
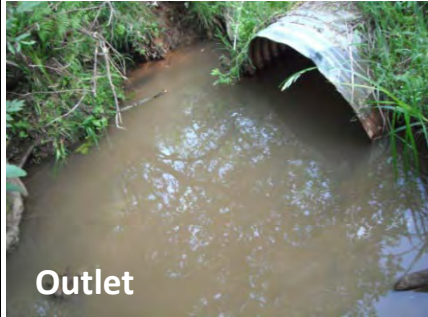
Shape	Circular	Inlet Gradient (%)	-31.8				
Material	Corrugated metal	Upstream Gradient (%)	0				
Length (ft)	34	Bankfull Width (ft)	44*				
Width (in)	48	Bankfull:Culvert Ratio	0.1				
Height (in)	48	According to ODF staff, this pipe is scheduled to be replaced in preparation for an upcoming timber sale.					
Outlet Perch (ft)	None						
Gradient (%)	8.3						
Rustline Height (in)	42						
Overall Condition	Critical						
PRIORITIZATION ANALYSIS

Habitat Quality	Good	Habitat Quality Points	3				
Fish Species	Anad.	Fish Points	3				
Barrier Class	Red	Barrier Points	3				
		Prioritization Total Points	10				
<b>Notes:</b> Pipe barrel deformed and invert highly corroded. Inlet nearly completely blocked with wood and sediment. *Series of beaver ponds along this stream. Inlet drains one of these ponds, and the culvert blockage noted below likely due to beaver activities.

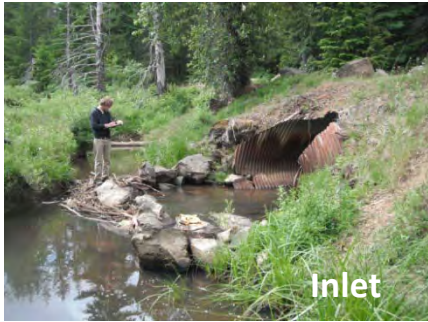
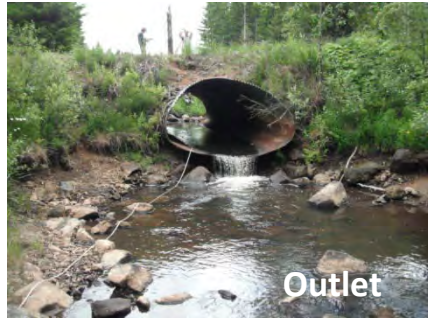
Shape	Pipe arch	Inlet Gradient (%)	-18.1				
Material	Corrugated metal	Upstream Gradient (%)	-1.1				
Length (ft)	50	Bankfull Width (ft)	13.2				
Width (in)	108	Bankfull:Culvert Ratio	0.7				
Height (in)	74						
Outlet Perch (ft)	2.0						
Gradient (%)	-0.2						
Rustline Height (in)	34						
Overall Condition	Poor

Barrier Class	Red	Barrier Points	3				
		Prioritization Total Points	10				
<b>Notes:</b> As of September 2012, this culvert has been replaced with a rail car bridge and this crossing no longer impedes fish passage.

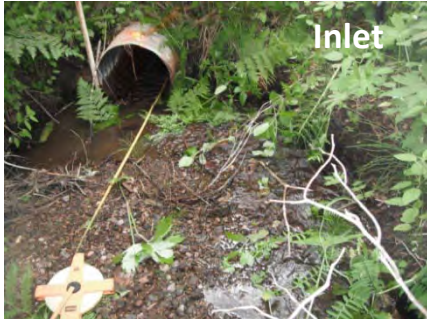
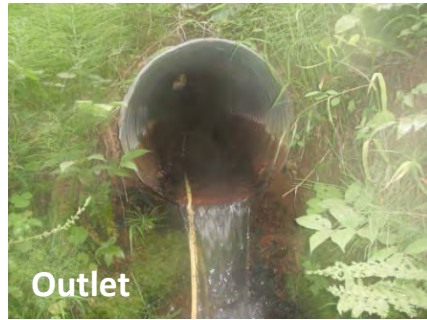
LOCATION INFO				Culvert #	246	Priority	L
Watershed				Wilson River			
Stream Name				Unnamed tributary of Devils Lake Fork Wilson River			
Township-Range-Section-1/4				T1N R5W, Sec. 5, NW¼ of NW¼			
UTM Easting/Northing (Zone 10, NAD 1983)				473811/5049357			
Road Name				OHV Trail off of Scoggins Creek Road			
Road/Culvert Owner				Oregon Department of Forestry			
Adjacent Landowners				Oregon Department of Forestry			
CULVERT INFO		CHANNEL INFO					
Shape		Circular	Inlet Gradient (%)	-15.0			
Material		Corrugated metal	Upstream Gradient (%)	8.5			
Length (ft)		34	Bankfull Width (ft)	4.4			
Width (in)		18	Bankfull:Culvert Ratio	0.3			
Height (in)		18					
Outlet Perch (ft)		2.6					
Gradient (%)		4.2					
Rustline Height (in)		8					
Overall Condition		Poor					
PRIORITIZATION ANALYSIS							
Upstream Habitat Length (mi)		0.1	Habitat Points		1		
Habitat Quality		Poor	Habitat Quality Points		1		
Fish Species		Anad.	Fish Points		3

Barrier Class		Red	Barrier Points		3		
			Prioritization Total Points		8		
<b>Notes:</b> This stream designated nonfish. However, it is a tributary to a known fishbearing stream and the lower portion appears to provide suitable habitat for fish. Thus, for this project we considered this stream as capable of supporting fish upstream to where it branches into two smaller headwater tributaries.
