**Kilchis River Basin
Culverts**

Kilchis Basin Crossings

Kilchis River Basin Clusters

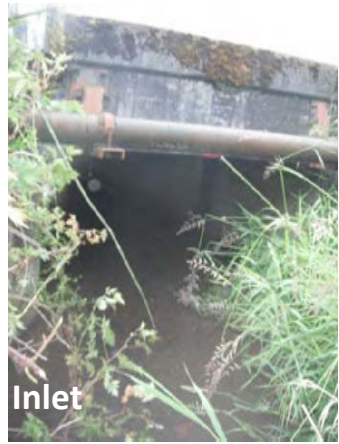
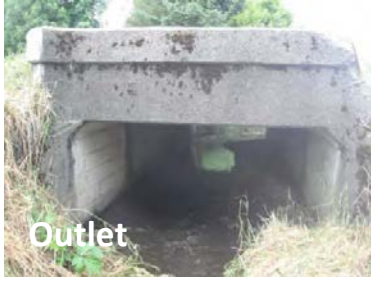
Notes: Upstream of this crossing Vaughn Creek passes through a golf course. Riparian and upland habitats are low-quality for fish and wildlife.

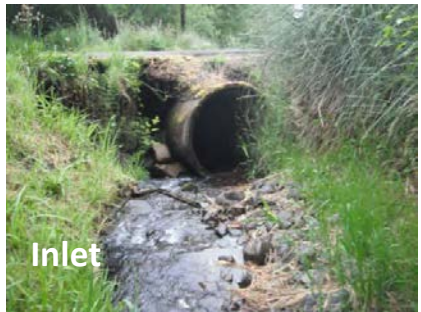
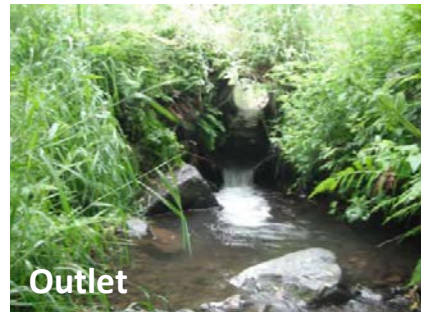
Shape	Circular	Inlet Gradient (%)	12.7				
Material	Concrete	Upstream Gradient (%)	7.2				
Length (ft)	34	Bankfull Width (ft)	7.4				
Width (in)	48	Bankfull:Culvert Ratio	0.5				
Height (in)	48						
Outlet Perch (ft)	0.8						
Slope (%)	5.9						
Rustline Height (in)	N/A						
Overall Condition	Fair						
PRIORITIZATION ANALYSIS							
Upstream Habitat Length (mi)	0.6	Habitat Points	2				
Habitat Quality	Fair(-)	Habitat Quality Points	2				
Fish Species	Anad.	Fish Points	3				
Barrier Type	Red	Barrier Points	3				
		Prioritization Total Points	10

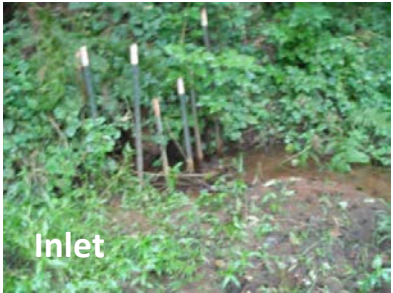
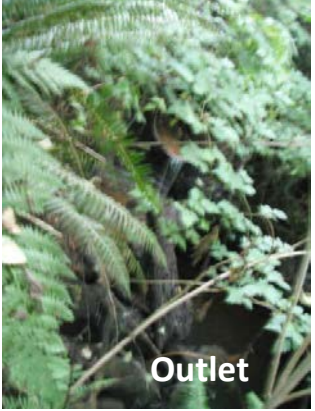
LOCATION INFO				Culvert #	674	Priority	M
Watershed		Kilchis River

Barrier Type	Red	Barrier Points	3				
		Prioritization Total Points	9				
Notes:

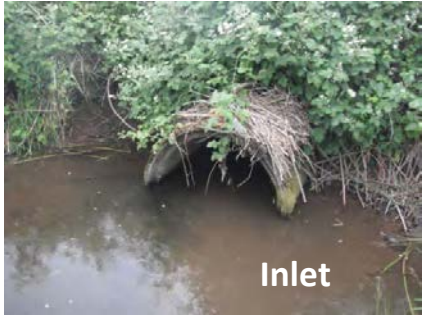
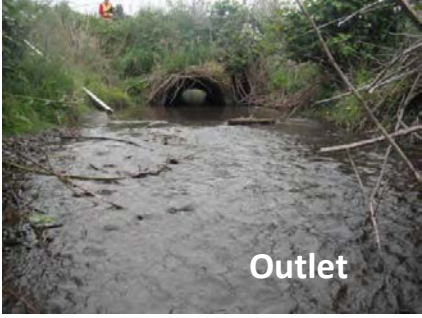
<p style="text-align: right; font-weight: bold;">Outlet</p>			
Shape	Circular	Inlet Gradient (%)	4.75				
Material	Concrete	Upstream Gradient (%)	0.2				
Length (ft)	40	Bankfull Width (ft)	6.0				
Width (in)	48	Bankfull:Culvert Ratio	0.7				
Height (in)	48						
Outlet Perch (ft)	None						
Slope (%)	-0.4						
Rustline Height (in)	n/a						
Overall Condition	Fair						
PRIORITIZATION ANALYSIS							
Upstream Habitat Length (mi)	2.0	Habitat Points	4				
Habitat Quality	Fair	Habitat Quality Points	2

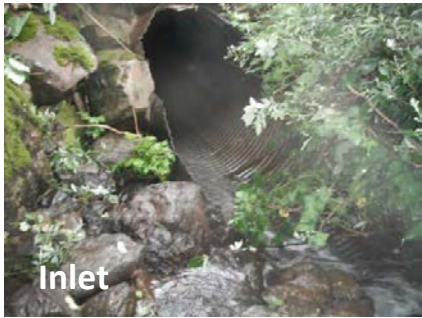
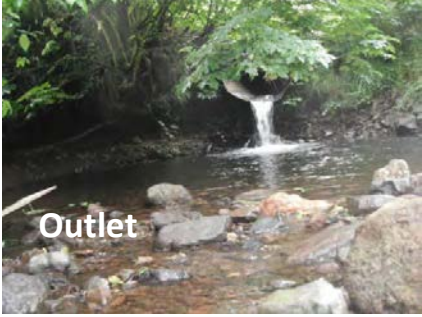
LOCATION INFO				Culvert #	591	Priority	H
Watershed		Kilchis River

Stream Name		Myrtle Creek					
Township-Range-Section-1/4		T1N, R9W, Sec. 32, SE¼ of SW¼					
UTM Easting/Northing (Zone 10, NAD 1983)		436198/5041562					
Road Name		Kilchis River Road					
Road/Culvert Owner		Tillamook County					
Adjacent Landowners		P. & M. Zweifel, Christensen Rock LLC					
CULVERT INFO		CHANNEL INFO					
Shape	Circular	Inlet Gradient (%)	13.3				
Material	Corrugated metal	Upstream Gradient (%)	3.5				
Length (ft)	41	Bankfull Width (ft)	12.8				
Width (in)	66	Bankfull:Culvert Ratio	0.4				
Height (in)	66						
Outlet Perch (ft)	3.7						
Slope (%)	3.3						
Rustline Height (in)	Entire pipe rusted						
Overall Condition	Poor						
PRIORITIZATION ANALYSIS

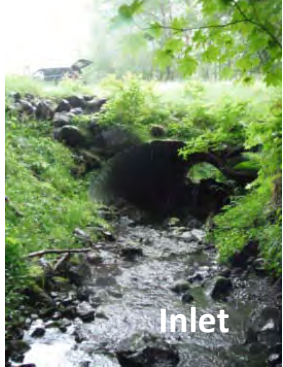
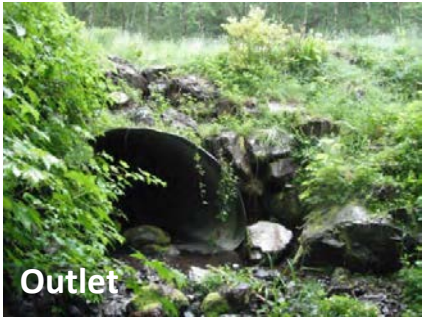
Shape	Pipe Arch	Inlet Gradient (%)	11.4						
Material	Corrugated metal	Upstream Gradient (%)	4.5						
Length (ft)	82	Bankfull Width (ft)	10.3						
Width (in)	144	Bankfull:Culvert Ratio	1.5						
Height (in)	90								
Outlet Perch (ft)	None								
Slope (%)	4.9								
Rustline Height (in)	N/A								
Overall Condition	Fair								
PRIORITIZATION ANALYSIS									
Upstream Habitat Length (mi)	0.4	Habitat Points	1						
Habitat Quality	Fair	Habitat Quality Points	2						
Fish Species	Anad.	Fish Points	3

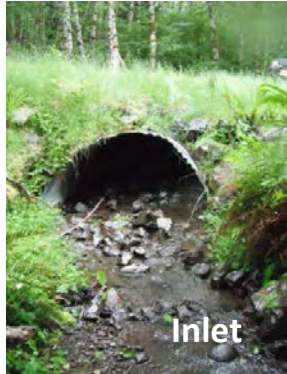
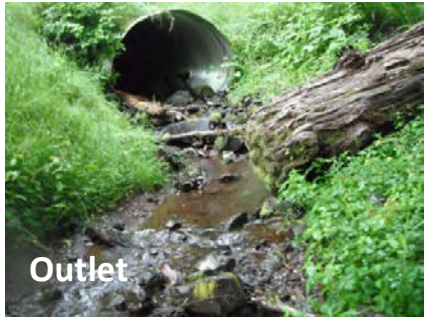
Shape	Pipe Arch	Inlet Gradient (%)	2.0						
Material	Corrugated metal	Upstream Gradient (%)	10.2						
Length (ft)	52	Bankfull Width (ft)	4.0						
Width (in)	96	Bankfull:Culvert Ratio	2.0						
Height (in)	72								
Outlet Perch (ft)	None								
Slope (%)	6.7								
Rustline Height (in)	6								
Overall Condition	Good								
PRIORITIZATION ANALYSIS									
Upstream Habitat Length (mi)	0.1	Habitat Points	1						
Habitat Quality	Poor	Habitat Quality Points	1						
Fish Species	Anad.	Fish Points	3

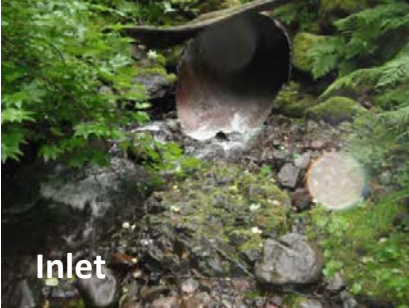
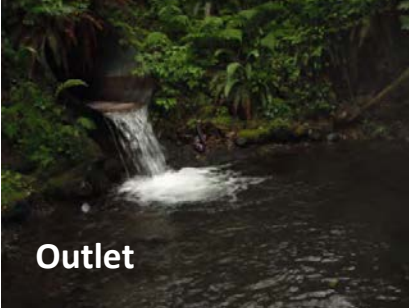
<p>Outlet</p>			
Shape	Circular	Inlet Gradient (%)	20.2				
Material	Corrugated metal	Upstream Gradient (%)	13.3				
Length (ft)	100	Bankfull Width (ft)	10.3				
Width (in)	60	Bankfull:Culvert Ratio	0.5				
Height (in)	60						
Outlet Perch (ft)	2.5						
Slope (%)	4.0						
Rustline Height (in)	42						
Overall Condition	Fair						
PRIORITIZATION ANALYSIS							
Upstream Habitat Length (mi)	0.5	Habitat Points	1				
Habitat Quality	Fair	Habitat Quality Points	2				
Fish Species	Anad.	Fish Points	3

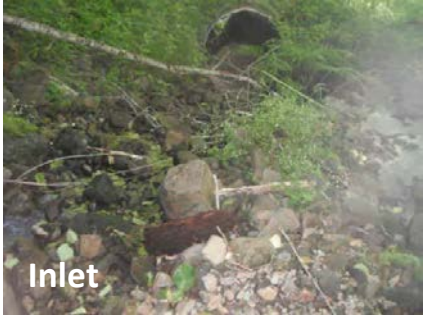
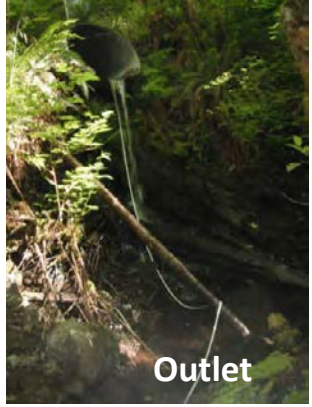
Stream Name		Tributary of Schroeder Creek					
Township-Range-Section-1/4		T2N, R8W, Sec. 30, NW¼ of SE¼					
UTM Easting/Northing (Zone 10, NAD 1983)		444731/5052521					
Road Name		Miami Divide Road					
Road/Culvert Owner		Oregon Department of Forestry					
Adjacent Landowners		Oregon Department of Forestry					
CULVERT INFO		CHANNEL INFO					
Shape	Circular	Inlet Gradient (%)	15.8				
Material	Corrugated Metal	Upstream Gradient (%)	6.9				
Length (ft)	46	Bankfull Width (ft)	4				
Width (in)	48	Bankfull:Culvert Ratio	1.0				
Height (in)	48						
Outlet Perch (ft)	9.8						
Slope (%)	6.8						
Rustline Height (in)	16						
Overall Condition	Fair						
PRIORITIZATION ANALYSIS							
Upstream Habitat Length (mi)	0.3	Habitat Points	1				
Habitat Quality	Poor	Habitat Quality Points	1				
Fish Species	Anad.	Fish Points	3				
Barrier Class	Red	Barrier Points	3

Prioritization Total Points	8				
Notes:

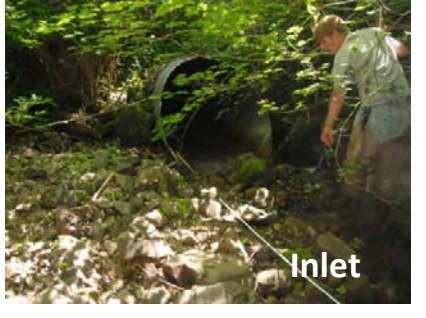
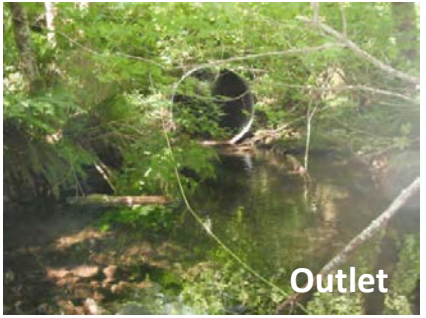
LOCATION INFO				Culvert #	181	Priority	M
Watershed		Tillamook Bay

Stream Name		Unnamed tributary of N. Fork Kilchis River					
Township-Range-Section-1/4		T2N, R8W, Sec. 34, SW¼ of SW¼					
UTM Easting/Northing (Zone 10, NAD 1983)		448643/ 5050834					
Road Name		Kilchis Forest Road					
Road/Culvert Owner		Oregon Department of Forestry					
Adjacent Landowners		Oregon Department of Forestry					
CULVERT INFO		CHANNEL INFO					
Shape	Circular	Inlet Gradient (%)	23.5				
Material	Corrugated Metal	Upstream Gradient (%)	5.3				
Length (ft)	51	Bankfull Width (ft)	8.2				
Width (in)	66	Bankfull:Culvert Ratio	0.7				
Height (in)	66						
Outlet Perch (ft)	0.1						
Slope (%)	7.1						
Rustline Height (in)	18						
Overall Condition	Good						
PRIORITIZATION ANALYSIS							
Upstream Habitat Length (mi)	0.5	Habitat Points	1				
Habitat Quality	Fair	Habitat Quality Points	2				
Fish Species	Anad.	Fish Points	3

Barrier Class	Red	Barrier Points	3				
		Prioritization Total Points	9				
Notes:
