**Miami River Basin  
Culverts**

### Miami River Basin Clusters

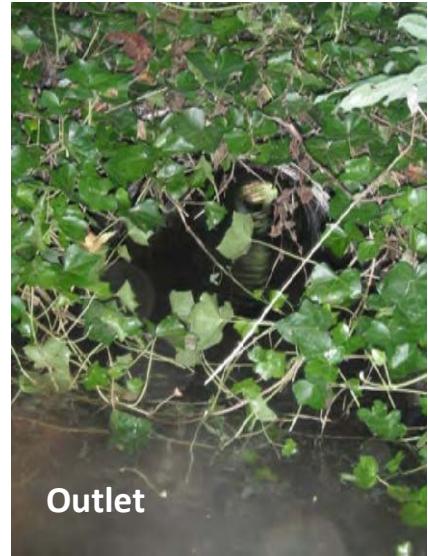
LOCATION INFO				Culvert #	352	Priority	H
Watershed		Miami River					
Stream Name		Waldron Creek					
Township-Range-Section-1/4		T1N, R10W, Sec. 11, SE $\frac{1}{4}$ of NW $\frac{1}{4}$					
UTM Easting/Northing (Zone 10, NAD 1983)		431665/5048197					
Road Name		Miami Foley Road					
Road/Culvert Owner		Tillamook County					
Adjacent Landowners		E. Waldron					
CULVERT INFO		CHANNEL INFO					
Shape	Circular	Inlet Gradient (%)	8.7				
Material	Concrete	Upstream Gradient (%)	3.4				
Length (ft)	52	Bankfull Width (ft)	8.5				
Width (in)	36	Bankfull:Culvert Ratio	0.4				
Height (in)	36						
Outlet Perch (ft)	None						
Slope (%)	2.5						
Rustline Height (in)	18						
Overall Condition	Fair						
PRIORITIZATION ANALYSIS							
Upstream Habitat Length (mi)	0.7	Habitat Points	2				
Habitat Quality	Fair	Habitat Quality Points	2				
Fish Species	Anad.	Fish Points	3				
Barrier Class	Red	Barrier Points	3				
		Prioritization Total Points	10

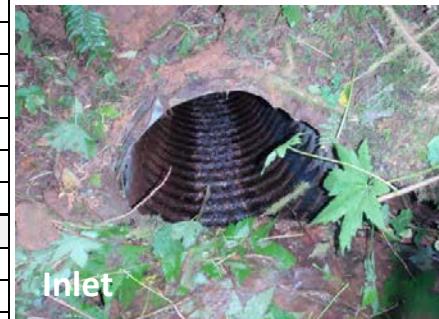
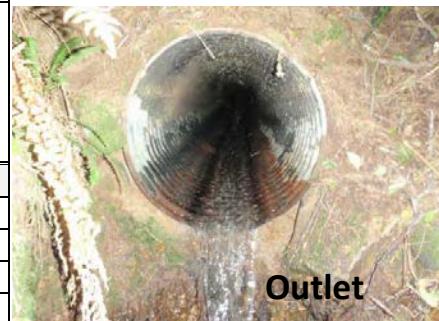
LOCATION INFO				Culvert #	273	Priority	M
Watershed		Miami River					
Stream Name		Unnamed tributary of Minich Creek					
Township-Range-Section-1/4		T1N, R10W, Sec. 10, NE $\frac{1}{4}$ of NE $\frac{1}{4}$					
UTM Easting/Northing (Zone 10, NAD 1983)		430996/5048047					
Road Name		Minich Creek Road					
Road/Culvert Owner		Oregon Department of Forestry					
Adjacent Landowners		Stimson Lumber Company					
CULVERT INFO		CHANNEL INFO					
Shape	Circular	Inlet Gradient (%)	7.0				
Material	Corrugated metal	Upstream Gradient (%)	9.0				
Length (ft)	61	Bankfull Width (ft)	9.6				
Width (in)	24	Bankfull:Culvert Ratio	0.2				
Height (in)	24						
Outlet Perch (ft)	1.8						
Slope (%)	7.0						
Rustline Height (in)	14						
Overall Condition	Fair						
PRIORITIZATION ANALYSIS							
Upstream Habitat Length (mi)	0.2	Habitat Points	1				
Habitat Quality	Fair	Habitat Quality Points	2				
Fish Species	Anad.	Fish Points	3

Barrier Class	Red	Barrier Points	3				
		Prioritization Total Points	9				
Notes:

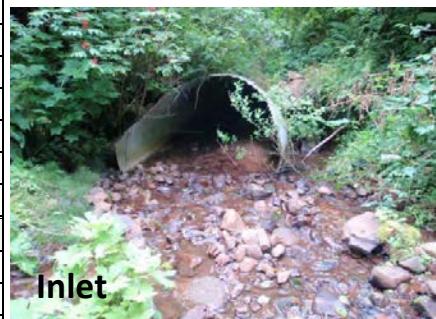
LOCATION INFO				Culvert #	279	Priority	L
<b>Watershed</b>		Miami River					
<b>Stream Name</b>		Unnamed tributary of Minich Creek					
<b>Township-Range-Section-1/4</b>		T1N, R11W, Sec. 10, NW $\frac{1}{4}$ of NW $\frac{1}{4}$					
<b>UTM Easting/Northing (Zone 10, NAD 1983)</b>		431186/5048972					
<b>Road Name</b>		Minich Creek Road					
<b>Road/Culvert Owner</b>		Oregon Department of Forestry					
<b>Adjacent Landowners</b>		Oregon Department of Forestry					
CULVERT INFO		CHANNEL INFO					
Shape	Pipe arch	Inlet Gradient (%)	26.0				
Material	Corrugated metal	Upstream Gradient (%)	10.0				
Length (ft)	60	Bankfull Width (ft)	7.0				
Width (in)	97	Bankfull:Culvert Ratio	1.16				
Height (in)	70						
Outlet Perch (ft)	None						
Slope (%)	2.0						
Rustline Height (in)	12						
Overall Condition	Fair						
PRIORITIZATION ANALYSIS							
Upstream Habitat Length (mi)	0.6	Habitat Points	2				
Habitat Quality	Fair	Habitat Quality Points	2

Fish Species	Anad.	Fish Points	3				
Barrier Class	Green	Barrier Points	1				
		Prioritization Total Points	8				
Notes:

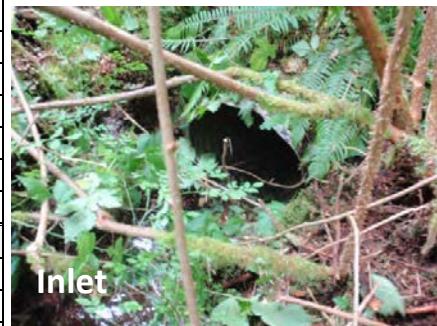
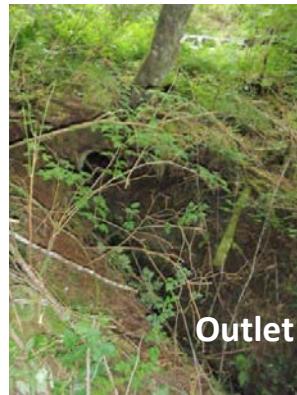
LOCATION INFO			Culvert #	320	Priority	H
Watershed		Miami River				
Stream Name		Minich Creek				
Township-Range-Section-1/4		T1N, R11W, Sec. 10, SE 1/4 of NE 1/4				
UTM Easting/Northing (Zone 10, NAD 1983)				431133/5048601		
Road Name		Minich Creek Road				
Road/Culvert Owner		Oregon Department of Forestry				
Adjacent Landowners		Oregon Department of Forestry				
CULVERT INFO		CHANNEL INFO				
Shape	Circular	Inlet Gradient (%)	2.0			
Material	Corrugated metal	Upstream Gradient (%)	2.5			
Length (ft)	68	Bankfull Width (ft)	6.6			
Width (in)	18	Bankfull:Culvert Ratio	0.2			
Height (in)	18					
Outlet Perch (ft)	6.8					
Slope (%)	7.0					
Rustline Height (in)	N/A					
Overall Condition	Poor					
PRIORITIZATION ANALYSIS						
Upstream Habitat Length (mi)	0.6	Habitat Points	2			
Habitat Quality	Fair	Habitat Quality Points	2			
Fish Species	Anad.	Fish Points	3			
Barrier Class	Red	Barrier Points	3			
		Prioritization Total Points	10

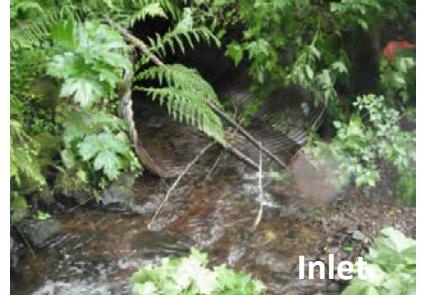
LOCATION INFO				Culvert #	138	Priority	H
Watershed		Miami River					
Stream Name		Prouty Creek					
Township-Range-Section-1/4		T2N, R10W, Sec. 36, NW $\frac{1}{4}$ of NE $\frac{1}{4}$					
UTM Easting/Northing (Zone 10, NAD 1983)		433364/5032149					
Road Name		Miami Forest River Road					
Road/Culvert Owner		Private Drive with Oregon Dept. of Forestry Easement					
Adjacent Landowners		State of Oregon and E. Frantz					
CULVERT INFO		CHANNEL INFO					
Shape	Pipe Arch	Inlet Gradient (%)	7.3				
Material	Corrugated metal	Upstream Gradient (%)	1.8				
Length (ft)	45	Bankfull Width (ft)	9.5				
Width (in)	110	Bankfull:Culvert Ratio	1.0				
Height (in)	82						
Outlet Perch (ft)	0.2						
Slope (%)	3.8						
Rustline Height (in)	18						
Overall Condition	Fair						
PRIORITIZATION ANALYSIS							
Upstream Habitat Length (mi)	1.1	Habitat Points	3				
Habitat Quality	Good	Habitat Quality Points	3				
Fish Species	Anad.	Fish Points	3

Barrier Class	Red	Barrier Points	3				
		Prioritization Total Points	12				
Notes:

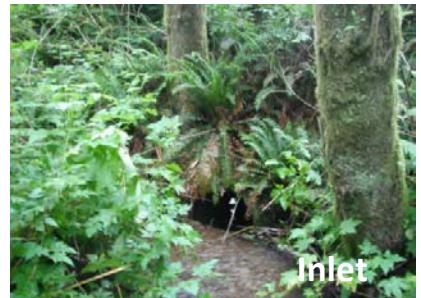
LOCATION INFO				Culvert #	126	Priority	M
Watershed		Miami River					
Stream Name		Carver Creek					
Township-Range-Section-1/4		T2N, R10W, Sec. 25, SE $\frac{1}{4}$ of SW $\frac{1}{4}$					
UTM Easting/Northing (Zone 10, NAD 1983)		433224/5052341					
Road Name		Miami Foley Road					
Road/Culvert Owner		Tillamook County					
Adjacent Landowners		N. Carver, W. Scholerman, W. Staben					
CULVERT INFO		CHANNEL INFO					
Shape	Circular	Inlet Gradient (%)	18.6				
Material	Concrete	Upstream Gradient (%)	4.2				
Length (ft)	91	Bankfull Width (ft)	7.4				
Width (in)	36	Bankfull:Culvert Ratio	0.4				
Height (in)	36						
Outlet Perch (ft)	2.2						
Slope (%)	3.1						
Rustline Height (in)	N/A						
Overall Condition	Poor						
PRIORITIZATION ANALYSIS							
Upstream Habitat Length (mi)	0.2	Habitat Points	1				
Habitat Quality	Fair	Habitat Quality Points	2				
Fish Species	Anad.	Fish Points	3				
Barrier Class	Red	Barrier Points	3

Prioritization Total Points	9				
Notes:

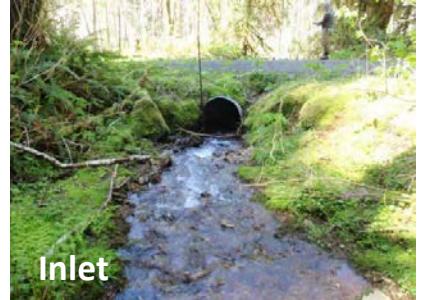
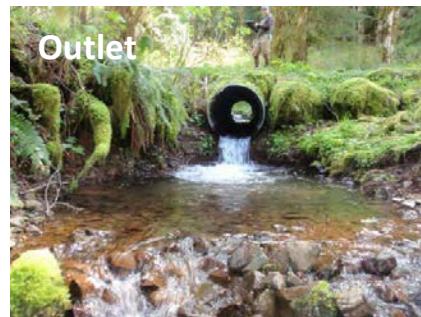
LOCATION INFO				Culvert #	115	Priority	L
Watershed		Miami River					
Stream Name		Unnamed tributary of Miami River					
Township-Range-Section-1/4		T2N, R9W, Sec. 29, SE $\frac{1}{4}$ of NW $\frac{1}{4}$					
UTM Easting/Northing (Zone 10, NAD 1983)			436328/5052920				
Road Name		Miami Forest River Road					
Road/Culvert Owner		Oregon Dept. of Forestry					
Adjacent Landowners		Oregon Department of Forestry					
CULVERT INFO		CHANNEL INFO					
Shape	Circular	Inlet Gradient (%)	9.2				
Material	Corrugated metal	Upstream Gradient (%)	6.9				
Length (ft)	30	Bankfull Width (ft)	7.6				
Width (in)	36	Bankfull:Culvert Ratio	0.4				
Height (in)	36						
Outlet Perch (ft)	1.6						
Slope (%)	4.4						
Rustline Height (in)	14						
Overall Condition	Fair						
PRIORITIZATION ANALYSIS							
Upstream Habitat Length (mi)	0.1	Habitat Points	1				
Habitat Quality	Poor	Habitat Quality Points	1				
Fish Species	Anad.	Fish Points	3

Barrier Class	Red	Barrier Points	3				
		Prioritization Total Points	8				
Notes:

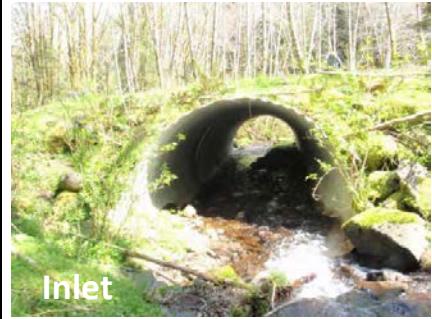
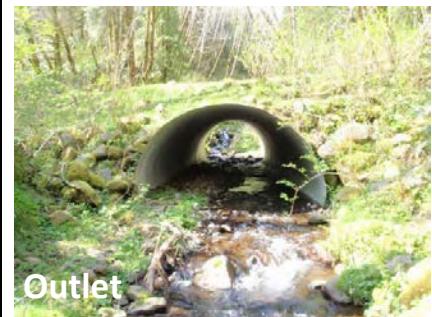
LOCATION INFO				Culvert #	93	Priority	NA
Watershed		Miami River					
Stream Name		Unnamed tributary to Miami River					
Township-Range-Section-1/4		T2N, R9W, Sec. 21, NW $\frac{1}{4}$ of SW $\frac{1}{4}$					
UTM Easting/Northing (Zone 10, NAD 1983)			438027/5054143				
Road Name		Miami Forest River Road					
Road/Culvert Owner		Oregon Dept. of Forestry					
Adjacent Landowners		Oregon Department of Forestry					
CULVERT INFO		CHANNEL INFO					
Shape	Pipe Arch	Inlet Gradient (%)	0.1				
Material	Corrugated metal	Upstream Gradient (%)	15.6				
Length (ft)	55	Bankfull Width (ft)	9.4				
Width (in)	120	Bankfull:Culvert Ratio	1.3				
Height (in)	96						
Outlet Perch (ft)	None						
Slope (%)	4.5						
Rustline Height (in)	N/A						
Overall Condition	Good						
PRIORITIZATION ANALYSIS							
Upstream Habitat Length (mi)	0.2	Habitat Points	1				
Habitat Quality	Poor	Habitat Quality Points	1				
Fish Species	Anad.	Fish Points	3

Barrier Class	Green	Barrier Points	1				
		Prioritization Total Points	6				
Notes:

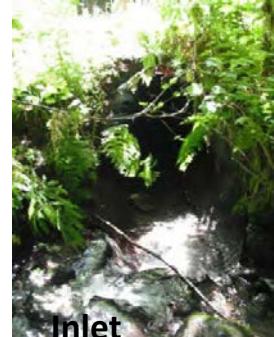
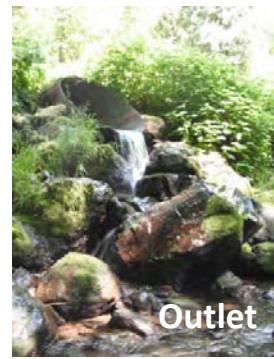
LOCATION INFO				Culvert #	5101	Priority	L				
<b>Watershed</b>		Miami River									
<b>Stream Name</b>		Unnamed tributary to Miami River									
<b>Township-Range-Section-1/4</b>		T2N, R9W, Sec. 15, SE $\frac{1}{4}$ of SW $\frac{1}{4}$									
<b>UTM Easting/Northing (Zone 10, NAD 1983)</b>		439759/5054992									
<b>Road Name</b>		Miami Forest River Road									
<b>Road/Culvert Owner</b>		Oregon Dept. of Forestry									
<b>Adjacent Landowners</b>		Oregon Department of Forestry									
CULVERT INFO		CHANNEL INFO									
<b>Shape</b>	Circular	<b>Inlet Gradient (%)</b>	12.5								
<b>Material</b>	Corrugated metal	<b>Upstream Gradient (%)</b>	14.3								
<b>Length (ft)</b>	42	<b>Bankfull Width (ft)</b>	9.0								
<b>Width (in)</b>	60	<b>Bankfull:Culvert Ratio</b>	0.6								
<b>Height (in)</b>	60										
<b>Outlet Perch (ft)</b>	7.2										
<b>Slope (%)</b>	1.8										
<b>Rustline Height (in)</b>	24

<b>Overall Condition</b>	Fair										
PRIORITIZATION ANALYSIS											
<b>Upstream Habitat Length (mi)</b>	0.1	<b>Habitat Points</b>	1								
<b>Habitat Quality</b>	Poor	<b>Habitat Quality Points</b>	1								
<b>Fish Species</b>	Anad.	<b>Fish Points</b>	3								
<b>Barrier Class</b>	Red	<b>Barrier Points</b>	3								
		<b>Prioritization Total Points</b>	8								
<b>Notes:</b>

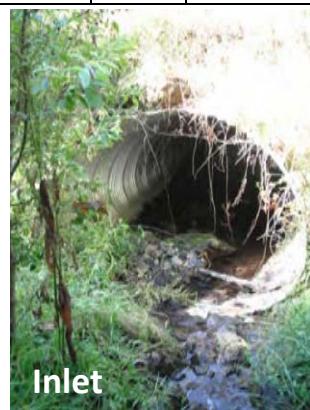
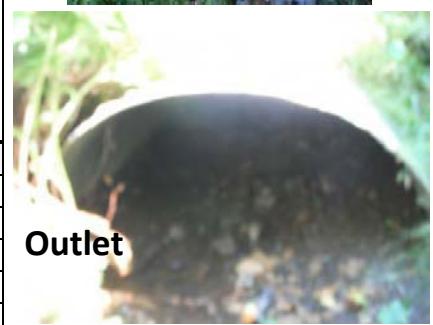
LOCATION INFO				Culvert #	87	Priority	L				
<b>Watershed</b>		Miami River									
<b>Stream Name</b>		Unnamed tributary to Miami River									
<b>Township-Range-Section-1/4</b>		T2N, R9W, Sec. 21, NW $\frac{1}{4}$ of SW $\frac{1}{4}$									
<b>UTM Easting/Northing (Zone 10, NAD 1983)</b>		440590/5054528									
<b>Road Name</b>		Miami Forest River Road									
<b>Road/Culvert Owner</b>		Oregon Dept. of Forestry									
<b>Adjacent Landowners</b>		Oregon Department of Forestry									
CULVERT INFO		CHANNEL INFO									
<b>Shape</b>	Pipe Arch	<b>Inlet Gradient (%)</b>	34.1								
<b>Material</b>	Corrugated metal	<b>Upstream Gradient (%)</b>	19.4								
<b>Length (ft)</b>	61	<b>Bankfull Width (ft)</b>	5.2								
<b>Width (in)</b>	104	<b>Bankfull:Culvert Ratio</b>	1.7								
<b>Height (in)</b>	66										
<b>Outlet Perch (ft)</b>	0.4										
<b>Slope (%)</b>	3.3										
<b>Rustline Height (in)</b>	4

<b>Overall Condition</b>	Good										
PRIORITIZATION ANALYSIS											
<b>Upstream Habitat Length (mi)</b>	0.1	<b>Habitat Points</b>	1								
<b>Habitat Quality</b>	Poor	<b>Habitat Quality Points</b>	1								
<b>Fish Species</b>	Anad.	<b>Fish Points</b>	3								
<b>Barrier Class</b>	Red	<b>Barrier Points</b>	3								
		<b>Prioritization Total Points</b>	8								
<b>Notes:</b>
