**Tillamook Bay Tributaries  
Culverts**

Tillamook Bay Tributaries Crossings

## **North Tillamook Bay Tributaries Culverts**

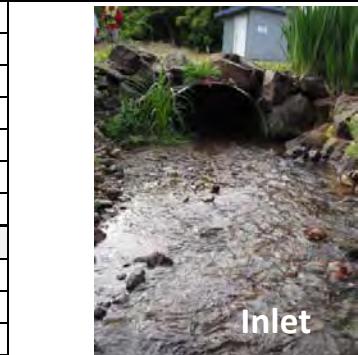
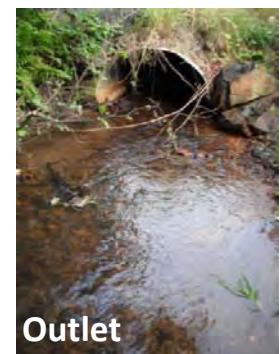
LOCATION INFO				Culvert #	5301	Priority	L				
Watershed				Tillamook Bay							
Stream Name				Whitney Creek							
Township-Range-Section-1/4				T1N, R10W, Sec. 22, NE <sup>1/4</sup> of NW <sup>1/4</sup>							
UTM Easting/Northing (Zone 10, NAD 1983)				429817/5045895							
Road Name				Arizona Way							
Road/Culvert Owner				City of Garibaldi							
Adjacent Landowners				D. Calliau and L. Godfrey							
CULVERT INFO		CHANNEL INFO									
Shape	Pipe arch	Inlet Gradient (%)	4.5								
Material	Corrugated metal	Upstream Gradient (%)	3.5								
Length (ft)	61	Bankfull Width (ft)	4.9								
Width (in)	42	Bankfull:Culvert Ratio	0.7								
Height (in)	30										
Outlet Perch (ft)	None										
Slope (%)	1.0										
Rustline Height (in)	9										
Overall Condition	Fair										
PRIORITIZATION ANALYSIS											
Upstream Habitat Length (mi)	0.4	Habitat Points	1								
Habitat Quality	Poor	Habitat Quality Points	1

Fish Species	Anad.	Fish Points	3								
Barrier Type	Gray	Barrier Points	2								
		Prioritization Total Points	7								
Notes:

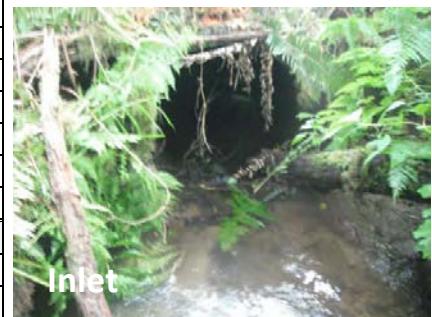
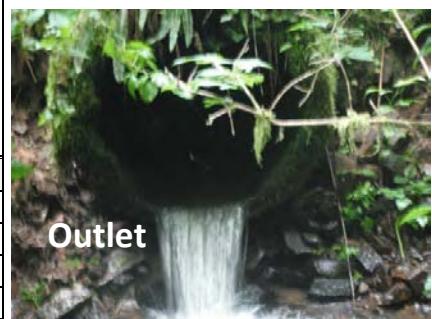
LOCATION INFO		Culvert #	559	Priority	M
Watershed	Tillamook Bay				
Stream Name	Larson Creek				
Township-Range-Section-1/4	T1N, R10W, Sec. 34, NE¼ of NE¼				
UTM Easting/Northing (Zone 10, NAD 1983)	430546/5042675				
Road Name	Old Bay City Road				
Road/Culvert Owner	Tillamook County				
Adjacent Landowners	Oregon Department of Forestry				
CULVERT INFO		CHANNEL INFO			
Shape	Circular	Inlet Gradient (%)	1.4		
Material	Concrete	Upstream Gradient (%)	0.4		
Length (ft)	55	Bankfull Width (ft)	3.6		
Width (in)	36	Bankfull:Culvert Ratio	0.8		
Height (in)	36				
Outlet Perch (ft)	1.5				
Slope (%)	1.8				
Rustline Height (in)	N/A				
Overall Condition	Poor				
PRIORITIZATION ANALYSIS					
Upstream Habitat Length (mi)	0.4	Habitat Points	1		
Habitat Quality	Fair	Habitat Quality Points	2		
Fish Species	Anad.	Fish Points	3		
Barrier Type	Red	Barrier Points	3		
		Prioritization Total Points	9		
Notes:

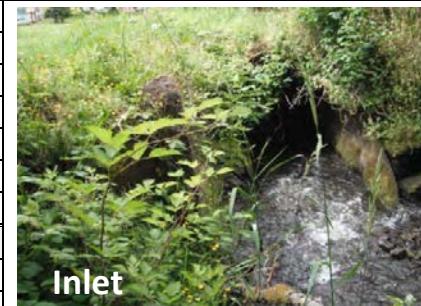
LOCATION INFO				Culvert #	579	Priority	H
Watershed		Tillamook Bay					
Stream Name		Patterson Creek					
Township-Range-Section-1/4		T1N, R10W, Sec. 22, NW $\frac{1}{4}$ of NW $\frac{1}{4}$					
UTM Easting/Northing (Zone 10, NAD 1983)		430484/5041795					
Road Name		4 <sup>th</sup> Street					
Road/Culvert Owner		City of Bay City					
Adjacent Landowners		City of Bay City, B.&C. Scovel					
CULVERT INFO		CHANNEL INFO					
Shape	Circular	Inlet Gradient (%)	7.6				
Material	Corrugated Metal	Upstream Gradient (%)	1.9				
Length (ft)	97	Bankfull Width (ft)	11.4				
Width (in)	72	Bankfull:Culvert Ratio	0.5				
Height (in)	72						
Outlet Perch (ft)	None						
Slope (%)	1.6						
Rustline Height (in)	33						
Overall Condition	Fair						
PRIORITIZATION ANALYSIS							
Upstream Habitat Length (mi)	3.7	Habitat Points	4				
Habitat Quality	Fair(-)	Habitat Quality Points	2				
Fish Species	Anad.	Fish Points	3				
Barrier Class	Gray	Barrier Points	2

Prioritization Total Points	11				
<p><b>Notes:</b></p>

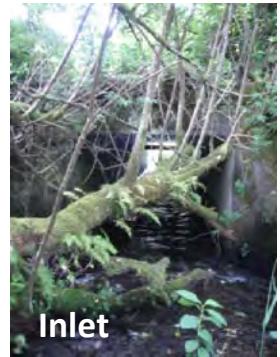
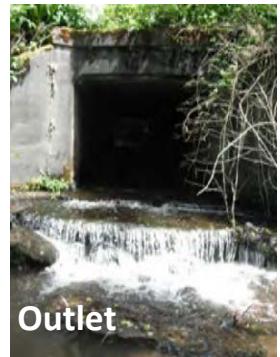
LOCATION INFO				Culvert #	578	Priority	H
Watershed			Tillamook Bay				
Stream Name			Patterson Creek				
Township-Range-Section-1/4			T1N, R10W, Sec. 35, SE $\frac{1}{4}$ of NW $\frac{1}{4}$				
UTM Easting/Northing (Zone 10, NAD 1983)			430568/5041806				
Road Name			5 <sup>th</sup> Street				
Road/Culvert Owner			City of Bay City				
Adjacent Landowners			A & E. Troyer, A. Harris, J. Fullan				
CULVERT INFO		CHANNEL INFO					
Shape	Box	Inlet Gradient (%)	4.2				
Material	Concrete	Upstream Gradient (%)	10				
Length (ft)	71	Bankfull Width (ft)	15.0				
Width (in)	96	Bankfull:Culvert Ratio	0.5				
Height (in)	72						
Outlet Perch (ft)	1.8						
Slope (%)	0.5						
Rustline Height (in)	24						
Overall Condition	Fair						
PRIORITIZATION ANALYSIS							
Upstream Habitat Length (mi)	3.6	Habitat Points	4				
Habitat Quality	Fair(-)	Habitat Quality Points	2				
Fish Species	Anad.	Fish Points	3				
Barrier Class	Red	Barrier Points	3

Prioritization Total Points	12				
Notes:

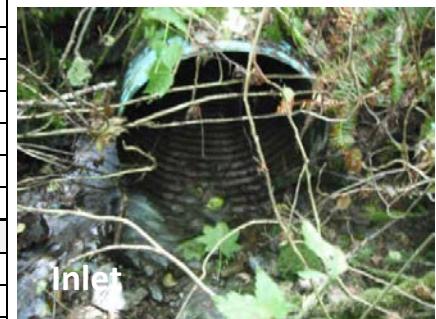
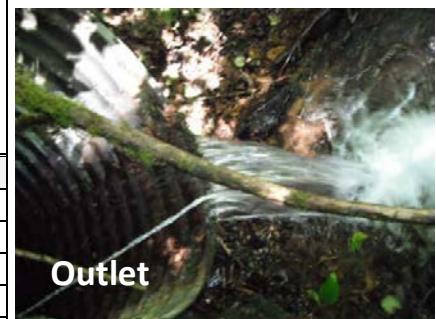
LOCATION INFO				Culvert #	528	Priority	L
Watershed		Tillamook Bay					
Stream Name		Patterson Creek					
Township-Range-Section-1/4		T1N, R10W, Sec. 26, NW $\frac{1}{4}$ of SE $\frac{1}{4}$					
UTM Easting/Northing (Zone 10, NAD 1983)		432101/5043624					
Road Name		Patterson Creek Road					
Road/Culvert Owner		Oregon Department of Forestry					
Adjacent Landowners		Oregon Department of Forestry					
CULVERT INFO		CHANNEL INFO					
Shape	Circular	Inlet Gradient (%)	4.0				
Material	Corrugated metal	Upstream Gradient (%)	3.5				
Length (ft)	74	Bankfull Width (ft)	6.9				
Width (in)	36	Bankfull:Culvert Ratio	0.4				
Height (in)	36						
Outlet Perch (ft)	2.2						
Slope (%)	2.0						
Rustline Height (in)	16						
Overall Condition	Poor						
PRIORITIZATION ANALYSIS							
Upstream Habitat Length (mi)	0.1	Habitat Points	1				
Habitat Quality	Poor	Habitat Quality Points	1				
Fish Species	Anad.	Fish Points	3

Barrier Type	Red	Barrier Points	3				
		Prioritization Total Points	8				
Notes:

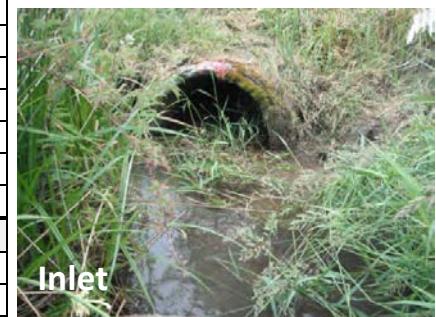
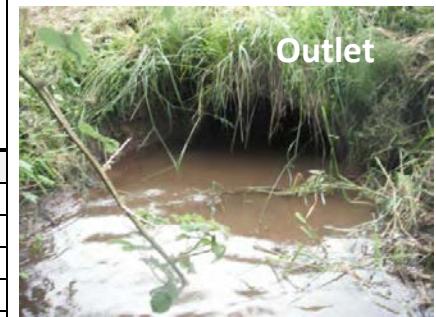
LOCATION INFO			Culvert #	637	Priority	H
Watershed		Kilchis River				
Stream Name		Doty Creek				
Township-Range-Section-1/4		T1S, R10W, Sec. 2, SE $\frac{1}{4}$ of SE $\frac{1}{4}$				
UTM Easting/Northing (Zone 10, NAD 1983)		432147/5040015				
Road Name		Alderbrook Loop Road				
Road/Culvert Owner		Tillamook County				
Adjacent Landowners		L.&C. Oswald, D.&C. Phillips, and J. Johnson				
CULVERT INFO		CHANNEL INFO				
Shape	Circular	Inlet Gradient (%)	13.6			
Material	Concrete	Upstream Gradient (%)	0.15			
Length (ft)	41	Bankfull Width (ft)	6.8			
Width (in)	36	Bankfull:Culvert Ratio	0.4			
Height (in)	36					
Outlet Perch (ft)	0.1					
Slope (%)	0.1					
Rustline Height (in)	N/A					
Overall Condition	Fair					
PRIORITIZATION ANALYSIS						
Upstream Habitat Length (mi)	1.4	Habitat Points	3			
Habitat Quality	Fair	Habitat Quality Points	2			
Fish Species	Anad.	Fish Points	3			
Barrier Type	Gray	Barrier Points	2

Prioritization Total Points	10			
Notes:

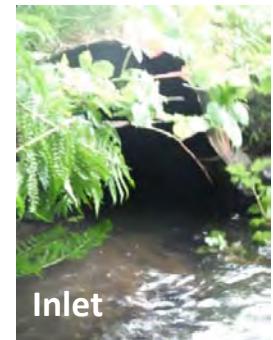
LOCATION INFO				Culvert #	613	Priority	M
<b>Watershed</b>		Tillamook Bay					
<b>Stream Name</b>		Doty Creek					
<b>Township-Range-Section-1/4</b>		T1S, R10W, Sec. 1, NW <sup>1/4</sup> of NW <sup>1/4</sup>					
<b>UTM Easting/Northing</b> (Zone 10, NAD 1983)		432729/5040868					
<b>Road Name</b>		Doughty Road					
<b>Road/Culvert Owner</b>		Tillamook County					
<b>Adjacent Landowners</b>		R. Rasmussen, Alderbrook Hills, W.&D. Collum					
CULVERT INFO			CHANNEL INFO				
<b>Shape</b>	Circular		<b>Inlet Gradient (%)</b>	10.8			
<b>Material</b>	Corrugated metal		<b>Upstream Gradient (%)</b>	3.5			
<b>Length (ft)</b>	36		<b>Bankfull Width (ft)</b>	6.5			
<b>Width (in)</b>	46		<b>Bankfull:Culvert Ratio</b>	0.6			
<b>Height (in)</b>	46						
<b>Outlet Perch (ft)</b>	None						
<b>Slope (%)</b>	-1.1						
<b>Rustline Height (in)</b>	17						
<b>Overall Condition</b>	Fair						
PRIORITIZATION ANALYSIS							
<b>Upstream Habitat Length (mi)</b>	0.7		<b>Habitat Points</b>	2

<b>Habitat Quality</b>	Fair		<b>Habitat Quality Points</b>	2			
<b>Fish Species</b>	Anad.		<b>Fish Points</b>	3			
<b>Barrier Type</b>	Gray		<b>Barrier Points</b>	2			
			<b>Prioritization Total Points</b>	9			
<b>Notes:</b>

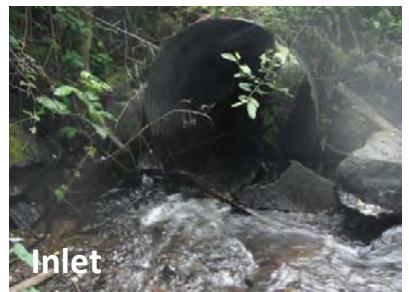
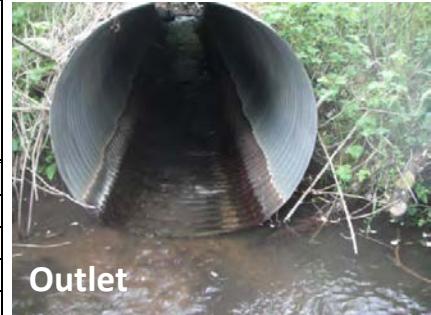
LOCATION INFO				Culvert #	605	Priority	M
<b>Watershed</b>		Tillamook Bay					
<b>Stream Name</b>		Doty Creek					
<b>Township-Range-Section-1/4</b>		T1N, R10W, Sec. 36, SE <sup>1/4</sup> of SW <sup>1/4</sup>					
<b>UTM Easting/Northing</b> (Zone 10, NAD 1983)		432768/5041048					
<b>Road Name</b>		Private Drive off Doughty Road					
<b>Road/Culvert Owner</b>		Oregon Department of Forestry					
<b>Adjacent Landowners</b>		Oregon Department of Forestry					
CULVERT INFO			CHANNEL INFO				
<b>Shape</b>	Circular		<b>Inlet Gradient (%)</b>	12.0			
<b>Material</b>	Corrugated metal		<b>Upstream Gradient (%)</b>	0.58			
<b>Length (ft)</b>	31		<b>Bankfull Width (ft)</b>	7.6			
<b>Width (in)</b>	48		<b>Bankfull:Culvert Ratio</b>	0.5			
<b>Height (in)</b>	48						
<b>Outlet Perch (ft)</b>	None						
<b>Slope (%)</b>	3.4						
<b>Rustline Height (in)</b>	20.4						
<b>Overall Condition</b>	Fair						
PRIORITIZATION ANALYSIS

<b>Upstream Habitat Length (mi)</b>	0.5		<b>Habitat Points</b>	1			
<b>Habitat Quality</b>	Fair		<b>Habitat Quality Points</b>	2			
<b>Fish Species</b>	Anad.		<b>Fish Points</b>	3			
<b>Barrier Type</b>	Red		<b>Barrier Points</b>	3			
			<b>Prioritization Total Points</b>	9			
<b>Notes:</b>

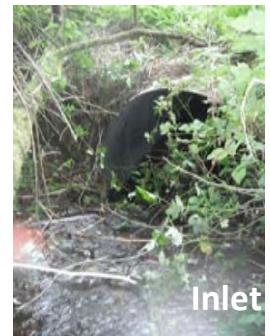
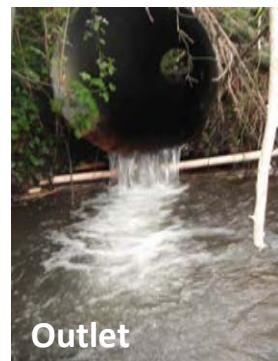
LOCATION INFO				Culvert #	599	Priority	M
Watershed		Tillamook Bay					
Stream Name		Doty Creek					
Township-Range-Section-1/4		T1N, R10W, Sec. 36, SE $\frac{1}{4}$ of SW $\frac{1}{4}$					
UTM Easting/Northing (Zone 10, NAD 1983)		432833/5041204					
Road Name		Timberline Drive					
Road/Culvert Owner		J.&S. Smith					
Adjacent Landowners		J.&S. Smith and P. Early					
CULVERT INFO		CHANNEL INFO					
Shape	Circular	Inlet Gradient (%)	18.1				
Material	Corrugated metal	Upstream Gradient (%)	3.1				
Length (ft)	40	Bankfull Width (ft)	9.0				
Width (in)	48	Bankfull:Culvert Ratio	0.4				
Height (in)	48						
Outlet Perch (ft)	0.9						
Slope (%)	1.2						
Rustline Height (in)	18						
Overall Condition	Good						
PRIORITIZATION ANALYSIS							
Upstream Habitat Length (mi)	0.4	Habitat Points	1				
Habitat Quality	Fair	Habitat Quality Points	2				
Fish Species	Anad.	Fish Points	3				
Barrier Type	Red	Barrier Points	3

Prioritization Total Points	9				
Notes:

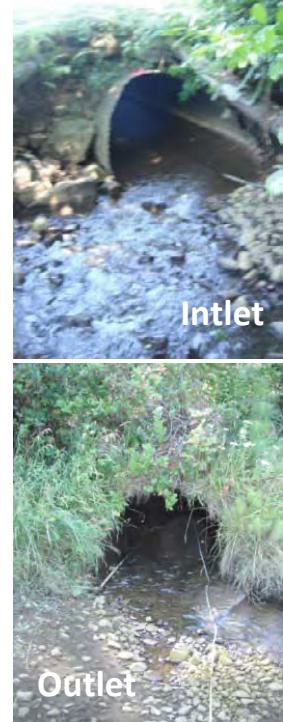
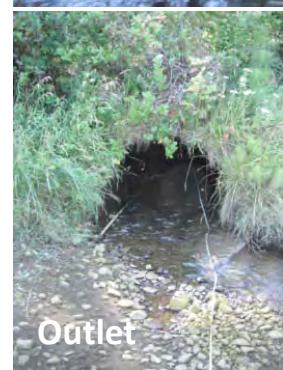
LOCATION INFO			Culvert #	778	Priority	L
Watershed		Tillamook Bay				
Stream Name		Dick Creek				
Township-Range-Section-1/4		T1S, R10W, Sec. 15, NW <sup>1/4</sup> of SW <sup>1/4</sup>				
UTM Easting/Northing (Zone 10, NAD 1983)		429330/5036881				
Road Name		Bayocean Road				
Road/Culvert Owner		Tillamook County				
Adjacent Landowners		J. Winter.				
CULVERT INFO		CHANNEL INFO				
Shape	Pipe Arch	Inlet Gradient (%)	1.5			
Material	Corrugated metal	Upstream Gradient (%)	3.8			
Length (ft)	44	Bankfull Width (ft)	11.4			
Width (in)	72	Bankfull:Culvert Ratio	0.5			
Height (in)	42					
Outlet Perch (ft)	Not measurable					
Slope (%)	2.1					
Rustline Height (in)	6					
Overall Condition	Poor					
PRIORITIZATION ANALYSIS						
Upstream Habitat Length (mi)	0.5	Habitat Points	1			
Habitat Quality	Fair	Habitat Quality Points	2			
Fish Species	Anad.	Fish Points	3			
Barrier Type	Gray	Barrier Points	2			
		Prioritization Total Points	8

Notes: Outlets directly into bay.

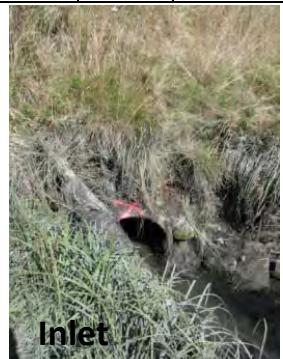
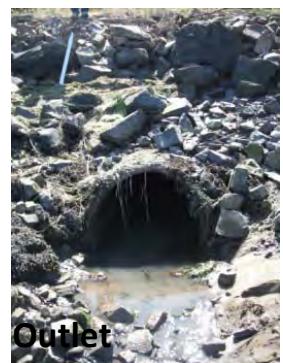
LOCATION INFO			Culvert #	757	Priority	L
Watershed		Tillamook Bay				
Stream Name		Unnamed Tributary near Bock Point				
Township-Range-Section-1/4		T1S, R10W, Sec. 16, SE <sup>1/4</sup> of NE <sup>1/4</sup>				
UTM Easting/Northing (Zone 10, NAD 1983)		429068/5037210				
Road Name		Bayocean Road				
Road/Culvert Owner		Tillamook County				
Adjacent Landowners		Stimson Lumber Co.				
CULVERT INFO		CHANNEL INFO				
Shape	Circular	Inlet Gradient (%)	15.3			
Material	Concrete	Upstream Gradient (%)	1.1			
Length (ft)	59	Bankfull Width (ft)	5.8			
Width (in)	36	Bankfull:Culvert Ratio	0.5			
Height (in)	36					
Outlet Perch (ft)	Not measurable					
Slope (%)	0.0					
Rustline Height (in)	12					
Overall Condition	Fair					
PRIORITIZATION ANALYSIS						
Upstream Habitat Length (mi)	0.3	Habitat Points	1			
Habitat Quality	Fair	Habitat Quality Points	2			
Fish Species	Anad.	Fish Points	3			
Barrier Type	Gray	Barrier Points	2

Prioritization Total Points	8			
Notes: Outlets directly into bay.

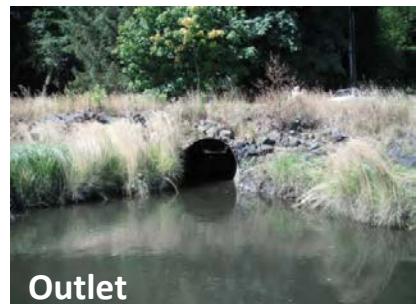
Outlet

LOCATION INFO				Culvert #	725	Priority	L				
<b>Watershed</b>		Tillamook Bay									
<b>Stream Name</b>		Unnamed Tributary at Boulder Point									
<b>Township-Range-Section-1/4</b>		T1S, R10W, Sec. 16, NE¼ of NW¼									
<b>UTM Easting/Northing (Zone 10, NAD 1983)</b>		428308/5037848									
<b>Road Name</b>		Bayocean Road									
<b>Road/Culvert Owner</b>		Tillamook County									
<b>Adjacent Landowners</b>		J. A. Johnson									
CULVERT INFO		CHANNEL INFO									
<b>Shape</b>	Circular	<b>Inlet Gradient (%)</b>	1.8								
<b>Material</b>	Corrugated metal	<b>Upstream Gradient (%)</b>	3.7								
<b>Length (ft)</b>	52	<b>Bankfull Width (ft)</b>	6.7								
<b>Width (in)</b>	72	<b>Bankfull:Culvert Ratio</b>	0.9								
<b>Height (in)</b>	72										
<b>Outlet Perch (ft)</b>	Not measurable										
<b>Slope (%)</b>	2.8										
<b>Rustline Height (in)</b>	30										
<b>Overall Condition</b>	Poor

PRIORITIZATION ANALYSIS											
<b>Upstream Habitat Length (mi)</b>	0.4	<b>Habitat Points</b>	1								
<b>Habitat Quality</b>	Fair	<b>Habitat Quality Points</b>	2								
<b>Fish Species</b>	Anad.	<b>Fish Points</b>	3								
<b>Barrier Class</b>	Gray	<b>Barrier Points</b>	2								
		<b>Prioritization Total Points</b>	8								
<b>Notes:</b> Outlets directly into bay.

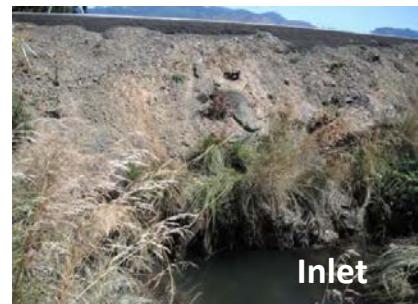
Inlet

LOCATION INFO				Culvert #	702	Priority	M				
<b>Watershed</b>		Tillamook Bay									
<b>Stream Name</b>		Unnamed tributary at McCoy Cove									
<b>Township-Range-Section-1/4</b>		T1S, R10W, Sec. 9, SE¼ of SW¼									
<b>UTM Easting/Northing (Zone 10, NAD 1983)</b>		428043/5038123									
<b>Road Name</b>		Bayocean Road									
<b>Road/Culvert Owner</b>		Tillamook County									
<b>Adjacent Landowners</b>		J. A. Johnson									
CULVERT INFO		CHANNEL INFO									
<b>Shape</b>	Circular	<b>Inlet Gradient (%)</b>	1.0								
<b>Material</b>	Concrete	<b>Upstream Gradient (%)</b>	0.5								
<b>Length (ft)</b>	48	<b>Bankfull Width (ft)</b>	9.3								
<b>Width (in)</b>	48	<b>Bankfull:Culvert Ratio</b>	0.4								
<b>Height (in)</b>	48										
<b>Outlet Perch (ft)</b>	Not measurable										
<b>Slope (%)</b>	0.2										
<b>Rustline Height (in)</b>	34										
<b>Overall Condition</b>	Fair

PRIORITIZATION ANALYSIS											
<b>Upstream Habitat Length (mi)</b>	0.9	<b>Habitat Points</b>	2								
<b>Habitat Quality</b>	Fair	<b>Habitat Quality Points</b>	2								
<b>Fish Species</b>	Anad.	<b>Fish Points</b>	3								
<b>Barrier Class</b>	Gray	<b>Barrier Points</b>	2								
		<b>Prioritization Total Points</b>	9								
<b>Notes:</b> Outlets directly into bay.

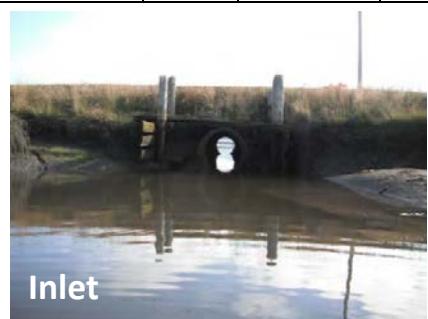
LOCATION INFO			Culvert #	689	Priority	H
Watershed		Tillamook Bay				
Stream Name		Flower Pot Creek				
Township-Range-Section-1/4		T1S, R10W, Sec. 8, SW $\frac{1}{4}$ of SE $\frac{1}{4}$				
UTM Easting/Northing (Zone 10, NAD 1983)		427301/5038583				
Road Name		Bayocean Road				
Road/Culvert Owner		Tillamook County				
Adjacent Landowners		Tillamook County				
CULVERT INFO		CHANNEL INFO				
Shape	Circular	Inlet Gradient (%)	0.2			
Material	Concrete	Upstream Gradient (%)	0.5			
Length (ft)	56	Bankfull Width (ft)	12.7			
Width (in)	48	Bankfull:Culvert Ratio	0.3			
Height (in)	48					
Outlet Perch (ft)	Not measurable					
Slope (%)	0.7					
Rustline Height (in)	36					
Overall Condition	Fair					
PRIORITIZATION ANALYSIS						
Upstream Habitat Length (mi)	1.4	Habitat Points	3			
Habitat Quality	Fair	Habitat Quality Points	2			
Fish Species	Anad.	Fish Points	3			
Barrier Class	Gray	Barrier Points	2			
		Prioritization Total Points	10

Notes: Outlets directly into bay.

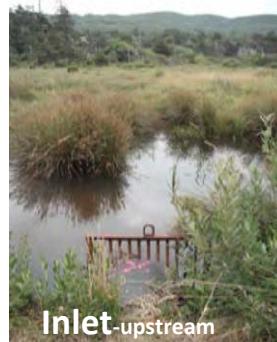
Inlet-upstream

LOCATION INFO				Culvert #	675	Priority	L
Watershed		Tillamook Bay					
Stream Name		Coleman Creek					
Township-Range-Section-1/4		T1S, R10W, Sec. 7, SE $\frac{1}{4}$ of NW $\frac{1}{4}$					
UTM Easting/Northing (Zone 10, NAD 1983)		425267/5039131					
Road Name		5 <sup>th</sup> Street					
Road/Culvert Owner		Tillamook County					
Adjacent Landowners		Tillamook County					
CULVERT INFO		CHANNEL INFO					
Shape	Circular	Inlet Gradient (%)	---				
Material	Plastic	Upstream Gradient (%)	---				
Length (ft)	50	Bankfull Width (ft)	---				
Width (in)	42	Bankfull:Culvert Ratio	---				
Height (in)	42	---					
Outlet Perch (ft)	Not measurable	---					
Slope (%)	6.1	---					
Rustline Height (in)	Unknown	---					
Overall Condition	Fair	---					
PRIORITIZATION ANALYSIS							
Upstream Habitat Length (mi)	1.0	Habitat Points	2				
Habitat Quality	Fair	Habitat Quality Points	2				
Fish Species	Resident	Fish Points	2				
Barrier Class	Gray	Barrier Points	2

Prioritization Total Points	8

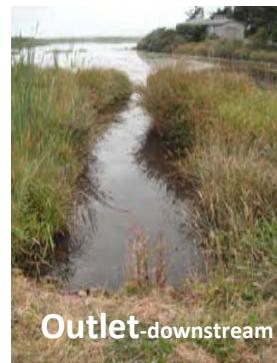
Outlet-downstream

Notes: Outlets directly into Cape Meares Lake.
