# **Tillamook River Basin Culverts**

### Tillamook River Basin Clusters

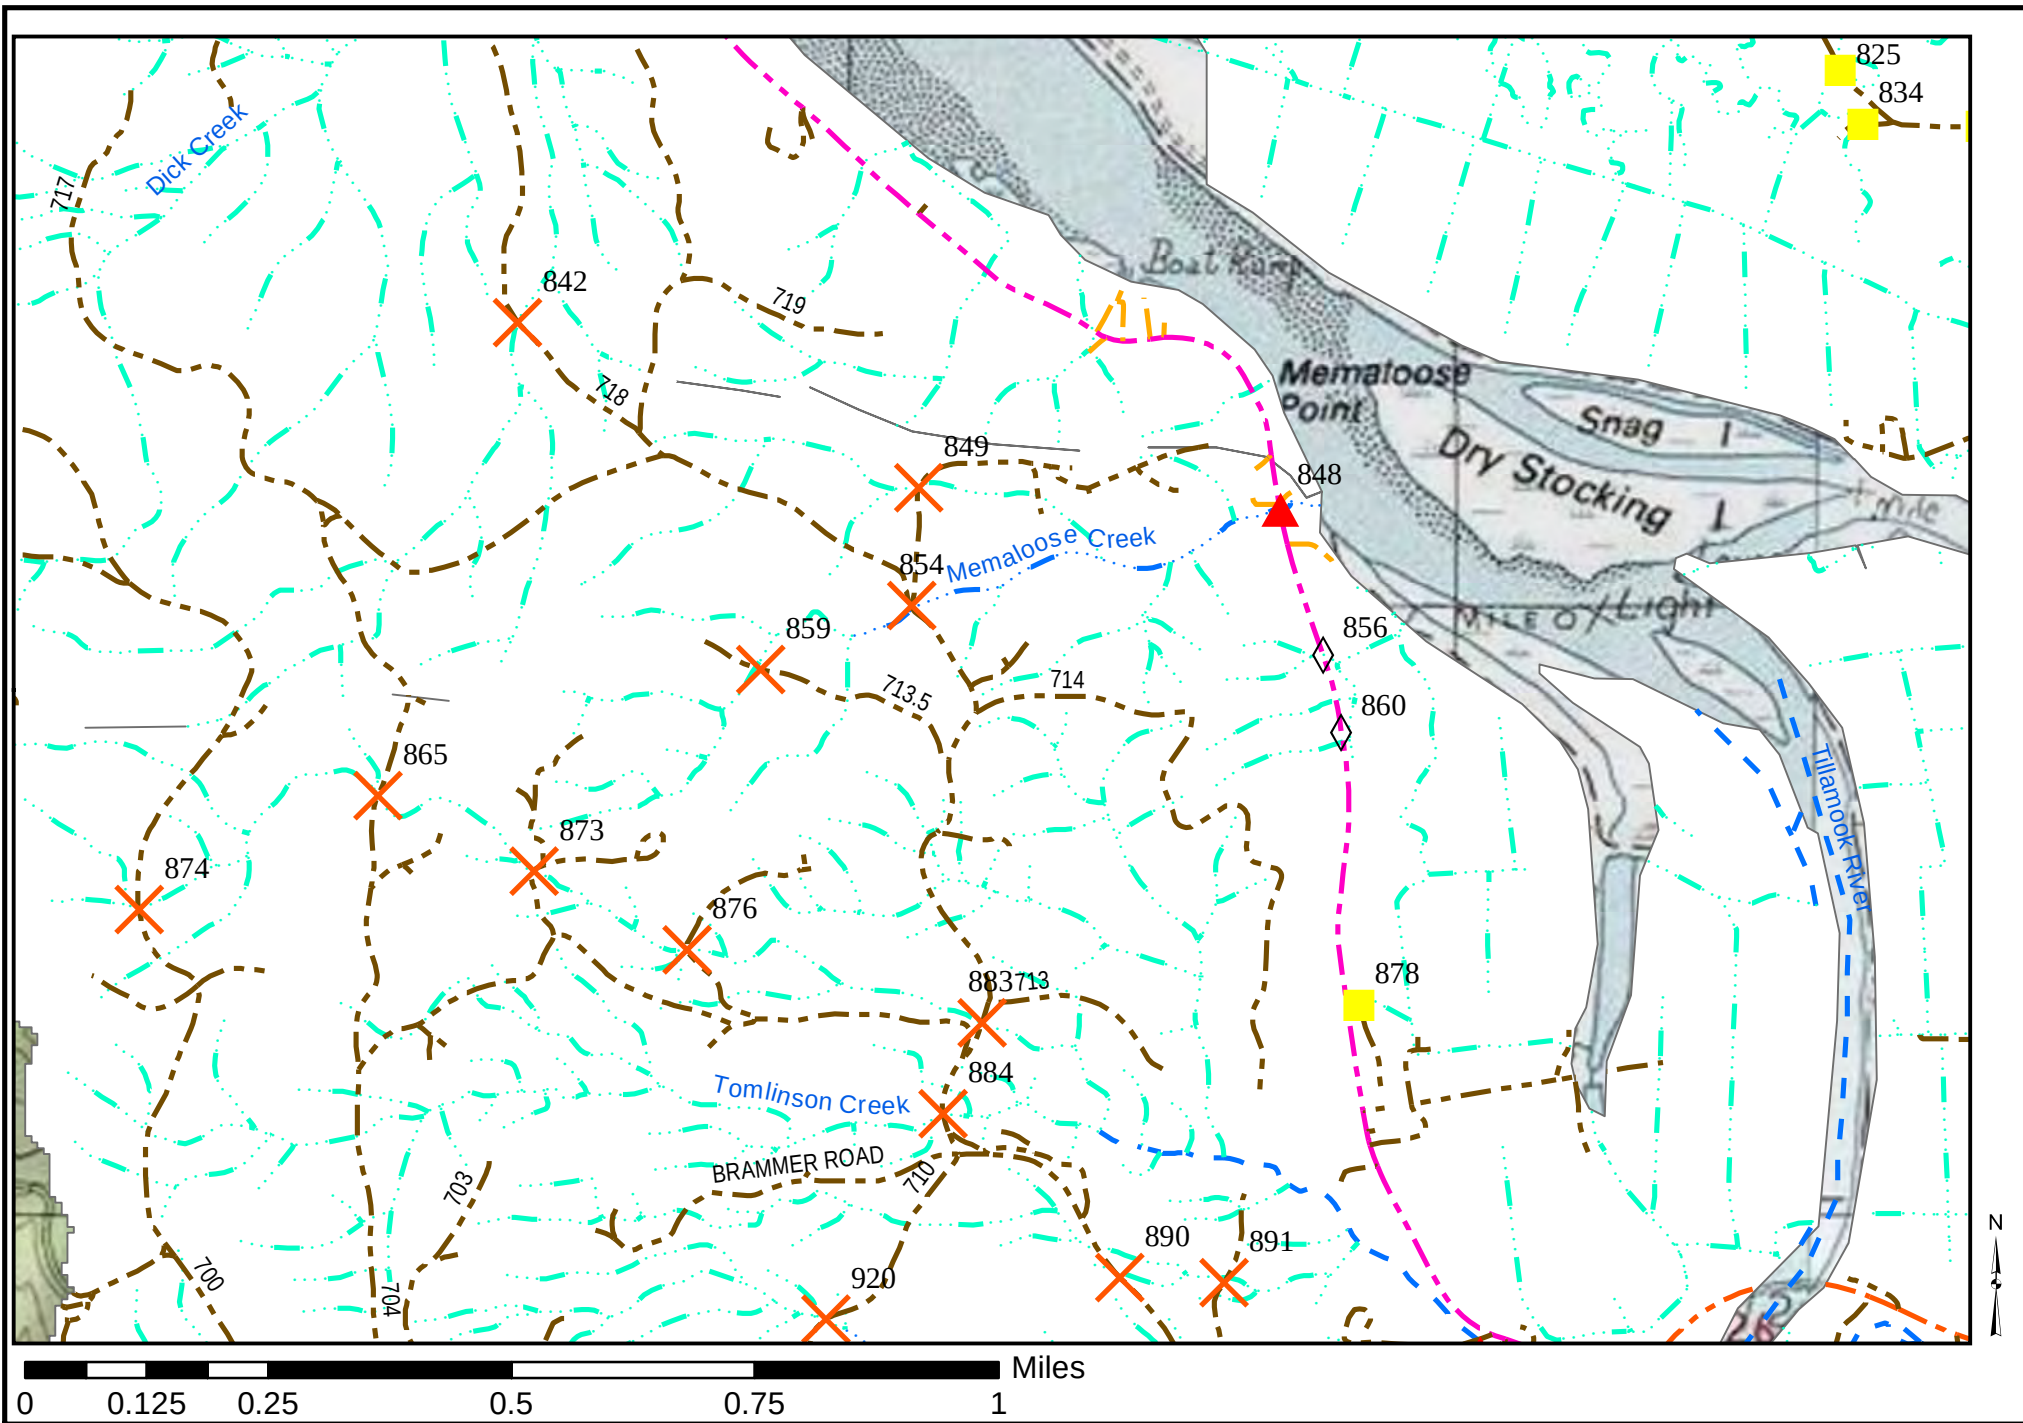
Memaloose Creek Culverts, Tillamook River Basin

| LOCATION INFO | | | | Culvert # | 848 | Priority | L |
|---|---|--|---|---|---|---|---|
| Overall Condition | Poor | | | | | | |
| <b>Notes:</b> Mixed construction crossing: inlet and outlet were corrugated metal pipe arches and central portion of crossing was a concrete box. Dimensions above are for the pipe arch portions. | | | | | | | |

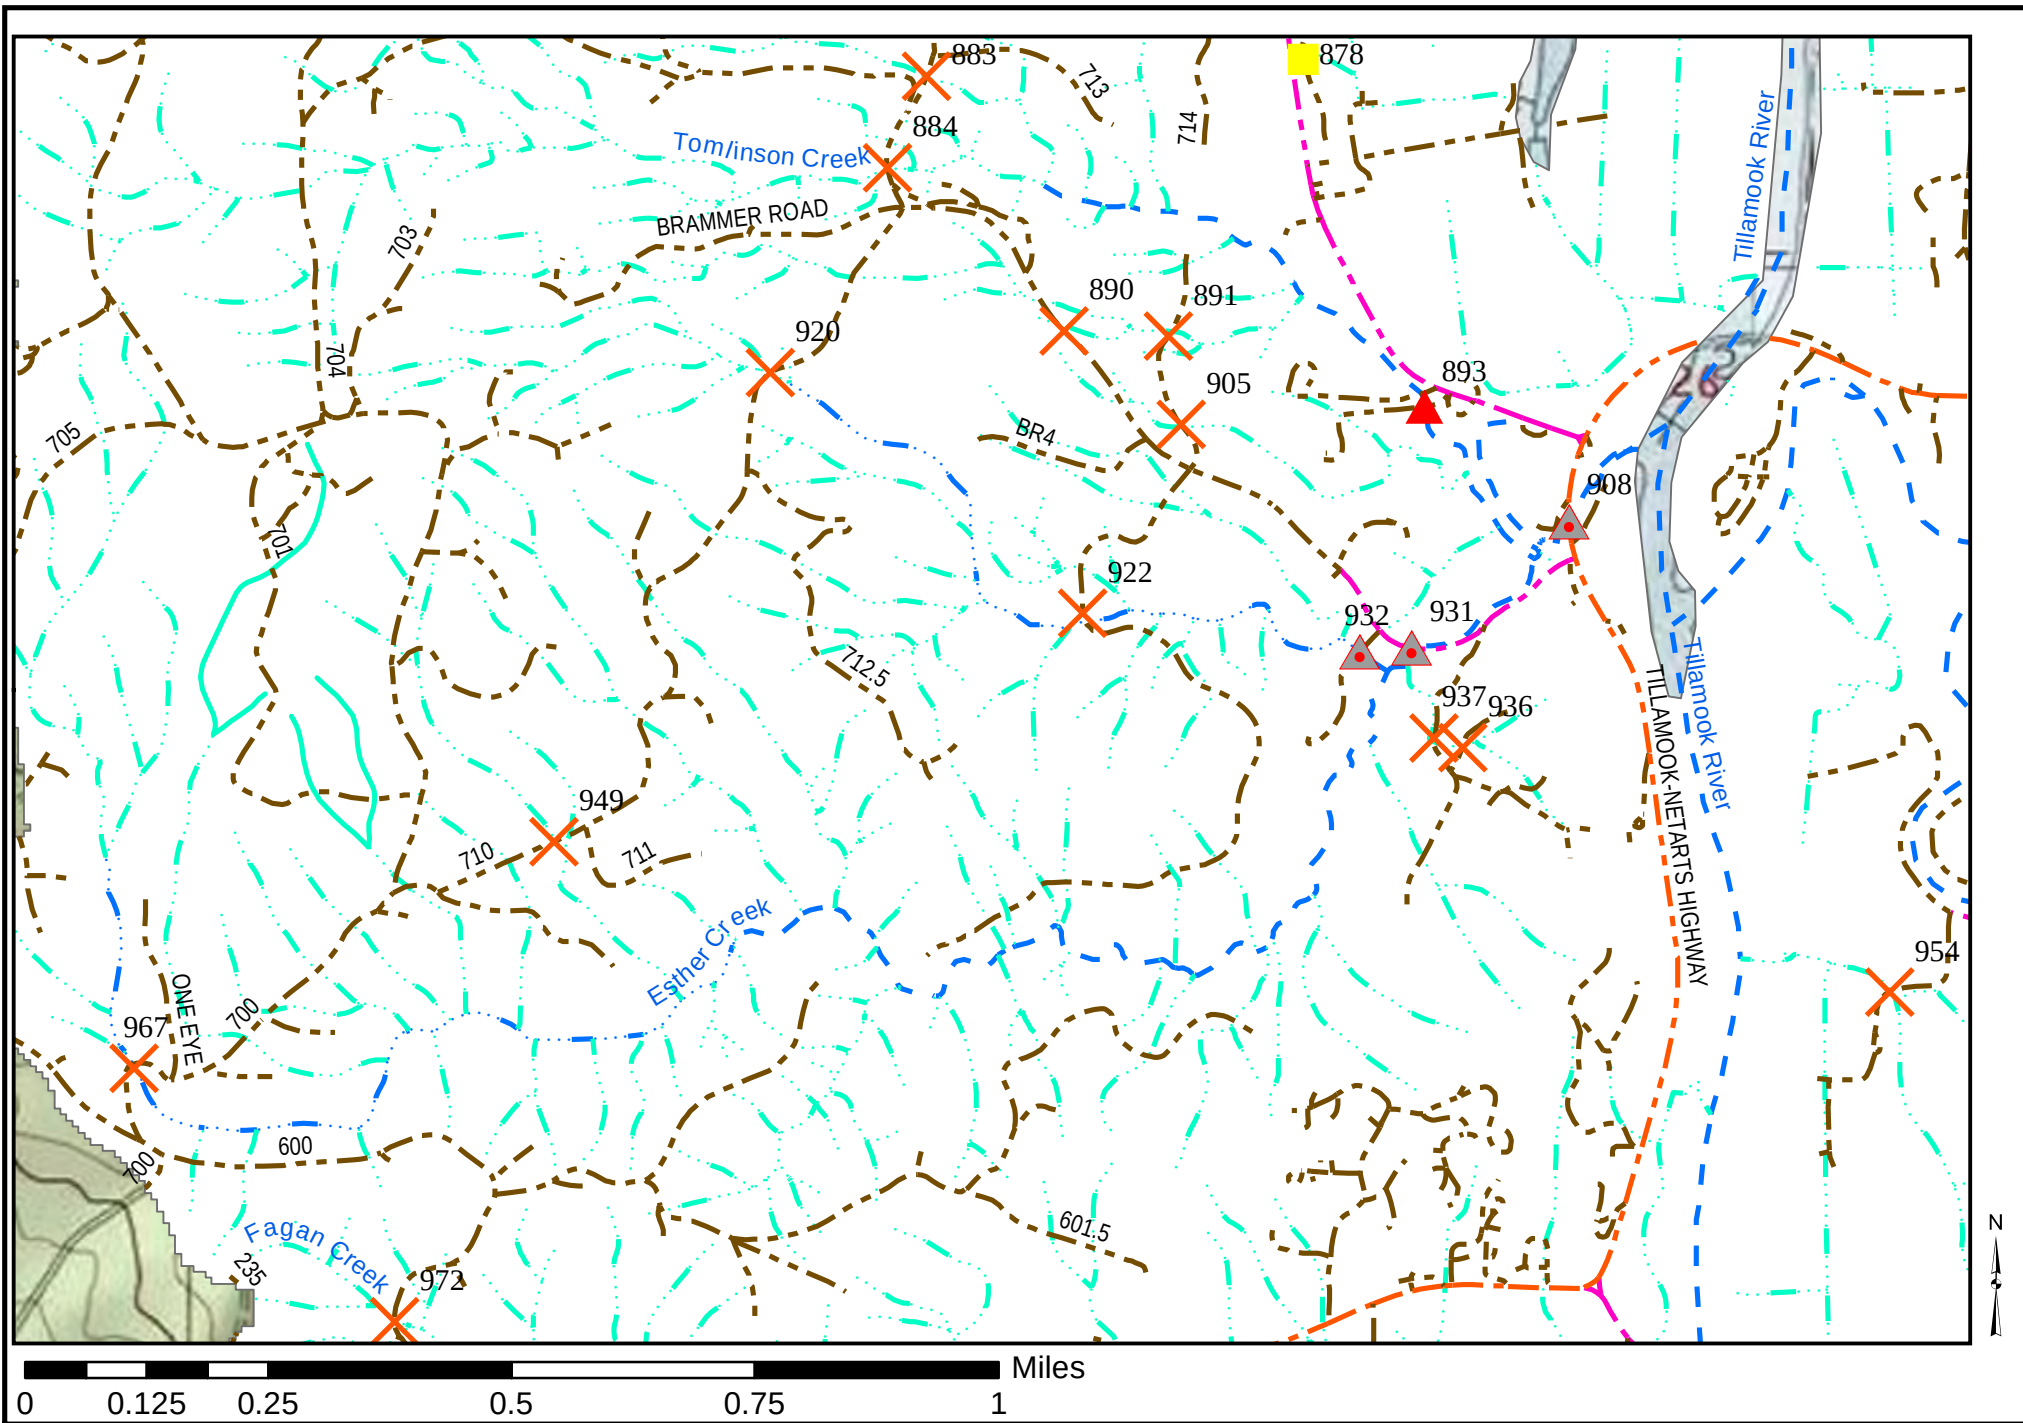
Tomlinson Creek and Esther Creek Culverts, Tillamook River Basin

| LOCATION INFO | | | | Culvert # | 908 | Priority | H |
|---|---|---|---|---|---|---|---|
| Height (in) | 78 | Seam separation and culvert barrel deformation noted. Also, there was a dike and system of tidegates that was not surveyed as part of this study approximately 100 m upstream of this culvert. | | | | | |
| <b>Notes:</b> Classification is based on BFW:Width Ratio. Because culvert is tidally influenced and completely backwatered under most conditions, it seems likely that passage is rarely inhibited by this crossing. However, the culvert is undersized and almost certainly impairs tidal processes. | | | | | | | |

| LOCATION INFO | | | | Culvert # | 893 | Priority | H |
|---|---|---|---|---|---|---|---|
| Height (in) | 48* | *Logs placed on top of pipe on inlet and outlet. Top of pipe bent down flat to accommodate logs (hence the 48" vertical dimension). Invert was very corroded and in critical condition. | | | | | |
| Overall Condition | Critical | | | | | | |

| LOCATION INFO | | | | Culvert # | 932 | Priority | H |
|---|---|---|---|---|---|---|---|
| Notes: A portion of this stream flows through pastures and has highly impaired riparian habitats. | | | | | | | |

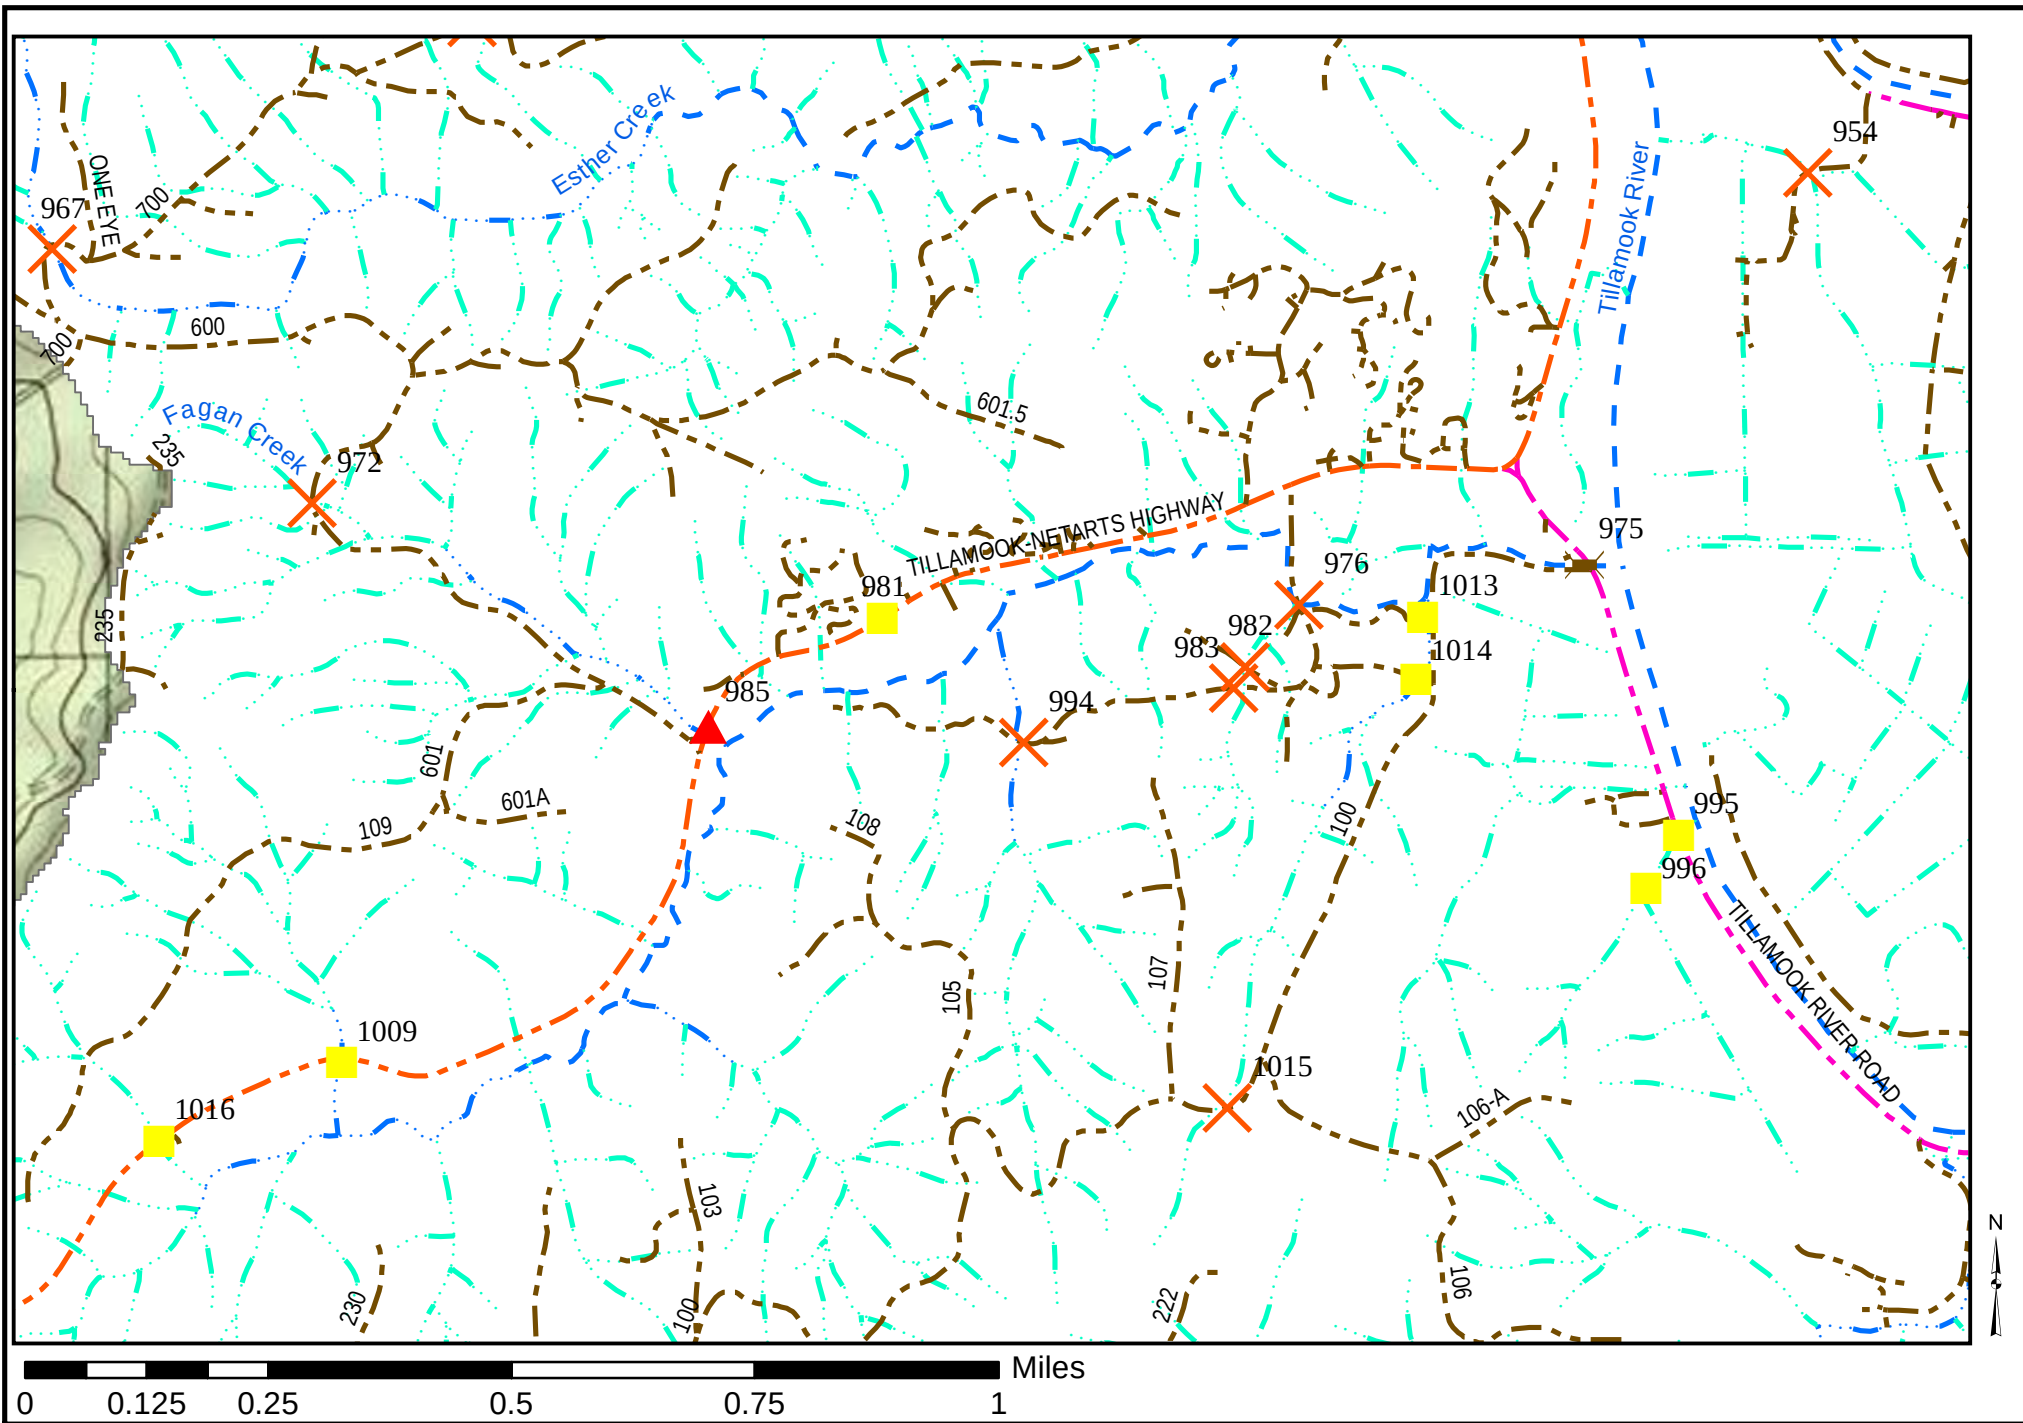
Fagan Creek Area Culverts, Tillamook River Basin

**Notes:** Inlet is a circular metal pipe that is approximately 75% blocked by sediment. Outlet was mostly submerged and concrete. The pipes appear to connect at a manhole near the intersection of Hwy 131 and a private drive. These two pipes appear to run approximately perpendicular to one another. Length of pipe estimated. In May 2012, we observed spawning Western Brook Lamprey immediately above this culvert.

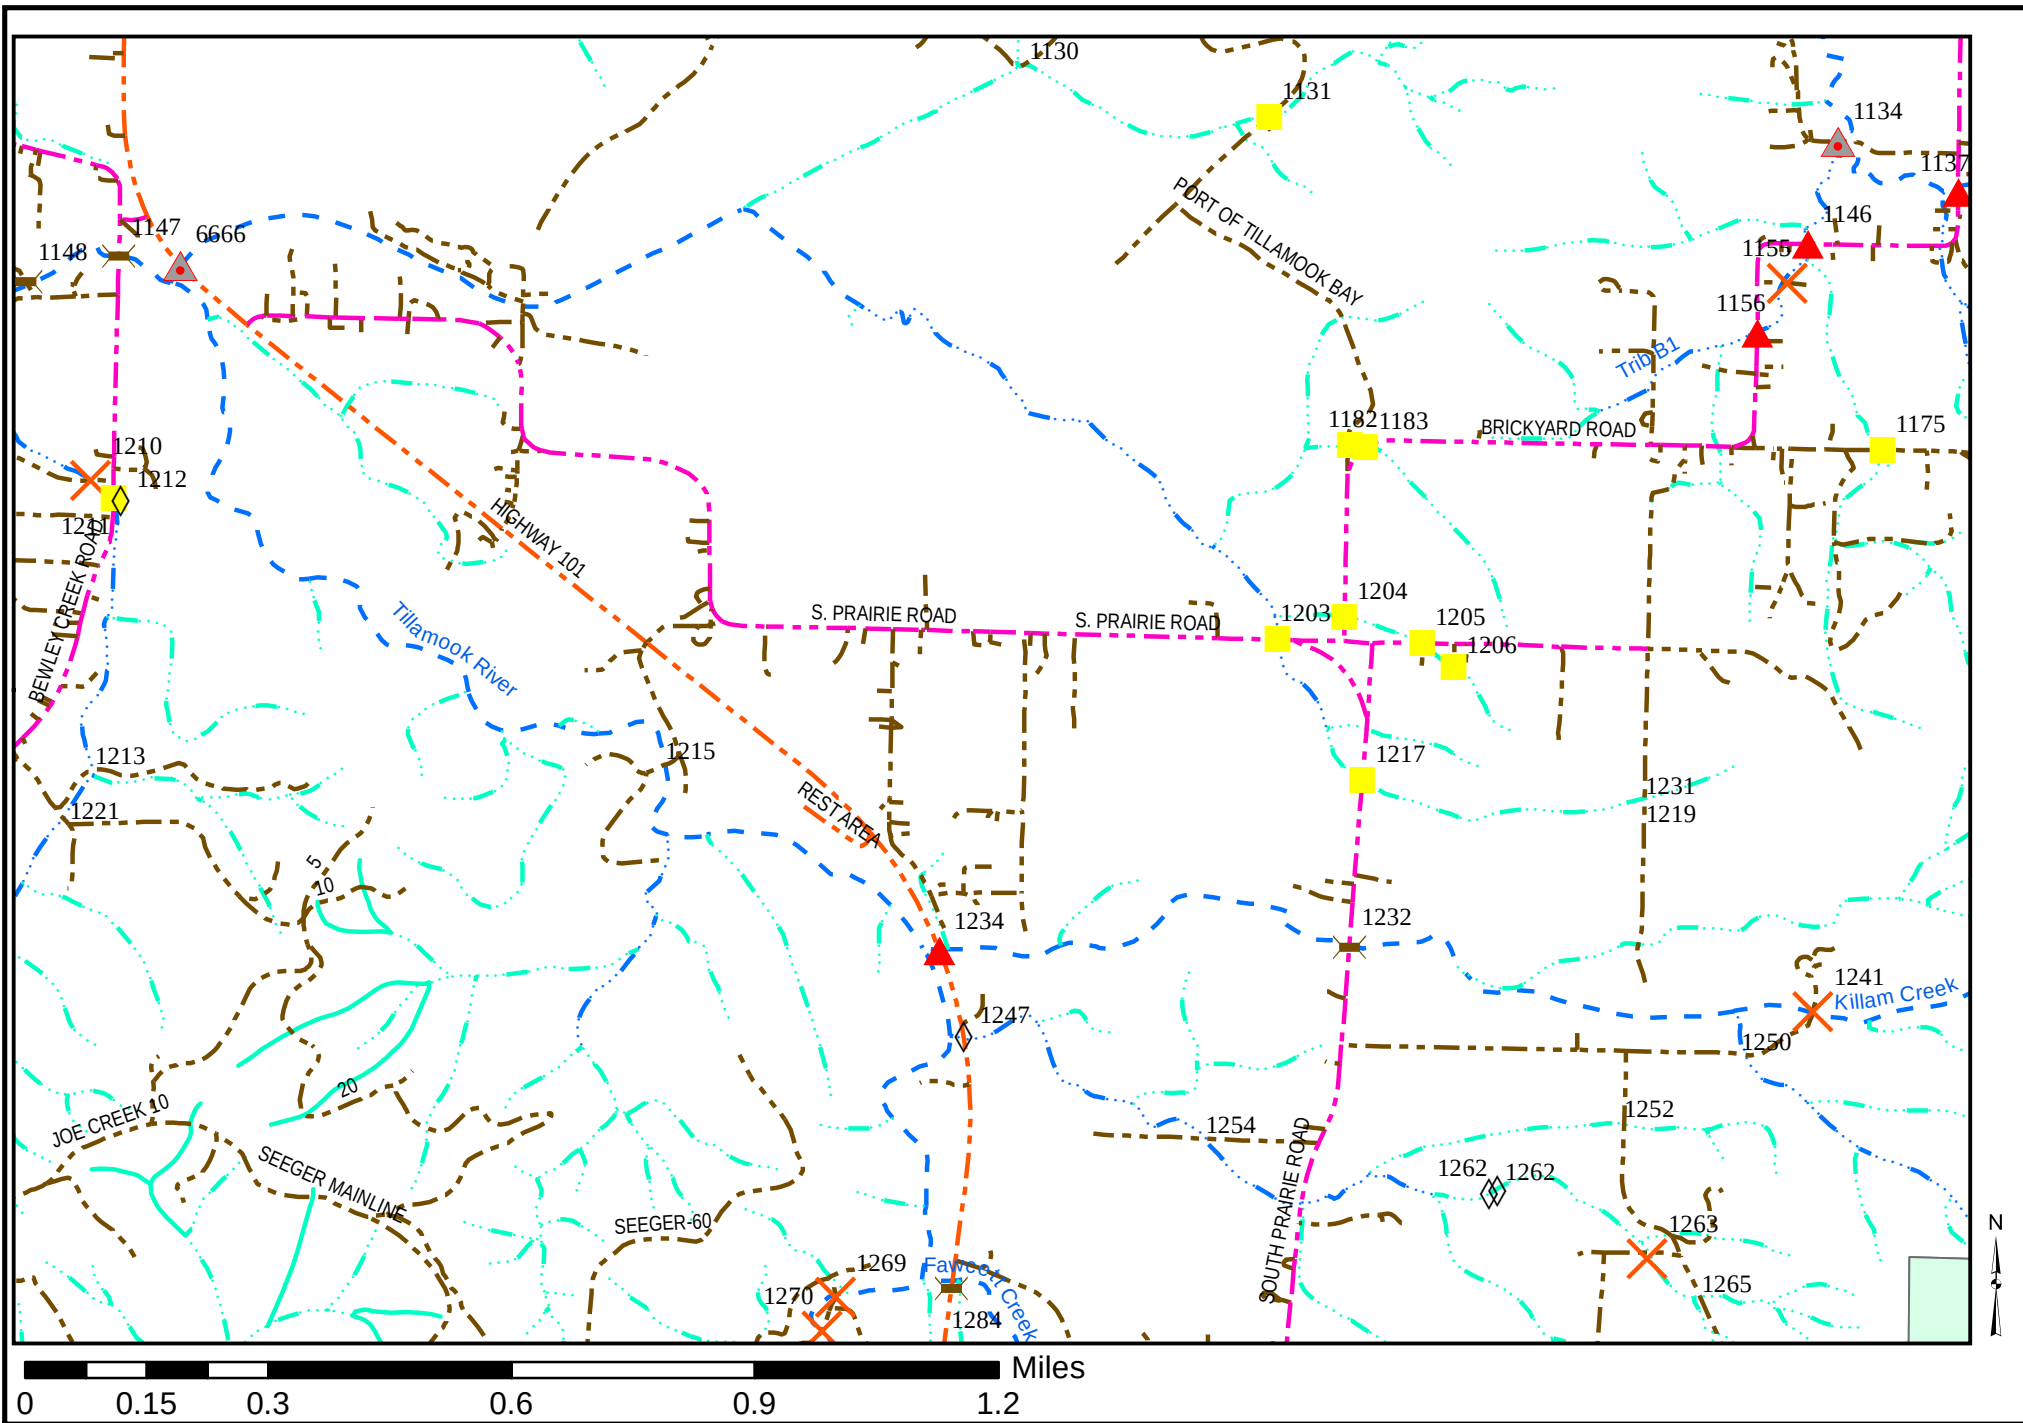
Highway 101 Near Port of Tillamook Bay Culverts, Tillamook River Basin

| LOCATION INFO | | | | Culvert # | 1234 | Priority | H |
|---|---|---|---|---|---|---|---|
| <b>Notes:</b> Perch based on elevation difference between outlet invert and outlet pool tailwater control point below fish ladder. Fish surveys indicate that adults are able to pass this culvert, but the ladder is clearly a barrier to juvenile passage. | | | | | | | |
