Lower South Fork Trask River Area Culverts, Trask River Basin

Edwards Creek Area Culverts, Trask River Basin

**UPPER SOUTH FORK TRASK RIVER AREA CULVERTS**

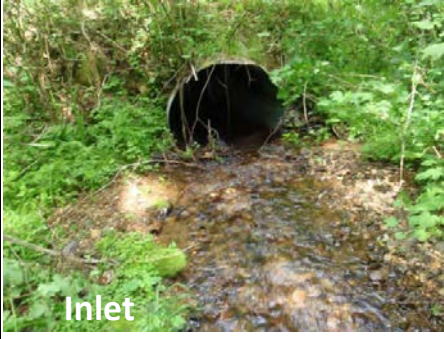
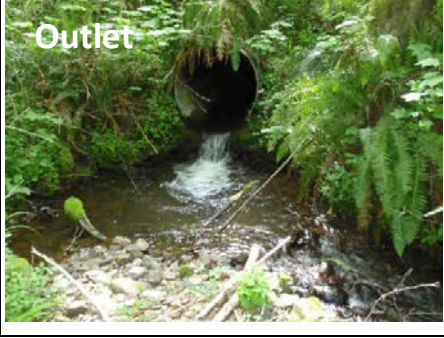
LOCATION INFO				Culvert #	1378	Priority	L
Watershed		Trask River

<p align="center">Outlet</p>		
Shape	Circular	Inlet Gradient (%)	10.3				
Material	Corrugated metal	Upstream Gradient (%)	5.9				
Length (ft)	61	Bankfull Width (ft)	7.1				
Width (in)	56	Bankfull:Culvert Ratio	0.7				
Height (in)	56						
Outlet Perch (ft)	1.6						
Slope (%)	5.9						
Rustline Height (in)	11						
Overall Condition	Fair						
PRIORITIZATION ANALYSIS							
Upstream Habitat Length (mi)	0.2	Habitat Points	1				
Habitat Quality	Fair	Habitat Quality Points	2

Fish Species	Anad.	Fish Points	3				
Barrier Class	Red	Barrier Points	3				
		Prioritization Total Points	9				
<p><b>Notes:</b></p>

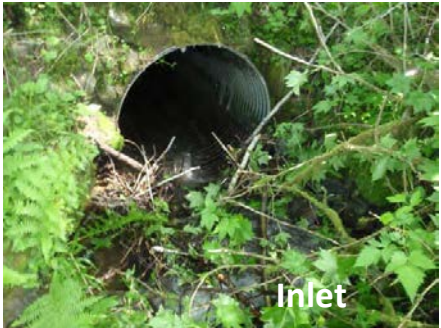
LOCATION INFO				Culvert #	1402	Priority	H
Watershed		Trask River

Stream Name		Unnamed tributary of South Fork Trask River					
Township-Range-Section-1/4		T2S, R8W, Sec. 25, NE¼ of SE¼					
UTM Easting/Northing (Zone 10, NAD 1983)		452161/5023649					
Road Name		South Fork Trask Road					
Road/Culvert Owner		Stimson Lumber Co.					
Adjacent Landowners		Stimson Lumber Co.					
CULVERT INFO		CHANNEL INFO					
Shape	Circular	Inlet Gradient (%)	21.3				
Material	Corrugated metal	Upstream Gradient (%)	4.1				
Length (ft)	45	Bankfull Width (ft)	8.0				
Width (in)	48	Bankfull:Culvert Ratio	0.5				
Height (in)	48						
Outlet Perch (ft)	None						
Slope (%)	6.2						
Rustline Height (in)	16						
Overall Condition	Poor						
PRIORITIZATION ANALYSIS							
Upstream Habitat Length (mi)	0.7	Habitat Points	2				
Habitat Quality	Good	Habitat Quality Points	3				
Fish Species	Anad.	Fish Points	3				
Barrier Class	Red	Barrier Points	3

Prioritization Total Points	11				
Notes:

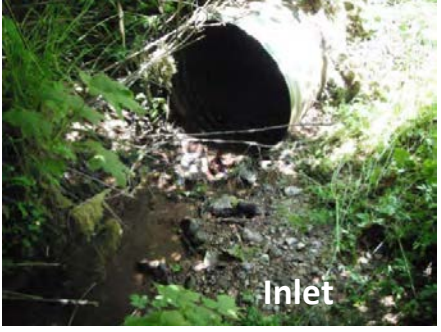
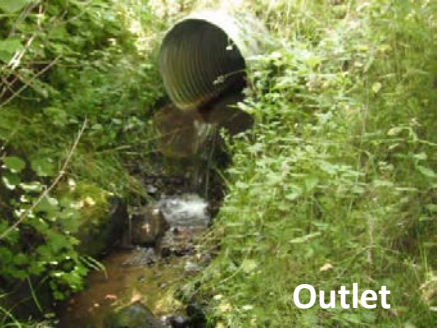
LOCATION INFO				Culvert #	1431	Priority	L
Watershed		Trask River

Stream Name		Unnamed tributary of Boundary Creek					
Township-Range-Section-1/4		T2S, R7W, Sec. 33, NE¼ of NE¼					
UTM Easting/Northing (Zone 10, NAD 1983)		457106/5023017					
Road Name		East Fork Road					
Road/Culvert Owner		Oregon Department of Forestry					
Adjacent Landowners		Oregon Department of Forestry					
CULVERT INFO		CHANNEL INFO					
Shape	Circular	Inlet Gradient (%)	21.0				
Material	Corrugated metal	Upstream Gradient (%)	0.8				
Length (ft)	41	Bankfull Width (ft)	3.9				
Width (in)	36	Bankfull:Culvert Ratio	0.8				
Height (in)	36

Outlet Perch (ft)	2.3						
Slope (%)	3.9						
Rustline Height (in)	12						
Overall Condition	Fair						
PRIORITIZATION ANALYSIS							
Upstream Habitat Length (mi)	0.3	Habitat Points	1				
Habitat Quality	Fair	Habitat Quality Points	2				
Fish Species	Anad.	Fish Points	3				
Barrier Class	Red	Barrier Points	3

<b>Prioritization Total Points</b>	<b>9</b>				
<p><b>Notes:</b> Stream listed as Nonfish. However, field crew thought it looked suitable, it is low-gradient, and it is a tributary to a good-quality stream so we elected to include this pipe in our assessment.</p>

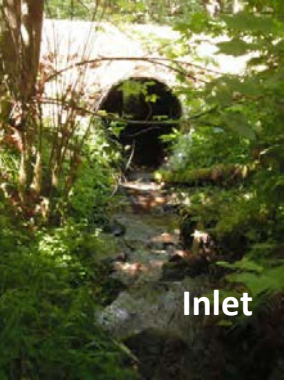
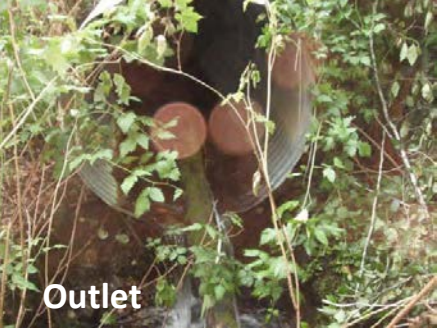
LOCATION INFO				Culvert #	1472	Priority	L
Watershed		Trask River

Stream Name		Unnamed tributary of Headquarters Camp Creek					
Township-Range-Section-1/4		T2S, R7W, Sec. 34, NE¼ of NW¼					
UTM Easting/Northing (Zone 10, NAD 1983)		457721/5022175					
Road Name		East Fork Road					
Road/Culvert Owner		Oregon Department of Forestry					
Adjacent Landowners		Oregon Department of Forestry					
CULVERT INFO		CHANNEL INFO					
Shape	Circular	Inlet Gradient (%)	1.3				
Material	Corrugated metal	Upstream Gradient (%)	3.6				
Length (ft)	50	Bankfull Width (ft)	4.9				
Width (in)	54	Bankfull:Culvert Ratio	0.9				
Height (in)	54

Outlet Perch (ft)	2.3						
Slope (%)	2.3						
Rustline Height (in)	12						
Overall Condition	Fair						
PRIORITIZATION ANALYSIS							
Upstream Habitat Length (mi)	0.3	Habitat Points	1				
Habitat Quality	Fair	Habitat Quality Points	2				
Fish Species	Anad.	Fish Points	3

Barrier Class	Red	Barrier Points	3				
		<b>Prioritization Total Points</b>	<b>9</b>				
<p><b>Notes:</b> Stream listed as Nonfish. However, field crew thought it looked suitable, it is low-gradient, it has a moderate intrinsic potential rating, and it is a tributary to a good-quality stream so we elected to include this pipe in our assessment.</p>

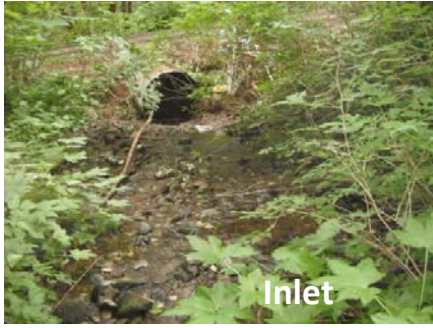
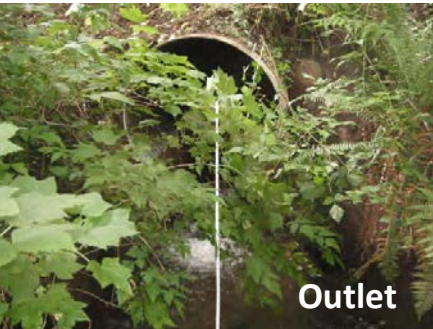
LOCATION INFO				Culvert #	1516	Priority	L	
Watershed		Trask River

<p align="right"><b>Outlet</b></p>			
Shape	Circular	Inlet Gradient (%)	21.1					
Material	Corrugated metal	Upstream Gradient (%)	10.4					
Length (ft)	33	Bankfull Width (ft)	7.6					
Width (in)	48	Bankfull:Culvert Ratio	0.5					
Height (in)	48							
Outlet Perch (ft)	1.2							
Slope (%)	2.2							
Rustline Height (in)	24							
Overall Condition	Fair							
PRIORITIZATION ANALYSIS								
Upstream Habitat Length (mi)	0.7	Habitat Points	2					
Habitat Quality	Poor	Habitat Quality Points	1

Fish Species	Anad.	Fish Points	3					
Barrier Class	Red	Barrier Points	3					
		Prioritization Total Points	9					
<b>Notes:</b>

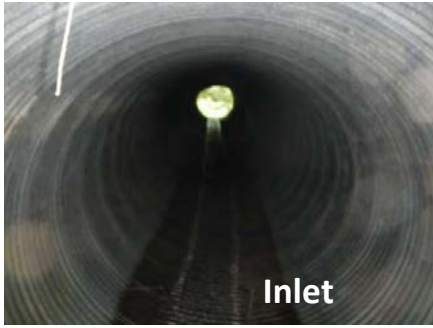
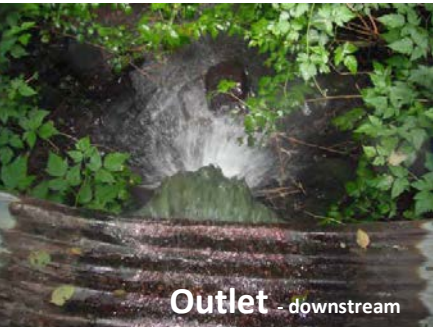
LOCATION INFO				Culvert #	1520	Priority	L	
Watershed		Trask River

<p align="right"><b>Outlet - downstream</b></p>			
Shape	Circular	Inlet Gradient (%)	50.0					
Material	Corrugated metal	Upstream Gradient (%)	6.2					
Length (ft)	90	Bankfull Width (ft)	3.8					
Width (in)	78	Bankfull:Culvert Ratio	1.7					
Height (in)	78							
Outlet Perch (ft)	2.0							
Slope (%)	3.7							
Rustline Height (in)	12							
Overall Condition	Fair							
PRIORITIZATION ANALYSIS								
Upstream Habitat Length (mi)	0.4	Habitat Points	1

Habitat Quality	Poor	Habitat Quality Points	1					
Fish Species	Anad.	Fish Points	3					
Barrier Class	Red	Barrier Points	3					
		Prioritization Total Points	8					
<b>Notes:</b> Above this culvert stream listed as Nonfish. However, field crew thought it looked suitable, the stream has suitable gradient for fish use and it is mapped as suitable for coho spawning. As a result, we included this pipe in our assessment.

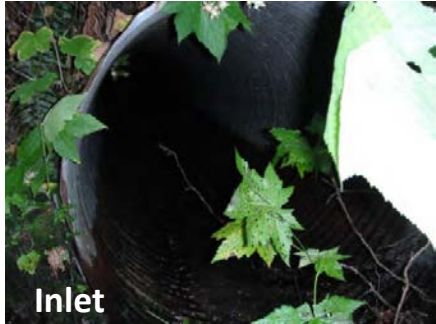
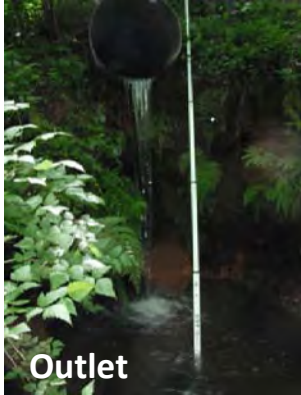
Shape	Circular		Inlet Gradient (%)					7.5		
Material	Corrugated metal		Upstream Gradient (%)					0.5		
Length (ft)	67		Bankfull Width (ft)					4.9		
Width (in)	36		Bankfull:Culvert Ratio					0.6		
Height (in)	36									
Outlet Perch (ft)	6.6									
Slope (%)	1.4									
Rustline Height (in)	20									
Overall Condition	Poor									
PRIORITIZATION ANALYSIS										
Upstream Habitat Length (mi)	0.1		Habitat Points	1						
Habitat Quality	Poor		Habitat Quality Points	1

Fish Species	Anad.		Fish Points	3						
Barrier Class	Red		Barrier Points	3						
			Prioritization Total Points	8						
<b>Notes:</b> Above this culvert stream listed as Nonfish. However, field crew thought it looked suitable in the field and the reach is low-gradient. As a result, we included this pipe in our assessment.

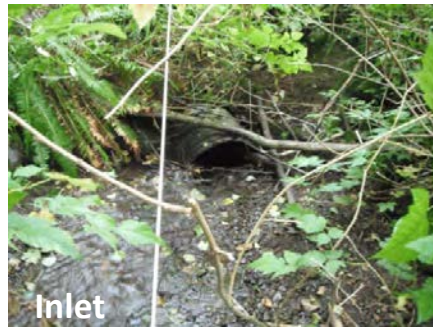
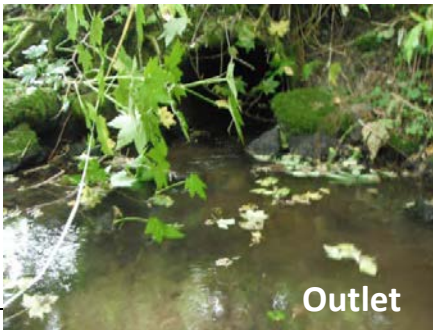
<p align="right">Outlet</p>			
Shape	Circular	Inlet Gradient (%)	21.9				
Material	Corrugated metal	Upstream Gradient (%)	3.4				
Length (ft)	32	Bankfull Width (ft)	8.5				
Width (in)	30	Bankfull:Culvert Ratio	0.3				
Height (in)	30						
Outlet Perch (ft)	None						
Slope (%)	5.7						
Rustline Height (in)	entirely rusted						
Overall Condition	Poor						
PRIORITIZATION ANALYSIS							
Upstream Habitat Length (mi)	1.0	Habitat Points	2				
Habitat Quality	Poor(+)	Habitat Quality Points	1				
Fish Species	Anad.	Fish Points	3

Barrier Class	Red	Barrier Points	3				
		Prioritization Total Points	9				
<b>Notes:</b>

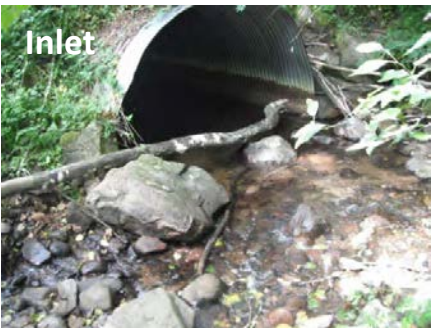
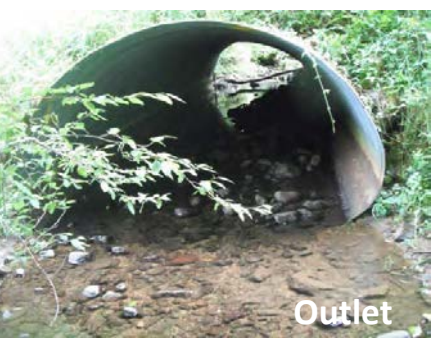
Material	Corrugated metal	Upstream Gradient (%)	1.0				
Length (ft)	40	Bankfull Width (ft)	10.0				
Width (in)	138	Bankfull:Culvert Ratio	1.15				
Height (in)	84						
Outlet Perch (ft)	None						
Slope (%)	-0.7						
Rustline Height (in)	30						
Overall Condition	Poor						
PRIORITIZATION ANALYSIS							
Upstream Habitat Length (mi)	0.8	Habitat Points	2				
Habitat Quality	Good	Habitat Quality Points	3				
Fish Species	Anad.	Fish Points	3				
Barrier Class	Green	Barrier Points	1

Prioritization Total Points	10				
Notes:

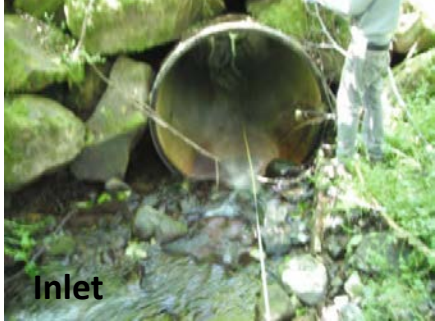
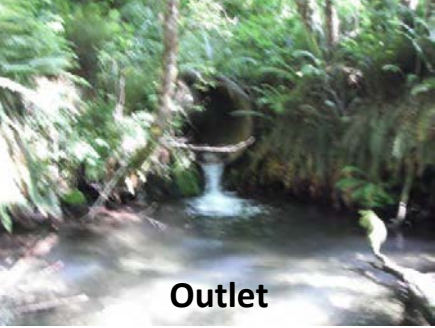
LOCATION INFO				Culvert #	1342	Priority	H
<b>Watershed</b>		Trask River

<p align="center"><b>Inlet</b></p>			
<b>Stream Name</b>		Pothole Creek					
<b>Township-Range-Section-1/4</b>		T1S, R7W, Sec. 23, SW¼ of SW¼					
<b>UTM Easting/Northing (Zone 10, NAD 1983)</b>		459224/5024799					
<b>Road Name</b>		Murphy Camp Road					
<b>Road/Culvert Owner</b>		Oregon Department of Forestry					
<b>Adjacent Landowners</b>		Oregon Department of Forestry					
CULVERT INFO		CHANNEL INFO					
<b>Shape</b>	Circular	<b>Inlet Gradient (%)</b>	11.5				
<b>Material</b>	steel lined with plastic	<b>Upstream Gradient (%)</b>	5.1				
<b>Length (ft)</b>	53	<b>Bankfull Width (ft)</b>	9.3				
<b>Width (in)</b>	60	<b>Bankfull:Culvert Ratio</b>	0.5				
<b>Height (in)</b>	60						
<b>Outlet Perch (ft)</b>	1.3						
<b>Slope (%)</b>	6.6						
<b>Rustline Height (in)</b>	N/A						
<b>Overall Condition</b>	Fair						
PRIORITIZATION ANALYSIS

<b>Upstream Habitat Length (mi)</b>	0.4	<b>Habitat Points</b>	2				
<b>Habitat Quality</b>	Good	<b>Habitat Quality Points</b>	3				
<b>Fish Species</b>	Anad.	<b>Fish Points</b>	3				
<b>Barrier Class</b>	Red	<b>Barrier Points</b>	3				
		<b>Prioritization Total Points</b>	11				
<b>Notes:</b>

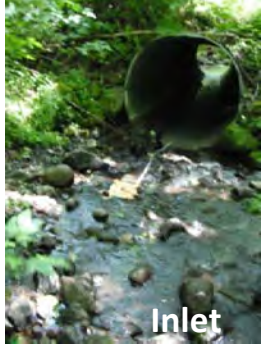
LOCATION INFO				Culvert #	1099	Priority	H
<b>Watershed</b>		Trask River

<p align="right"><b>Inlet</b></p>			
<b>Stream Name</b>		Unnamed tributary to Bark Shanty Creek					
<b>Township-Range-Section-1/4</b>		T2S, R7W, Sec. 3, NE¼ of SE¼					
<b>UTM Easting/Northing (Zone 10, NAD 1983)</b>		458843/5029888					
<b>Road Name</b>		Bark Shanty Road					
<b>Road/Culvert Owner</b>		Oregon Department of Forestry					
<b>Adjacent Landowners</b>		Oregon Department of Forestry					
CULVERT INFO		CHANNEL INFO					
<b>Shape</b>	Circular	<b>Inlet Gradient (%)</b>	17.5				
<b>Material</b>	Corrugated metal	<b>Upstream Gradient (%)</b>	9.5				
<b>Length (ft)</b>	40	<b>Bankfull Width (ft)</b>	11.6				
<b>Width (in)</b>	66	<b>Bankfull:Culvert Ratio</b>	0.5				
<b>Height (in)</b>	66

<p align="left"><b>Outlet</b></p>					
<b>Outlet Perch (ft)</b>	1.4						
<b>Slope (%)</b>	9.2						
<b>Rustline Height (in)</b>	19

<b>Overall Condition</b>	Fair						
<b>PRIORITIZATION ANALYSIS</b>							
<b>Upstream Habitat Length (mi)</b>	0.6	<b>Habitat Points</b>	2				
<b>Habitat Quality</b>	Fair	<b>Habitat Quality Points</b>	2				
<b>Fish Species</b>	Anad.	<b>Fish Points</b>	3				
<b>Barrier Class</b>	Red	<b>Barrier Points</b>	3				
		<b>Prioritization Total Points</b>	10				
<b>Notes:</b>

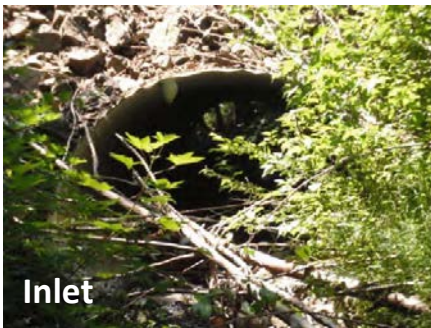
<p style="text-align: center; font-weight: bold;">Inlet</p>			
Stream Name		Unnamed tributary of July Creek					
Township-Range-Section-1/4		T2S, R6W, Sec. 6, SW¼ of NW¼					
UTM Easting/Northing (Zone 10, NAD 1983)		462266/5030364					
Road Name		Cruiser Creek Road					
Road/Culvert Owner		Oregon Department of Forestry					
Adjacent Landowners		Oregon Department of Forestry					
CULVERT INFO		CHANNEL INFO					
Shape	Pipe arch	Inlet Gradient (%)	8.0				
Material	Corrugated metal	Upstream Gradient (%)	7.0				
Length (ft)	78	Bankfull Width (ft)	10.5				
Width (in)	126	Bankfull:Culvert Ratio	1.0				
Height (in)	84	An active wasp nest at inlet precluded use of survey equipment to collect longitudinal profile data.					
Outlet Perch (ft)	None						
Slope (%)	3.0						
Rustline Height (in)	12						
Overall Condition	Fair						
PRIORITIZATION ANALYSIS

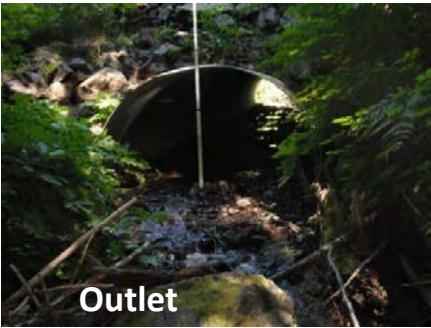
<p style="text-align: center; font-weight: bold;">Outlet</p>

Upstream Habitat Length (mi)	1.3	Habitat Points	3				
Habitat Quality	Good	Habitat Quality Points	3				
Fish Species	Anad.	Fish Points	3				
Barrier Class	Green	Barrier Points	1				
		Prioritization Total Points	10				
Notes:

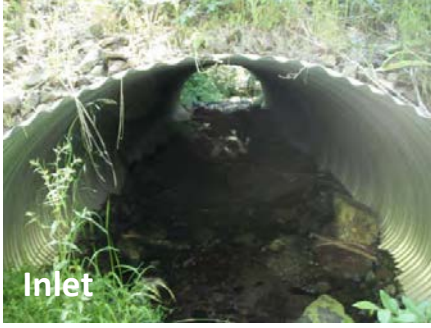
<p style="text-align: center; font-weight: bold;">Inlet</p>			
Stream Name		July Creek					
Township-Range-Section-1/4		T2S, R6W, Sec. 6, SW¼ of NW¼					
UTM Easting/Northing (Zone 10, NAD 1983)		462101/5030429					
Road Name		Cruiser Creek Road					
Road/Culvert Owner		Oregon Department of Forestry					
Adjacent Landowners		Oregon Department of Forestry					
CULVERT INFO		CHANNEL INFO					
Shape	Pipe arch	Inlet Gradient (%)	3.8				
Material	Corrugated metal	Upstream Gradient (%)	7.6				
Length (ft)	51	Bankfull Width (ft)	6.2				
Width (in)	120	Bankfull:Culvert Ratio	1.6				
Height (in)	78	An active wasp nest at inlet precluded use of survey equipment to collect longitudinal profile data.					
Outlet Perch (ft)	None						
Slope (%)	7.3						
Rustline Height (in)	None						
Overall Condition	Fair						
PRIORITIZATION ANALYSIS

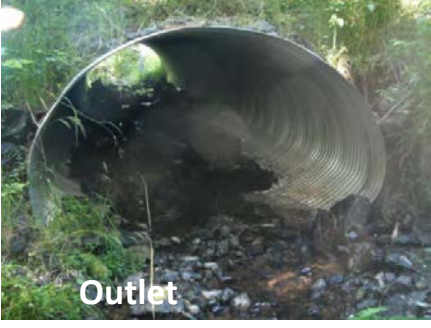
<p style="text-align: center; font-weight: bold;">Outlet</p>

Upstream Habitat Length (mi)	0.4	Habitat Points	1				
Habitat Quality	Fair	Habitat Quality Points	2				
Fish Species	Anad.	Fish Points	3				
Barrier Class	Green	Barrier Points	1				
		Prioritization Total Points	7				
Notes:

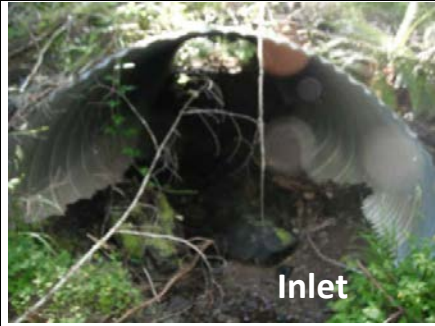
Inlet			
Stream Name		Whirlwind Creek					
Township-Range-Section-1/4		T2S, R7W, Sec. 1, NE¼ of SE¼					
UTM Easting/Northing (Zone 10, NAD 1983)		461662/5030154					
Road Name		Cruiser Creek Road					
Road/Culvert Owner		Oregon Department of Forestry					
Adjacent Landowners		Oregon Department of Forestry					
CULVERT INFO		CHANNEL INFO					
Shape	Circular	Inlet Gradient (%)	7.7				
Material	Corrugated metal	Upstream Gradient (%)	1.8				
Length (ft)	43	Bankfull Width (ft)	4.9				
Width (in)	120	Bankfull:Culvert Ratio	2.0				
Height (in)	84						
Outlet Perch (ft)	None						
Slope (%)	3.1						
Rustline Height (in)	None						
Overall Condition	Fair						
PRIORITIZATION ANALYSIS

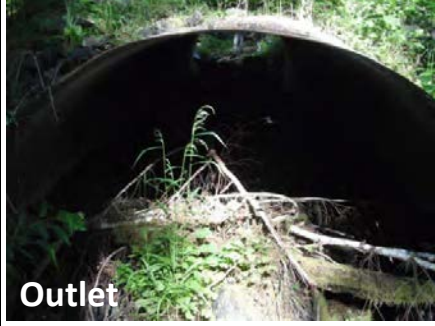
Outlet			
Upstream Habitat Length (mi)	0.3	Habitat Points	1				
Habitat Quality	Fair	Habitat Quality Points	2				
Fish Species	Anad.	Fish Points	3				
Barrier Class	Green	Barrier Points	1

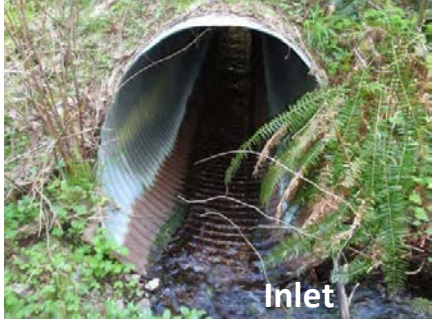
<p style="text-align: right;"><b>Inlet</b></p>			
Stream Name	Unnamed tributary of Cruiser Creek						
Township-Range-Section-1/4		T2S, R7W, Sec. 1, SE¼ of SE¼					
UTM Easting/Northing (Zone 10, NAD 1983)		461704/5029778					
Road Name	Cruiser Creek Road						
Road/Culvert Owner		Oregon Department of Forestry					
Adjacent Landowners		Oregon Department of Forestry					
CULVERT INFO		CHANNEL INFO					
Shape	Circular	Inlet Gradient (%)	4.9				
Material	Corrugated metal	Upstream Gradient (%)	4.9				
Length (ft)	44	Bankfull Width (ft)	5.9				
Width (in)	48	Bankfull:Culvert Ratio	0.7				
Height (in)	48						
Outlet Perch (ft)	None						
Slope (%)	4.6						
Rustline Height (in)	22						
Overall Condition	Fair						
PRIORITIZATION ANALYSIS

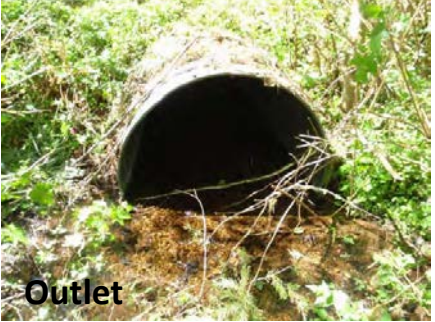
<p style="text-align: right;"><b>Outlet</b></p>			
Upstream Habitat Length (mi)	0.3	Habitat Points	1

Habitat Quality	Poor	Habitat Quality Points	1				
Fish Species	Anad.	Fish Points	3				
Barrier Class	Red	Barrier Points	3				
		<b>Prioritization Total Points</b>	<b>8</b>				
<p><b>Notes:</b> This crossing was located on a stream designated as Nonfish-modeled. However, because this stream is a tributary of Cruiser Creek, one of the more productive coho streams in the Trask Basin, we elected to include this culvert in this report. There are bedrock falls that appear to limit the distribution of coho on Cruiser Creek. However, based on GIS data it is unclear to us exactly where this tributary lies relative to these falls. Habitat quality was based primarily on stream gradient, bankfull width, and intrinsic potential modeling.</p>

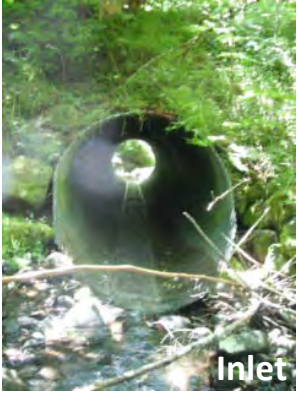
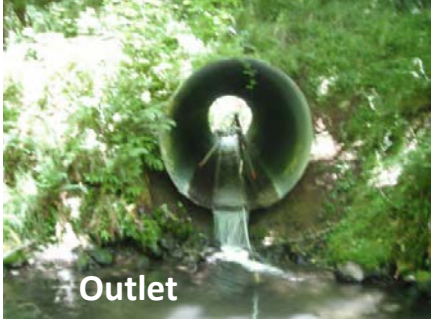
LOCATION INFO				Culvert #	864	Priority	M
<b>Watershed</b>		Trask River

<b>Stream Name</b>		Unnamed tributary of North Fork Trask River					
<b>Township-Range-Section-1/4</b>		T1S, R6W, Sec. 19, SW¼ of SW¼					
<b>UTM Easting/Northing (Zone 10, NAD 1983)</b>		463625/5034818					
<b>Road Name</b>		North Fork Trask River Road					
<b>Road/Culvert Owner</b>		US Bureau of Land Management					
<b>Adjacent Landowners</b>		US Bureau of Land Management					
<b>CULVERT INFO</b>		<b>CHANNEL INFO</b>					
<b>Shape</b>	Circular	<b>Inlet Gradient (%)</b>	6.6				
<b>Material</b>	Corrugated metal	<b>Upstream Gradient (%)</b>	6.4				
<b>Length (ft)</b>	60	<b>Bankfull Width (ft)</b>	11.9				
<b>Width (in)</b>	90	<b>Bankfull:Culvert Ratio</b>	0.7				
<b>Height (in)</b>	90						
<b>Outlet Perch (ft)</b>	2.4						
<b>Slope (%)</b>	8.4						
<b>Rustline Height (in)</b>	12						
<b>Overall Condition</b>	Fair						
<b>PRIORITIZATION ANALYSIS</b>

<b>Upstream Habitat Length (mi)</b>	0.6	<b>Habitat Points</b>	2				
<b>Habitat Quality</b>	Fair	<b>Habitat Quality Points</b>	2				
<b>Fish Species</b>	Anad.	<b>Fish Points</b>	3				
<b>Barrier Class</b>	Red	<b>Barrier Points</b>	3				
		<b>Prioritization Total Points</b>	10				
<b>Notes:</b>

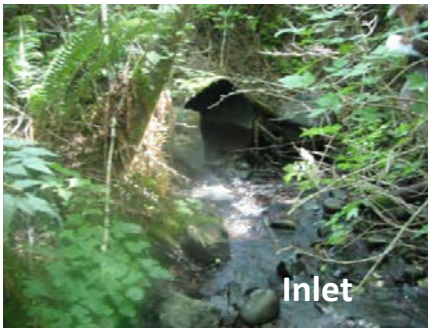
LOCATION INFO				Culvert #	965	Priority	L
Watershed		Trask River

Stream Name	Unnamed tributary of Middle Fork North Fork Trask River						
Township-Range-Section-1/4		T1S, R6W, Sec. 26, SW¼ of SW¼					
UTM Easting/Northing (Zone 10, NAD 1983)		468598/5032837					
Road Name		Unnamed Forest Road (ODF ID = REIMO25B)					
Road/Culvert Owner		Oregon Department of Forestry					
Adjacent Landowners		Oregon Department of Forestry					
CULVERT INFO		CHANNEL INFO					
Shape	Circular	Inlet Gradient (%)	9.0				
Material	Corrugated metal	Upstream Gradient (%)	7.5				
Length (ft)	60	Bankfull Width (ft)	6.5				
Width (in)	36	Bankfull:Culvert Ratio	0.5				
Height (in)	36	Topography precluded use of surveying equipment to collect longitudinal profile data.					
Outlet Perch (ft)	~6.0						
Slope (%)	5.0						
Rustline Height (in)	18						
Overall Condition	Fair						
PRIORITIZATION ANALYSIS							
Upstream Habitat Length (mi)	0.7	Habitat Points	2

Habitat Quality	Poor	Habitat Quality Points	1				
Fish Species	Anad.	Fish Points	3				
Barrier Class	Red	Barrier Points	3				
		Prioritization Total Points	9				
Notes:

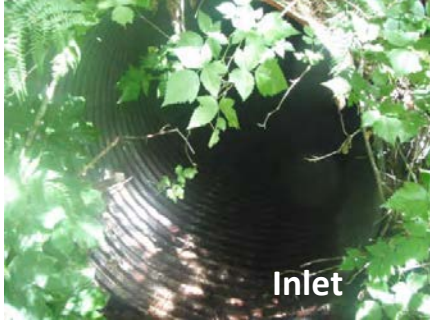
<p align="right">Inlet</p>			
Stream Name		Middle Fork North Fork Trask River					
Township-Range-Section-1/4		T2S, R6W, Sec. 10, NE¼ of NE¼					
UTM Easting/Northing (Zone 10, NAD 1983)		468438/5029260					
Road Name		Flora Mainline Road					
Road/Culvert Owner		Weyerhaeuser Company					
Adjacent Landowners		Weyerhaeuser Company					
CULVERT INFO		CHANNEL INFO					
Shape	Circular	Inlet Gradient (%)	10.0				
Material	Corrugated metal	Upstream Gradient (%)	5.0				
Length (ft)	105	Bankfull Width (ft)	8.3				
Width (in)	64	Bankfull:Culvert Ratio	0.6				
Height (in)	64	Topography precluded use of survey equipment to collect longitudinal profile data					
Outlet Perch (ft)	1.5						
Slope (%)	7.0						
Rustline Height (in)	24						
Overall Condition	Poor						
PRIORITIZATION ANALYSIS							
Upstream Habitat Length (mi)	1.0	Habitat Points	2

Habitat Quality	Fair	Habitat Quality Points	2				
Fish Species	Resident	Fish Points	2				
Barrier Class	Red	Barrier Points	3				
		Prioritization Total Points	9				
Notes:

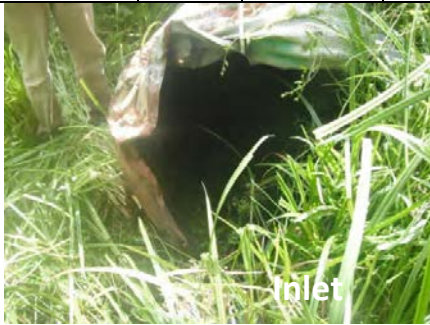
<p align="right">Inlet</p>			
Stream Name		Unnamed tributary of Middle Fork North Fork Trask River					
Township-Range-Section-1/4		T2S, R6W, Sec. 11, NW¼ of NW¼					
UTM Easting/Northing (Zone 10, NAD 1983)		468510/5029400					
Road Name		Unnamed off of Flora Mainline Road					
Road/Culvert Owner		Weyerhaeuser Company					
Adjacent Landowners		Weyerhaeuser Company					
CULVERT INFO		CHANNEL INFO					
Shape	Circular	Inlet Gradient (%)	2.0				
Material	Corrugated metal	Upstream Gradient (%)	10.2				
Length (ft)	100	Bankfull Width (ft)	5.0				
Width (in)	42	Bankfull:Culvert Ratio	0.7				
Height (in)	42	Topography precluded use of survey equipment to collect longitudinal profile data					
Outlet Perch (ft)	3.0						
Slope (%)	12.0						
Rustline Height (in)	14						
Overall Condition	Poor						
PRIORITIZATION ANALYSIS							
Upstream Habitat Length (mi)	0.1	Habitat Points	1

Habitat Quality	Poor	Habitat Quality Points	1				
Fish Species	Resident	Fish Points	2				
Barrier Class	Red	Barrier Points	3				
		Prioritization Total Points	7				
Notes:
