**Trask River Basin
Culverts**

Trask Basin Crossings

Trask River Basin Clusters

HOLDEN CREEK CULVERTS

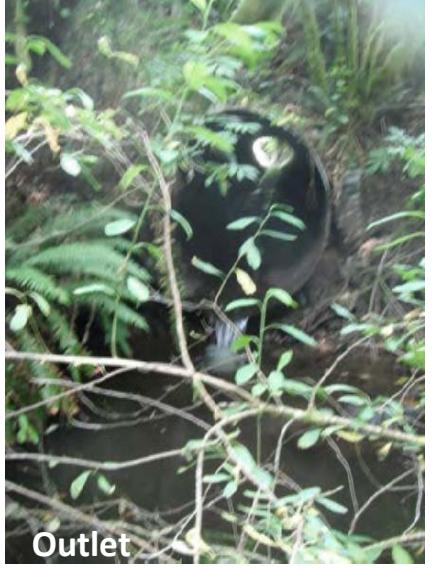
| LOCATION INFO | | Culvert # | 907 | Priority | L | | |
|--|---|---|---|--|---|--|--|
| Rustline Height (in) | 29 | | | | | | |
| Overall Condition | Poor | | | | | | |

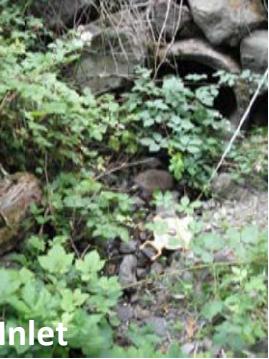
| LOCATION INFO | | Culvert # | 903 | Priority | L | | |
|---|---|---|---|--|---|--|--|
| Shape | Circular | Inlet Gradient (%) | 13.8 | Inlet | | | |
| Material | Concrete | Upstream Gradient (%) | 8.4 | | | | |
| Length (ft) | 56 | Bankfull Width (ft) | 7.8 | | | | |

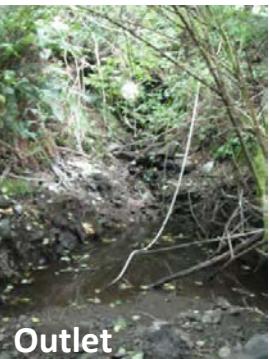
| LOCATION INFO | | Culvert # | 903 | Priority | L | | |
|---|---|---|---|--|---|--|--|
| Rustline Height (in) | N/A | | | | | | |
| Overall Condition | Fair | | | | | | |
