Kansas Creek Culverts, Wilson River Basin

BEAR CREEK AREA CULVERT

LOCATION INFO				Culvert #	723	Priority	L
Watershed		Wilson River

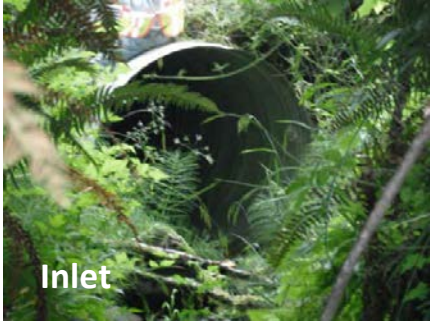
LOCATION INFO				Culvert #	604	Priority	L
Watershed		Wilson River

<p align="center">Inlet</p>			
Stream Name		Unnamed tributary of Wilson River					
Township-Range-Section-1/4		T1S, R8W, Sec. 1, NW¼ of NE¼					
UTM Easting/Northing (Zone 10, NAD 1983)		451998/5041075					
Road Name		Highway 6					
Road/Culvert Owner		Oregon Department of Transportation					
Adjacent Landowners		Oregon Department of Forestry					
CULVERT INFO		CHANNEL INFO					
Shape	Circular	Inlet Gradient (%)	35.3				
Material	Corrugated metal	Upstream Gradient (%)	14.9				
Length (ft)	99	Bankfull Width (ft)	6.7				
Width (in)	60	Bankfull:Culvert Ratio	0.8				
Height (in)	60	Stream dry during summer 2011 data collection effort.					
Outlet Perch (ft)	0.1						
Gradient (%)	7.3						
Rustline Height (in)	None						
Overall Condition	Good						
PRIORITIZATION ANALYSIS							
Upstream Habitat Length (mi)	0.1	Habitat Points	1				
Habitat Quality	Poor	Habitat Quality Points	1

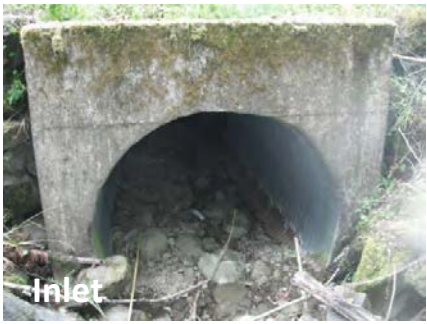
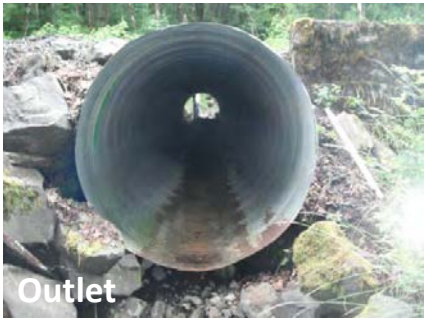
LOCATION INFO				Culvert #	447	Priority	L
Watershed		Wilson River

Shape	Circular	Inlet Gradient (%)	20.7				
Material	Corrugated metal	Upstream Gradient (%)	10.1				
Length (ft)	66	Bankfull Width (ft)	8.5				
Width (in)	72	Bankfull:Culvert Ratio	0.7				
Height (in)	72						
Outlet Perch (ft)	2.2						
Gradient (%)	3.6						
Rustline Height (in)	18						
Overall Condition	Fair						
PRIORITIZATION ANALYSIS							
Upstream Habitat Length (mi)	0.1	Habitat Points	1				
Habitat Quality	Fair	Habitat Quality Points	2				
Fish Species	Anad.	Fish Points	3				
Barrier Class	Red	Barrier Points	3

Prioritization Total Points	9				
Notes: Stream was dry during summer 2011 survey visit.

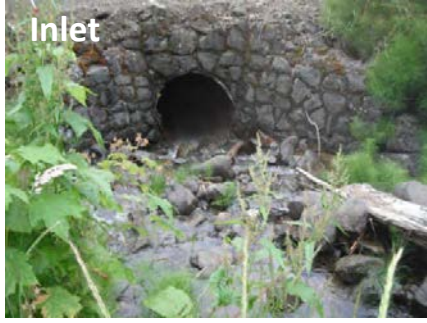
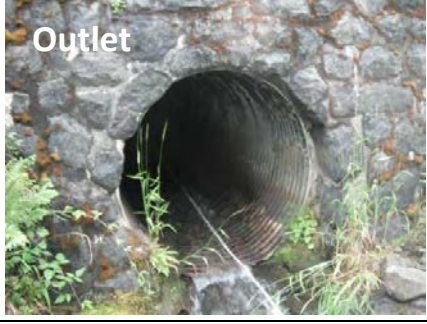
LOCATION INFO				Culvert #	405	Priority	M
Watershed		Wilson River

Shape	Circular	Inlet Gradient (%)	26.5				
Material	Corrugated metal	Upstream Gradient (%)	15.5				
Length (ft)	51	Bankfull Width (ft)	6.7				
Width (in)	54	Bankfull:Culvert Ratio	0.7				
Height (in)	54						
Outlet Perch (ft)	1.1						
Gradient (%)	10.8						
Rustline Height (in)	30						
Overall Condition	Fair						
PRIORITIZATION ANALYSIS							
Upstream Habitat Length (mi)	0.7	Habitat Points	2				
Habitat Quality	Fair	Habitat Quality Points	2				
Fish Species	Anad.	Fish Points	3				
Barrier Class	Red	Barrier Points	3

Prioritization Total Points	10				
Notes: This culvert has rock headwalls and wingwalls that may have been constructed by the Civilian Conservation Corps. The Oregon State Historical Preservation Office should be consulted regarding these features. Replacement of this culvert will likely require compliance with applicable cultural resources protection laws.

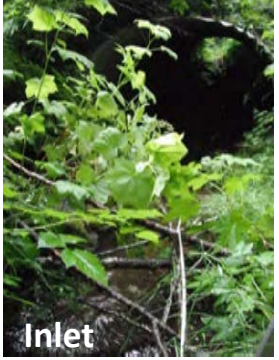
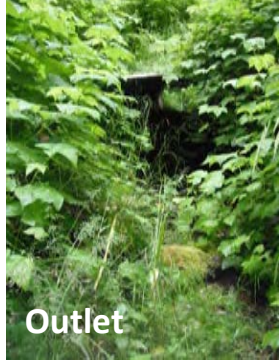
LOCATION INFO				Culvert #	304	Priority	L
Watershed		Wilson River

Shape	Pipe arch	Inlet Gradient (%)	2.5				
Material	Corrugated metal	Upstream Gradient (%)	5.4				
Length (ft)	45	Bankfull Width (ft)	6.2				
Width (in)	100	Bankfull:Culvert Ratio	1.4				
Height (in)	68						
Outlet Perch (ft)	1.0						
Gradient (%)	1.8						
Rustline Height (in)	None						
Overall Condition	Fair						
PRIORITIZATION ANALYSIS							
Upstream Habitat Length (mi)	0.4	Habitat Points	1				
Habitat Quality	Fair	Habitat Quality Points	2				
Fish Species	Anad.	Fish Points	3

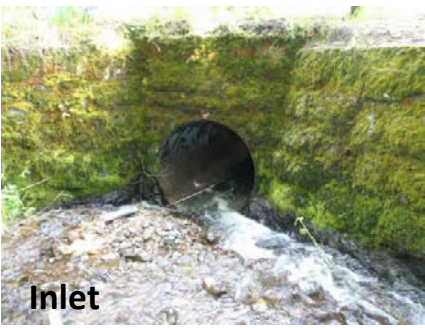
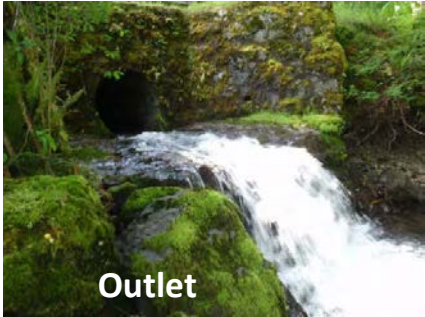
LOCATION INFO				Culvert #	333	Priority	H
Watershed		Wilson River

Shape	Circular	Inlet Gradient (%)	4.0				
Material	Corrugated metal	Upstream Gradient (%)	3.0				
Length (ft)	42	Bankfull Width (ft)	11.2				
Width (in)	51	Bankfull:Culvert Ratio	1.4				
Height (in)	51						
Outlet Perch (ft)	8.0						
Gradient (%)	1.0	*Used Abney Level to determine gradients.					
Rustline Height (in)	22						
Overall Condition	Poor						
PRIORITIZATION ANALYSIS							
Upstream Habitat Length (mi)	0.9	Habitat Points	2				
Habitat Quality	Good	Habitat Quality Points	3				
Fish Species	Anad.	Fish Points	3

Barrier Class	Red	Barrier Points	3				
		Prioritization Total Points	11				
Notes: This culvert has rock headwalls, wingwalls, and an outlet apron that may have been constructed by the Civilian Conservation Corps. The Oregon State Historical Preservation Office should be consulted regarding these features. Replacement of this culvert will likely require compliance with applicable cultural resources protection laws.

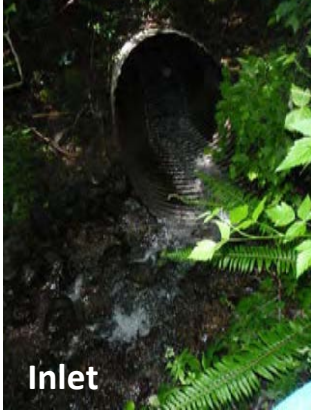
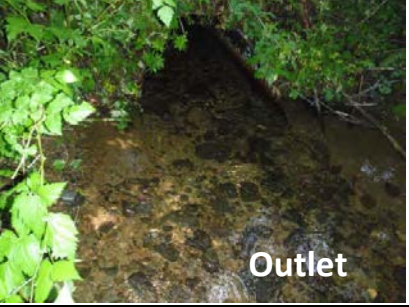
LOCATION INFO				Culvert #	305	Priority	H
Watershed		Wilson River

Fish Species	Anad.	Fish Points	3				
Barrier Class	Red	Barrier Points	3				
		Prioritization Total Points	11				
Notes: Tech. team noted that, based on their experience, an unidentified barrier culvert occurs on a utility Right-of-Way across private land approximately 0.1 miles upstream of this crossing.

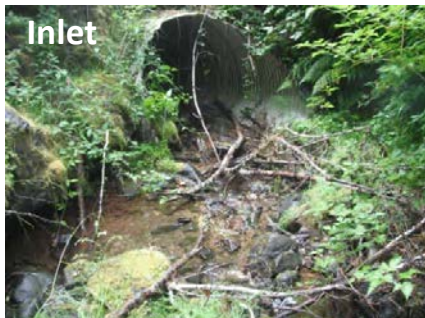
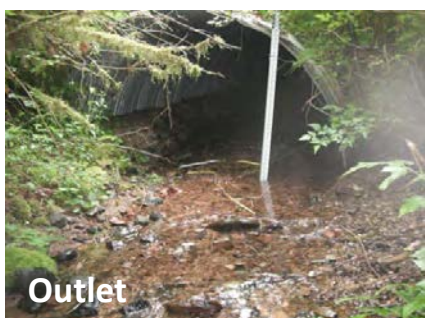
LOCATION INFO				Culvert #	388	Priority	L
Watershed		Wilson River

Barrier Class	Gray	Barrier Points	2				
		Prioritization Total Points	8				
Notes: Barrier class based on culvert slope being greater than ± 1 percent of stream gradient.

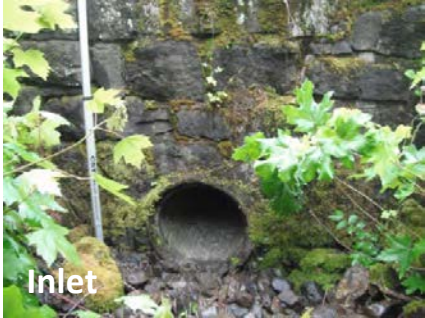
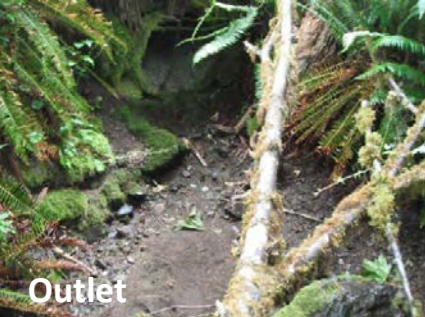
LOCATION INFO				Culvert #	240	Priority	L
Watershed		Wilson River

Fish Species	Anad.	Fish Points	3				
Barrier Class	Red	Barrier Points	3				
		Prioritization Total Points	9				
Notes: Stream dry during summer 2011 site visit. This culvert has rock headwalls that may have been constructed by the Civilian Conservation Corps. The Oregon State Historical Preservation Office should be consulted regarding these features. Replacement of this culvert will likely require compliance with applicable cultural resources protection laws.

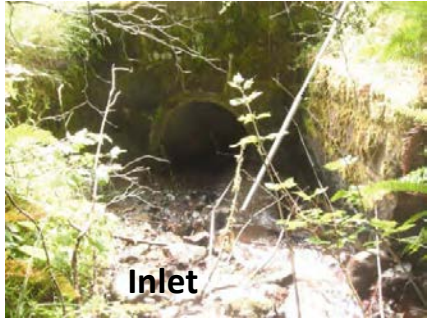
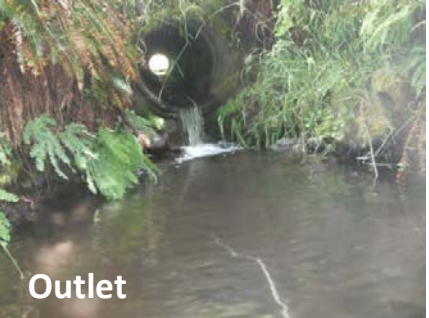
LOCATION INFO				Culvert #	227	Priority	L
Watershed		Wilson River

Shape	Circular	Inlet Gradient (%)	20.5				
Material	Concrete	Upstream Gradient (%)	6.3				
Length (ft)	61	Bankfull Width (ft)	7.2				
Width (in)	36	Bankfull:Culvert Ratio	0.4				
Height (in)	36						
Outlet Perch (ft)	1.8						
Gradient (%)	4.3						
Rustline Height (in)	N/A						
Overall Condition	Fair						
PRIORITIZATION ANALYSIS							
Upstream Habitat Length (mi)	0.2	Habitat Points	1				
Habitat Quality	Fair	Habitat Quality Points	2				
Fish Species	Anad.	Fish Points	3				
Barrier Class	Red	Barrier Points	3

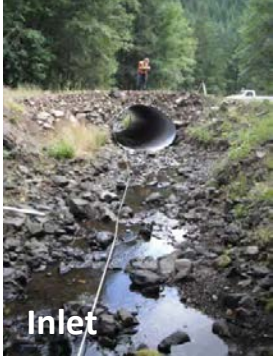
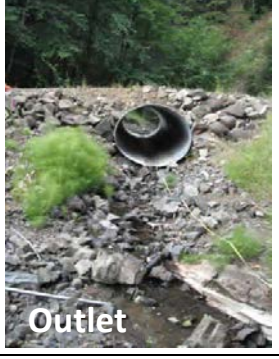
LOCATION INFO				Culvert #	300	Priority	L
Watershed		Wilson River

<p align="center">Outlet</p>			
Shape	Pipe arch	Inlet Gradient (%)	5.1				
Material	Corrugated metal	Upstream Gradient (%)	4.0				
Length (ft)	43	Bankfull Width (ft)	9.2				
Width (in)	94	Bankfull:Culvert Ratio	0.9				
Height (in)	72						
Outlet Perch (ft)	2.2						
Gradient (%)	4.5						
Rustline Height (in)	6						
Overall Condition	Good						
PRIORITIZATION ANALYSIS							
Upstream Habitat Length (mi)	0.2	Habitat Points	1				
Habitat Quality	Fair	Habitat Quality Points	2

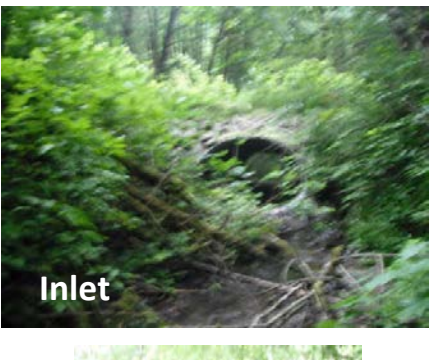
<p align="center">Outlet</p>			
Shape	Pipe arch	Inlet Gradient (%)	5.2				
Material	Corrugated metal	Upstream Gradient (%)	6.5				
Length (ft)	67	Bankfull Width (ft)	11.1				
Width (in)	126	Bankfull:Culvert Ratio	0.9				
Height (in)	86						
Outlet Perch (ft)	4.3						
Gradient (%)	9.2						
Rustline Height (in)	4						
Overall Condition	Fair						
PRIORITIZATION ANALYSIS							
Upstream Habitat Length (mi)	0.3	Habitat Points	1				
Habitat Quality	Poor	Habitat Quality Points	1

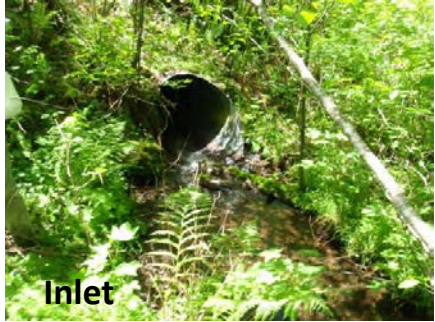
<p>Inlet</p>

<p>Outlet</p>		
Stream Name	Unnamed tributary of South Fork Wilson River						
Township-Range-Section-1/4	T1N R5W, Sec. 4, SE¼ of SE¼						
UTM Easting/Northing (Zone 10, NAD 1983)	466347/5048623						
Road Name	Stage Road						
Road/Culvert Owner	Oregon Department of Forestry						
Adjacent Landowners	Oregon Department of Forestry						
CULVERT INFO		CHANNEL INFO					
Shape	Circular	Inlet Gradient (%)	12.0				
Material	Corrugated metal	Upstream Gradient (%)	18.0				
Length (ft)	67	Bankfull Width (ft)	11.2				
Width (in)	57	Bankfull:Culvert Ratio	0.4				
Height (in)	57						
Outlet Perch (ft)	None						
Gradient (%)	6.0						
Rustline Height (in)	-						
Overall Condition	Good						
PRIORITIZATION ANALYSIS							
Upstream Habitat Length (mi)	0.1	Habitat Points	1				
Habitat Quality	Poor	Habitat Quality Points	1				
Fish Species	Anad.	Fish Points	3

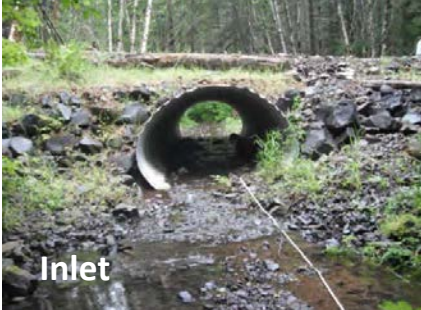
<p>Inlet</p>			
Stream Name		Elliot Creek					
Township-Range-Section-1/4		T1N R6W, Sec. 2, SE¼ of SE¼					
UTM Easting/Northing (Zone 10, NAD 1983)		470043/5049124					
Road Name		Unnamed off Beaver Dam Road					
Road/Culvert Owner		Oregon Department of Forestry					
Adjacent Landowners		Oregon Department of Forestry					
CULVERT INFO		CHANNEL INFO					
Shape	Pipe arch	Inlet Gradient (%)	5.2				
Material	Corrugated metal	Upstream Gradient (%)	6.2				
Length (ft)	41	Bankfull Width (ft)	8.0				
Width (in)	102	Bankfull:Culvert Ratio	1.1				
Height (in)	72	Crossing approx 250 ft upstream of University Falls, a complete passage barrier. Beaver dam blocking inlet in summer 2011, creating large wetland above culvert. 2012 photos.					
Outlet Perch (ft)	0.2						
Gradient (%)	2.6						
Rustline Height (in)	5						
Overall Condition	Good

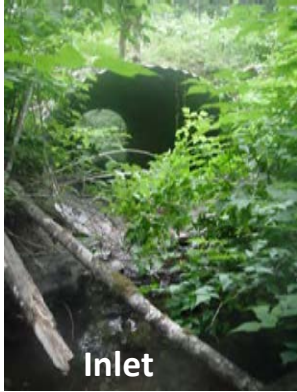
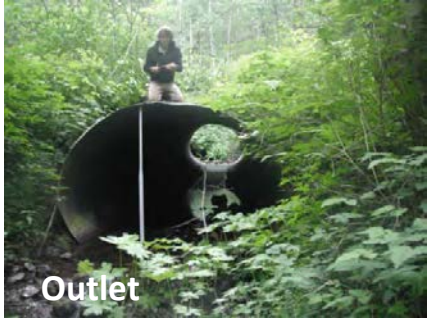
LOCATION INFO				Culvert #	266	Priority	M
Watershed		Wilson River

Shape	Pipe arch	Inlet Gradient (%)	2.4				
Material	Corrugated metal	Upstream Gradient (%)	5.2				
Length (ft)	66	Bankfull Width (ft)	9.8				
Width (in)	120	Bankfull:Culvert Ratio	1.0				
Height (in)	96						
Outlet Perch (ft)	1.1						
Gradient (%)	2.7						
Rustline Height (in)	9						
Overall Condition	Poor						
PRIORITIZATION ANALYSIS							
Upstream Habitat Length (mi)	1.0	Habitat Points	2				
Habitat Quality	Good	Habitat Quality Points	3				
Fish Species	Resident	Fish Points	2				
Barrier Class	Red	Barrier Points	3

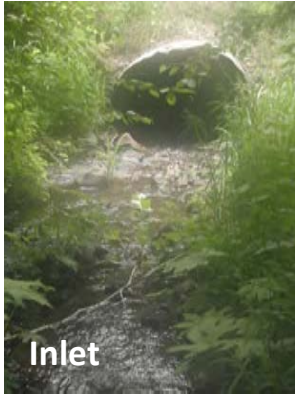
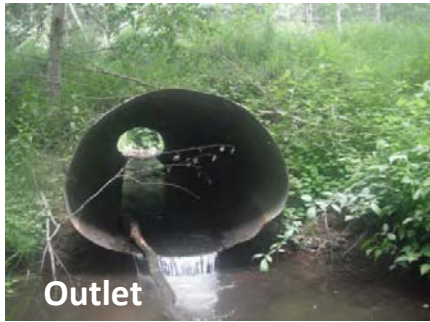
LOCATION INFO				Culvert #	249	Priority	H
Watershed		Wilson River

Shape	Pipe arch	Inlet Gradient (%)	4.8				
Material	Corrugated metal	Upstream Gradient (%)	5.1				
Length (ft)	50	Bankfull Width (ft)	10.6				
Width (in)	76	Bankfull:Culvert Ratio	0.6				
Height (in)	54						
Outlet Perch (ft)	0.6						
Gradient (%)	0.6						
Rustline Height (in)	12						
Overall Condition	Poor						
PRIORITIZATION ANALYSIS							
Upstream Habitat Length (mi)	1.7	Habitat Points	4				
Habitat Quality	Good	Habitat Quality Points	3				
Fish Species	Anad.	Fish Points	3				
Barrier Class	Red	Barrier Points	3

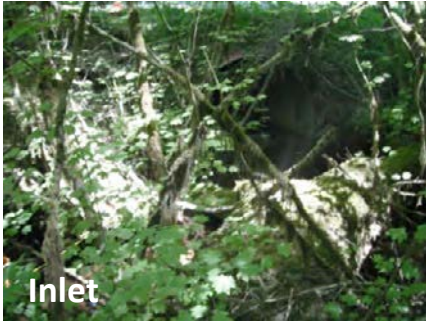
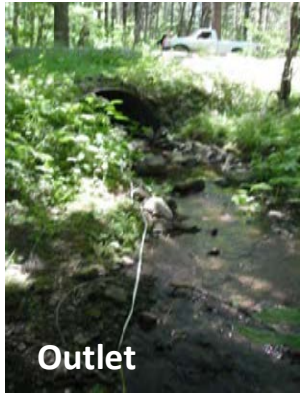
LOCATION INFO				Culvert #	202	Priority	H
Watershed		Wilson River

Shape	Pipe arch	Inlet Gradient (%)	-8.6				
Material	Corrugated metal	Upstream Gradient (%)	0.5				
Length (ft)	54	Bankfull Width (ft)	7.8				
Width (in)	94	Bankfull:Culvert Ratio	1.0				
Height (in)	60						
Outlet Perch (ft)	None	Crew couldn't find invert of pipe below substrate, but it appears to be a pipe arch and not an open-bottomed arch.					
Gradient (%)	1.8						
Rustline Height (in)	12						
Overall Condition	Good						
PRIORITIZATION ANALYSIS							
Upstream Habitat Length (mi)	0.8	Habitat Points	2
