# NESTUCCA / NESKOWIN WATERSHEDS

## CULVERT PRIORITIZATION AND ACTION PLAN FOR FISH PASSAGE

**Rachel Hoffman  
Environmental Project Manager  
Tillamook Estuaries Partnership**

**May 2006**

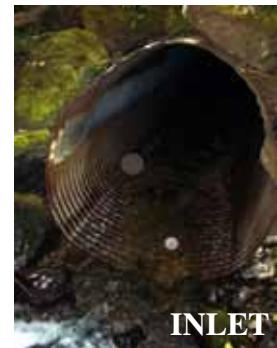
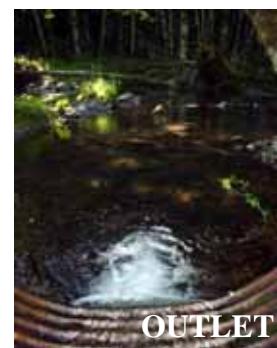
LOCATION INFO		CULVERT #	1090	PRIORITY	H
Watershed	Nestucca				
Stream Name	Ginger Creek				
Township-Range-Section-1/4	3S – 6W – S7 – NE of SE				
UTM Easting / Northing	463721 / 5018630				
Road Name	3613 – Nestucca Access Road				
Road/Culvert Owner	BLM				
Adjacent Landowners	BLM				
CULVERT INFO		CHANNEL INFO			
Shape	Circular	Inlet Gradient (%)	21.0		
Material	Corrugated metal	Upstream Gradient (%)	10.0		
Length (ft)	82.1	Bankfull Width (ft)	20.0		
Width (in)	60.0	Bankfull Ratio	0.3		
Height (in)	60.0				
Outlet Drop (ft)	1.3				
Slope (%)	2.0				
PRIORITIZATION ANALYSIS					
Habitat Length	0.7 miles	(1) Habitat Pts	2		
Habitat Quality	fair	(2) Habitat Quality Pts	2		
Fish Species	co stw chf ct	(3) Fish Pts	3		
Barrier Type	RED	(4) Barrier Pts	3		
		Prioritization Total Pts	<b>10</b>

**NOTES:** Located at Ginger Creek's confluence with the mainstem Nestucca, this culvert is adjacent to a very productive salmon spawning reach. BLM has completed an Environmental Assessment for the replacement. Approximately 400' upstream is a 6' bedrock jump, created from past debris torrents, that appears to stop adult and juvenile passage. Although this barrier currently truncates anadromous distribution, the barrier is not permanent.

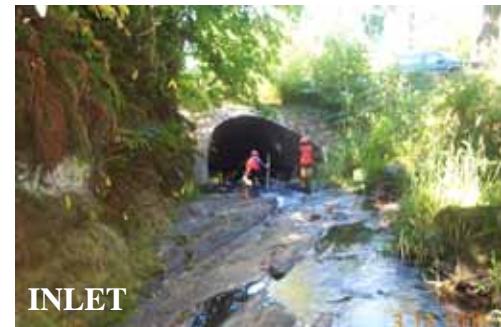
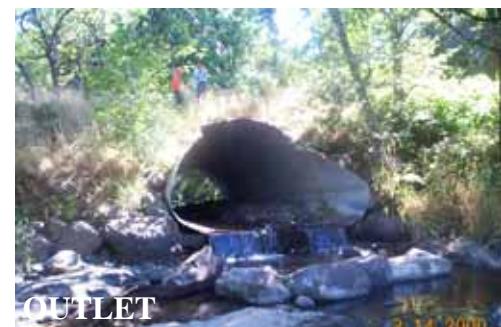
LOCATION INFO		CULVERT #	1376	PRIORITY	M
Watershed	Nestucca				
Stream Name	Slick Rock Creek				
Township-Range-Section-1/4	4S – 8W – S1 – SE of NW				
UTM Easting / Northing	451373 / 5011137				
Road Name	Blaine Road				
Road/Culvert Owner	Tillamook County				
Adjacent Landowners	Alicia Boicken, Wendell Larrew				
CULVERT INFO		CHANNEL INFO			
Shape	Pipe arch	Inlet Gradient (%)	17.0		
Material	Corrugated metal	Upstream Gradient (%)	4.0		
Length (ft)	83.0	Bankfull Width (ft)	22.3		
Width (in)	210.0	Bankfull Ratio	0.8		
Height (in)	150.0				
Outlet Drop (ft)	2.1				
Slope (%)	2.0				
PRIORITIZATION ANALYSIS					
Habitat Length	1.0 mile	(1) Habitat Pts	2		
Habitat Quality	good	(2) Habitat Quality Pts	3		
Fish Species	co stw chf ct	(3) Fish Pts	3		
Barrier Type	RED	(4) Barrier Pts	3		
		Prioritization Total Pts	<b>11</b>

**NOTES:** A 60' barrier falls exists 1.0 mile upstream. According to the RBA, coho distribution terminates 0.3 miles below the falls at a series of 6' bedrock slides.

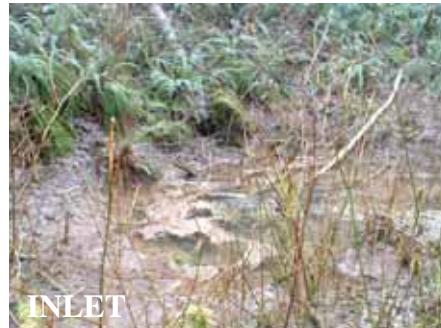
**INLET**

LOCATION INFO		CULVERT #	F761	PRIORITY	M
Watershed	Nestucca				
Stream Name	Niagara Creek tributary				
Township-Range-Section-1/4	4S – 8W – S27 – SW of SW				
UTM Easting / Northing	448144 / 5004228				
Road Name	2283				
Road/Culvert Owner	USFS				
Adjacent Landowners	USFS				
CULVERT INFO		CHANNEL INFO			
Shape	Circular	Inlet Gradient (%)	3.0		
Material	Corrugated metal	Upstream Gradient (%)	2.0		
Length (ft)	89.0	Bankfull Width (ft)	11.8		
Width (in)	48.0	Bankfull Ratio	0.3		
Height (in)	48.0				
Outlet Drop (ft)	1.7				
Slope (%)	3.0				
PRIORITIZATION ANALYSIS					
Habitat Length	0.8 miles	(1) Habitat Pts	2		
Habitat Quality	fair	(2) Habitat Quality Pts	2		
Fish Species	ct	(3) Fish Pts	2		
Barrier Type	RED	(4) Barrier Pts	3		
		Prioritization Total Pts	9

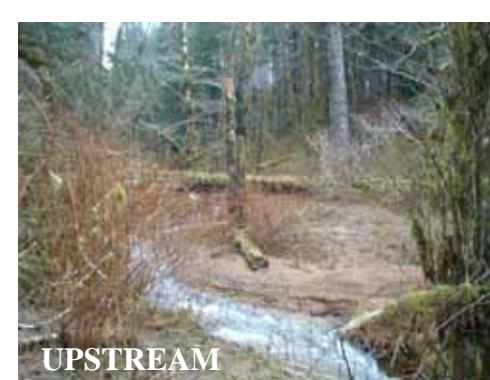
**UPSTREAM**

LOCATION INFO		CULVERT #	F762	PRIORITY	M
Watershed	Nestucca				
Stream Name	Niagara Creek tributary				
Township-Range-Section-1/4	4S – 8W – S27 – SW of SW				
UTM Easting / Northing	448109 / 5004132				
Road Name	2283				
Road/Culvert Owner	USFS				
Adjacent Landowners	USFS				
CULVERT INFO		CHANNEL INFO			
Shape	Circular	Inlet Gradient (%)	44.0		
Material	Corrugated metal	Upstream Gradient (%)	2.0		
Length (ft)	111.0	Bankfull Width (ft)	7.8		
Width (in)	48.0	Bankfull Ratio	0.5		
Height (in)	48.0				
Outlet Drop (ft)	1.8				
Slope (%)	0.0				
PRIORITIZATION ANALYSIS					
Habitat Length	0.5 miles	(1) Habitat Pts	1		
Habitat Quality	fair	(2) Habitat Quality Pts	2		
Fish Species	ct	(3) Fish Pts	2		
Barrier Type	RED	(4) Barrier Pts	3		
		Prioritization Total Pts	8

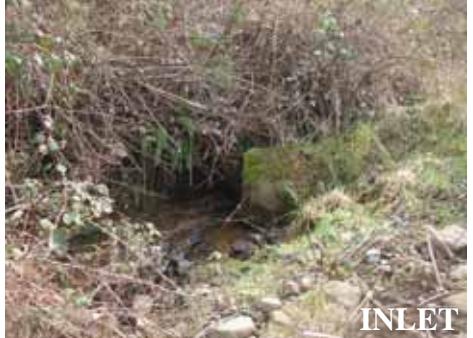
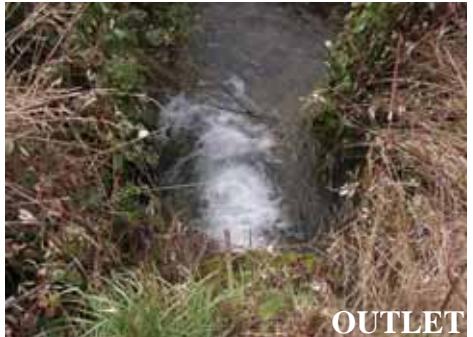
LOCATION INFO		CULVERT #		1208	PRIORITY	H
Watershed	Nestucca					
Stream Name	Moon Creek tributary					
Township-Range-Section-1/4	3S – 8W – S20 – SW of SW					
UTM Easting / Northing	444987 / 5015146					
Road Name	863 – Moon Creek Road					
Road/Culvert Owner	Tillamook County					
Adjacent Landowners	John Luciano					
CULVERT INFO		CHANNEL INFO				
Shape	Circular	Inlet Gradient (%)	22.0			
Material	Concrete	Upstream Gradient (%)	4.0			
Length (ft)	51.0	Bankfull Width (ft)	6.0			
Width (in)	30.0	Bankfull Ratio	0.4			
Height (in)	30.0					
Outlet Drop (ft)	0.6					
Slope (%)	4.0					
PRIORITIZATION ANALYSIS						
Habitat Length	0.6 miles	(1) Habitat Pts	2			
Habitat Quality	poor	(2) Habitat Quality Pts	1			
Fish Species	ct	(3) Fish Pts	2			
Barrier Type	RED	(4) Barrier Pts	3			
		Prioritization Total Pts	8

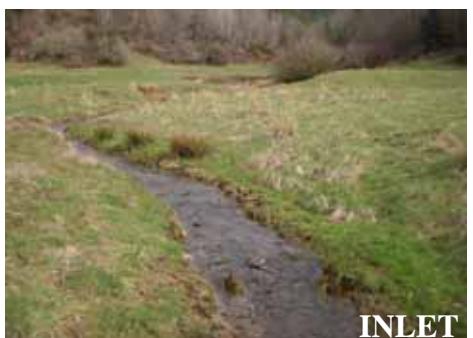
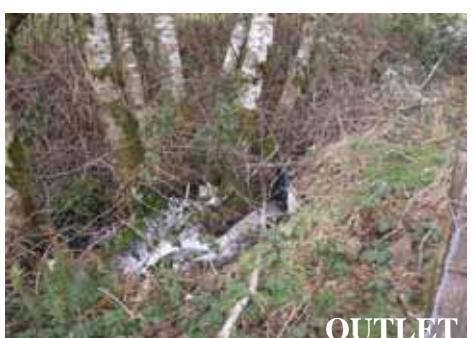
LOCATION INFO		CULVERT #		03020	PRIORITY	H
Watershed	Nestucca					
Stream Name	Moon Creek tributary					
Township-Range-Section-1/4	3S – 8W – S20 – NW of NW					
UTM Easting / Northing	44890 / 5016400					
Road Name	863 – Moon Creek Road					
Road/Culvert Owner	Private					
Adjacent Landowners	Lyle Bledsoe					
CULVERT INFO		CHANNEL INFO				
Shape	Circular	Inlet Gradient (%)	---			
Material	Corrugated metal	Upstream Gradient (%)	5.0			
Length (ft)	50.0	Bankfull Width (ft)	---			
Width (in)	12.0	Bankfull Ratio	---			
Height (in)	12.0					
Outlet Drop (ft)	0.0					
Slope (%)	3.0					
PRIORITIZATION ANALYSIS						
Habitat Length	0.5 miles	(1) Habitat Pts	1			
Habitat Quality	fair	(2) Habitat Quality Pts	2			
Fish Species	ct	(3) Fish Pts	2			
Barrier Type	RED	(4) Barrier Pts	3			
		Prioritization Total Pts	8

**NOTES:** One plastic culvert has recently been installed, adjacent to the metal pipe, and is now carrying most of the streamflow.

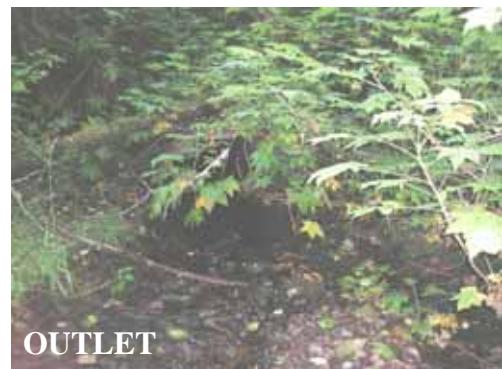
OUTLET

LOCATION INFO		CULVERT #	2016	PRIORITY	M
<b>Watershed</b>	Nestucca				
<b>Stream Name</b>	East Creek tributary				
<b>Township-Range-Section-1/4</b>	3S– 8W – S15 – NE of NW				
<b>UTM Easting / Northing</b>	448137 / 5017918				
<b>Road Name</b>	3727 – East Creek Road				
<b>Road/Culvert Owner</b>	BLM				
<b>Adjacent Landowners</b>	BLM				
CULVERT INFO		CHANNEL INFO			
<b>Shape</b>	Circular	<b>Inlet Gradient (%)</b>	3.0		
<b>Material</b>	Corrugated metal	<b>Upstream Gradient (%)</b>	5.0		
<b>Length (ft)</b>	60.0	<b>Bankfull Width (ft)</b>	15.2		
<b>Width (in)</b>	42.0	<b>Bankfull Ratio</b>	0.2		
<b>Height (in)</b>	42.0				
<b>Outlet Drop (ft)</b>	0.0				
<b>Slope (%)</b>	2.0				
PRIORITIZATION ANALYSIS					
<b>Habitat Length</b>	0.2 miles	<b>(1) Habitat Pts</b>	1		
<b>Habitat Quality</b>	fair	<b>(2) Habitat Quality Pts</b>	2		
<b>Fish Species</b>	co stw ct	<b>(3) Fish Pts</b>	3		
<b>Barrier Type</b>	RED	<b>(4) Barrier Pts</b>	3

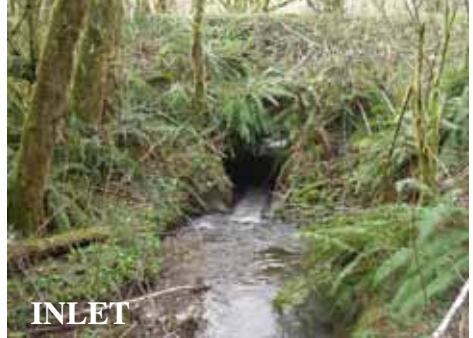
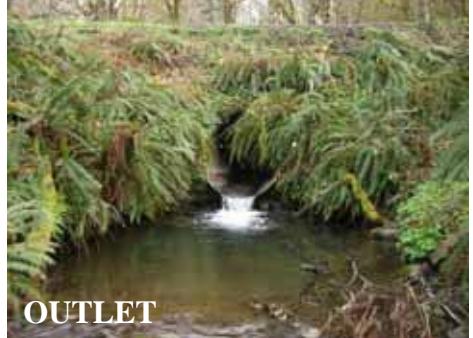
LOCATION INFO		CULVERT #	F2024	PRIORITY	M
Watershed	Nestucca				
Stream Name	Bays Creek tributary				
Township-Range-Section-1/4	3S – 9W – S13 – NE of NW				
UTM Easting / Northing	442582 / 5016182				
Road Name	8573				
Road/Culvert Owner	USFS				
Adjacent Landowners	USFS				
CULVERT INFO		CHANNEL INFO			
Shape	Circular	Inlet Gradient (%)	17.0		
Material	Corrugated metal	Upstream Gradient (%)	3.0		
Length (ft)	54.0	Bankfull Width (ft)	11.9		
Width (in)	72.0	Bankfull Ratio	0.5		
Height (in)	72.0				
Outlet Drop (ft)	0.8				
Slope (%)	5.0				
PRIORITIZATION ANALYSIS					
Habitat Length	0.7 miles	(1) Habitat Pts	2		
Habitat Quality	poor	(2) Habitat Quality Pts	1		
Fish Species	co stw ct	(3) Fish Pts	3		
Barrier Type	RED	(4) Barrier Pts	3		
		Prioritization Total Pts	9

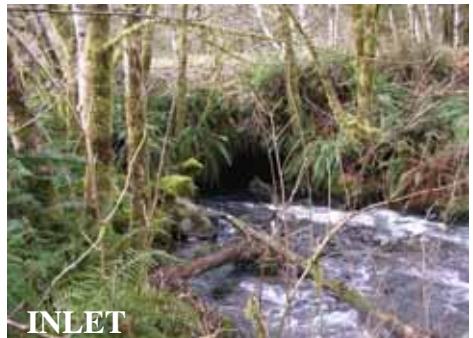
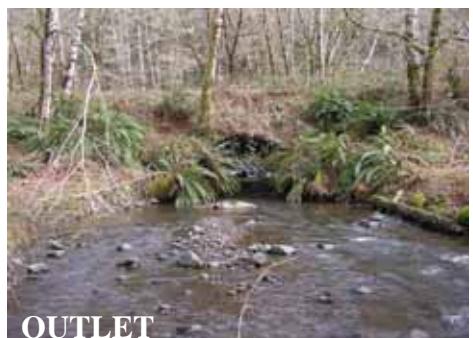
LOCATION INFO		CULVERT #	F2025	PRIORITY	M
Watershed	Nestucca				
Stream Name	Bays Creek				
Township-Range-Section-1/4	3S – 9W – S13 – SE of SW				
UTM Easting / Northing	442266 / 5016722				
Road Name	8573				
Road/Culvert Owner	USFS				
Adjacent Landowners	USFS				
CULVERT INFO		CHANNEL INFO			
Shape	Open bottom arch	Inlet Gradient (%)	36.0		
Material	Corrugated metal	Upstream Gradient (%)	1.0		
Length (ft)	60.0	Bankfull Width (ft)	16.5		
Width (in)	145.0	Bankfull Ratio	0.7		
Height (in)	114.0				
Outlet Drop (ft)	0.0				
Slope (%)	5.0				
PRIORITIZATION ANALYSIS					
Habitat Length	0.5 miles	(1) Habitat Pts	1		
Habitat Quality	good	(2) Habitat Quality Pts	3		
Fish Species	co stw chf ct	(3) Fish Pts	3		
Barrier Type	RED	(4) Barrier Pts	3		
		Prioritization Total Pts	10

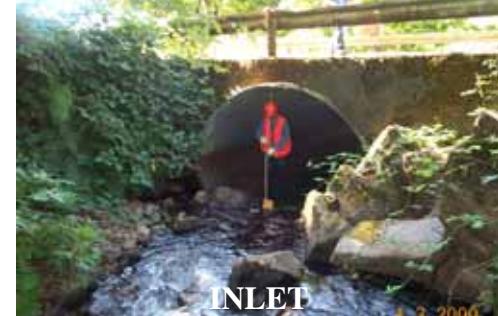
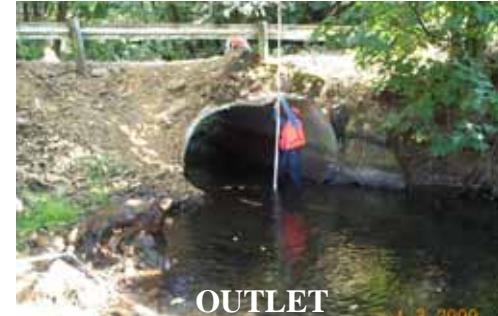
LOCATION INFO		CULVERT #	1237	PRIORITY	H
<b>Watershed</b>	Nestucca				
<b>Stream Name</b>	Boulder Creek				
<b>Township-Range-Section-1/4</b>	3S – 9W – S26 – SW of NE				
<b>UTM Easting / Northing</b>	441128 / 5014415				
<b>Road Name</b>	Blankenship Road				
<b>Road/Culvert Owner</b>	Tillamook County				
<b>Adjacent Landowners</b>	Walter Blankenship, Tillamook County				
CULVERT INFO		CHANNEL INFO			
<b>Shape</b>	Pipe arch	<b>Inlet Gradient (%)</b>	9.0		
<b>Material</b>	Corrugated metal	<b>Upstream Gradient (%)</b>	7.0		
<b>Length (ft)</b>	32.5	<b>Bankfull Width (ft)</b>	17.0		
<b>Width (in)</b>	108.0	<b>Bankfull Ratio</b>	0.5		
<b>Height (in)</b>	72.0				
<b>Outlet Drop (ft)</b>	0.0				
<b>Slope (%)</b>	2.0				
PRIORITIZATION ANALYSIS					
<b>Habitat Length</b>	4.1 miles	<b>(1) Habitat Pts</b>	4		
<b>Habitat Quality</b>	fair	<b>(2) Habitat Quality Pts</b>	2		
<b>Fish Species</b>	co stw chf ct	<b>(3) Fish Pts</b>	3

<b>Barrier Type</b>	GREY	<b>(4) Barrier Pts</b>	2		
		<b>Prioritization Total Pts</b>	11

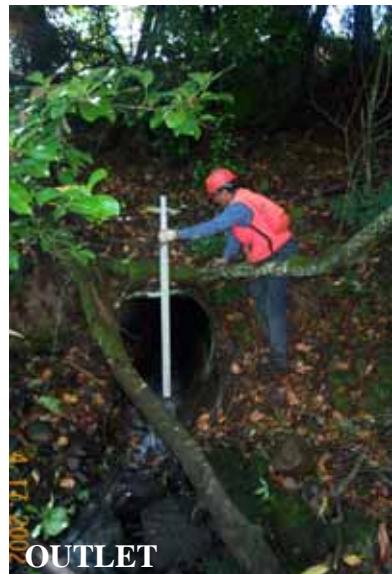
OUTLET

LOCATION INFO		CULVERT #	1253	PRIORITY	M
Watershed	Nestucca				
Stream Name	Nestucca River tributary				
Township-Range-Section-1/4	3S – 9W – S27 – SW of NW				
UTM Easting / Northing	438633 / 5014230				
Road Name	Blaine Road				
Road/Culvert Owner	Tillamook County				
Adjacent Landowners	Doris Sorenson Trust				
CULVERT INFO		CHANNEL INFO			
Shape	Circular	Inlet Gradient (%)	9.0		
Material	Concrete/Corrugated metal	Upstream Gradient (%)	4.0		
Length (ft)	53.0	Bankfull Width (ft)	11.0		
Width (in)	42.0	Bankfull Ratio	0.3		
Height (in)	42.0				
Outlet Drop (ft)	1.5				
Slope (%)	12.0				
PRIORITIZATION ANALYSIS					
Habitat Length	0.3 miles	(1) Habitat Pts	1		
Habitat Quality	poor	(2) Habitat Quality Pts	1		
Fish Species	co ct	(3) Fish Pts	3		
Barrier Type	RED	(4) Barrier Pts	3		
		Prioritization Total Pts	8

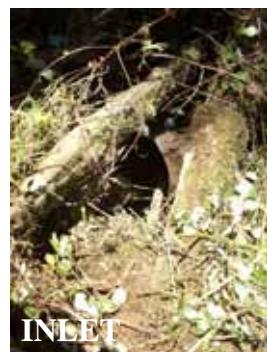
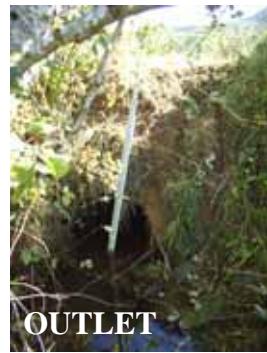
LOCATION INFO		CULVERT #	1278	PRIORITY	M
Watershed	Nestucca				
Stream Name	Nestucca River tributary				
Township-Range-Section-1/4	3S – 9W – S27 – NW of SW				
UTM Easting / Northing	438599 / 5014078				
Road Name	Unnamed				
Road/Culvert Owner	Private				
Adjacent Landowners	Doris Sorenson Trust				
CULVERT INFO		CHANNEL INFO			
Shape	Circular	Inlet Gradient (%)	12.0		
Material	Corrugated metal	Upstream Gradient (%)	2.0		
Length (ft)	24.0	Bankfull Width (ft)	6.0		
Width (in)	24.0	Bankfull Ratio	0.3		
Height (in)	24.0				
Outlet Drop (ft)	0.0				
Slope (%)	4.0				
PRIORITIZATION ANALYSIS					
Habitat Length	0.4 miles	(1) Habitat Pts	1		
Habitat Quality	poor	(2) Habitat Quality Pts	1		
Fish Species	co ct	(3) Fish Pts	3		
Barrier Type	RED	(4) Barrier Pts	3		
		Prioritization Total Pts	8

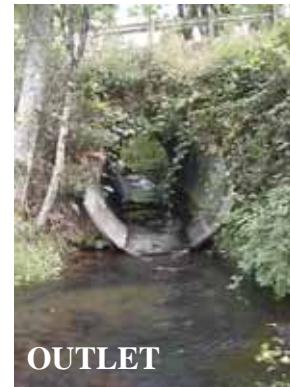
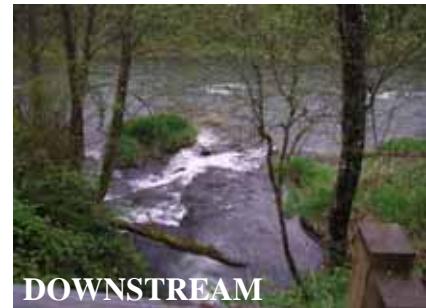
<b>LOCATION INFO</b>		<b>CULVERT #</b>	<b>O3058</b>	<b>PRIORITY</b>	<b>H</b>
<b>Watershed</b>	Nestucca				
<b>Stream Name</b>	Wolfe Creek				
<b>Township-Range-Section-1/4</b>	3S – 9W – S28 – NE of NE				
<b>UTM Easting / Northing</b>	438210 / 5014600				
<b>Road Name</b>	860 – Wolfe Creek Road				
<b>Road/Culvert Owner</b>	Tillamook County				
<b>Adjacent Landowners</b>	Thomas Deyoe, Bryan Measor				
<b>CULVERT INFO</b>		<b>CHANNEL INFO</b>			
<b>Shape</b>	Circular	<b>Inlet Gradient (%)</b>	3.0		
<b>Material</b>	Corrugated metal	<b>Upstream Gradient (%)</b>	4.0		
<b>Length (ft)</b>	65.0	<b>Bankfull Width (ft)</b>	30.0		
<b>Width (in)</b>	120.0	<b>Bankfull Ratio</b>	0.3		
<b>Height (in)</b>	120.0				
<b>Outlet Drop (ft)</b>	0.1				
<b>Slope (%)</b>	2.0				
<b>PRIORITIZATION ANALYSIS</b>					
<b>Habitat Length</b>	4.4 miles	<b>(1) Habitat Pts</b>	4		
<b>Habitat Quality</b>	good	<b>(2) Habitat Quality Pts</b>	3

<b>Fish Species</b>	co stw chf ct	<b>(3) Fish Pts</b>	3		
<b>Barrier Type</b>	RED	<b>(4) Barrier Pts</b>	3		
		<b>Prioritization Total Pts</b>	<b>13</b>

Engineering for replacing this culvert is underway and on-the-ground construction is scheduled for 2007. Along with the culvert replacement, adjacent landowners have agreed to extensive instream and riparian enhancements. ODFW is assisting with instream enhancement designs and the NNWC is assisting with riparian enhancements. All partners listed below are contributing match to the project.

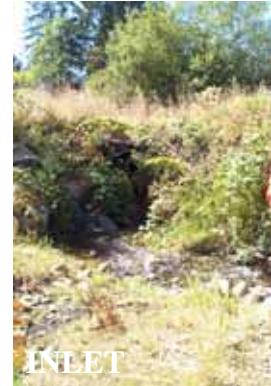
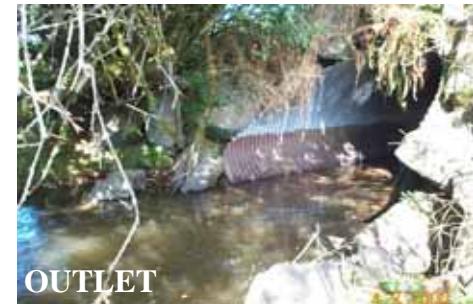
LOCATION INFO		CULVERT #	1309	PRIORITY	H
<b>Watershed</b>	Nestucca				
<b>Stream Name</b>	Foland Creek				
<b>Township-Range-Section-1/4</b>	3S – 9W – S29 – SE of SW				
<b>UTM Easting / Northing</b>	436193 / 5013691				
<b>Road Name</b>	Bixby Road				
<b>Road/Culvert Owner</b>	Tillamook County				
<b>Adjacent Landowners</b>	Timothy Strong, Ollie Woods (Trustee)				
CULVERT INFO		CHANNEL INFO			
<b>Shape</b>	Pipe arch	<b>Inlet Gradient (%)</b>	4.0		
<b>Material</b>	Corrugated metal	<b>Upstream Gradient (%)</b>	2.0		
<b>Length (ft)</b>	52.0	<b>Bankfull Width (ft)</b>	20.0		
<b>Width (in)</b>	96.0	<b>Bankfull Ratio</b>	0.4		
<b>Height (in)</b>	72.0				
<b>Outlet Drop (ft)</b>	0.0				
<b>Slope (%)</b>	0.0				
PRIORITIZATION ANALYSIS					
<b>Habitat Length</b>	2.4 miles	<b>(1) Habitat Pts</b>	4		
<b>Habitat Quality</b>	fair	<b>(2) Habitat Quality Pts</b>	2		
<b>Fish Species</b>	co stw chf ct	<b>(3) Fish Pts</b>	3

<b>Barrier Type</b>	RED	<b>(4) Barrier Pts</b>	3		
		<b>Prioritization Total Pts</b>	<b>12</b>

Both culverts are located under Bixby Road, which is managed by Tillamook County and surrounded by rural landowners. The County could take the lead on culvert #1321, since it is becoming a failure risk, and a partner could take the lead on culvert #1309. The two replacements could leverage the other.

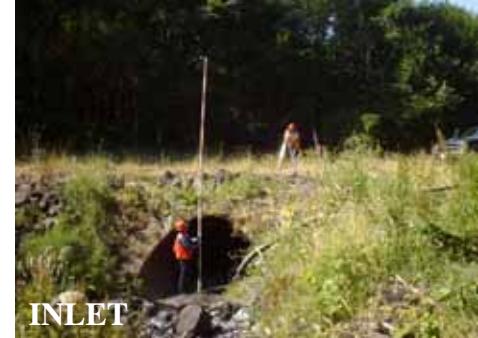
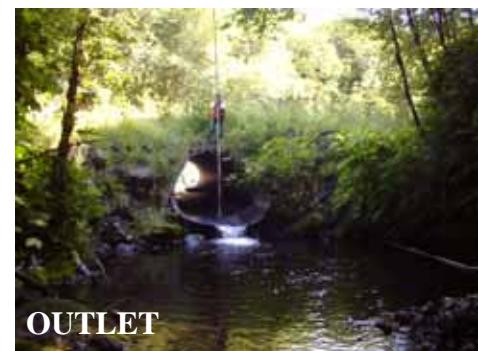
LOCATION INFO		CULVERT #	1001	PRIORITY	H
Watershed	Nestucca				
Stream Name	East Beaver Creek				
Township-Range-Section-1/4	2S – 8W – S29 – NE of SE				
UTM Easting / Northing	446698 / 5023125				
Road Name	857 – East Beaver Creek Road				
Road/Culvert Owner	BLM				
Adjacent Landowners	Green Diamond				
CULVERT INFO		CHANNEL INFO			
Shape	Pipe arch	Inlet Gradient (%)	16.0		
Material	Corrugated metal	Upstream Gradient (%)	9.0		
Length (ft)	60.0	Bankfull Width (ft)	24.5		
Width (in)	96.0	Bankfull Ratio	0.3		
Height (in)	67.0				
Outlet Drop (ft)	1.2				
Slope (%)	6.0				
PRIORITIZATION ANALYSIS					
Habitat Length	0.5 miles	(1) Habitat Pts	1		
Habitat Quality	good	(2) Habitat Quality Pts	3		
Fish Species	co stw ct	(3) Fish Pts	3		
Barrier Type	RED	(4) Barrier Pts	3		
		Prioritization Total Pts	<b>10</b>		
NOTES: BLM has completed an Environmental Assessment for the replacement and is implementation is scheduled for 2006.

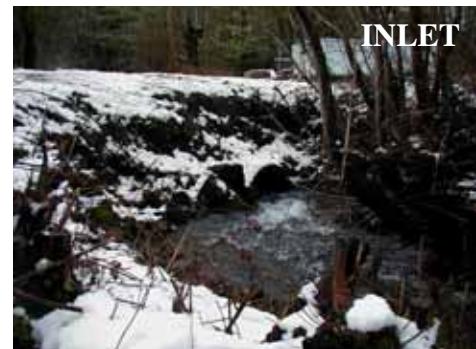
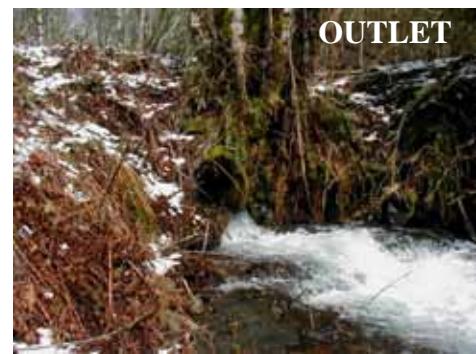
LOCATION INFO		CULVERT #	O3012	PRIORITY	H
Watershed	Nestucca				
Stream Name	Wildcat Creek (East Beaver Creek)				
Township-Range-Section-1/4	3S – 9W – S18 – NW of NE				
UTM Easting / Northing	434925 / 5017825				
Road Name	East Beaver Creek Road				
Road/Culvert Owner	Tillamook County				
Adjacent Landowners	Richard Clark, James Kessinger				
CULVERT INFO		CHANNEL INFO			
Shape	Circular	Inlet Gradient (%)	---		
Material	Corrugated metal	Upstream Gradient (%)	5.0		
Length (ft)	60.0	Bankfull Width (ft)	---		
Width (in)	36.0	Bankfull Ratio	---		
Height (in)	36.0				
Outlet Drop (ft)	0.5				
Slope (%)	4.0				
PRIORITIZATION ANALYSIS					
Habitat Length	1.5 miles	(1) Habitat Pts	4		
Habitat Quality	fair	(2) Habitat Quality Pts	2		
Fish Species	co stw ct	(3) Fish Pts	3		
Barrier Type	RED	(4) Barrier Pts	3		
		Prioritization Total Pts	12		
NOTES: Low priority culvert #1971 and #1972 are upstream but are not barriers. USFS has completed a design for the replacement of this culvert. NNWC is leading implementation, which is scheduled for 2007.

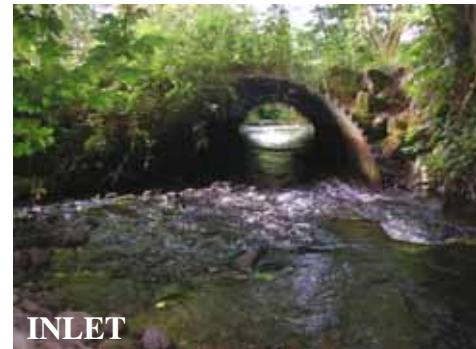
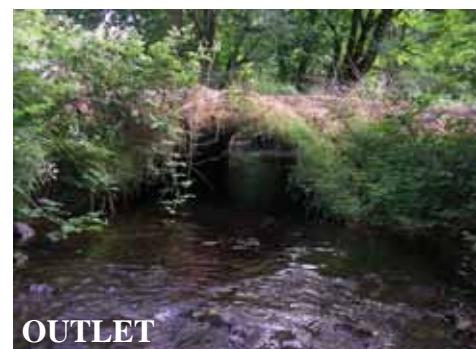
LOCATION INFO		CULVERT #	O3017	PRIORITY	M
Watershed	Nestucca				
Stream Name	Bear Creek (East Beaver Creek)				
Township-Range-Section-1/4	3S – 9W – S18 – NE of NW				
UTM Easting / Northing	434665 / 5017925				
Road Name	857 – East Beaver Creek Road				
Road/Culvert Owner	Tillamook County				
Adjacent Landowners	James Kessinger, William Miles				
CULVERT INFO		CHANNEL INFO			
Shape	Open bottom arch	Inlet Gradient (%)	---		
Material	Corrugated metal	Upstream Gradient (%)	---		
Length (ft)	---	Bankfull Width (ft)	---		
Width (in)	---	Bankfull Ratio	---		
Height (in)	---				
Outlet Drop (ft)	0.0				
Slope (%)	---				
PRIORITIZATION ANALYSIS					
Habitat Length	4.4 miles	(1) Habitat Pts	4		
Habitat Quality	good	(2) Habitat Quality Pts	3		
Fish Species	co stw chf ct	(3) Fish Pts	3		
Barrier Type	GREY	(4) Barrier Pts	2		
		Prioritization Total Pts	12

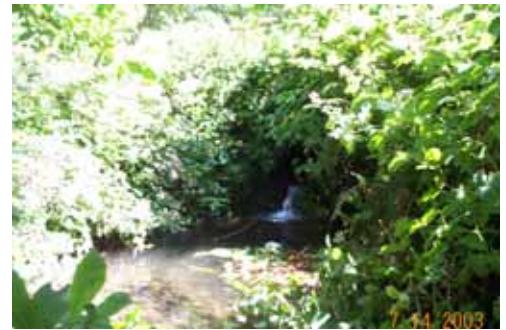
LOCATION INFO		CULVERT #	1134	PRIORITY	M
Watershed	Nestucca				
Stream Name	Bummer Creek (East Beaver Creek)				
Township-Range-Section-1/4	3S – 9W – S17 – NE of SE				
UTM Easting / Northing	436721 / 5017066				
Road Name	Unnamed				
Road/Culvert Owner	Private				
Adjacent Landowners	Curt Schonbrod, Mary Tattooed				
CULVERT INFO		CHANNEL INFO			
Shape	Circular	Inlet Gradient (%)	34.0		
Material	Corrugated metal	Upstream Gradient (%)	6.0		
Length (ft)	30.5	Bankfull Width (ft)	10.0		
Width (in)	36.0	Bankfull Ratio	0.3		
Height (in)	36.0				
Outlet Drop (ft)	1.6				
Slope (%)	9.0				
PRIORITIZATION ANALYSIS					
Habitat Length	0.6 miles	(1) Habitat Pts	2		
Habitat Quality	good	(2) Habitat Quality Pts	3		
Fish Species	ct	(3) Fish Pts	2		
Barrier Type	RED	(4) Barrier Pts	3		
		Prioritization Total Pts	<b>10</b>

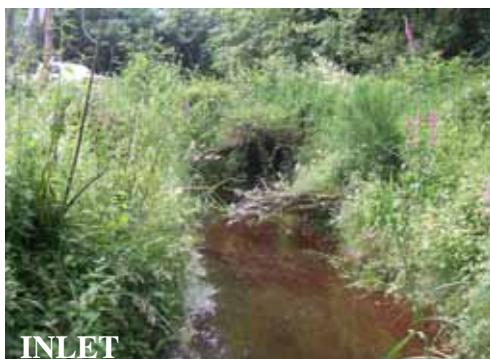
**OUTLET**

LOCATION INFO		CULVERT #	1065	PRIORITY	M
Watershed	Nestucca				
Stream Name	Tiger Creek tributary (Beaver Creek)				
Township-Range-Section-1/4	3S – 9W – S7 – NE of NW				
UTM Easting / Northing	434430 / 5019555				
Road Name	Nosacks Road (unofficial name)				
Road/Culvert Owner	Green Diamond				
Adjacent Landowners	Green Diamond				
CULVERT INFO		CHANNEL INFO			
Shape	Circular	Inlet Gradient (%)	1.0		
Material	Corrugated metal	Upstream Gradient (%)	1.0		
Length (ft)	27.0	Bankfull Width (ft)	12.6		
Width (in)	72.0	Bankfull Ratio	0.5		
Height (in)	72.0				
Outlet Drop (ft)	0.0				
Slope (%)	6.0				
PRIORITIZATION ANALYSIS					
Habitat Length	4.2 miles	(1) Habitat Pts	4		
Habitat Quality	good	(2) Habitat Quality Pts	3		
Fish Species	co stw ct	(3) Fish Pts	3		
Barrier Type	RED	(4) Barrier Pts	3		
		Prioritization Total Pts	13

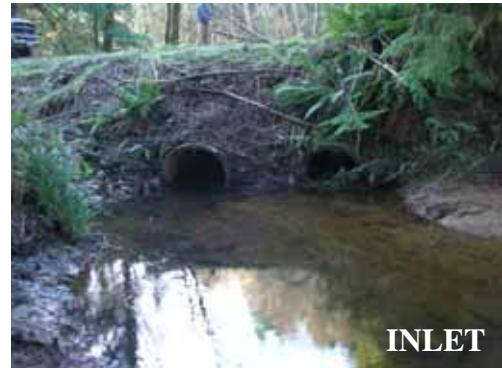
**INLET**

LOCATION INFO			CULVERT #	1012	PRIORITY	M
Watershed		Nestucca				
Stream Name		North Beaver Creek tributary				
Township-Range-Section-1/4		3S – 10W – S3 – SE of NW				
UTM Easting / Northing		429932 / 5020960				
Road Name		310B				
Road/Culvert Owner		Stimson Lumber				
Adjacent Landowners		Stimson Lumber				
CULVERT INFO		CHANNEL INFO				
Shape	Circular	Inlet Gradient (%)	2.0			
Material	Concrete	Upstream Gradient (%)	2.0			
Length (ft)	50.0	Bankfull Width (ft)	16.7			
Width (in)	48.0	Bankfull Ratio	0.2			
Height (in)	48.0					
Outlet Drop (ft)	0.0					
Slope (%)	0.0					
PRIORITIZATION ANALYSIS						
Habitat Length	1.1 miles	(1) Habitat Pts	3			
Habitat Quality	fair	(2) Habitat Quality Pts	2			
Fish Species	co, stw, ct	(3) Fish Pts	3			
Barrier Type	RED	(4) Barrier Pts	3			
		Prioritization Total Pts	11

NOTES: Stimson intends to replace in 2007 or 2008.

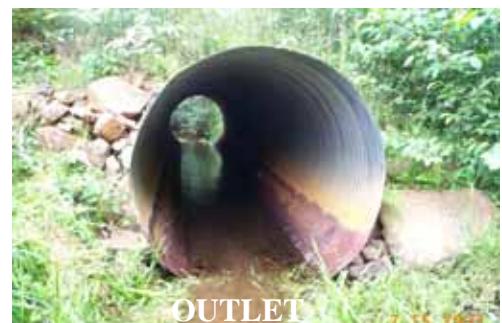
INLET

LOCATION INFO			CULVERT #	1070	PRIORITY	M
Watershed		Nestucca				
Stream Name		West Beaver Creek tributary				
Township-Range-Section-1/4		3S – 10W – S10 – SE of NE				
UTM Easting / Northing		430664 / 5019464				
Road Name		370 – Newberg Road				
Road/Culvert Owner		Stimson Lumber				
Adjacent Landowners		Stimson Lumber				
CULVERT INFO		CHANNEL INFO				
Shape	Circular	Inlet Gradient (%)	30.0			
Material	Corrugated metal	Upstream Gradient (%)	3.0			
Length (ft)	41.0	Bankfull Width (ft)	7.0			
Width (in)	72.0	Bankfull Ratio	0.9			
Height (in)	72.0					
Outlet Drop (ft)	0.0					
Slope (%)	0.0					
PRIORITIZATION ANALYSIS						
Habitat Length	2.8 miles	(1) Habitat Pts	4			
Habitat Quality	fair	(2) Habitat Quality Pts	2			
Fish Species	co stw ct	(3) Fish Pts	3			
Barrier Type	GREY	(4) Barrier Pts	2			
		Prioritization Total Pts	11

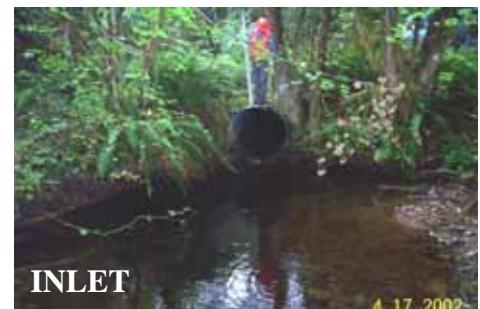
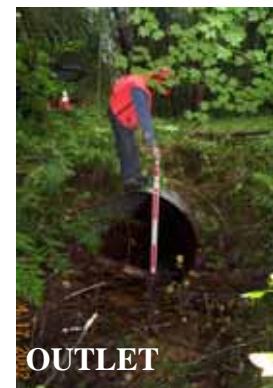
LOCATION INFO		CULVERT #	1078	PRIORITY	H
Watershed	Nestucca				
Stream Name	West Beaver Creek tributary				
Township-Range-Section-1/4	3S – 10W – S11 – NE of SE				
UTM Easting / Northing	432085 / 5019056				
Road Name	Unnamed				
Road/Culvert Owner	Green Diamond				
Adjacent Landowners	Green Diamond				
CULVERT INFO		CHANNEL INFO			
Shape	Circular	Inlet Gradient (%)	21.0		
Material	Corrugated metal	Upstream Gradient (%)	4.0		
Length (ft)	40.0	Bankfull Width (ft)	18.0		
Width (in)	48.0	Bankfull Ratio	0.2		
Height (in)	48.0				
Outlet Drop (ft)	0.4				
Slope (%)	3.0				
PRIORITIZATION ANALYSIS					
Habitat Length	0.9 miles	(1) Habitat Pts	2		
Habitat Quality	good	(2) Habitat Quality Pts	3		
Fish Species	co stw ct	(3) Fish Pts	3		
Barrier Type	RED	(4) Barrier Pts	3		
		Prioritization Total Pts	11

NOTES: Culvert #O3055 downstream was replaced in 2005 with a backwatered, countersunk concrete box culvert (good passage).

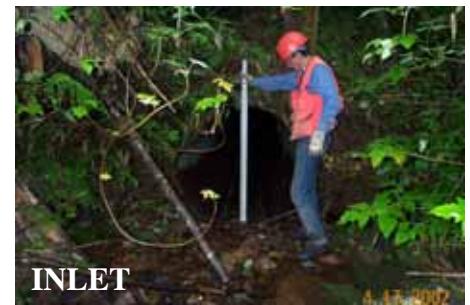
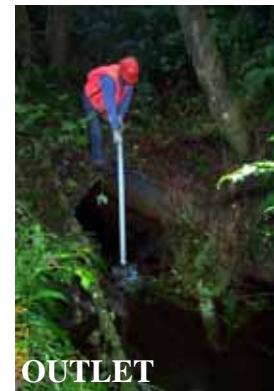
LOCATION INFO			CULVERT #	1108	PRIORITY	M
Watershed	Nestucca					
Stream Name	West Beaver Creek tributary					
Township-Range-Section-1/4	3S – 10W – S14 – NW of NE					
UTM Easting / Northing	431980 / 5018260					
Road Name	Unnamed					
Road/Culvert Owner	Green Diamond					
Adjacent Landowners	Green Diamond					
CULVERT INFO		CHANNEL INFO				
Shape	Circular	Inlet Gradient (%)	4.0			
Material	Corrugated metal	Upstream Gradient (%)	6.0			
Length (ft)	71.0	Bankfull Width (ft)	15.0			
Width (in)	48.0	Bankfull Ratio	0.3			
Height (in)	48.0					
Outlet Drop (ft)	0.5					
Slope (%)	3.0					
PRIORITIZATION ANALYSIS						
Habitat Length	0.3 miles	(1) Habitat Pts	1			
Habitat Quality	good	(2) Habitat Quality Pts	3			
Fish Species	ct	(3) Fish Pts	2			
Barrier Type	RED	(4) Barrier Pts	3			
		Prioritization Total Pts	9

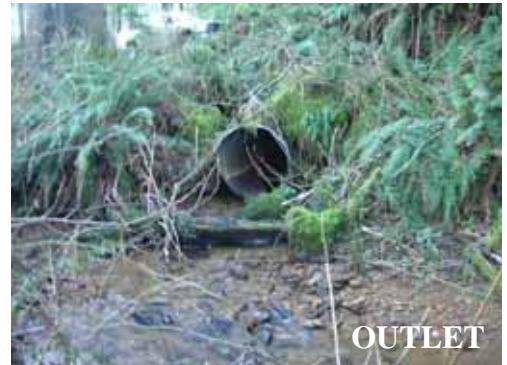
OUTLET

LOCATION INFO			CULVERT #	1121	PRIORITY	M
Watershed	Nestucca					
Stream Name	West Beaver Creek tributary					
Township-Range-Section-1/4	3S – 10W – S14 – NW of SW					
UTM Easting / Northing	431010 / 5017689					
Road Name	Unnamed					
Road/Culvert Owner	Green Diamond					
Adjacent Landowners	Green Diamond					
CULVERT INFO		CHANNEL INFO				
Shape	Circular	Inlet Gradient (%)	20.0			
Material	Corrugated metal	Upstream Gradient (%)	4.0			
Length (ft)	63.0	Bankfull Width (ft)	11.0			
Width (in)	36.0	Bankfull Ratio	0.3			
Height (in)	36.0					
Outlet Drop (ft)	0.9					
Slope (%)	3.0					
PRIORITIZATION ANALYSIS						
Habitat Length	0.3 miles	(1) Habitat Pts	1			
Habitat Quality	fair	(2) Habitat Quality Pts	2			
Fish Species	ct	(3) Fish Pts	2			
Barrier Type	RED	(4) Barrier Pts	3			
		Prioritization Total Pts	8

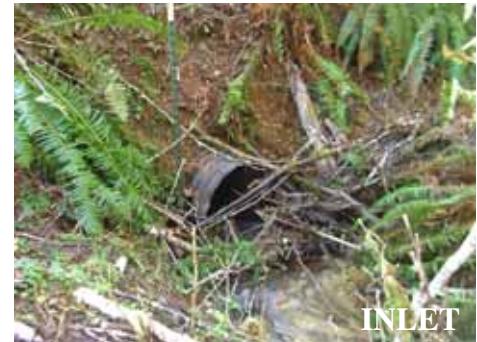
LOCATION INFO		CULVERT #	F3	PRIORITY	M
Watershed	Nestucca				
Stream Name	West Creek tributary				
Township-Range-Section-1/4	3S – 10W – S24 – NE of SE				
UTM Easting / Northing	433595 / 5015412				
Road Name	1004				
Road/Culvert Owner	USFS				
Adjacent Landowners	Forest Capital Partners LLC				
CULVERT INFO		CHANNEL INFO			
Shape	Circular	Inlet Gradient (%)	17.0		
Material	Corrugated metal	Upstream Gradient (%)	1.0		
Length (ft)	36.0	Bankfull Width (ft)	5.3		
Width (in)	24.0	Bankfull Ratio	0.4		
Height (in)	24.0				
Outlet Drop (ft)	1.9				
Slope (%)	2.0				
PRIORITIZATION ANALYSIS					
Habitat Length	0.2 miles	(1) Habitat Pts	1		
Habitat Quality	good	(2) Habitat Quality Pts	3		
Fish Species	co stw ct	(3) Fish Pts	3		
Barrier Type	RED	(4) Barrier Pts	3		
		Prioritization Total Pts	<b>10</b>		
NOTES: This culvert is failing and the inlet is partially blocked.

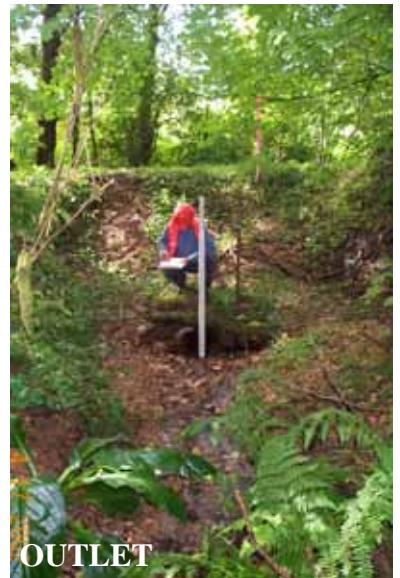
OUTLET

LOCATION INFO				CULVERT #	1213	PRIORITY	M
Watershed	Nestucca						
Stream Name	West Creek tributary						
Township-Range-Section-1/4	3S – 9W – S30 – NE of NW						
UTM Easting / Northing	434583 / 5015055						
Road Name	1004						
Road/Culvert Owner	USFS						
Adjacent Landowners	Green Diamond, Clayton Rees						
CULVERT INFO		CHANNEL INFO					
Shape	Circular	Inlet Gradient (%)	39.0				
Material	Corrugated metal	Upstream Gradient (%)	5.0				
Length (ft)	40.0	Bankfull Width (ft)	9.0				
Width (in)	18.0	Bankfull Ratio	0.2				
Height (in)	18.0						
Outlet Drop (ft)	0.7						
Slope (%)	7.0						
PRIORITIZATION ANALYSIS							
Habitat Length	0.1 miles	(1) Habitat Pts	1				
Habitat Quality	good	(2) Habitat Quality Pts	3				
Fish Species	co stw ct	(3) Fish Pts	3				
Barrier Type	GREY	(4) Barrier Pts	2				
		Prioritization Total Pts	<b>9</b>

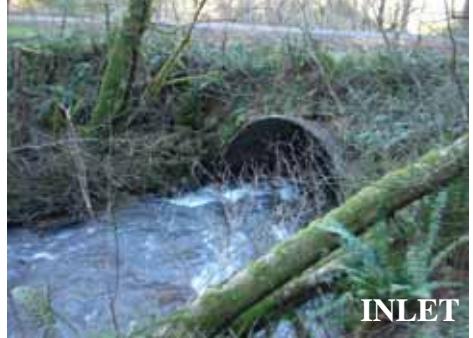
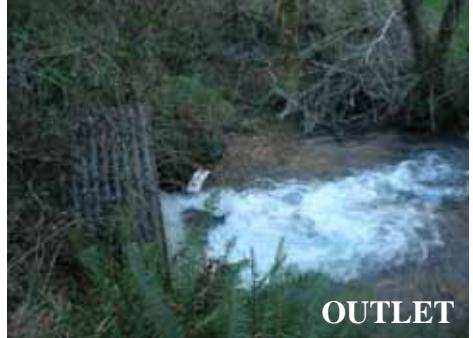
LOCATION INFO		CULVERT #	O3032	PRIORITY	M
Watershed	Nestucca				
Stream Name	Farmer Creek				
Township-Range-Section-1/4	4S – 10W – S1 – SW of NW				
UTM Easting / Northing	432420 / 5011350				
Road Name	880 – Farmer Creek Road				
Road/Culvert Owner	Tillamook County				
Adjacent Landowners	William Loewen, Nora Welty, State of Oregon				
CULVERT INFO		CHANNEL INFO			
Shape	Circular	Inlet Gradient (%)	---		
Material	Corrugated metal	Upstream Gradient (%)	3.0		
Length (ft)	60.0	Bankfull Width (ft)	---		
Width (in)	96.0	Bankfull Ratio	---		
Height (in)	96.0				
Outlet Drop (ft)	0.7				
Slope (%)	2.0				
PRIORITIZATION ANALYSIS					
Habitat Length	3.7 miles	(1) Habitat Pts	4		
Habitat Quality	good	(2) Habitat Quality Pts	3		
Fish Species	co stw chf ct chum	(3) Fish Pts	3		
Barrier Type	RED	(4) Barrier Pts	3		
		Prioritization Total Pts	13

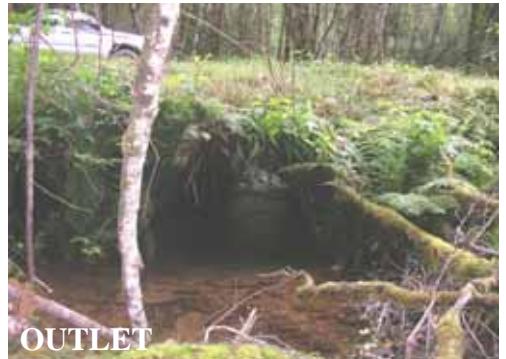
OUTLET

LOCATION INFO		CULVERT #	F23	PRIORITY	H
Watershed	Nestucca				
Stream Name	Farmer Creek tributary				
Township-Range-Section-1/4	4S – 10W – S3 – NE of NE				
UTM Easting / Northing	430342 / 5011773				
Road Name	880 – Farmer Creek Road				
Road/Culvert Owner	USFS				
Adjacent Landowners	Green Diamond				
CULVERT INFO		CHANNEL INFO			
Shape	Open Bottom Arch	Inlet Gradient (%)	---		
Material	Corrugated metal	Upstream Gradient (%)	---		
Length (ft)	41.0	Bankfull Width (ft)	15.0		
Width (in)	102.0	Bankfull Ratio	0.6		
Height (in)	94.0				
Outlet Drop (ft)	0.0				
Slope (%)	2.0				
PRIORITIZATION ANALYSIS					
Habitat Length	0.8 miles	(1) Habitat Pts	2		
Habitat Quality	fair	(2) Habitat Quality Pts	2		
Fish Species	co stw ct	(3) Fish Pts	3		
Barrier Type	GREY	(4) Barrier Pts	2		
		Prioritization Total Pts	9

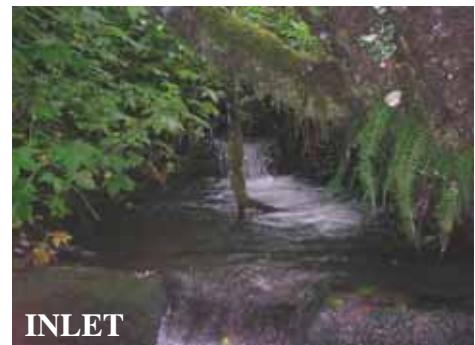
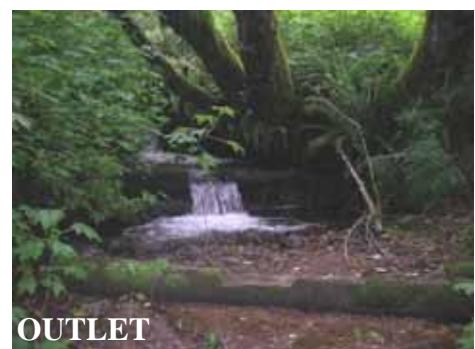
LOCATION INFO		CULVERT #	F24	PRIORITY	H
Watershed	Nestucca				
Stream Name	Farmer Creek tributary				
Township-Range-Section-1/4	4S – 10W – S3 – NW of NE				
UTM Easting / Northing	430159 / 5011964				
Road Name	1034				
Road/Culvert Owner	USFS				
Adjacent Landowners	Green Diamond				
CULVERT INFO		CHANNEL INFO			
Shape	Circular	Inlet Gradient (%)	9.0		
Material	Corrugated metal	Upstream Gradient (%)	1.0		
Length (ft)	38.5	Bankfull Width (ft)	6.3		
Width (in)	60.0	Bankfull Ratio	0.8		
Height (in)	60.0				
Outlet Drop (ft)	1.8				
Slope (%)	3.0				
PRIORITIZATION ANALYSIS					
Habitat Length	0.2 miles	(1) Habitat Pts	1		
Habitat Quality	fair	(2) Habitat Quality Pts	2		
Fish Species	co stw chf ct	(3) Fish Pts	3		
Barrier Type	RED	(4) Barrier Pts	3		
		Prioritization Total Pts	<b>9</b>

NOTES: USFS design is complete. No implementation is scheduled.

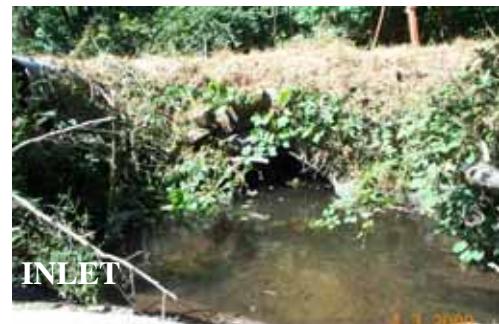
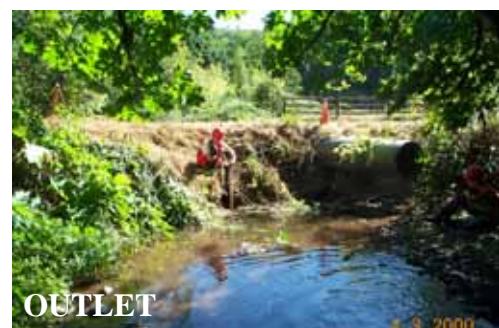
LOCATION INFO		CULVERT #	1412	PRIORITY	H
Watershed	Nestucca				
Stream Name	George Creek				
Township-Range-Section-1/4	4S – 10W – S12 – SW of NE				
UTM Easting / Northing	433164 / 5009810				
Road Name	Evergreen Drive				
Road/Culvert Owner	Private				
Adjacent Landowners	Mark Cavatorta				
CULVERT INFO		CHANNEL INFO			
Shape	Circular	Inlet Gradient (%)	7.0		
Material	Corrugated metal	Upstream Gradient (%)	4.0		
Length (ft)	36.0	Bankfull Width (ft)	30.0		
Width (in)	60.0	Bankfull Ratio	0.2		
Height (in)	60.0				
Outlet Drop (ft)	0.0				
Slope (%)	3.0				
PRIORITIZATION ANALYSIS					
Habitat Length	0.9 miles	(1) Habitat Pts	2		
Habitat Quality	fair	(2) Habitat Quality Pts	2		
Fish Species	co stw ct chum	(3) Fish Pts	3		
Barrier Type	RED	(4) Barrier Pts	3		
		Prioritization Total Pts	<b>10</b>

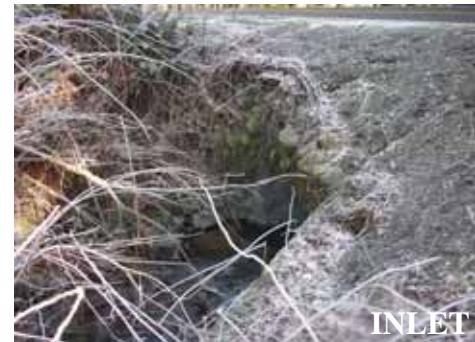
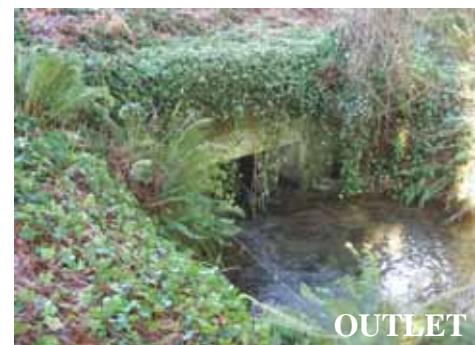
LOCATION INFO			CULVERT #	O353	PRIORITY	M
<b>Watershed</b>	Nestucca					
<b>Stream Name</b>	Woods Creek					
<b>Township-Range-Section-1/4</b>	5S – 9W – S4 – SW of NW					
<b>UTM Easting / Northing</b>	436952 / 5001833					
<b>Road Name</b>	Highway 22					
<b>Road/Culvert Owner</b>	ODOT					
<b>Adjacent Landowners</b>	Gibbs Family LLC					
CULVERT INFO		CHANNEL INFO				
<b>Shape</b>	Box	<b>Inlet Gradient (%)</b>	---			
<b>Material</b>	Concrete	<b>Upstream Gradient (%)</b>	4.0			
<b>Length (ft)</b>	50.0	<b>Bankfull Width (ft)</b>	---			
<b>Width (in)</b>	72.0	<b>Bankfull Ratio</b>	---			
<b>Height (in)</b>	72.0					
<b>Outlet Drop (ft)</b>	0.0					
<b>Slope (%)</b>	4.0					
PRIORITIZATION ANALYSIS						
<b>Habitat Length</b>	1.6 miles	<b>(1) Habitat Pts</b>	4			
<b>Habitat Quality</b>	fair	<b>(2) Habitat Quality Pts</b>	2			
<b>Fish Species</b>	ct	<b>(3) Fish Pts</b>	2			
<b>Barrier Type</b>	RED	<b>(4) Barrier Pts</b>	3

<b>Prioritization Total Pts</b>	11

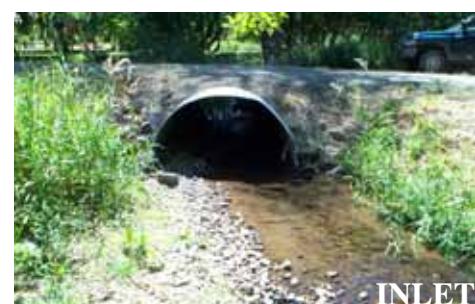
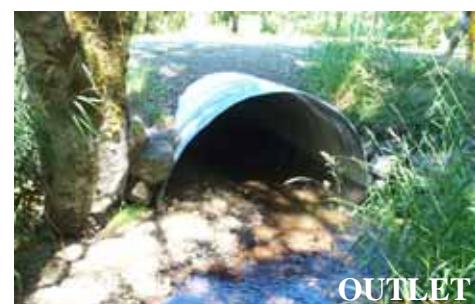
LOCATION INFO			CULVERT #	1574	PRIORITY	M
<b>Watershed</b>	Nestucca					
<b>Stream Name</b>	Three Rivers tributary					
<b>Township-Range-Section-1/4</b>	4S – 9W – S30 – SW of NE					
<b>UTM Easting / Northing</b>	434705 / 5004948					
<b>Road Name</b>	3094 – Big Trout Road					
<b>Road/Culvert Owner</b>	Three Rivers Road District					
<b>Adjacent Landowners</b>	Karl Vogel, Maxine Wright					
CULVERT INFO		CHANNEL INFO				
<b>Shape</b>	Circular	<b>Inlet Gradient (%)</b>	2.0			
<b>Material</b>	Corrugated metal	<b>Upstream Gradient (%)</b>	1.0			
<b>Length (ft)</b>	31.0	<b>Bankfull Width (ft)</b>	11.0			
<b>Width (in)</b>	60.0	<b>Bankfull Ratio</b>	0.5			
<b>Height (in)</b>	60.0					
<b>Outlet Drop (ft)</b>	0.9					
<b>Slope (%)</b>	2.0					
PRIORITIZATION ANALYSIS						
<b>Habitat Length</b>	0.4 miles	<b>(1) Habitat Pts</b>	1			
<b>Habitat Quality</b>	good	<b>(2) Habitat Quality Pts</b>	3			
<b>Fish Species</b>	co stw chf ct chum	<b>(3) Fish Pts</b>	3

<b>Barrier Type</b>	RED	<b>(4) Barrier Pts</b>	3			
		<b>Prioritization Total Pts</b>	10

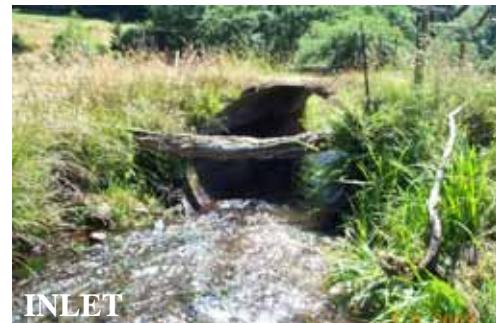
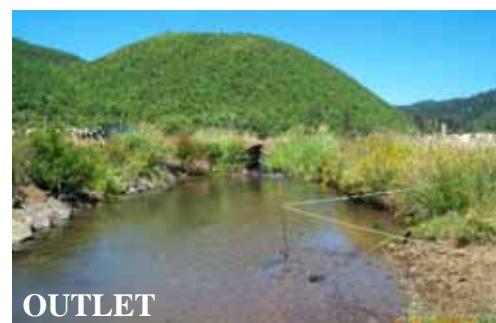
LOCATION INFO		CULVERT #	1527	PRIORITY	H
Watershed	Nestucca				
Stream Name	Horn Creek				
Township-Range-Section-1/4	4S – 10W – S20 – NE of SW				
UTM Easting / Northing	426612 / 5006208				
Road Name	Unnamed				
Road/Culvert Owner	Private				
Adjacent Landowners	Carl Hurliman				
CULVERT INFO		CHANNEL INFO			
Shape	Circular	Inlet Gradient (%)	1.0		
Material	Corrugated metal	Upstream Gradient (%)	1.0		
Length (ft)	25.0	Bankfull Width (ft)	16.0		
Width (in)	72.0	Bankfull Ratio	0.4		
Height (in)	72.0				
Outlet Drop (ft)	0.0				
Slope (%)	0.0				
PRIORITIZATION ANALYSIS					
Habitat Length	5.0 miles	(1) Habitat Pts	4		
Habitat Quality	good	(2) Habitat Quality Pts	3		
Fish Species	co stw ct chum	(3) Fish Pts	3		
Barrier Type	RED	(4) Barrier Pts	3		
		Prioritization Total Pts	13

**NOTES:** USFS engineering complete. NNWC implementation 2007.

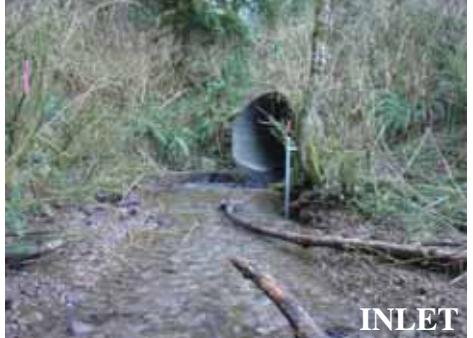
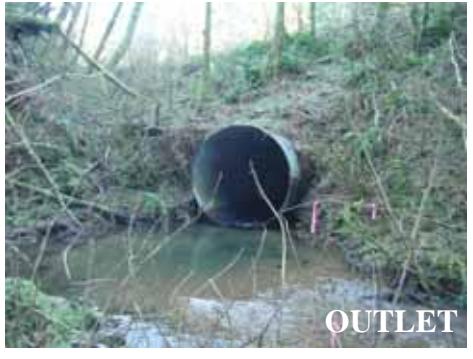
<b>Prioritization Total Pts</b>	<b>11</b>

**NOTES:** This culvert is located in Yamhill County. ODOT engineering is complete and construction planned for 2007.

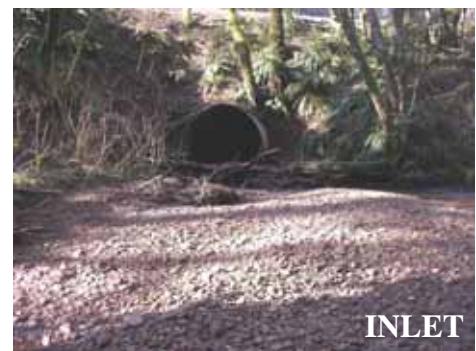
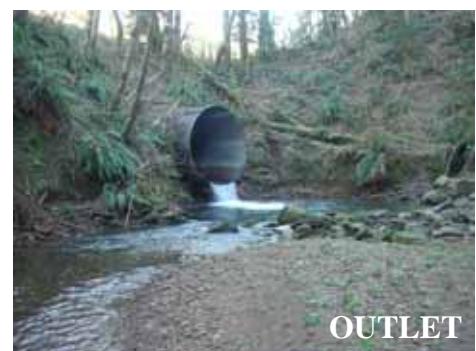
LOCATION INFO		CULVERT #	O356	PRIORITY	H
Watershed	Little Nestucca				
Stream Name	Sourgrass Creek				
Township-Range-Section-1/4	5S – 9W – S34 – SE of SW				
UTM Easting / Northing	438929 / 4994452				
Road Name	Highway 22				
Road/Culvert Owner	ODOT				
Adjacent Landowners	Green Diamond				
CULVERT INFO		CHANNEL INFO			
Shape	Circular	Inlet Gradient (%)	---		
Material	Corrugated metal	Upstream Gradient (%)	2.0		
Length (ft)	120.0	Bankfull Width (ft)	---		
Width (in)	120.0	Bankfull Ratio	---		
Height (in)	120.0				
Outlet Drop (ft)	2.0				
Slope (%)	2.0				
PRIORITIZATION ANALYSIS					
Habitat Length	2.2 miles	(1) Habitat Pts	4		
Habitat Quality	good	(2) Habitat Quality Pts	3		
Fish Species	co stw chf ct	(3) Fish Pts	3		
Barrier Type	RED	(4) Barrier Pts	3		
		Prioritization Total Pts	13

NOTES: This culvert is located in Yamhill County.

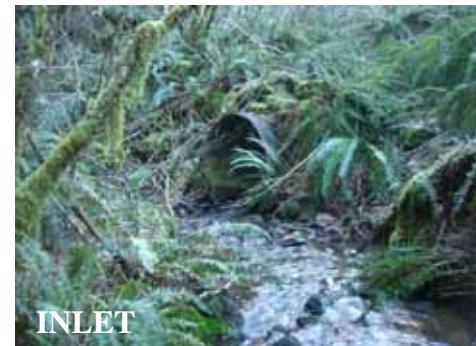
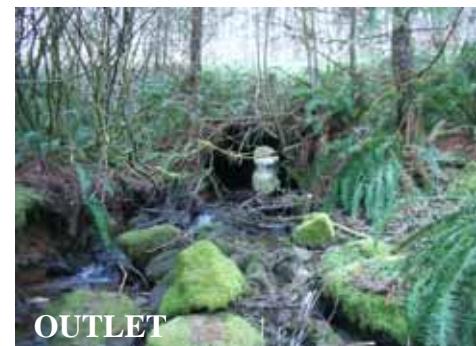
LOCATION INFO		CULVERT #	F734	PRIORITY	M
Watershed	Little Nestucca				
Stream Name	Sourgrass Creek tributary				
Township-Range-Section-1/4	5S – 9W – S35 – NW of NE				
UTM Easting / Northing	440821 / 4993434				
Road Name	223411				
Road/Culvert Owner	USFS				
Adjacent Landowners	USFS				
CULVERT INFO		CHANNEL INFO			
Shape	Circular	Inlet Gradient (%)	4.0		
Material	Corrugated metal	Upstream Gradient (%)	4.0		
Length (ft)	70.5	Bankfull Width (ft)	7.6		
Width (in)	54.0	Bankfull Ratio	0.6		
Height (in)	54.0				
Outlet Drop (ft)	0.0				
Slope (%)	2.0				
PRIORITIZATION ANALYSIS					
Habitat Length	0.8 miles	(1) Habitat Pts	2		
Habitat Quality	poor	(2) Habitat Quality Pts	1		
Fish Species	ct	(3) Fish Pts	2		
Barrier Type	GREY	(4) Barrier Pts	2		
		Prioritization Total Pts	7

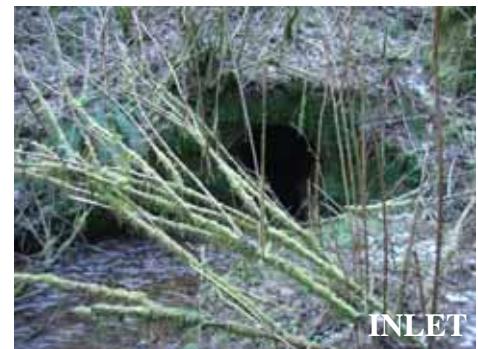
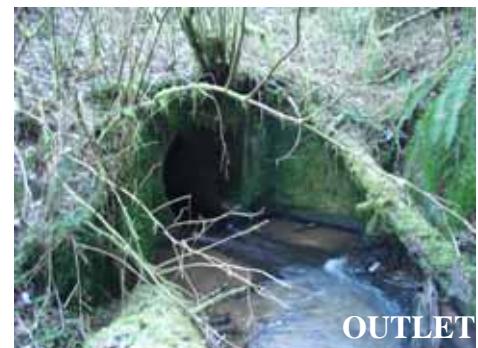
LOCATION INFO		CULVERT #	O354	PRIORITY	M
Watershed	Little Nestucca				
Stream Name	Sourgrass Creek tributary				
Township-Range-Section-1/4	5S – 9W – S35 – NE of SW				
UTM Easting / Northing	440738 / 4993143				
Road Name	Highway 22				
Road/Culvert Owner	ODOT				
Adjacent Landowners	USFS				
CULVERT INFO		CHANNEL INFO			
Shape	Circular	Inlet Gradient (%)	---		
Material	Concrete	Upstream Gradient (%)	3.0		
Length (ft)	100.0	Bankfull Width (ft)	---		
Width (in)	48.0	Bankfull Ratio	---		
Height (in)	48.0				
Outlet Drop (ft)	0.0				
Slope (%)	2.0				
PRIORITIZATION ANALYSIS					
Habitat Length	0.7 miles	(1) Habitat Pts	2		
Habitat Quality	poor	(2) Habitat Quality Pts	1		
Fish Species	ct	(3) Fish Pts	2		
Barrier Type	RED	(4) Barrier Pts	3		
		Prioritization Total Pts	<b>8</b>

NOTES: Concrete sill on outlet pool.

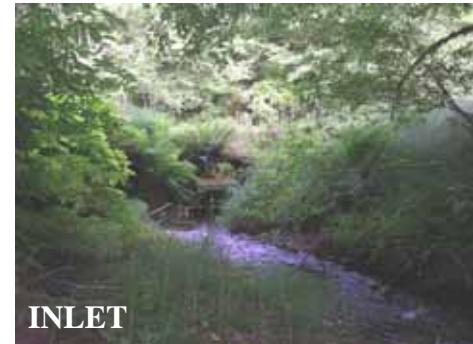
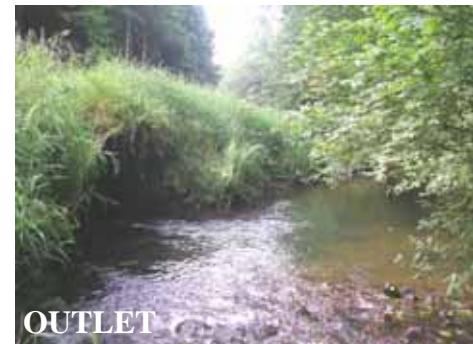
LOCATION INFO		CULVERT #	O3001	PRIORITY	M
Watershed	Little Nestucca				
Stream Name	Baxter Creek (Louie Creek)				
Township-Range-Section-1/4	5S – 9W – S28 – SW of NE				
UTM Easting / Northing	437710 / 4995425				
Road Name	Highway 22				
Road/Culvert Owner	ODOT				
Adjacent Landowners	Green Diamond				
CULVERT INFO		CHANNEL INFO			
Shape	Circular	Inlet Gradient (%)	---		
Material	Corrugated metal	Upstream Gradient (%)	2.0		
Length (ft)	60.0	Bankfull Width (ft)	---		
Width (in)	112.0	Bankfull Ratio	---		
Height (in)	112.0				
Outlet Drop (ft)	0.0				
Slope (%)	1.0				
PRIORITIZATION ANALYSIS					
Habitat Length	2.7 miles	(1) Habitat Pts	4		
Habitat Quality	good	(2) Habitat Quality Pts	3		
Fish Species	co stw chf ct	(3) Fish Pts	3		
Barrier Type	GREY	(4) Barrier Pts	2		
		Prioritization Total Pts	12		
NOTES: This culvert is lined with a concrete pad.

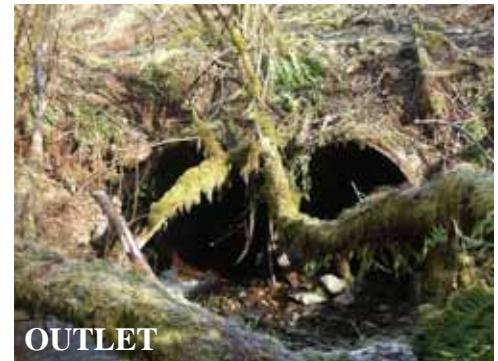
LOCATION INFO		CULVERT #	O3003	PRIORITY	H
Watershed	Little Nestucca				
Stream Name	Louie Creek				
Township-Range-Section-1/4	5S – 9W – S28 – SW of NE				
UTM Easting / Northing	437679 / 4995524				
Road Name	Highway 22				
Road/Culvert Owner	ODOT				
Adjacent Landowners	Green Diamond				
CULVERT INFO		CHANNEL INFO			
Shape	Circular	Inlet Gradient (%)	---		
Material	Corrugated metal	Upstream Gradient (%)	---		
Length (ft)	---	Bankfull Width (ft)	---		
Width (in)	60.0	Bankfull Ratio	---		
Height (in)	60.0				
Outlet Drop (ft)	0.2				
Slope (%)	---				
PRIORITIZATION ANALYSIS					
Habitat Length	1.3 miles	(1) Habitat Pts	3		
Habitat Quality	good	(2) Habitat Quality Pts	3		
Fish Species	co stw chf ct	(3) Fish Pts	3		
Barrier Type	RED	(4) Barrier Pts	3		
		Prioritization Total Pts	12

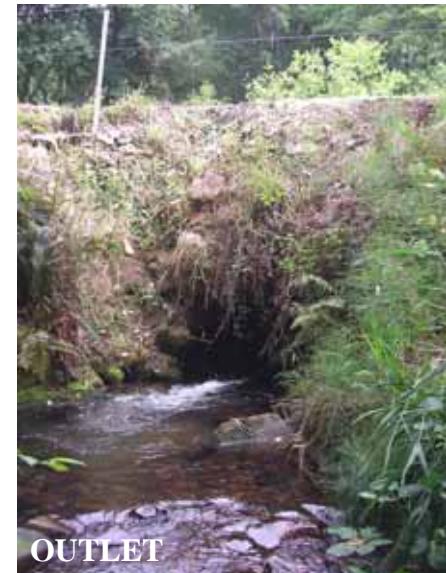
LOCATION INFO		CULVERT #	O3002	PRIORITY	H
<b>Watershed</b>	Little Nestucca				
<b>Stream Name</b>	Judson Creek				
<b>Township-Range-Section-1/4</b>	5S – 9W – S30 – NW of SE				
<b>UTM Easting / Northing</b>	434450 / 4995100				
<b>Road Name</b>	Highway 130				
<b>Road/Culvert Owner</b>	ODOT				
<b>Adjacent Landowners</b>	Kathleen Ziegler, Sashanna Ellinwood				
CULVERT INFO		CHANNEL INFO			
<b>Shape</b>	Circular	<b>Inlet Gradient (%)</b>	---		
<b>Material</b>	Concrete	<b>Upstream Gradient (%)</b>	5.0		
<b>Length (ft)</b>	60.0	<b>Bankfull Width (ft)</b>	---		
<b>Width (in)</b>	36.0	<b>Bankfull Ratio</b>	---		
<b>Height (in)</b>	36.0				
<b>Outlet Drop (ft)</b>	0.3				
<b>Slope (%)</b>	4.0				
PRIORITIZATION ANALYSIS					
<b>Habitat Length</b>	0.4 miles	<b>(1) Habitat Pts</b>	1		
<b>Habitat Quality</b>	fair	<b>(2) Habitat Quality Pts</b>	2		
<b>Fish Species</b>	co ct	<b>(3) Fish Pts</b>	3		
<b>Barrier Type</b>	RED	<b>(4) Barrier Pts</b>	3

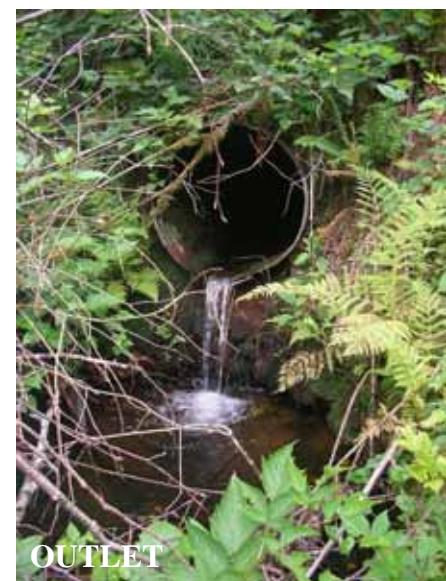
LOCATION INFO		CULVERT #	O3004	PRIORITY	H
<b>Watershed</b>	Little Nestucca				
<b>Stream Name</b>	McKnight Creek				
<b>Township-Range-Section-1/4</b>	5S – 10W – S25 – NE of SE				
<b>UTM Easting / Northing</b>	433375 / 4995050				
<b>Road Name</b>	Highway 130				
<b>Road/Culvert Owner</b>	ODOT				
<b>Adjacent Landowners</b>	Marlon Fessler				
CULVERT INFO		CHANNEL INFO			
<b>Shape</b>	Circular	<b>Inlet Gradient (%)</b>	---		
<b>Material</b>	Corrugated metal	<b>Upstream Gradient (%)</b>	3.0		
<b>Length (ft)</b>	60.0	<b>Bankfull Width (ft)</b>	---		
<b>Width (in)</b>	72.0	<b>Bankfull Ratio</b>	---		
<b>Height (in)</b>	72.0				
<b>Outlet Drop (ft)</b>	0.0				
<b>Slope (%)</b>	4.0				
PRIORITIZATION ANALYSIS					
<b>Habitat Length</b>	0.8 miles	<b>(1) Habitat Pts</b>	2		
<b>Habitat Quality</b>	poor	<b>(2) Habitat Quality Pts</b>	1		
<b>Fish Species</b>	co stw ct	<b>(3) Fish Pts</b>	3		
<b>Barrier Type</b>	RED	<b>(4) Barrier Pts</b>	3

**NOTES:** The ODOT survey noted that there is a poor culvert 100' upstream on private, but GIS layers indicate otherwise.

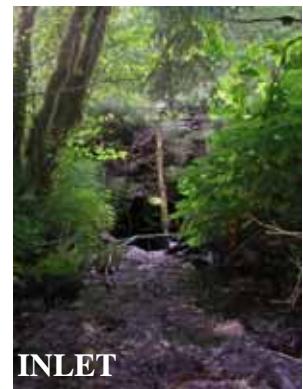
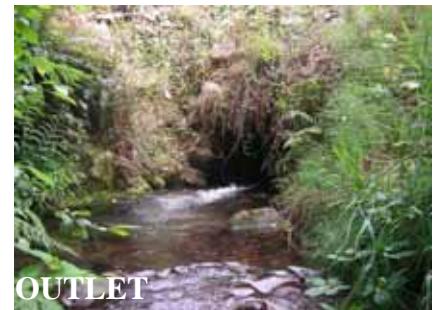
LOCATION INFO		CULVERT #	O3005	PRIORITY	M
Watershed	Little Nestucca				
Stream Name	Small Creek				
Township-Range-Section-1/4	5S – 9W – S30 – NE of SE				
UTM Easting / Northing	435050 / 4995150				
Road Name	Highway 130				
Road/Culvert Owner	ODOT				
Adjacent Landowners	Richard Murray				
CULVERT INFO		CHANNEL INFO			
Shape	Circular	Inlet Gradient (%)	---		
Material	Corrugated metal	Upstream Gradient (%)	4.0		
Length (ft)	60.0	Bankfull Width (ft)	---		
Width (in)	48.0	Bankfull Ratio	---		
Height (in)	48.0				
Outlet Drop (ft)	1.7				
Slope (%)	2.0				
PRIORITIZATION ANALYSIS					
Habitat Length	0.8 miles	(1) Habitat Pts	2		
Habitat Quality	fair	(2) Habitat Quality Pts	2		
Fish Species	co stw ct	(3) Fish Pts	3		
Barrier Type	RED	(4) Barrier Pts	3		
		Prioritization Total Pts	<b>10</b>

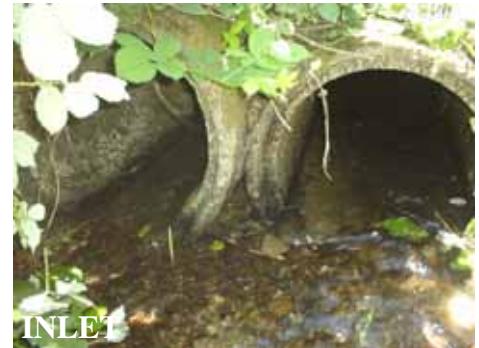
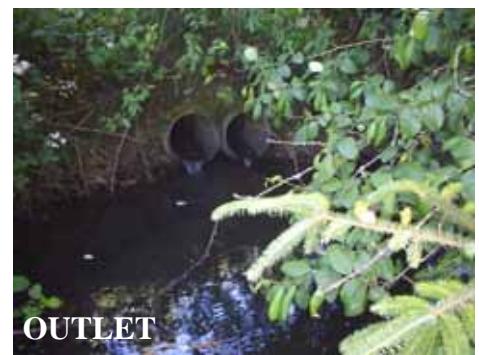
This high priority culvert is isolated in the watershed, with no medium or high priority barriers in its vicinity for clustering. In addition to impeding fish passage, the two culverts are significantly undersized and creating a failure risk.

LOCATION INFO		CULVERT #	1700	PRIORITY	H
Watershed	Little Nestucca				
Stream Name	Little Nestucca River tributary				
Township-Range-Section-1/4	5S – 10W – S9 – NE of SE				
UTM Easting / Northing	428893 / 4999797				
Road Name	Irish Road				
Road/Culvert Owner	Tillamook County				
Adjacent Landowners	Richard Heathershaw (Little River Jersey Dairy)				
CULVERT INFO		CHANNEL INFO			
Shape	Circular	Inlet Gradient (%)	1.0		
Material	Concrete	Upstream Gradient (%)	2.0		
Length (ft)	35.0	Bankfull Width (ft)	11.6		
Width (in)	27.0	Bankfull Ratio	0.2		
Height (in)	27.0				
Outlet Drop (ft)	0.5				
Slope (%)	1.0				
PRIORITIZATION ANALYSIS					
Habitat Length	0.4 miles	(1) Habitat Pts	1		
Habitat Quality	fair	(2) Habitat Quality Pts	2		
Fish Species	co stw ct	(3) Fish Pts	3		
Barrier Type	RED	(4) Barrier Pts	3		
		Prioritization Total Pts	<b>9</b>
