# NESTUCCA / NESKOWIN WATERSHEDS

## CULVERT PRIORITIZATION AND ACTION PLAN FOR FISH PASSAGE

**Rachel Hoffman  
Environmental Project Manager  
Tillamook Estuaries Partnership**

**May 2006**

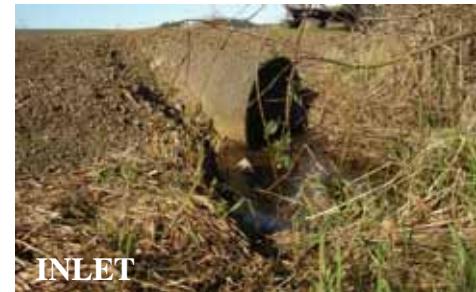
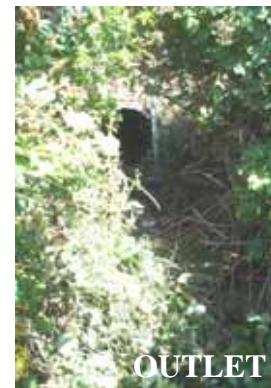
LOCATION INFO		CULVERT #	1708	PRIORITY	M
<b>Watershed</b>	Little Nestucca				
<b>Stream Name</b>	Bower Creek tributary				
<b>Township-Range-Section-1/4</b>	5S – 10W – S9 – SE of SW				
<b>UTM Easting / Northing</b>	428190 / 4999485				
<b>Road Name</b>	Meda Loop				
<b>Road/Culvert Owner</b>	Tillamook County				
<b>Adjacent Landowners</b>	Bearl Seals, CJ Hurliman				
CULVERT INFO		CHANNEL INFO			
<b>Shape</b>	Circular	<b>Inlet Gradient (%)</b>	1.0		
<b>Material</b>	Concrete	<b>Upstream Gradient (%)</b>	0.0		
<b>Length (ft)</b>	35.0	<b>Bankfull Width (ft)</b>	6.0		
<b>Width (in)</b>	36.0	<b>Bankfull Ratio</b>	0.5		
<b>Height (in)</b>	36.0				
<b>Outlet Drop (ft)</b>	0.3				
<b>Slope (%)</b>	3.0				
PRIORITIZATION ANALYSIS					
<b>Habitat Length</b>	0.9 miles	<b>(1) Habitat Pts</b>	2		
<b>Habitat Quality</b>	poor	<b>(2) Habitat Quality Pts</b>	1		
<b>Fish Species</b>	ct	<b>(3) Fish Pts</b>	2		
<b>Barrier Type</b>	RED	<b>(4) Barrier Pts</b>	3

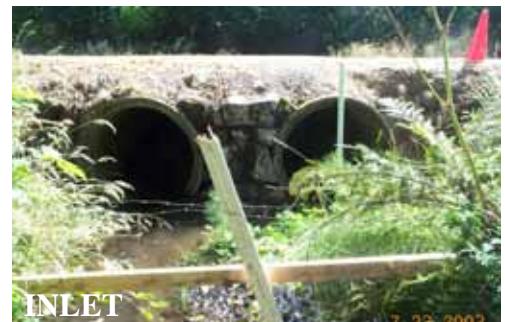
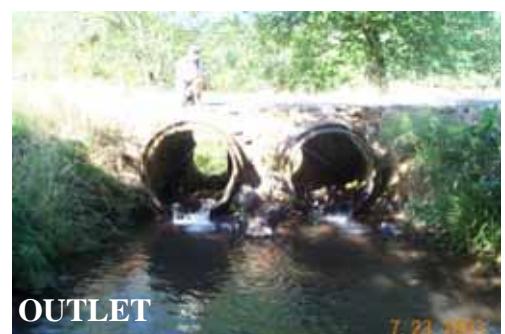
LOCATION INFO		CULVERT #	1717	PRIORITY	H
<b>Watershed</b>	Little Nestucca				
<b>Stream Name</b>	Bower Creek				
<b>Township-Range-Section-1/4</b>	5S – 10W – S16 – NW of NW				
<b>UTM Easting / Northing</b>	427727 / 4998982				
<b>Road Name</b>	Meda Loop				
<b>Road/Culvert Owner</b>	Tillamook County				
<b>Adjacent Landowners</b>	John Powers, Clem Jr. Hurliman				
CULVERT INFO		CHANNEL INFO			
<b>Shape</b>	Circular	<b>Inlet Gradient (%)</b>	7.0		
<b>Material</b>	Concrete	<b>Upstream Gradient (%)</b>	1.0		
<b>Length (ft)</b>	26.0	<b>Bankfull Width (ft)</b>	11.0		
<b>Width (in)</b>	48.0	<b>Bankfull Ratio</b>	0.4		
<b>Height (in)</b>	48.0				
<b>Outlet Drop (ft)</b>	0.6				
<b>Slope (%)</b>	2.0				
PRIORITIZATION ANALYSIS					
<b>Habitat Length</b>	1.1 miles	<b>(1) Habitat Pts</b>	3		
<b>Habitat Quality</b>	good	<b>(2) Habitat Quality Pts</b>	3		
<b>Fish Species</b>	co stw ct chum	<b>(3) Fish Pts</b>	3		
<b>Barrier Type</b>	RED	<b>(4) Barrier Pts</b>	3

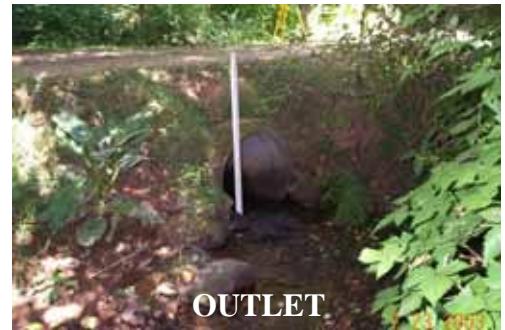
LOCATION INFO		CULVERT #	1719	PRIORITY	H
Watershed	Little Nestucca				
Stream Name	Bower Creek				
Township-Range-Section-1/4	5S – 10W – S16 – SW of NW				
UTM Easting / Northing	427667 / 4998682				
Road Name	Unnamed				
Road/Culvert Owner	Private				
Adjacent Landowners	John Powers				
CULVERT INFO		CHANNEL INFO			
Shape	Circular	Inlet Gradient (%)	7.0		
Material	Concrete	Upstream Gradient (%)	2.0		
Length (ft)	20.0	Bankfull Width (ft)	10.0		
Width (in)	36.0	Bankfull Ratio	0.3		
Height (in)	36.0				
Outlet Drop (ft)	0.7				
Slope (%)	7.0				
PRIORITIZATION ANALYSIS					
Habitat Length	0.5 miles	(1) Habitat Pts	1		
Habitat Quality	fair	(2) Habitat Quality Pts	2		
Fish Species	co stw ct chum	(3) Fish Pts	3		
Barrier Type	RED	(4) Barrier Pts	3		
		Prioritization Total Pts	<b>9</b>

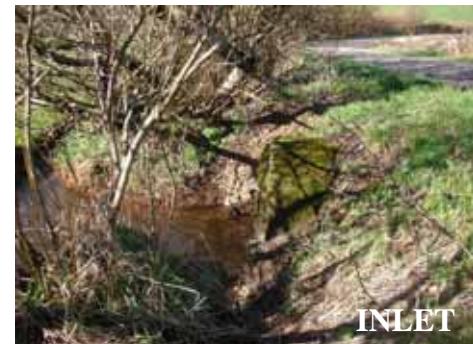
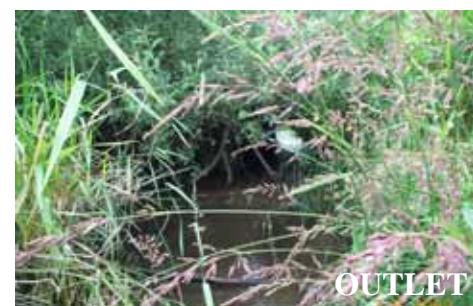
LOCATION INFO		CULVERT #	1686	PRIORITY	M
Watershed	Nestucca				
Stream Name	Upton Slough				
Township-Range-Section-1/4	5S – 10W – S7 – SW of NE				
UTM Easting / Northing	425220 / 5000645				
Road Name	Christensen Road				
Road/Culvert Owner	Private				
Adjacent Landowners	Seymour Family, Eula Pearn (life estate), USA				
CULVERT INFO		CHANNEL INFO			
Shape	Circular	Inlet Gradient (%)	0.0		
Material	Concrete	Upstream Gradient (%)	1.0		
Length (ft)	30.0	Bankfull Width (ft)	12.0		
Width (in)	48.0	Bankfull Ratio	0.3		
Height (in)	48.0				
Outlet Drop (ft)	0.0				
Slope (%)	2.0				
PRIORITIZATION ANALYSIS					
Habitat Length	0.8 miles	(1) Habitat Pts	2		
Habitat Quality	fair	(2) Habitat Quality Pts	2		
Fish Species	ct	(3) Fish Pts	2		
Barrier Type	RED	(4) Barrier Pts	3		
		Prioritization Total Pts	9

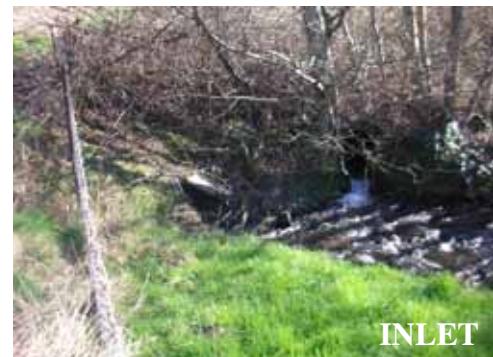
INLET

LOCATION INFO		CULVERT #	1689	PRIORITY	M
Watershed	Nestucca				
Stream Name	Upton Slough				
Township-Range-Section-1/4	5S – 10W – S7 – SW of NE				
UTM Easting / Northing	425093 / 5000440				
Road Name	Oretown Road				
Road/Culvert Owner	Tillamook County				
Adjacent Landowners	Eula Pearn (life estate)				
CULVERT INFO		CHANNEL INFO			
Shape	Circular	Inlet Gradient (%)	14.0		
Material	Corrugated metal	Upstream Gradient (%)	1.0		
Length (ft)	61.0	Bankfull Width (ft)	8.0		
Width (in)	66.0	Bankfull Ratio	0.7		
Height (in)	66.0				
Outlet Drop (ft)	0.4				
Slope (%)	6.0				
PRIORITIZATION ANALYSIS					
Habitat Length	0.7 miles	(1) Habitat Pts	2		
Habitat Quality	fair	(2) Habitat Quality Pts	2		
Fish Species	ct	(3) Fish Pts	2		
Barrier Type	RED	(4) Barrier Pts	3		
		Prioritization Total Pts	9

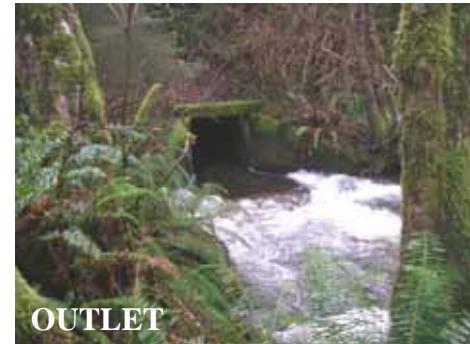
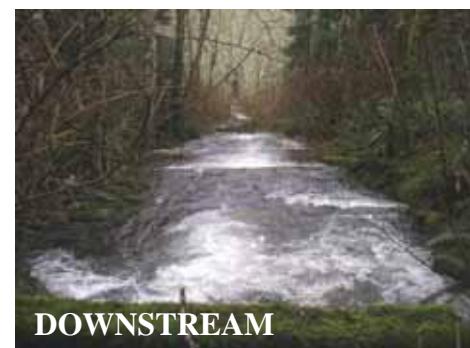
This culvert is located under Highway 101 with a huge amount of fill. The likelihood of this culvert being replaced is quite low, but that does not mean it is not a high priority. ODOT has installed log weirs downstream, but fish passage is still inhibited. During the summer, RBA surveyors noted a 4 foot drop from one of the weirs. According to the RBA, excellent habitat exists in Fall Creek with at least one mile of deep pool scours, abundant gravels, and high flows. Water quality (temperature) in this tributary is excellent and the result of an intact late successional canopy. Access may be improved through additional retrofitting.

LOCATION INFO		CULVERT #	O339	PRIORITY	H
Watershed	Neskowin				
Stream Name	Fall Creek				
Township-Range-Section-1/4	6S – 10W – S6 – SE of NW				
UTM Easting / Northing	424405 / 4992548				
Road Name	Highway 101				
Road/Culvert Owner	ODOT				
Adjacent Landowners	USFS				
CULVERT INFO		CHANNEL INFO			
Shape	Box	Inlet Gradient (%)	---		
Material	Concrete	Upstream Gradient (%)	4.0		
Length (ft)	380.0	Bankfull Width (ft)	20.0		
Width (in)	60.0	Bankfull Ratio	0.3		
Height (in)	60.0				
Outlet Drop (ft)	1.0				
Slope (%)	3.0				
PRIORITIZATION ANALYSIS					
Habitat Length	2.7 miles	(1) Habitat Pts	4		
Habitat Quality	good	(2) Habitat Quality Pts	3		
Fish Species	co stw ct	(3) Fish Pts	3		
Barrier Type	RED	(4) Barrier Pts	3		
		Prioritization Total Pts	13

**NOTES:** ODOT installed log weirs below outlet.

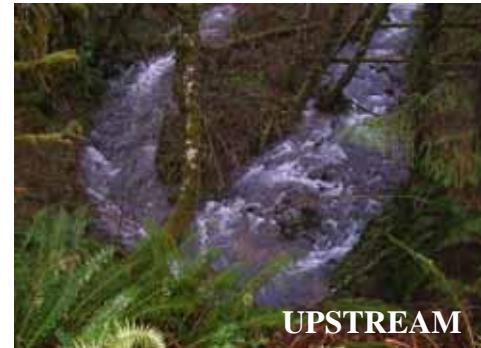
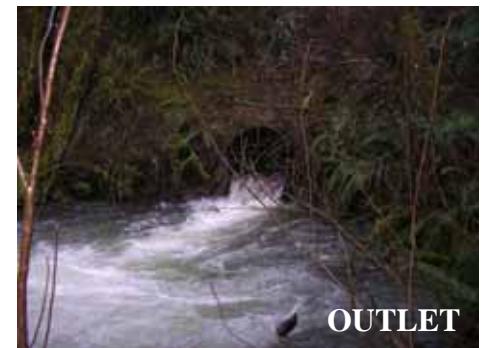
LOCATION INFO		CULVERT #	F6	PRIORITY	M
<b>Watershed</b>	Neskowin				
<b>Stream Name</b>	Lewis Creek				
<b>Township-Range-Section-1/4</b>	6S – 10W – S4 – NE of SE				
<b>UTM Easting / Northing</b>	428890 / 4991981				
<b>Road Name</b>	1280				
<b>Road/Culvert Owner</b>	USFS				
<b>Adjacent Landowners</b>	USFS				
CULVERT INFO		CHANNEL INFO			
<b>Shape</b>	Circular	<b>Inlet Gradient (%)</b>	27.0		
<b>Material</b>	Corrugated metal	<b>Upstream Gradient (%)</b>	3.0		
<b>Length (ft)</b>	77.0	<b>Bankfull Width (ft)</b>	22.5		
<b>Width (in)</b>	60.0	<b>Bankfull Ratio</b>	0.2		
<b>Height (in)</b>	60.0				
<b>Outlet Drop (ft)</b>	0.8				
<b>Slope (%)</b>	11.0				
PRIORITIZATION ANALYSIS					
<b>Habitat Length</b>	0.8 miles	<b>(1) Habitat Pts</b>	2		
<b>Habitat Quality</b>	fair	<b>(2) Habitat Quality Pts</b>	2		
<b>Fish Species</b>	co stw ct	<b>(3) Fish Pts</b>	3		
<b>Barrier Type</b>	RED	<b>(4) Barrier Pts</b>	3		
		<b>Prioritization Total Pts</b>	<b>10</b>

NOTES: There is a log jam grade control structure downstream 50 feet.

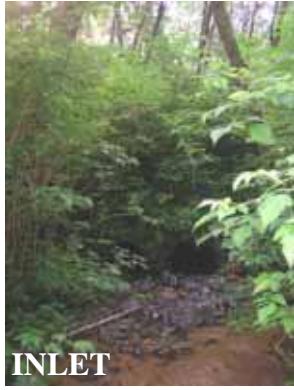
LOCATION INFO				CULVERT #	F1	PRIORITY	H		
<b>Watershed</b>		Neskowin

<p>INLET</p>			
<b>Stream Name</b>		Sloan Creek							
<b>Township-Range-Section-1/4</b>		6S – 10W – S9 – SE of NW							
<b>UTM Easting / Northing</b>		428400 / 4990928							
<b>Road Name</b>		12							
<b>Road/Culvert Owner</b>		USFS							
<b>Adjacent Landowners</b>		USFS							
CULVERT INFO			CHANNEL INFO						
<b>Shape</b>	Circular		<b>Inlet Gradient (%)</b>	9.0					
<b>Material</b>	Corrugated metal		<b>Upstream Gradient (%)</b>	3.0					
<b>Length (ft)</b>	57.0		<b>Bankfull Width (ft)</b>	10.5					
<b>Width (in)</b>	36.0		<b>Bankfull Ratio</b>	0.1					
<b>Height (in)</b>	36.0								
<b>Outlet Drop (ft)</b>	2.8								
<b>Slope (%)</b>	3.0								
PRIORITIZATION ANALYSIS									
<b>Habitat Length</b>	0.5 miles		<b>(1) Habitat Pts</b>	1					
<b>Habitat Quality</b>	fair		<b>(2) Habitat Quality Pts</b>	2					
<b>Fish Species</b>	co stw ct		<b>(3) Fish Pts</b>	3

<b>Barrier Type</b>	RED		<b>(4) Barrier Pts</b>	3					
			<b>Prioritization Total Pts</b>	<b>9</b>					
<b>NOTES:</b> RBA indicates the two pipes have rusted out and flows are draining out through the middle of the culverts and eroding substantial amounts of fill from underneath the road crossing. The crossing is a high priority for both passage and road maintenance. Almost all steelhead observed in the Sloan Creek were present in the plunge pool below the culverts. USFS design is complete with no scheduled implementation.

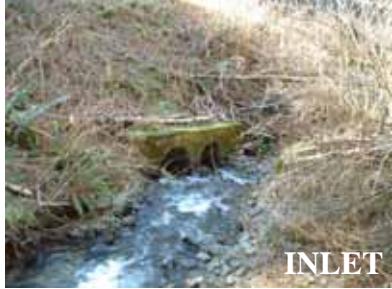
LOCATION INFO				CULVERT #	F181	PRIORITY	H		
<b>Watershed</b>		Neskowin

<p>INLET</p>			
<b>Stream Name</b>		Neskowin Creek tributary							
<b>Township-Range-Section-1/4</b>		6S – 10W – S10 – SW of SW							
<b>UTM Easting / Northing</b>		429031 / 4989965							
<b>Road Name</b>		Slab Creek Road							
<b>Road/Culvert Owner</b>		Tillamook County							
<b>Adjacent Landowners</b>		USFS							
CULVERT INFO			CHANNEL INFO						
<b>Shape</b>	Circular		<b>Inlet Gradient (%)</b>	32.0					
<b>Material</b>	Concrete		<b>Upstream Gradient (%)</b>	5.0					
<b>Length (ft)</b>	78.0		<b>Bankfull Width (ft)</b>	12.0					
<b>Width (in)</b>	36.0		<b>Bankfull Ratio</b>	0.3					
<b>Height (in)</b>	36.0								
<b>Outlet Drop (ft)</b>	1.8								
<b>Slope (%)</b>	1.0								
PRIORITIZATION ANALYSIS									
<b>Habitat Length</b>	0.1		<b>(1) Habitat Pts</b>	1					
<b>Habitat Quality</b>	good		<b>(2) Habitat Quality Pts</b>	3

<b>Fish Species</b>	co stw ct		<b>(3) Fish Pts</b>	3					
<b>Barrier Type</b>	RED		<b>(4) Barrier Pts</b>	3					
			<b>Prioritization Total Pts</b>	<b>10</b>					
<b>NOTES:</b> Road is slumping above the culvert. RBA indicates that most flow is draining underneath the culvert and there is a large accumulation of debris upstream. The condition of this culvert significantly worsened over the course of the 3 year survey. Coho seeding in this stream is well below capacity.

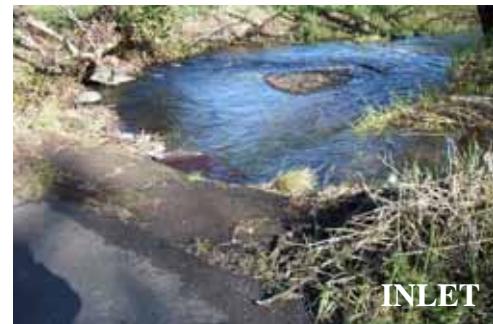
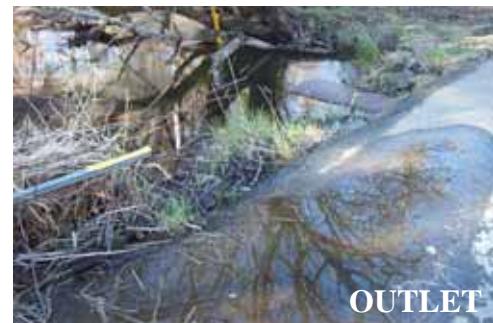
LOCATION INFO		CULVERT #	2078	PRIORITY	H
Watershed	Neskowin				
Stream Name	Hawk Creek				
Township-Range-Section-1/4	5S – 11W – S25 – SW of SW				
UTM Easting / Northing	422862 / 4994937				
Road Name	Hawk Street				
Road/Culvert Owner	Private				
Adjacent Landowners	William Clark, Nestucca Fire District, USA				
CULVERT INFO		CHANNEL INFO			
Shape	Circular	Inlet Gradient (%)	---		
Material	Corrugated metal	Upstream Gradient (%)	---		
Length (ft)	---	Bankfull Width (ft)	---		
Width (in)	---	Bankfull Ratio	---		
Height (in)	---				
Outlet Drop (ft)	0.0				
Slope (%)	---				
PRIORITIZATION ANALYSIS					
Habitat Length	1.8	(1) Habitat Pts	4		
Habitat Quality	good	(2) Habitat Quality Pts	3		
Fish Species	co stw ct chum	(3) Fish Pts	3		
Barrier Type	RED	(4) Barrier Pts	3		
		Prioritization Total Pts	<b>13</b>

**NOTES:** NNWC is leading a replacement project for implementation in 2008.

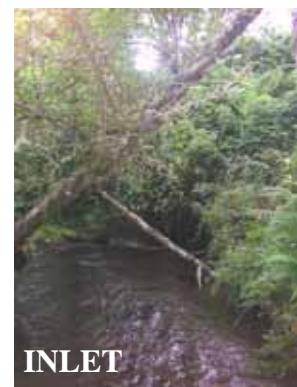
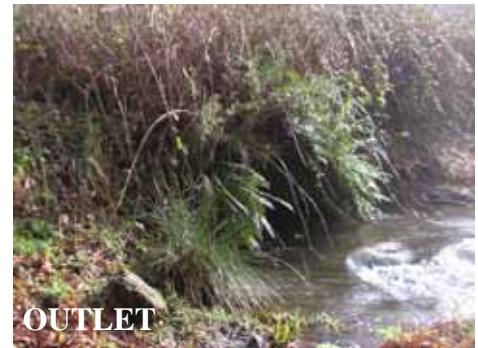
LOCATION INFO		CULVERT #	O336	PRIORITY	H
Watershed	Neskowin				
Stream Name	Butte Creek				
Township-Range-Section-1/4	5S – 11W – S25 – SW of NE				
UTM Easting / Northing	423405 / 4995429				
Road Name	Highway 101				
Road/Culvert Owner	ODOT				
Adjacent Landowners	Russell Jackson, Frank Herbert, Robert Affolter, Margaret Berglund, David Heonpud				
CULVERT INFO		CHANNEL INFO			
Shape	Circular	Inlet Gradient (%)	---		
Material	Corrugated metal	Upstream Gradient (%)	4.0		
Length (ft)	200.0	Bankfull Width (ft)	20.0		
Width (in)	72.0	Bankfull Ratio	0.3		
Height (in)	72.0				
Outlet Drop (ft)	0.0				
Slope (%)	5.0				
PRIORITIZATION ANALYSIS					
Habitat Length	2.0 miles	(1) Habitat Pts	4		
Habitat Quality	good	(2) Habitat Quality Pts	3		
Fish Species	co stw ct	(3) Fish Pts	3		
Barrier Type	RED	(4) Barrier Pts	3		
		Prioritization Total Pts	13

NOTES: Center is sagging.

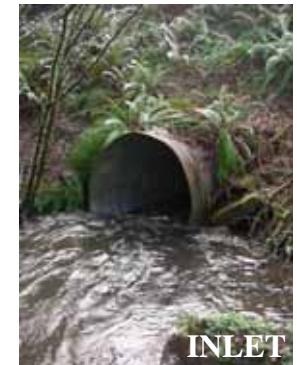
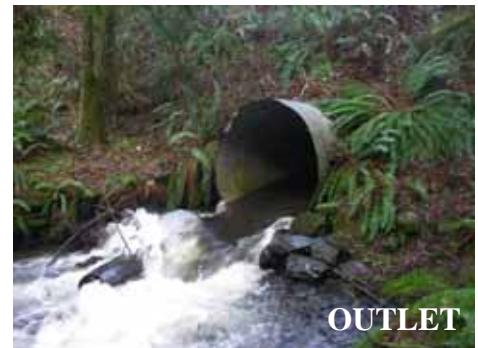
LOCATION INFO		CULVERT #	2080	PRIORITY	H
Watershed	Neskowin				
Stream Name	Butte Creek				
Township-Range-Section-1/4	5S – 11W – S25 – SW of NE				
UTM Easting / Northing	423571 / 4995531				
Road Name	Sunbow Road				
Road/Culvert Owner	Tillamook County				
Adjacent Landowners	Unknown				
CULVERT INFO		CHANNEL INFO			
Shape	Circular	Inlet Gradient (%)	---		
Material	Corrugated metal	Upstream Gradient (%)	---		
Length (ft)	110.0	Bankfull Width (ft)	---		
Width (in)	78.0	Bankfull Ratio	---		
Height (in)	78.0				
Outlet Drop (ft)	0.5				
Slope (%)	2.0				
PRIORITIZATION ANALYSIS					
Habitat Length	1.8	(1) Habitat Pts	4		
Habitat Quality	good	(2) Habitat Quality Pts	3		
Fish Species	co stw ct chum	(3) Fish Pts	3		
Barrier Type	RED	(4) Barrier Pts	3		
		Prioritization Total Pts	13

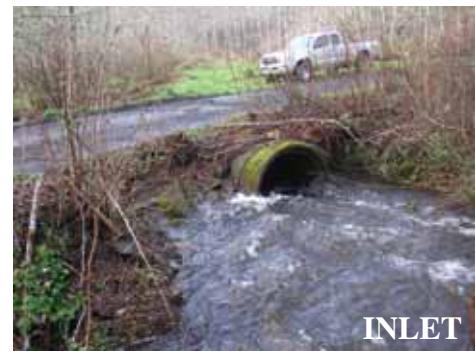
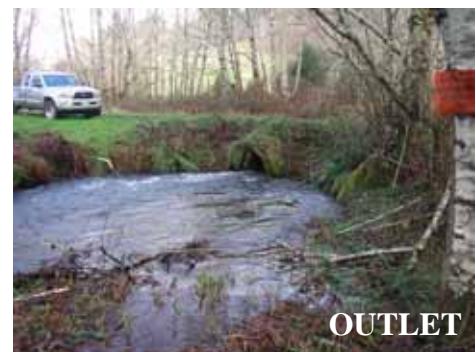
LOCATION INFO		CULVERT #	2081	PRIORITY	H
Watershed	Neskowin				
Stream Name	Butte Creek				
Township-Range-Section-1/4	5S – 11W – S25 – NE of NE				
UTM Easting / Northing	423833 / 4995738				
Road Name	Unnamed				
Road/Culvert Owner	Private				
Adjacent Landowners	Michael Kowalski, Margaret Berglund, Louise Jose				
CULVERT INFO		CHANNEL INFO			
Shape	Circular	Inlet Gradient (%)	---		
Material	Concrete	Upstream Gradient (%)	---		
Length (ft)	30.0	Bankfull Width (ft)	---		
Width (in)	48.0	Bankfull Ratio	---		
Height (in)	48.0				
Outlet Drop (ft)	0.0				
Slope (%)	4.0				
PRIORITIZATION ANALYSIS					
Habitat Length	1.7	(1) Habitat Pts	4		
Habitat Quality	good	(2) Habitat Quality Pts	3		
Fish Species	co stw ct chum	(3) Fish Pts	3		
Barrier Type	RED	(4) Barrier Pts	3		
		Prioritization Total Pts	<b>13</b>

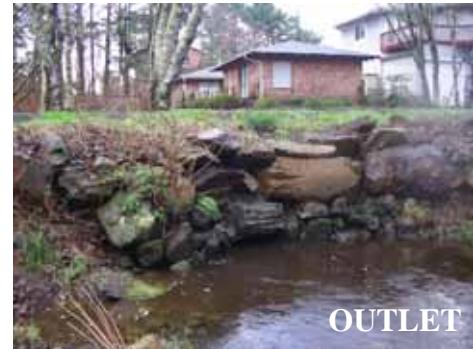
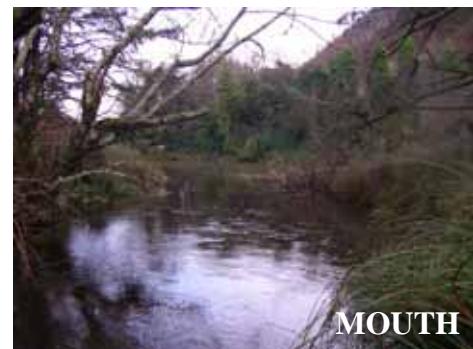
LOCATION INFO		CULVERT #	2082	PRIORITY	H
Watershed	Neskowin				
Stream Name	Sutton Creek				
Township-Range-Section-1/4	5S – 11W – S36 – NE of NW				
UTM Easting / Northing	422895 / 4994152				
Road Name	Proposal Rock Loop Road				
Road/Culvert Owner	Private				
Adjacent Landowners	Unknown				
CULVERT INFO		CHANNEL INFO			
Shape	Circular	Inlet Gradient (%)	---		
Material	Corrugated metal	Upstream Gradient (%)	---		
Length (ft)	24.0	Bankfull Width (ft)	---		
Width (in)	48.0	Bankfull Ratio	---		
Height (in)	48.0				
Outlet Drop (ft)	0.0				
Slope (%)	1.0				
PRIORITIZATION ANALYSIS					
Habitat Length	0.3	(1) Habitat Pts	1		
Habitat Quality	good	(2) Habitat Quality Pts	3		
Fish Species	co stw ct chum	(3) Fish Pts	3		
Barrier Type	RED	(4) Barrier Pts	3		
		Prioritization Total Pts	<b>10</b>

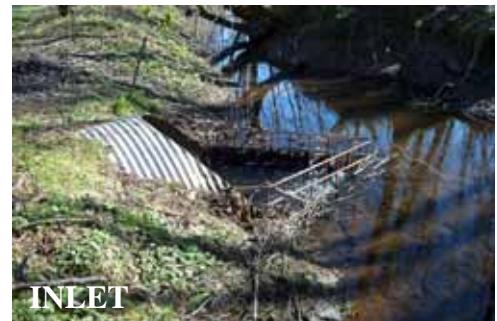
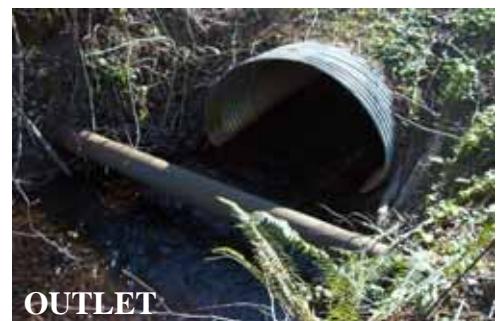
LOCATION INFO			CULVERT #	2084	PRIORITY	H
Watershed	Neskowin					
Stream Name	Sutton Creek					
Township-Range-Section-1/4	5S – 11W – S36 – SW of NW					
UTM Easting / Northing	422833 / 4993948					
Road Name	South Beach Road					
Road/Culvert Owner	Private					
Adjacent Landowners	Unknown					
CULVERT INFO		CHANNEL INFO				
Shape	Pipe arch	Inlet Gradient (%)	---			
Material	Corrugated metal	Upstream Gradient (%)	---			
Length (ft)	26.0	Bankfull Width (ft)	---			
Width (in)	60.0	Bankfull Ratio	---			
Height (in)	46.0					
Outlet Drop (ft)	0.0					
Slope (%)	3.0					
PRIORITIZATION ANALYSIS						
Habitat Length	0.2	(1) Habitat Pts	1			
Habitat Quality	good	(2) Habitat Quality Pts	3			
Fish Species	co stw ct chum	(3) Fish Pts	3			
Barrier Type	RED	(4) Barrier Pts	3			
		Prioritization Total Pts	10

NOTES: A new trash rack installed in 2003. An 8" waterline at the outlet traps debris and may impede fish passage at some flows.

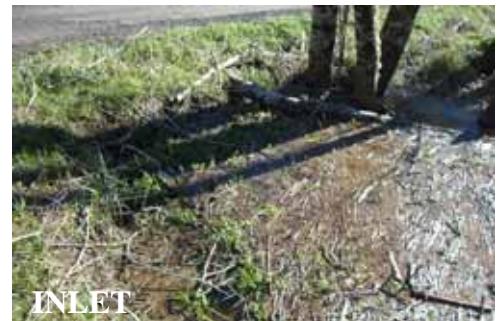
INLET

LOCATION INFO			CULVERT #	2085	PRIORITY	H
Watershed	Neskowin					
Stream Name	Sutton Creek					
Township-Range-Section-1/4	5S – 11W – S36 – SW of NW					
UTM Easting / Northing	422683 / 4993860					
Road Name	South Beach Road					
Road/Culvert Owner	Private					
Adjacent Landowners	Unknown					
CULVERT INFO		CHANNEL INFO				
Shape	Circular	Inlet Gradient (%)	---			
Material	Corrugated metal	Upstream Gradient (%)	---			
Length (ft)	26.0	Bankfull Width (ft)	---			
Width (in)	36.0	Bankfull Ratio	---			
Height (in)	36.0					
Outlet Drop (ft)	0.0					
Slope (%)	1.0					
PRIORITIZATION ANALYSIS						
Habitat Length	0.2	(1) Habitat Pts	1			
Habitat Quality	good	(2) Habitat Quality Pts	3			
Fish Species	co stw ct chum	(3) Fish Pts	3			
Barrier Type	RED	(4) Barrier Pts	3			
		Prioritization Total Pts	10

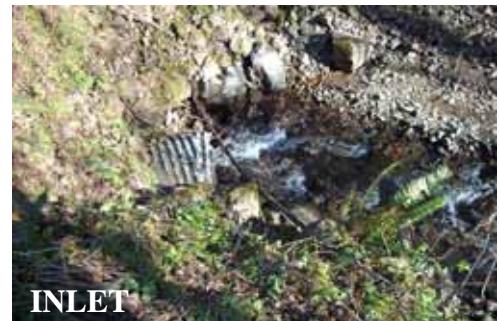
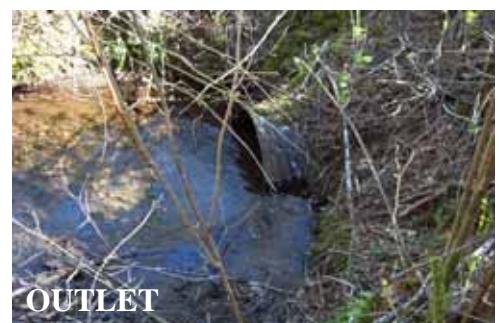
LOCATION INFO		CULVERT #	2086	PRIORITY	H
Watershed	Neskowin				
Stream Name	Sutton Creek				
Township-Range-Section-1/4	5S – 11W – S36 – SW of NW				
UTM Easting / Northing	422540 / 4993667				
Road Name	South Beach Road				
Road/Culvert Owner	Private				
Adjacent Landowners	Unknown				
CULVERT INFO		CHANNEL INFO			
Shape	Circular	Inlet Gradient (%)	---		
Material	Corrugated metal	Upstream Gradient (%)	---		
Length (ft)	---	Bankfull Width (ft)	---		
Width (in)	---	Bankfull Ratio	---		
Height (in)	---				
Outlet Drop (ft)	1.0				
Slope (%)	---				
PRIORITIZATION ANALYSIS					
Habitat Length	0.1	(1) Habitat Pts	1		
Habitat Quality	good	(2) Habitat Quality Pts	3		
Fish Species	co stw ct chum	(3) Fish Pts	3		
Barrier Type	RED	(4) Barrier Pts	3		
		Prioritization Total Pts	<b>10</b>

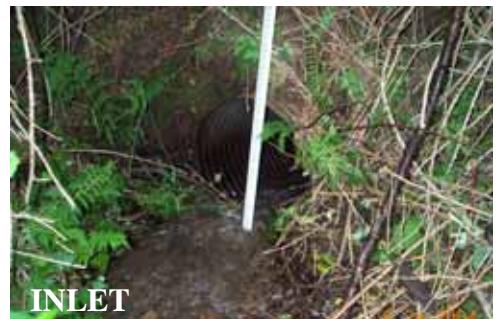
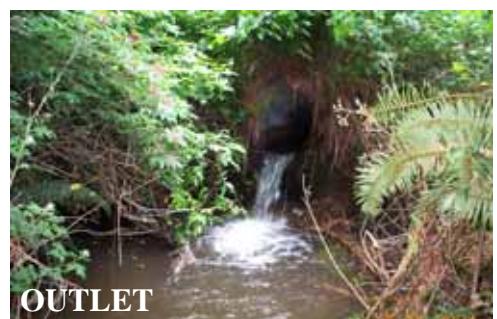
LOCATION INFO			CULVERT #	1219	PRIORITY	M
Watershed	Nestucca					
Stream Name	Hastor Creek (Beaver Creek)					
Township-Range-Section-1/4	3S – 9W – S29 – NE of NW					
UTM Easting / Northing	435947 / 5014949					
Road Name	Beaver-Becker Road (unofficial name)					
Road/Culvert Owner	Green Diamond					
Adjacent Landowners	Green Diamond					
CULVERT INFO		CHANNEL INFO				
Shape	Circular	Inlet Gradient (%)	11.0			
Material	Corrugated metal	Upstream Gradient (%)	2.0			
Length (ft)	25.0	Bankfull Width (ft)	9.0			
Width (in)	36.0	Bankfull Ratio	0.3			
Height (in)	36.0					
Outlet Drop (ft)	0.0					
Slope (%)	4.0					
PRIORITIZATION ANALYSIS						
Habitat Length	0.6 miles	(1) Habitat Pts	2			
Habitat Quality	fair	(2) Habitat Quality Pts	2			
Fish Species	co stw ct	(3) Fish Pts	3			
Barrier Type	RED	(4) Barrier Pts	3			
		Prioritization Total Pts	10

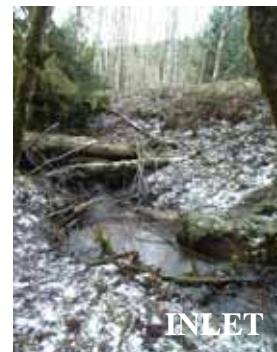
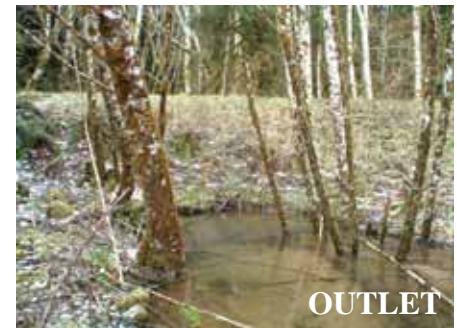
LOCATION INFO			CULVERT #	F155	PRIORITY	M
Watershed	Little Nestucca					
Stream Name	Hiack Creek tributary					
Township-Range-Section-1/4	6S – 9W – S8 – NE of NE					
UTM Easting / Northing	436330 / 4991186					
Road Name	12					
Road/Culvert Owner	USFS					
Adjacent Landowners	USFS					
CULVERT INFO		CHANNEL INFO				
Shape	Circular	Inlet Gradient (%)	---			
Material	Corrugated metal	Upstream Gradient (%)	2.0			
Length (ft)	45.0	Bankfull Width (ft)	3.8			
Width (in)	24.0	Bankfull Ratio	0.5			
Height (in)	24.0					
Outlet Drop (ft)	1.3					
Slope (%)	0.0					
PRIORITIZATION ANALYSIS						
Habitat Length	0.5 miles	(1) Habitat Pts	1			
Habitat Quality	fair	(2) Habitat Quality Pts	2			
Fish Species	stw ct	(3) Fish Pts	3			
Barrier Type	RED	(4) Barrier Pts	3			
		Prioritization Total Pts	9

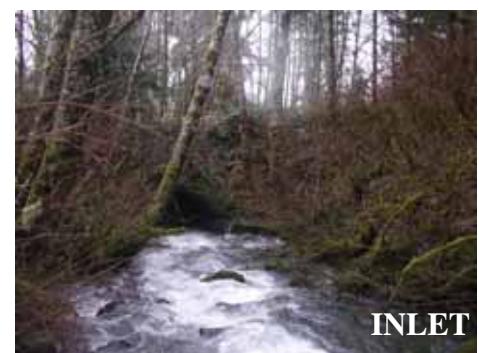
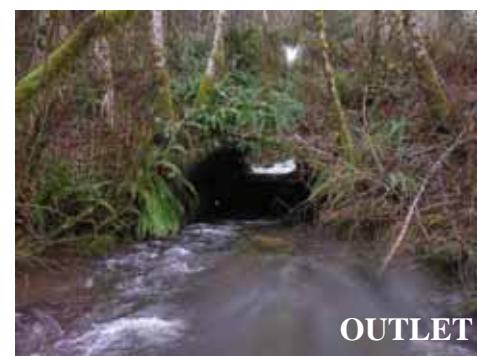
LOCATION INFO		CULVERT #	F2055	PRIORITY	M
Watershed	Nestucca				
Stream Name	Limestone Creek tributary				
Township-Range-Section-1/4	4S – 8W – S6 – SE of NW				
UTM Easting / Northing	443825 / 5011140				
Road Name	8598				
Road/Culvert Owner	USFS				
Adjacent Landowners	USFS				
CULVERT INFO		CHANNEL INFO			
Shape	Circular	Inlet Gradient (%)	0.0		
Material	Concrete	Upstream Gradient (%)	2.0		
Length (ft)	48.0	Bankfull Width (ft)	7.0		
Width (in)	24.0	Bankfull Ratio	0.3		
Height (in)	24.0				
Outlet Drop (ft)	0.2				
Slope (%)	0.0				
PRIORITIZATION ANALYSIS					
Habitat Length	1.5 miles	(1) Habitat Pts	3		
Habitat Quality	poor	(2) Habitat Quality Pts	1		
Fish Species	co stw ct	(3) Fish Pts	3		
Barrier Type	RED	(4) Barrier Pts	3		
		Prioritization Total Pts	10

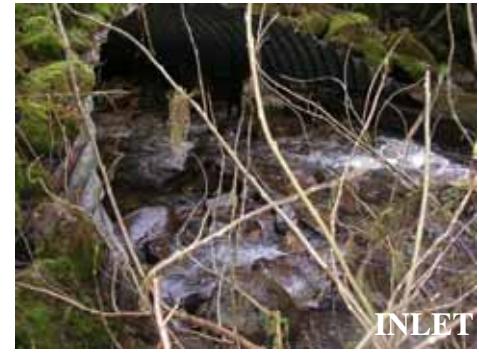
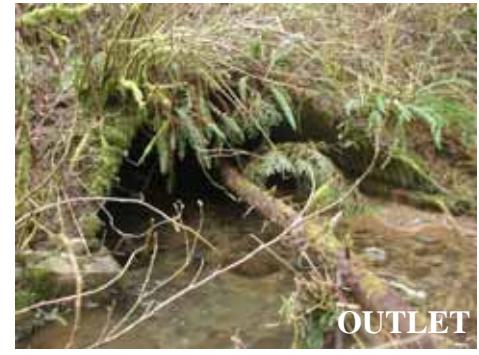
LOCATION INFO		CULVERT #	F2060	PRIORITY	M
Watershed	Nestucca				
Stream Name	Alder Creek				
Township-Range-Section-1/4	4S – 9W – S1 – NE of NW				
UTM Easting / Northing	442252 / 5011654				
Road Name	8598				
Road/Culvert Owner	USFS				
Adjacent Landowners	USFS				
CULVERT INFO		CHANNEL INFO			
Shape	Open bottom arch	Inlet Gradient (%)	12.0		
Material	Corrugated metal	Upstream Gradient (%)	6.0		
Length (ft)	68.0	Bankfull Width (ft)	16.5		
Width (in)	145.0	Bankfull Ratio	0.7		
Height (in)	70.0				
Outlet Drop (ft)	0.0				
Slope (%)	5.0				
PRIORITIZATION ANALYSIS					
Habitat Length	0.6 miles	(1) Habitat Pts	2		
Habitat Quality	fair	(2) Habitat Quality Pts	2		
Fish Species	co stw ct	(3) Fish Pts	3		
Barrier Type	GREY	(4) Barrier Pts	2		
		Prioritization Total Pts	9

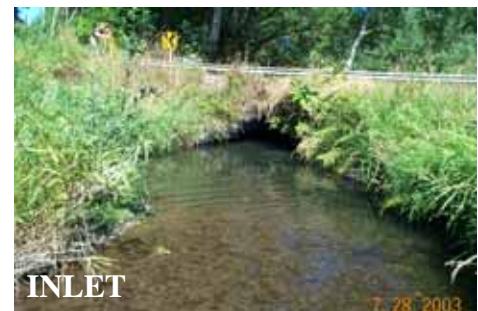
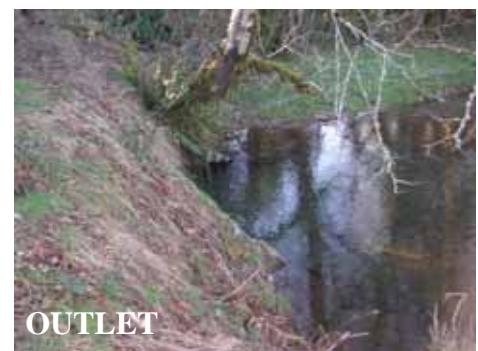
LOCATION INFO		CULVERT #	1610	PRIORITY	M
Watershed	Nestucca				
Stream Name	Clear Creek				
Township-Range-Section-1/4	4S – 10W – S34 – NE of NW				
UTM Easting / Northing	429407 / 5003996				
Road Name	Jenck Road				
Road/Culvert Owner	Tillamook County				
Adjacent Landowners	Marlene Trent, Ray Jones				
CULVERT INFO		CHANNEL INFO			
Shape	Pipe arch	Inlet Gradient (%)	0.0		
Material	Corrugated metal	Upstream Gradient (%)	2.0		
Length (ft)	34.0	Bankfull Width (ft)	14.0		
Width (in)	144.0	Bankfull Ratio	0.9		
Height (in)	84.0				
Outlet Drop (ft)	0.0				
Slope (%)	2.0				
PRIORITIZATION ANALYSIS					
Habitat Length	3.3 miles	(1) Habitat Pts	4		
Habitat Quality	good	(2) Habitat Quality Pts	3		
Fish Species	co stw chf ct chum	(3) Fish Pts	3		
Barrier Type	GREY	(4) Barrier Pts	2		
		Prioritization Total Pts	12

NOTES: USFS engineering design complete. No plans for implementation.
