# **Riparian Habitat Prioritization: Tillamook Lowlands**

Report to:

Philip Williams & Associates, Ltd.  
322 NW 5th Avenue, Suite 234  
Portland, OR 97209-3827

October 6, 1999

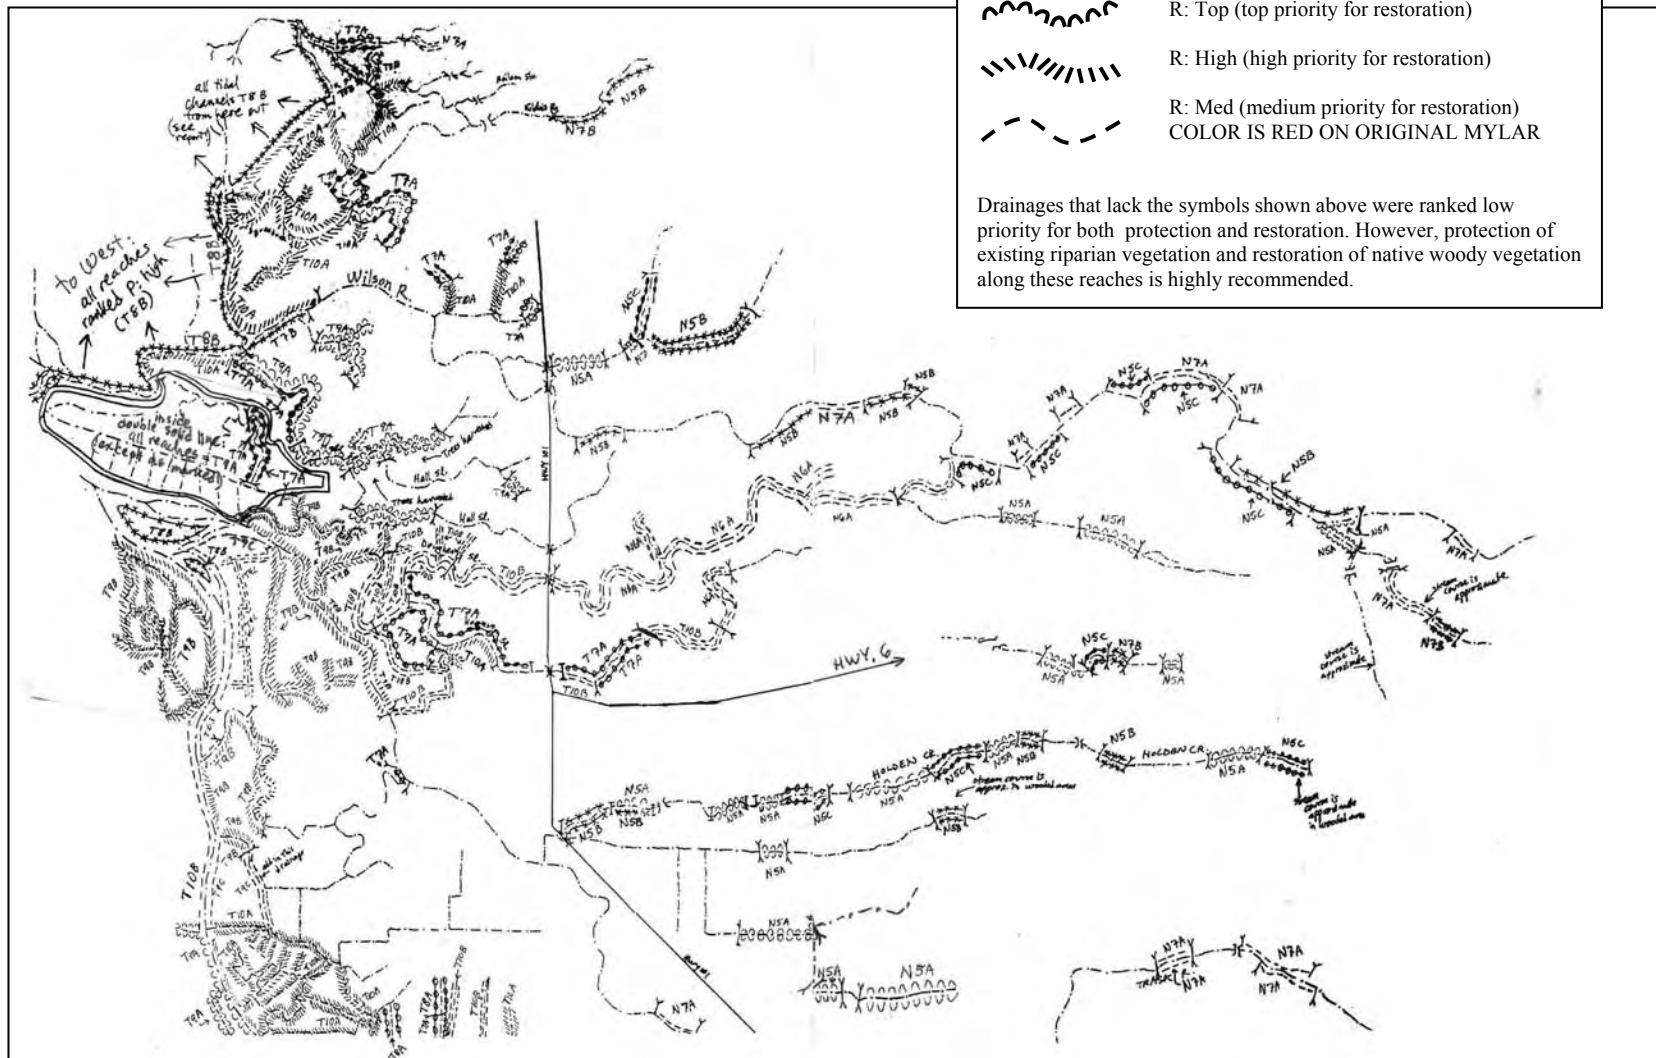
## Appendix 2. Mapping

Please note: The map provided here is intended only to provide an illustration of the type of mapping produced for this project. It is not intended for use outside the context of development of the IRMS. Original mapping was in color and consisted of mylar overlays over digital ortho-quarter-quad printouts. Anyone interested in using this map should contact Philip Williams Associates for access to the original mapping. Use magnifier (zoom) tool in Adobe Acrobat Reader to zoom in on map.

## Reach coding

Reaches in the "Istreams" and "Irivers" layer that were ranked low priority for both protection and restoration were not marked on the mylar. However, protection of existing
